**PEACE REGION – GRANDE PRAIRIE
GEOHAZARD RISK ASSESSMENT
SITE INSPECTION FORM**

SITE NUMBER GP-18	SITE NAME Sturgeon Creek	HIGHWAY & KM Hwy 49:12	PREVIOUS INSPECTION DATE May 18, 2010	INSPECTION DATE May 31, 2011
LEGAL DESCRIPTION LSD 13-35-70-22-W5M	NAD 83 COORDINATES N 6,107,120 E 483,726	PREVIOUS RISK ASSESSMENT PF: 2 CF: 1 TOTAL: 2 (after repair 2010) PF: 10 CF: 4 TOTAL: 40 (prior to 2010 repair)		
		CURRENT 2011 RISK ASSESSMENT PF: 2 CF: 1 TOTAL: 2

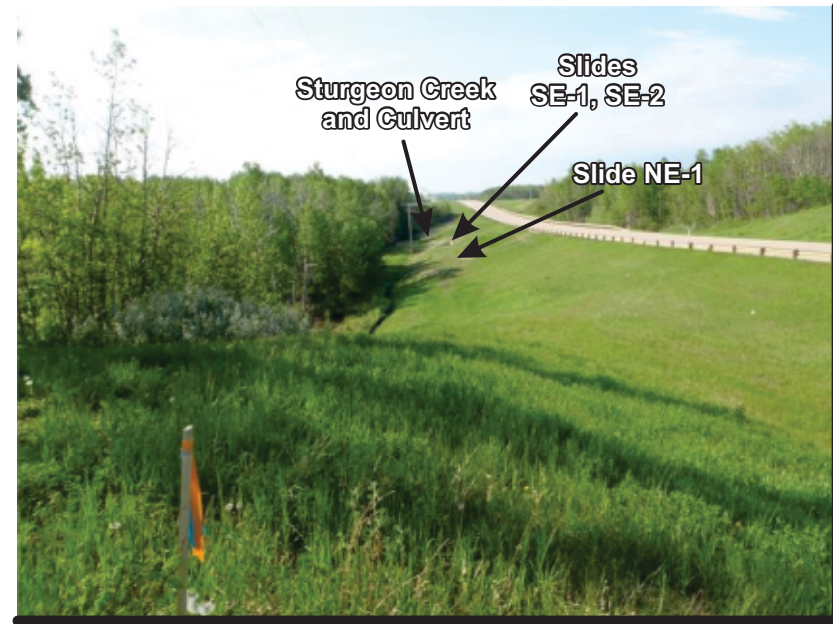
Photo 1

Looking south along east sideslope (downstream side of roadway)

- Repaired Slides NE-1 with sturgeon creek separating, SE-1 and SE-2 along east ditch – General view

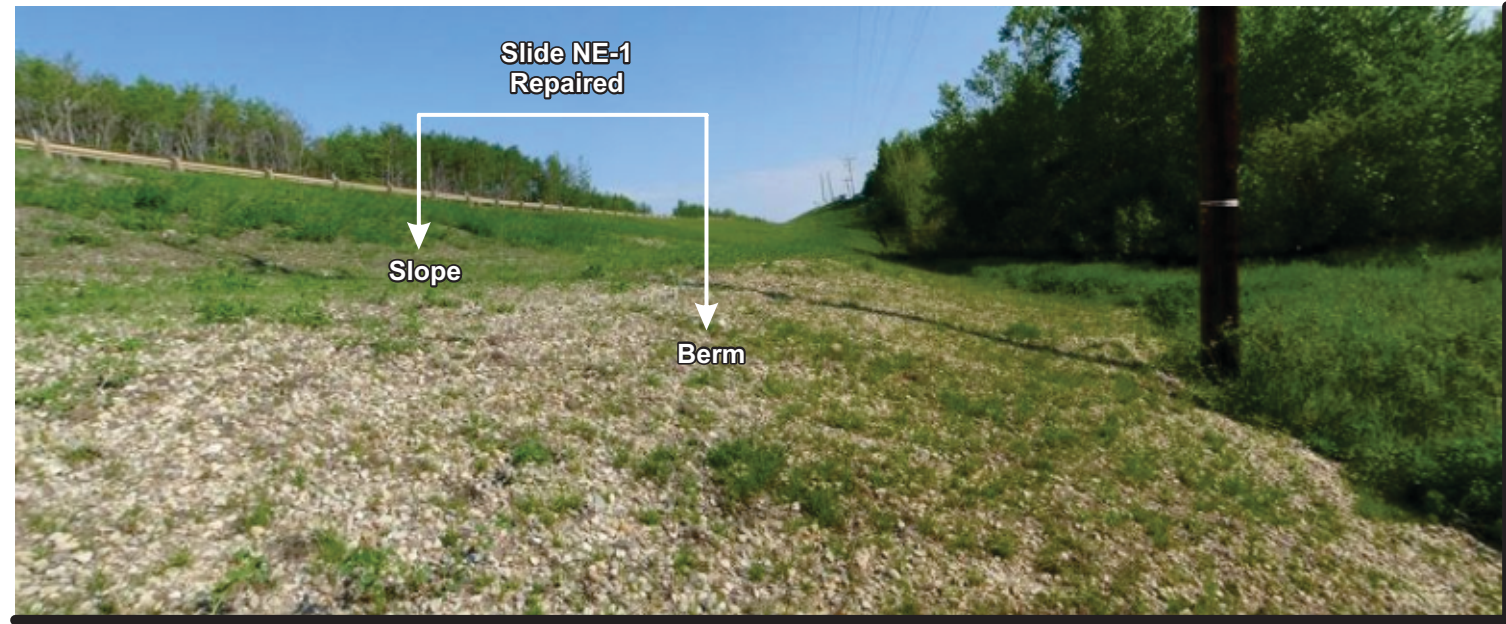
Photo 1a

Repaired slope NE-1 - Looking North from Sturgeon Creek Culvert

- Closed up view

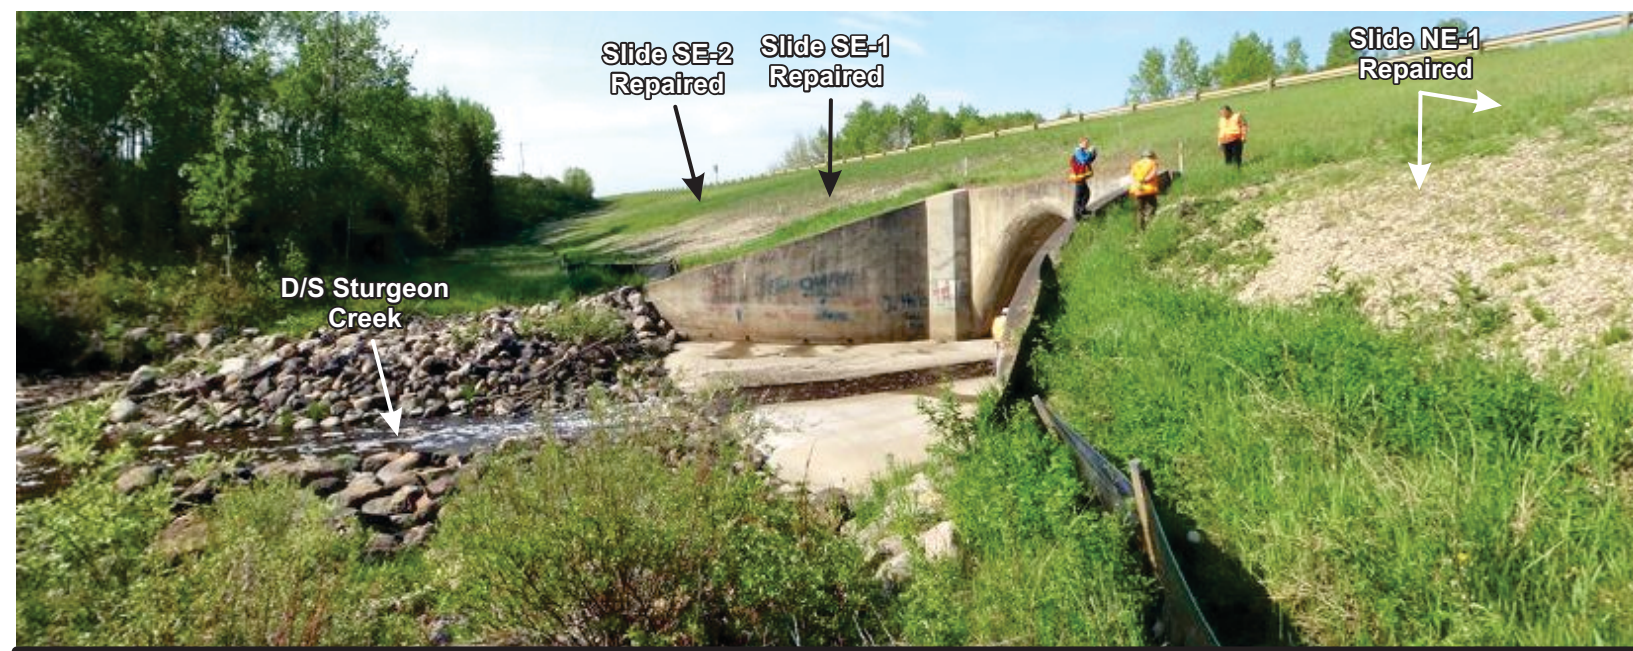
Photo 2

D/S of Sturgeon Creek - Looking South along East Ditch

- Repaired Slopes NE-1, SE-1 and SE-2 on both sides of d/s outlet

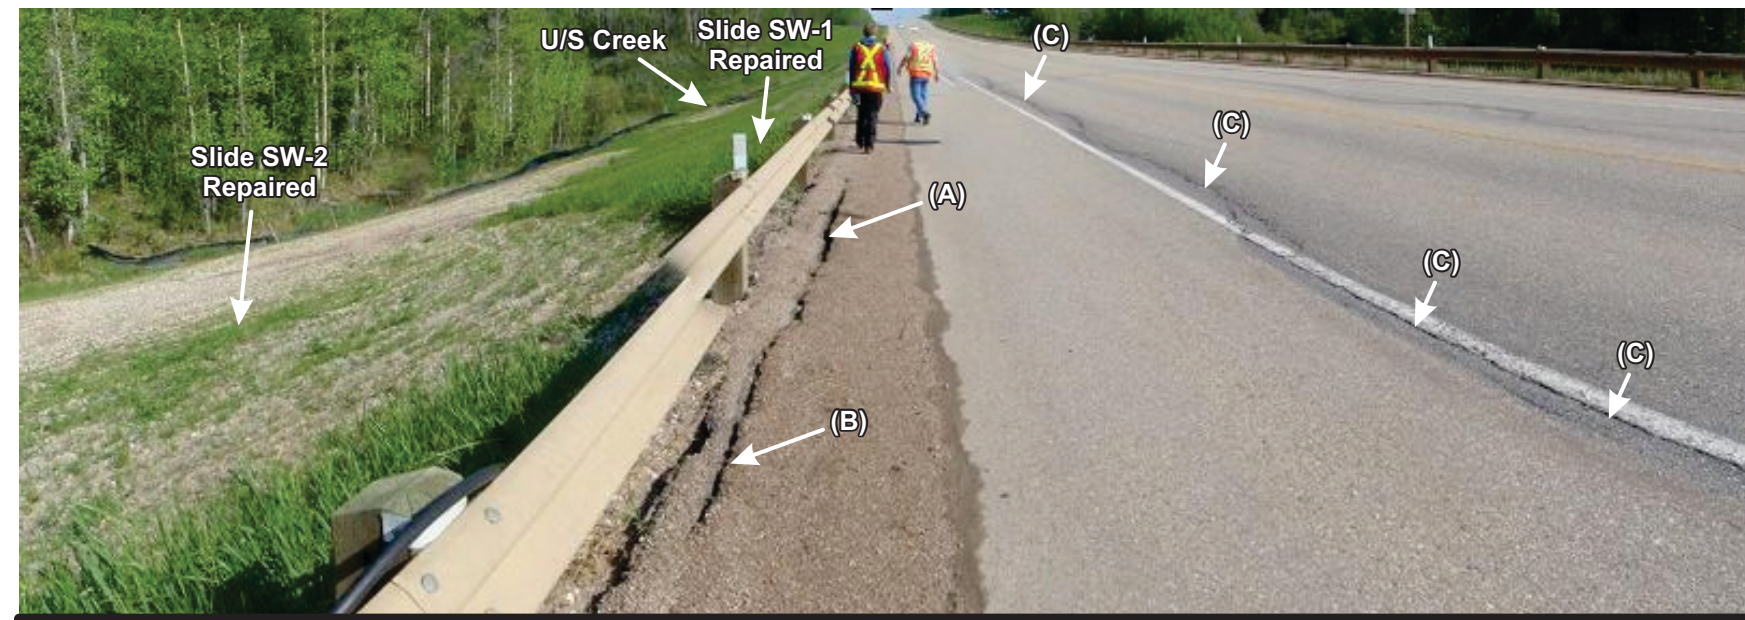
Photo 3

Looking north along west sideslope (upstream side) of approach fill embankment across Sturgeon Creek

- A series of 2 Repaired Slides (SW-1, SW-2) along west side
- At top of fill slope repair, a gap (A-B) has generated along guardrail edge at top of repaired fill slope. This gap can be caused from the loosening of new fills at head of new fill repair which was expeditiously constructed (in winter) without disturbance to roadway proper. This gap should be sealed off by crack sealant.
- Crackings (C) along pavement wheel paths can be due to pavement rutting cracks

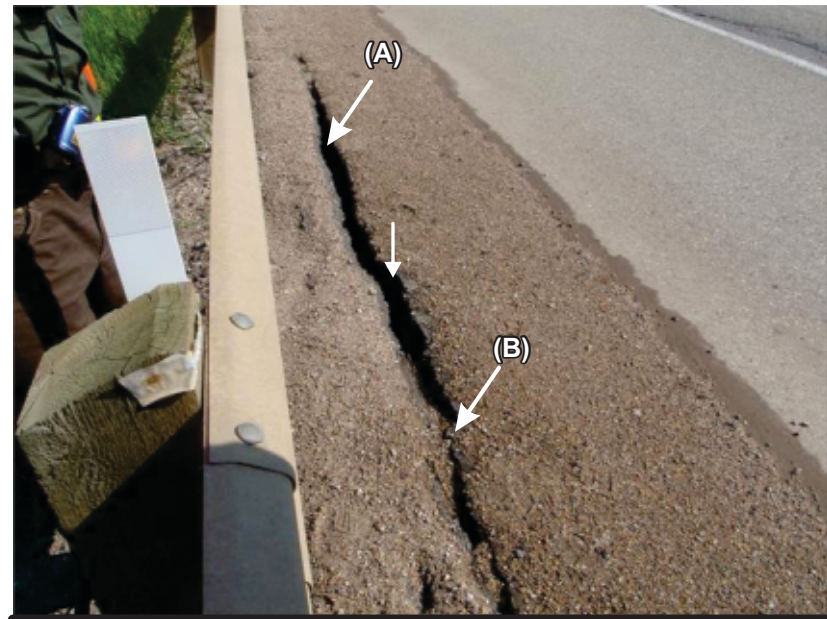
Photo 3a

Looking north along top of west sideslope (upstream side)

- Gap (A-B) at pavement shoulder at head of fill
- Closed up

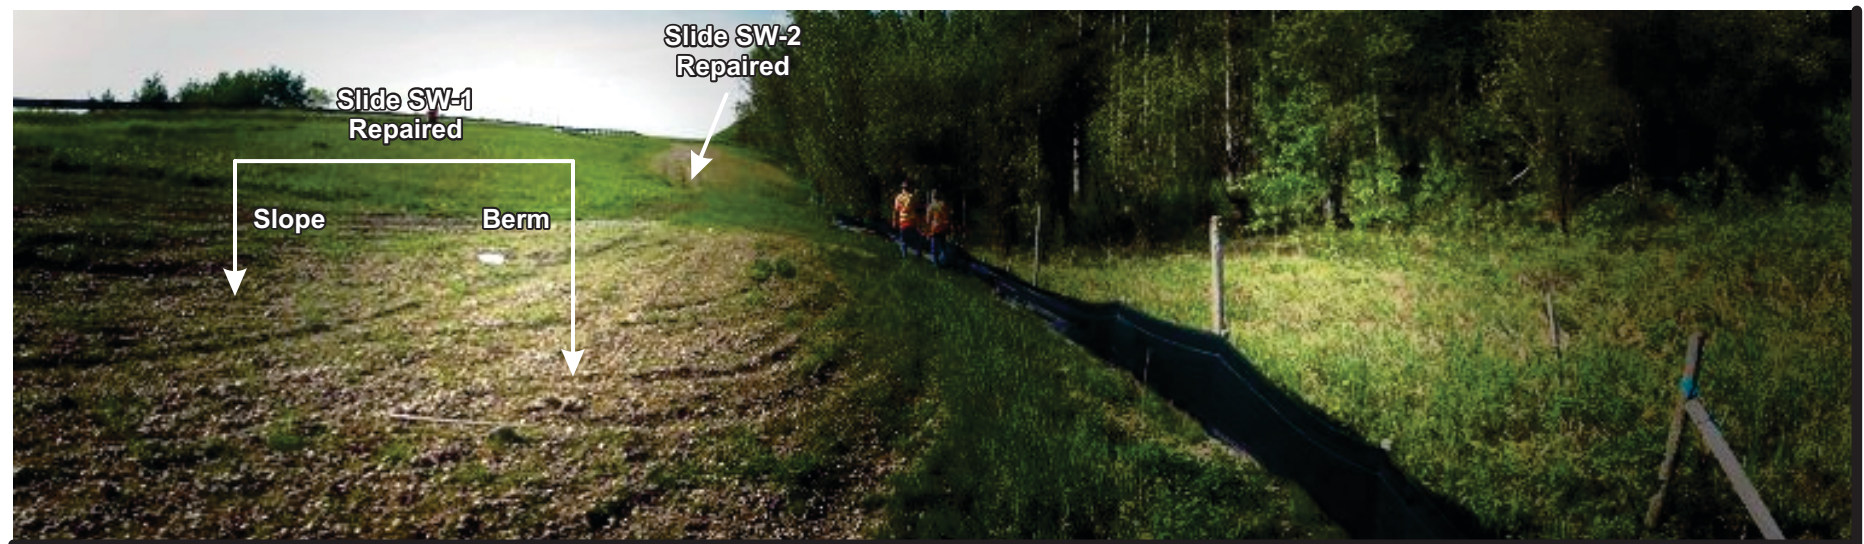
Photo 3b

Looking south (along toe of new fill) along west ditch

- Repaired (SW-1 and SW-2) Slopes

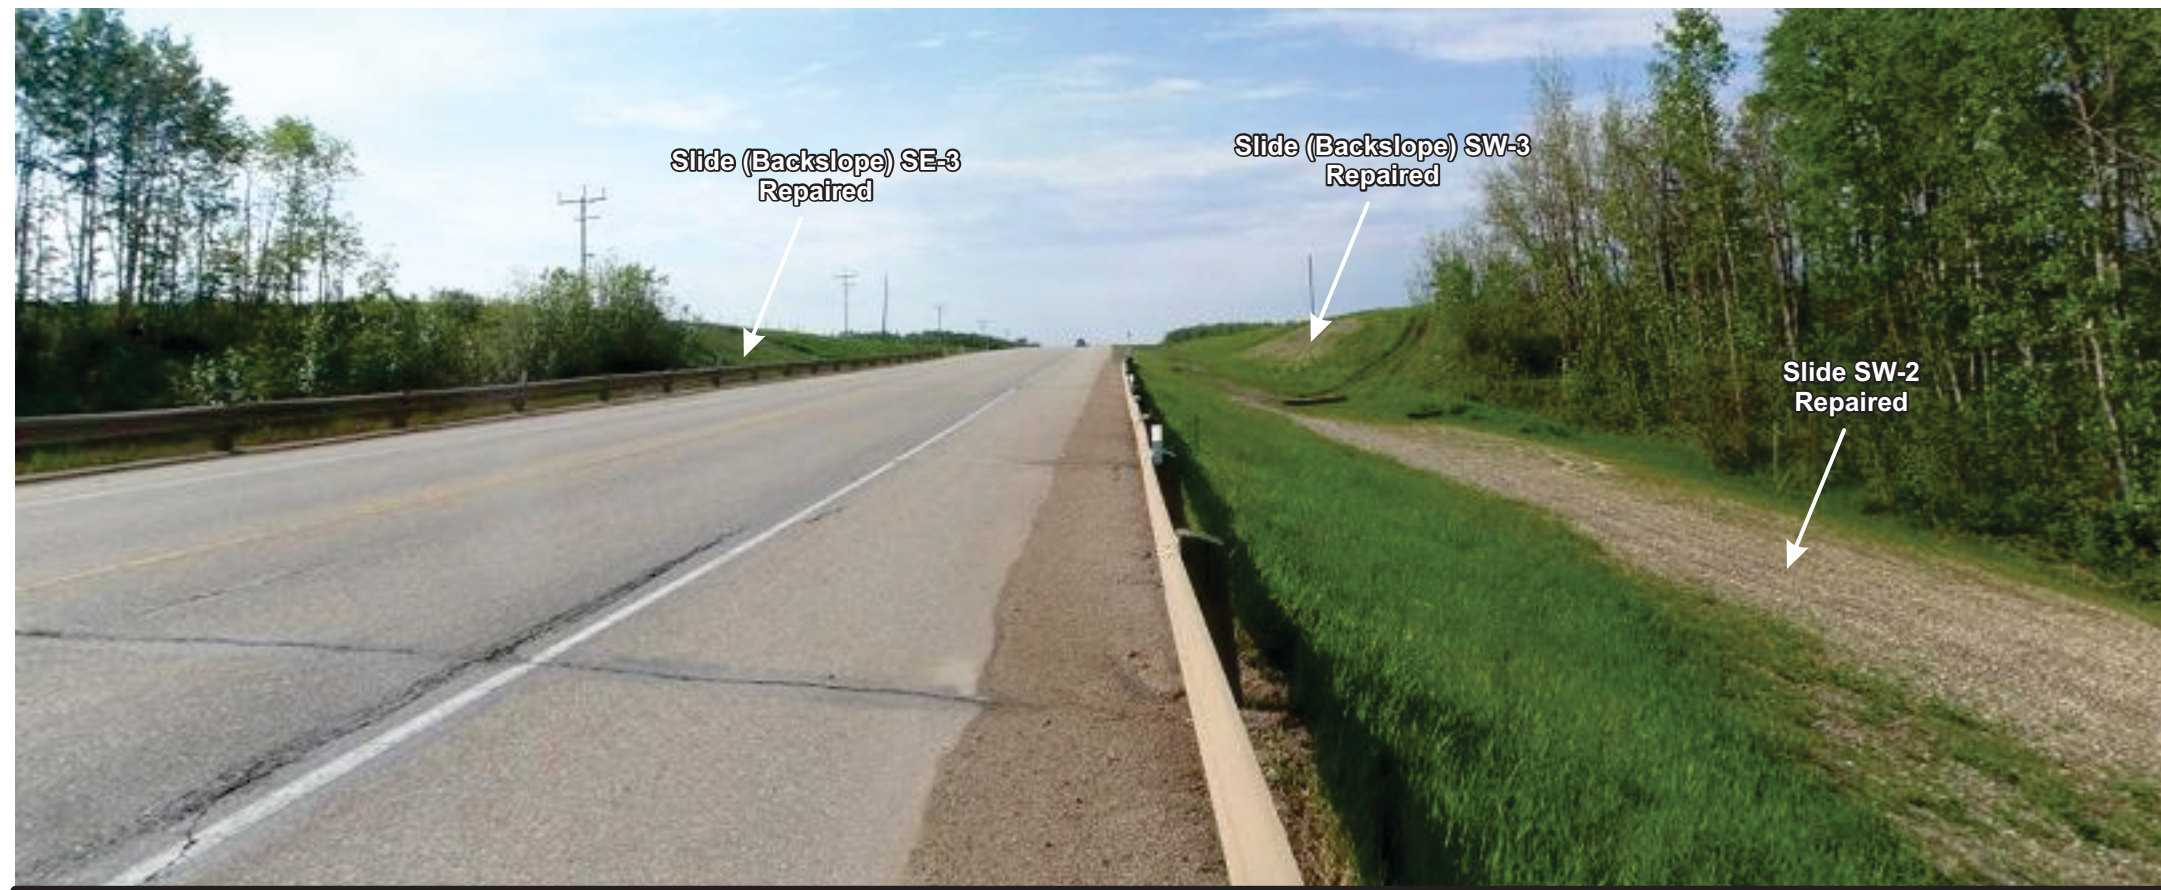
Photo 4

- Looking south along west ditch (upstream side of culvert) culvert inlet**
- Repaired (SW-3) Slide at backslope at upland verge at west ditch
 - Repaired (SE-3) Slide at backslope at upland verge at east (opposite) ditch
