Slide Name: (GP 13) SH 722:02 Red Willow Creek
Inspection Date: N/A
Inspection By: N/A

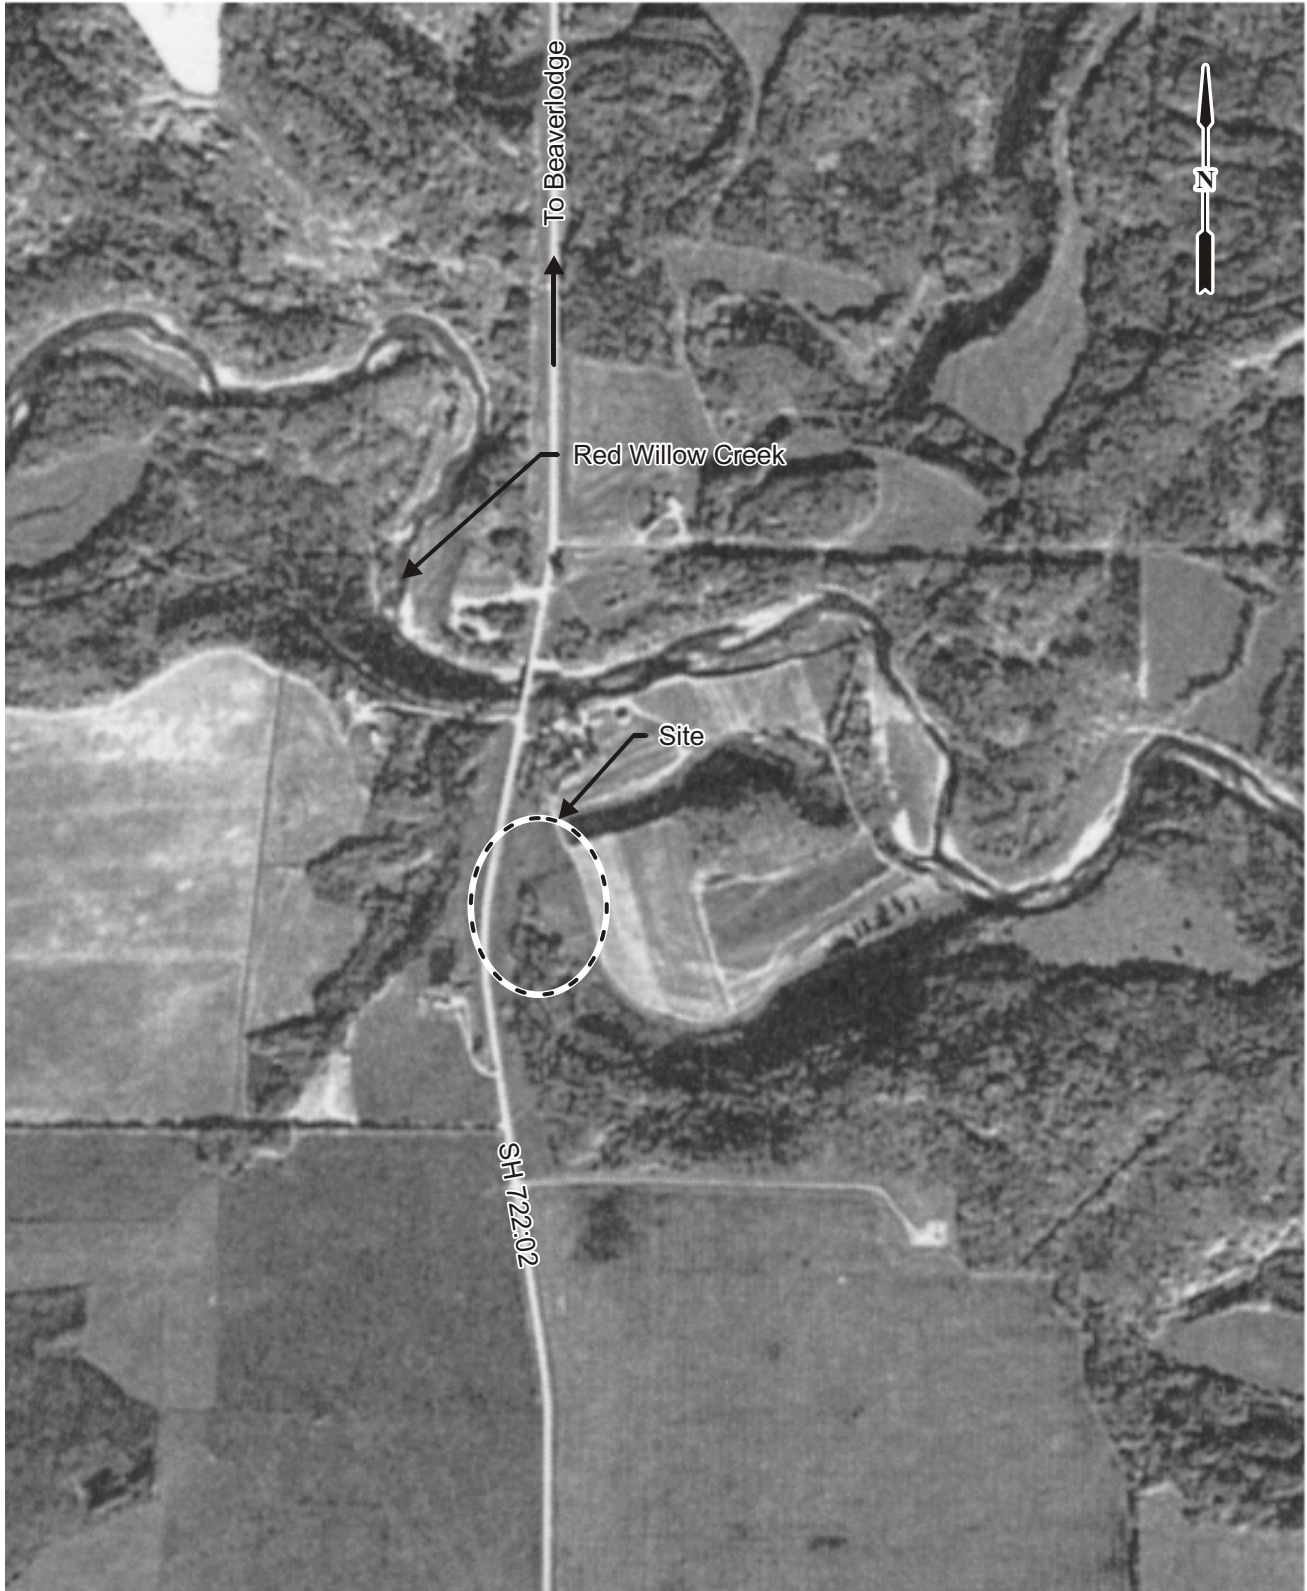
Figure 1
Site Plan

Based on 1995 Aerial Photograph
