Slide Name: (GP 32) SH 736 Little Puskwaskau River (BF 76515)
Inspection Date: May 3, 2005
Inspection by: Alberta Infrastructure & Transportation and EBA staff listed on Page 1

Figure 1
Plan of Slide at
Downstream Fill Slope

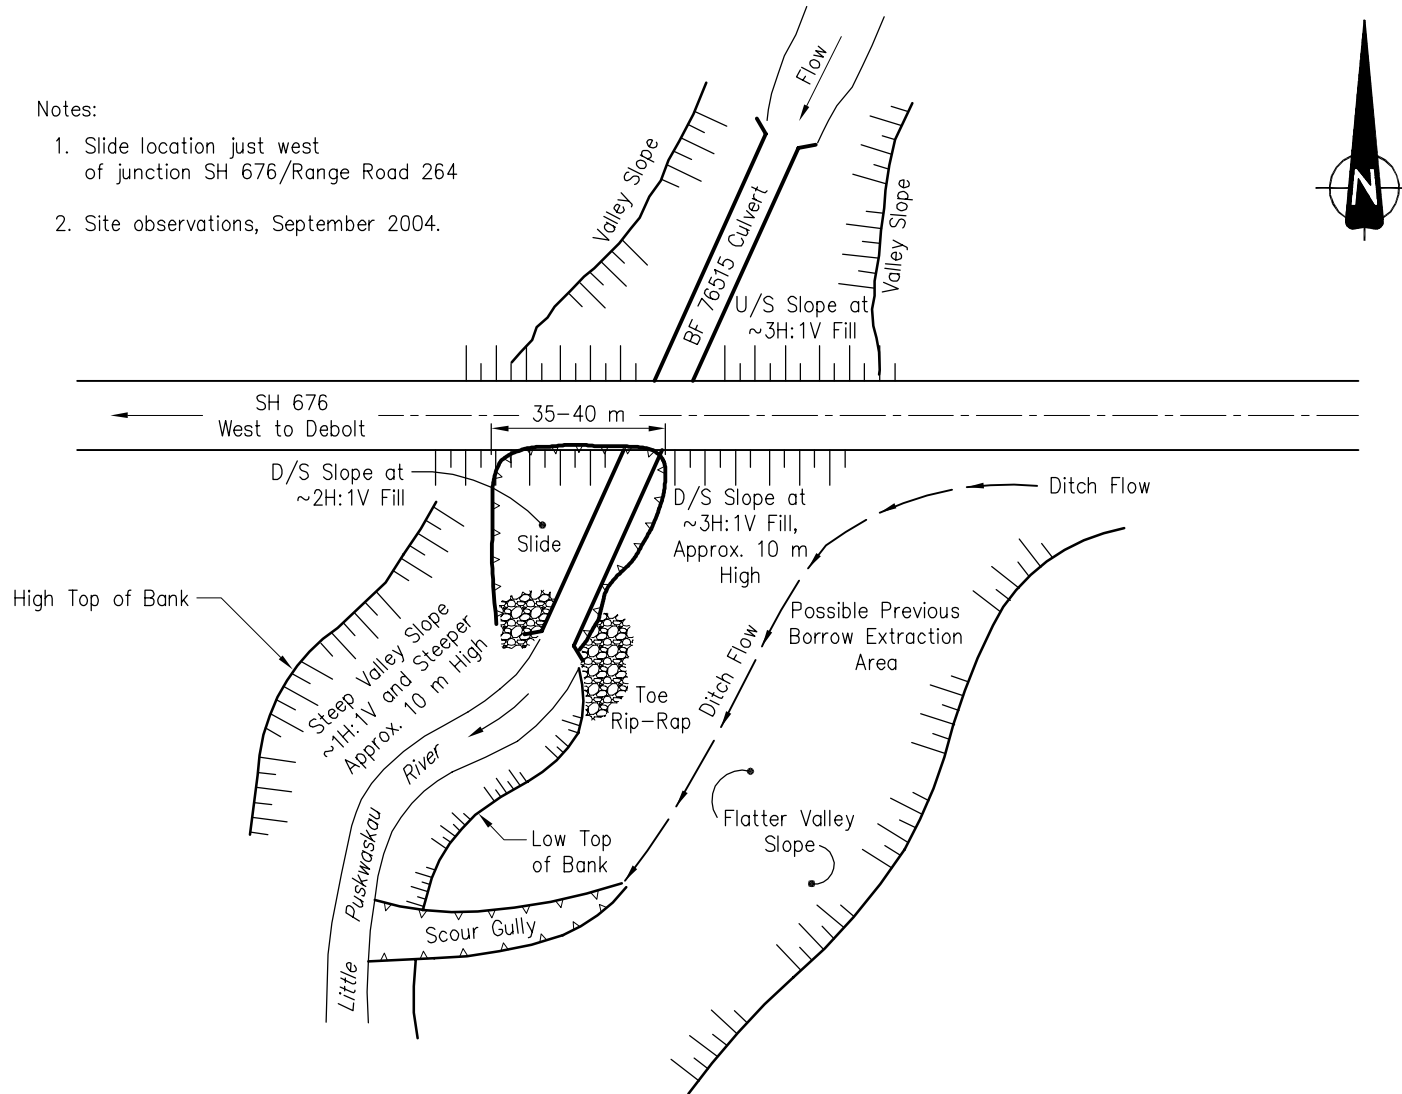
1. Slide location just west of junction SH 676/Range Road 264
2. Site observations, September 2004.

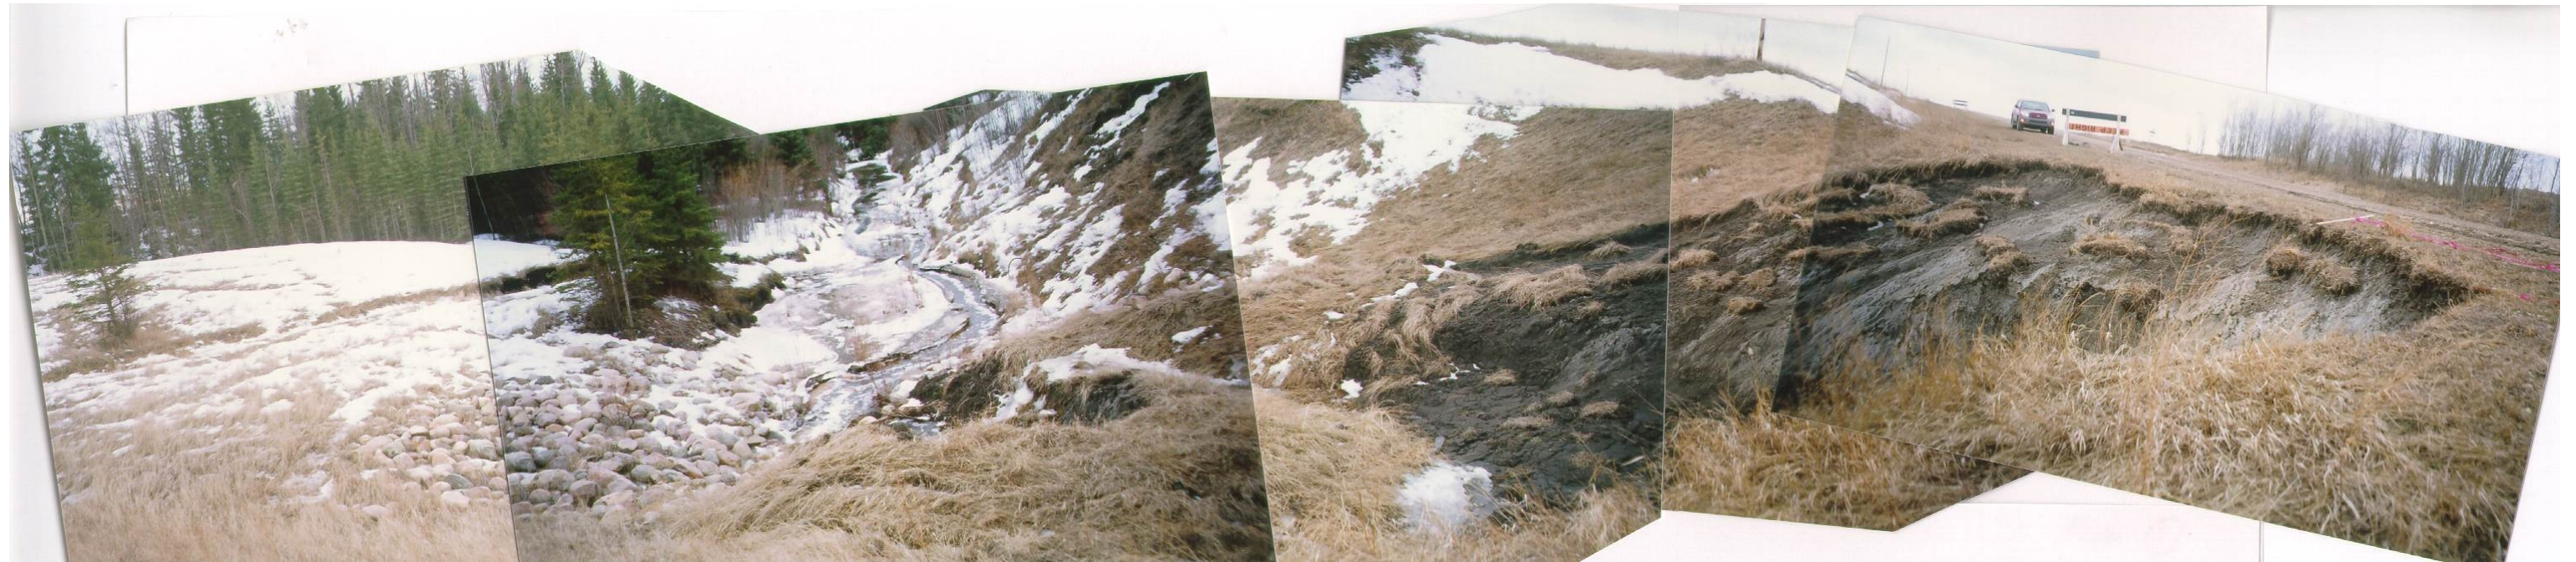
**Photo 1**

Looking west and downstream

- 1) Sideslope slide at west downstream face of 8 to 10 m high fill embankment
- 2) 4.3 m diameter SPCSP culvert (with 3.6 m inner lining) on a skew to roadway

- 3) West side of downstream slope (failed) slightly steeper (~2H:1V); east side of downstream slope at gentler (~3H:1V) slope (not failed)
- 4) Culvert was apparently not extended on downstream side; culvert was extended longer at upstream side (fill at 3H:1V to 4H:1V)

- 5a) Culvert outlet seemed to flow and scour onto west rip rap apron (prior to failure)
- 5b) Internal erosion of fill (from seepage and leakage from culvert joints) may have weakened toe area of this steep downstream fill slope

- 5c) Both upstream and downstream fill slopes failed (1996) due to flood event. Fill slopes were reconstructed with (3H:1V to 4H:1V) upstream fill (culvert extension at upstream end) and with a steep (2H:1V at west corner) downstream fill slope unchanged (no extension at downstream end)

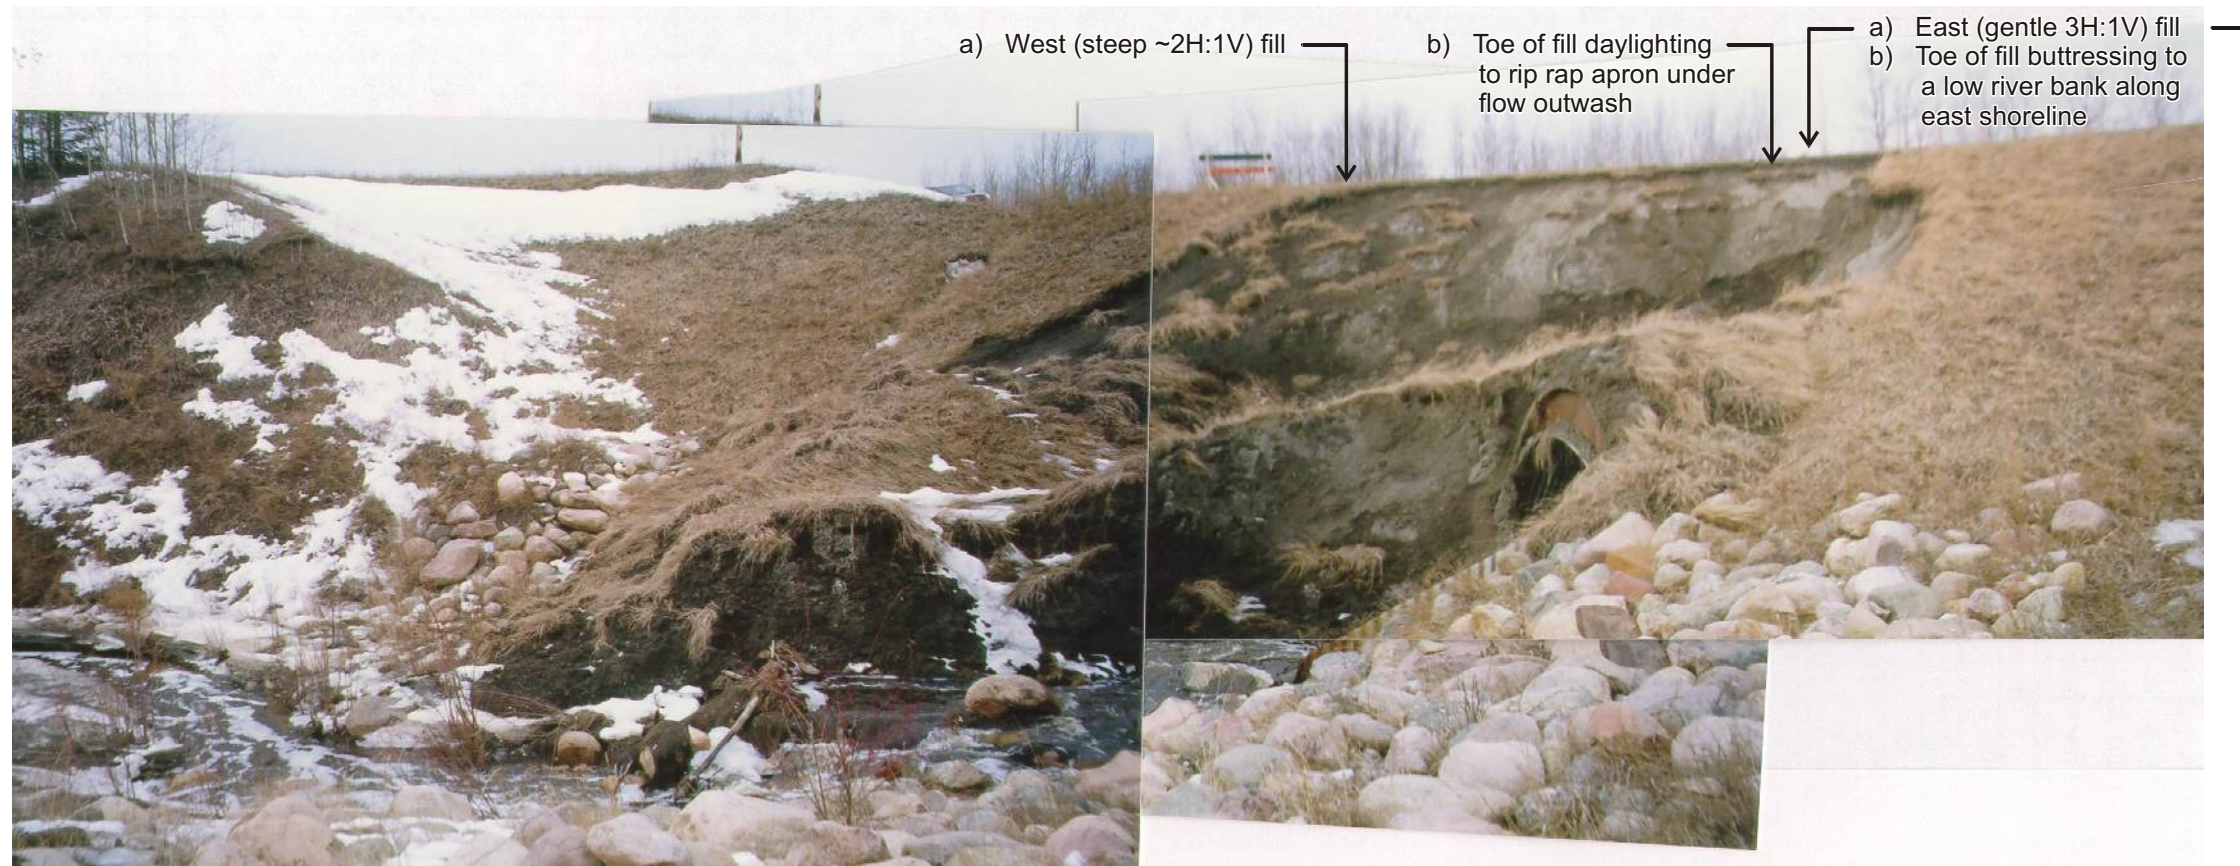
**Photo 2**

Looking west

- 1) Culvert outflowed and scoured on west downstream rip rap apron
- 2) Culvert aligned on a skew to outflow over toe of steep fill corner of west half fill
- 3) Steepness of fill is apparent at the west corner
- 4a) Culvert apparently too short and was cosmetically extended at outlet with bevel triangular plates to allow rip rap placement
- 4b) Inward deflections (1200 mm on east-failure side; 300 mm on west side) of outlet bevel observed by AT in 2003 - 2004
- 5) Toe scour fill can be partial cause of slope failure; other causes include steep slope design, fill construction and internal erosion of fill

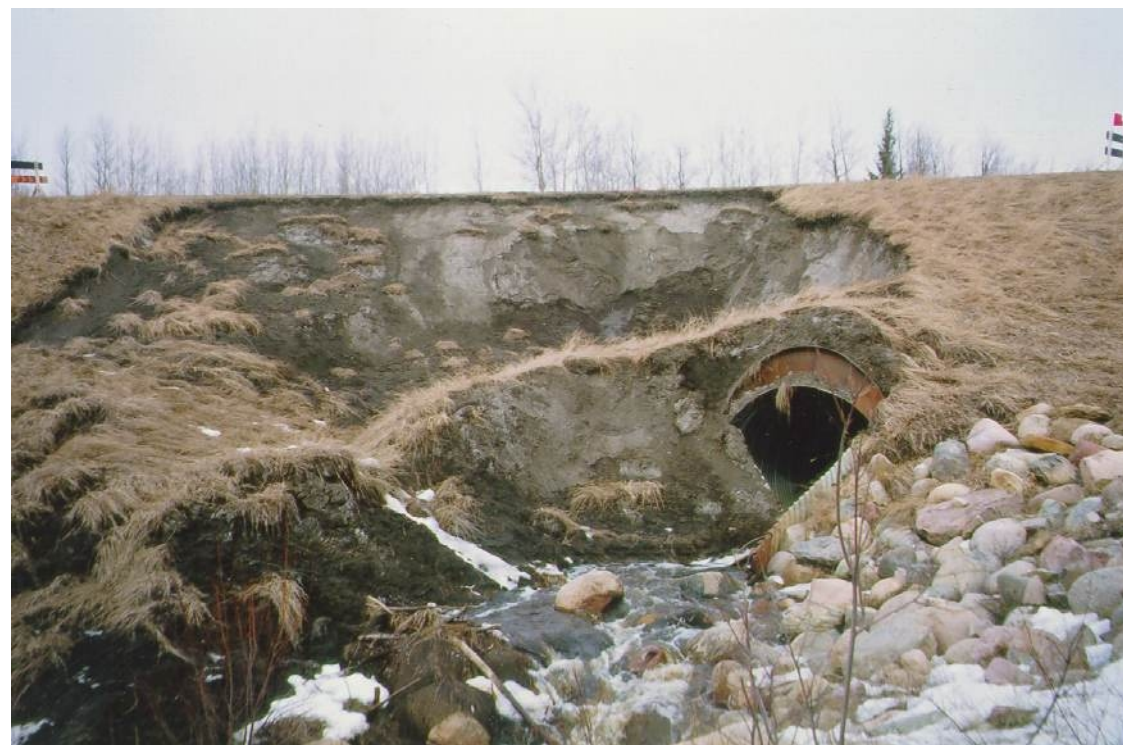
**Photo 3**

Looking north

- 1) Another view of outlet and toe scour
- 2) Slide debris covered over rip rap apron (east and downstream portion)

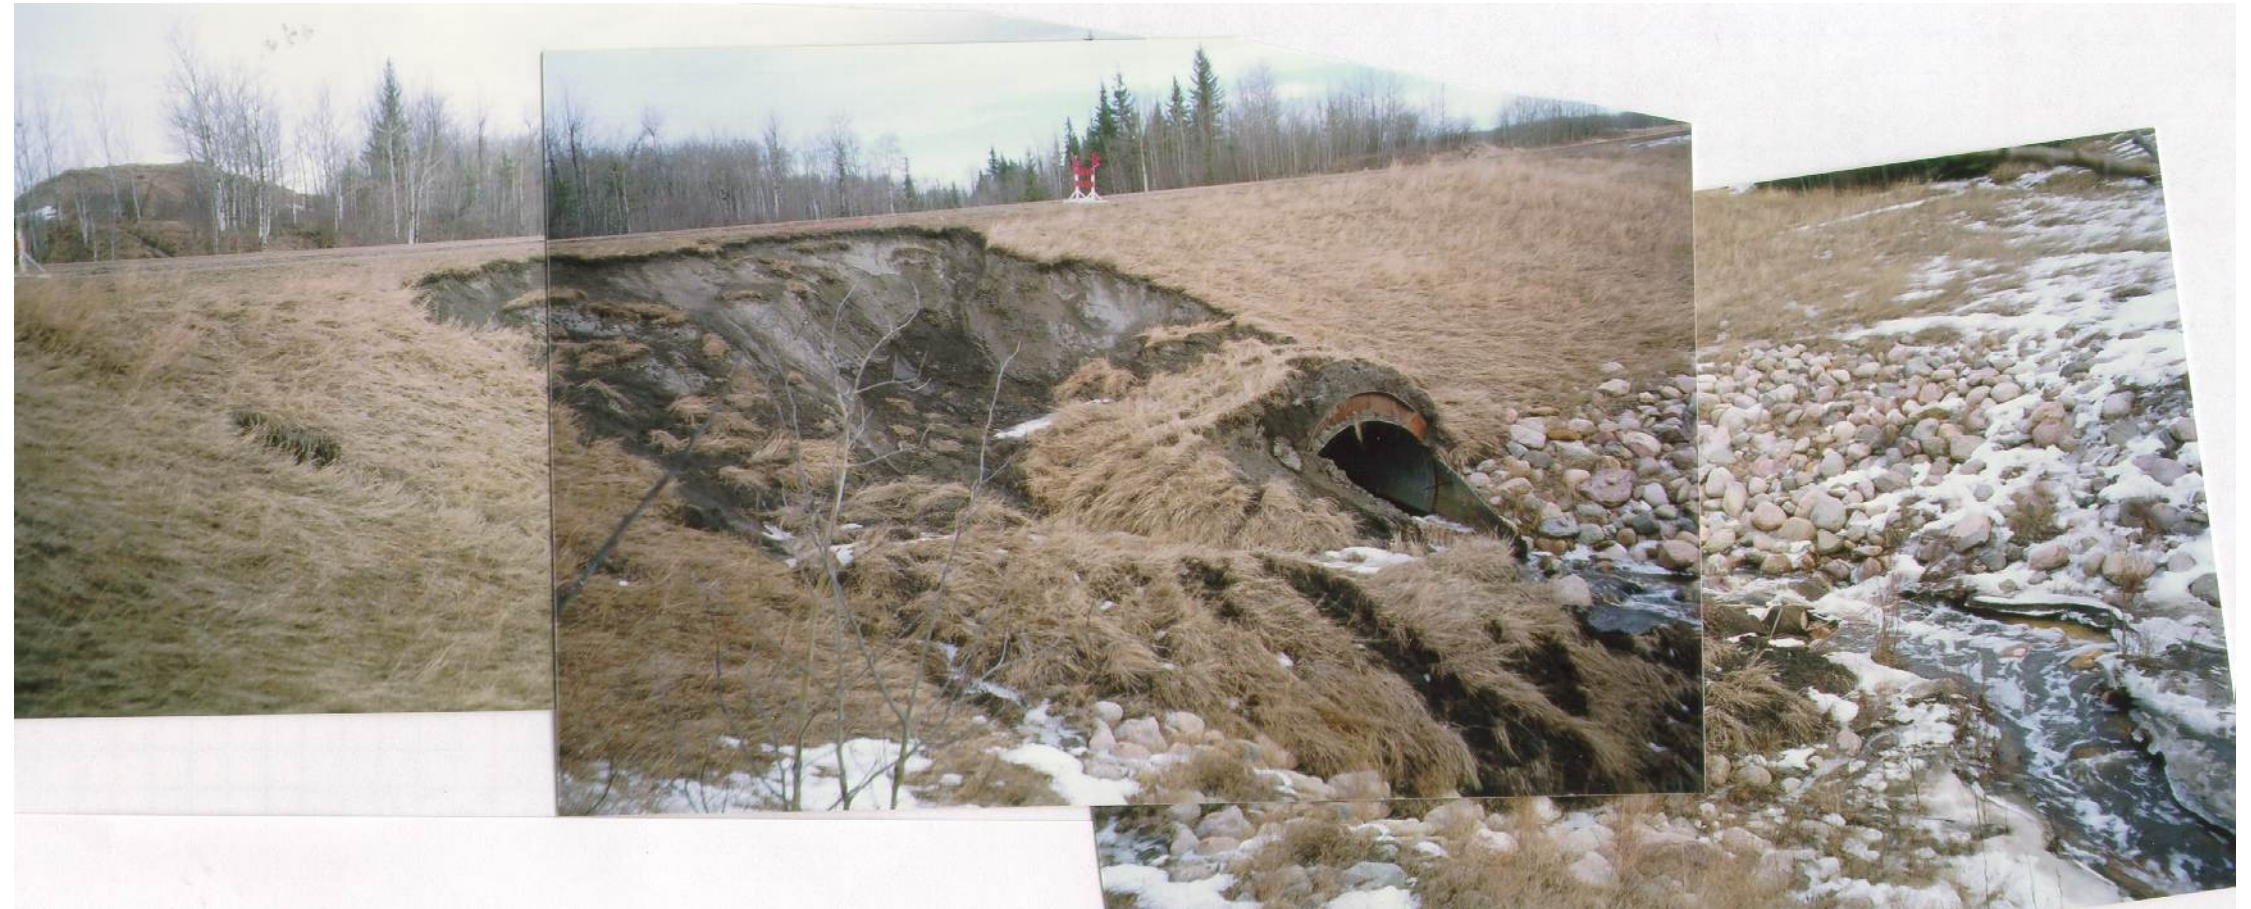
Photo 4

Looking east

- 1) Another view of slide movement and headscarp of fill

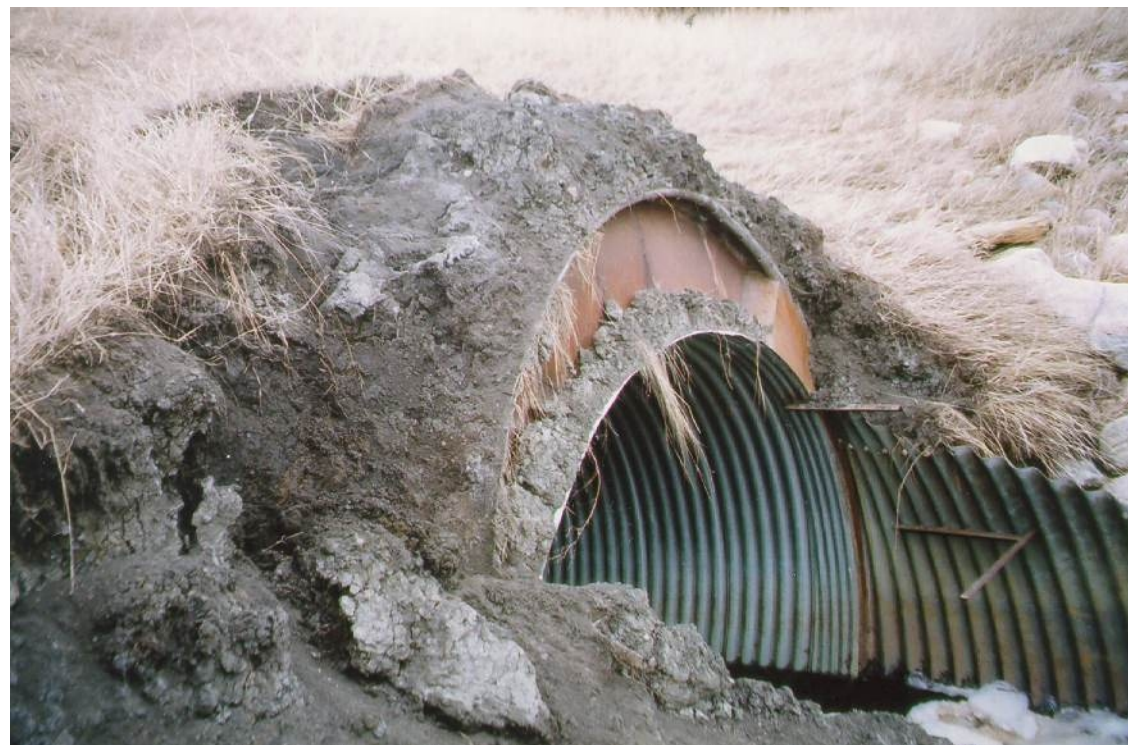
Photo 5

Looking east

- 1) Nominal bevel (1/2) extension of culvert installed for fitting in rip rap apron
- 2) Near side of culvert bevel (slide side) failed under slide movement

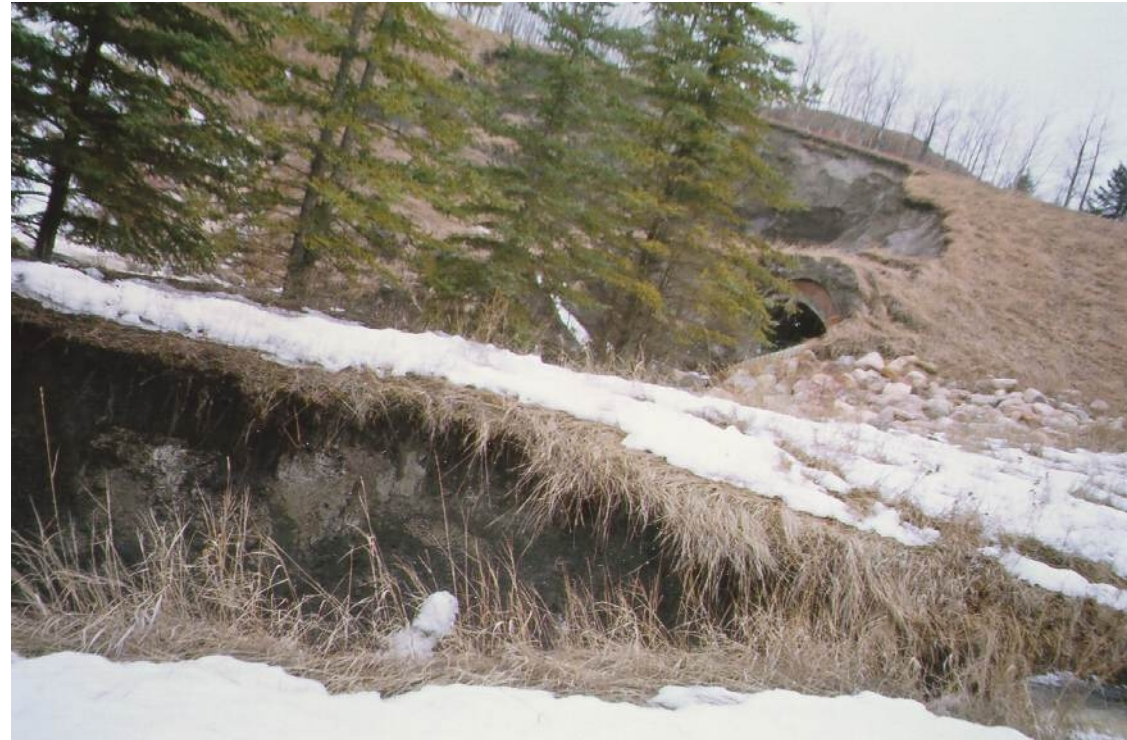
**Photo 6**

Looking at slide from east bank gentle bench

- 1) An erosion gully formed from ditch (south side of highway) outfall

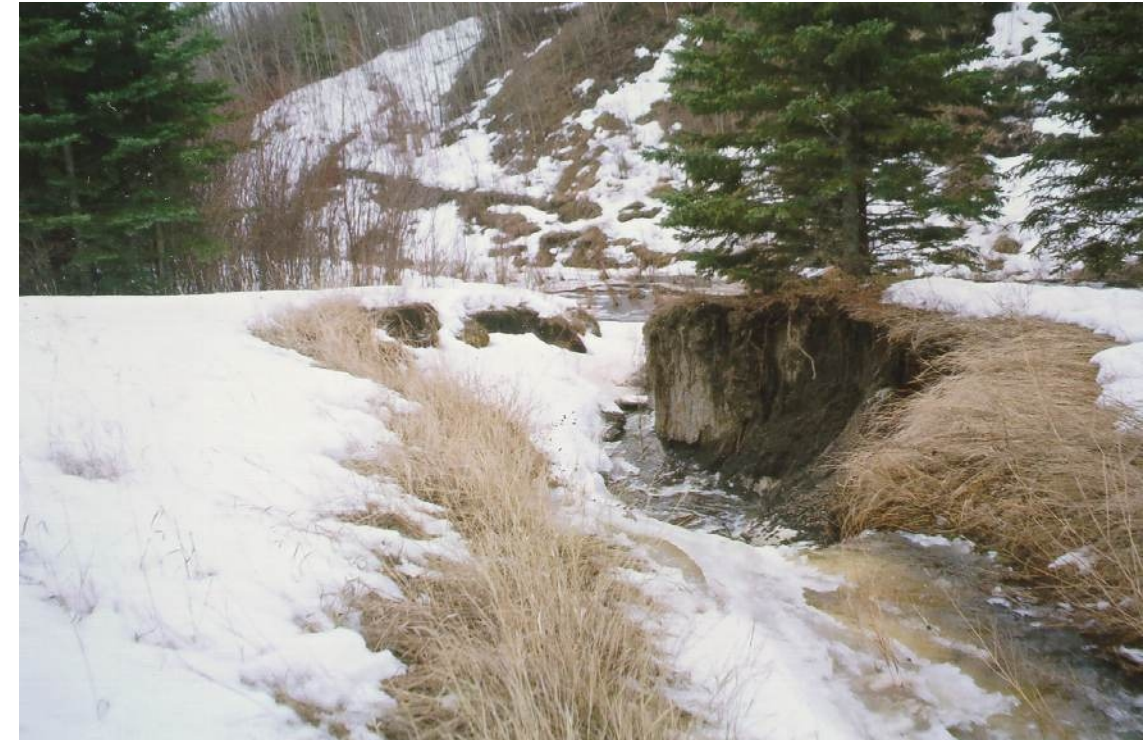
**Photo 7**

Looking downstream along eroded gully

- 1) Steep gully (2 m deep and 3 m wide) along east side of river bank (gentle bench) and was caused by erosion from ditch outfall towards river
- 2) The highway south ditch flows down the shoulder of fill and valley slope
