**ALBERTA TRANSPORTATION
GEOHAZARD ASSESSMENT PROGRAM
PEACE REGION – GRANDE PRAIRIE DISTRICT
2018 INSPECTION**

Site Number	Location	Name	Hwy	km
GP09	East of Grande Cache	Muskeg River Bank Protection	40:32	47.5
Legal Description		UTM Co-ordinates (NAD 83)		
S1/2-15—57-5-W6		11U N 5,976,192	E 391,234

**PEACE REGION (GRANDE PRAIRIE) 2018
GP09-1**

2018 INSPECTION PLAN

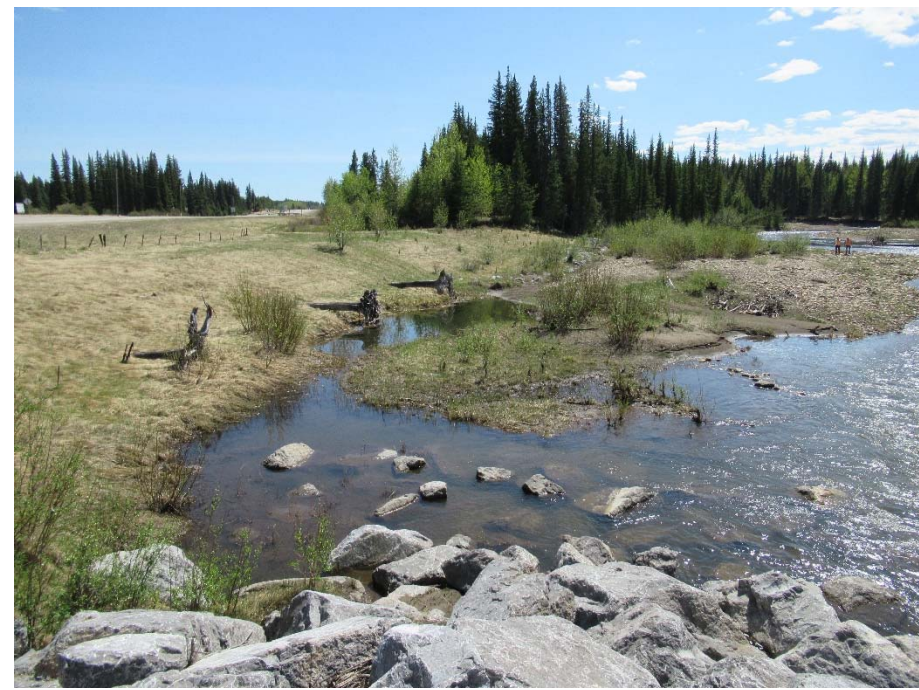
Photo 1.
Looking east from the
Class 3+ rock riprap
spur at the root wads
protruding
from the
embankment.

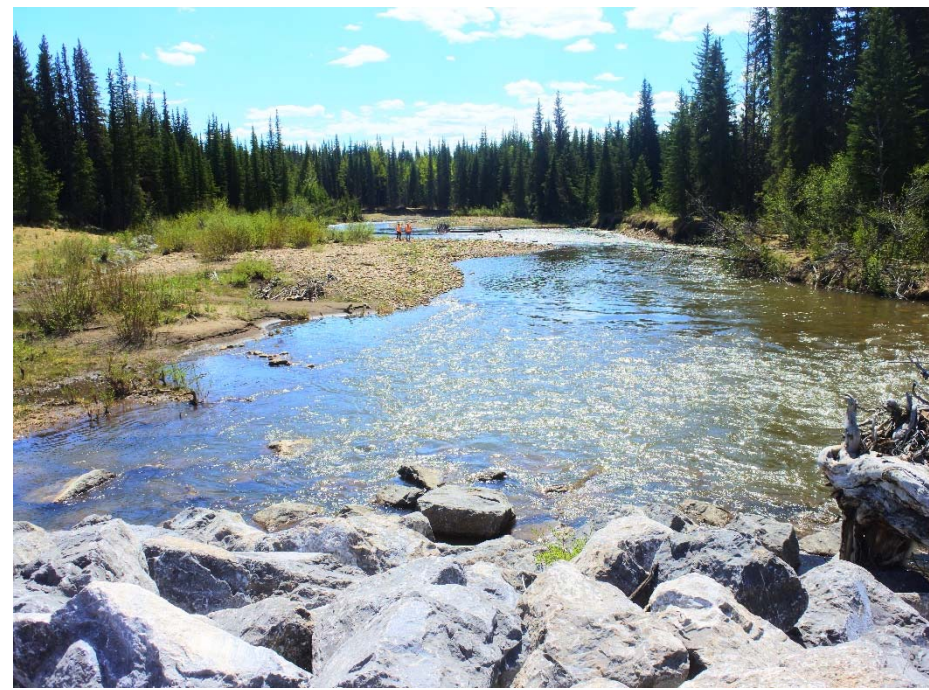
Photo 2.
Looking southeast
(upstream) along the
river from the rock
spur.

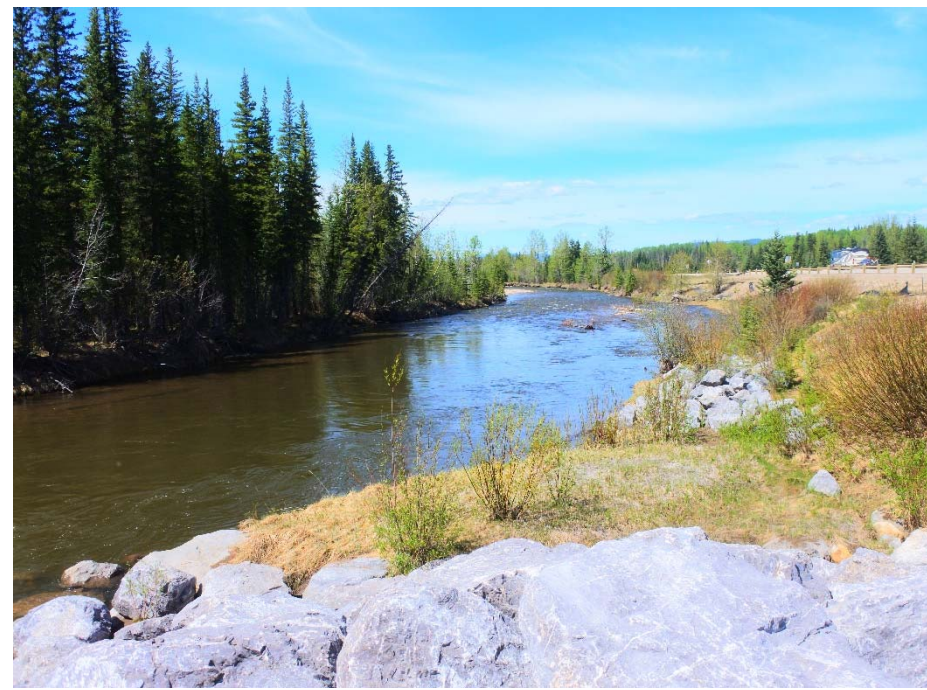
Photo 3.
Looking northwest
(downstream) along
the river from the
rock spur.

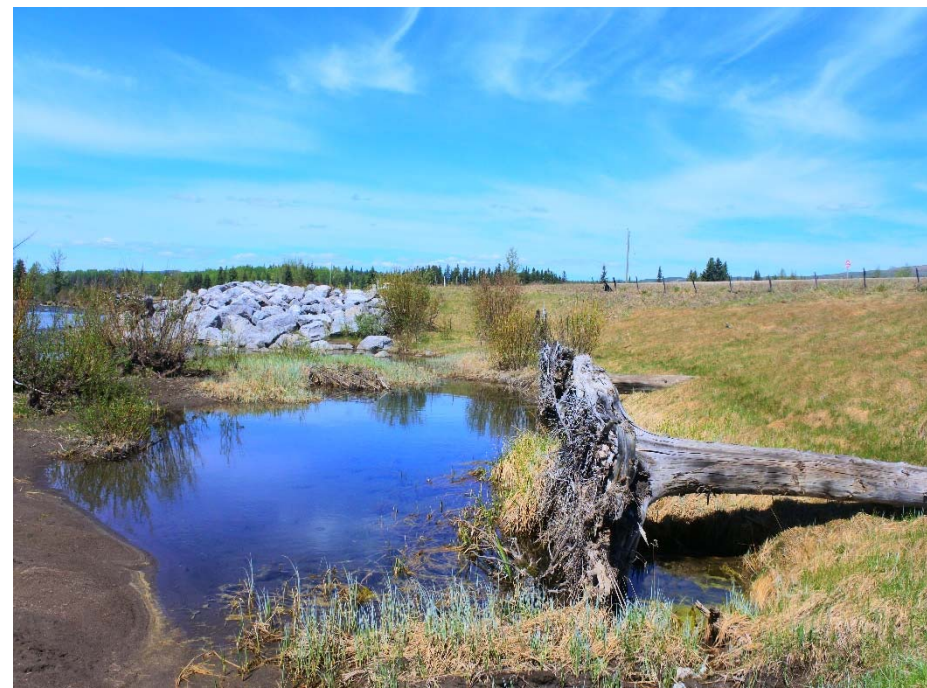
Photo 4.
Looking west at the
rock spur. A root wad
is in the picture
foreground.

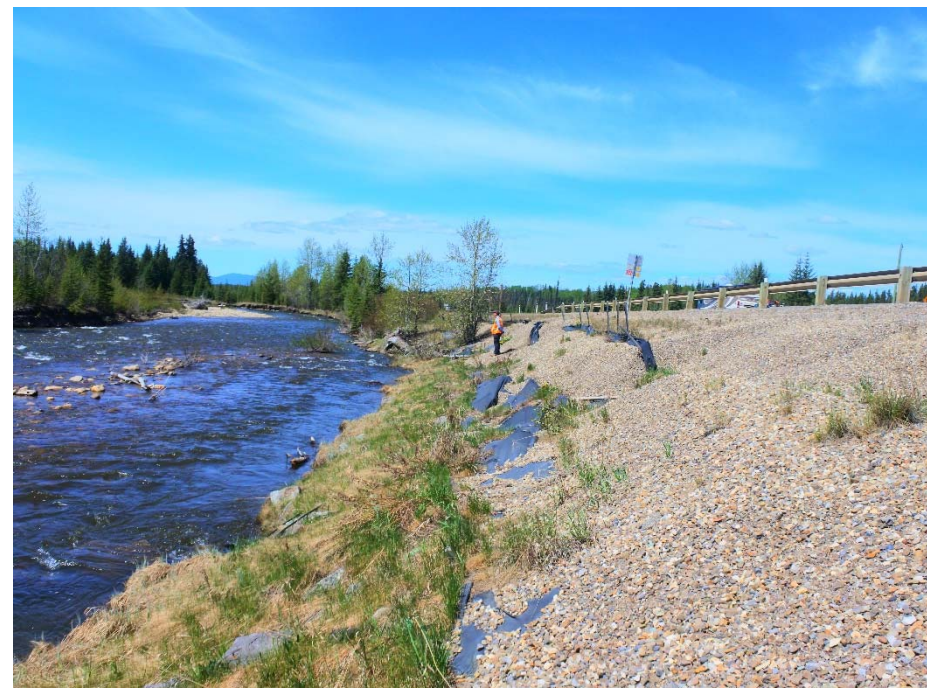
In 2003, the implemented remediation methods described above (and detailed on the attached drawing 21211-P) appear to have controlled the erosion to date for the most part at this location. There is still some surface erosion due to highway runoff that is affecting the embankment consisting of crushed gravel over woven geotextile. There is about a 10.7 m distance from the guardrail to the waters edge at the narrowest point. The channel diversion techniques have transferred the riverbank toe erosion further downstream. There is an approximate 130 m length of active toe erosion beginning about 50 m downstream of the previously affected toe erosion area. The highway is further from the edge of the river at this location (measured at about 21.4 m from the shoulder to the top of the 1.2 m high eroded bank), therefore a buffer exists before it intrudes into the highway clear zone.

Photo 5.
Looking west along the toe of the embankment. Note the grass covered riprap and the gully in the crushed gravel embankment that is overtop woven geotextile.

Additional gravel replenishment may be required on the crushed gravel surface overlying woven geotextile that is being affected by surface erosion.

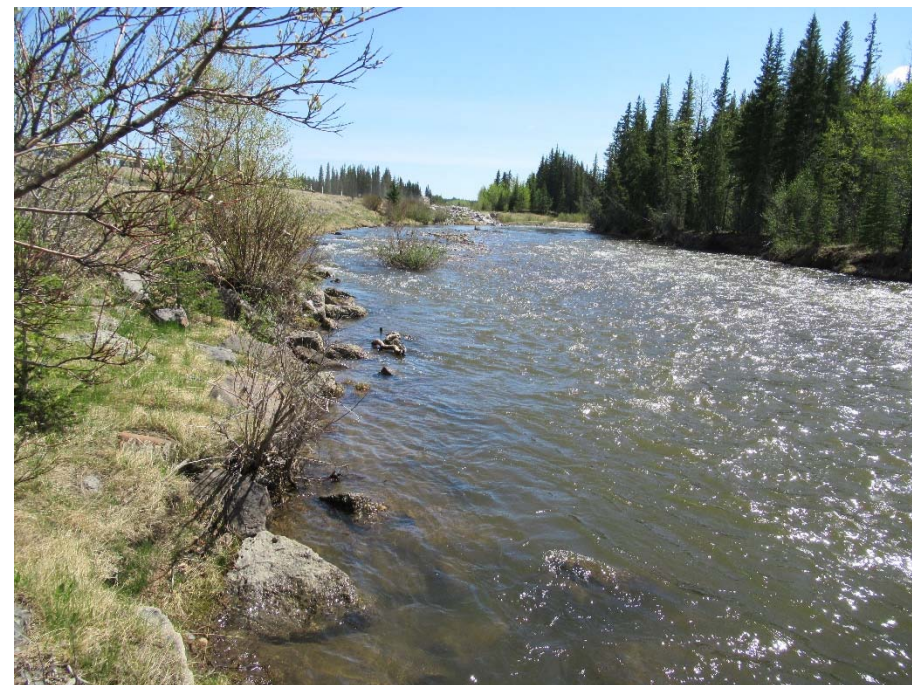
Photo 6.
Looking east along the toe of the south highway. No significant toe erosion here.

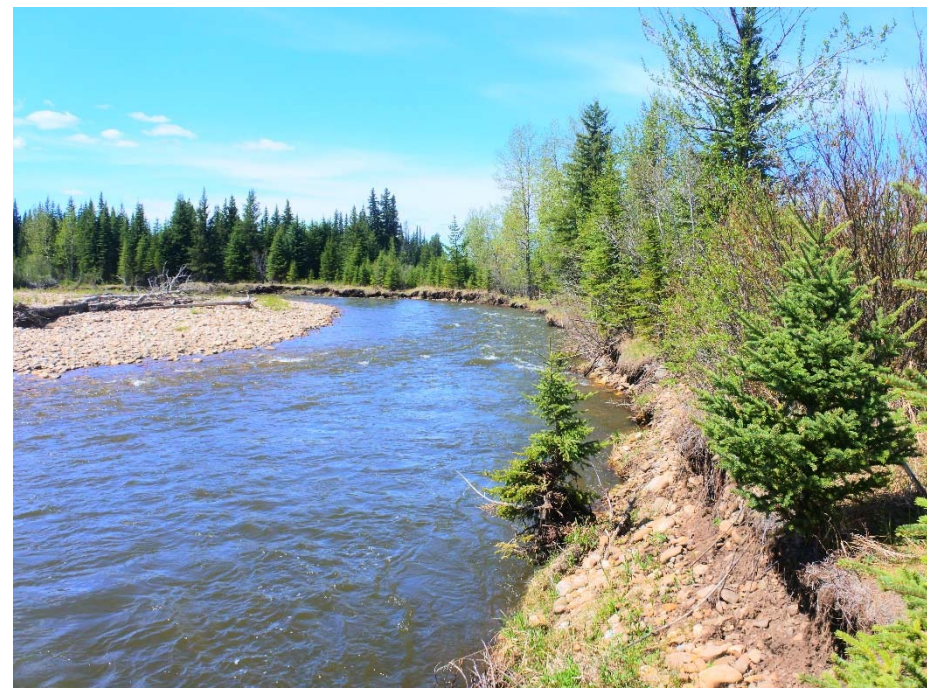
Photo 7.
Looking west along
the river bank at
active toe erosion.

Continue monitoring the effects of the previously mitigated area for performance information, as well as the new active erosion developing further downstream. Monitoring points (consisting of semi permanent hubs/lathe or steel pins) should be installed so that lateral erosion in proximity to the highway shoulder can be tracked. Due to the favorable performance, and since the active erosion is still quite far from the highway, it is suggested that inspection for this site be relaxed to once every 2 years unless a flow event occurs.

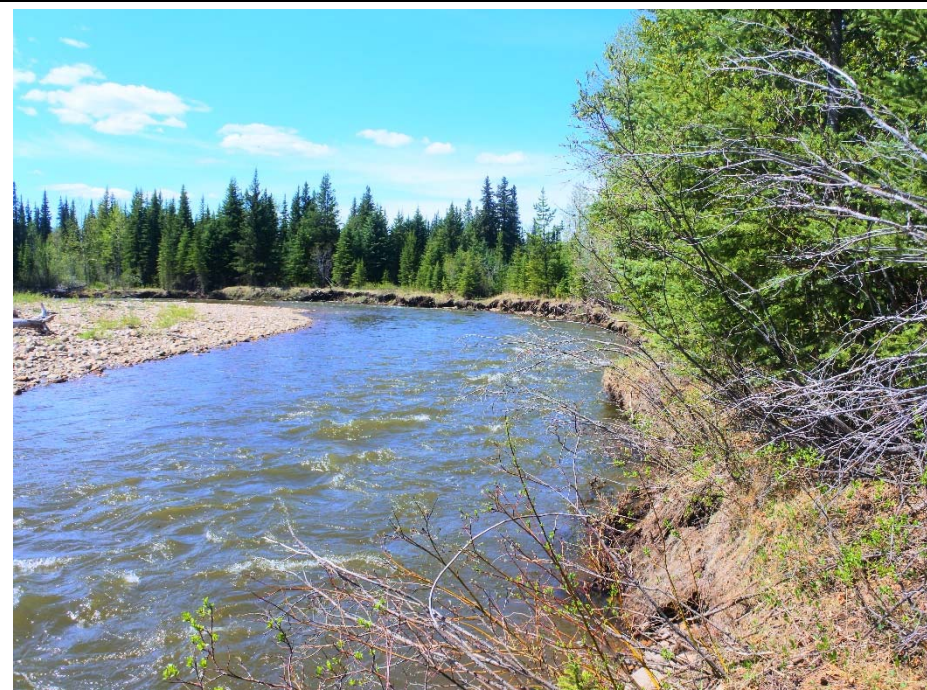
Photo 8.
Looking west along
the edge of the river.
Note the continued
erosion of the outside
bank.
