SITE INSPECTION FORM

SITE NUMBER AND NAME: GP009 Lone Teepee Creek Erosion		HIGHWAY & KM: 40:32, 47.476	PREVIOUS INSPECTION DATE: May 22, 2018	INSPECTION DATE: June 13, 2022
LEGAL DESCRIPTION: SE 15-57-05-W6M	NAD 83 COORDINATES: UTM Northing Easting 11 5976167 391261		RISK ASSESSMENT: PF: 7 CF: 2 TOTAL: 14	
AVERAGE ANNUAL DAILY TRAFFIC (AADT): 1090 (west) & 990 (east) (Reference No. 27580, 2021)			CONTRACT MAINTENANCE AREA (CMA): 504

PROJECT
 PEACE REGION (GRANDE PRAIRIE DISTRICT-SOUTH)
 GEOHAZARD RISK MANAGEMENT PROGRAM

TITLE
 Site Plan
 GP009 - Lone Teepee Creek Erosion
 Hwy 40:32, km 47.476

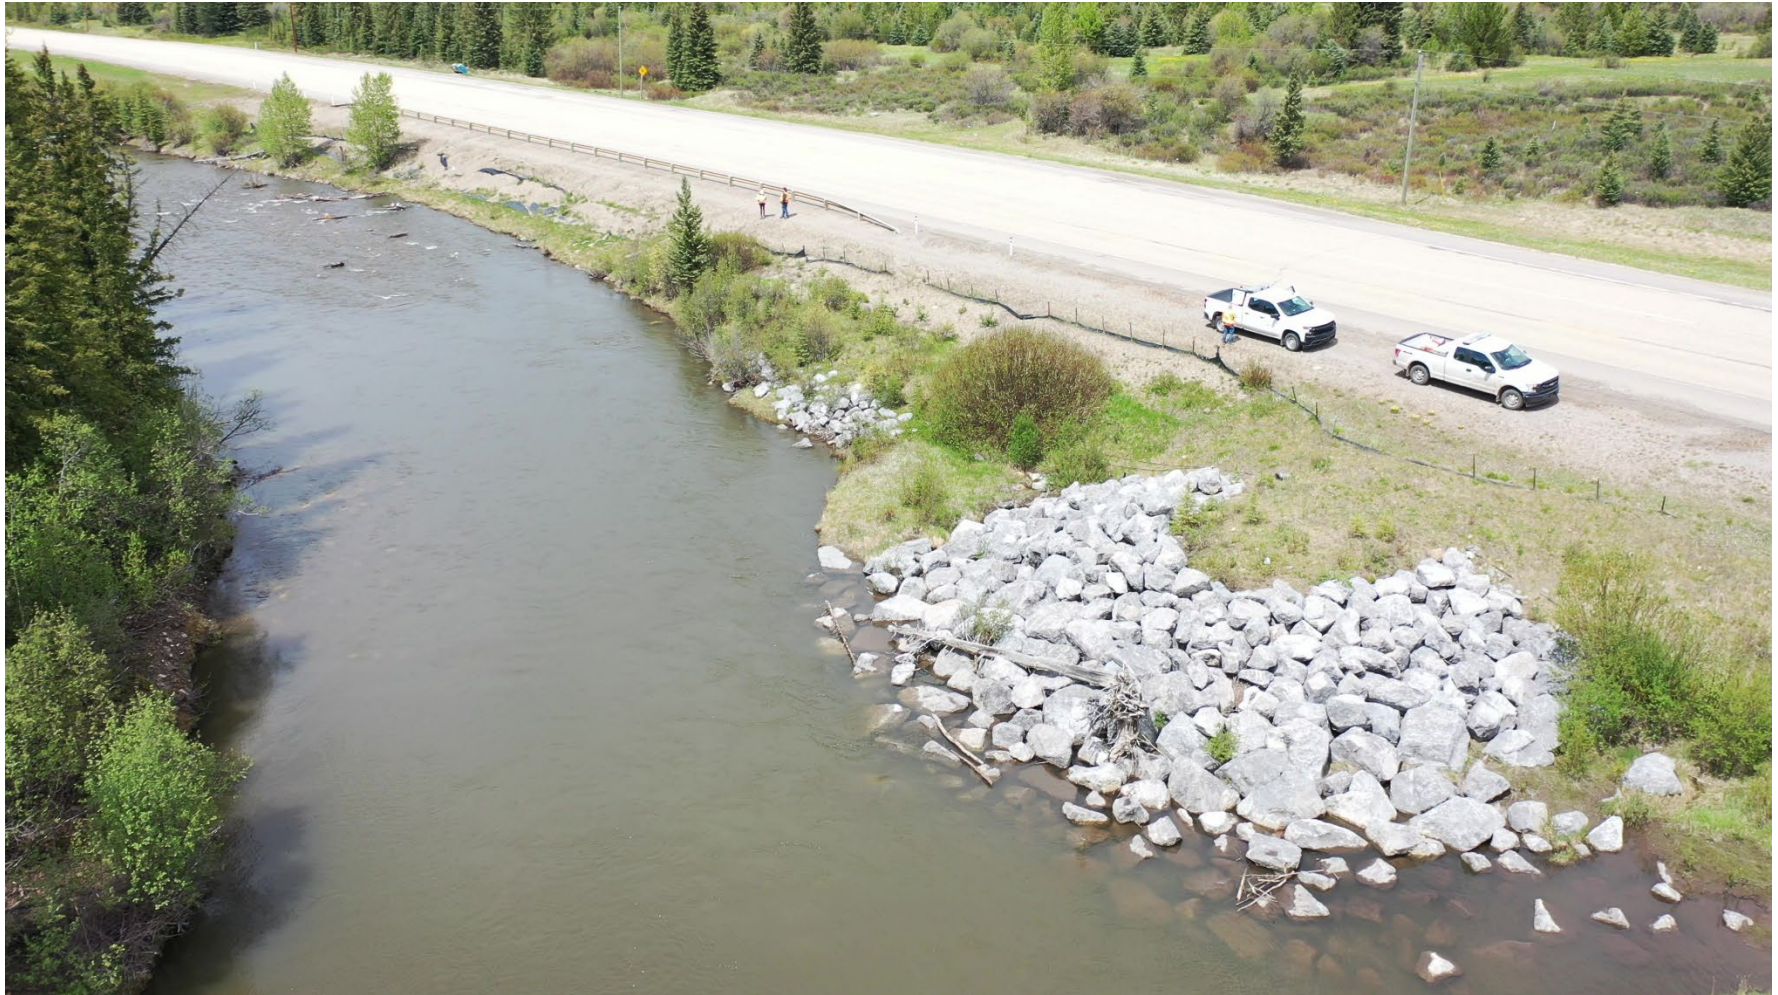
Photo 1 Overview of GP009 site on Hwy 40:32. Photo taken June 13, 2022, with unmanned aerial vehicle (UAV) facing northwest.

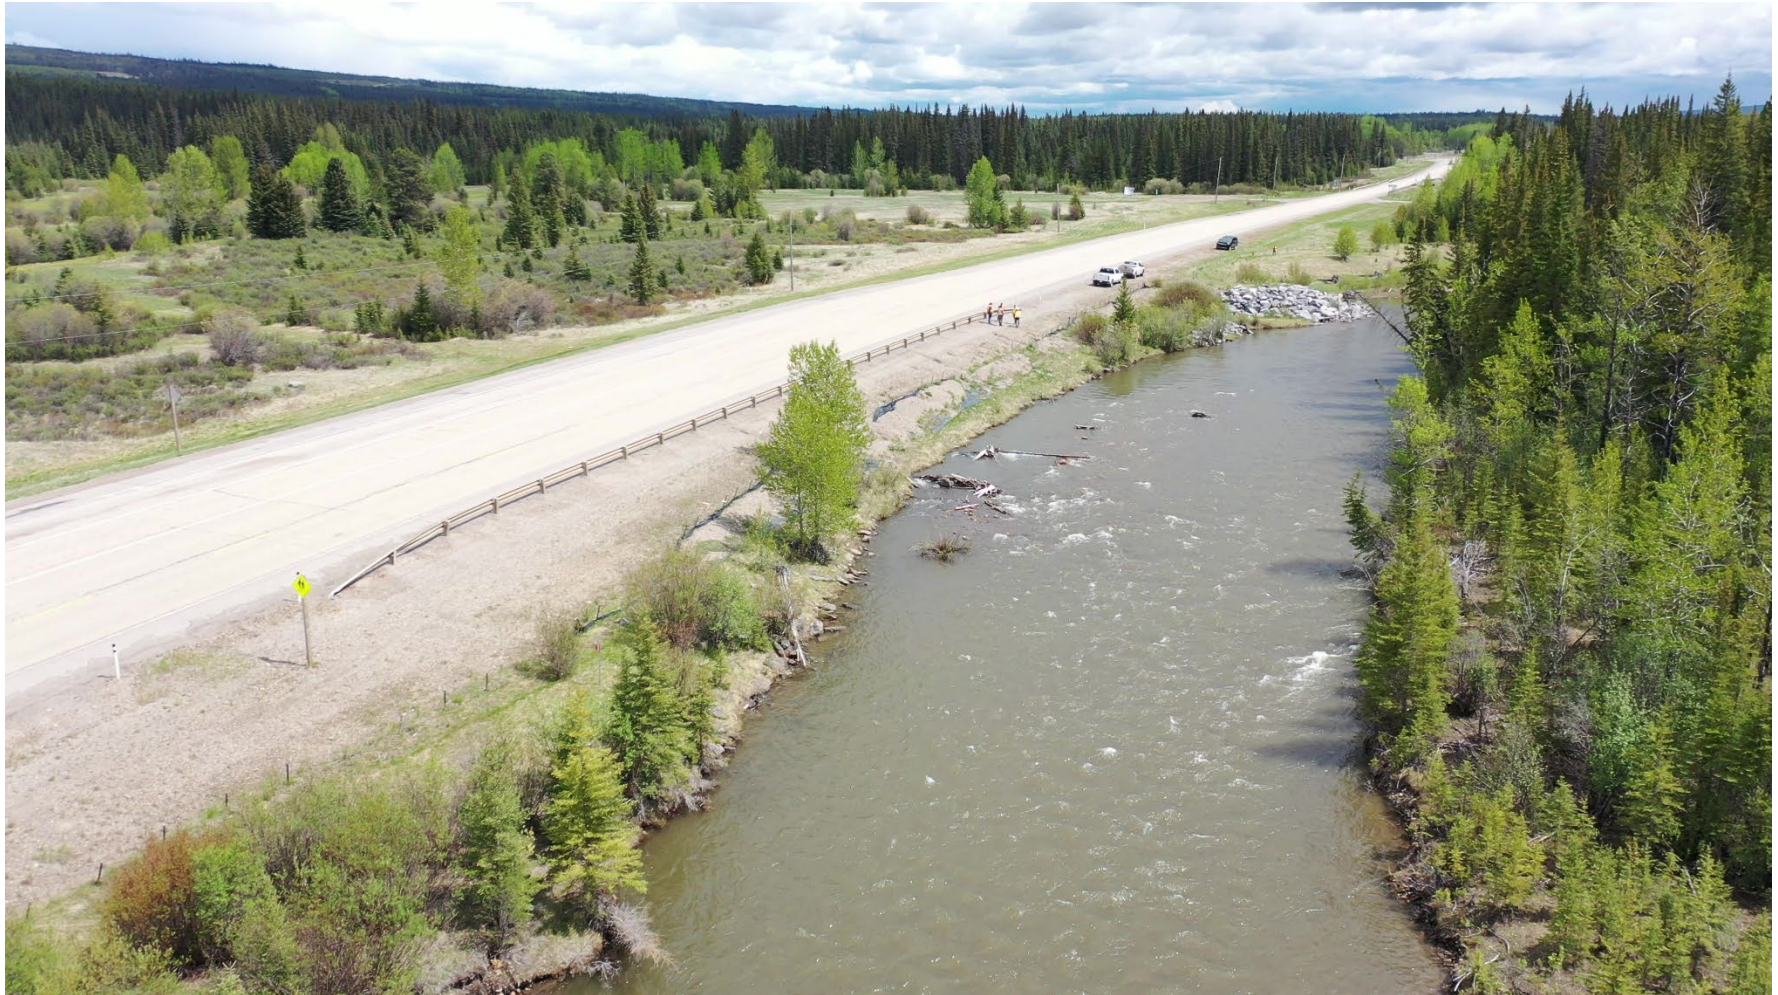
Photo 2 Overview of GP009 site along Hwy 40:32. Photo taken June 13, 2022, with UAV facing northeast.

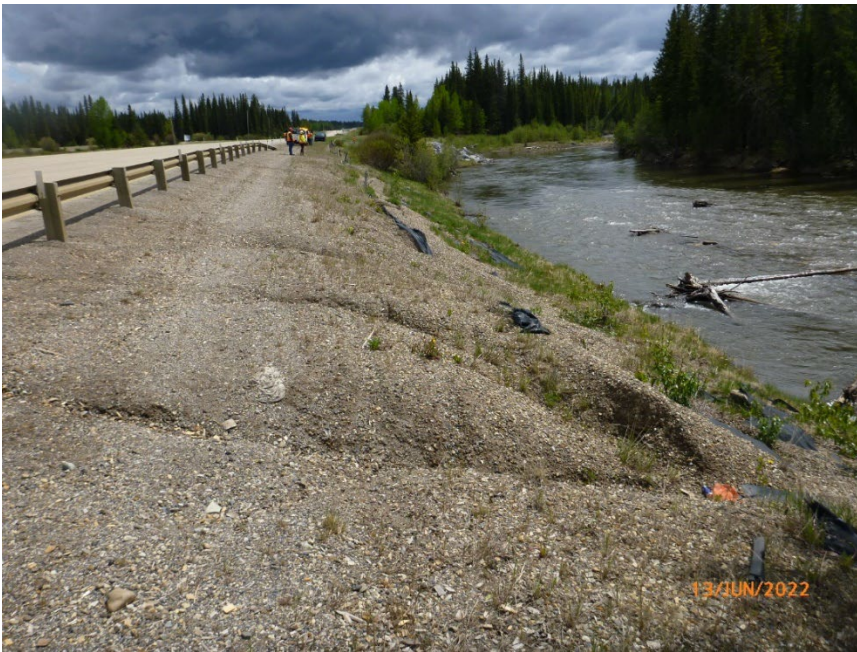
Photo 3 Rill and gully erosion along south side of Hwy 40:38 embankment. Photo taken June 13, 2022, facing east.

- Silt fencing between guardrail and creek is falling down and should be removed/disposed of.
- Grade gravel and infill rills and gully along south side of highway embankment above riprap. Previous gravel lasted about 15 years before getting eroded. Estimated cost: \$10,000 to \$20,000.

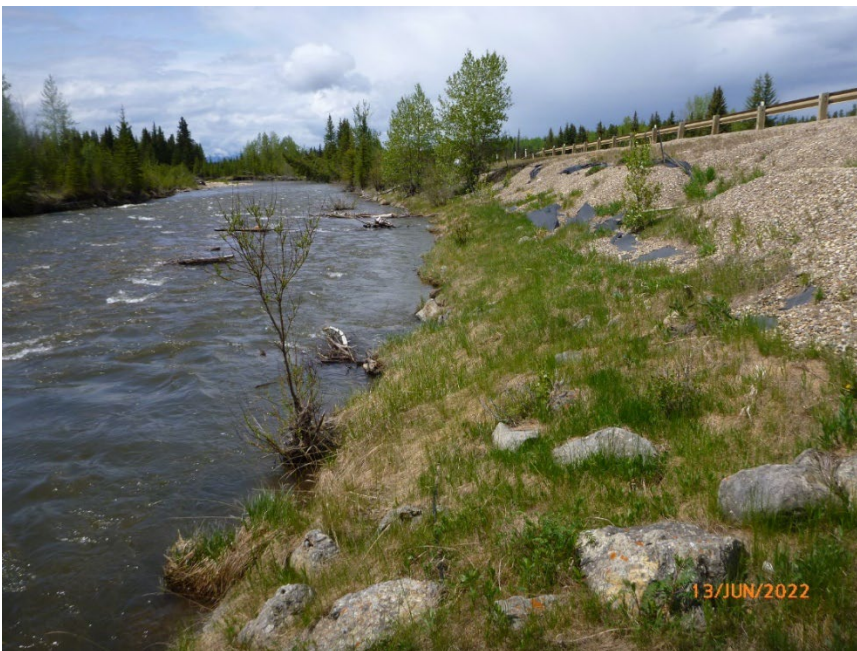
COMMENTS
Spur at south/eastern site limit consists of Class 3 limestone riprap and appears to be in good condition. Construction of spur resulted in bank erosion shifting west to current location along highway embankment.
Riprap along highway embankment covered in gravel. Some geotextile and conglomerate riprap exposed at toe of highway embankment, which is deteriorating. Toe of highway embankment well vegetated with minimal to no erosion.
Some woody debris in creek channel and along west creek bank at toe of highway embankment.

Photo 4 Erosion along north bank of Lone Teepee Creek along south toe of Hwy 40:32 embankment. Note conglomerate riprap particles and exposed geotextile. Photo taken June 13, 2022, facing west.
