Slide Name: (GP 17) Hwy 40:34 Grande Cache Lake
Inspection Date: June 26, 2003
Inspection By: Alberta Transportation and EBA Staff listed on Page 1

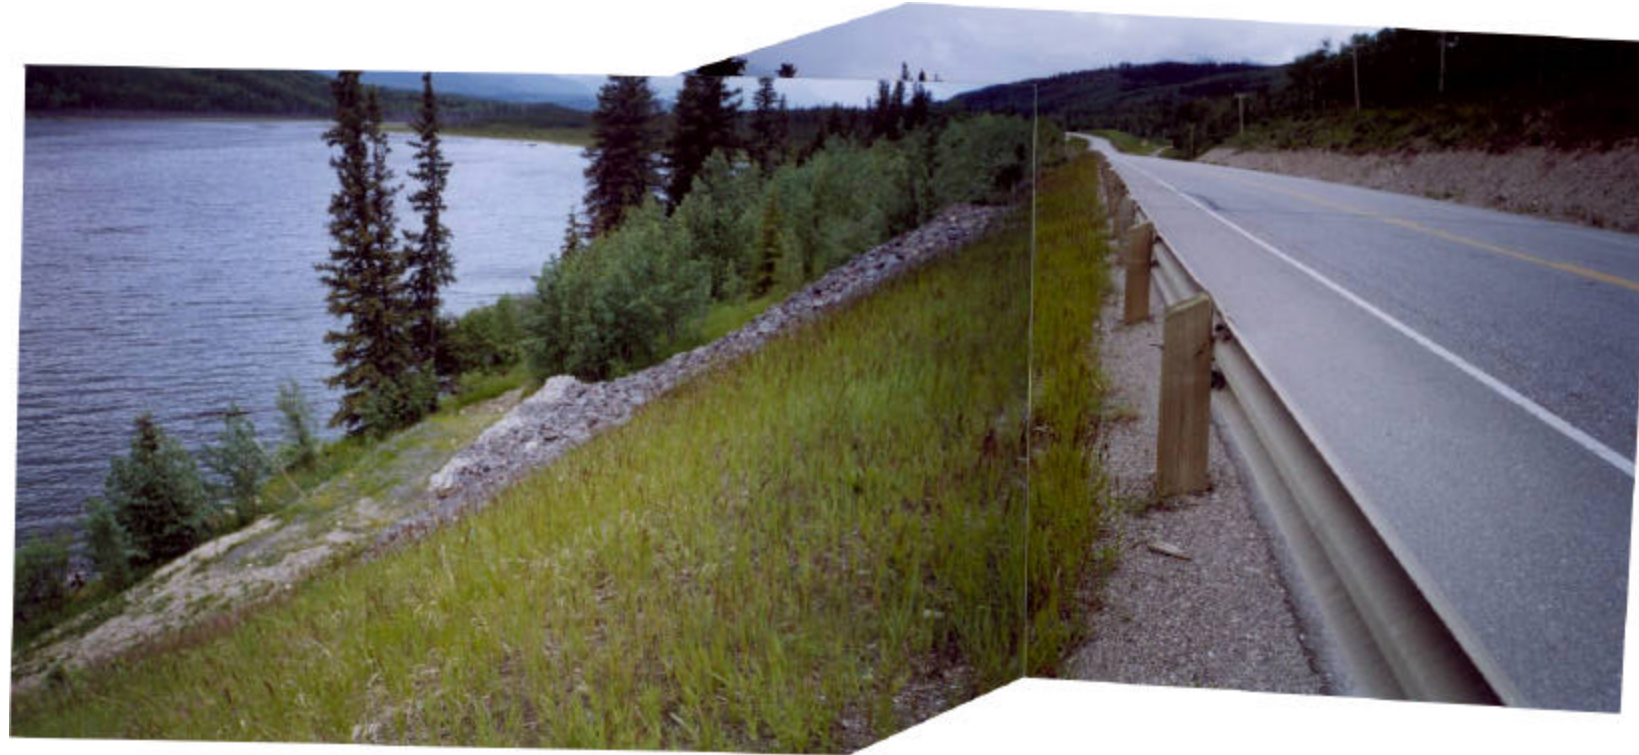
Photo 1
Looking north towards Grande Cache
- Repaired slope in relation to roadway

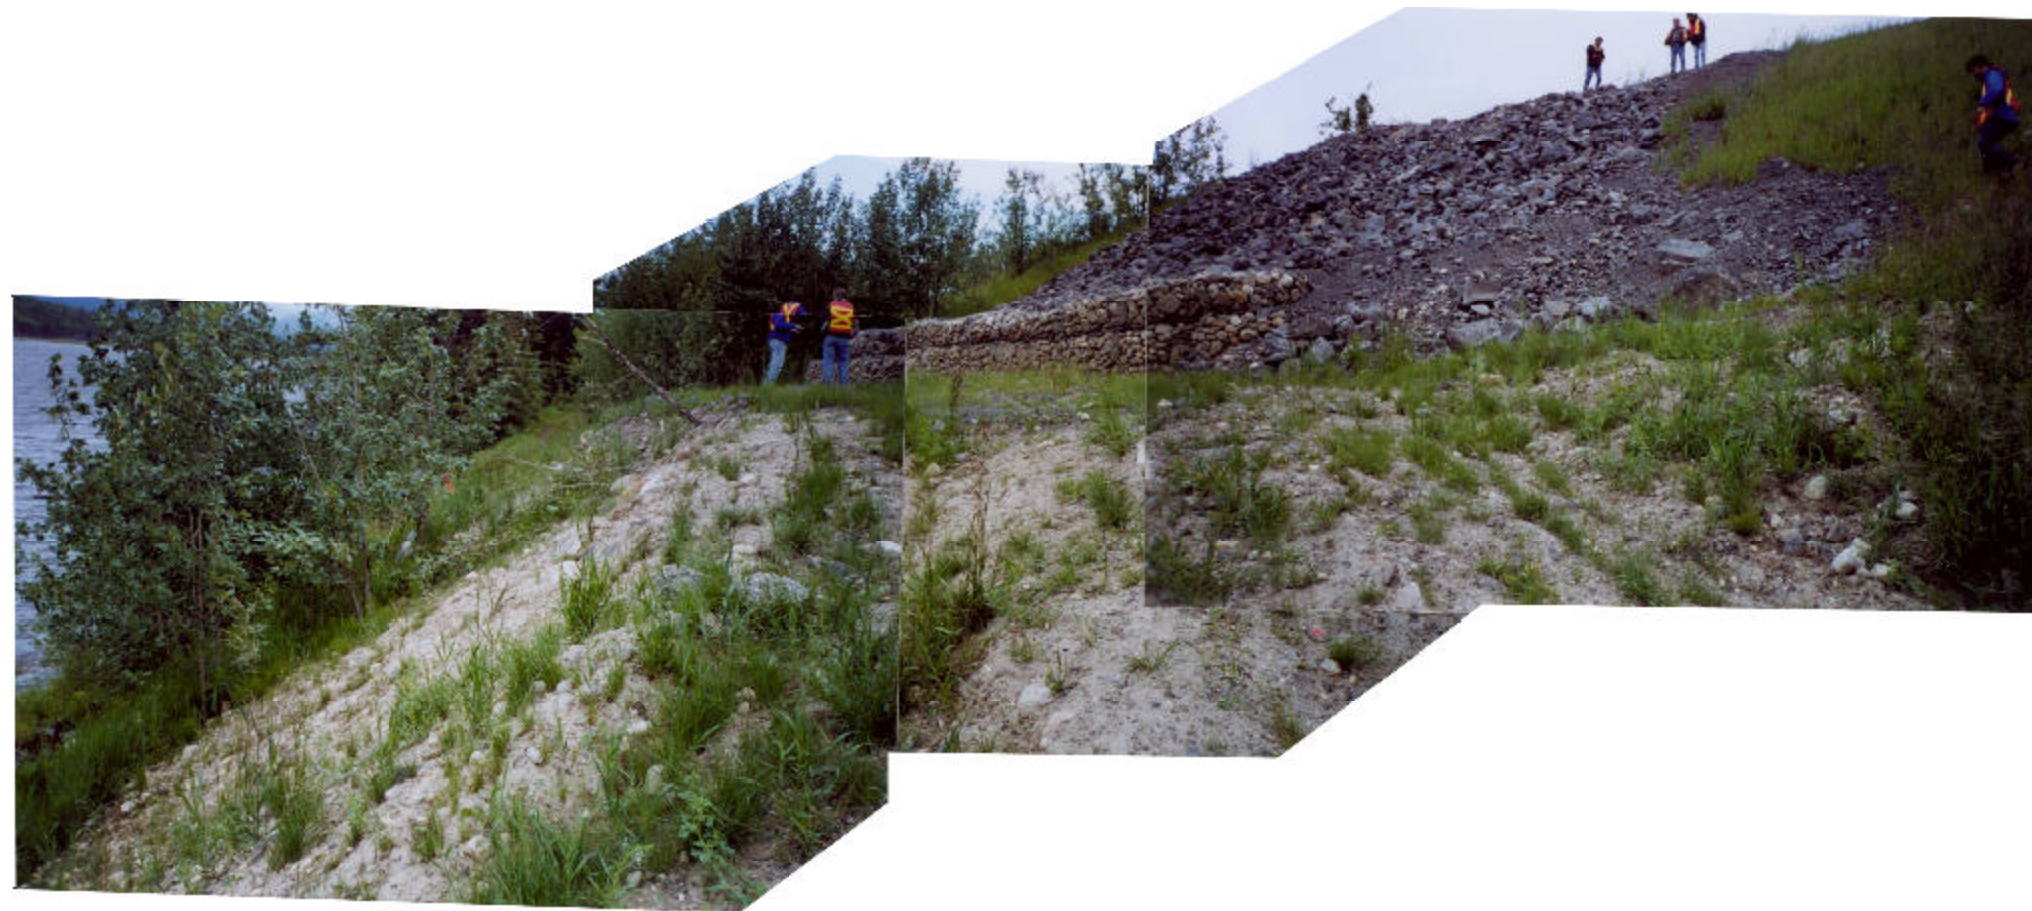
Photo 2
Looking north towards Grande Cache
- Raising elevation of shoreline trail as a berm
- Utility below/along shoreline trail
- Gabion wall
- Reconstruction of slope with shot rock
- herring bone drain at back of slope
