Slide Name: (GP 17) Hwy 40:34 Grande Cache Lake

**Inspection Date:** June 24, 2004

Inspection By: Alberta Transportation and EBA Staff listed on Page 1

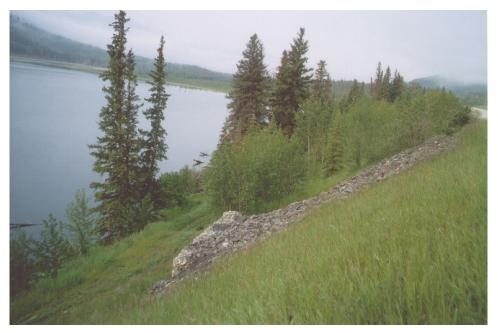
Photo 1
Looking west (toward Grande Cache) at Grande Cache Lake.

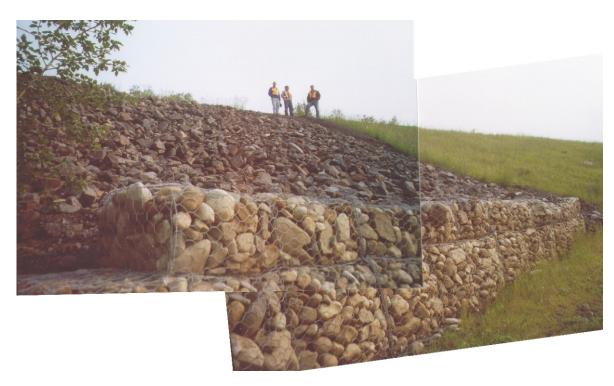
Photo 2
Looking east and up slope from trail at toe area.
