**SITE INSPECTION FORM**

<b>SITE NUMBER AND NAME:</b> <b>GP017 Grande Cache Lake Slide</b>		<b>HIGHWAY &amp; KM:</b> 40:34, 26.680	<b>PREVIOUS INSPECTION DATE:</b> June 12, 2023 Section B June 10, 2024 Construction	<b>INSPECTION DATE:</b> <b>June 2, 2025</b>
<b>LEGAL DESCRIPTION:</b> SW 12-57-08-W6M	<b>NAD 83 COORDINATES:</b> UTM Northing Easting 11 5974943 364960		<b>RISK ASSESSMENT:</b> PF: 1 CF: 3 TOTAL: 3	
<b>AVERAGE ANNUAL DAILY TRAFFIC (AADT):</b> 1,660 (west) & 1,520 (east) (Reference No. 70000983, 2024)			<b>CONTRACT MAINTENANCE AREA (CMA):</b> 504

PEACE REGION (GRANDE PRAIRIE DISTRICT-SOUTH)  
GEOHAZARD RISK MANAGEMENT PROGRAM

Site Plan  
GP017 - Grande Cache Lake Slide  
Hwy 40:34, km 26.680

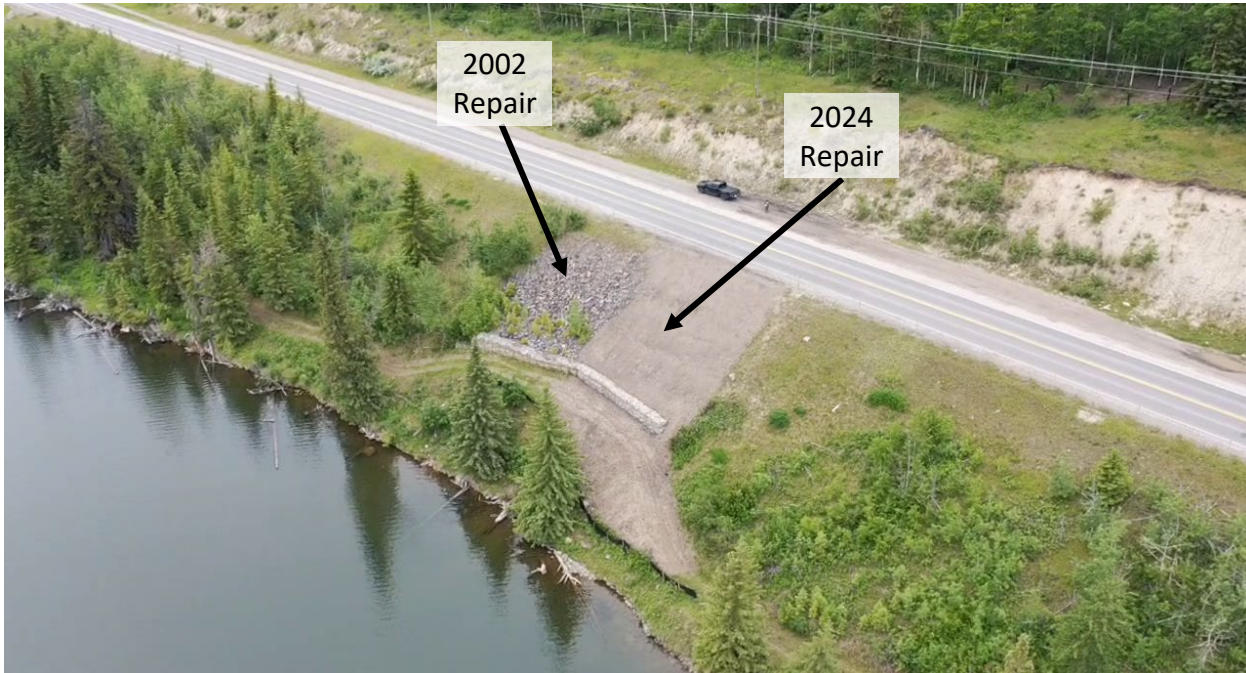
Approximate 2-m-wide trail at toe of slide area used for the Great Canadian Death Race (Photos 1, 2, 4, and 5).

**Photo 1** Repaired slide and erosion on south side of Hwy 40:34. Note trail at toe of highway embankment and Grande Cache Lake at toe of slope. UAV photo taken June 26, 2024, facing northwest.

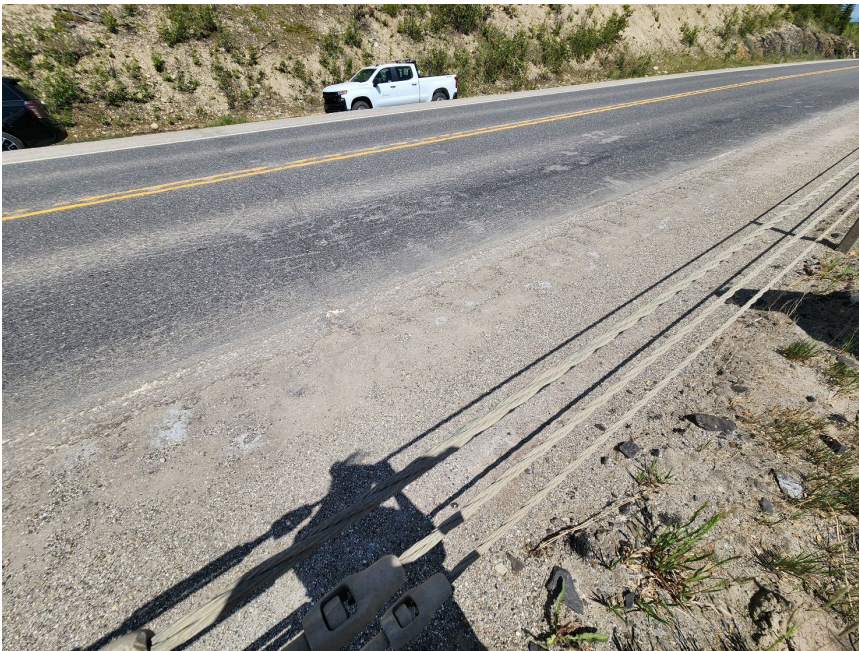
**Photo 2** Distress in pavement surface of Hwy 40:34 above repair completed in 2024. Photo taken June 2, 2025, facing northeast.

- TEC should consider patching the pavement above the recently repaired slope.
- Based on observation made during the 2025 inspection, vegetation is slowly re-establishing and coverage on the repaired slope is poor and minor rill erosion has formed (Photos 3 through 5). Hydro mulching of the slope could be considered to help establish vegetation and reduce erosion potential. Estimated cost: \$10,000 to \$15,000.

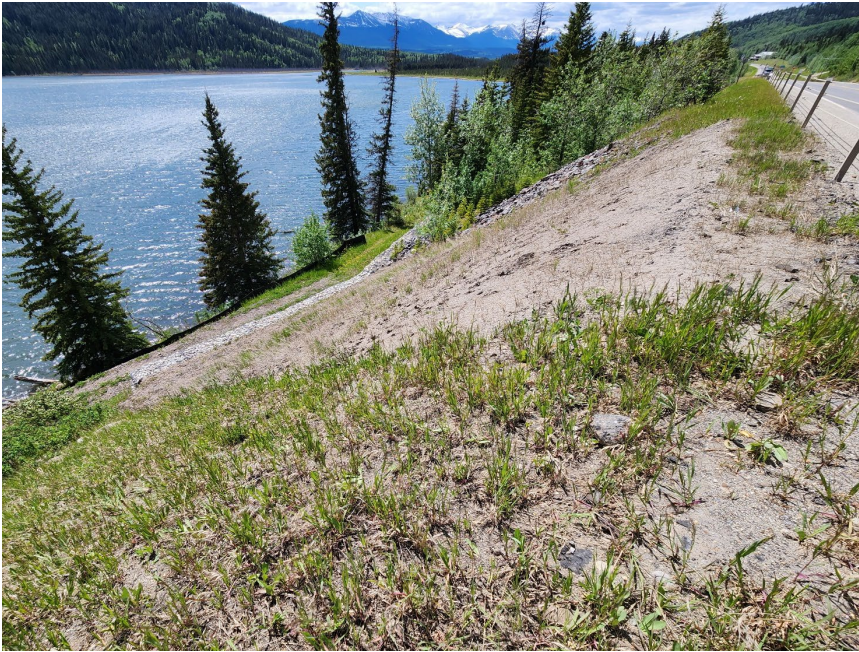
**Photo 3**      **Repaired slide and erosion on south side of Hwy 40:34. Note repaired slope is poorly vegetated. Photo taken June 2, 2025, facing southwest.**

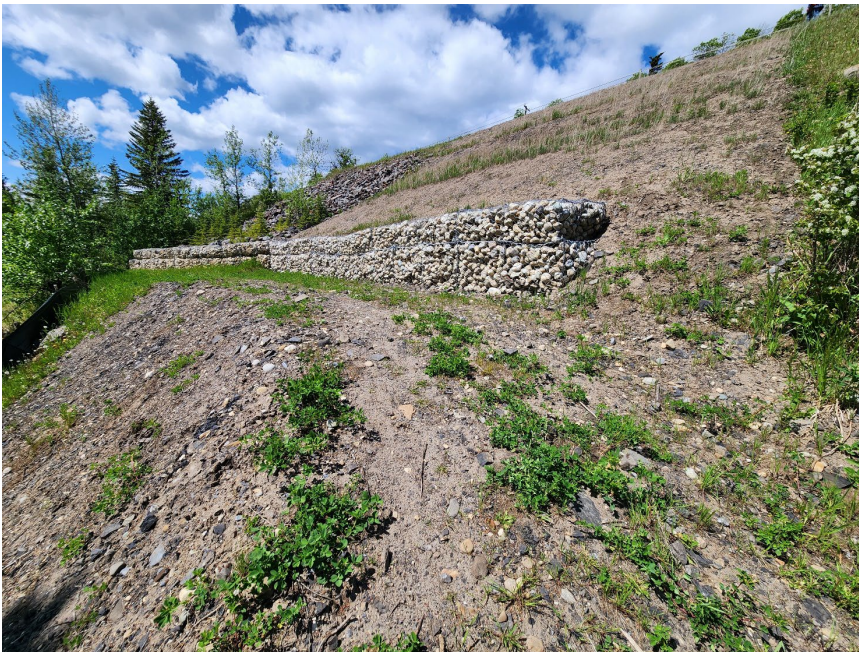
**Photo 4**      **Repaired slide and erosion on south side of Hwy 40:34. Note extension of existing gabion baskets and toe berm from previously repaired section. Photo taken June 2, 2025, facing northwest.**

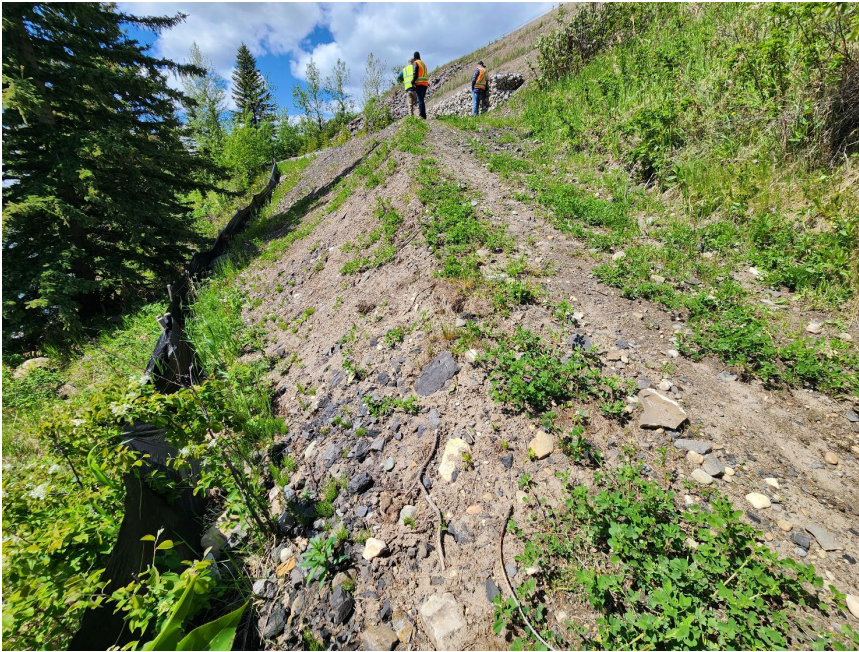
**Photo 5** Toe berm and trail at toe of highway embankment on south side of Hwy 40:34.  
Photo taken June 2, 2025, facing northwest.

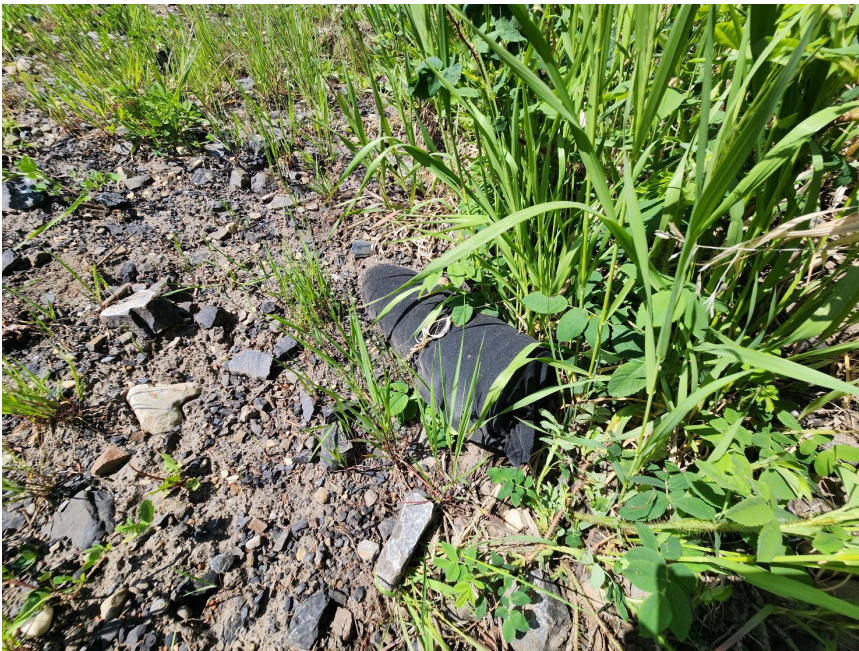
**Photo 6** Outlet of drainpipes along toe berm crest installed in 2024 to convey flow from within the slide zone. Photo taken June 2, 2025.
