**PEACE REGION
(GRANDE PRAIRIE DISTRICT – SOUTH) GRMP**

SITE INSPECTION FORM

SITE NUMBER AND NAME: GP020-II Backslope Slump North of Grande Cache		HIGHWAY & KM: 40:34, 35.998	PREVIOUS INSPECTION DATE: May 25, 2020	INSPECTION DATE: June 13, 2022
LEGAL DESCRIPTION: NE 32-56-08-W6M	NAD 83 COORDINATES: UTM Northing Easting 11 5973303 358690		RISK ASSESSMENT: PF: 10 CF: 3 TOTAL: 30	
AVERAGE ANNUAL DAILY TRAFFIC (AADT): 1530 (north) (Reference No. 70000104, 2021) 1020 (south) (Reference No. 25592, 2021)			CONTRACT MAINTENANCE AREA (CMA): 504

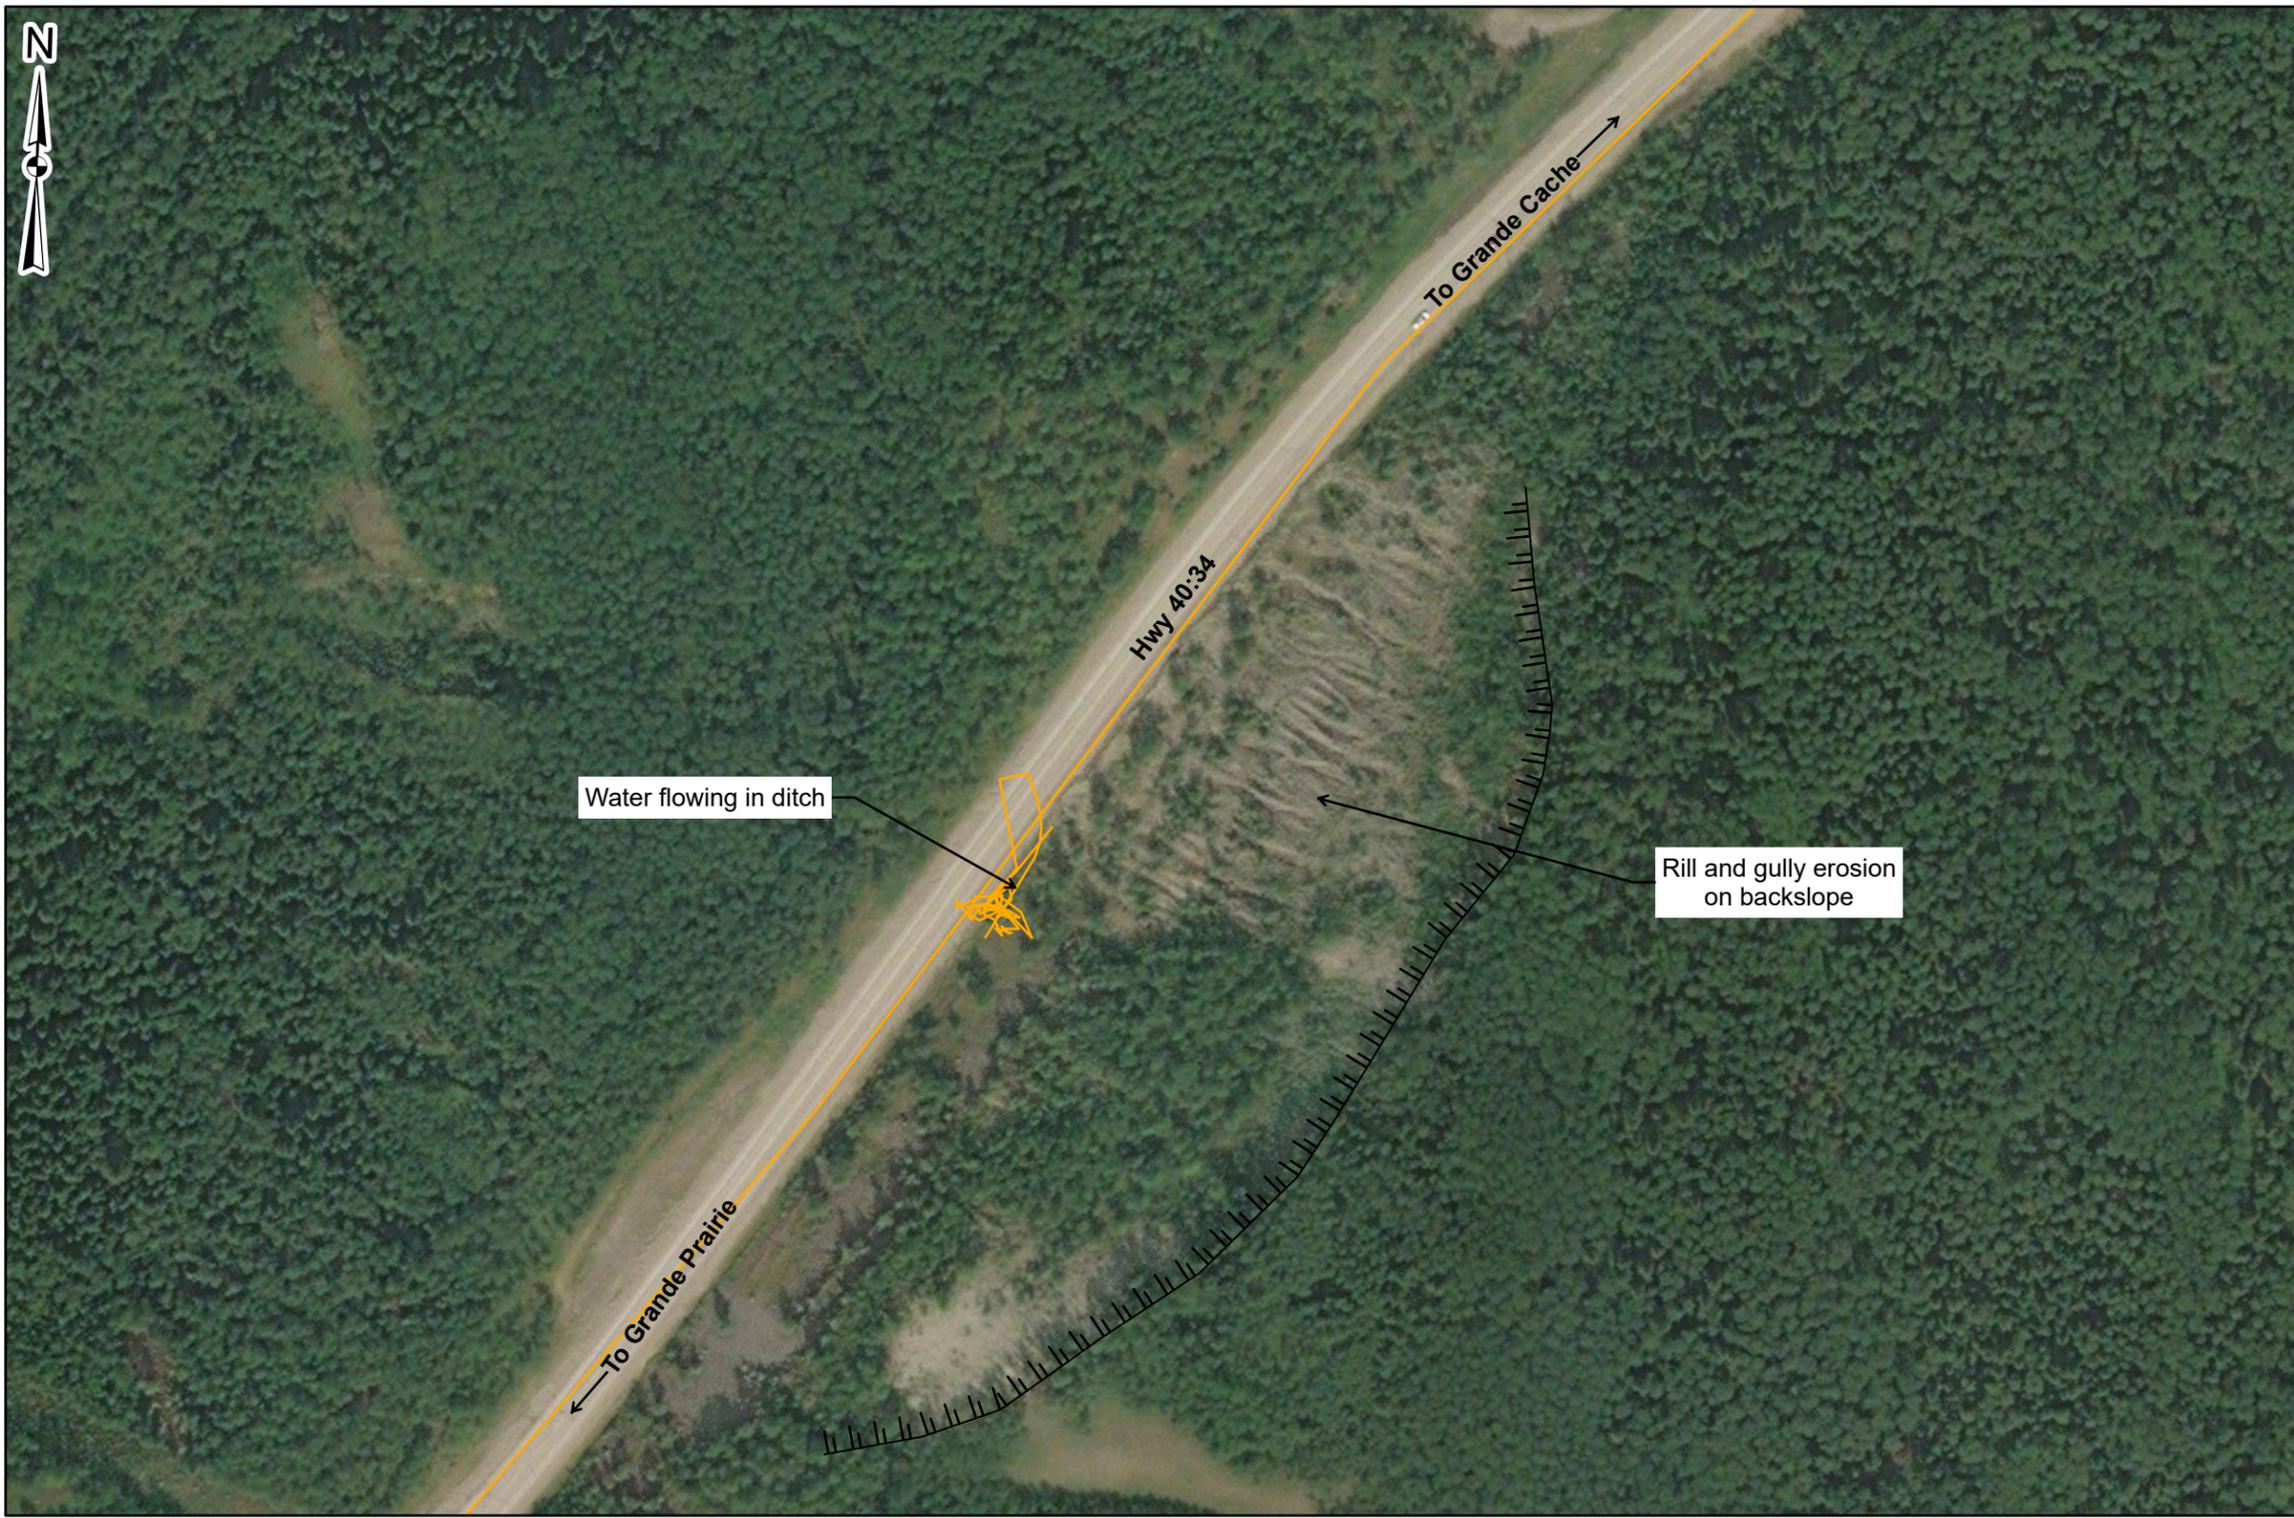
PROJECT PEACE REGION (GRANDE PRAIRIE DISTRICT-SOUTH) GEOHAZARD RISK MANAGEMENT PROGRAM		
TITLE Site Plan GP020-II - Backslope Slump North of Grande Cache Hwy 40:34, km 35.998		
SCALE 1:2,000	PROJECT No. A05116A01	FIG No. 1

- GPS Track (June 13, 2022)
- Scarp

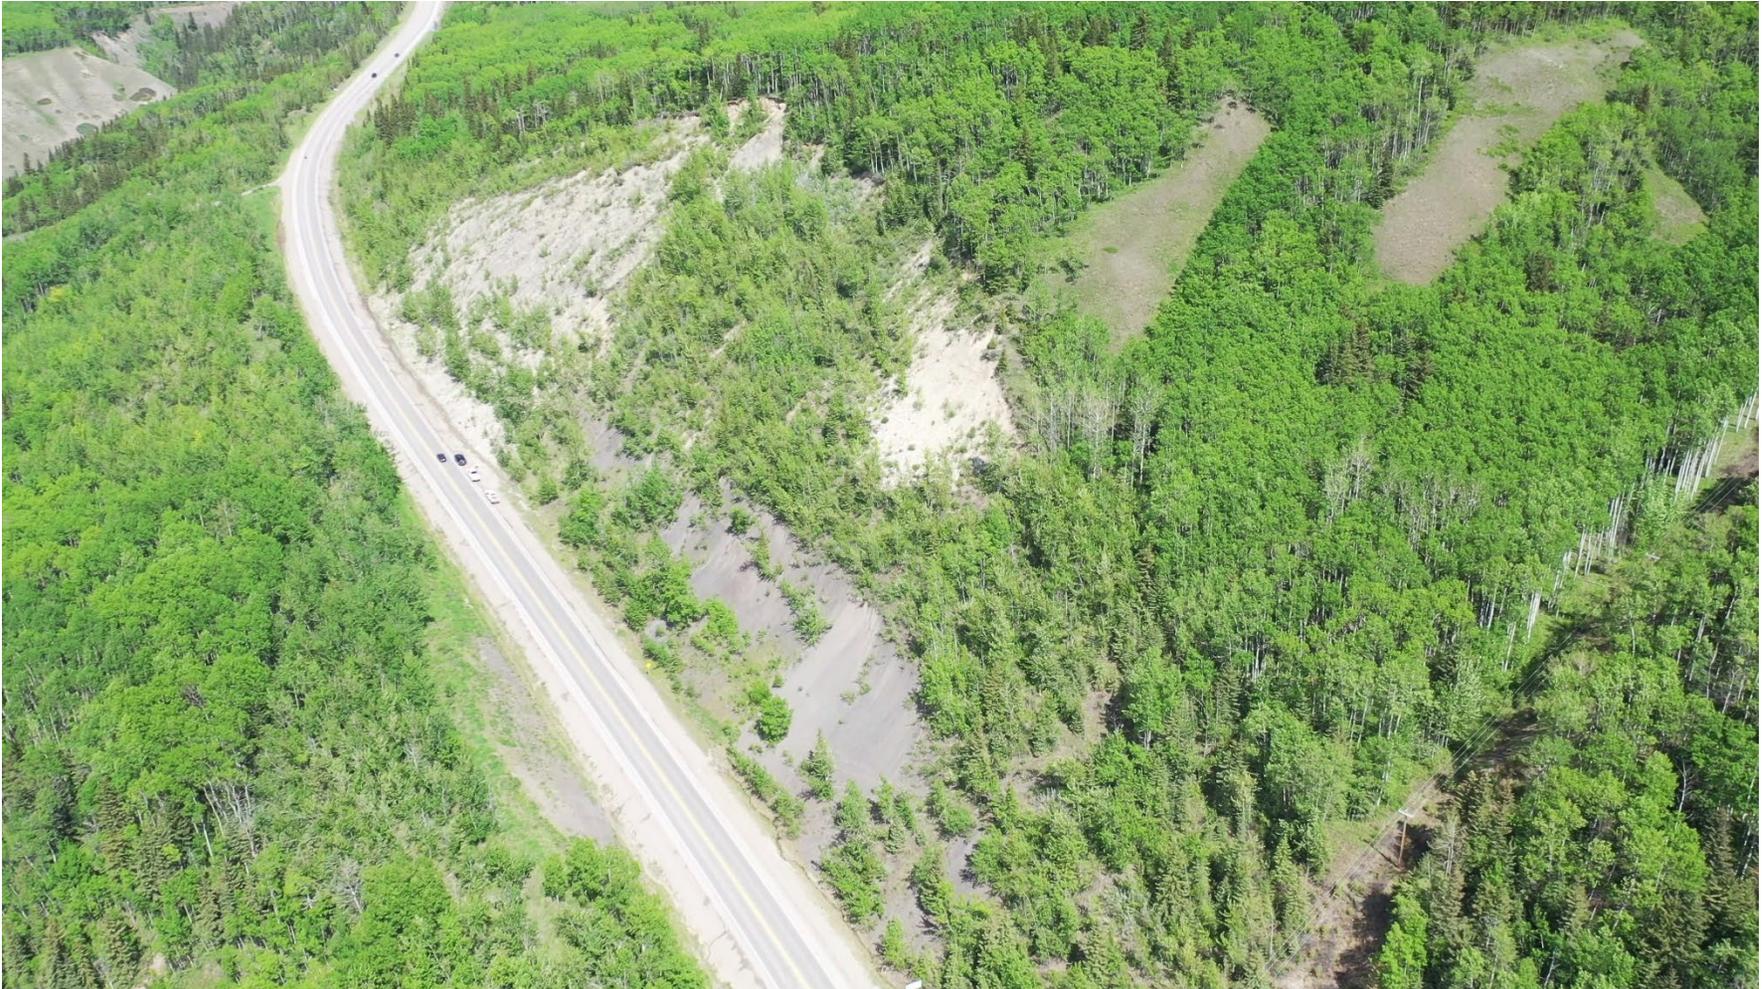
Photo 1 Overview of GP020-II site on Hwy 40:34. Photo taken June 13, 2022, with unmanned aerial vehicle (UAV) facing northeast.

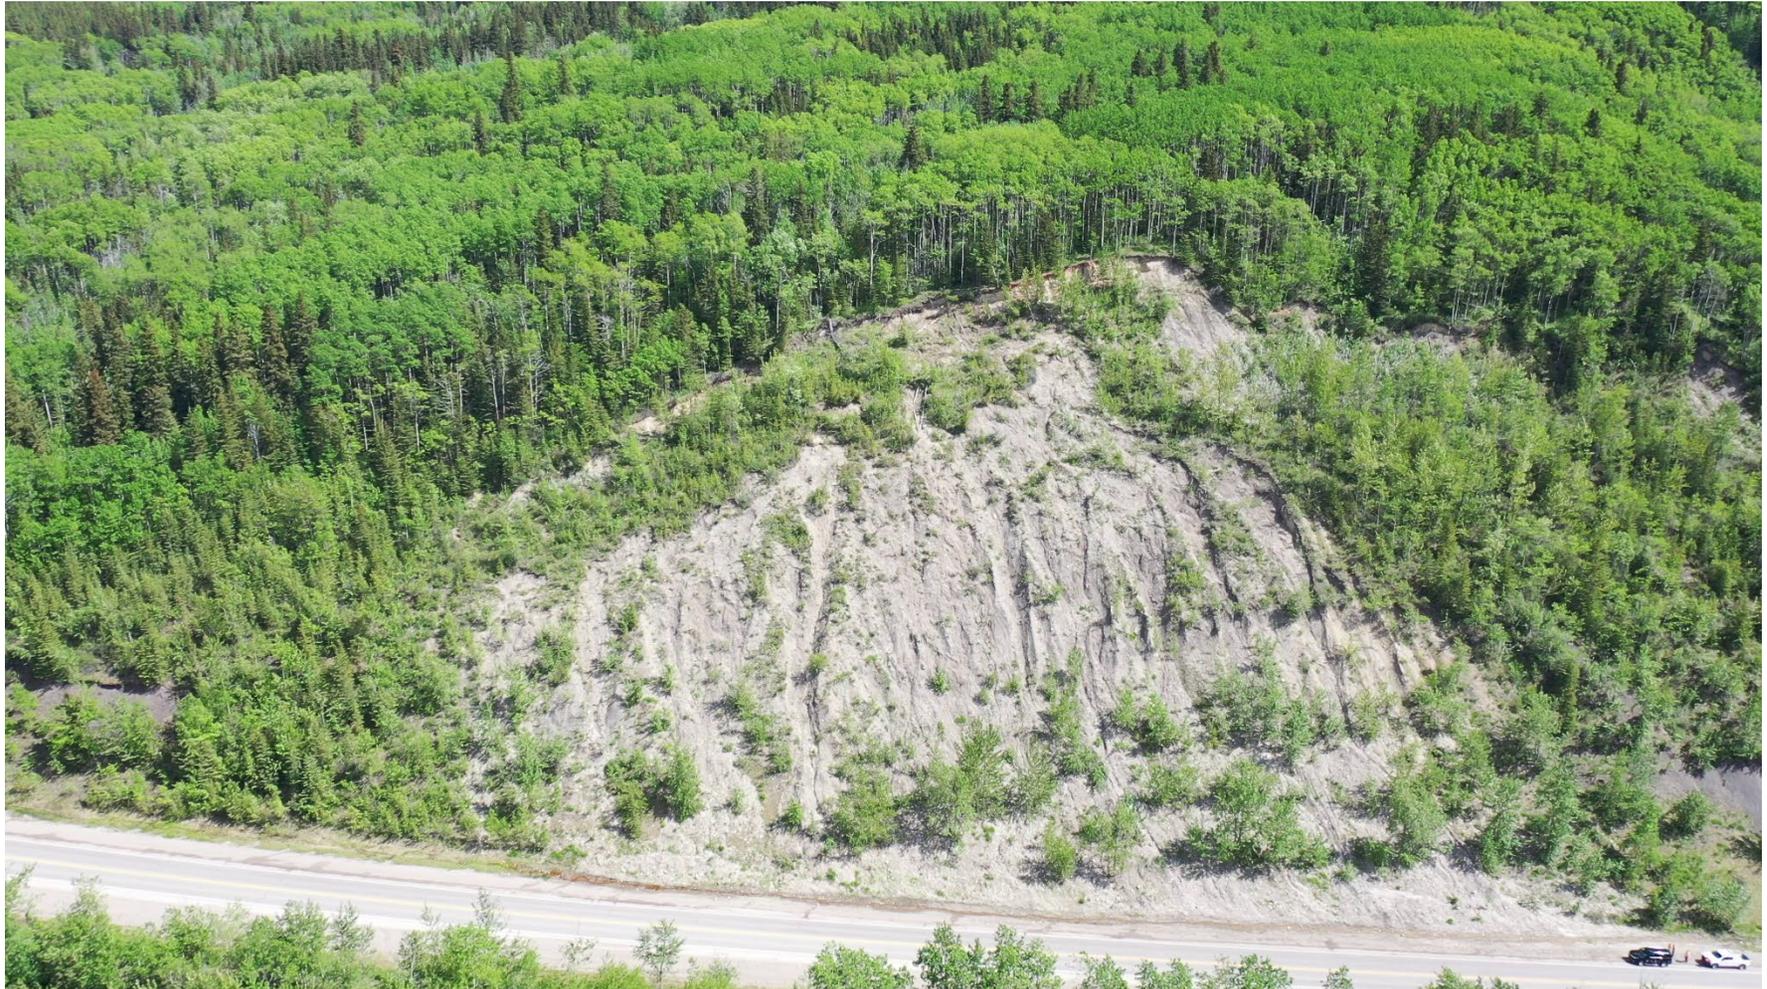
Photo 2 Overview of GP020-II site on Hwy 40:34. Note erosion gullies and poorly vegetated areas on backslope along east side of Hwy 40:34. Photo taken June 13, 2022, with UAV facing west.

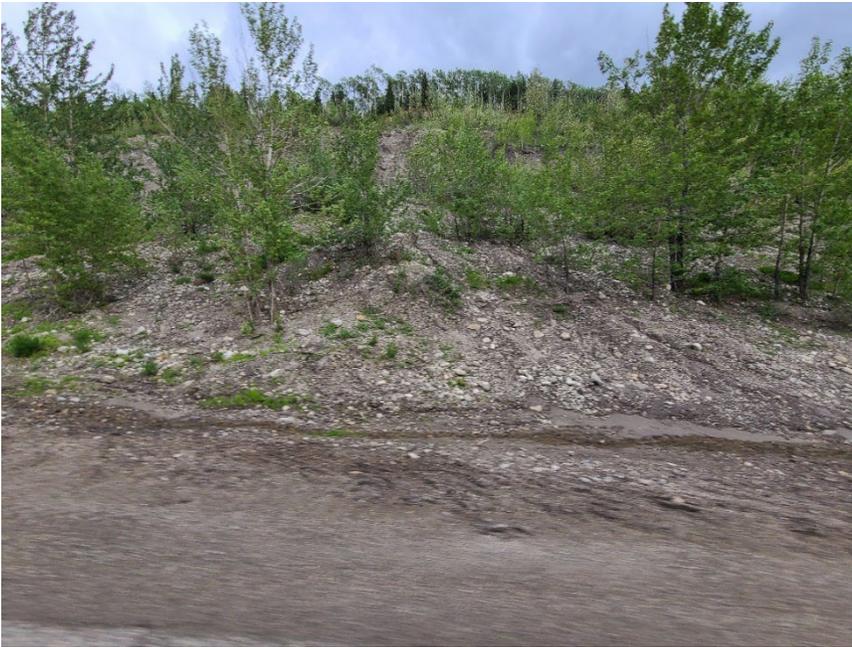
Earthflows and gravity movement of particles likely occurring in response to seepage, surface-water runoff flowing over crest of slope, and precipitation infiltrating into slope softening slope materials. Rate of occurrence and volume of mudflows likely to increase in response to freshet and/or periods of prolonged and/or heavy rainfall.

Photo 3 Erosion gully and debris fan on backslope along east side of Hwy 40:34. Note exposed gravelly material on backslope. Photo taken June 13, 2022, facing east.

- A diversion ditch could be constructed at the crest of the backslope to divert surface water runoff away from crest of the mudflow area. However, review of 2022 unmanned-aerial-vehicle (UAV) flight imagery indicates construction of a diversion ditch may not be practical due to lack of access and topography.
- Most material being deposited in upslope/east highway ditch appears to slow ditch flows and not block them completely (ditch is wide and shallow). Icing problems in ditch reported in winter of 2021/2022. Water currently flowing in ditch to southwest. Continue to clean ditch to maintain mudflow storage volume (i.e., keep ditch as wide and deep as possible to retain material within the ditch) and reduce the potential for material reaching the highway.

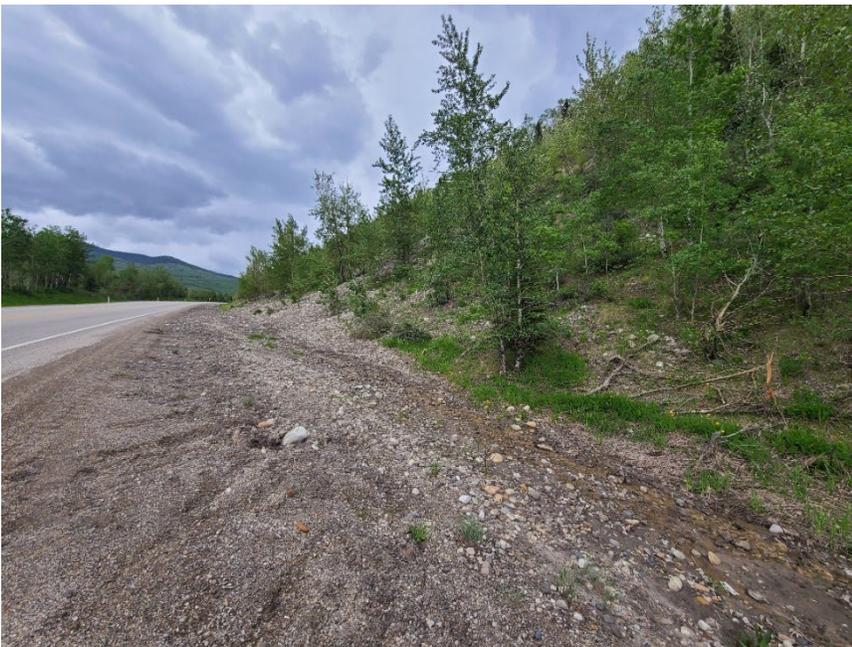
Photo 4 Water flowing in upslope/east ditch of Hwy 40:34 at toe of backslope. Photo taken June 13, 2022, facing northeast.

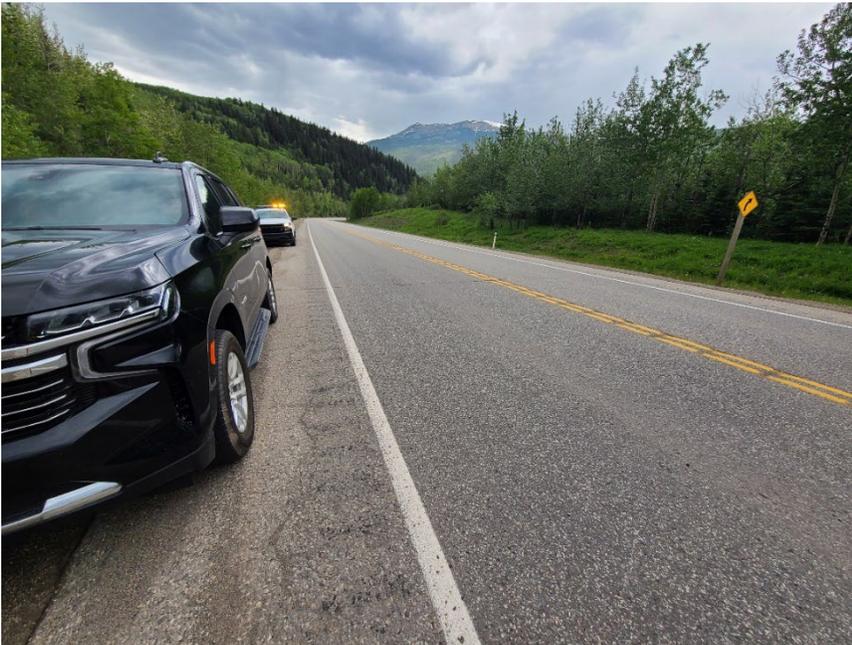
Photo 5 Pavement surface of Hwy 40:34. Photo taken June 13, 2022, facing southwest.

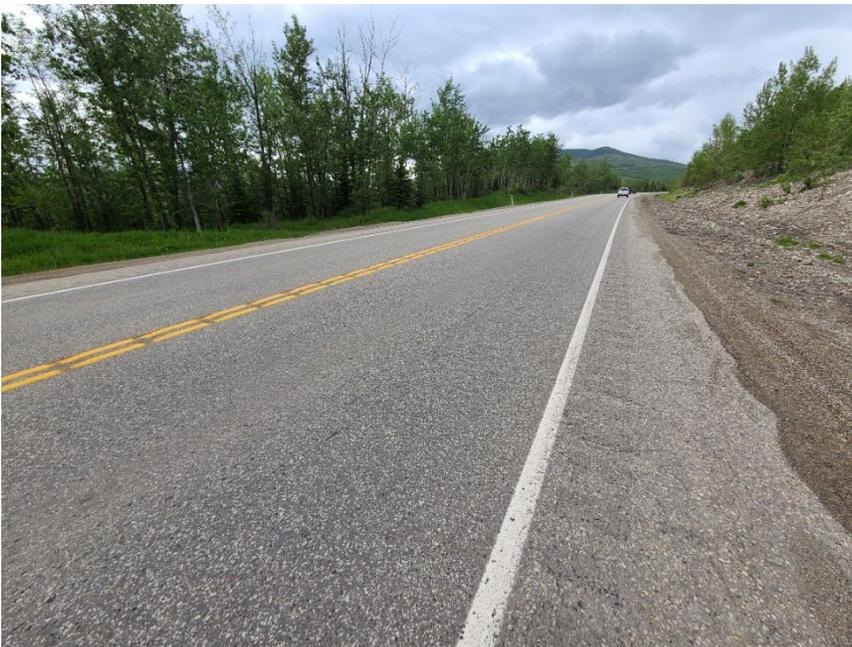
Photo 6 Pavement surface of Hwy 40:34. Photo taken June 13, 2022, facing northeast.
