**ALBERTA TRANSPORTATION  
GEOHAZARD ASSESSMENT PROGRAM  
PEACE REGION – GRANDE PRAIRIE DISTRICT  
2020 INSPECTION**

<b>Site Number</b>	<b>Location</b>	<b>Name</b>	<b>Hwy</b>	<b>km</b>
GP32	E of Grande Cache	S Curves	40:34	16.4
<b>Legal Description</b>		<b>UTM Co-ordinates (NAD 83)</b>		
W1/2-13-57-7-W6		11U N 5,976,985	E 374,415

<b>Date</b>	<b>PF</b>	<b>CF</b>	<b>Total</b>
<b>Previous Inspection:</b>	May 27, 2019	9	2	18
<b>Current Inspection:</b>	May 25, 2020	9	2	18
<b>Road AADT:</b>	1,380	<b>Year:</b>	2019	
<b>Inspected By:</b>	Don Proudfoot, Nicole Wilder (Thurber) Ed Szmata, Rishi Adhikari (AT)			
<b>Report Attachments:</b>	<input checked="" type="checkbox"/> Photographs <input checked="" type="checkbox"/> Plans <input type="checkbox"/> Maintenance Items

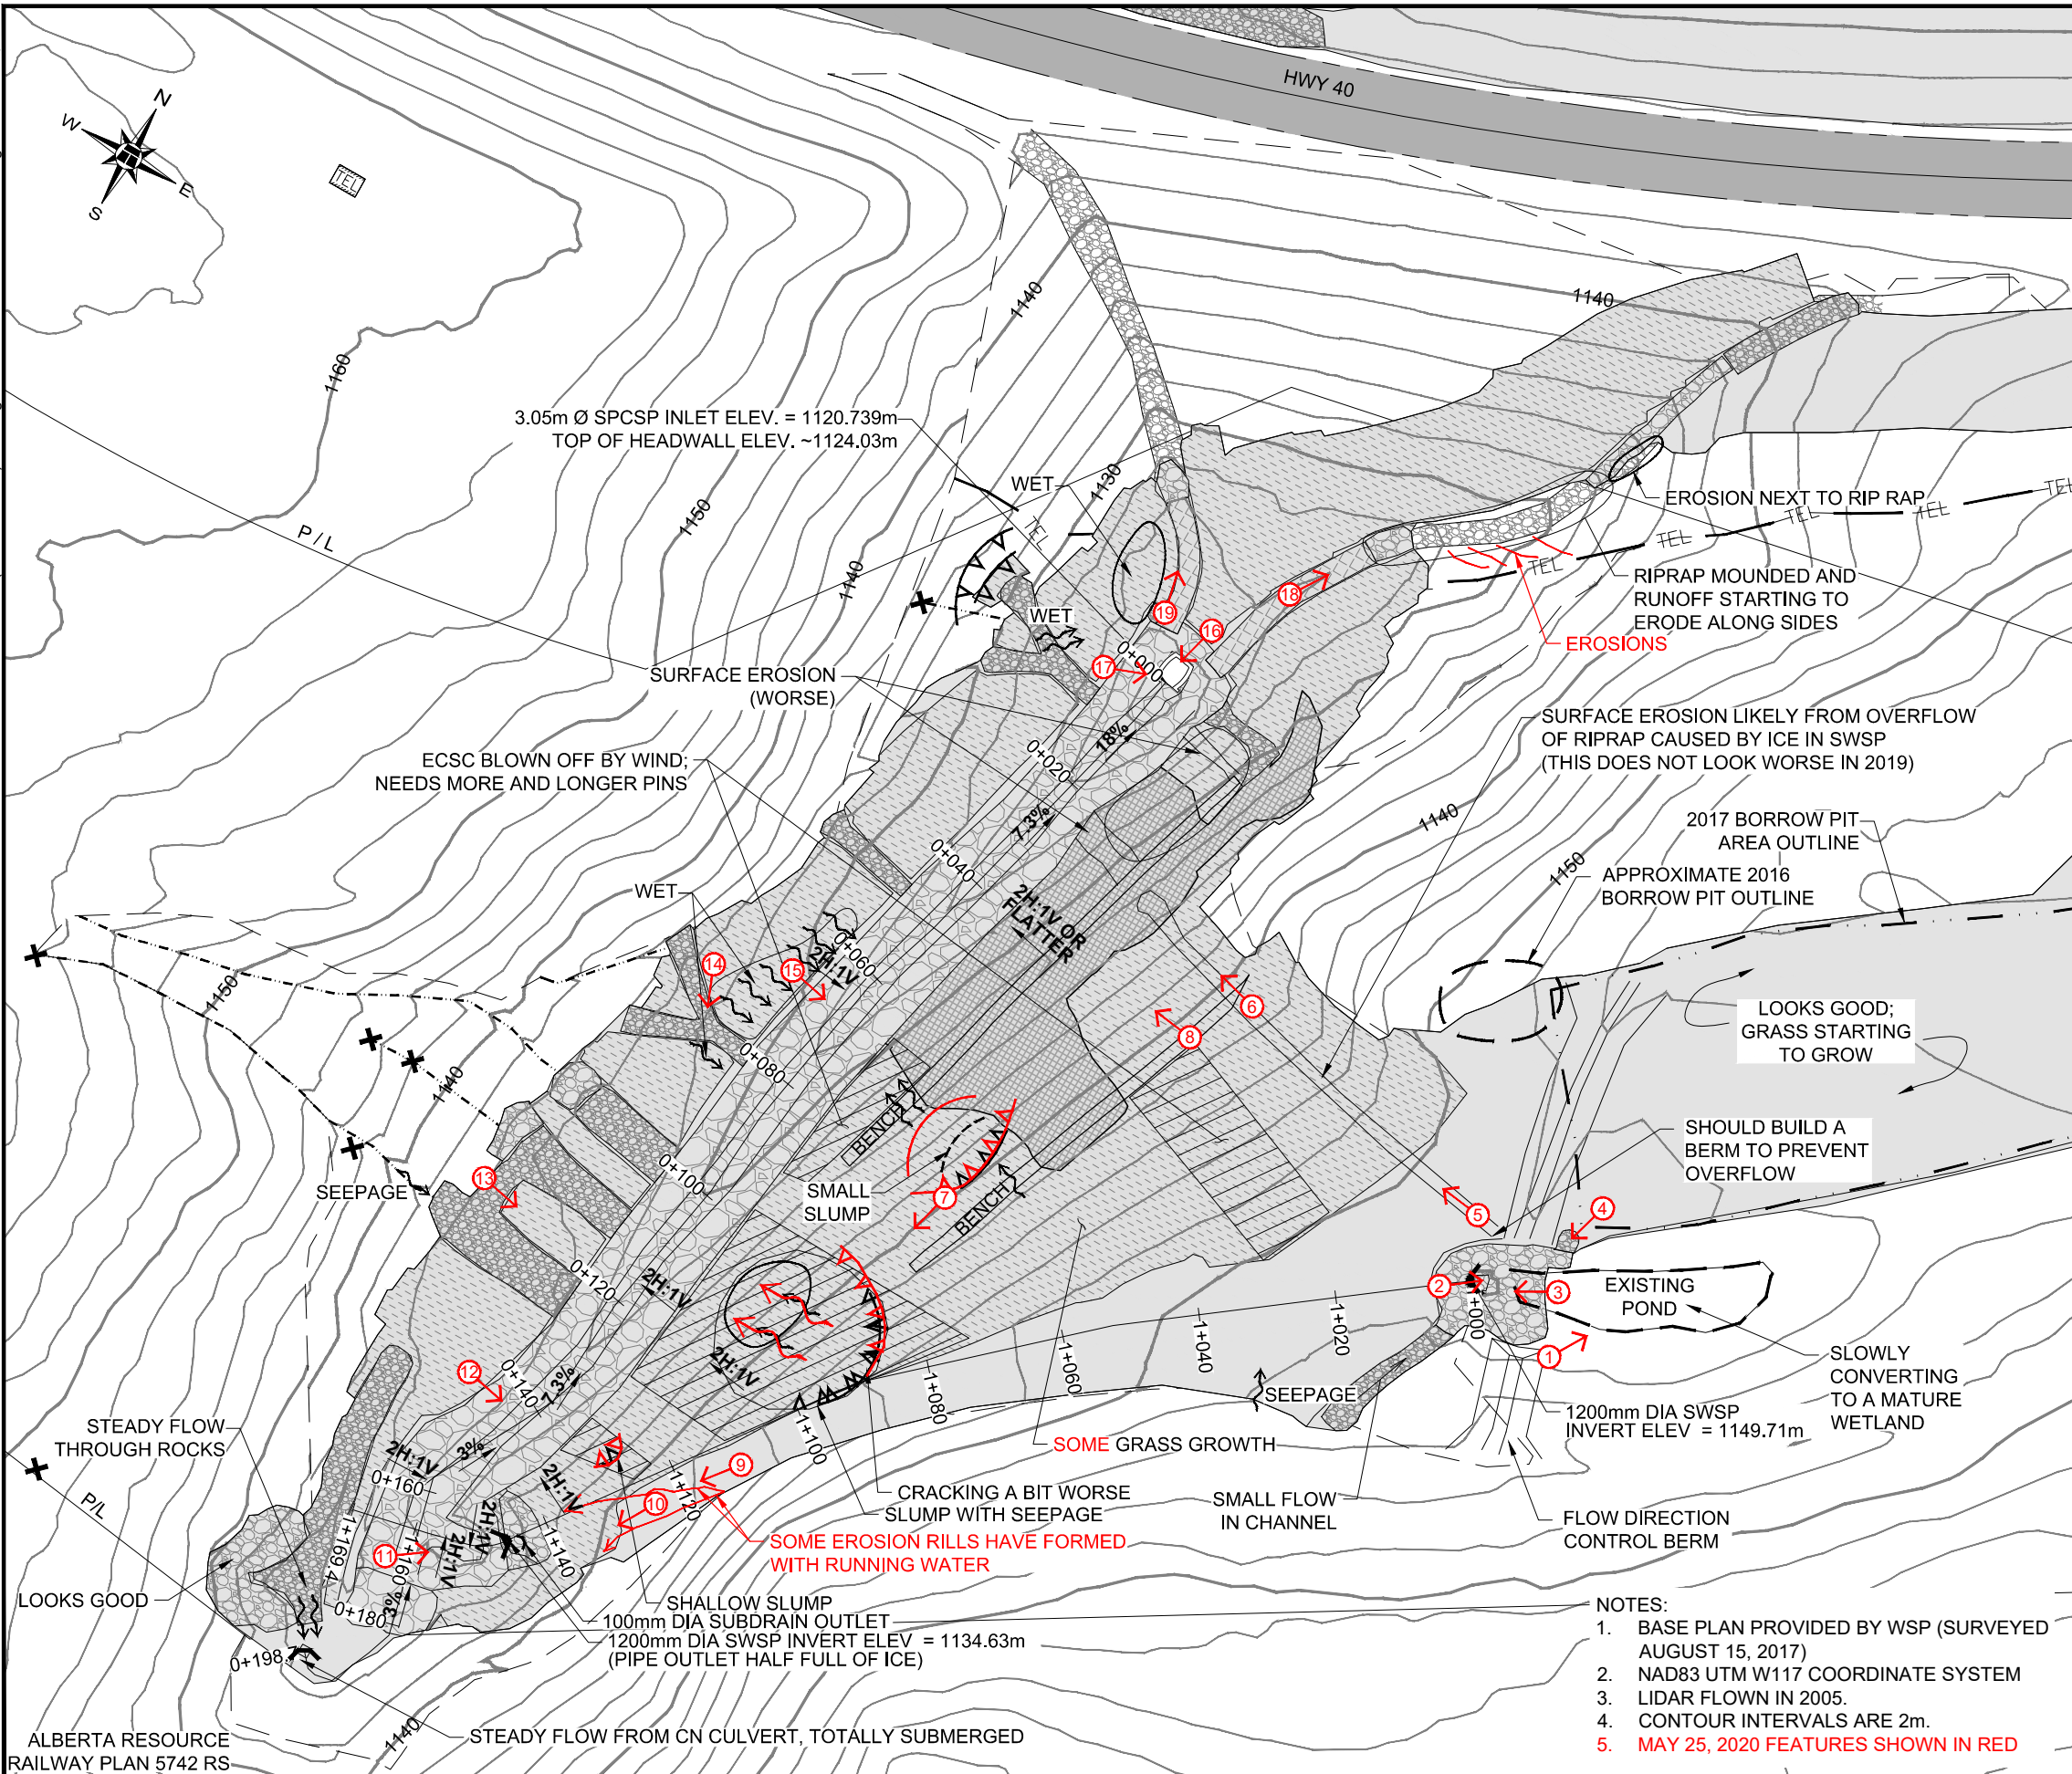
**2020 INSPECTION PLAN (SOUTH)**

<b>Primary Site Issue:</b>	<p>South Side of Highway: The original issues were severe creek erosion and gulying of the east cut slope. Site construction has been completed however, erosion has occurred adjacent to the pond and 1200 mm diameter SWSP culvert inlet and has eroded down past the bench towards the main channel. In several areas the erosion control soil covering has been lifted off by the wind and these areas are now prone to erosion as hydroseeding was not observed. A 25 m wide slump has occurred about 20 m east of the main channel. There is another shallow ~25 m slump that has occurred in the east slope and a tiny slump closer to the 1200 mm diameter culvert outlet on the east slope both of which appeared to have seepage. The east crotch ditch was not U shaped, and erosion is developing along the sides.</p> <p>North Side of Highway: The original issue was severe and extensive erosion. Since construction erosion is moderate. Erosion is evident along the north side of the east crotch ditch which gets slightly worse each year.</p>

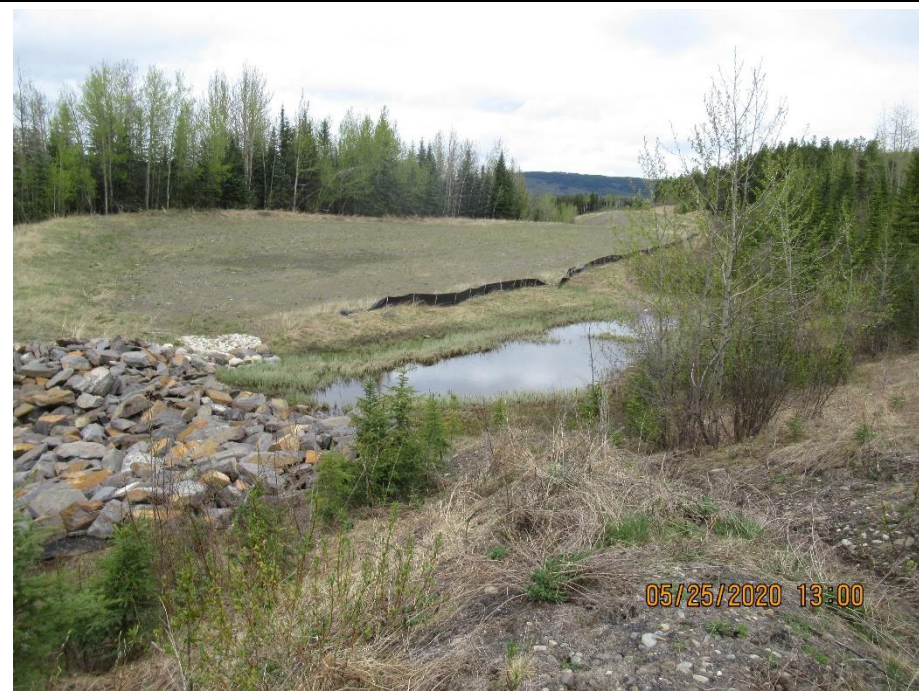
**Photo 1.**  
Looking east at small  
trickling creek and  
ground water  
seepage area  
upslope of pond.

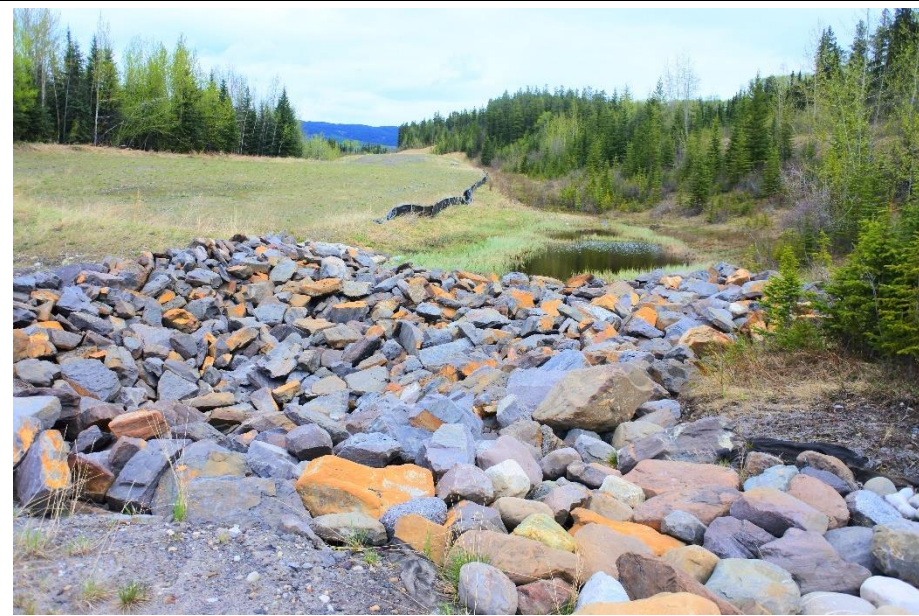
**Photo 2.**  
Looking east at the  
pond area above the  
culvert inlet.

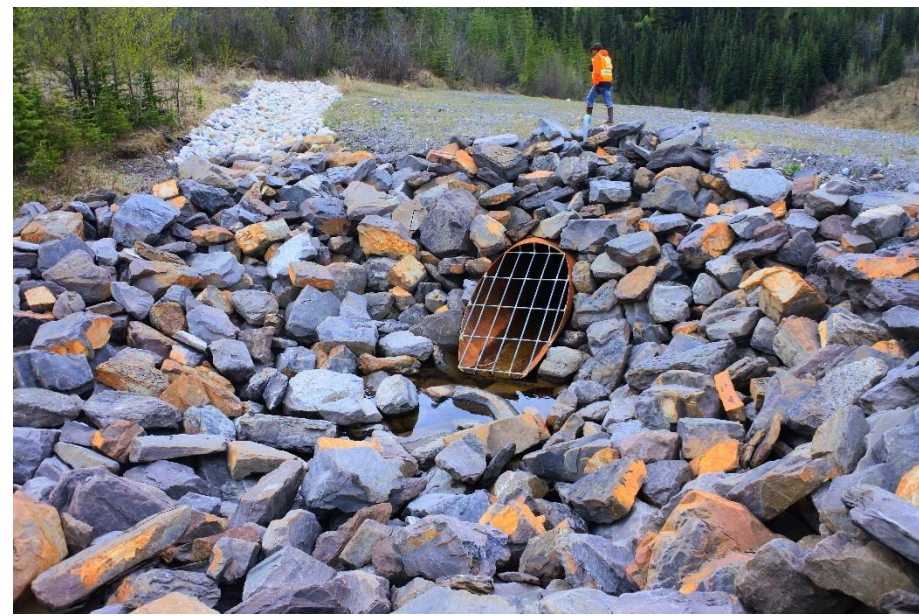
**Photo 3.**  
Looking southwest at  
1200 mm Diam.  
SWSP inlet and  
surrounding rip rap.

6. Complete regular inspections of the 1200 SWSP in the winter by the maintenance contractor to determine when ice build up needs to be removed from the upstream pond and/or when ice in the pipe needs to be cleaned by steaming.

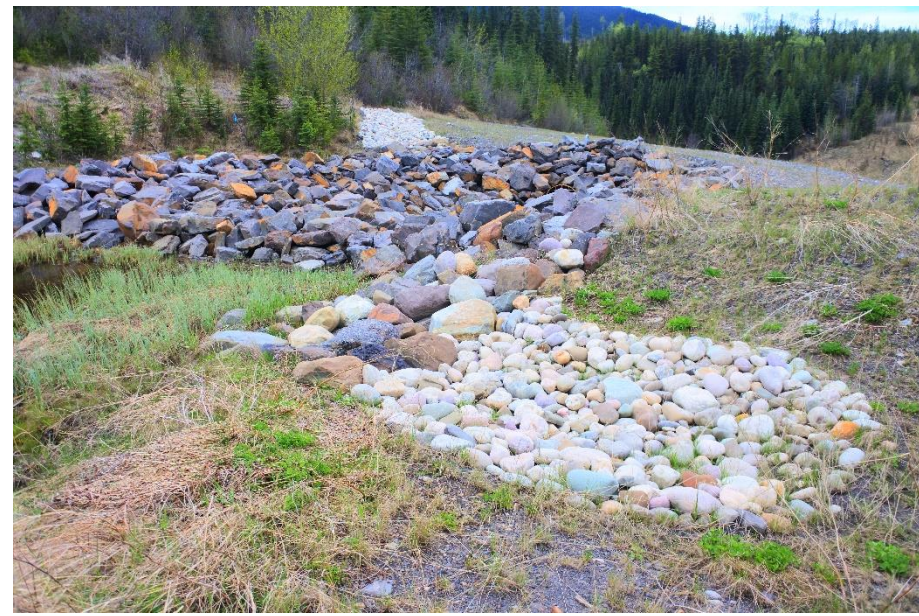
**Photo 4.**  
Looking southwest at  
the added swale  
adjacent and  
downslope of the  
culvert inlet.

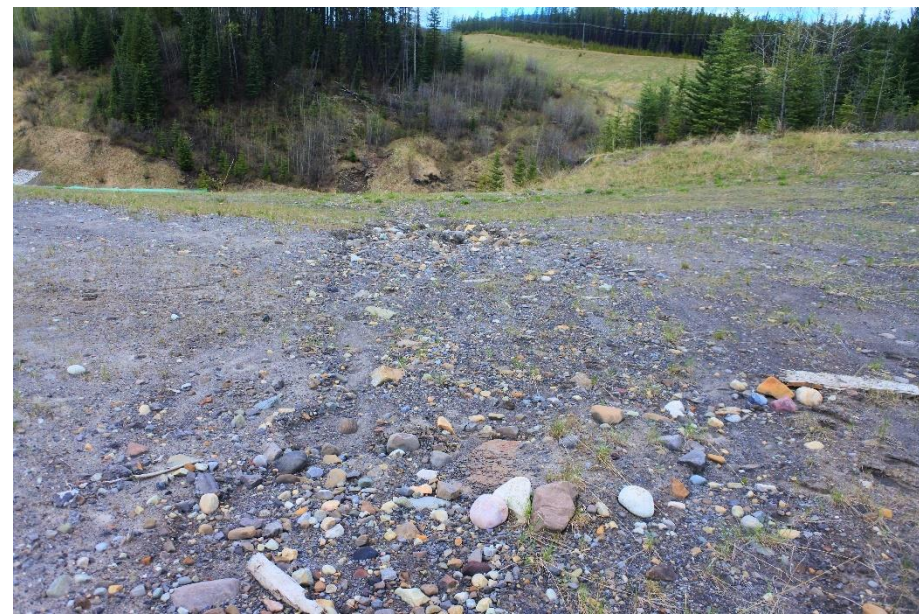
After the repair construction was completed in 2017-2018 erosion was noted in three locations on both the south and north slopes. Ground seepage was also noted in several locations including within the slumped area east of the main channel. Erosion control soil coverings were not adequately pinned down and had been swept off the slope from the wind in some locations. This may be contributing to the erosion below the pond and culvert inlet. The primary cause of this erosion appears to be attributed to the inlet being frozen, the water backing up and overflowing over the slope. Erosion along the edge of the ditches

**Photo 5.**  
Looking west at area eroded by surface water which appears to have been from an overflow over the rip rap due to the culvert being frozen/blocked.

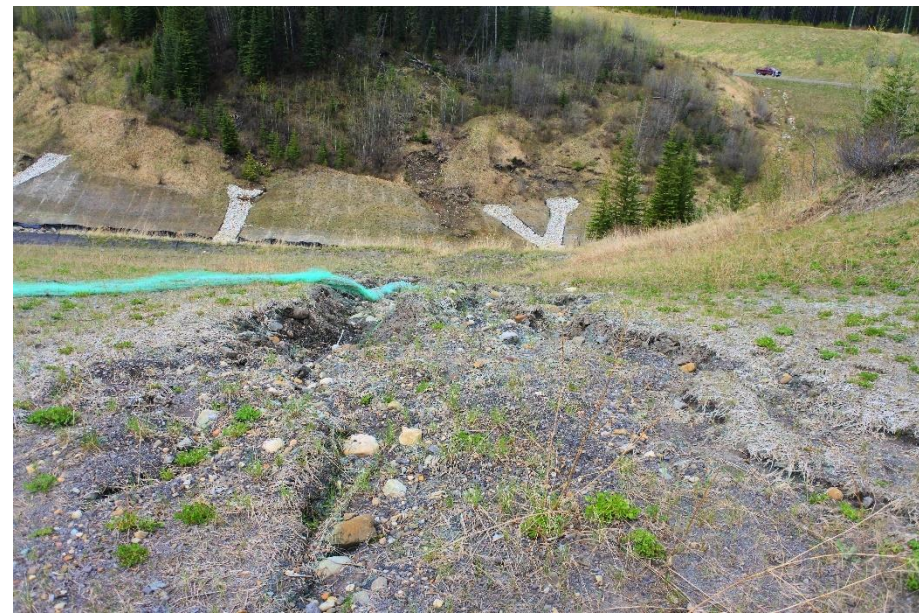
**Photo 6.**  
Looking south at slope east of main channel where erosion control covering had been swept off from wind.

2. Repair the erosion in the east slope of the main channel with compacted clay fill prior to doing step 3.
3. Replace the erosion control matting back onto the slope and properly pin in place, after re-seeding the slopes.

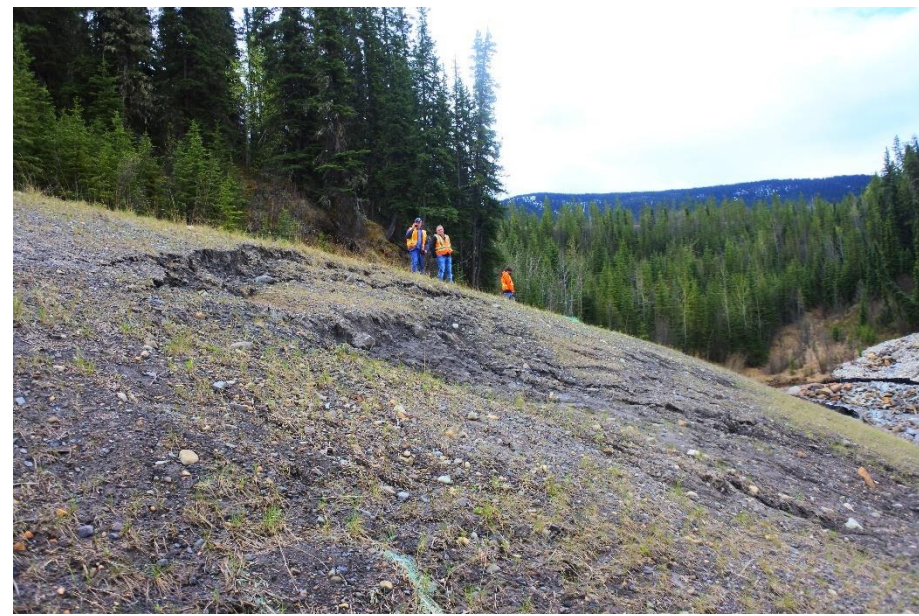
The first slump observed on the east side slope above the main channel had seepage flowing out of the middle, this may be due to a spring or potential buried subdrain outlet.

**Photo 7.**  
Looking south at slumped area. Note ground seepage.

1. Investigate whether the seepage in the slump is due to ground water or the subdrain outlet by digging a test pit. Repair the slumps along the east sidewall of the main channel by removing the slumped material and replacing it with granular fill. Add an armoured swale to allow seepage to flow to main channel and prevent future erosion.

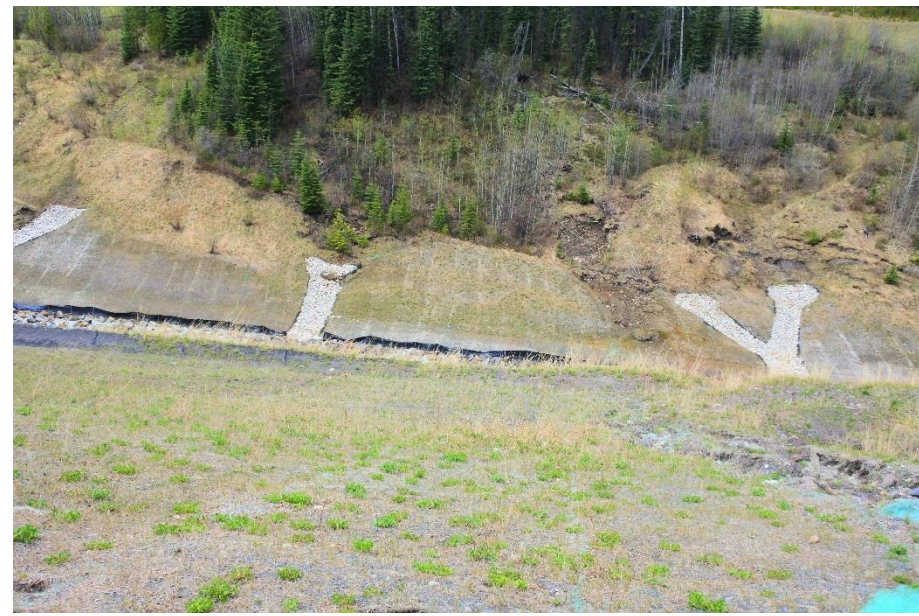
**Photo 8.**  
Looking west towards slope on west side of main channel.

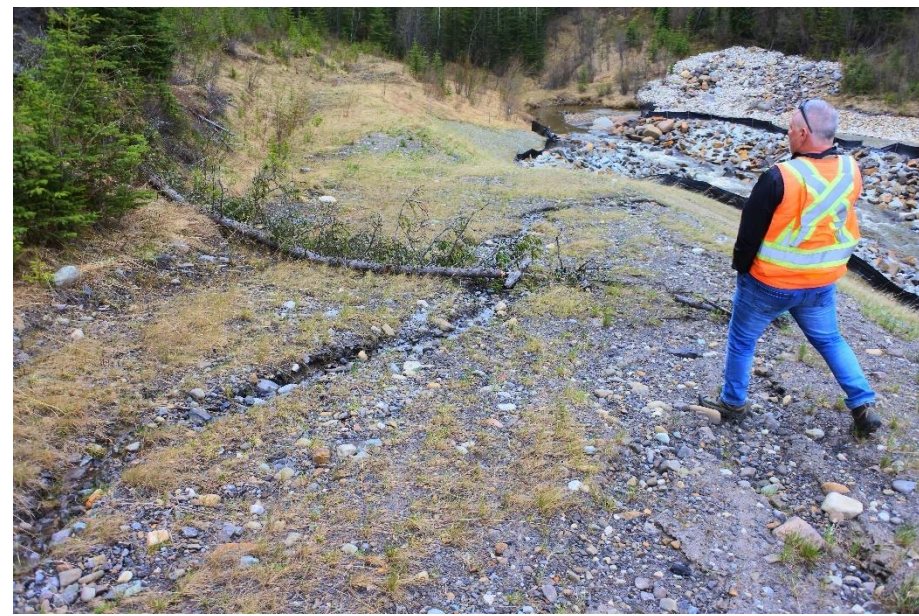
**Photo 9.**  
Looking southwest at  
the buried SWSP  
culvert path.

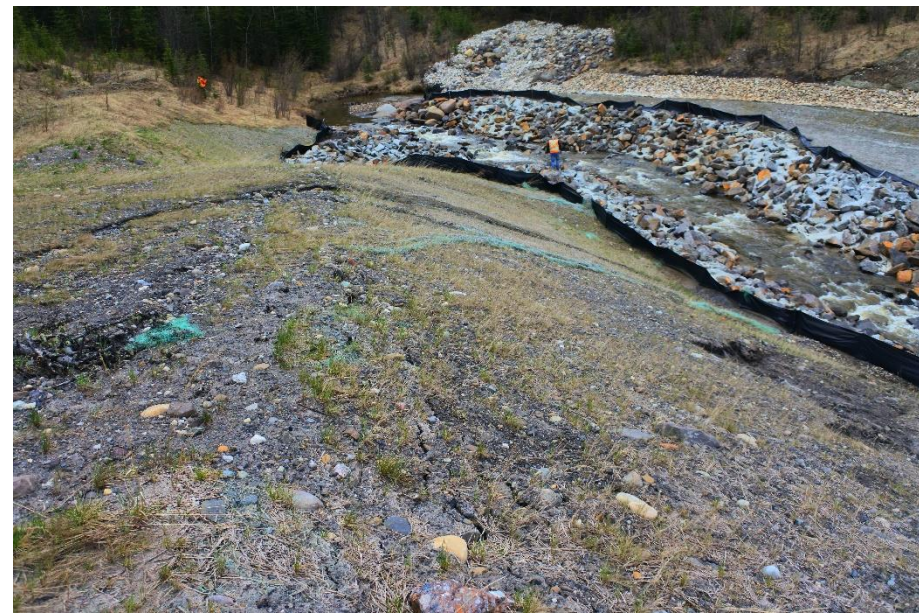
**Photo 10.**  
Looking southwest  
towards dissipation  
bowl, some slight  
surficial erosion.

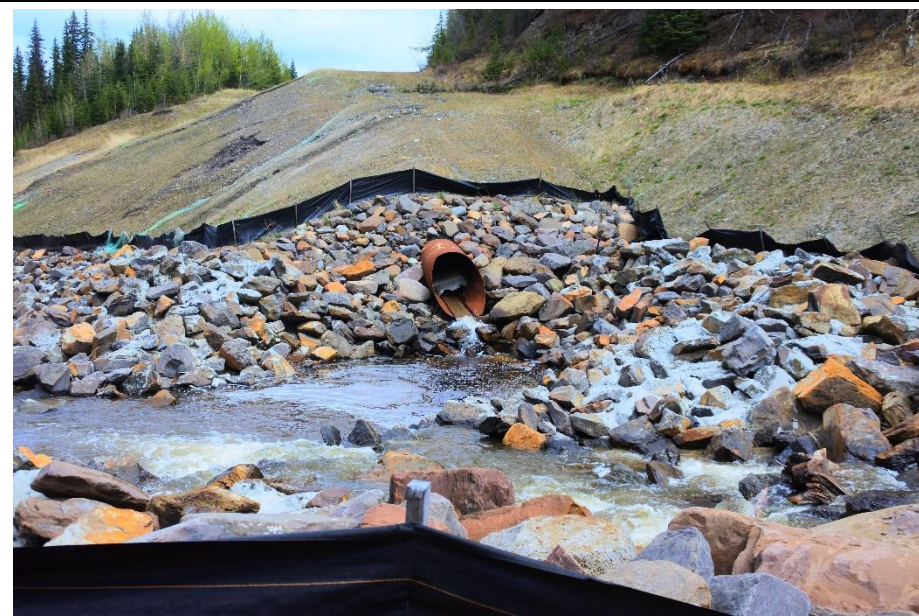
**Photo 11.**  
Looking at outlet of  
1200 mm diam.  
SWSP culvert into  
dissipation bowl.

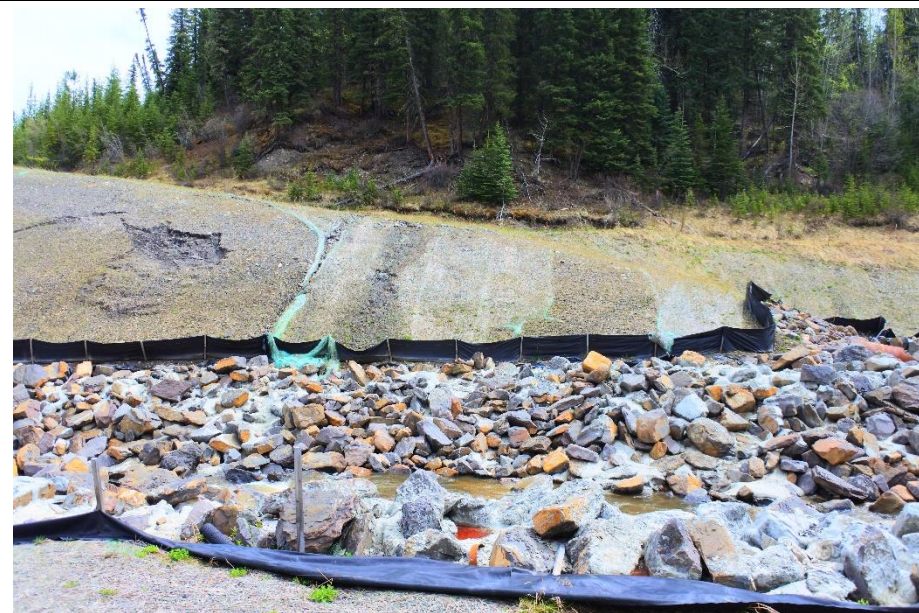
**Photo 12.**  
Looking east at small  
slump.

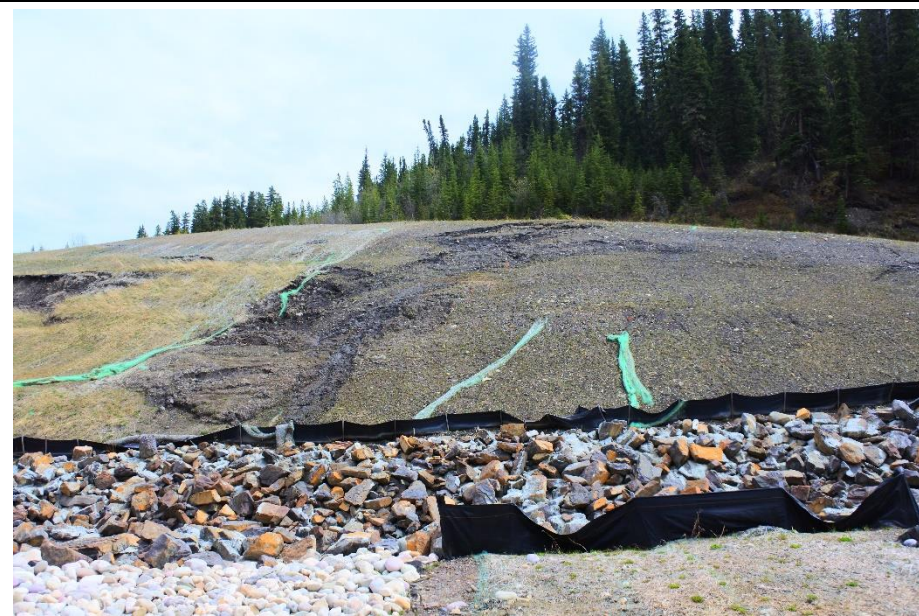
**Photo 13.**  
Looking east at the slumped areas on the east side slope of the main channel.

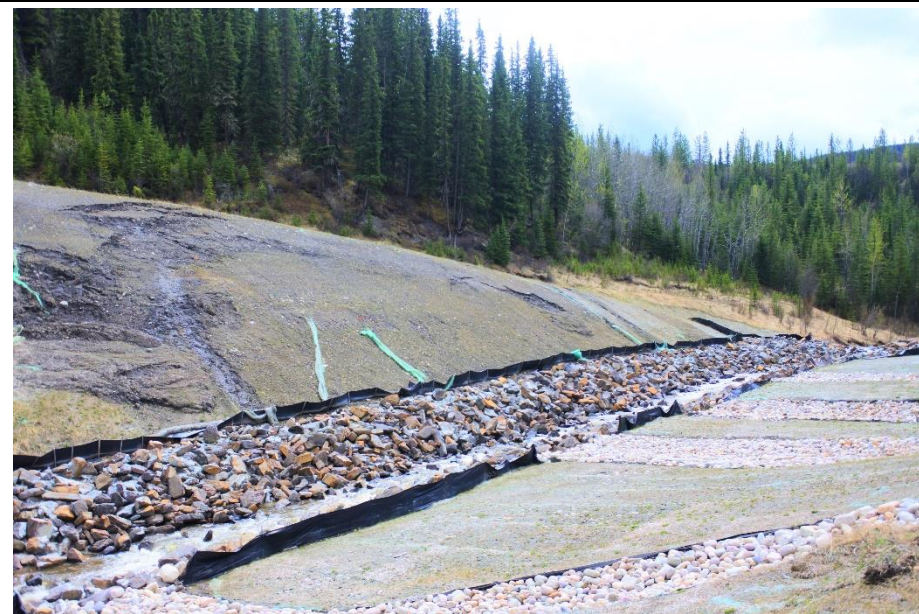
**Photo 14.**  
Looking southeast at the main channel.

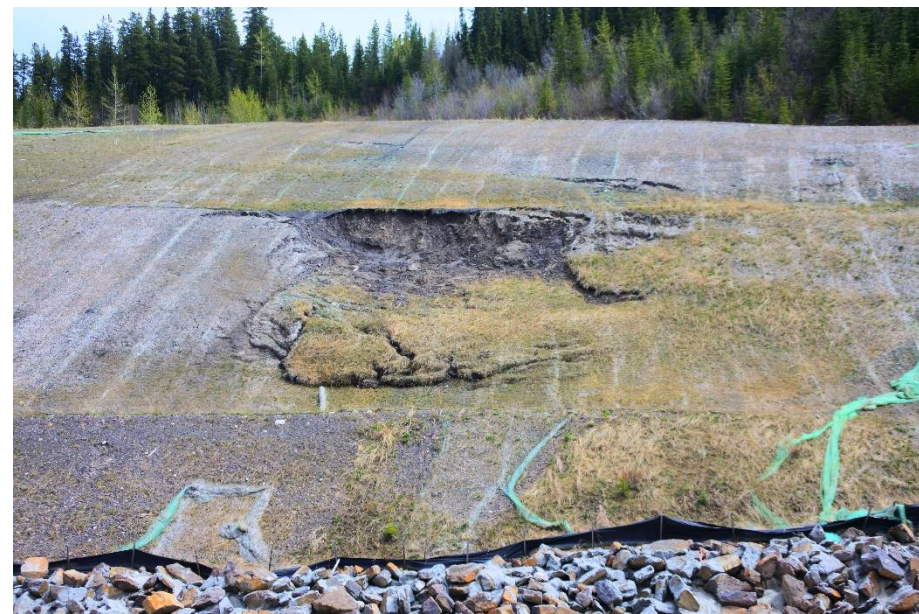
**Photo 15.**  
Looking east at a slump on the east slope.

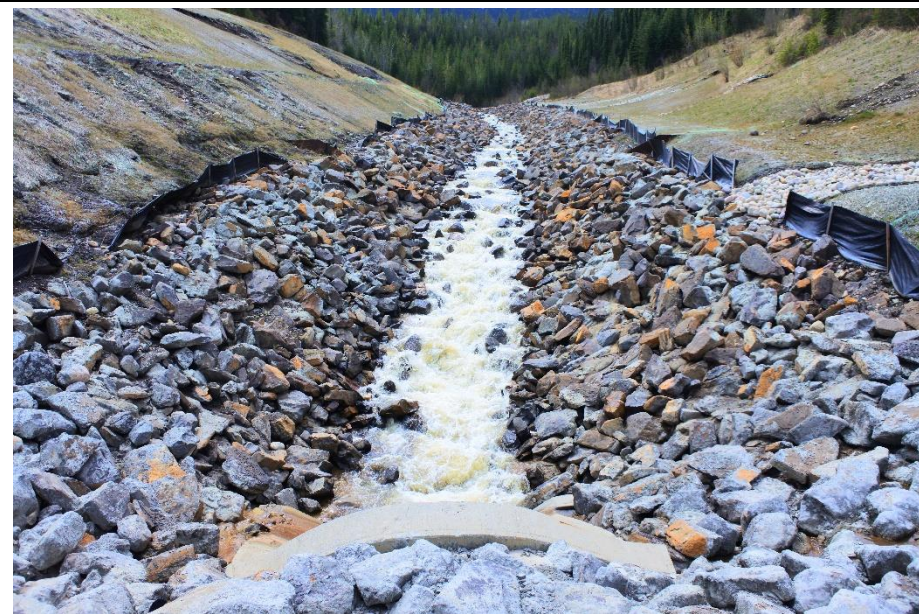
**Photo 16.**  
Looking south at the main channel standing on top of the culvert inlet.

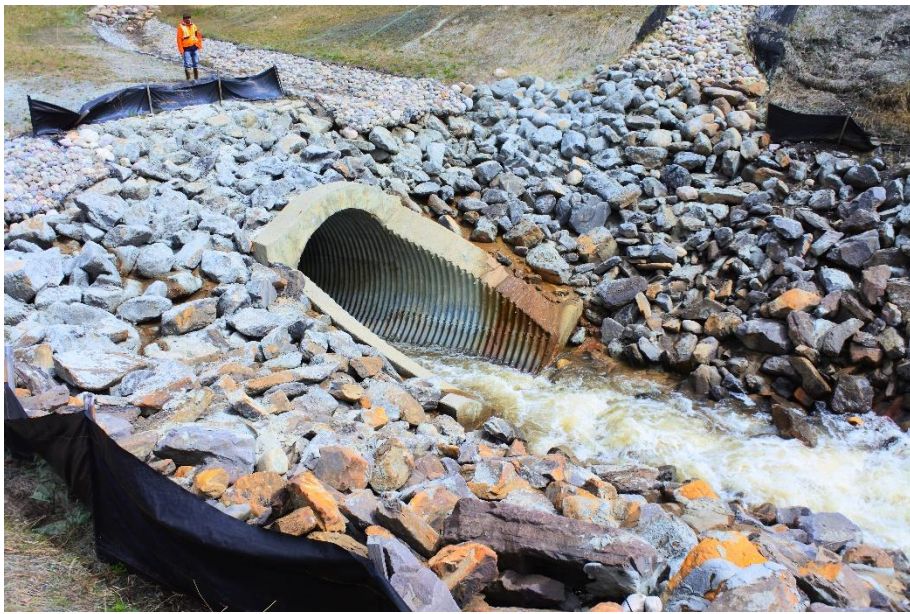
**Photo 17.**  
Looking northeast at the main channel culvert inlet and east crotch ditch.

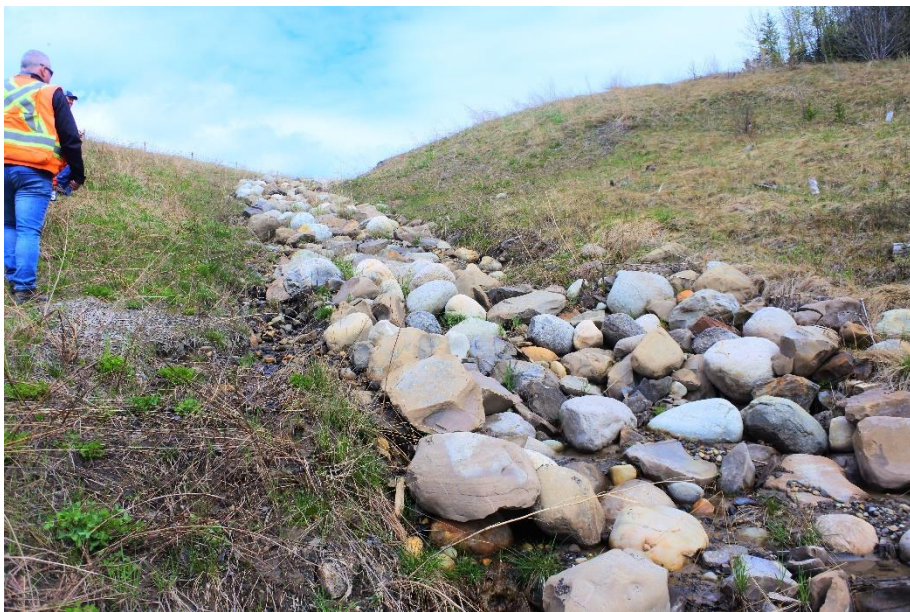
appears to be taking place due to the rip rap being mounded instead of a u-shaped swale. Areas that have been broadcast seeded are showing some signs of grass growth; however, the areas that were supposedly hydroseeded did not show any signs of grass growth.

**Photo 18.**  
Looking northeast at the east crotch ditch that has some erosion along its sides.

4. Repair the erosion along the east crotch ditch on the north side of the highway by filling the gully with compacted clay and add more riprap.
5. Repair the shape of the east crotch ditch on the south side of highway to u-shaped and repair erosion with compacted clay and additional riprap.

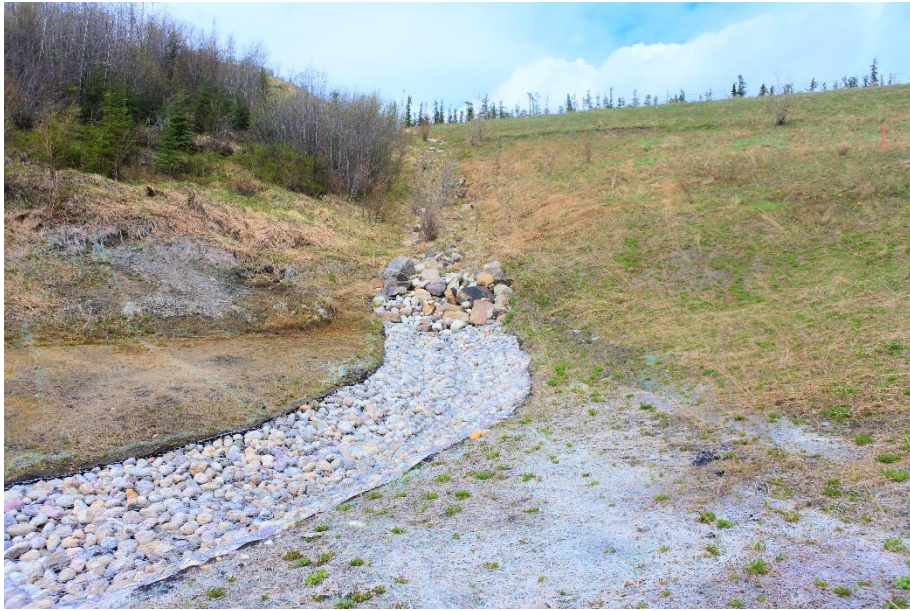
**Photo 19.**  
Looking northwest at  
west crotch ditch.

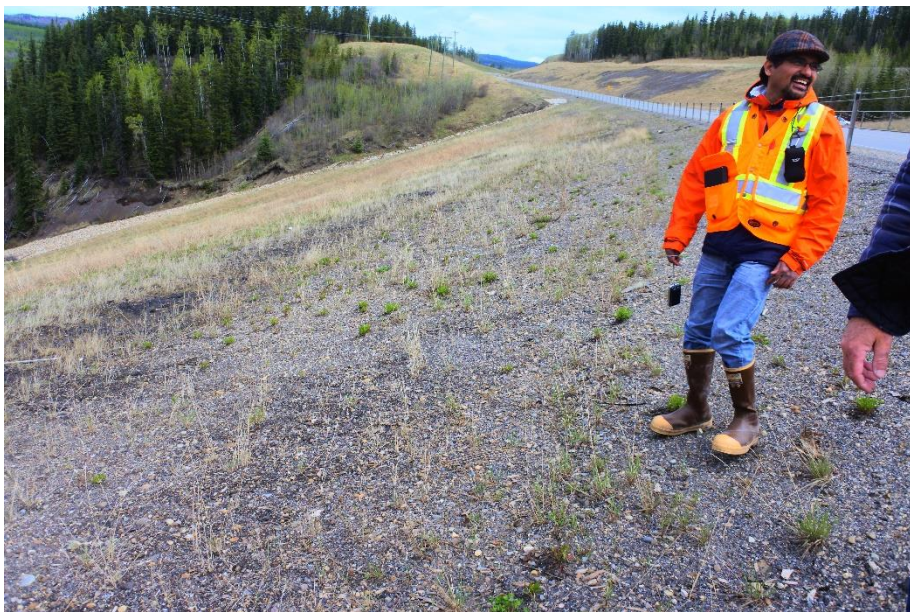
**Photo 20.**  
Looking northeast at  
slope north of the  
highway. Some grass  
is growing from  
broadcast seeding.

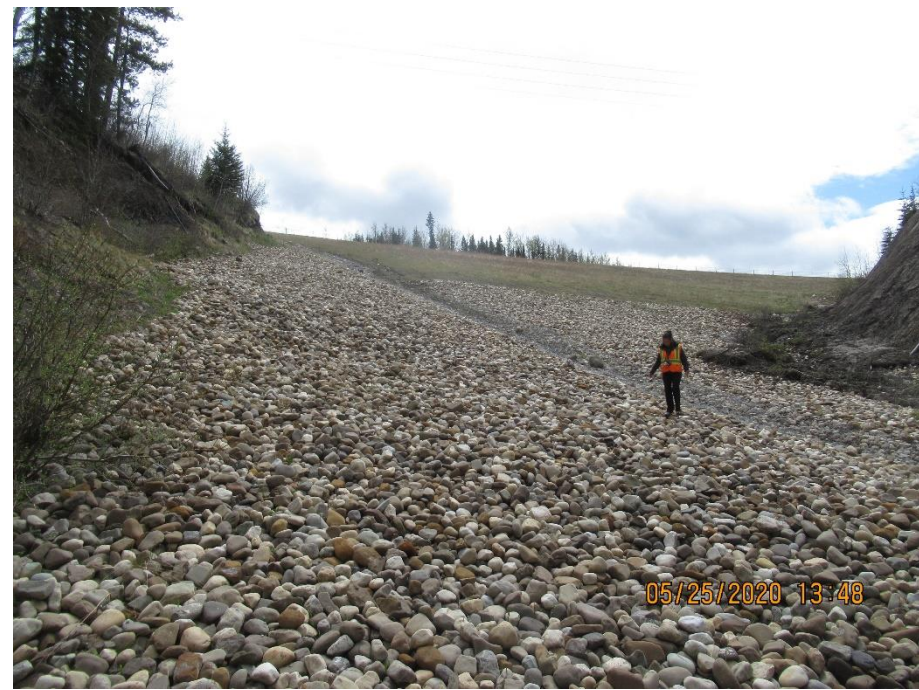
**Photo 21.**  
Looking south at beginning of crotch ditches and gabion mattresses on the north side of the highway.

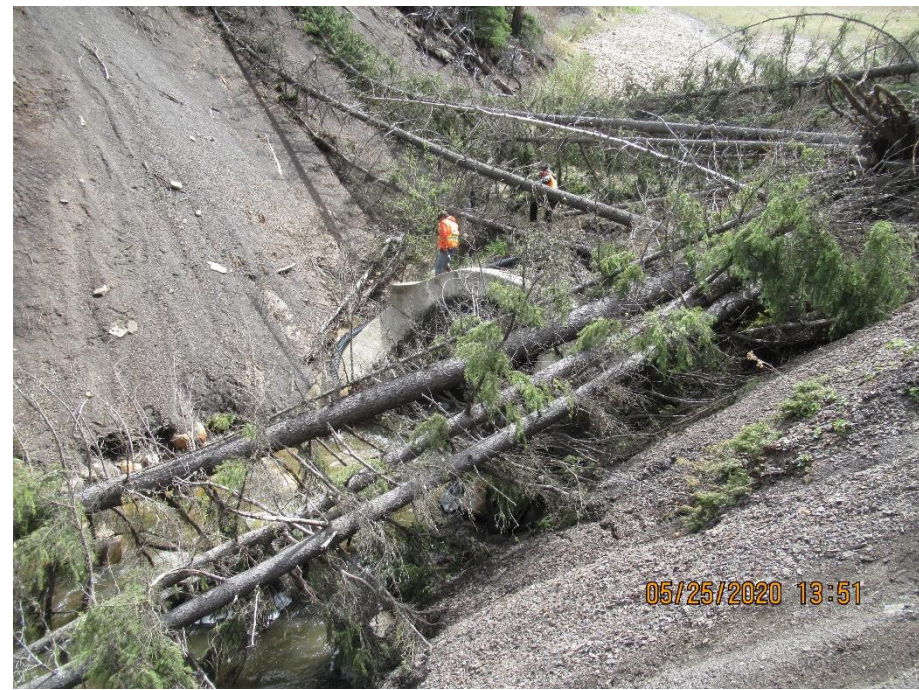
**Photo 22.**  
Looking southeast at the culvert outlet covered by fallen trees.

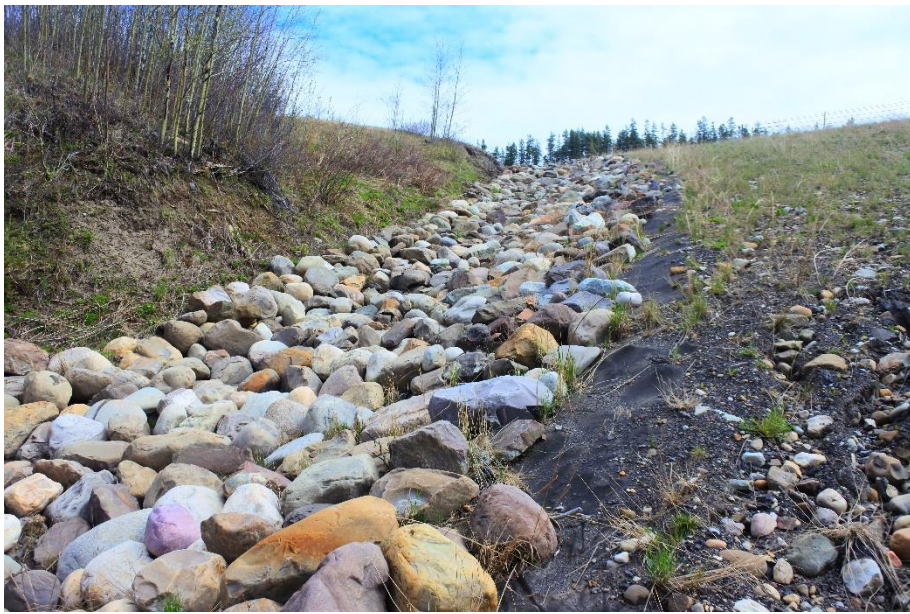
**Photo 23.**  
Looking southeast at  
the east crotch ditch.

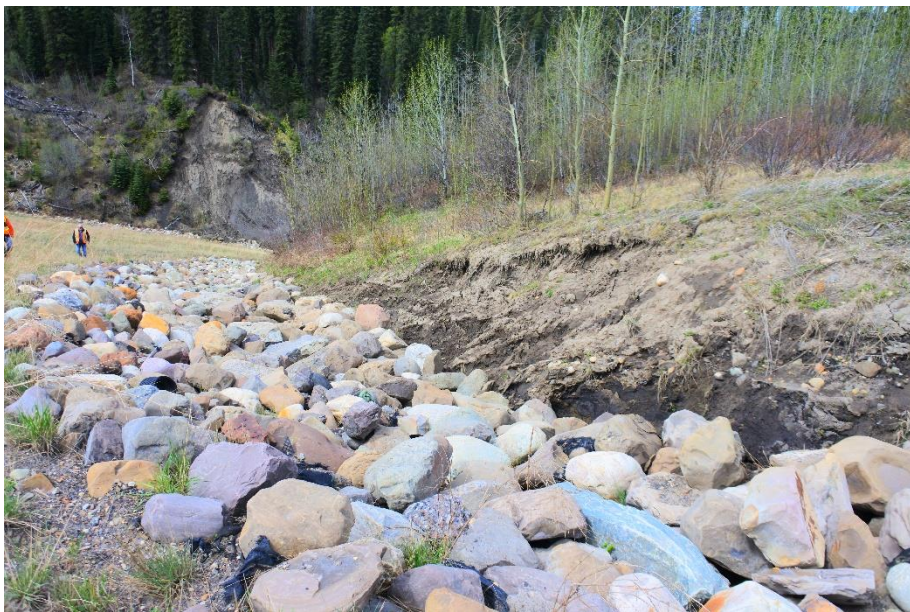
**Photo 24.**  
Looking northwest at  
erosion occurring on  
the north side of the  
east crotch ditch.
