SITE INSPECTION FORM

SITE NUMBER AND NAME: GP032 South Curve Realignment		HIGHWAY & KM: 40:34, 16.385	PREVIOUS INSPECTION DATE: May 25, 2020	INSPECTION DATE: June 13, 2022
LEGAL DESCRIPTION: SW 13-57-07-W6M	NAD 83 COORDINATES: UTM Northing Easting 11 5976757 374408		RISK ASSESSMENT: PF: 8 CF: 2 TOTAL: 16	
AVERAGE ANNUAL DAILY TRAFFIC (AADT): 1320 (west) & 1290 (east) (Reference No. 70000102, 2021)			CONTRACT MAINTENANCE AREA (CMA): 504

PRIMARY SITE ISSUE: Several areas of (geotechnical) distress/concern along channel upstream/south of Hwy 40:34 embankment, including a series of slope failures, rill and gully erosion, and areas of seepage (moist, no visible flow) and leakage (visible flow).
APPROXIMATE DIMENSIONS: Highway embankment approximately 40 m to 50 m high with an approximate 3H:1V slope. Channel upstream of culvert/toe of highway embankment is approximately 180 m long.
DATE OF ANY REMEDIAL ACTION: 2017/2018 – repair completed, including lining channel with riprap, constructing several riprap-lined finger and slope drains, and constructing a catch basin and buried smooth-walled-steel-pipe (SWSP) slope drain.

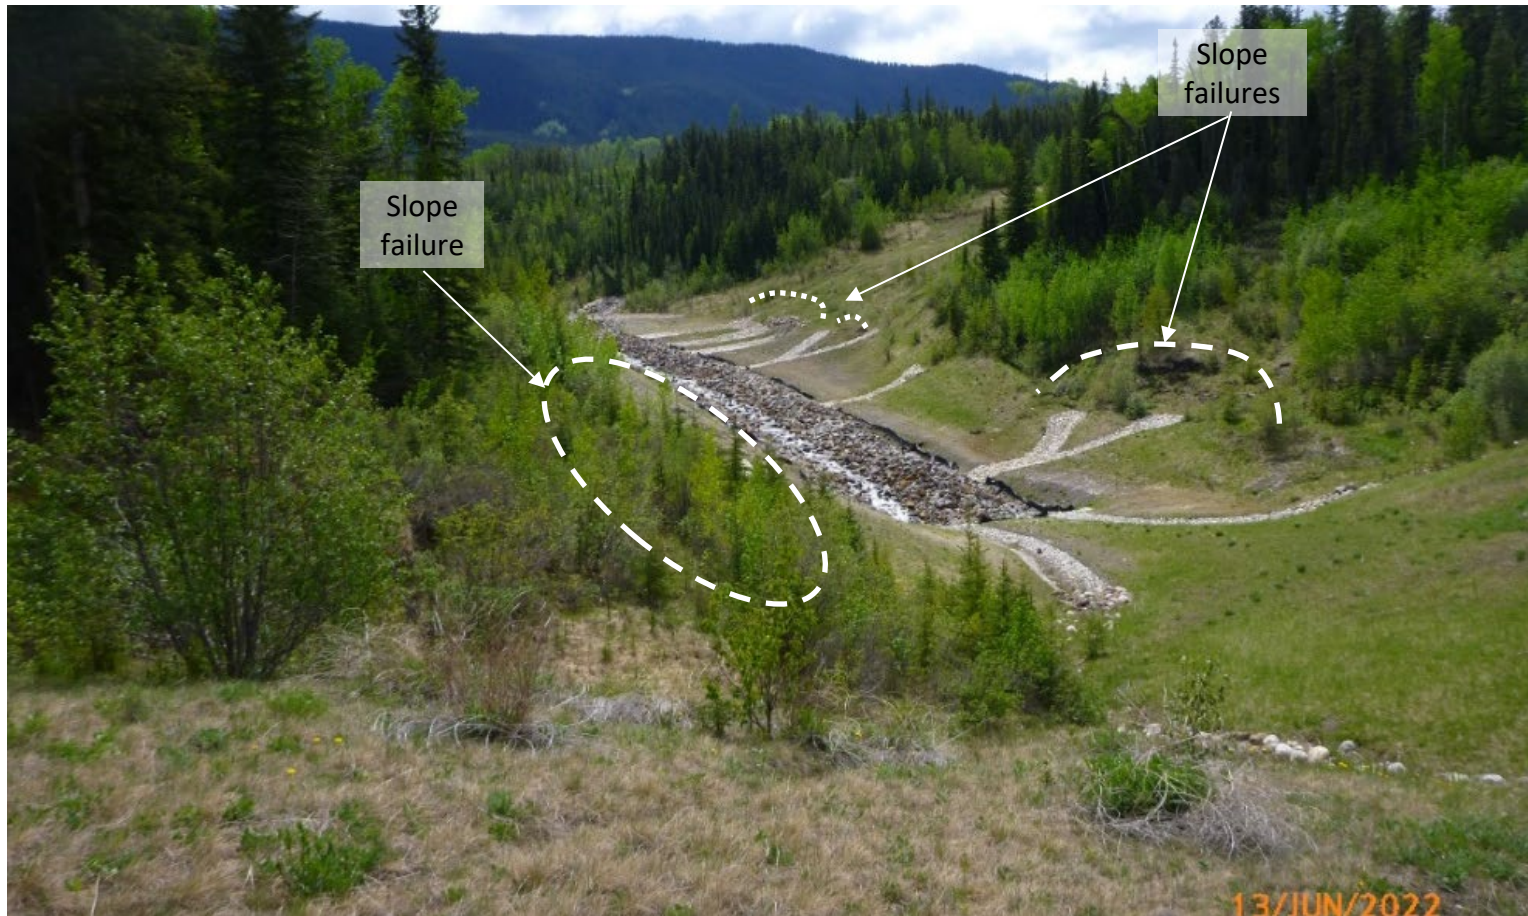
Photo 1 Overview of channel upstream/south of Hwy 40:34. Note riprap-lined channel and finger drains. As well as location of cracking and slope movement along valley slopes (circled in white/indicated with dotted white lines) (Photos 2, 4 and 6), and. Photo taken June 13, 2022, facing southwest.

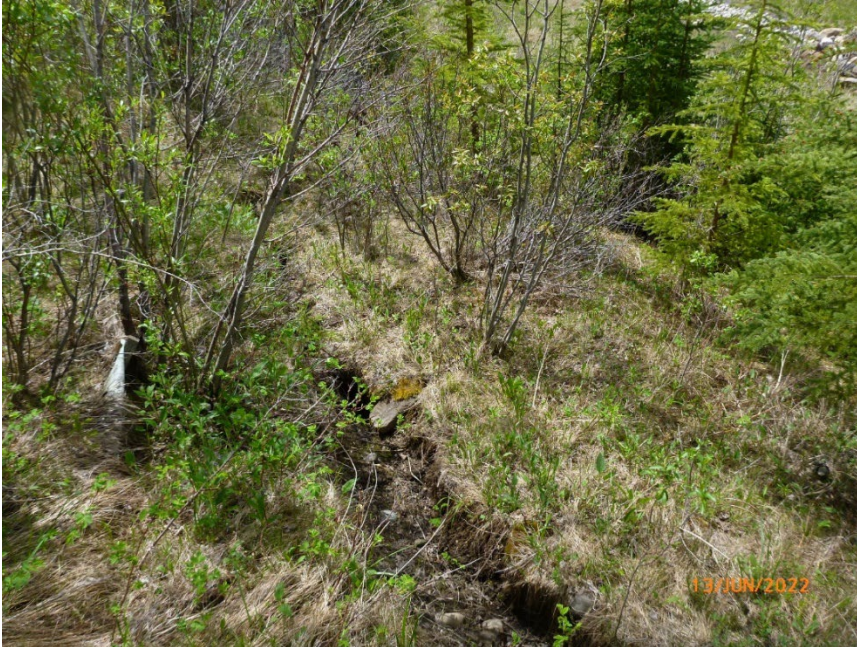
Photo 2 **Cracking along valley slope near southeast abutment of highway embankment.**
Photo taken June 13, 2022, facing south.

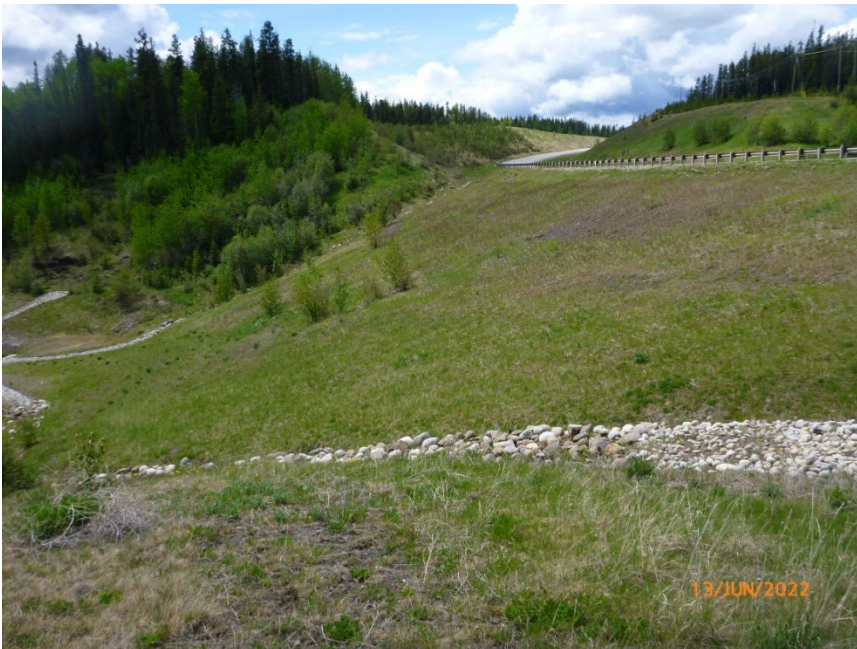
Photo 3 **Upstream/south slope of Hwy 40:34 embankment above culvert inlet. Photo taken**
June 13, 2022, facing west.

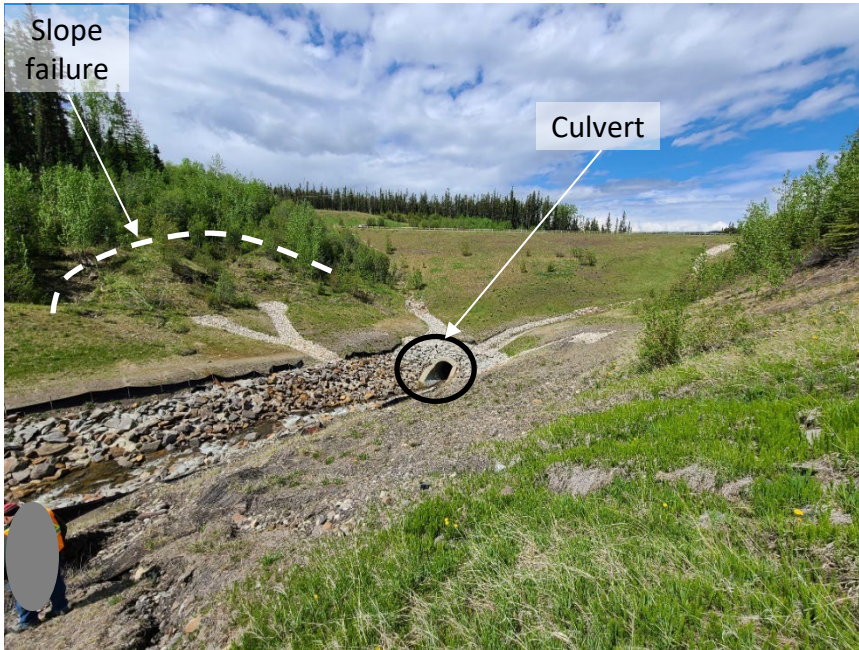
Photo 4 Upstream/south slope and toe of Hwy 40:34 embankment. Note culvert inlet (circled black) and slope failure above “Y-shaped” finger drain on west valley slope (indicated with dotted white line). Photo taken June 13, 2022, facing northwest.

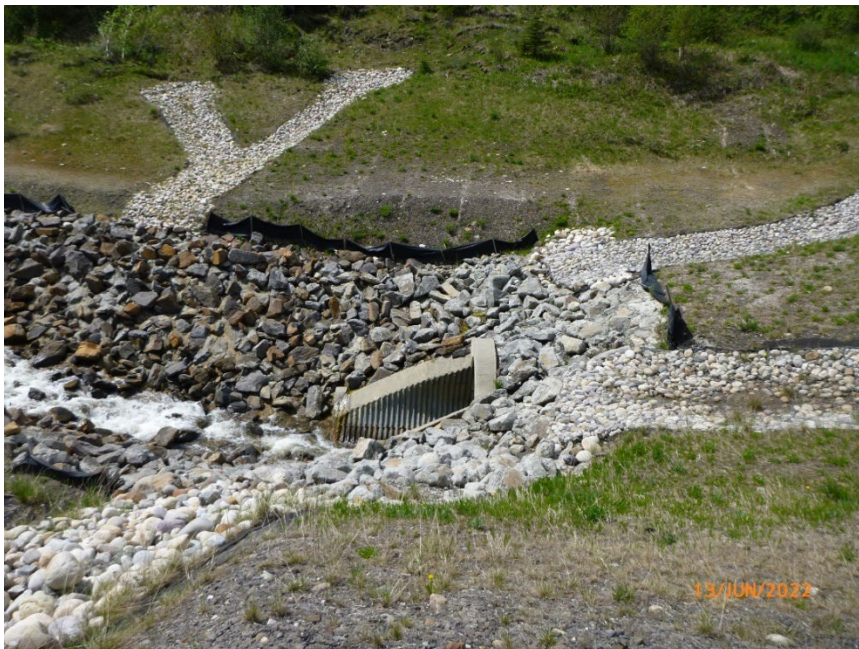
- These generally appear to be in good condition.
- Riprap at base of channel was grouted.

Photo 5 Inlet of 3000-mm diameter CSP culvert at upstream/south toe of Hwy 40:34 embankment. Photo taken June 13, 2022, facing west.

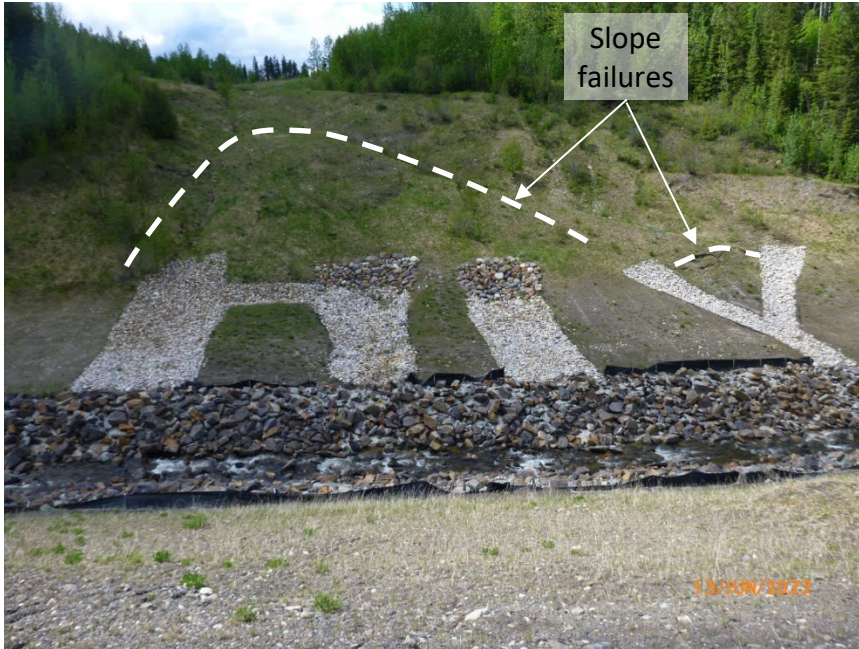
- Three slope failures/slumps observed on slope above finger drains. Otherwise, finger drains appear to be in good condition.
- AT noted west slope was so wet during construction equipment could not track area. Surface conditions improved after finger drains were constructed.

Photo 6 Slope failures/slumps above finger drains on west valley slope (indicated with dotted white lines). Photo taken June 13, 2022, facing west.

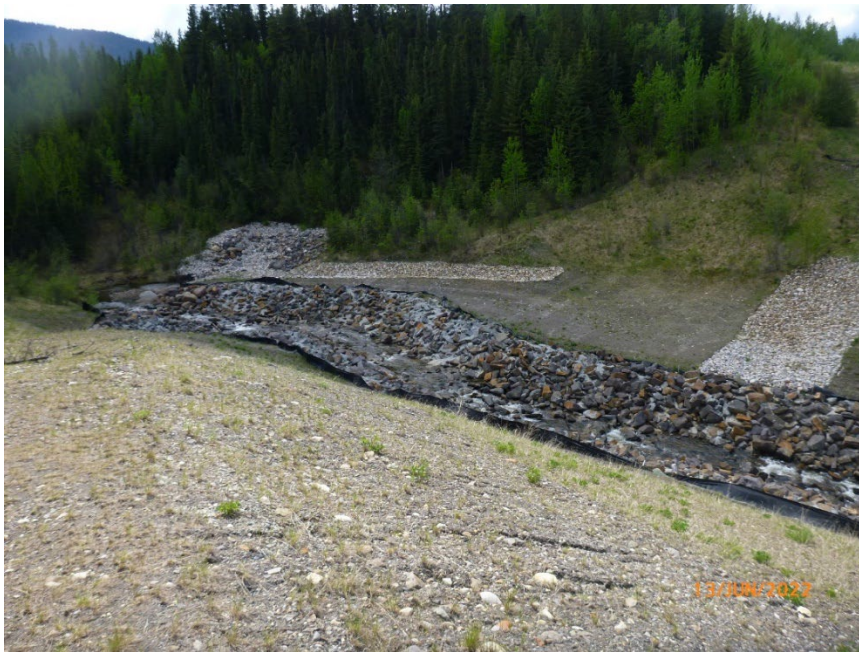
Photo 7 Upstream/south extent of riprap-lined channel. Note rill erosion on east valley slope. Photo taken June 13, 2022, facing southwest.

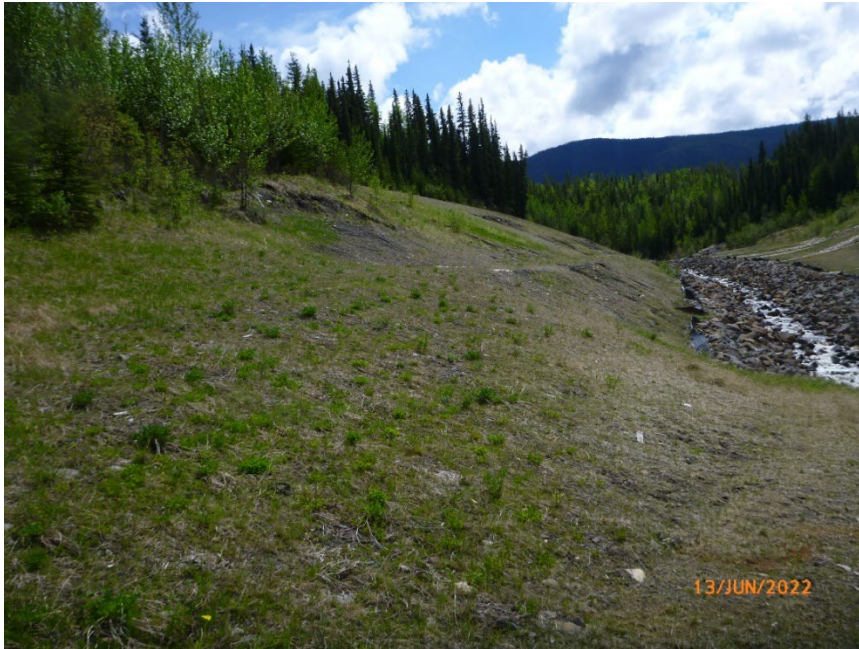
- Two slope failures, rill and gully erosion (including a well-formed “Y-shaped” gully at WP184), and seepage/leakage observed on slope. North slope failure at WP183 is within trees and difficult to assess. South slope failure at WP185 may consist of three separate slope failures, one of which extends to the slope crest and is within 5 m of the buried slope drain.
- Mid-slope bench (approximately 1 m to 2 m wide) has insufficient freeboard and requires grading.
- Slope is poorly vegetated in areas with rolled erosion control product exposed.

Photo 8 East valley slope. Note gully erosion and slope failures along slope. Photo taken June 13, 2022, facing south.

- KCB requested by AT to prepare a proposal for a “sketch” design package for a highway maintenance contractor (HMC) repair. The repair will include:
 - Construction of a berm around the riprap-lined catch basin and culvert inlet at the crest of the east valley slope with swales if catch basin were to overflow again.
 - Armoring the “Y-shaped” gully on the east valley slope to the toe of the slope/creek to create a slope drain.
 - Drainage improvements along the mid-slope bench on the east valley slope, which may include installation of a half-section of corrugated-steel pipe (CSP) along the bench.
 - Regrading of the slope failures on the east valley slope.
 - Reseeding the east valley slope.
 - Removal of silt fence, which is falling down.

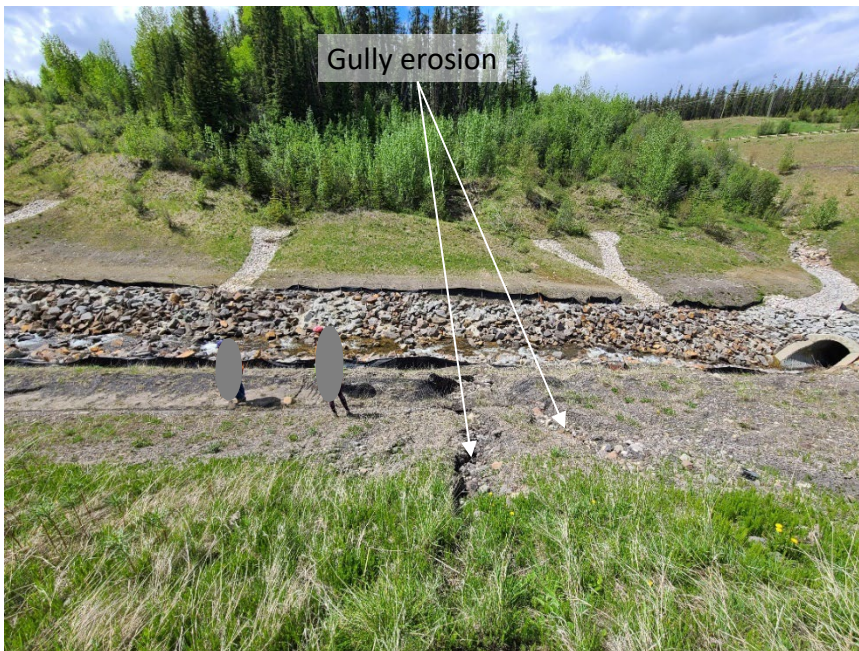
Photo 9 Erosion gullies on east valley slope at WP184. Photo taken June 13, 2022, facing west.

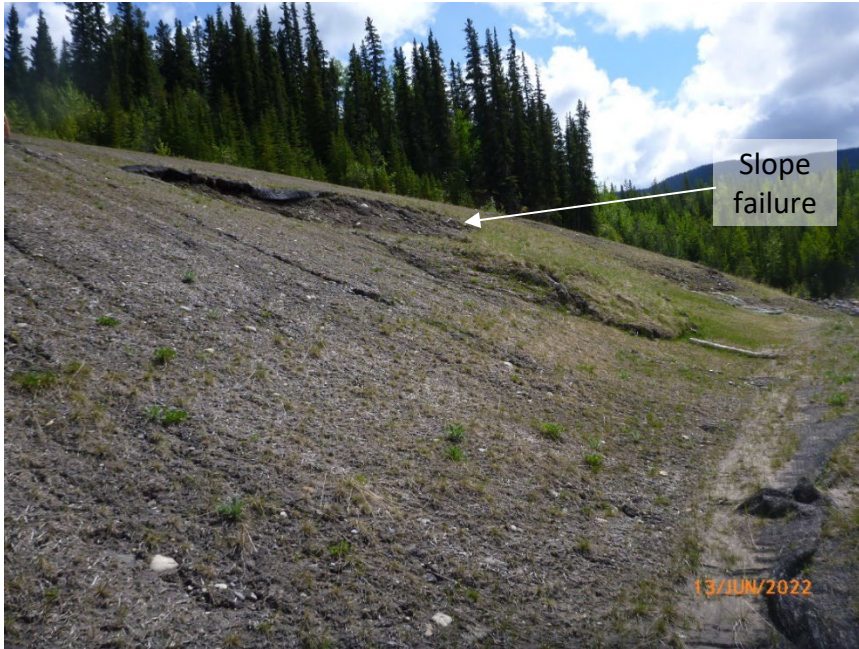
Photo 10 Slope failure and rill erosion on east valley slope between WP184 and WP185. Photo taken June 13, 2022, facing southeast.

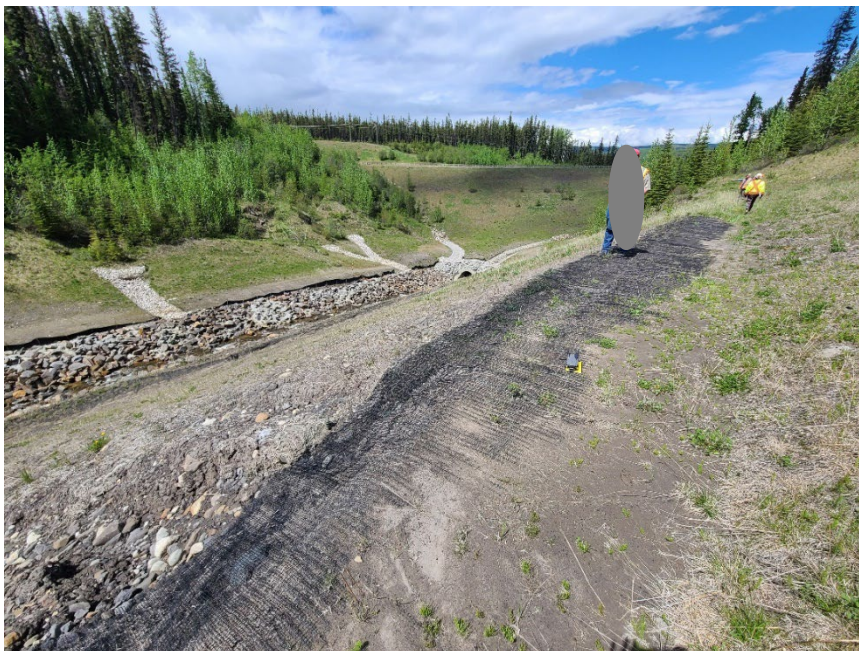
Photo 11 Mid-slope bench on east valley slope. Photo taken June 13, 2022, facing northwest.

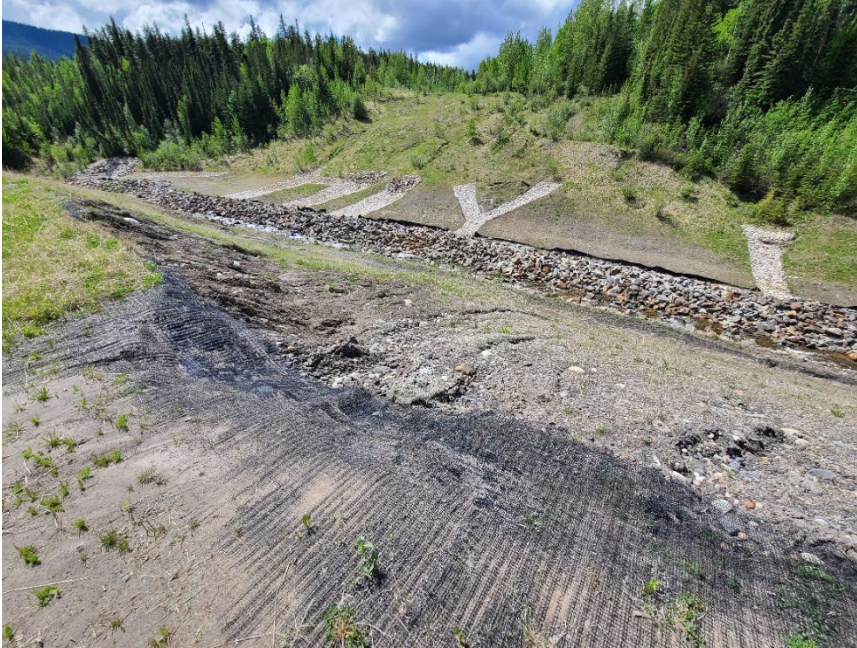
Photo 12 Crest of slope failure along mid-slope bench on east valley slope between WP184 and WP185. Slope failure is about 5 m from buried slope drain. Photo taken June 13, 2022, facing southwest.

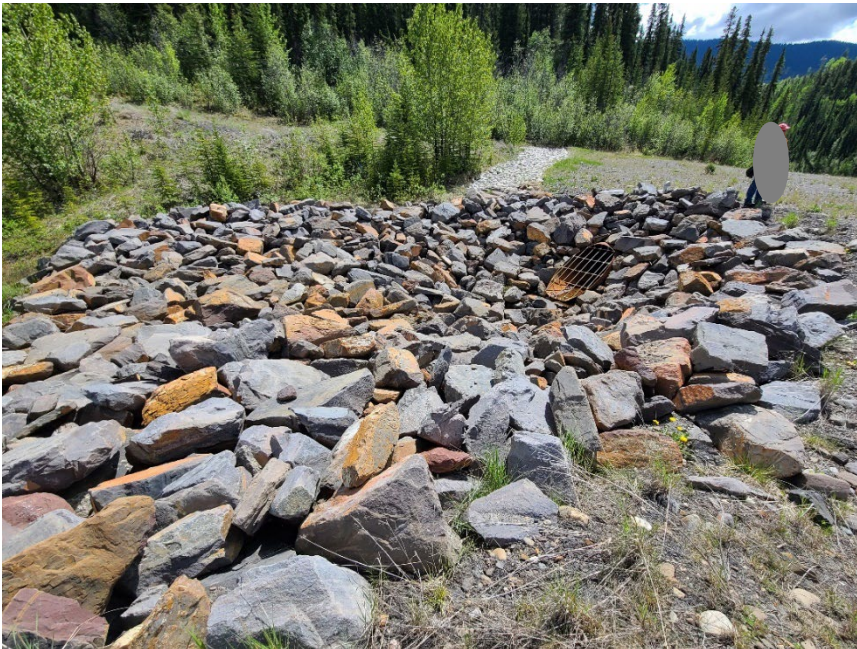
- Slope drain installed at shallow depth and is possibly freezing. Rill and gully erosion on crest of slope adjacent to catch basin and down east valley slope indicates catch basin has overflowed likely due to ice blocking culvert flow.
- Trash rack over slope drain inlet.

Photo 13 Riprap-lined catch basin and buried slope drain inlet. Photo taken June 13, 2022, facing south.

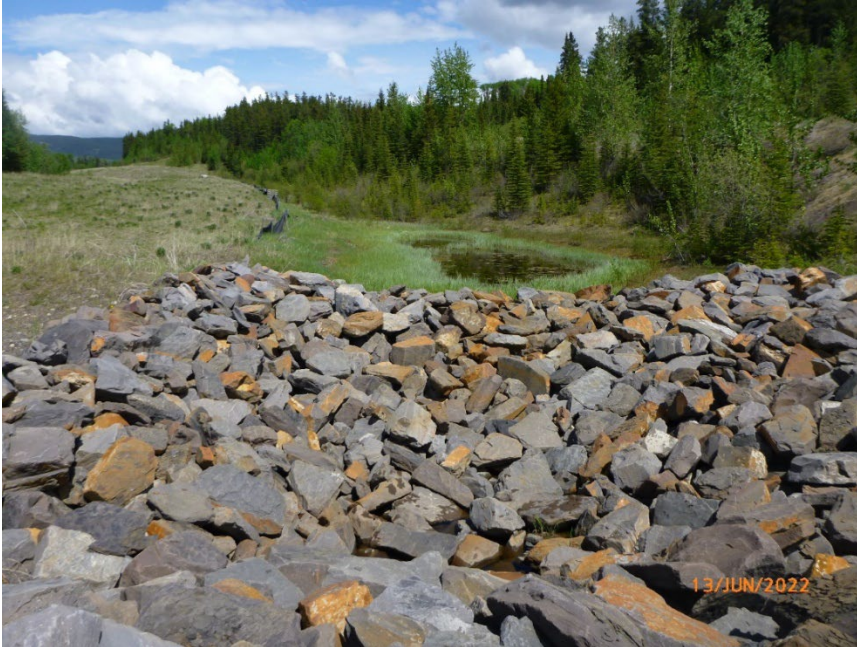
Photo 14 Pond upstream/northeast of riprap-lined catch basin. Photo taken June 13, 2022, facing northeast.

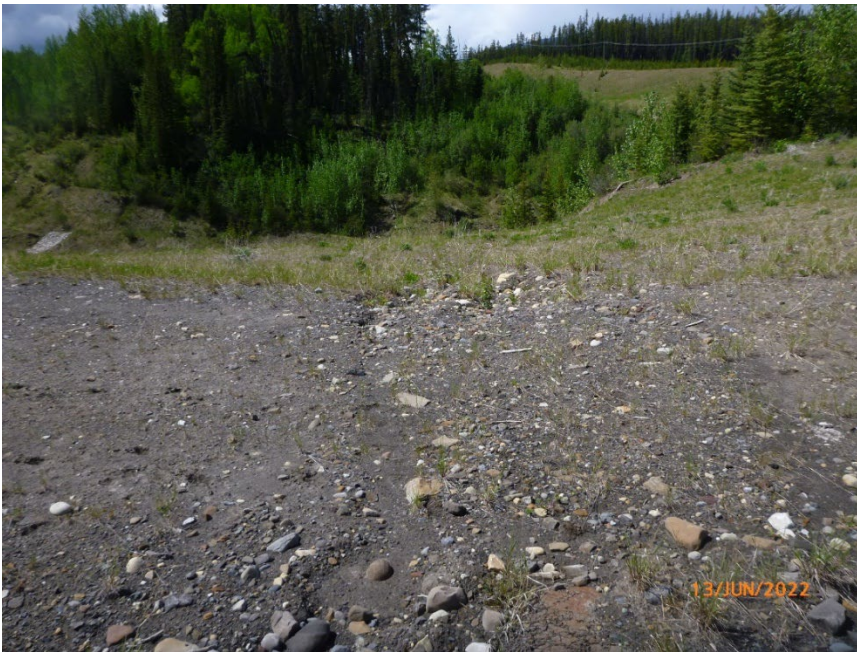
Photo 15 Erosion between catch basin and crest of east valley slope indicates catch basin may have previously overflowed. Photo taken June 13, 2022, facing west.
