SITE INSPECTION FORM

SITE NUMBER AND NAME: GP032 South Curve (S-Curve) Realignment		HIGHWAY & KM: 40:34, 16.385	PREVIOUS INSPECTION DATE: June 13, 2022	INSPECTION DATE: June 2, 2025
LEGAL DESCRIPTION: SW 13-57-07-W6M	NAD 83 COORDINATES: UTM Northing Easting 11 5976757 374408		RISK ASSESSMENT: PF: 4 CF: 6 TOTAL: 24	
AVERAGE ANNUAL DAILY TRAFFIC (AADT): 1,190 (west) & 1,170 (east) (Reference No. 70000102, 2024)			CONTRACT MAINTENANCE AREA (CMA): 504

PRIMARY SITE ISSUE: Several areas of (geotechnical) distress/concern along channel within former Hwy 40:34 alignment (south of current highway alignment), including a series of slope failures, rill and gully erosion, and areas of seepage (moist, no visible flow) and leakage (visible flow). Some of which was repaired in 2017/2018 and 2024.

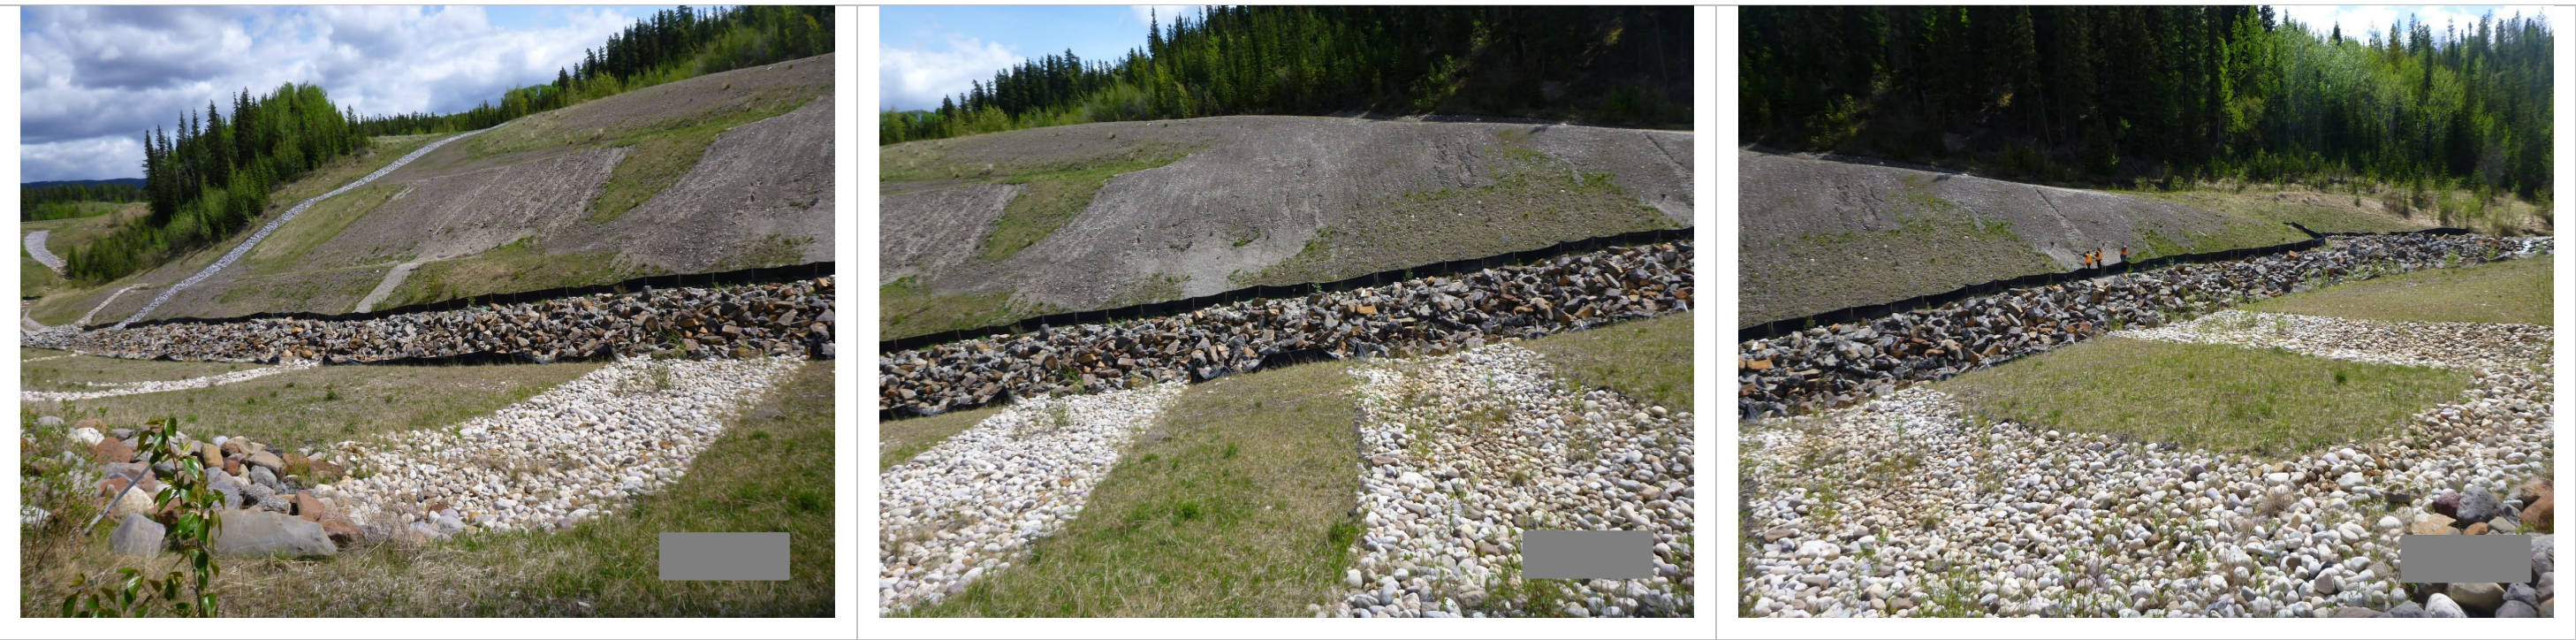
- Vegetation is slowly growing and coverage on the repaired slope was poor (Photos 3 through 5).
- Three slides repaired in 2024 generally appeared to be in good condition, except for some rill and gully erosion, including a gully down the middle of the south slide repair (Photo 12, WP025), and a seepage spot that appeared at the south edge of the north slide repair shortly after the repair was completed (Photo 7). The seepage spot appeared drier than it was in 2024 and does not appear to be expanding in size.

Photo 1 East valley slope repaired in 2024. Note repaired areas are poorly vegetated. Photos taken June 2, 2025, facing northeast, east, and southeast, respectively.

- Hydro mulching of the areas repaired and used for construction access in 2024 should be considered to help establish vegetation and reduce erosion potential. Estimated cost: \$10,000 to \$15,000.
- This site should continue to be inspected by the Maintenance Contract Inspector (MCI) and inspected at least once during the next contract cycle as part of the GP South GRMP Section B inspections. If the repairs continue to perform well, TEC could consider removing the site from the list of active GRMP sites and excluding it from the GP South GRMP Section B inspections. If site conditions were to deteriorate, the site could always be returned to the list of active GRMP sites and inspected again as part of a Section B inspection or Section D call-out inspection.

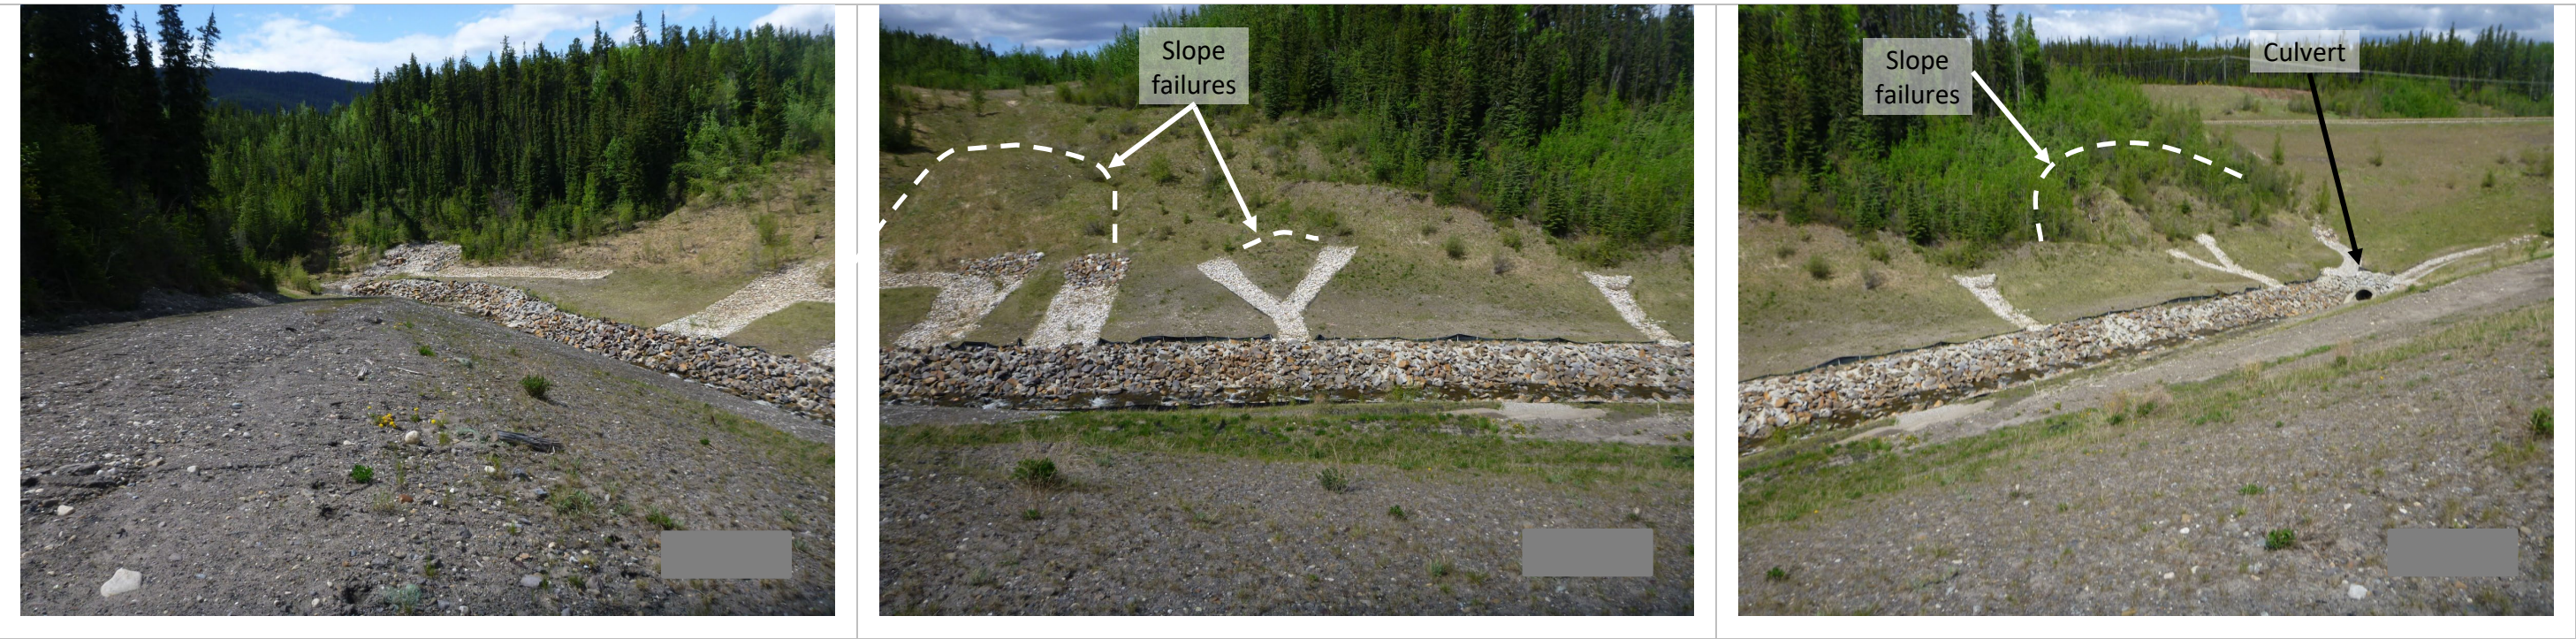
- Three slope failures/slumps observed on slope above finger drains. Otherwise, finger drains appeared to be in good condition.
- TEC has previously noted west slope was so wet during construction equipment could not track area. Surface conditions improved after finger drains were constructed. At the time of the 2025 inspection, a wet spot was observed at WP026.

Photo 2 West slope previously repaired in 2017/2018. Note slope failures/slumps above finger drains (indicated with white lines) and inlet of 3-m diameter culvert at south toe of Hwy 40:34 embankment. Photos taken June 2, 2025, facing southwest, west, and northwest, respectively.

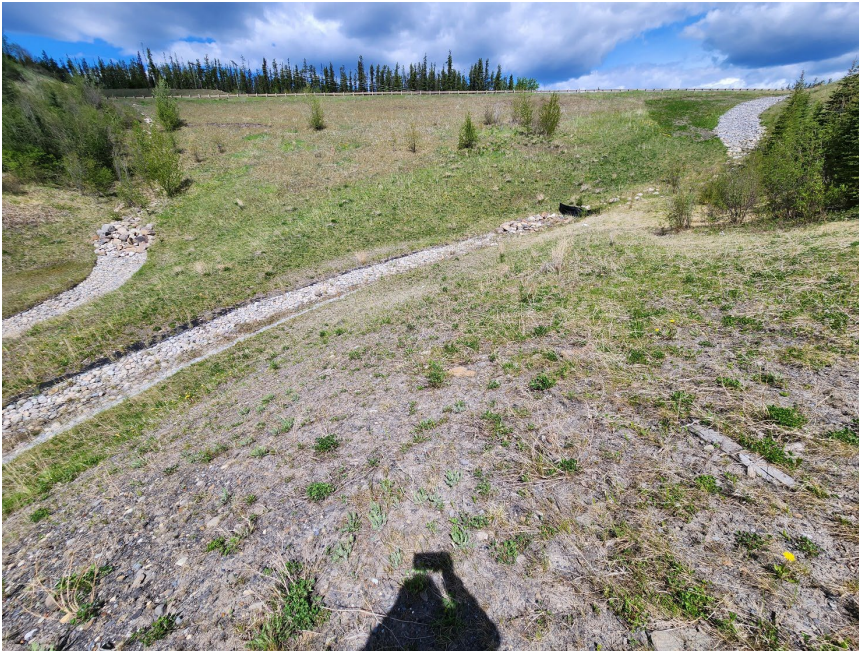
- South slope of the highway embankment appeared to be in good condition (Photo 3). Slope is well vegetated with grass. No visual indications of slope movement or erosion. North slope of the highway embankment and culvert outlet not visited at the time of the 2025 inspection.
- Cross ditches along highway embankment abutments generally appeared to be in good condition, including the east ditch repaired in 2024 (Photos 13 and 14).
- Riprap-lined channel and 3.0-m diameter corrugated-steel-pipe (CSP) culvert inlet appeared to be in good condition (Photos 1, 2, and 4). Riprap at base of channel is grouted.

Photo 3 South slope of Hwy 40:34 embankment. Photo taken June 2, 2025, facing northwest.

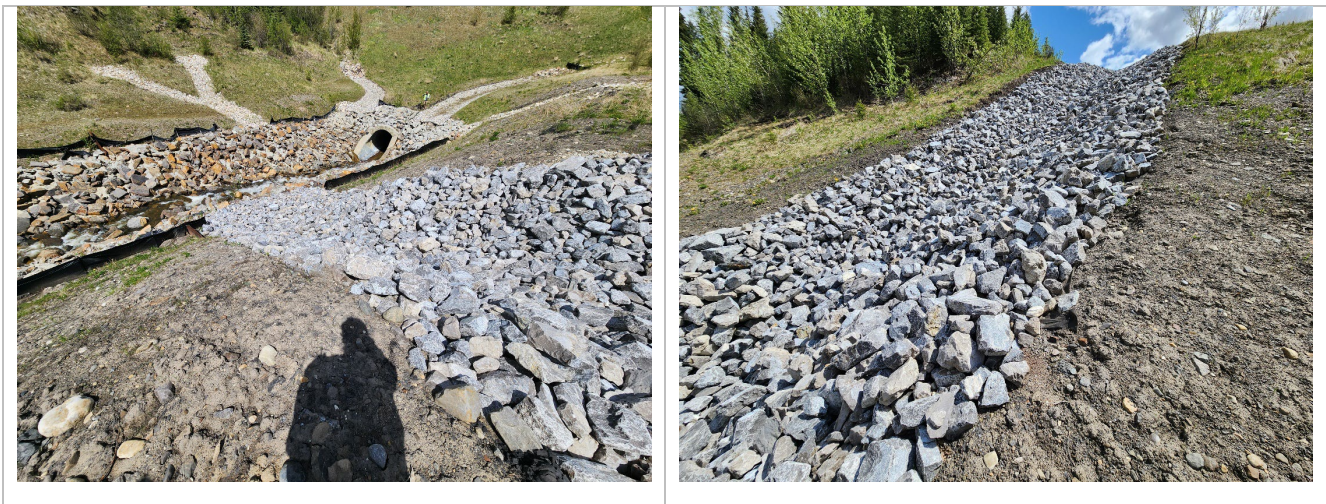
- The perforated drains pipes were dry to damp at the south slide repair (Photo 12), and damp at the middle and north slide repairs (Photos 8 and 10).
- Riprap-lined trapezoidal channel on the appeared to be in good condition with no flow or signs of riprap displacement (Photo 4).

Photo 4 Riprap-lined trapezoidal channel constructed in 2024 on east valley slope. Photo taken June 2, 2025, facing northwest and northeast, respectively.

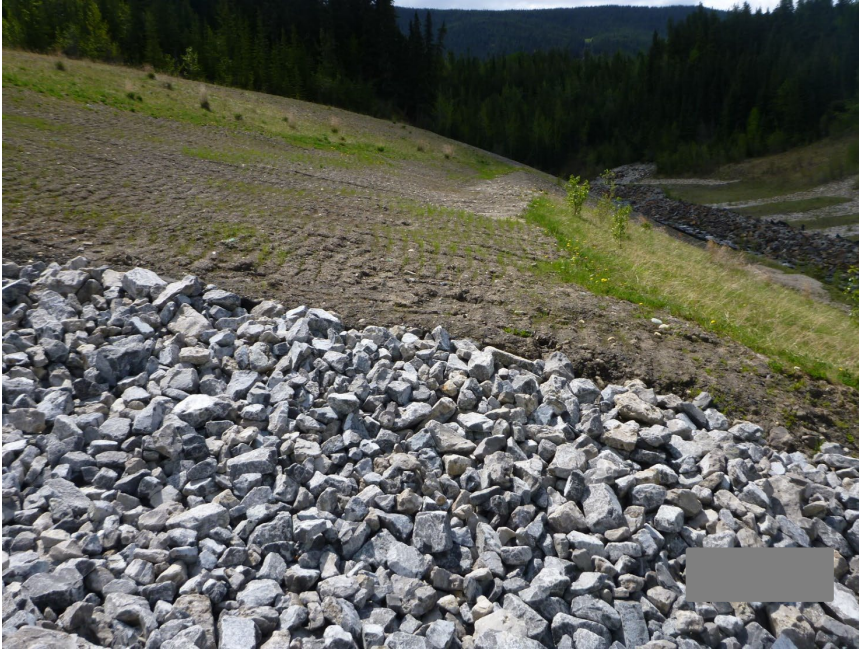
Photo 5 **Upper mid-slope bench across east valley slope. Photo taken June 2, 2025, facing southwest from trapezoidal channel.**

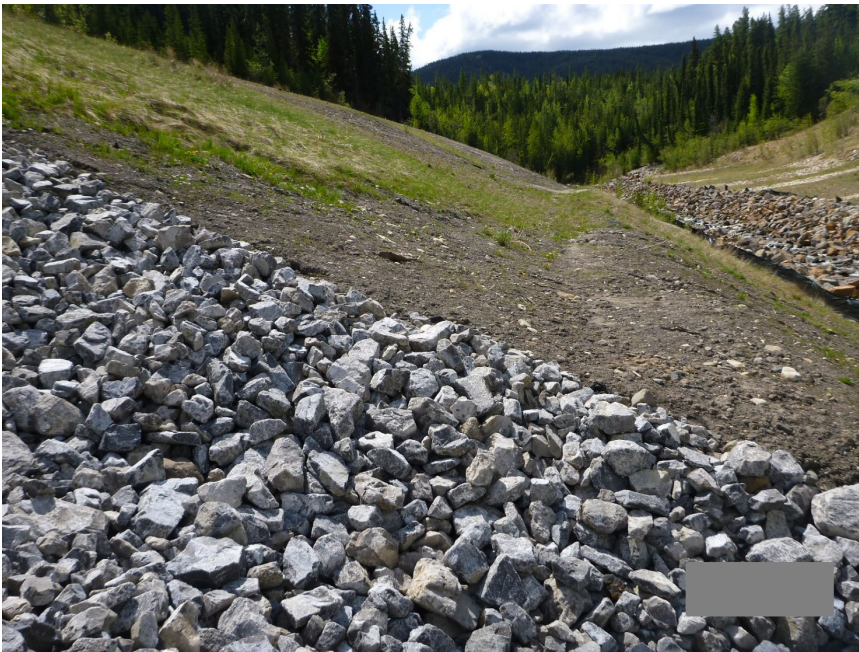
Photo 6 **Lower mid-slope bench across east valley slope. Photo taken June 2, 2025, facing southwest from trapezoidal channel.**

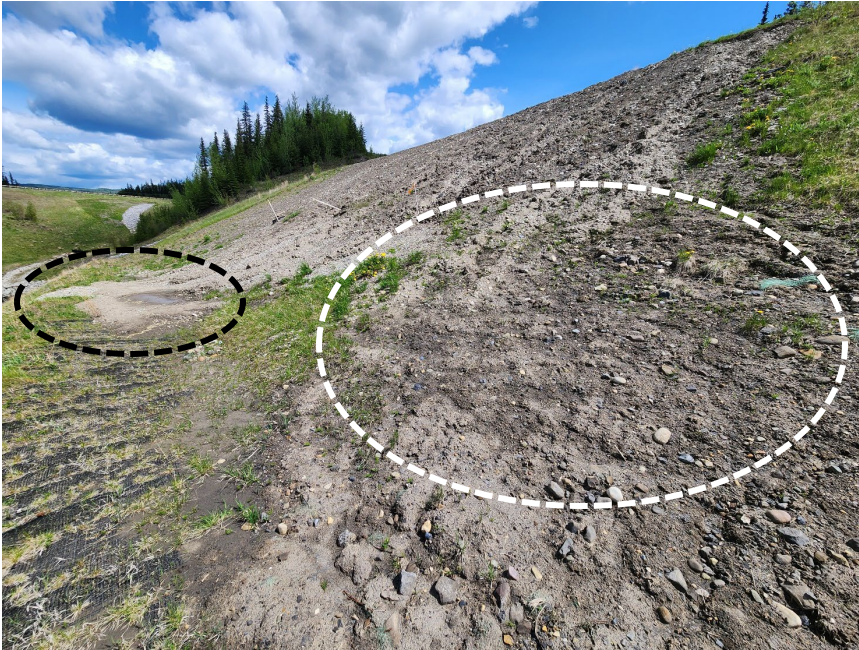
- Material eroded from the north slide repair has accumulated on the lower mid-slope bench and may impede flows on the bench (Photo 7). It also appears that flow from the upper mid-slope bench flows to the lower mid-slope bench and not into riprap-lined trapezoidal channel.

Photo 7 North slide area on east valley slope repaired in 2024. Note erosion on repaired slope, sediment build up on lower mid-slope bench (circled in black), and seepage spot next to repaired slide area (circled in white). Photo taken June 2, 2025, facing northeast.

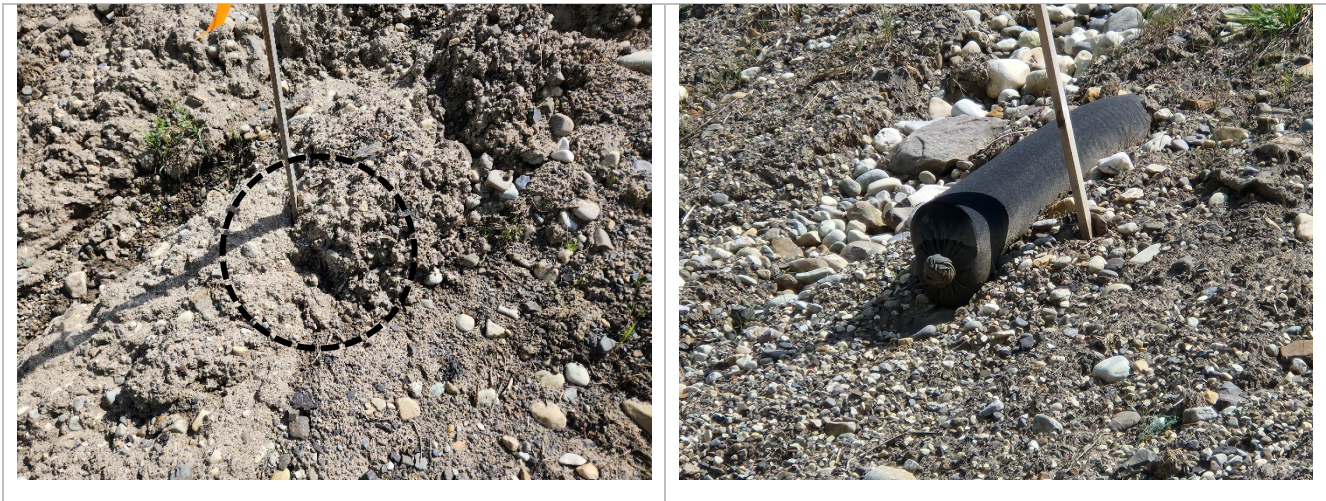
Photo 8 Drainpipe outlets in middle slide area. Photos taken June 2, 2025.

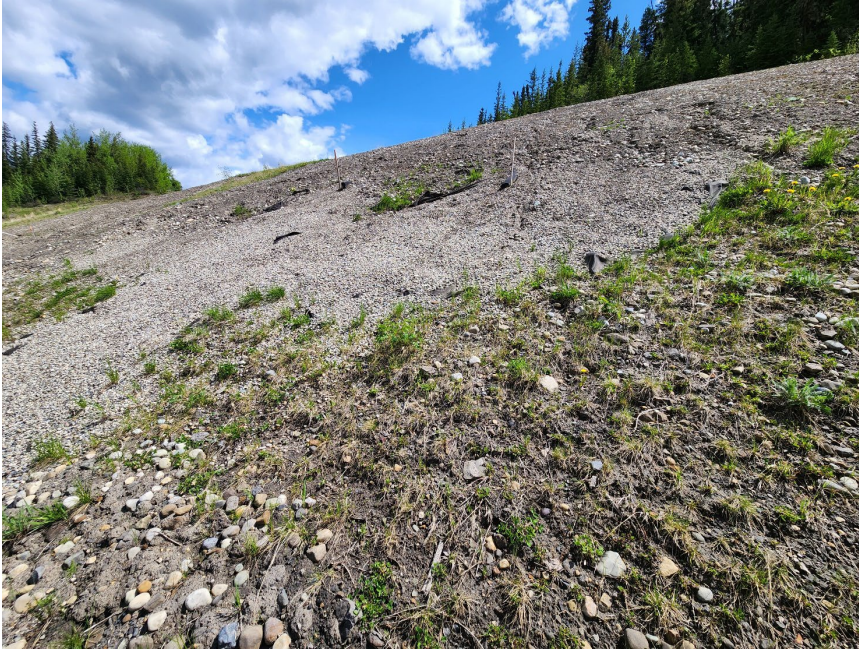
Photo 9 Middle slide area on east valley slope repaired in 2024. Photo taken June 2, 2025, facing northeast.

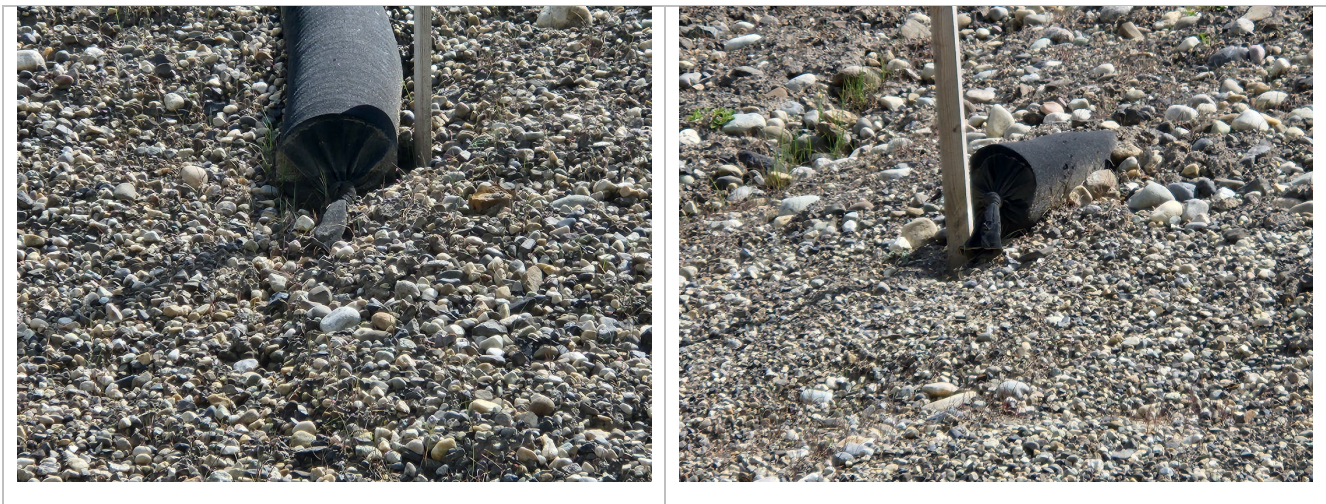
Photo 10 Drainpipe outlets in middle slide area. Photos taken June 2, 2025.

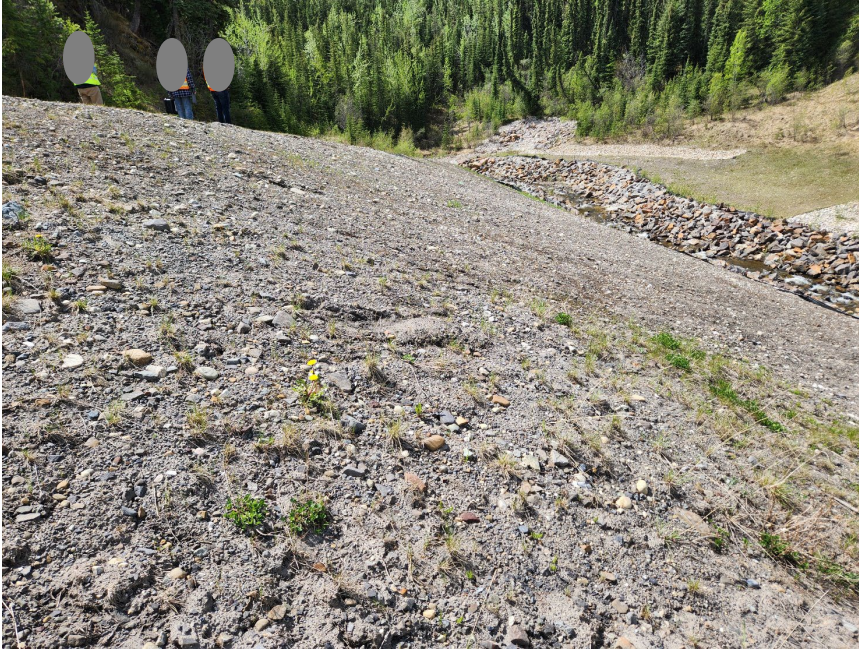
Photo 11 South slide area on east valley slope repaired in 2024. Photo taken June 2, 2025, facing southwest.

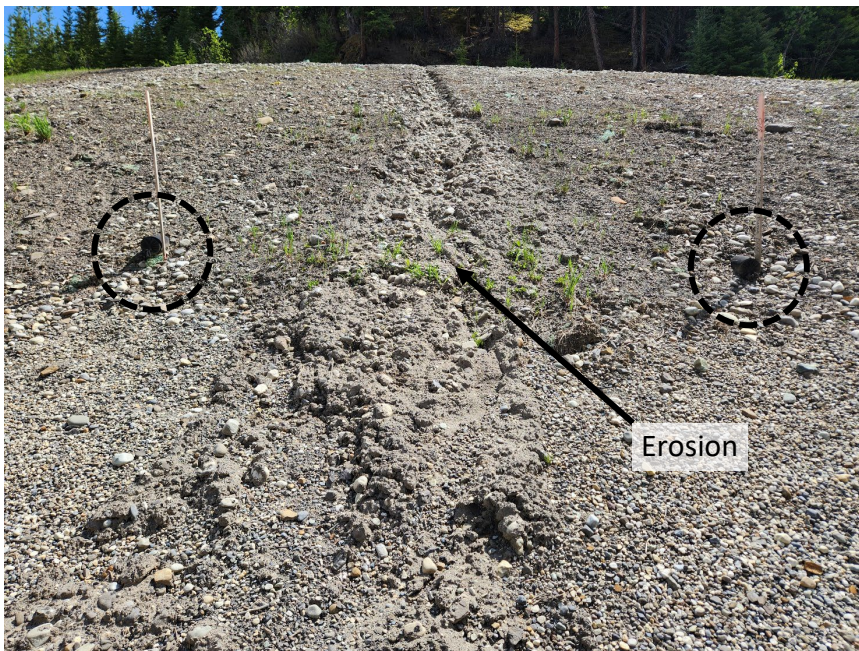
Photo 12 South slide area on east valley slope repaired in 2024. Note erosion down center and drainpipe outlets (circled in black). Photo taken June 2, 2025, facing east.

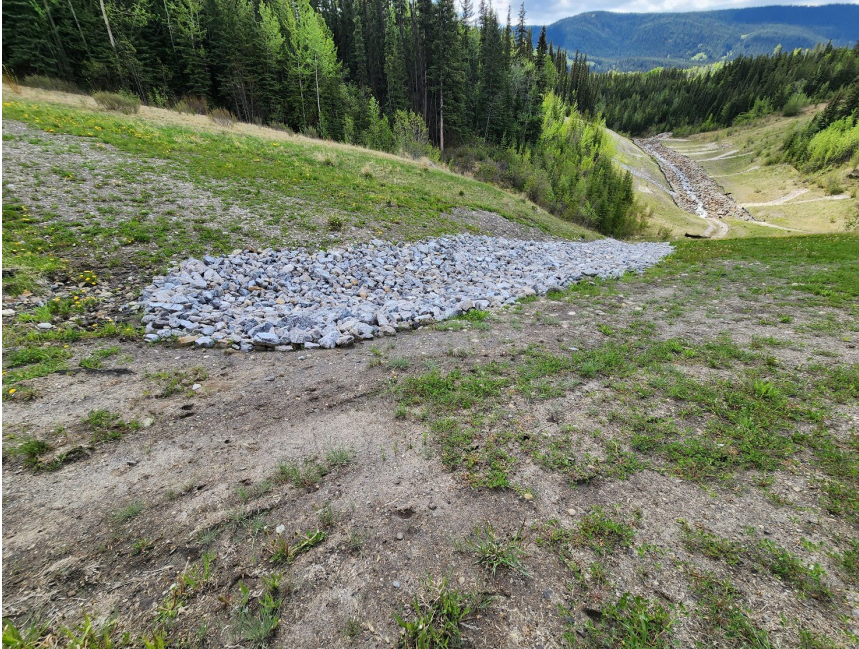
Photo 13 Riprap-lined cross ditch along east abutment of highway embankment, at north end of site. Note new riprap placed in 2024. Photo taken June 2, 2025, facing south.

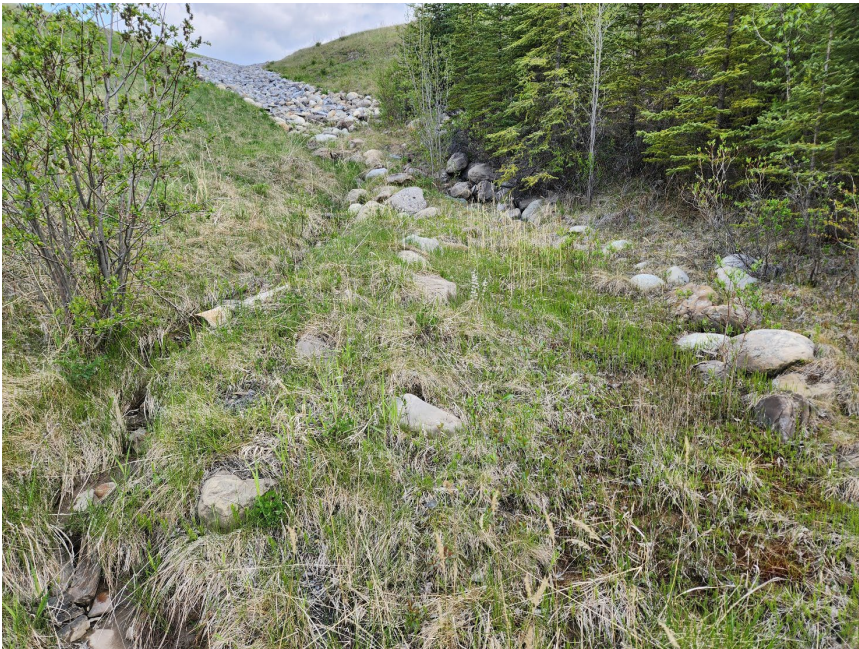
Photo 14 Riprap-lined cross ditch along east abutment of highway embankment, at north end of site. Note portion of ditch is not lined with riprap. Photo taken June 2, 2025, facing northeast.

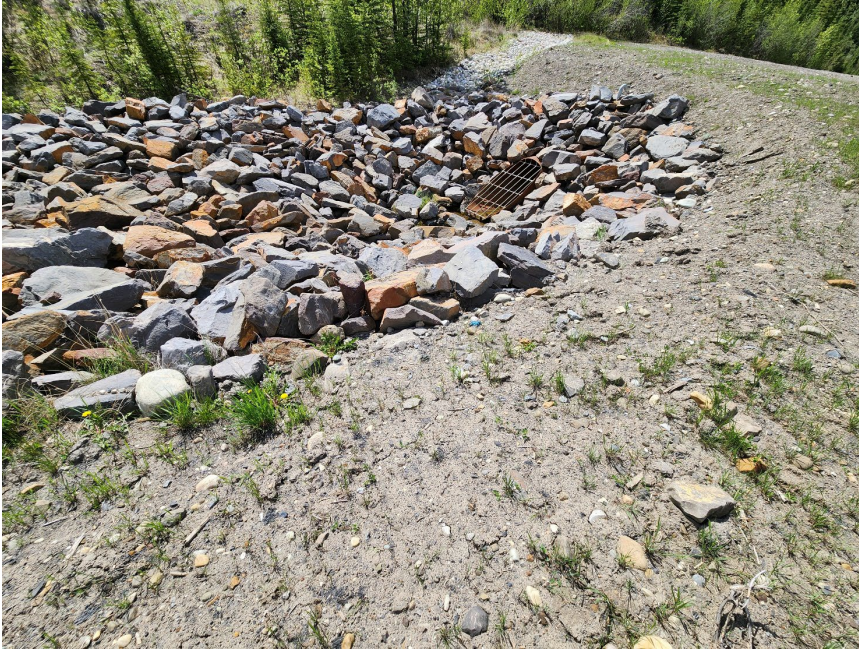
- Berm constructed around catch basin in 2024. At the time of the 2025 inspection, there were no visual indications that the catch basin had overflowed since the berm was constructed.
- Trash rack over smooth-walled-steel-pipe (SWSP) slope drain inlet.

Photo 15 Riprap-lined catch basin and buried slope drain inlet. Catch basin perimeter berm height increased in 2024. Photo taken June 2, 2025, facing southwest.

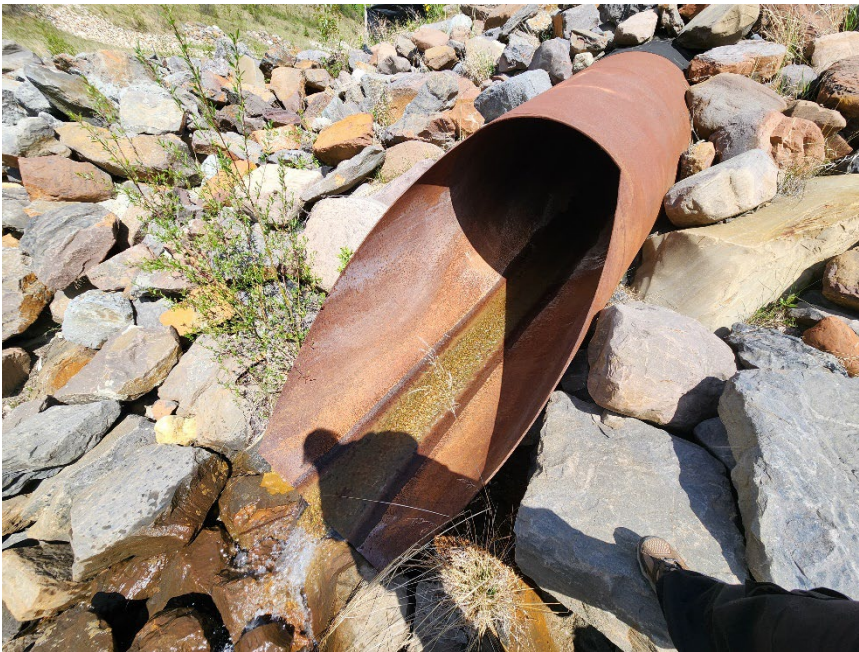
Photo 16 Buried slope drain outlet at toe of east valley slope, near south end of site. Photo taken June 2, 2025.
