SITE NUMBER AND NAME: GP041 Hwy 40:34 Ditch Erosion		HIGHWAY & KM: 40:34, 32.405	PREVIOUS INSPECTION DATE: May 25, 2020	INSPECTION DATE: July 21, 2021
LEGAL DESCRIPTION: SE 04-57-08-W6M	NAD 83 COORDINATES: UTM Northing Easting 11 5973931 360755		RISK ASSESSMENT: PF: 11 CF: 2 TOTAL: 22	
AVERAGE ANNUAL DAILY TRAFFIC (AADT): 1450 (north) & 1470 (south) (Reference No. 70000104)			CONTRACT MAINTENANCE AREA (CMA): 504

NOTES: 1. HORIZONTAL DATUM: NAD83 2. GRID ZONE: UTM Zone 11N 3. IMAGE SOURCE: Microsoft BING Maps	CLIENT 	PROJECT GRANDE PRAIRIE SOUTH REGION GEOHAZARD RISK MANAGEMENT PROGRAM
		TITLE Site Plan GP041 Ditch Erosion Hwy 40:34, km 32.405
	SCALE 1:4,000	PROJECT No. A05116A01
		FIG No. 1

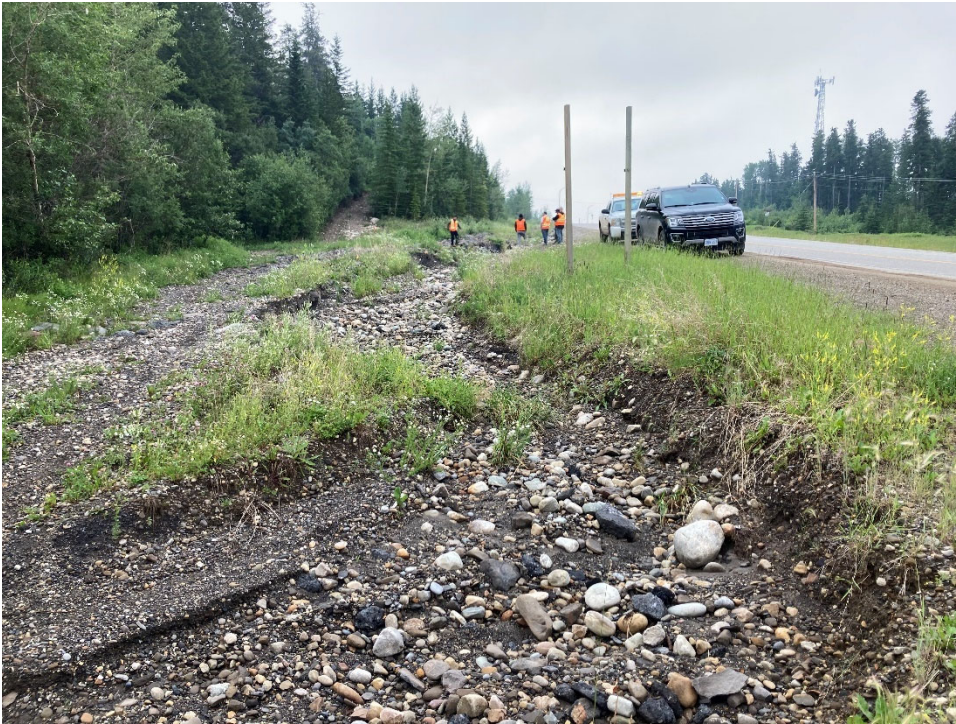
Photo 1 North extent of the ditch erosion on the east (northbound) side of Hwy 40. Photo taken July 21, 2021 facing south.

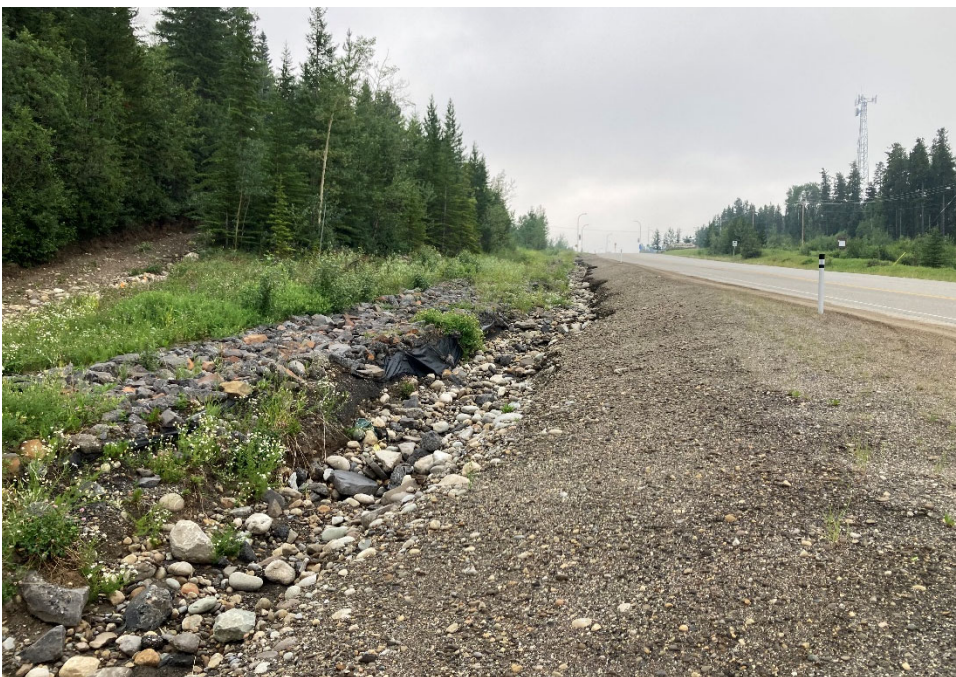
- Erosion repair in 2006 or 2007 is also located on west side of highway. Repair work was conducted using conglomerate riprap from the old Savage Rail quarry. The conglomerate has poor long-term durability, requiring the addition of riprap by the HMC from once or twice since 2013 as the conglomerate breaks down.

Photo 2 Exposed geotextile from a previous repair, on the east edge of the ditch erosion. Photo taken July 21, 2021 facing south.

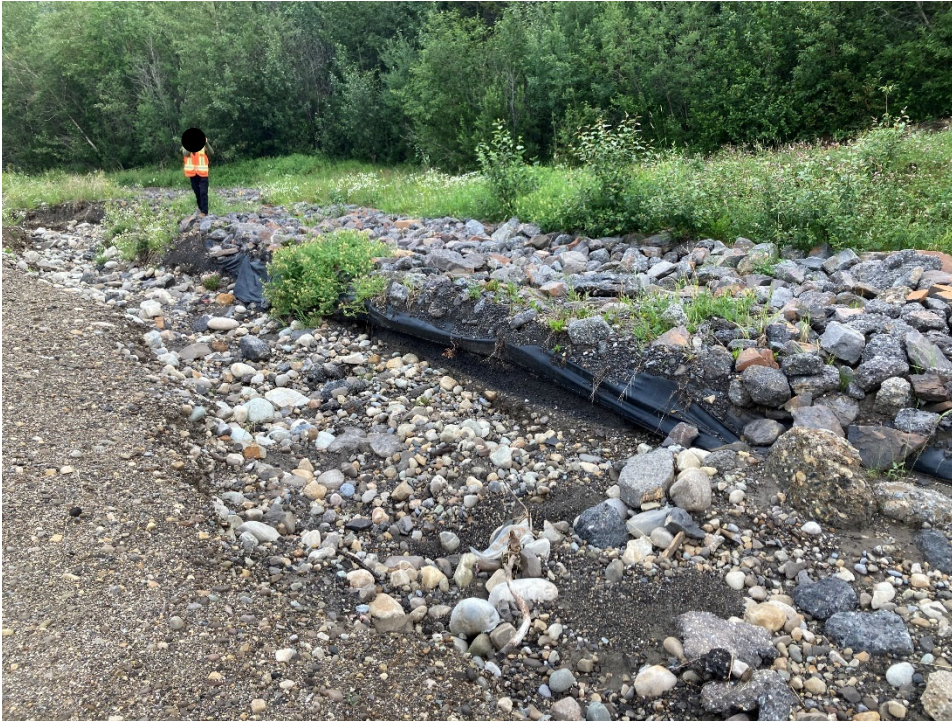
COMMENTS
- Erosion is on east side of Hwy 40 north of Grande Cache. Previous ditch riprap work was conducted that did not include adequate channel freeboard to contain the ditch flows. The riprap armoured ditch was constructed above the toe of the road embankment, leaving a secondary channel for water to flow in closer to the road.

Photo 3 Exposed geotextile on the east edge of the ditch erosion (riprap channel being bypassed and undermined by the ongoing erosion). Photo taken July 21, 2021 facing northeast.

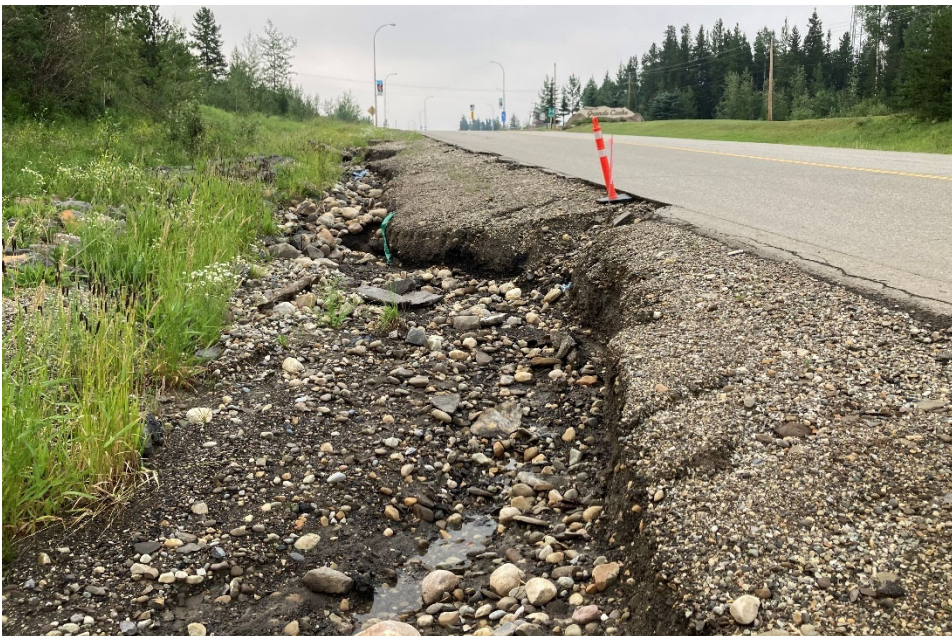
ITEM	CONDITION EXISTS		DESCRIPTION AND LOCATION	NOTICABLE CHANGE FROM LAST INSPECTION	
	YES	NO		YES	NO
Pavement Distress	X		Where the erosion has progressed to the edge of pavement.		
Slope Movement		X			
Erosion	X		From edge of pavement to about 4 m away, within clear zone.	X	
Seepage		X			
Culvert Distress		X

Photo 4 The ditch erosion has retrogressed to the east edge (southbound lane) of Hwy 40 and is beginning to impact the shoulder of the highway. Photo taken July 21, 2021 facing south.

<p>water to flow on un-armoured soil or fill, and that ATVs are using the ditch as a trail which can create tire ruts that can cause erosion to form.</p>	
<p>- Short term solution – Sheep Creek fill will be used to fill the erosion gully at the edge of the pavement</p>	
<p>- Long-term solution – HMC will shape a new ditch, salvage durable intact pieces of riprap from existing armoring and import some new, better-quality riprap, and rebuild the armoured ditch with adequate freeboard.</p>	
<p>This report is an instrument of service of Klohn Crippen Berger (KCB). The report has been prepared for the exclusive use of Alberta Transportation (Client) for the specific application to the Central Region Geohazard Risk Management Program (Contract No. CON0022166) and it may not be relied upon by any other party without KCB's written consent.</p> <p>KCB has prepared this report in a manner consistent with the level of care, skill and diligence ordinarily provided by members of the same profession for projects of a similar nature at the time and place the services were rendered. KCB makes no warranty, express or implied.</p> <p>Use of or reliance upon this instrument of service by the Client is subject to the following conditions:</p> <ul style="list-style-type: none">(i) The report is to be read in full, with sections or parts of the report relied upon in the context of the whole report.(ii) The observations, findings and conclusions in this report are based on observed factual data and conditions that existed at the time of the work and should not be relied upon to precisely represent conditions at any other time.(iii) KCB should be consulted regarding the interpretation or application of the findings and recommendations in the report.
