**SITE INSPECTION FORM**

<b>SITE NUMBER AND NAME:</b> GP041 Ditch Erosion North of Grande Cache		<b>HIGHWAY &amp; KM:</b> 40:34, 32.405	<b>PREVIOUS INSPECTION DATE:</b> June 12, 2023	<b>INSPECTION DATE:</b> <b>June 2, 2025</b>
<b>LEGAL DESCRIPTION:</b> SE 04-57-08-W6M	<b>NAD 83 COORDINATES:</b> UTM    Northing    Easting 11       5973931    360755		<b>RISK ASSESSMENT:</b>  PF: 10    CF: 3    TOTAL: 30	
<b>AVERAGE ANNUAL DAILY TRAFFIC (AADT):</b> 1,570 (north) & 1,700 (south) (Reference No. 70000104, 2024)			<b>CONTRACT MAINTENANCE AREA (CMA):</b> 504

PROJECT  
PEACE REGION (GRANDE PRAIRIE DISTRICT-SOUTH)  
GEOHAZARD RISK MANAGEMENT PROGRAM

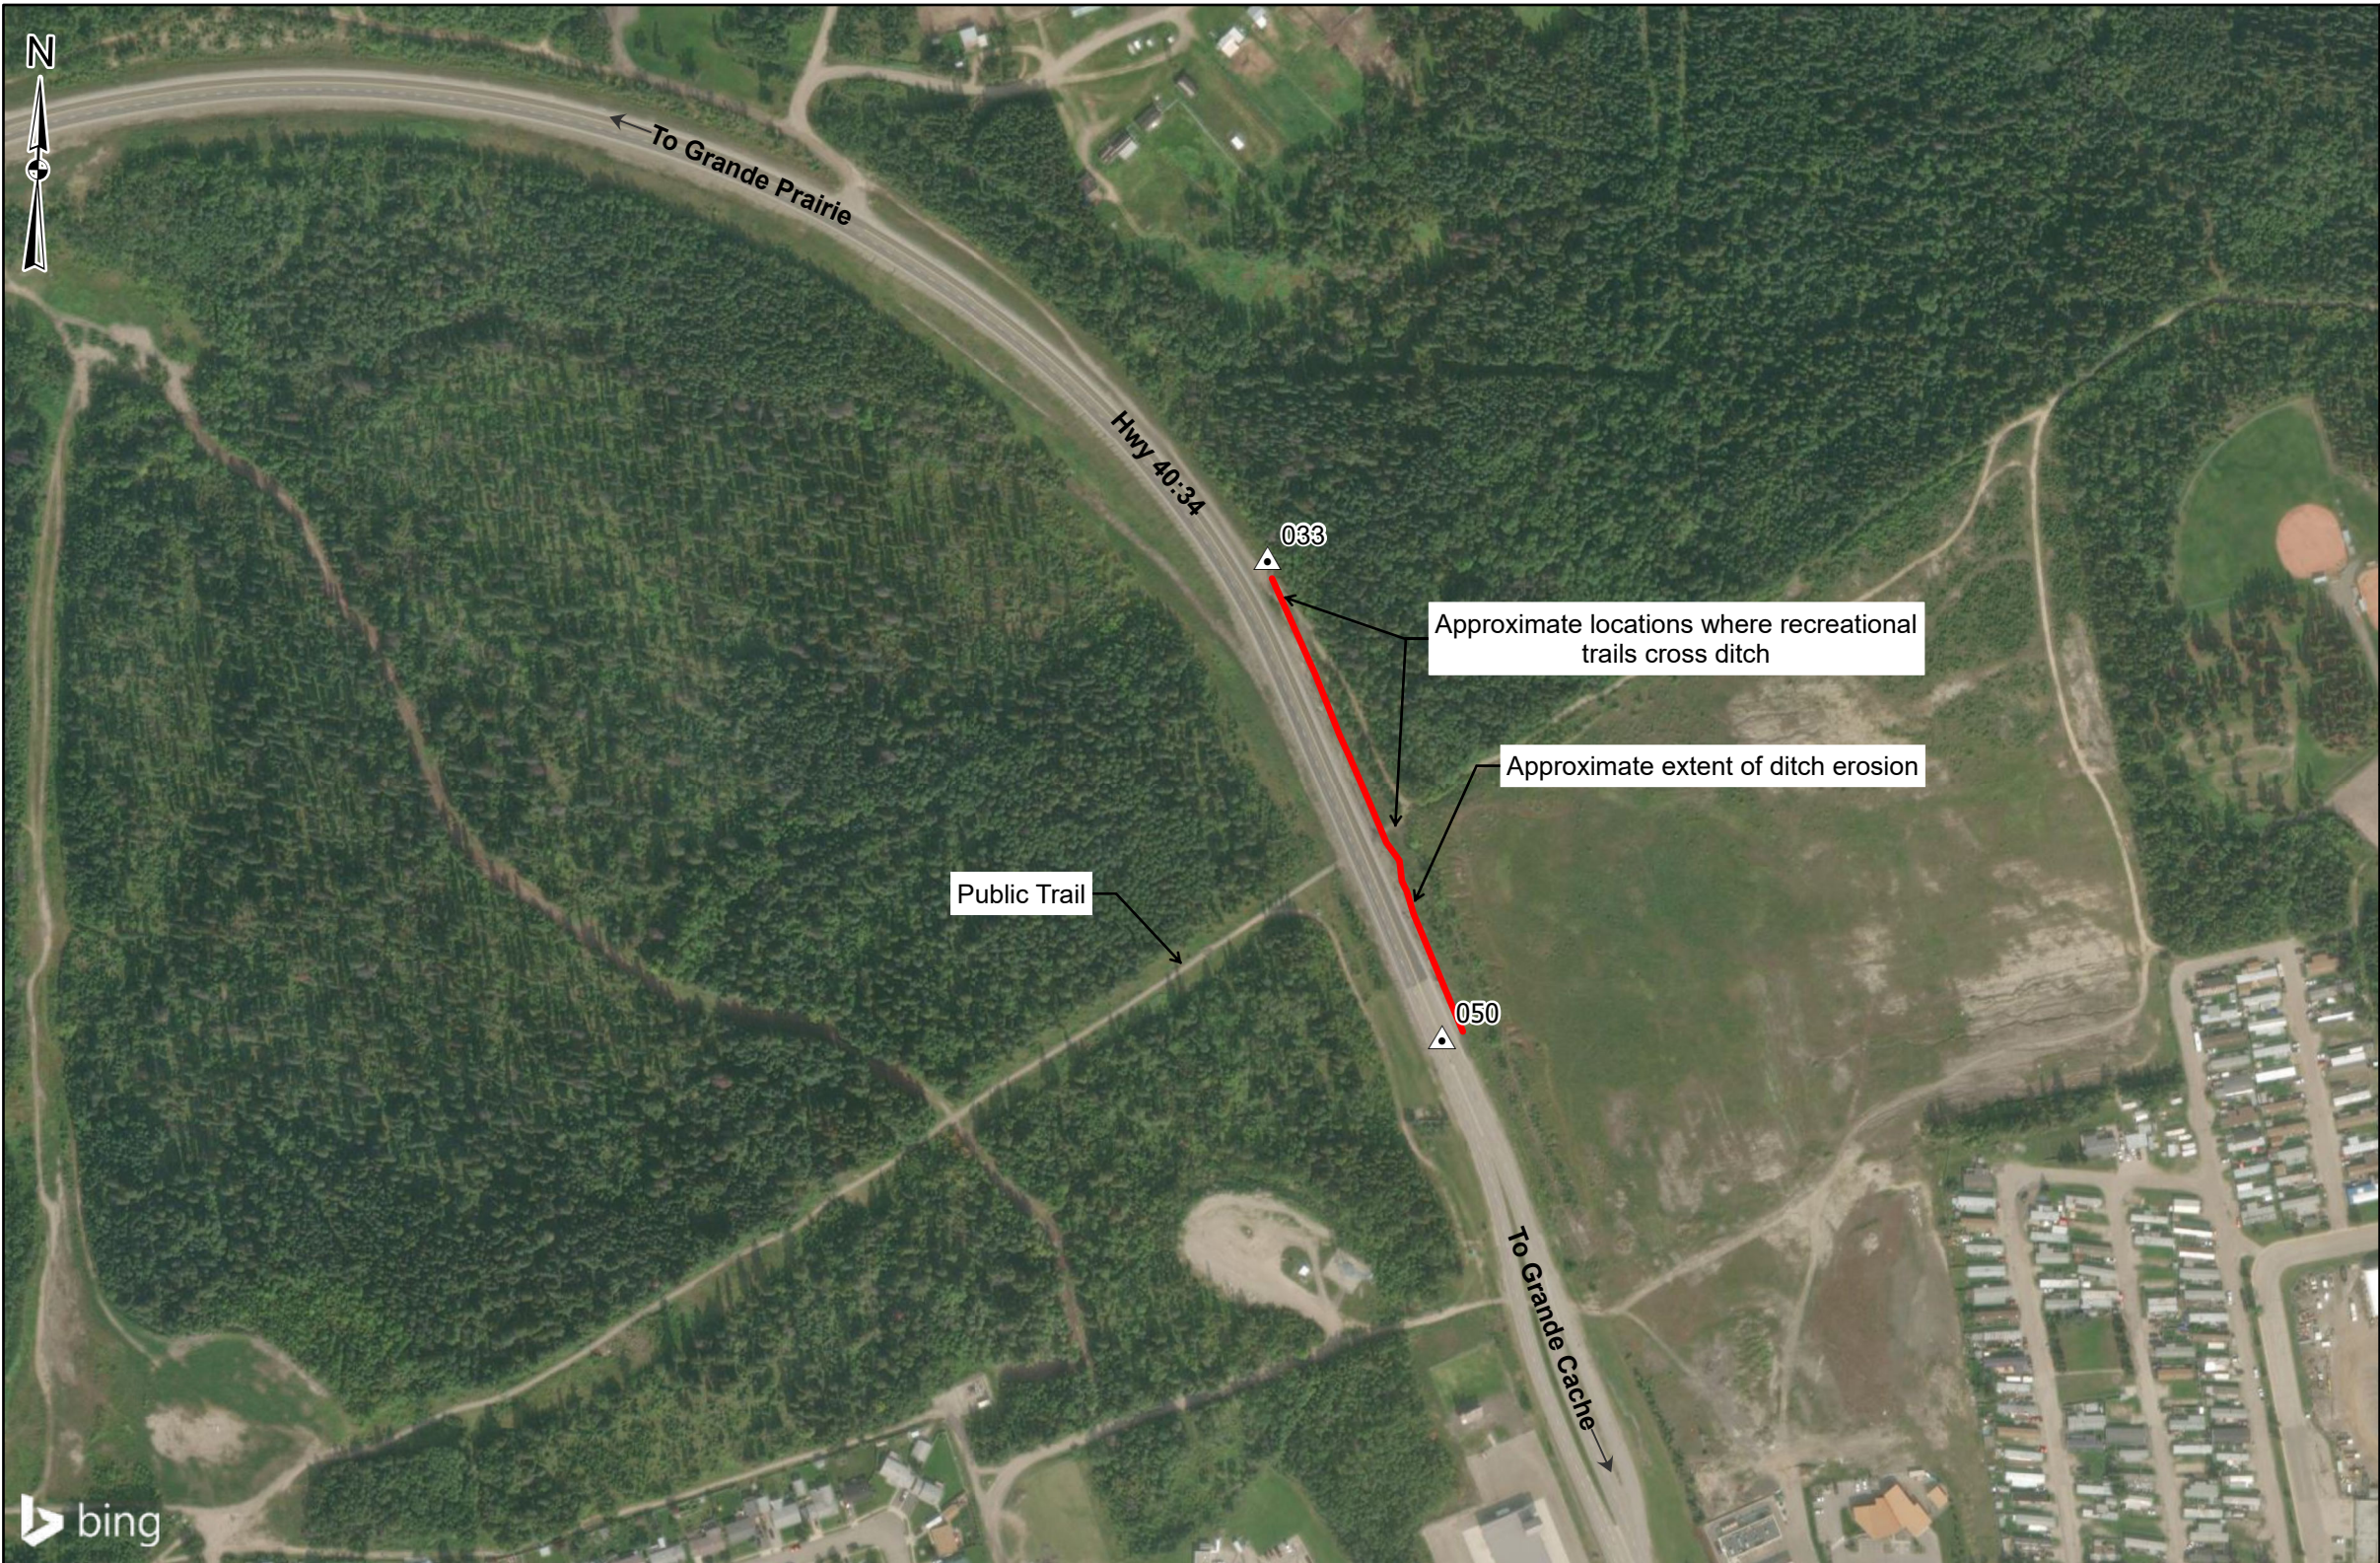
SCALE 1:4,000 PROJECT No. A05116A01 FIG No. 1

TITLE  
Site Plan  
GP041 - Ditch Erosion South of Grande Cache  
Hwy 40:34, km 32.405

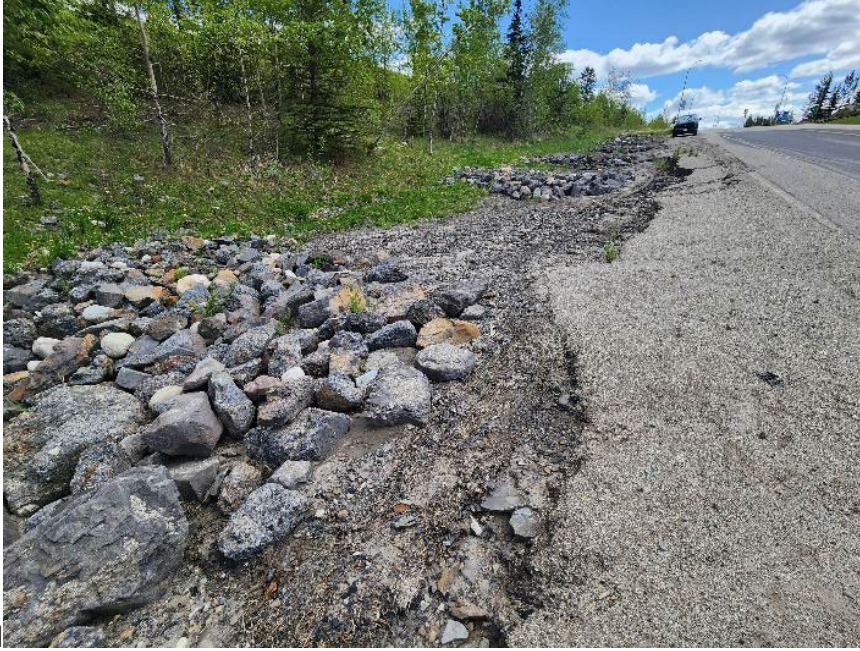
- Since the 2024 repair, an erosion feature has formed on the north side of the highway between the shoulder and the ditch bottom (Photos 1 through 8) due to surface water flow bypassing the TRM and above-grade riprap check dams, and potentially due to inadequate riprap/channel freeboard and snow clearing activities as described below. The erosion feature extends approximately 270 m from WP050 to WP033 and is approximately 0.5 m to 1.0 m wide and up to 0.5 m deep. After WP033, ditch flow shifts towards the tree line and away from the highway. Erosion was not observed within the tree line at the toe of the highway embankment.

- Material is beginning to build up behind the check dams (almost to the top of some of the check dams and may overtop soon) placed in the ditch in 2024 (Photos 1, 2, and 5), possibly exacerbating the flow that is causing the erosion discussed in the previous bullet.

**Photo 1** Ditch on east side of Hwy 40:34. Note erosion between highway shoulder and ditch from flow bypassing check dams. Photo taken June 2, 2025, facing southeast.

- In the Spring the 2025, KCB completed an environmental evaluation (EE) and preliminary engineering of ditch repairs at the site, including the section previously repaired in 2024. At TEC's request, KCB will complete detailed design and prepare a tender for the selected design option: removing the existing above-ground check dams, regrading the ditch, installing below-grade check dams, and armouring the ditch with riprap. Estimated cost: approximately \$800,000 to \$1,000,000 based on a repair length of 640 m, and the price of hard, durable limestone that is not likely to be locally available. The final repair length will be determined during detailed design. The cost for riprap could be considerably lower if TEC considers the use of locally available greywacke for this repair. The use of greywacke and concerns about variability in particle durability could potentially be addressed through special provisions within the tender which could include inspection and testing quality control / quality assurance (QA/QC) during production and placement, and an extended warranty period. The repair may be tendered together with GP026 highway ditch erosion repairs.

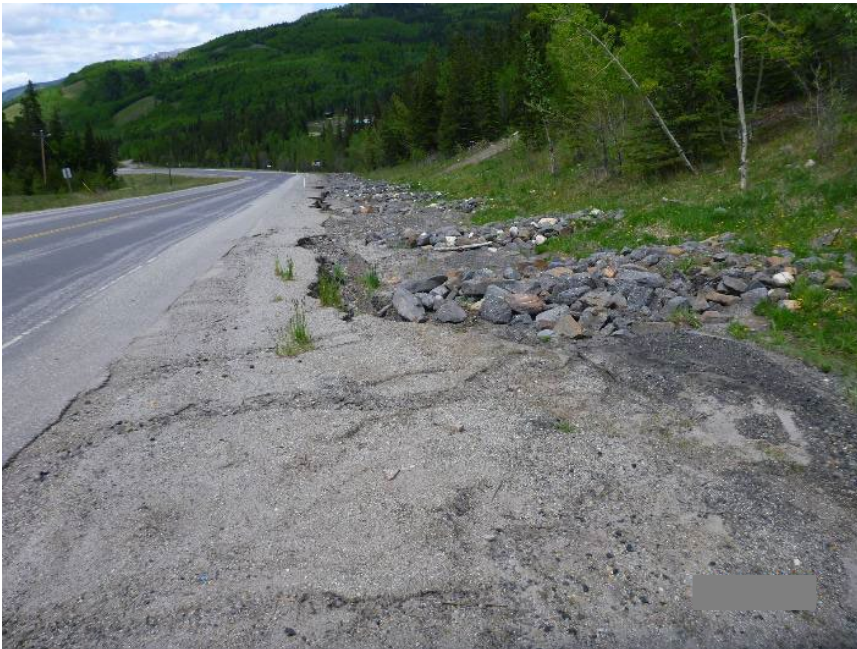
**Photo 2** Ditch on east side of Hwy 40:34. Note erosion between highway shoulder and ditch from flow bypassing check dams. Photo taken June 2, 2025, facing northwest.

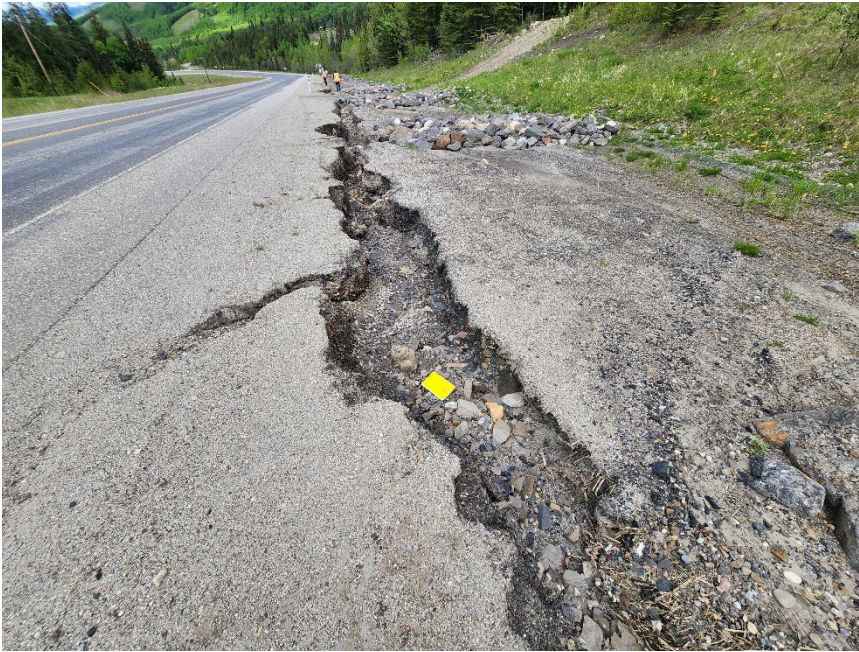
**Photo 3** Ditch on east side of Hwy 40:34. Note erosion between highway shoulder and ditch from flow bypassing check dams. Photo taken June 2, 2025, facing northwest.

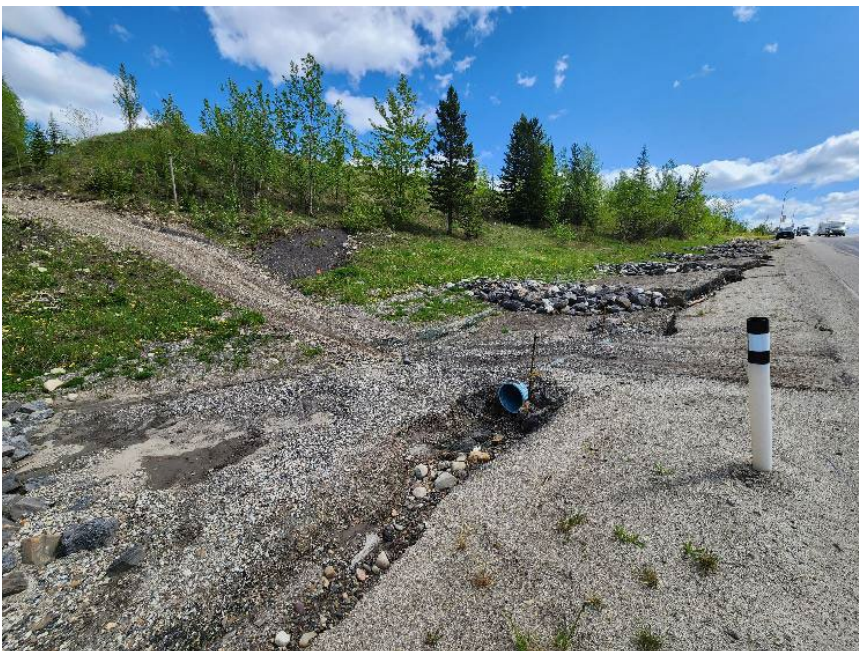
- off-road vehicles (e.g., ATVs) are using the highway ditch as a trail which can create tire ruts that can cause erosion to form.
- Two recreational trails cross the north highway ditch (Photo 4).

**Photo 4** Ditch on east side of Hwy 40:34. Note recreational trail/road that crosses highway ditch. Photo taken June 2, 2025, facing southeast.

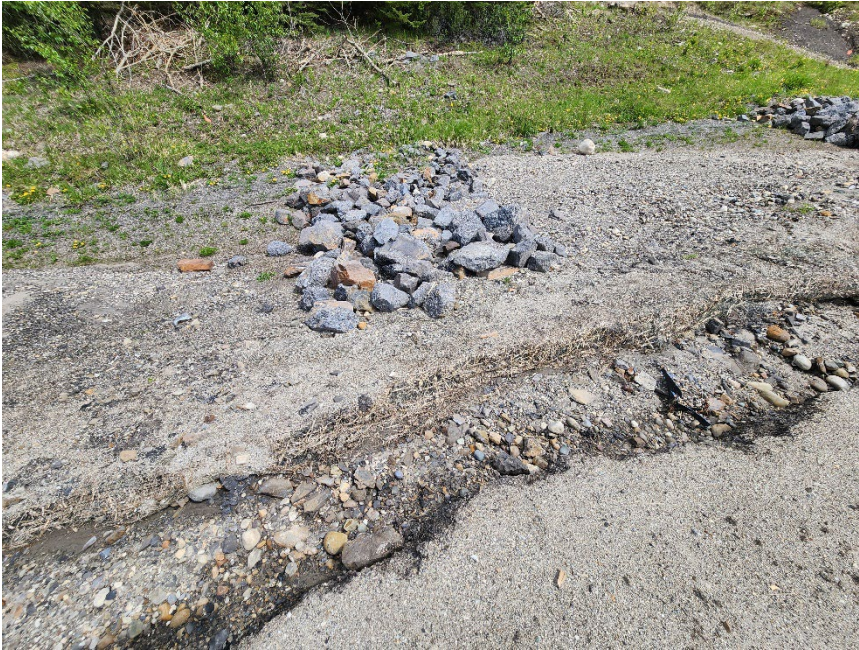
- TEC's Highway Maintenance Contractor (HMC), graded the north highway ditch, installed a turf reinforcement mat (TRM), and installed approximately 20 above-grade riprap check dams in spring 2024. The check dams include some particles of conglomerate (Photo 5) that will likely experience breakdown similar to the riprap placed during 2006 repairs.

- TRM placed in the ditch in 2024 is beginning to deteriorate and be undermined.
- TEC has previously mentioned that:
  - erosion worsened since the area upslope/east of highway was developed within Grande Cache (clearing, grading, gas station, parking lot);

**Photo 5** Ditch on east side of Hwy 40:34. Note erosion between highway shoulder and ditch from flow bypassing check dams, material building up behind checks dam, and deterioration and undermining of turf reinforcement mat. Photo taken June 2, 2025, facing west.

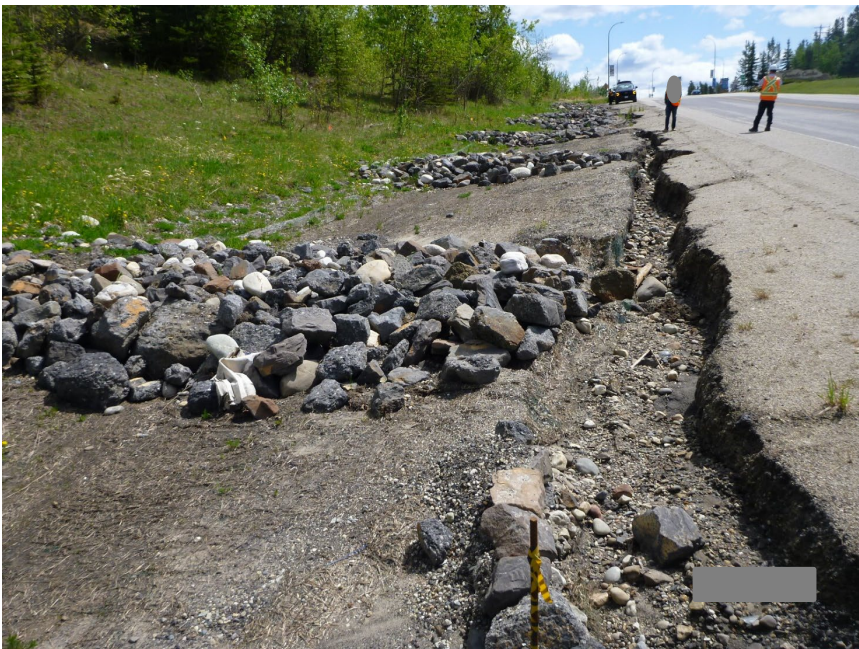
- An erosion feature in the north highway ditch was repaired in 2006 by placing riprap on a woven geotextile separating medium. The riprap was conglomerate from a nearby quarry and has since experienced various degrees of breakdown due to the matrix material for the conglomerate being sandstone with variable resistance to freeze-thaw particle breakdown. Sometime afterwards (at least once since 2013) limestone or greywacke riprap from a nearby quarry was placed on the 2006 repair to augment the riprap armoring where conglomerate riprap had deteriorated due to freeze-thaw action.

**Photo 6** Ditch on east side of Hwy 40:34. Note erosion between highway shoulder and ditch from flow bypassing check dams, deterioration and undermining of turf reinforcement mat, and quality of riprap particles in ditch, some of which are composed of conglomerate. Photo taken June 2, 2025, facing southeast.

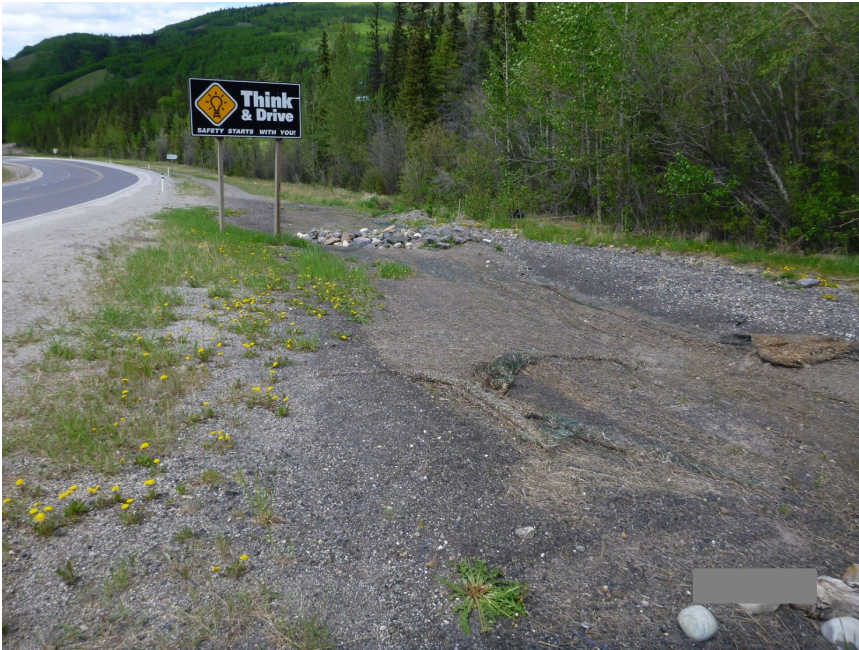
**Photo 7** Ditch on east side of Hwy 40:34, at north end of site. Photo taken June 2, 2025, facing northwest.

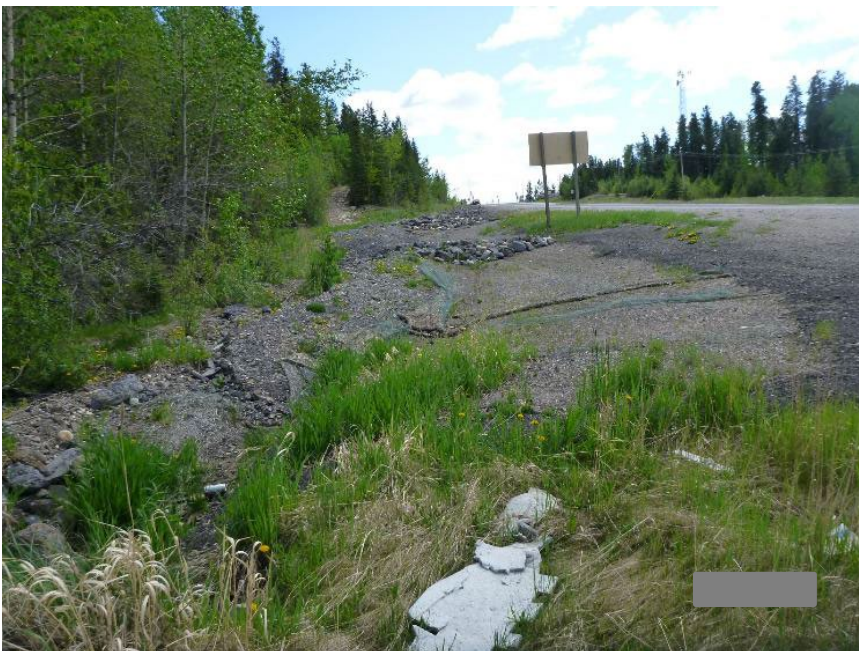
**Photo 8** Ditch on east side of Hwy 40:34, at north end of site. Photo taken June 2, 2025, facing southeast near WP033.
