Slide Name: (GP 20) Hwy 40:36 North of Grande Cache - Backslope of Climbing Lane
Inspection Date: June 25, 2003
Inspection By: Alberta Transportation and EBA Staff listed on Page 1

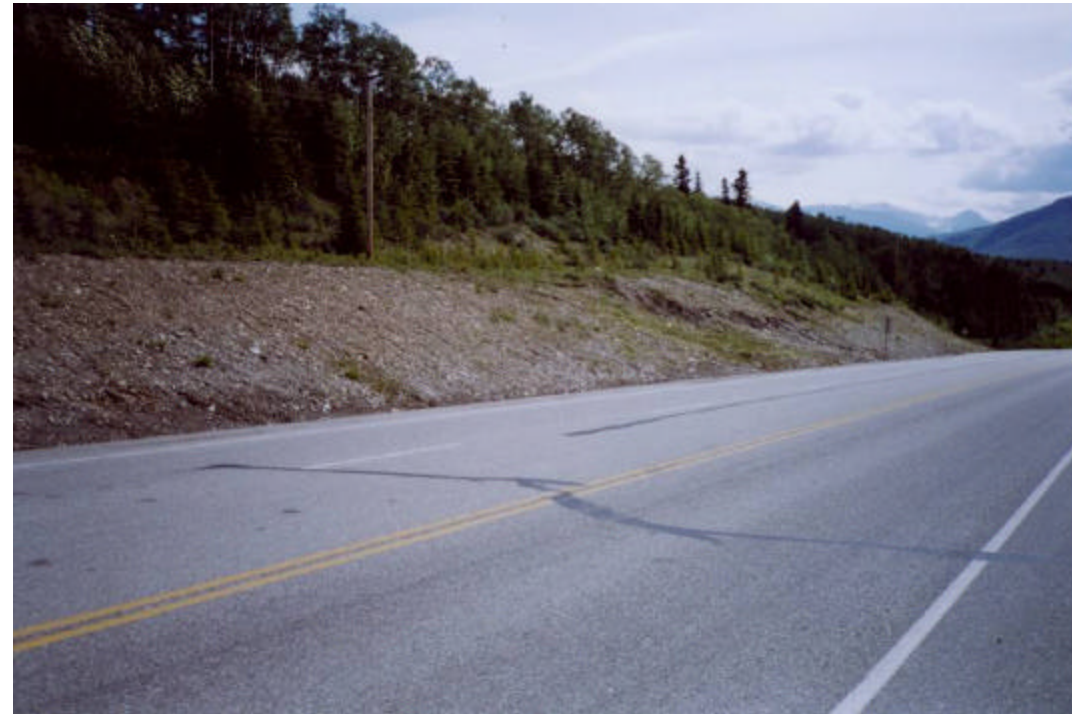
- No adverse change of site conditions was observed.
- Previous backslope sloughing was caused by seepage from horizontal drains that were severed by widening construction in 1999/2000.
- The reconstruction of the sloughed area with pit run material may not be necessary due to low height of the slope and gravel overburden material that will drain relatively freely.
- The low backslope has apparently stabilized through minor regrading efforts and continual clean-out of ditch is a pragmatic measure.

Photo 1
Looking downgrade (away from Grande Cache)
- Seepage noted along backslope

- Continue visual monitoring of the slope on an annual basis.
- Due to the low height of backslope and the granular overburden material, it is considered pragmatic to allow the backslope to undergo its natural stabilization process and clean out the ditch when required.

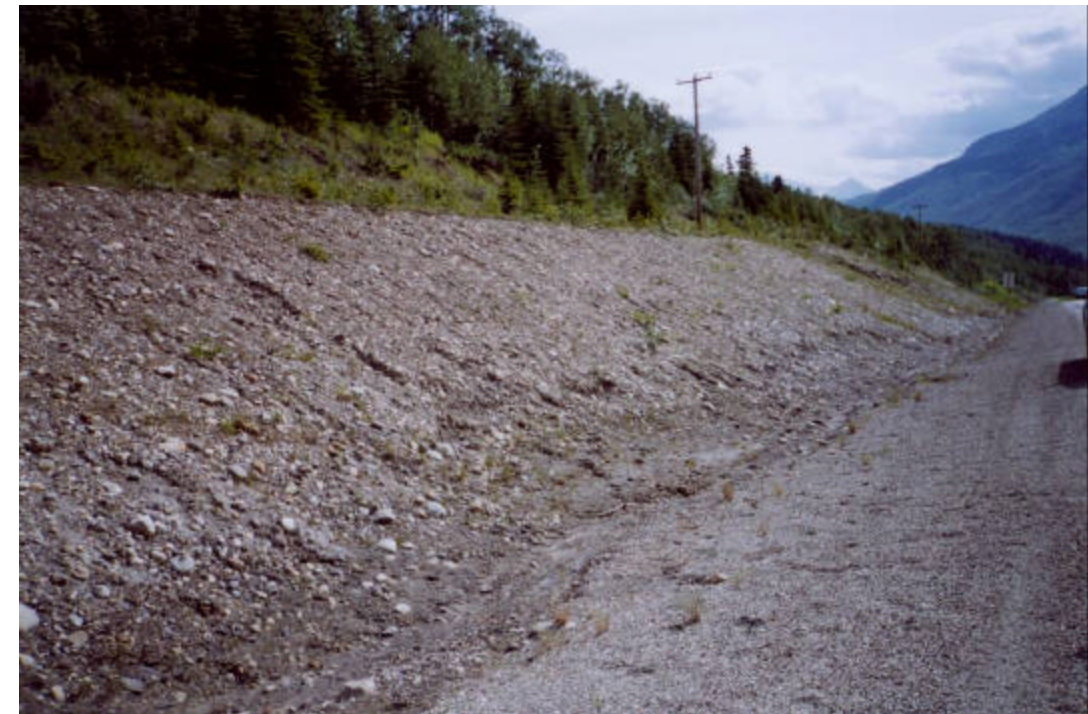
Photo 2
Close up - Looking downgrade (away from Grande Cache)

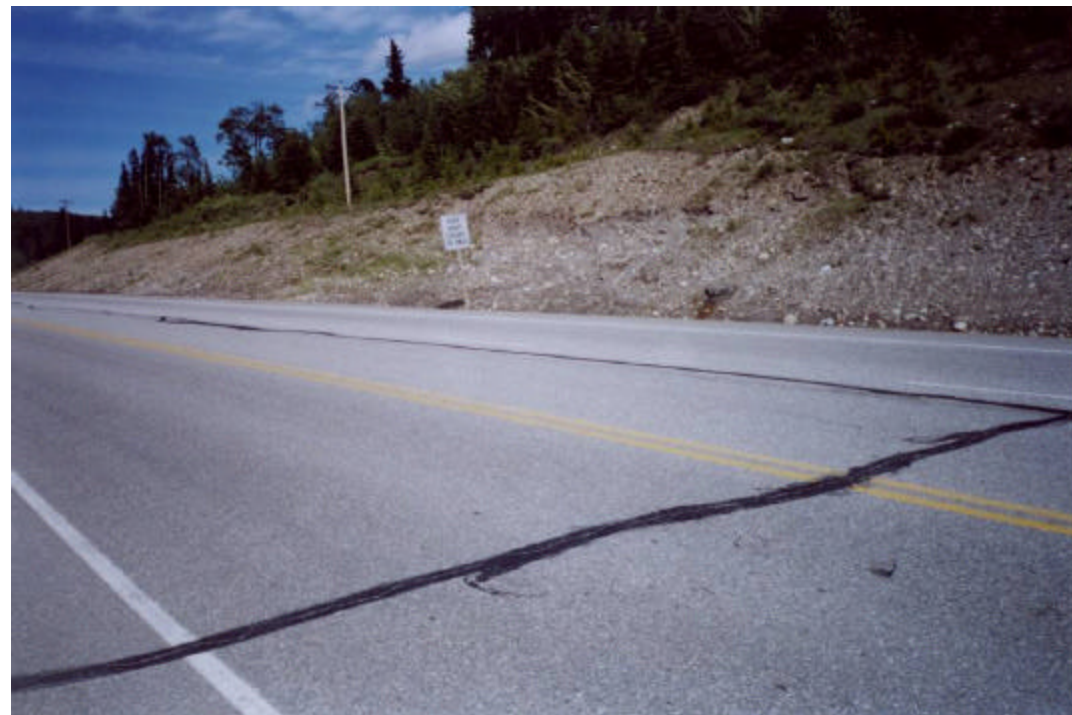
Photo 3
Looking upgrade (towards Grande Cache)
- Seepage noted along backslope

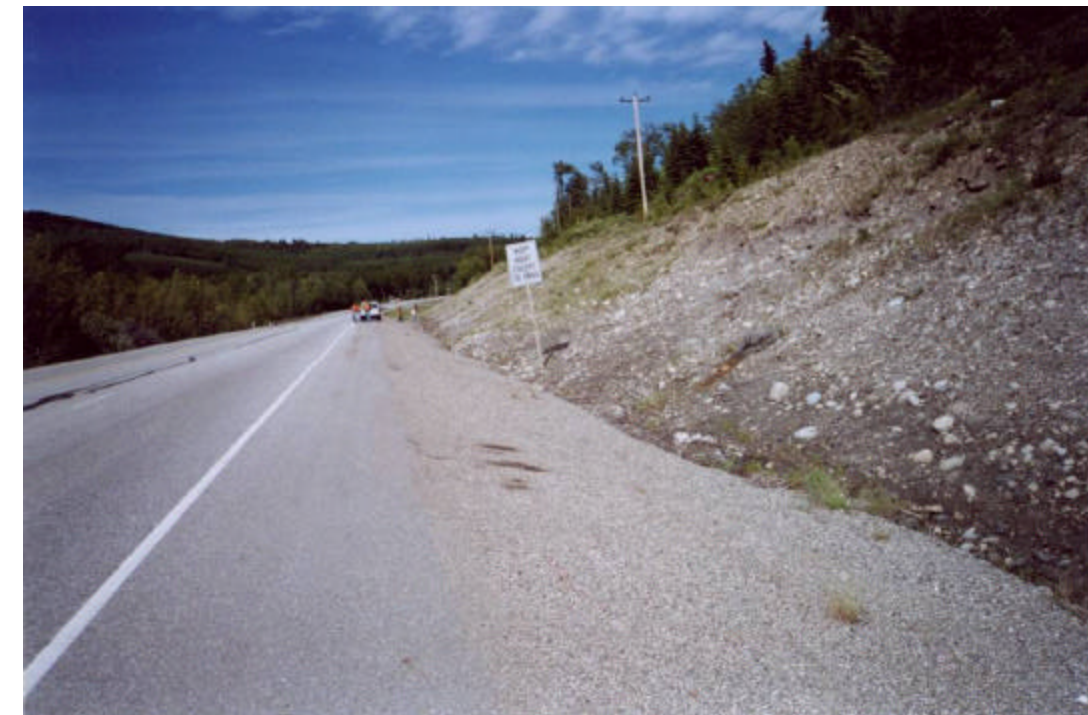
Photo 4
Close up - Looking upgrade (towards Grande Cache)
