Slide Name: (GP 20) Hwy 40:36 North of Grande Cache - Backslope of Climbing Lane
Inspection Date: June 23, 2004
Inspection By: Alberta Transportation and EBA Staff listed on Page 1

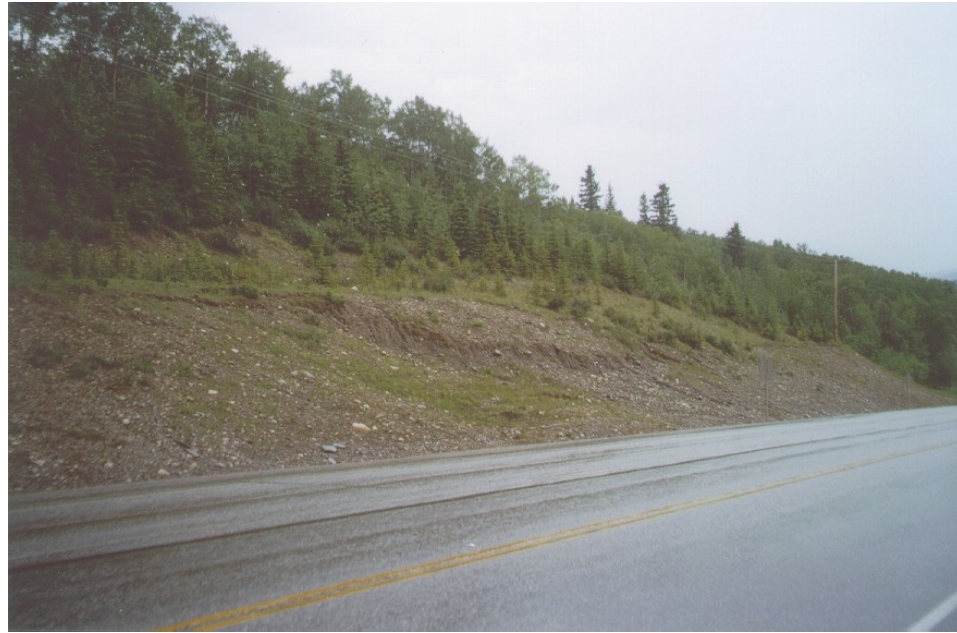
Photo 1
Looking south downgrade at climbing lane.

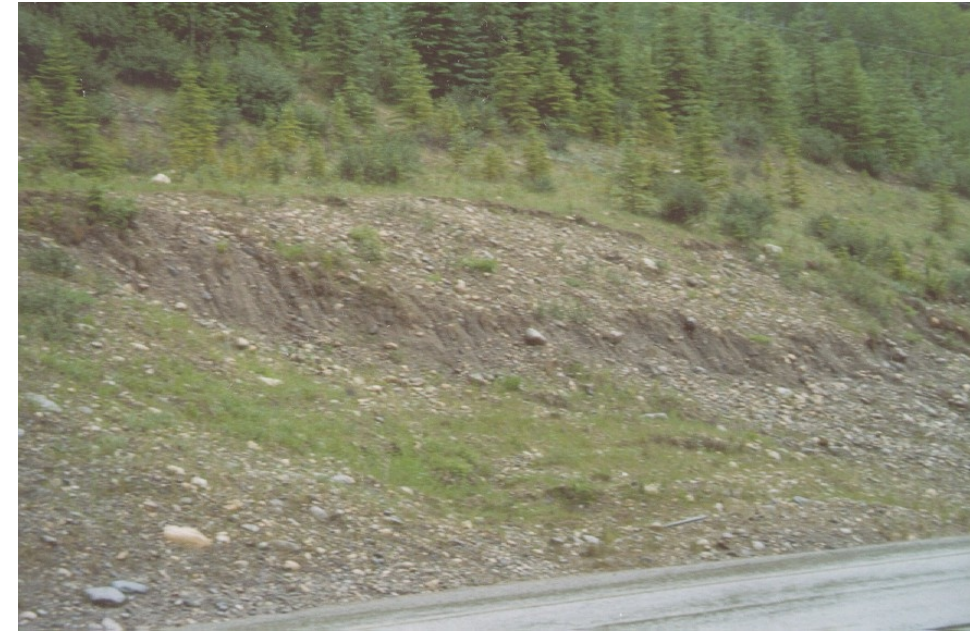
Photo 2
Close-up at slumping area.

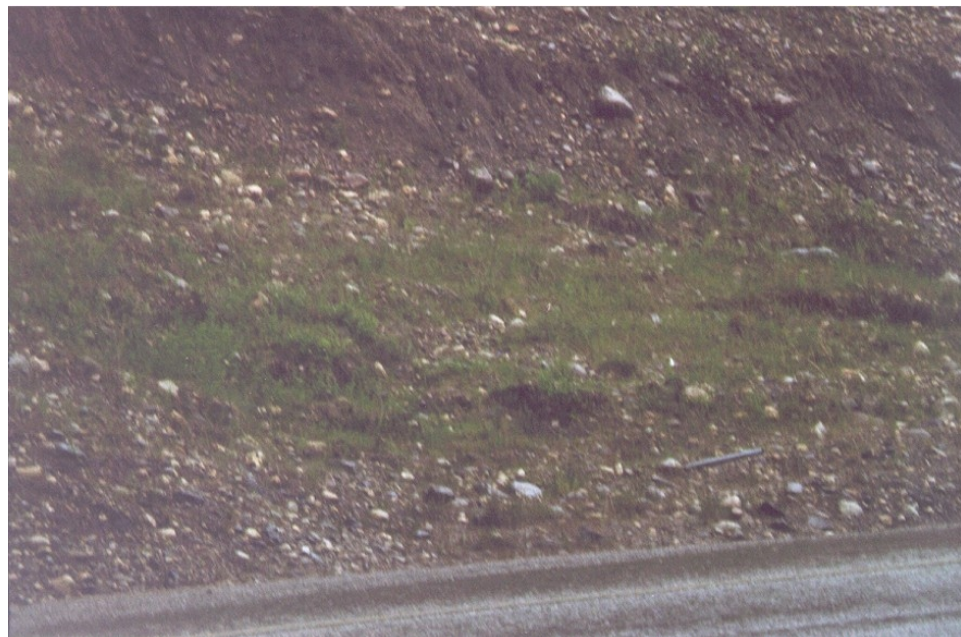
Photo 3
Close-up
1) Minor sloughing at horizontal drain pipe (possibly severed)

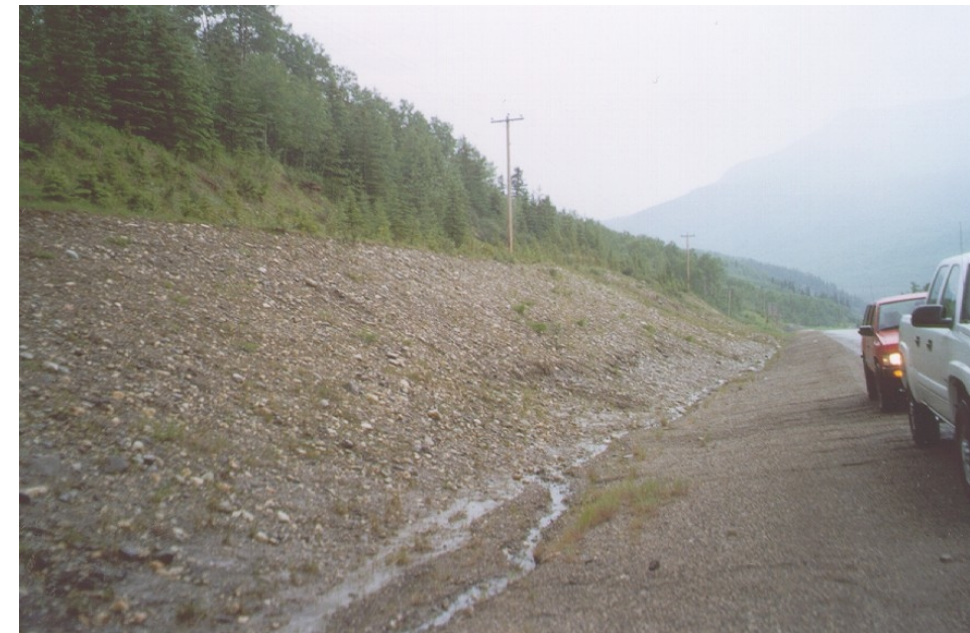
Photo 4
Looking south and downgrade.
1) Minor Toe bulging and sloughing toward ditch

- Continue visual monitoring of the slope on an annual basis.
- Due to the low height of backslope and the granular overburden material, it is considered pragmatic to allow the backslope to undergo its natural stabilization process and clean out the ditch when required.
