<b>SITE NUMBER AND NAME:</b> GP036 Rock Fall S McIntyre Mine		<b>HIGHWAY &amp; KM:</b> 40:36, 12.061	<b>PREVIOUS INSPECTION DATE:</b> May 25, 2020	<b>INSPECTION DATE:</b> July 21, 2021
<b>LEGAL DESCRIPTION:</b> NW 04-58-08-W6M	<b>NAD 83 COORDINATES:</b> UTM Northing Easting 11 5984469 359856		<b>RISK ASSESSMENT:</b> PF: 15 CF: 4 TOTAL: 60	
<b>AVERAGE ANNUAL DAILY TRAFFIC (AADT):</b> 900 (north) & 1120 (south) (Reference No. 25592)			<b>CONTRACT MAINTENANCE AREA (CMA):</b> 504

PROJECT	GRANDE PRAIRIE SOUTH REGION GEOHAZARD RISK MANAGEMENT PROGRAM	
TITLE	Site Plan GP036 Rock Fall South of McIntyre Mine Hwy 40:36, km 12.061	
SCALE	PROJECT No.	FIG No.
1:1,250	A05116A01	1

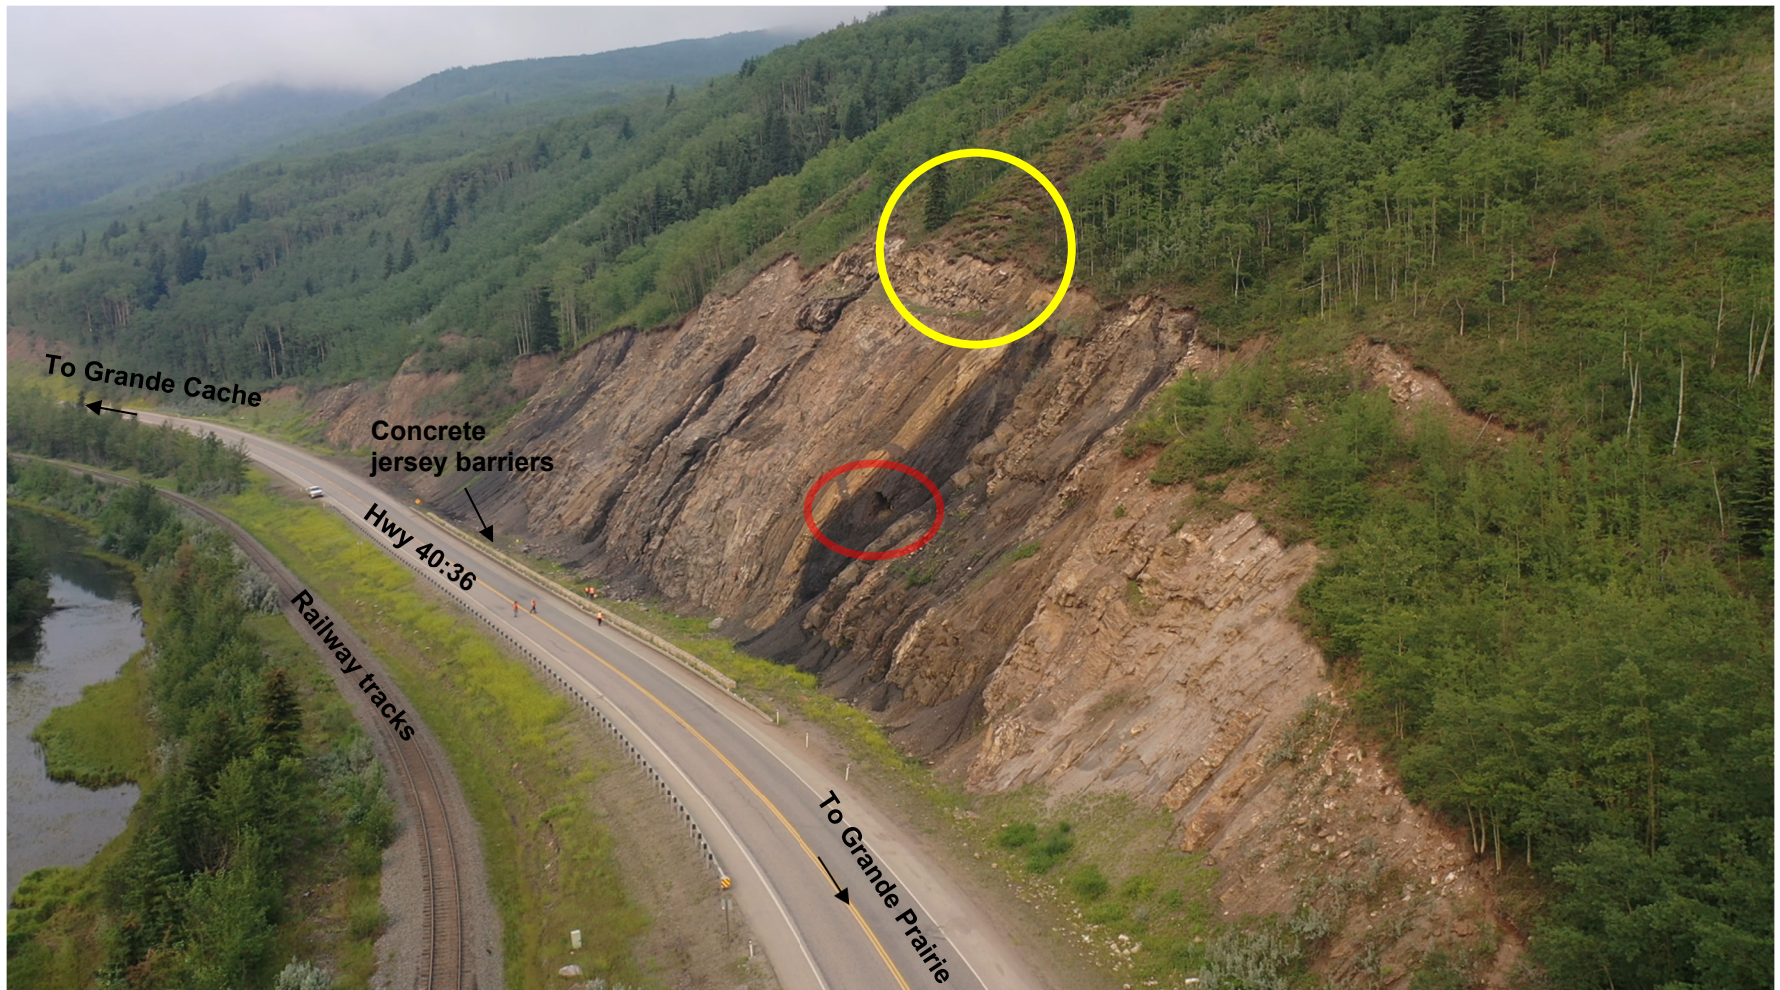
**Photo 1** Overview of the GP036 site, indicating Hwy 40, railway tracks, concrete lock blocks, and decommissioned coal mine shaft entrance (indicated by red circle). Note the overburden above the brow of the rock slope is failing (yellow circle). Photo taken July 21, 2021 facing south.

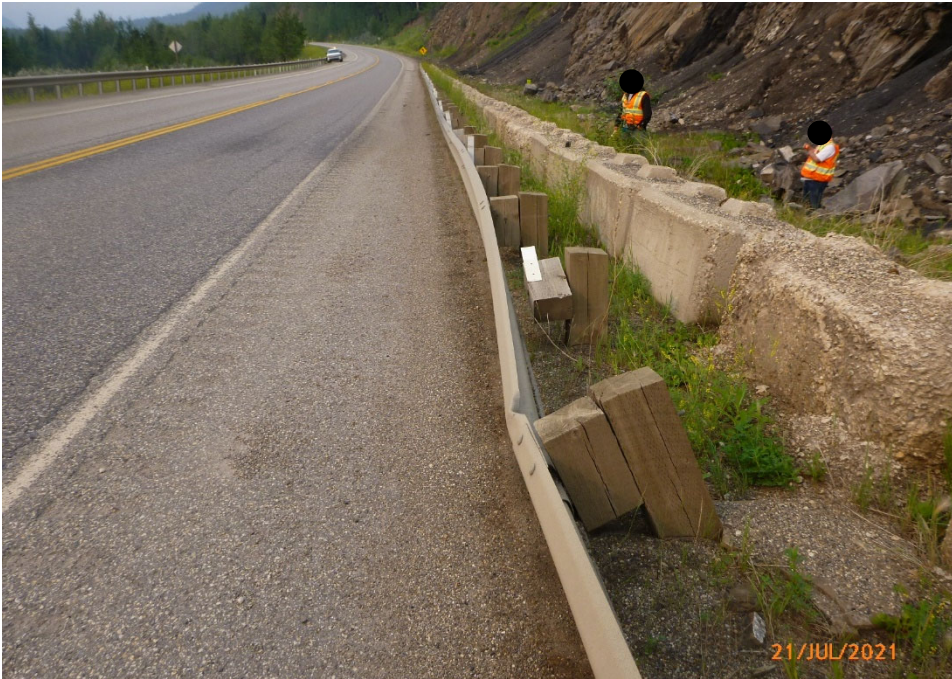
<ul style="list-style-type: none"> <li>- Rock strike on guardrail deflected guardrail and pushed it towards traffic</li> </ul>	
<ul style="list-style-type: none"> <li>- Wide ditch, about 7 m wide, gets cleaned out once a year. Ditch has not been cleaned out since last year, material in ditch is about 1 year accumulation</li> </ul>	
<ul style="list-style-type: none"> <li>- Centreline culvert at WP 0105 blocked with debris, some rockfall particles removed at time of site visit</li> </ul>	
<ul style="list-style-type: none"> <li>- Usually 10 to 15 cu.m. gets cleaned out each year, occasional particles big enough to need a loader to remove them, fall onto the road, don't usually make it past centreline</li> </ul>	
<ul style="list-style-type: none"> <li>- Some of the concrete lock blocks are deteriorating and will eventually need to be replaced</li> </ul>	
<u>Debris Flow site</u>	
<ul style="list-style-type: none"> <li>- Located at WP 0106 – major event in 2005</li> </ul>

**Photo 2** Deflection in guardrail caused by a particle falling down the slope. Photo taken July 21, 2021 facing south. Note some lock blocks are deteriorating.

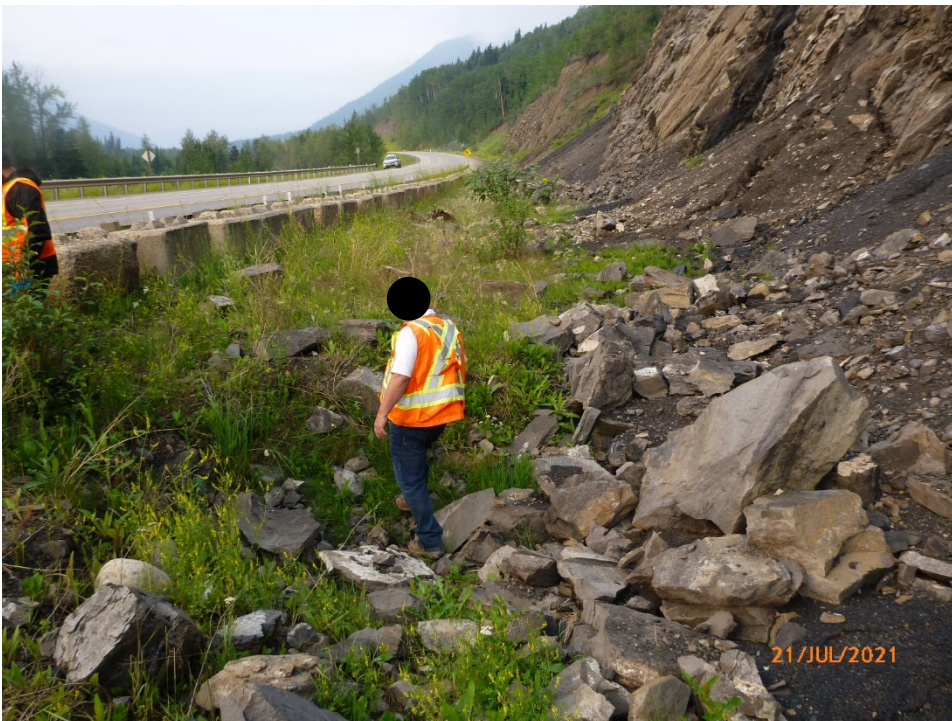
**Photo 3** Rockfall debris observed in the west (southbound) ditch at WP105. Photo taken July 21, 2021 facing southwest.

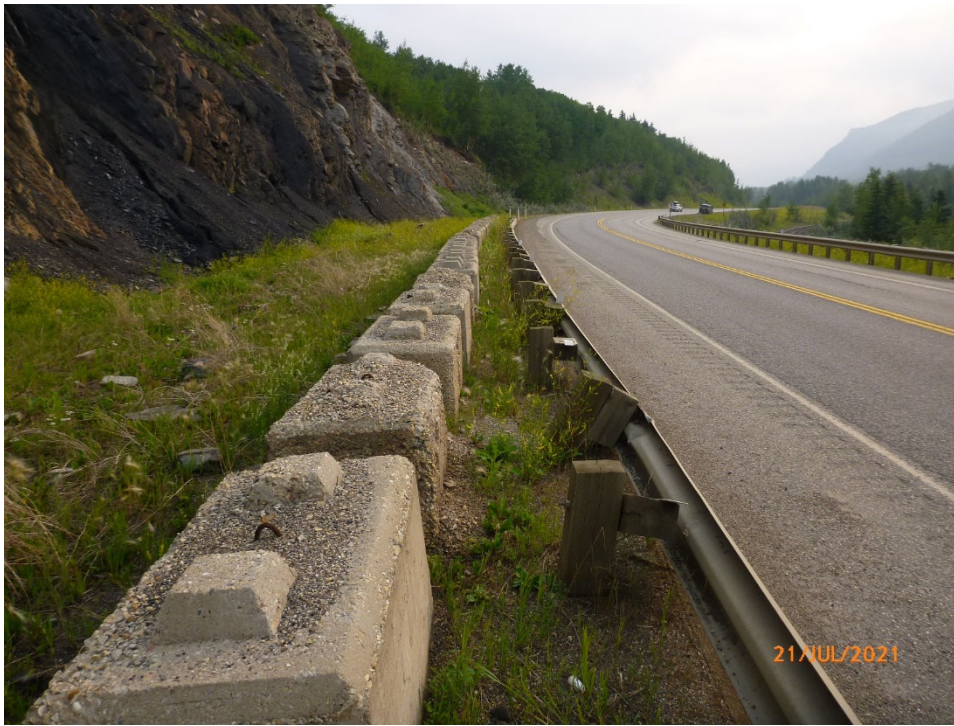
**Photo 4** Concrete jersey barriers installed on the west side of the guardrail, in the west (southbound) ditch. Photo taken July 21, 2021 facing north.

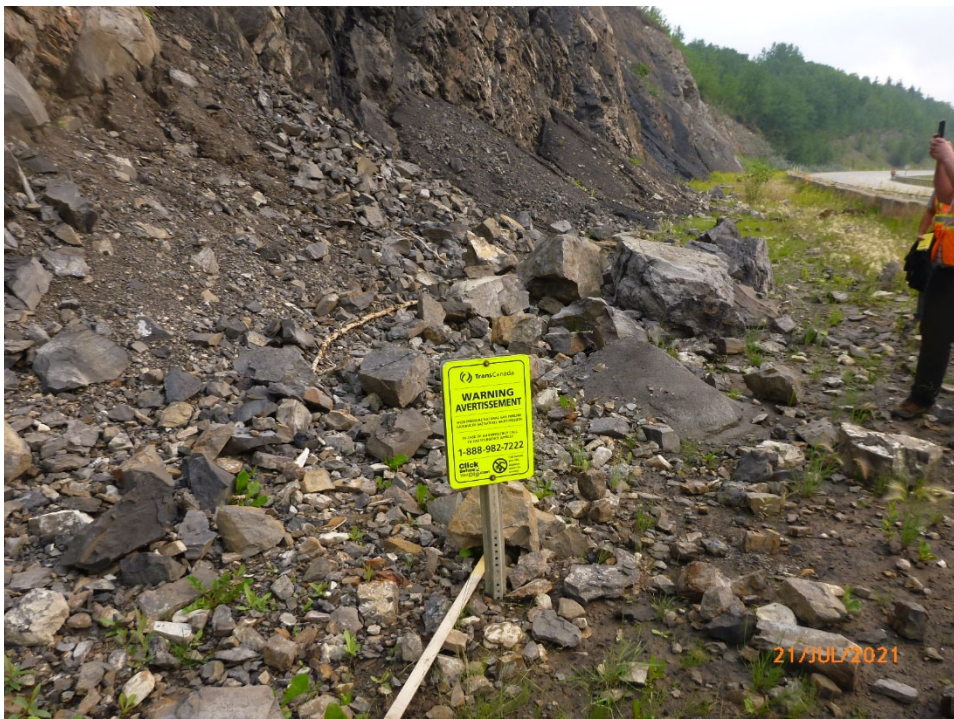
**Photo 5** Warning sign installed near the base of the slope in the west (southbound) ditch. Note gas line marker in ditch. Photo taken July 21, 2021 facing north.

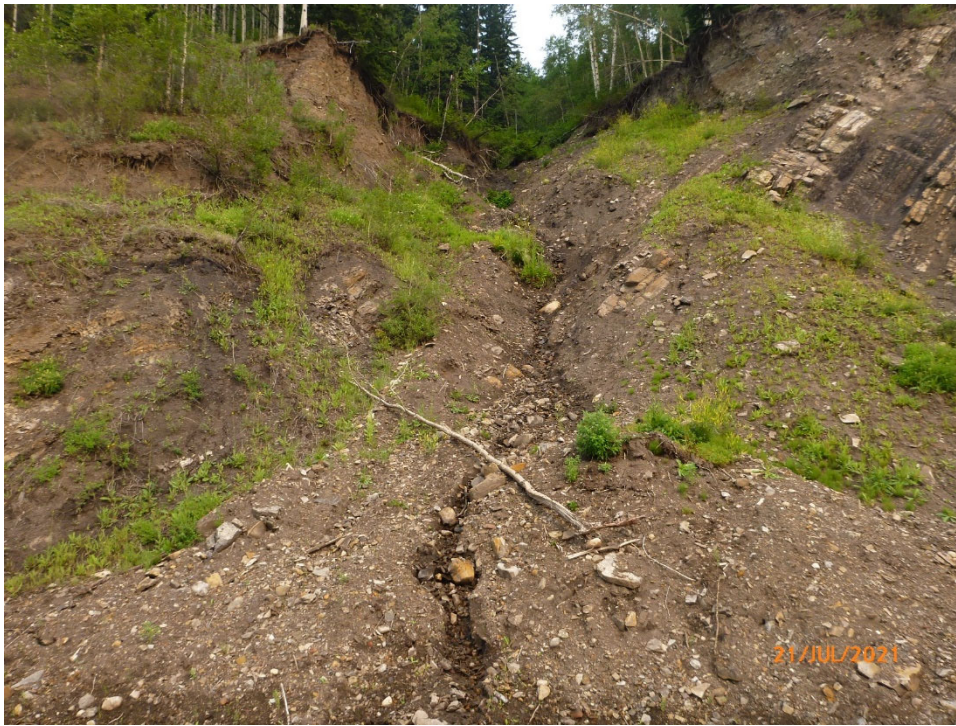
**Photo 6** Erosion gully located at the south end of the GP036 site at debris flow location (WP 106). Photo taken July 21, 2021 facing west.
