**PEACE REGION
(GRANDE PRAIRIE DISTRICT – SOUTH) GRMP**

SITE INSPECTION FORM

SITE NUMBER AND NAME: GP036 Rockfall 2.0 km South of McIntyre Mine		HIGHWAY & KM: 40:36, 12.061	PREVIOUS INSPECTION DATE: July 21, 2021	INSPECTION DATE: June 14, 2022
LEGAL DESCRIPTION: NW 04-58-08-W6M	NAD 83 COORDINATES: UTM Northing Easting 11 5984469 359856		RISK ASSESSMENT: PF: 14 CF: 4 TOTAL: 56	
AVERAGE ANNUAL DAILY TRAFFIC (AADT): 820 (north) & 1020 (south) (Reference No. 25592, 2021)			CONTRACT MAINTENANCE AREA (CMA): 504

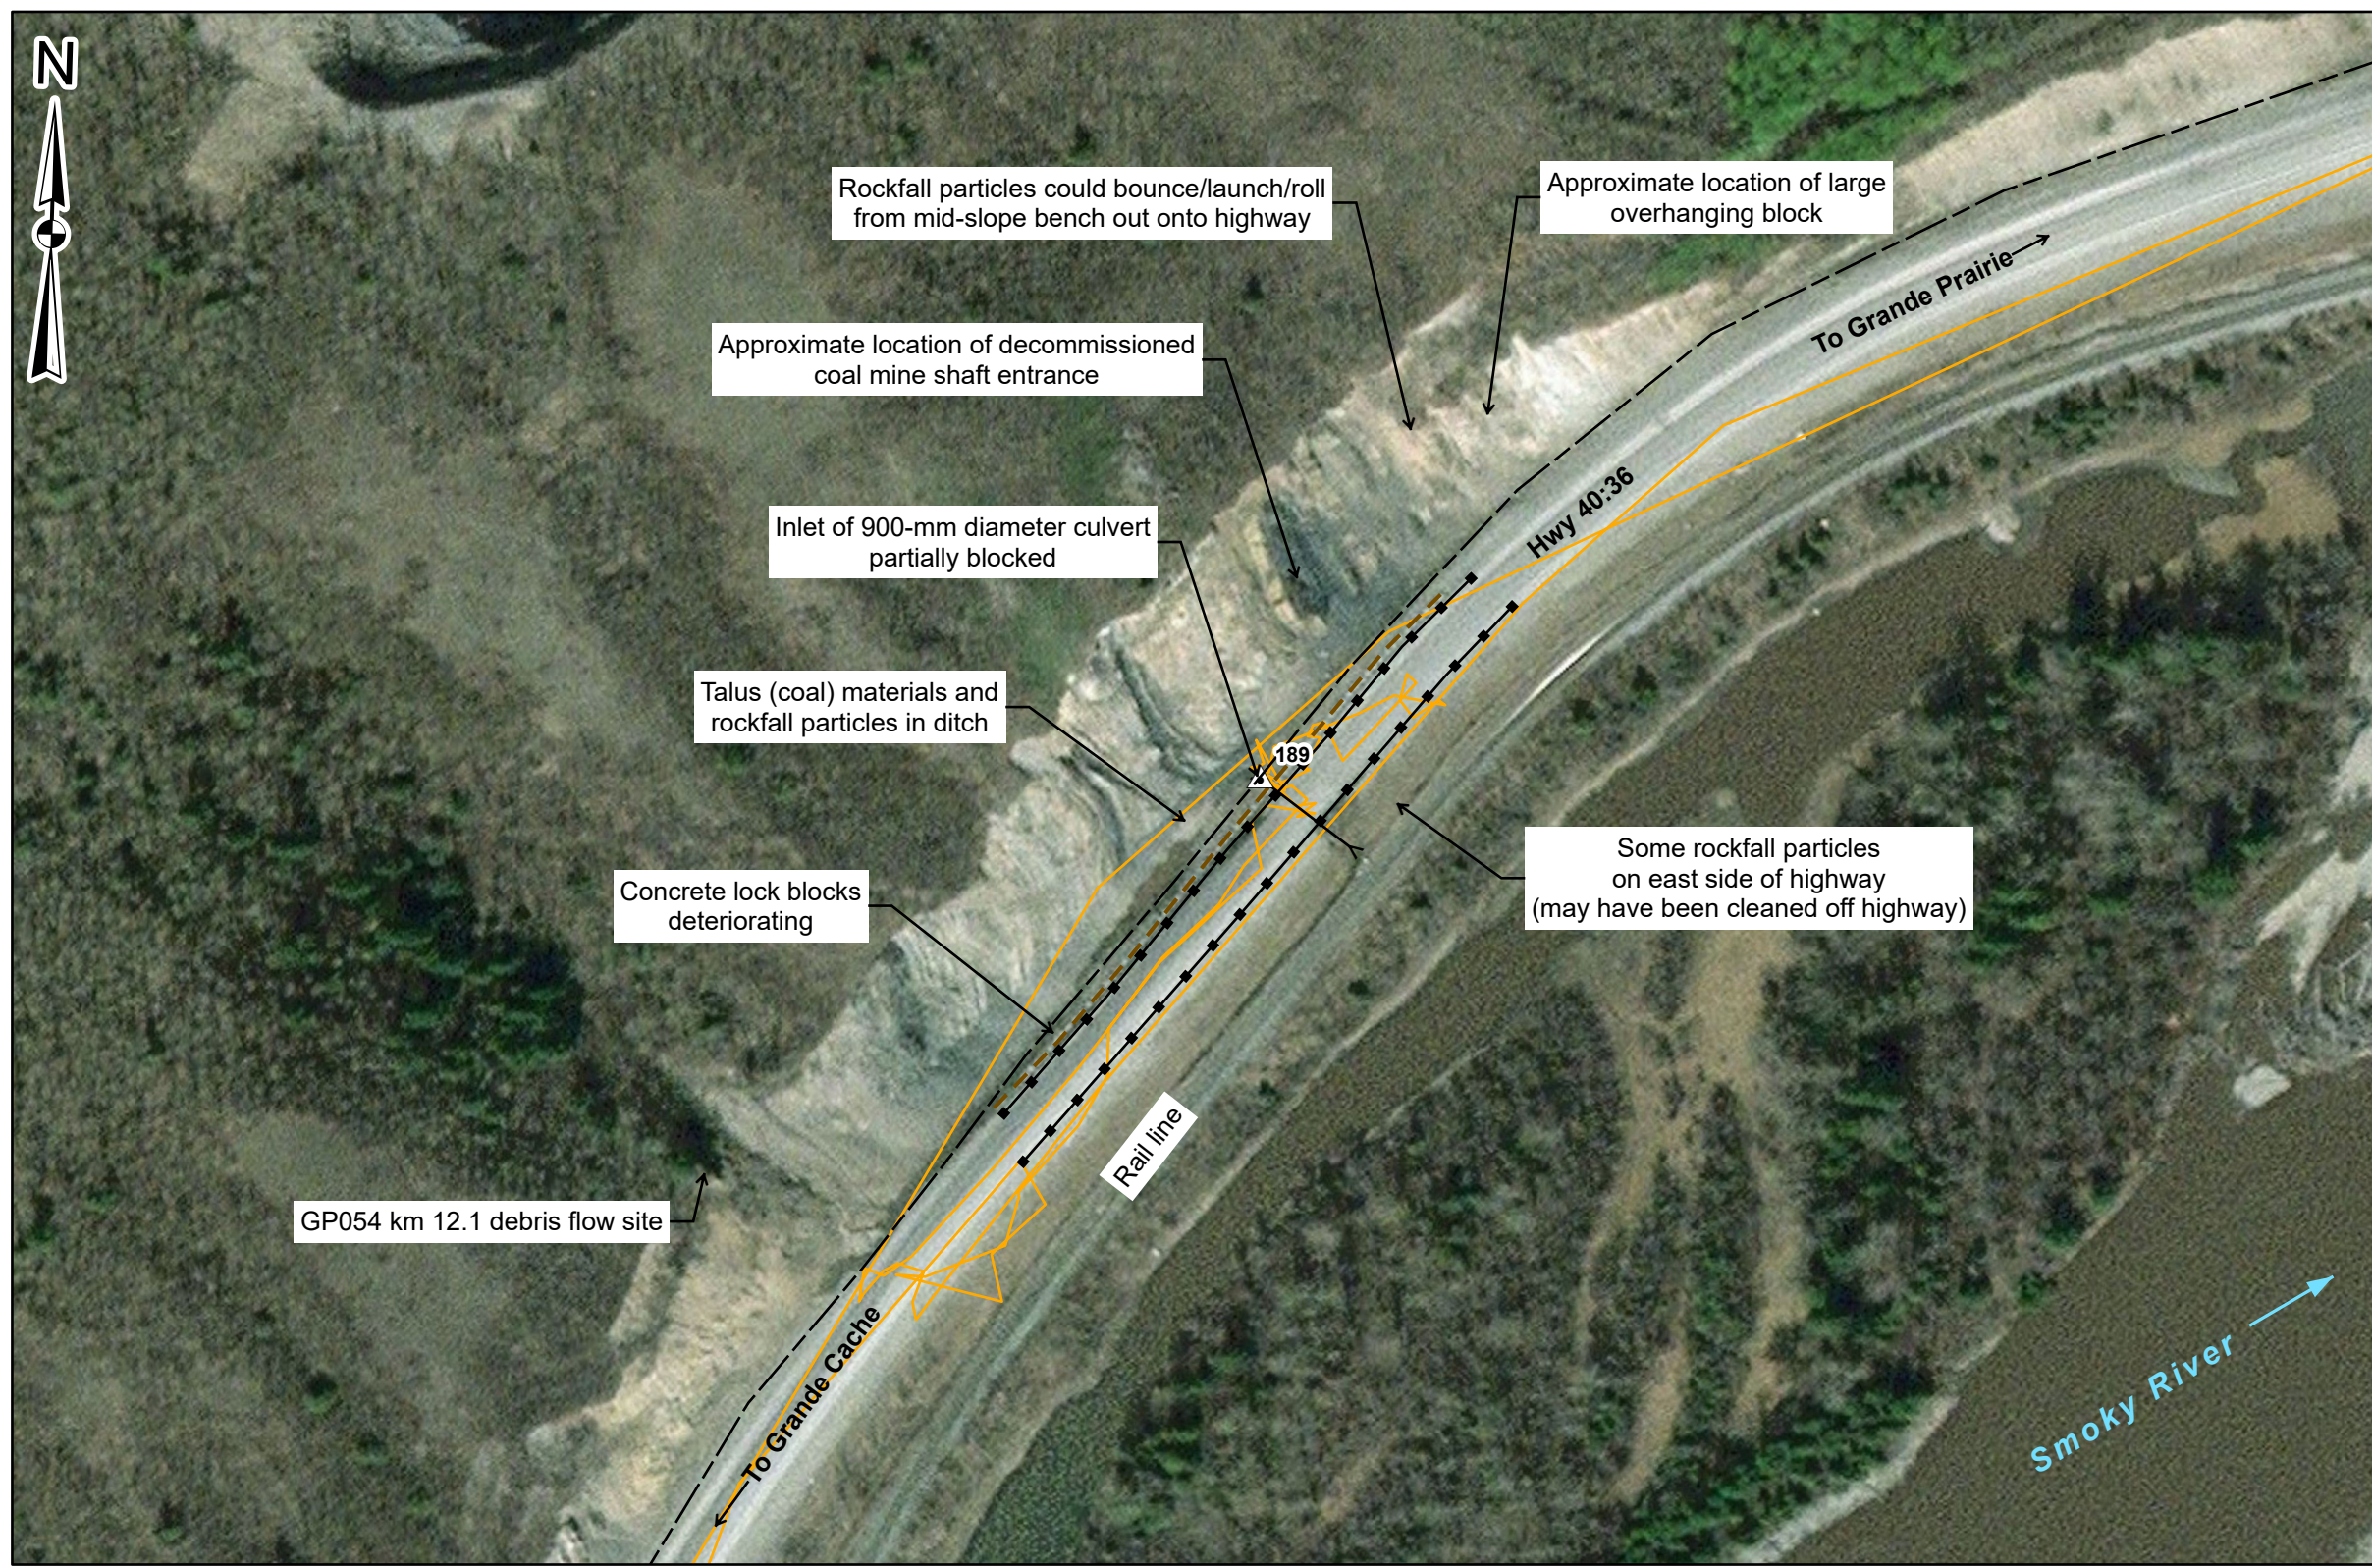
PROJECT PEACE REGION (GRANDE PRAIRIE DISTRICT-SOUTH) GEOHAZARD RISK MANAGEMENT PROGRAM		
TITLE Site Plan GP036 - Rockfall 2.0 km South of McIntyre Mine Hwy 40:36, km 12.061		
SCALE 1:1,500	PROJECT No. A05116A01	FIG No. 1

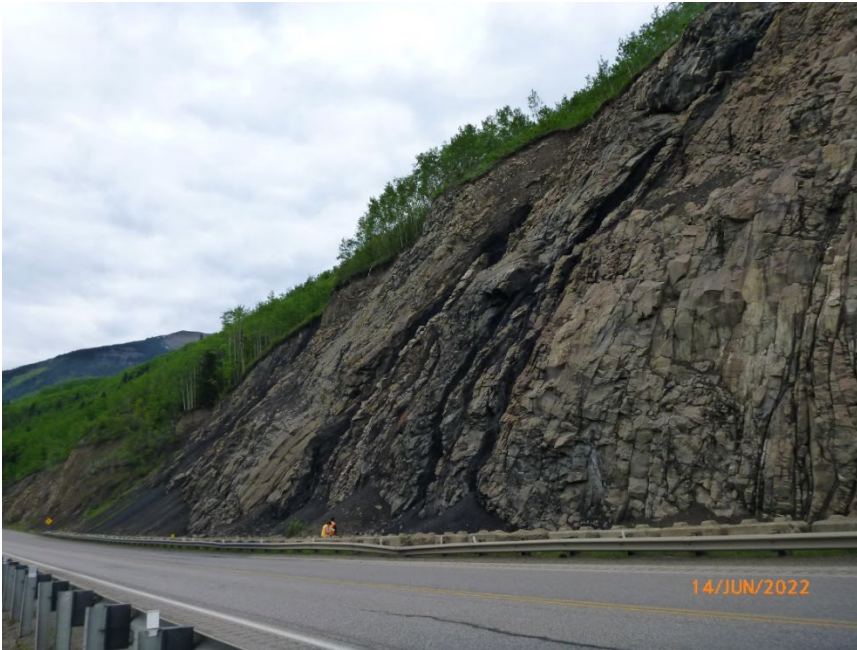
Photo 1 South extent of rock cut slope along west side of Hwy 40:36. Photo taken June 14, 2022, facing southwest.

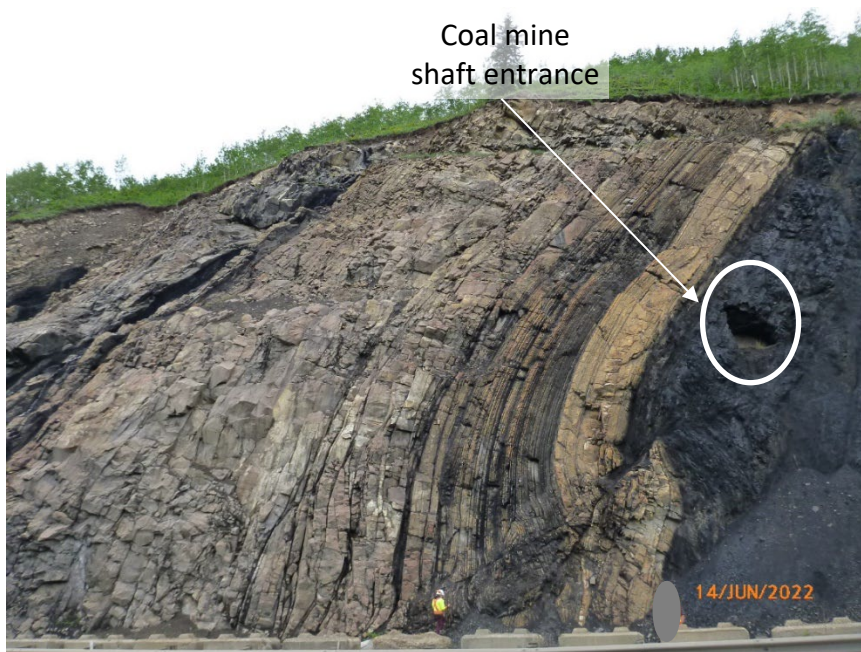
Photo 2 Middle of rock cut slope along west side of Hwy 40:36. Note decommissioned coal mine shaft entrance on slope (circled in white). Photo taken June 14, 2022, facing northwest.

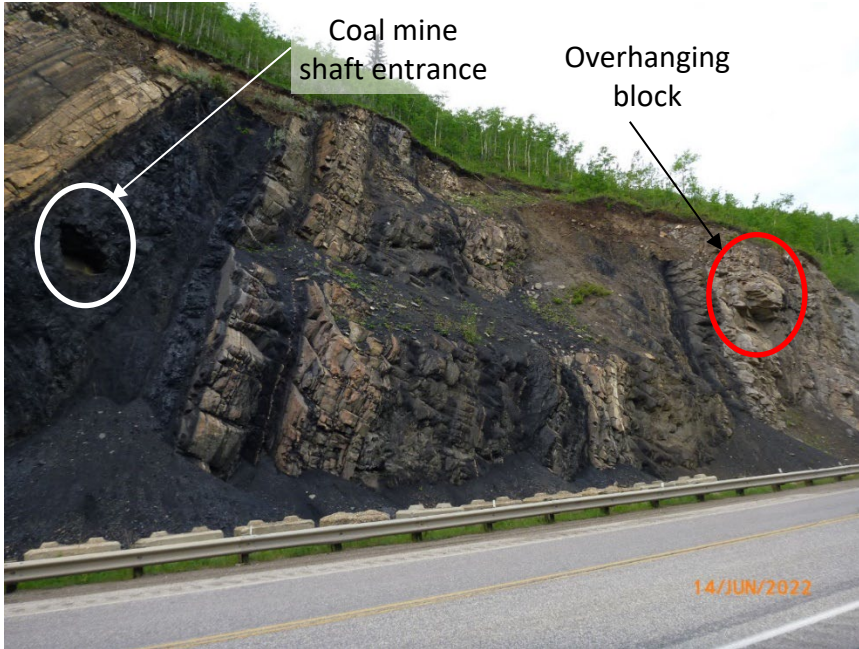
Several hanging rock blocks close to falling.
Mid-slope bench and talus cones/slope could potentially bounce/launch/roll rockfall particles out onto highway.
AT says that some rock particles make it to the highway, and some are large enough to require a front-end loader to remove. AT reported in the spring of Spring 2022, a large event occurred where rockfall particles made it across the highway. A few rockfall particles were observed on the opposite side of the highway between the guardrail and railway line.
Rockfall particles up to 1.5 m x 1.0 m x 0.8 m, estimated average particle size of 0.5 m x 0.5 m x 0.5 m.
Decommissioned coal mine shaft entrance approximately midway up rock cut slope.
Ponded water in ditch at toe of rock slope, which could be due to seepage and/or poor ditch drainage.
Segment of guardrail deflected and pushed towards south/westbound traffic from rockfall strike.
“Watch for fallen rock” signs on either side of site, on east shoulder before site for northbound traffic and on west shoulder before site for southbound traffic. Also, no parking sign on east side of highway at northern site limit (end of guardrail) for northbound traffic.

Photo 3 North extent of rock cut slope along west side of Hwy 40:36. Note decommissioned coal mine shaft entrance on slope (circled in white) and overhanging block (circled in red). Photo taken June 14, 2022, facing northwest.

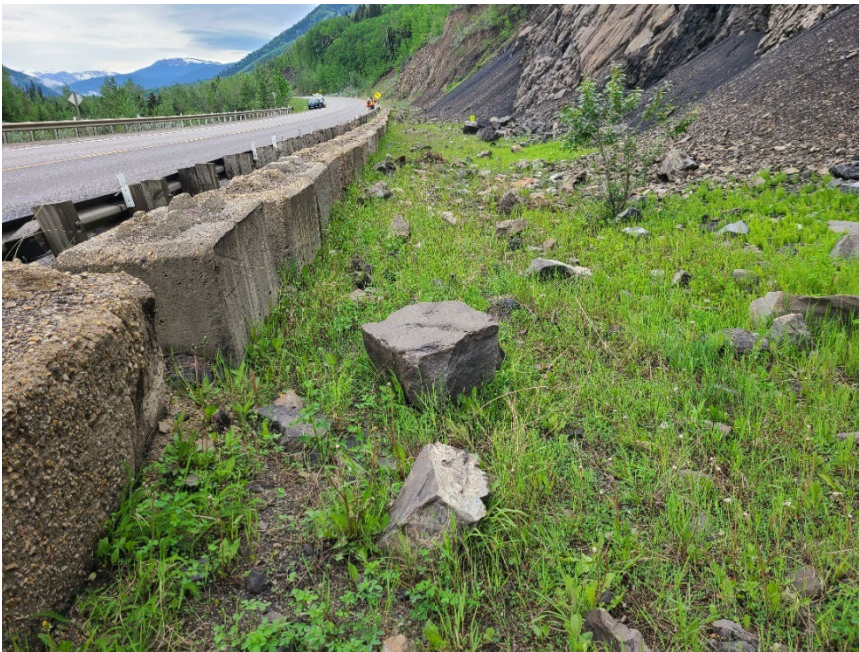
Photo 4 Talus (coal) deposits and rockfall particles in upslope/west ditch of Hwy 40:36. Note lock blocks are deteriorating. Photo taken June 14, 2022, facing southwest.

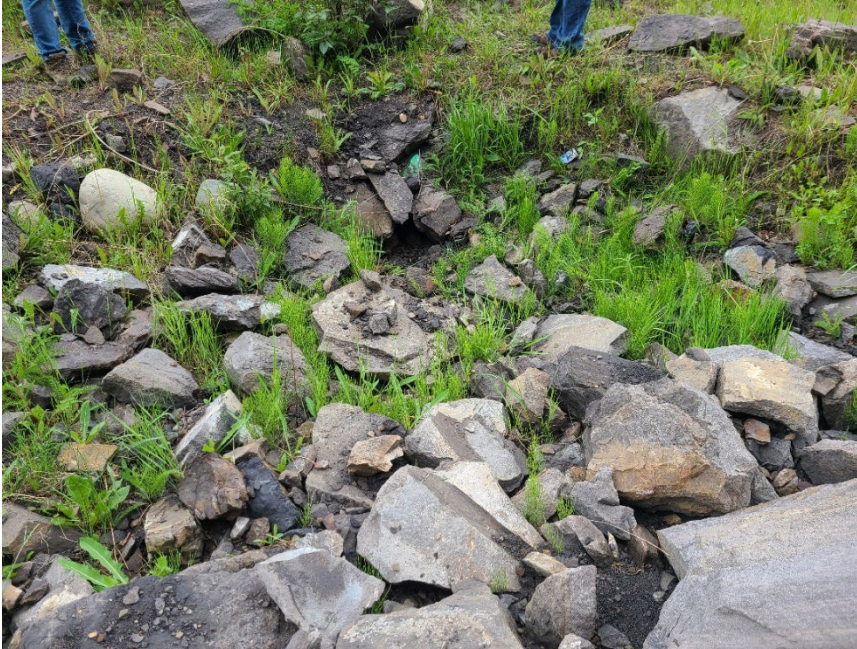
Photo 5 Culvert inlet on west side of highway partially blocked with debris. Some rockfall particles removed from culvert inlet by AT by hand during the 2022 inspection. Photo taken June 14, 2022, facing southeast.

<p><u>Maintenance/Repair/Monitoring Recommendations:</u></p> <ul style="list-style-type: none"> • Call out completed at the GP036, GP049, and GP053 sites on July 14, 2022 after increased rockfall activity was triggered by wet weather. As part of the call out a review will be completed to determine where scaling and an attenuating mesh is needed. <ul style="list-style-type: none"> ○ Short term – Rock slope should be scaled by a high-angle specialty contractor. Scaled materials and other rockfall materials should be cleaned out of the ditch. Estimated cost: \$100,000 to \$140,000 if entire rock face scaled. ○ Long term – Rock slope should be draped in an attenuating mesh that reduces the energy of falling rocks and limits their potential to reach the highway. Estimated cost: \$360,000 to \$490,000 if entire rock face draped with mesh. • Some of the concrete lock blocks are deteriorating and have been damaged by rock strikes. They will eventually need to be replaced. • Upslope/west ditch approximately 7 m wide. MCI reported ditch has been cleaned twice in the last six years. Continue to clean ditch to maintain rockfall storage volume (i.e., keep ditch as wide and deep as possible to retain material within the ditch) and reduce the potential for material reaching the highway. Buried gas line and fiber optics cable below ditch limits depth that ditch can be excavated or cleaned out. • Inlet of culvert should also be cleaned to maintain ditch flow.

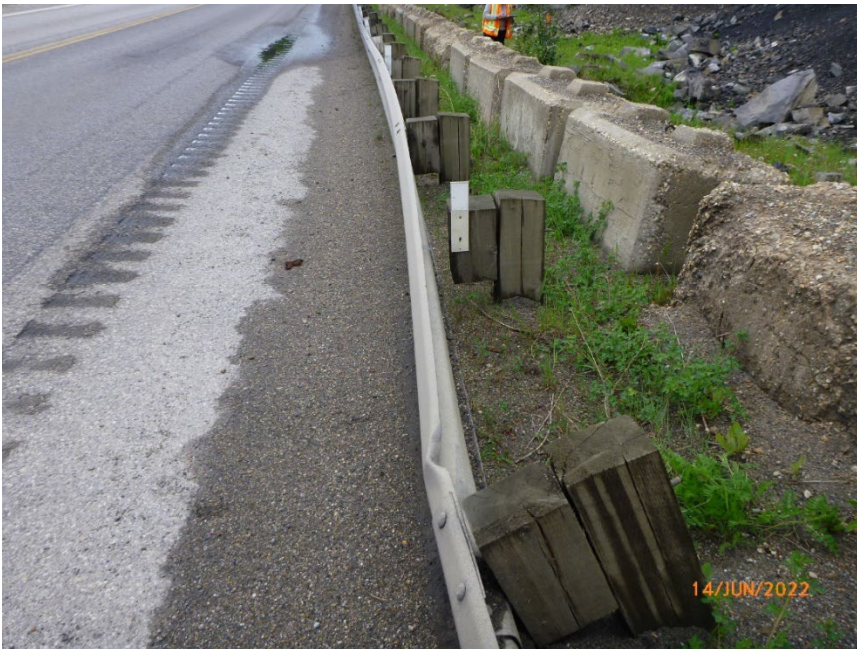
Photo 6 Segment of guardrail deflected and pushed towards southbound traffic from rockfall strike. Photo taken June 14, 2022, facing southwest.

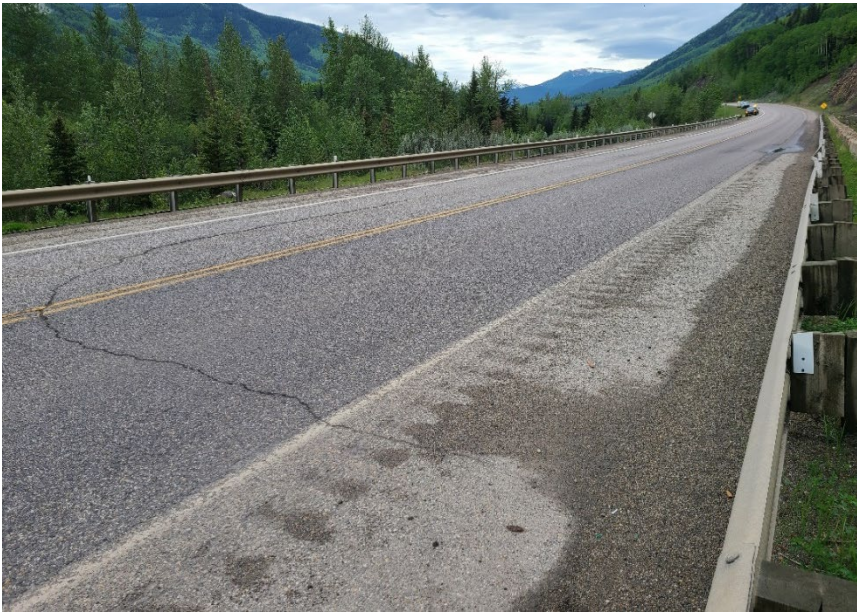
Photo 7 **Pavement surface of Hwy 40:36. Photo taken June 14, 2022, facing south.**

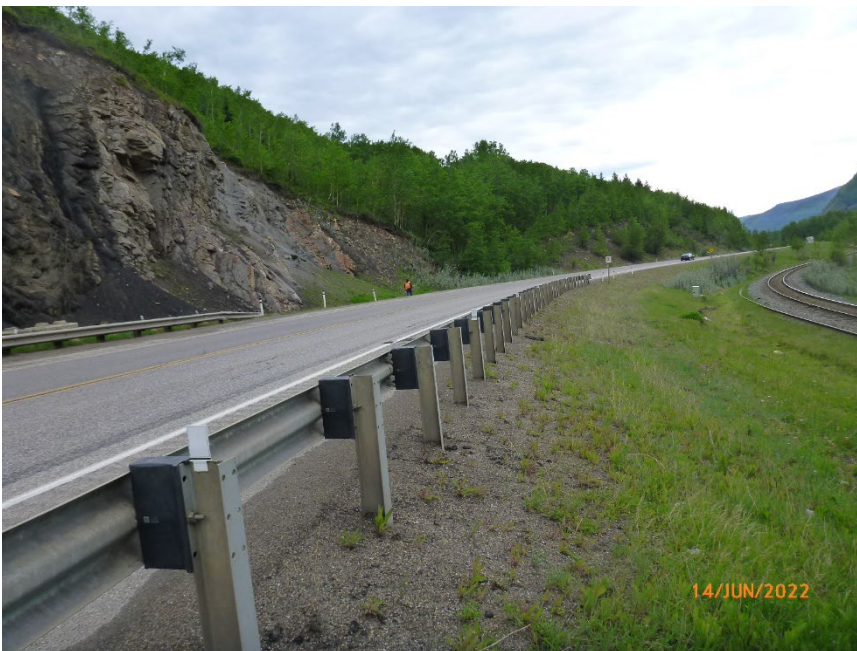
Photo 8 **Some rockfall particles on east side of Hwy 40:36 between guardrail and railway tracks. These particles may have been cleaned off highway, but AT has reported rockfall particles making it across highway. Photo taken June 14, 2022, facing northeast.**

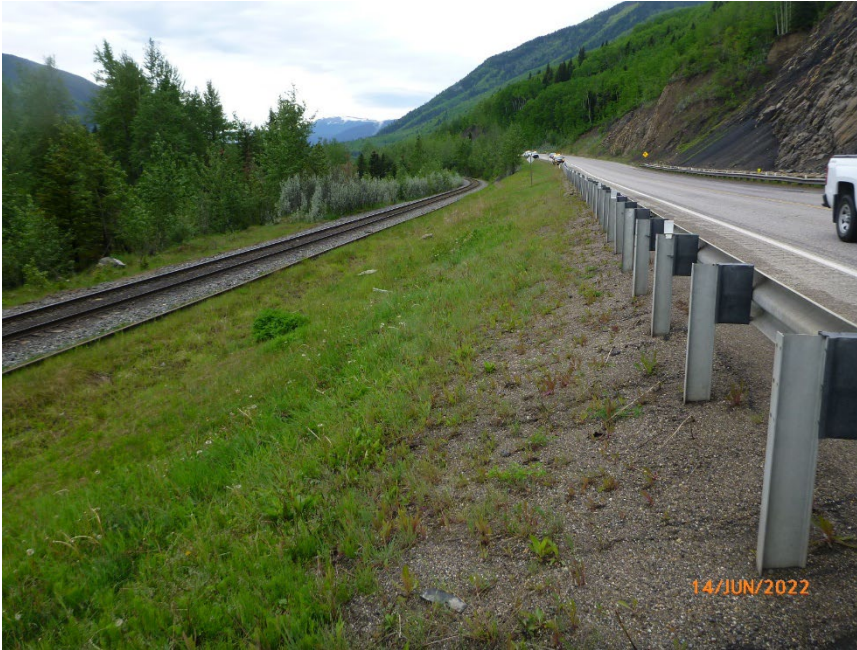
Photo 9 **Some rockfall particles on east side of Hwy 40:36 between guardrail and railway tracks. These particles may have been cleaned off highway, but AT has reported rockfall particles making it across highway. Photo taken June 14, 2022, facing southwest.**
