SITE INSPECTION FORM

SITE NUMBER AND NAME: GP036 Rockfall 2.0 km South of McIntyre Mine		HIGHWAY & KM: 40:36, 12.061	PREVIOUS INSPECTION DATE: June 10, 2024	INSPECTION DATE: June 2, 2025
LEGAL DESCRIPTION: NW 04-58-08-W6M	NAD 83 COORDINATES: UTM Northing Easting 11 5984469 359856		RISK ASSESSMENT: PF: 16 CF: 6 TOTAL: 96	
AVERAGE ANNUAL DAILY TRAFFIC (AADT): 760 (north) & 960 (south) (Reference No. 25592, 2024)			CONTRACT MAINTENANCE AREA (CMA): 504

PROJECT PEACE REGION (GRANDE PRAIRIE DISTRICT-SOUTH) GEOHAZARD RISK MANAGEMENT PROGRAM		
TITLE Site Plan GP036 - Rockfall 2.0 km South of McIntyre Mine Hwy 40:36, km 12.061		
SCALE 1:1,500	PROJECT No. A05116A01	FIG No. 1

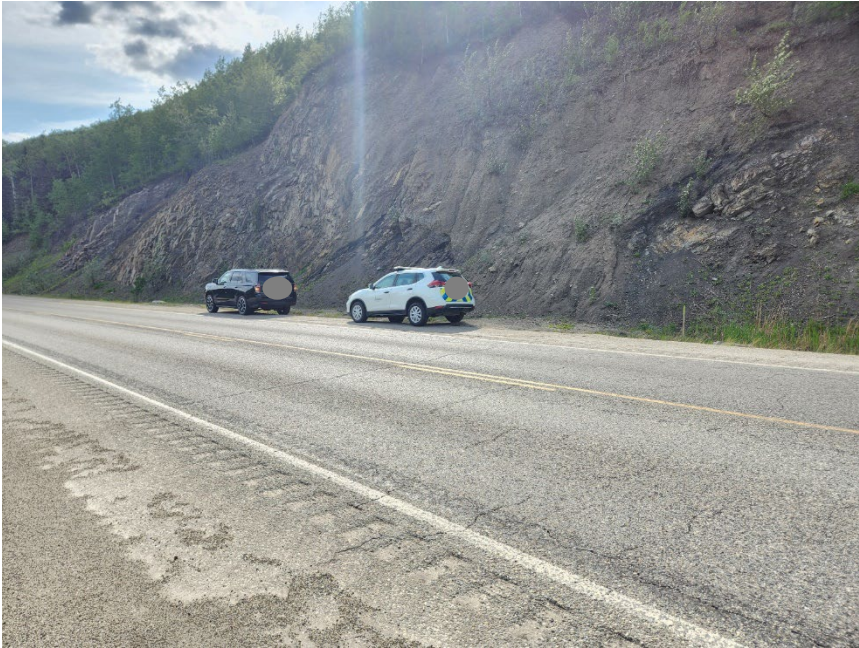
Mid-slope ledges and talus cones/slope could potentially bounce/launch/roll rockfall particles out onto the highway (Photo 9).
Previously fallen rockfall particles (up to 1.5 m x 1.0 m x 0.8 m) and talus materials continue to accumulate at the toe of the rock slope and in the west highway ditch (Photos 2, 3, and 6 through 10). Some rockfall particles on the east side of the highway, but they may have been cleaned off the highway (Photo 7). TEC has previously mentioned that some rock particles make it to the highway, and some are large enough to require a front-end loader to remove.
Relaxations of joints on the rock slope appear to have increased over the past two years. A few larger particles have fallen near the middle of the site (Photo 8) and some additional material appears to have fallen at the north end of site (Photo 10) since the 2024 inspection.
Possible fault structure located between rock slopes that is infilled with soil (Photos 1 and 2).

Photo 1 Rock slope along west side of Hwy 40:36, south of GP054 debris flow site. Photo taken June 2, 2025, facing southwest.

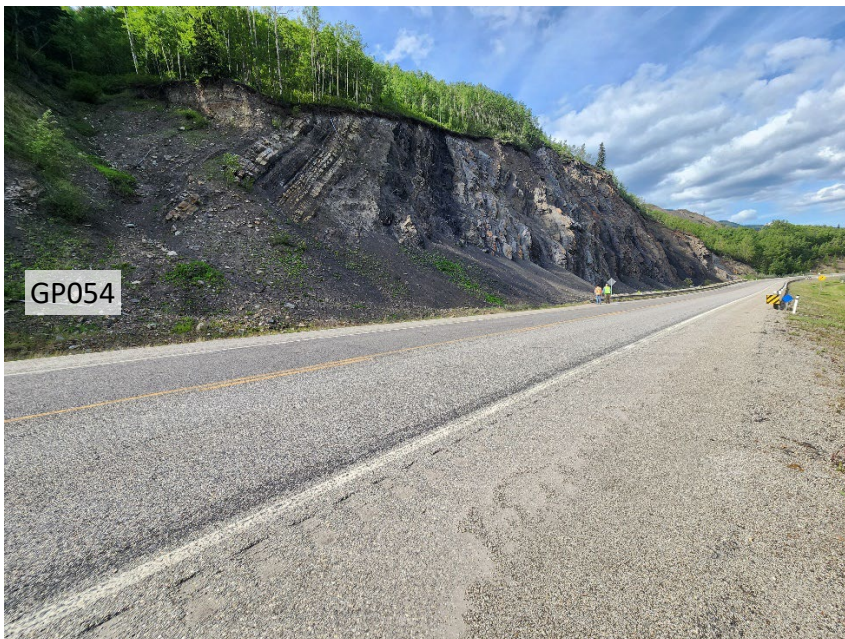
Photo 2 Rock slope along west side of Hwy 40:36, north of GP054 debris flow site. Note GP054 km 12.1 debris flow site on left. Photo taken June 2, 2025, facing northeast.

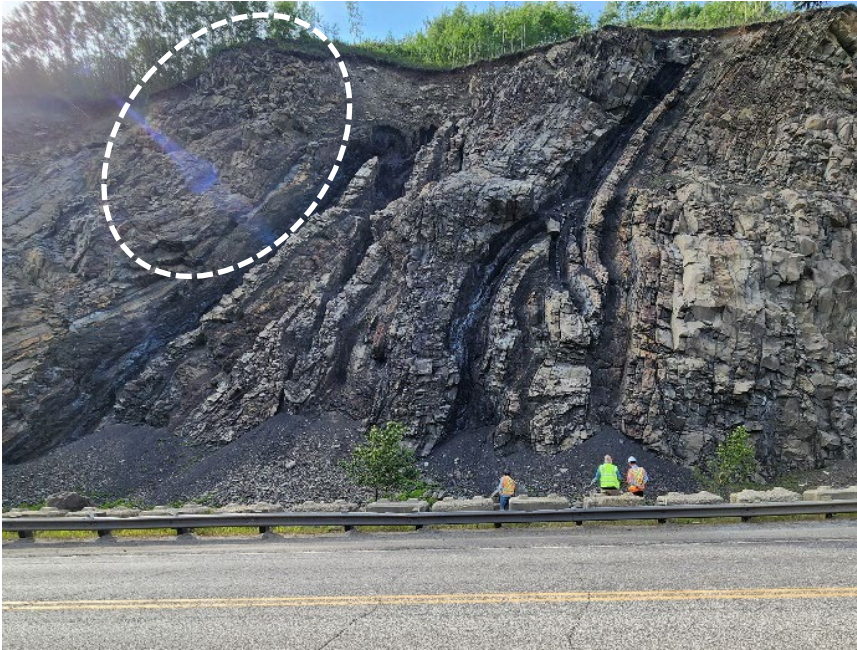
Photo 3 Rock slope along west side of Hwy 40:36. Note talus material mainly from coal seams in highway ditch, potential rock block on upper slope (circled in white, see photo below), and thin layer of soil at crest of slope. Photo taken June 2, 2025, facing northwest.

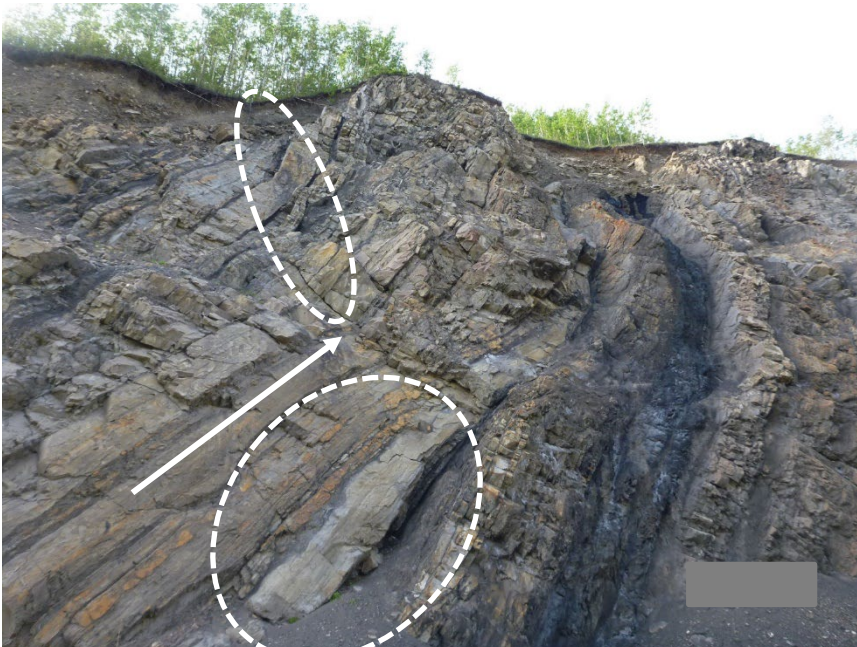
Photo 4 Potential rock block on upper slope shown in previous photo. Note dilated or open joints below rock block (indicated with white arrow), joints or shear planes to left and below rock block (circled in white), and rock and coal to right of rock block which is eroding. Photo taken June 2, 2025, facing northwest.

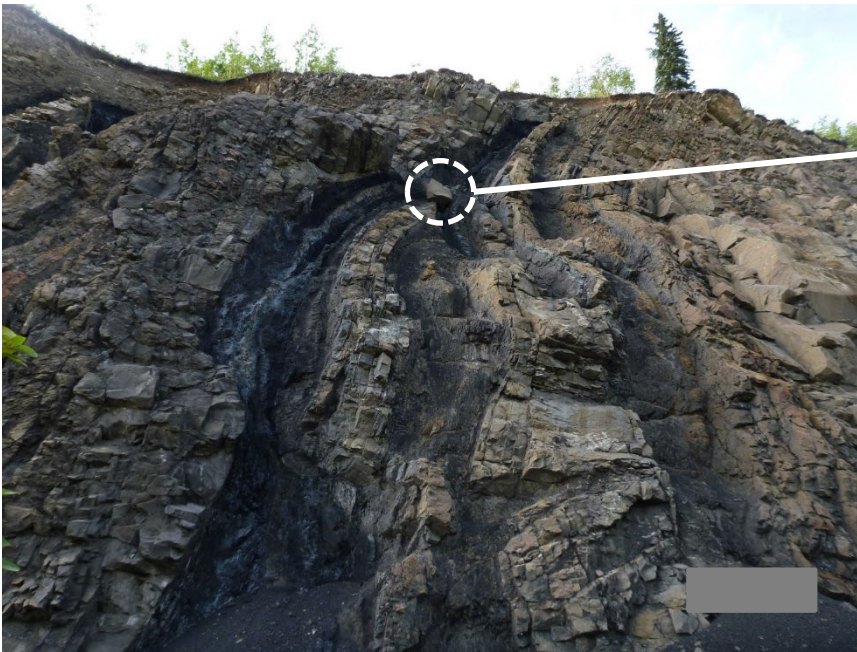
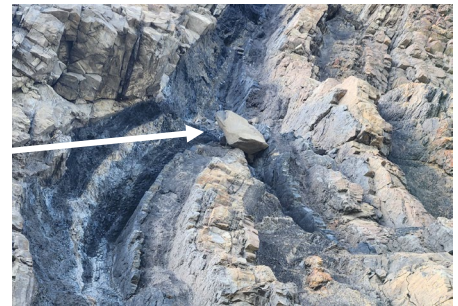
Photo 5 Rock slope along west side of Hwy 40:36. Note loose rock block (circled in white) on slope. Photo taken June 2, 2025, facing northwest.

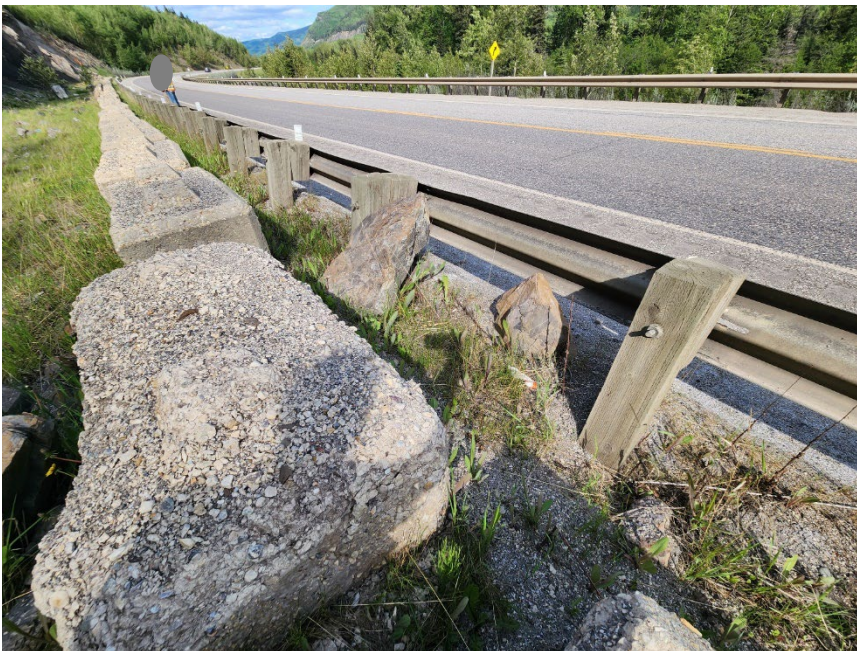
Photo 6 Rockfall particle leaning against guardrail along west shoulder of Hwy 40:36. Photo taken June 2, 2025, facing northeast.

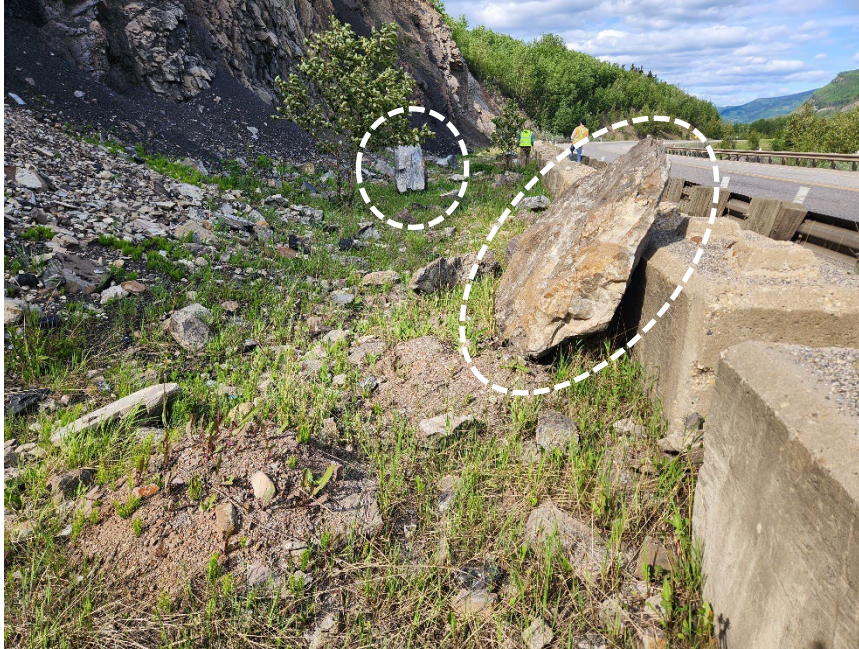
Photo 7 **Rockfall particles in ditch on west side of Hwy 40:36. Note two large rock particles (circled in white) that fell between 2023 and 2024 inspections. Photo taken June 2, 2025, facing northeast.**

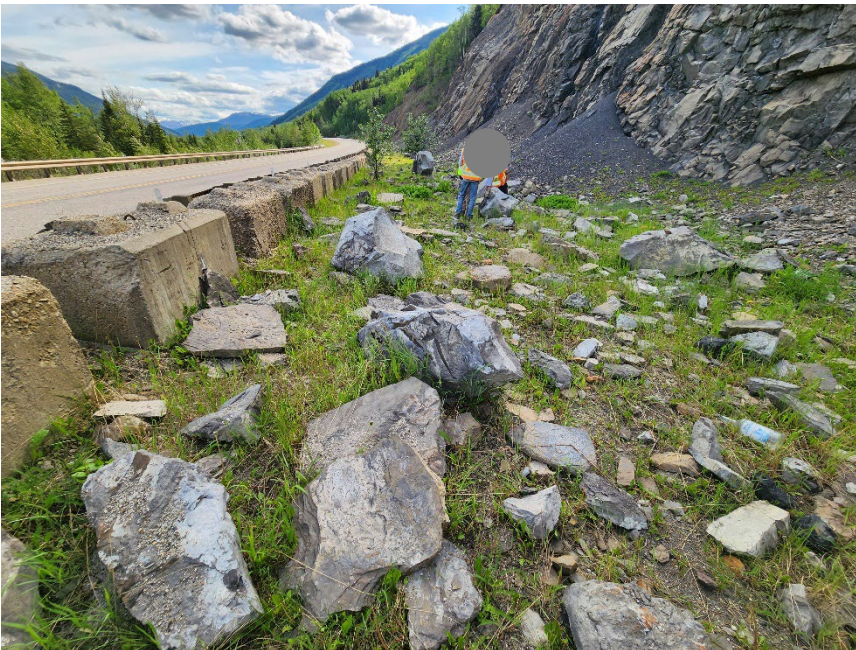
ITEM	CONDITION EXISTS		DESCRIPTION AND LOCATION	NOTICABLE CHANGE FROM LAST INSPECTION	
	YES	NO		YES	NO
Pavement Distress		X	None from rock hazards observed at time of 2025 inspection (Photo 8).		X
Slope Movement	X		Rockfall particles and talus materials continues to accumulate at toe of slope and in west highway ditch.	X	
Erosion	X		Differential weathering, freeze thaw, ice jacking, and seepage eroding rock mass. Some erosion along crest of slope.	X	
Seepage	X		Seepage sometimes observed flowing from rock slope.		X
Culvert Distress	X		Culvert inlet on west side of highway partially blocked with rockfall particles. Some rockfall particles removed by TEC during 2025 inspection by hand.	X

Photo 8 **Rockfall particles in ditch on west side of Hwy 40:36. Additional particles appears to have fallen since 2024 inspection. Photo taken June 2, 2025, facing southwest.**

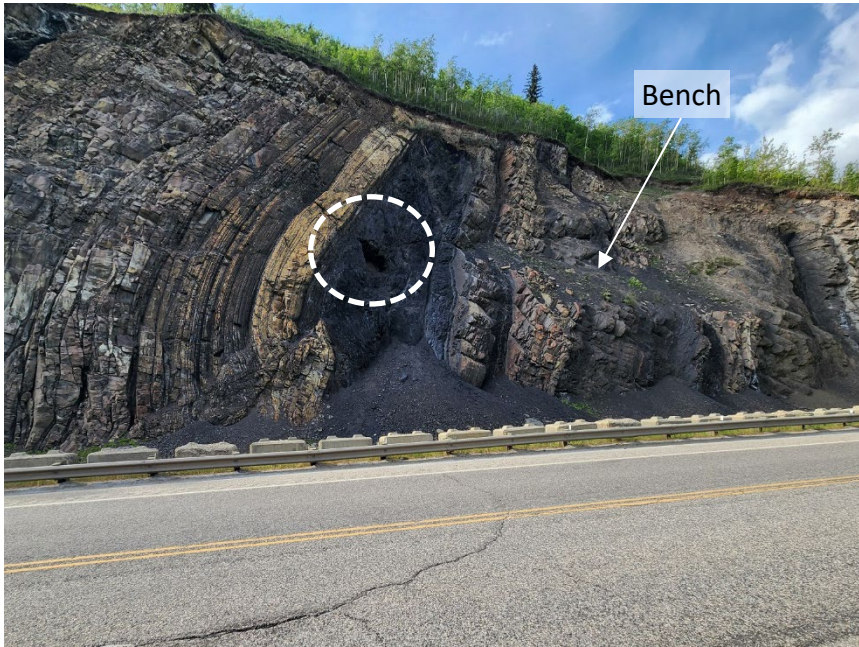
Decommissioned coal mine shaft entrance approximately midway up rock slope (Photo 9).
Ponded water is sometimes observed in the west highway ditch at the toe of the rock slope, which could be due to seepage and/or poor ditch drainage. During the 2025 inspection, the ditch channel was relatively dry.
A high-pressure natural-gas pipeline is located below the west highway ditch.
“Watch for fallen rock” signs on either side of site, located on the east shoulder before the site for northbound traffic and on the west shoulder before the site for southbound traffic. Also, no parking sign on the east side of the highway at the northern site limit (end of guardrail) for northbound traffic.
Swallows have been previously observed at the site. Construction would need to be outside the nesting period.

Photo 9 Rock slope along west side of Hwy 40:36. Note near-vertical bedding orientation of bedrock, talus material mainly from coal seams in highway ditch, bench which could launch rockfall particles from mid slope, and decommissioned coal mine shaft entrance (circled in white). Photo taken June 2, 2025, facing north.

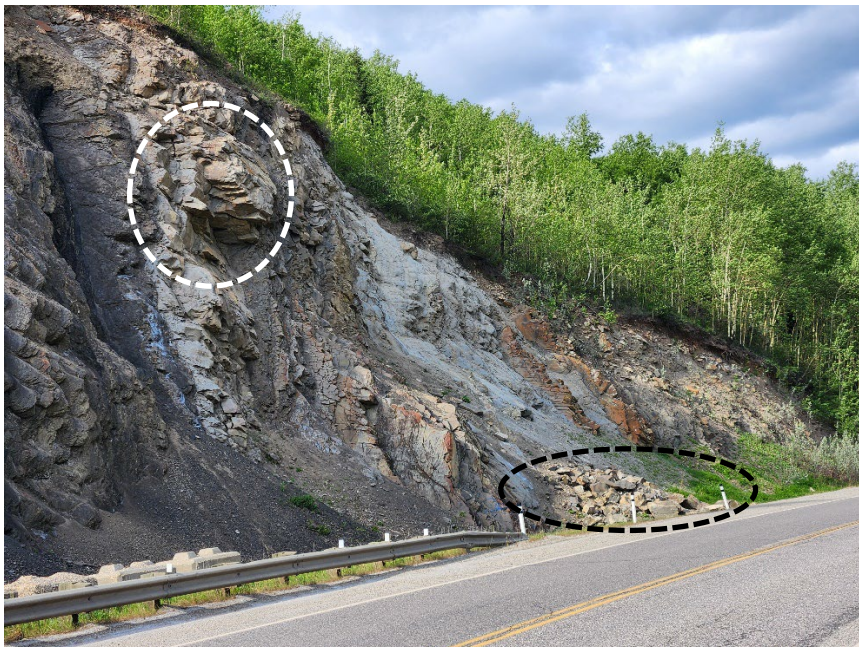
Photo 10 Rock slope along west side of Hwy 40:36 near north end of site. Note hanging rock block (circled in white) and rockfall that occurred between 2023 and 2024 inspections (circled in black). Additional material appears to have fallen since 2024 inspection. Photo taken June 2, 2025, facing north.

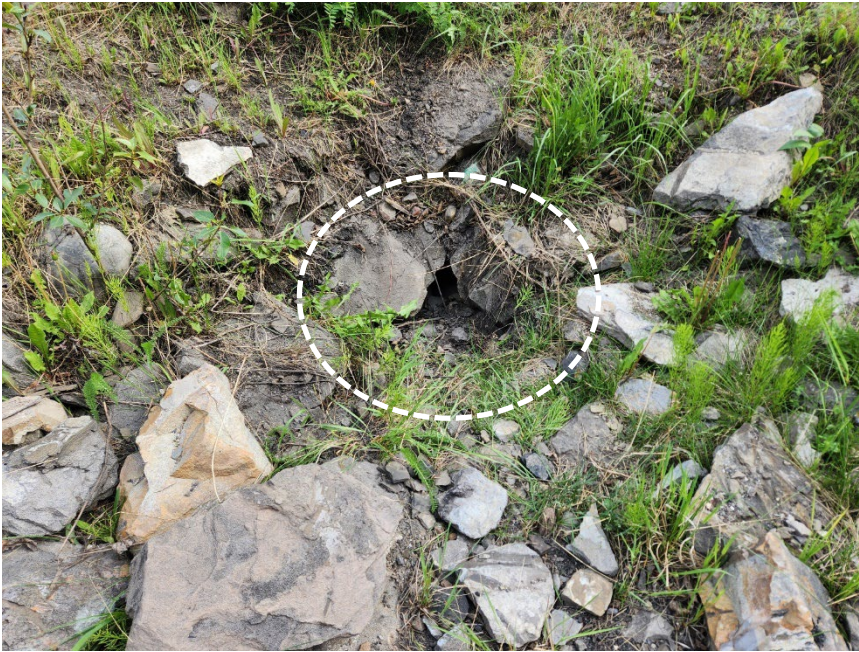
Photo 11 Culvert inlet (circled in white) in ditch on west side of Hwy 40:36 partially blocked with rocks. Photo taken June 2, 2025.

- Clean the west highway ditch regularly to maintain rockfall storage volume (i.e., keep ditch as wide and deep as possible to retain material within the ditch) and reduce the potential for material reaching the highway. This includes cleaning the culvert inlet which is typically partially blocked with rockfall particles (Photo 11). A buried gas line and fiber optics cable along the ditch limits the depth the ditch can be excavated or cleaned out. Estimated cost: approximately \$25,000 to \$40,000.

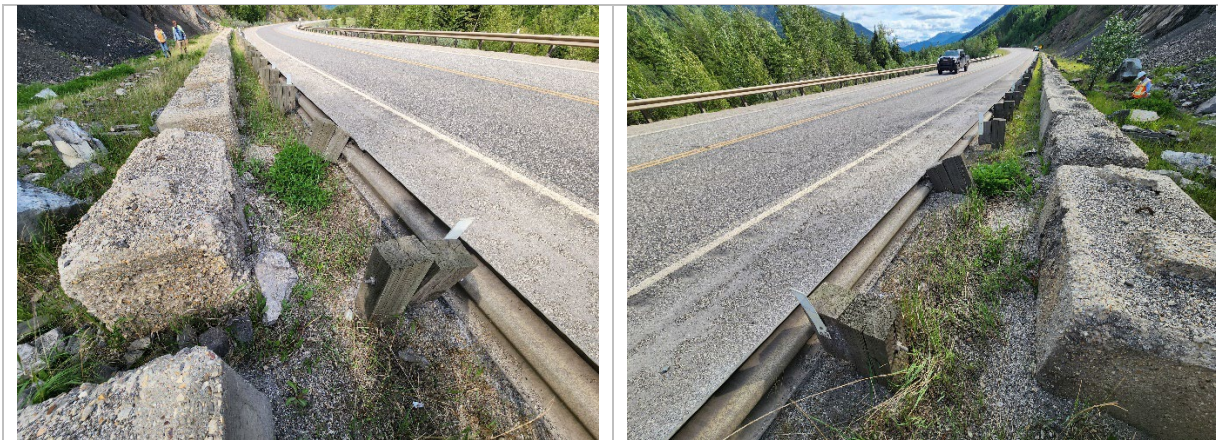
- Along the west highway shoulder, some of the concrete lock blocks are deteriorating and have been damaged by rock strikes, and a segment of the guardrail is deflected and has been pushed towards the southbound lane from rock strikes (Photo 12). Eventually, the lock blocks will eventually need to be replaced and the guardrail will need to be repaired.

Photo 12 Pavement surface of Hwy 40:36. Note lock blocks are deteriorating and segment of guardrail deflected and pushed towards southbound lane from rock strikes. Photos taken June 2, 2025, facing northeast and southwest, respectively.

- A 90% rockfall catchment, extension of the existing concrete lock block barrier towards the south end of the site, and replacement of the existing concrete lock blocks that have deteriorated. Additionally, installation of fiber-reinforced shotcrete protection over fractured coal seams. Estimated cost: approximately \$1.8 Million.
