**ALBERTA TRANSPORTATION
GEOHAZARD ASSESSMENT PROGRAM
PEACE REGION – GRANDE PRAIRIE DISTRICT
2018 INSPECTION**

Site Number	Location	Name	Hwy	km
GP42 Call Out	North of Grande Cache	9 km N of Wanyandie Rd	40:36	37.5
Legal Description		UTM Co-ordinates (NAD 83)		
NE16-59-6-W6		11U N 5,996,900	E 379,900

2018 INSPECTION PLAN

DWG No. 13353-GP42-1

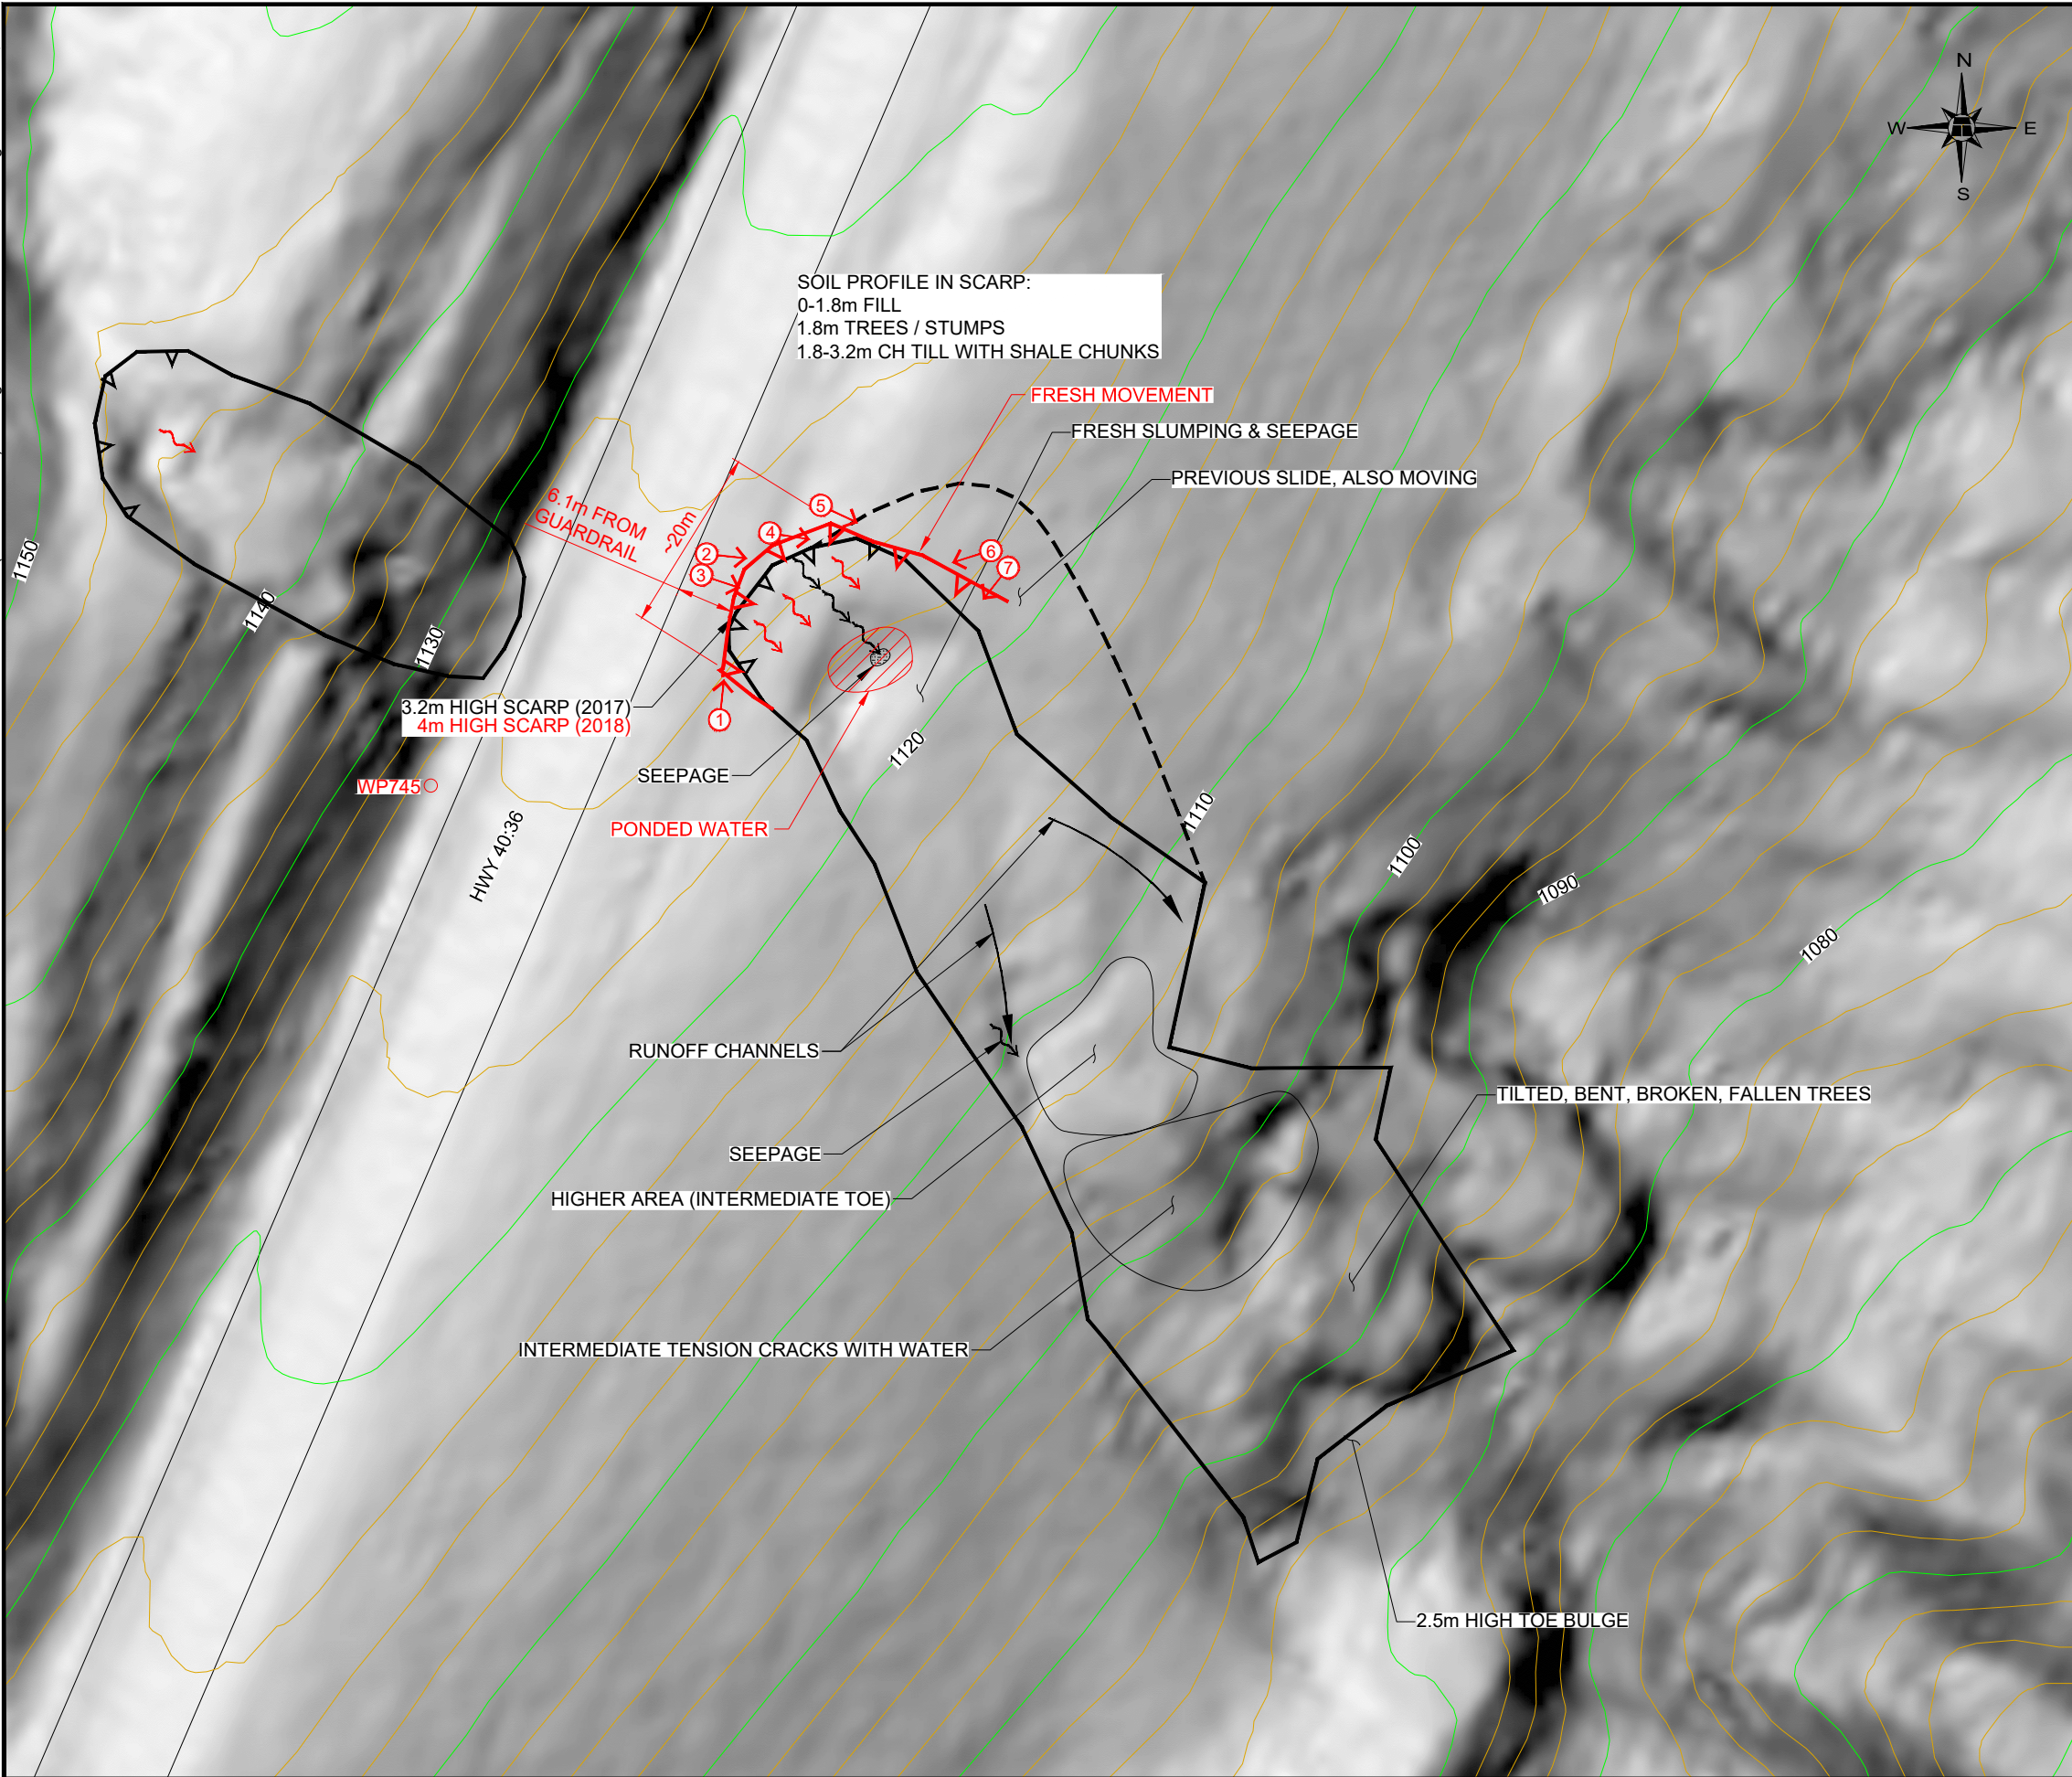
SOIL PROFILE IN SCARP:
 0-1.8m FILL
 1.8m TREES / STUMPS
 1.8-3.2m CH TILL WITH SHALE CHUNKS

3.2m HIGH SCARP (2017)
 4m HIGH SCARP (2018)

6.1m FROM GUARDRAIL
 >20m

SEEPAGE
 SEEPAGE
 HIGHER AREA (INTERMEDIATE TOE)
 INTERMEDIATE TENSION CRACKS WITH WATER

FRESH MOVEMENT
 FRESH SLUMPING & SEEPAGE
 PREVIOUS SLIDE, ALSO MOVING

TILTED, BENT, BROKEN, FALLEN TREES

2.5m HIGH TOE BULGE

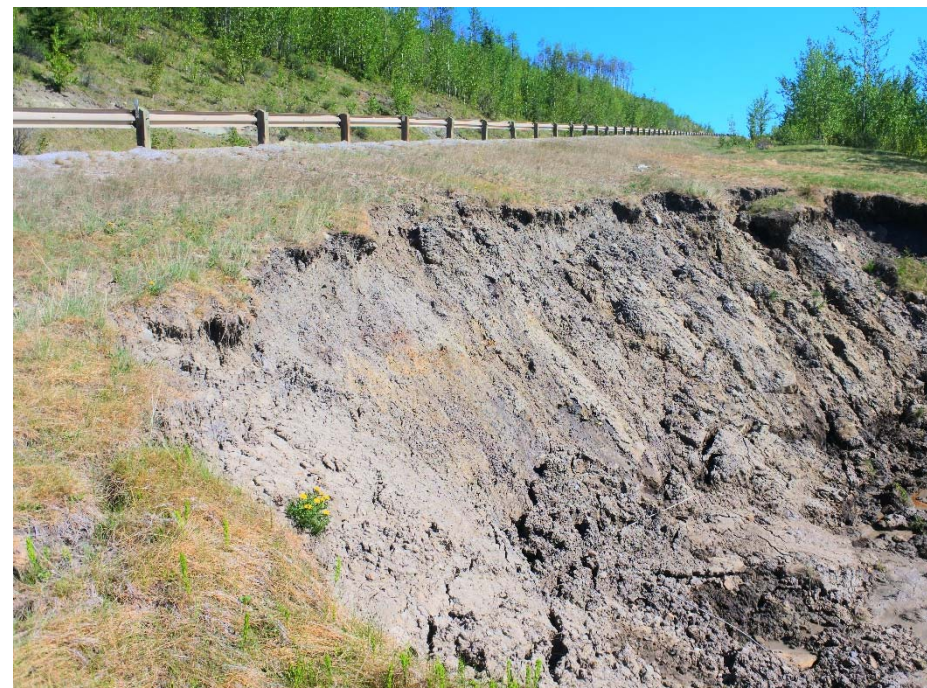
Photo 1.
Looking northeast
at the main scarp.

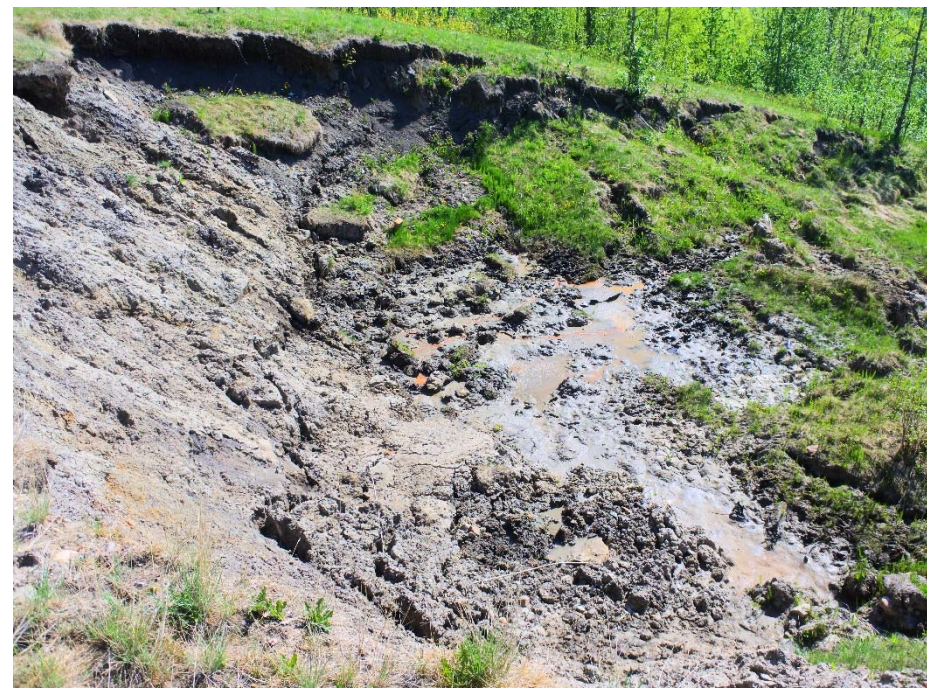
Photo 2.
Looking east at the
east flank of the
main scarp.

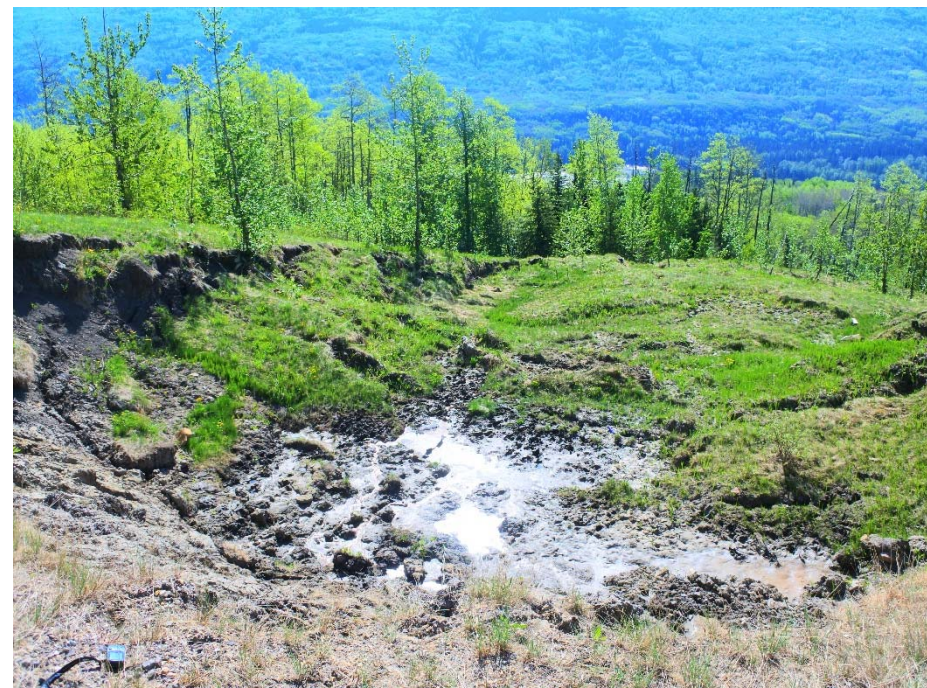
Primary Site Issue:	Landslide with 3.2 m high backscarp in embankment fill on east side of highway (6.1 m from guardrail).	
Dimensions:	About ~100 m long by 50 m wide. The main scarp is approximately 20 m wide.	
Date of any remediation:		
Maintenance:		
Observations:	Description	Worse?
<input type="checkbox"/> Pavement Distress		<input type="checkbox"/>
<input checked="" type="checkbox"/> Slope Movement	The landslide occurred within the east embankment fill. The slump appears to be a shallow retrogressive slide. Fresh retrogressive movement was noted towards the northeast.	<input checked="" type="checkbox"/>
<input checked="" type="checkbox"/> Erosion	Active erosion taking place by surface water and seepage flowing down slope.	<input type="checkbox"/>
<input checked="" type="checkbox"/> Seepage	Seepage was observed from the base of the main scarp, and within intermediate tension cracks throughout the slide mass. There are preferential water runoff channels on either side of the higher lobe near center of slide mass. Water is ponding at the bottom of the main scarp (Photo 3).	<input checked="" type="checkbox"/>

Photo 3.
Looking east at the slide from above the main scarp.

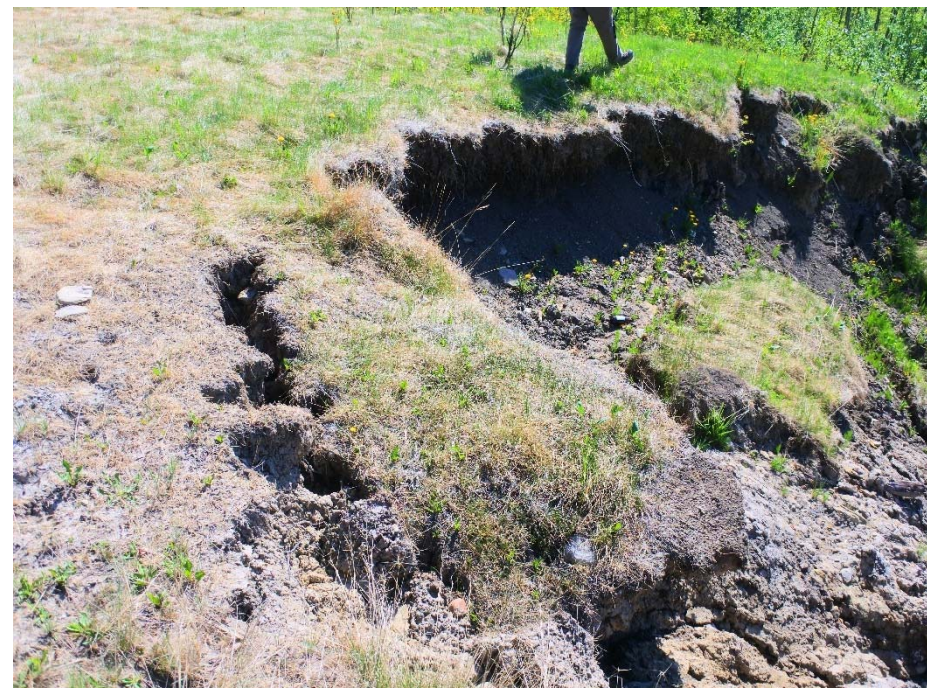
Photo 4.
Looking east at recent tears and sloughed material.

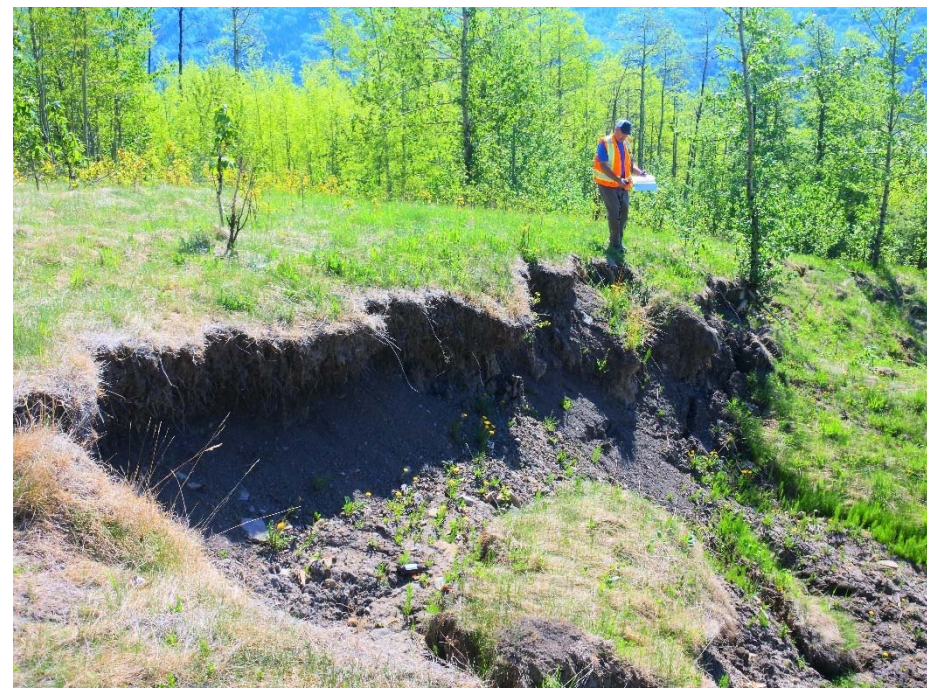
Photo 5.
Looking southeast
at area observed
with fresh
sloughing and
tears.

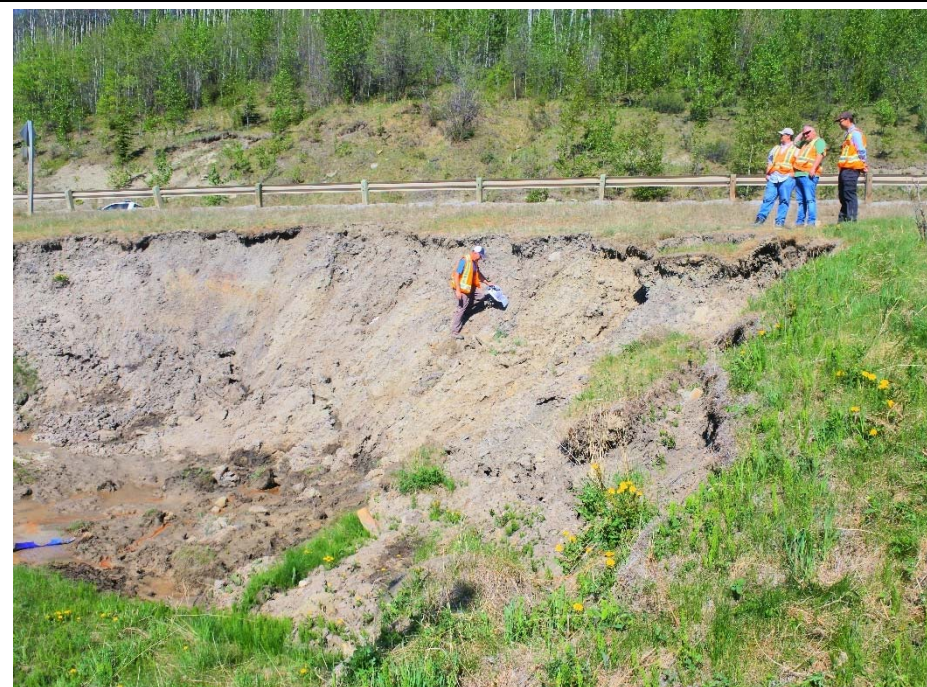
Photo 6.
Looking northwest
at the main scarp.

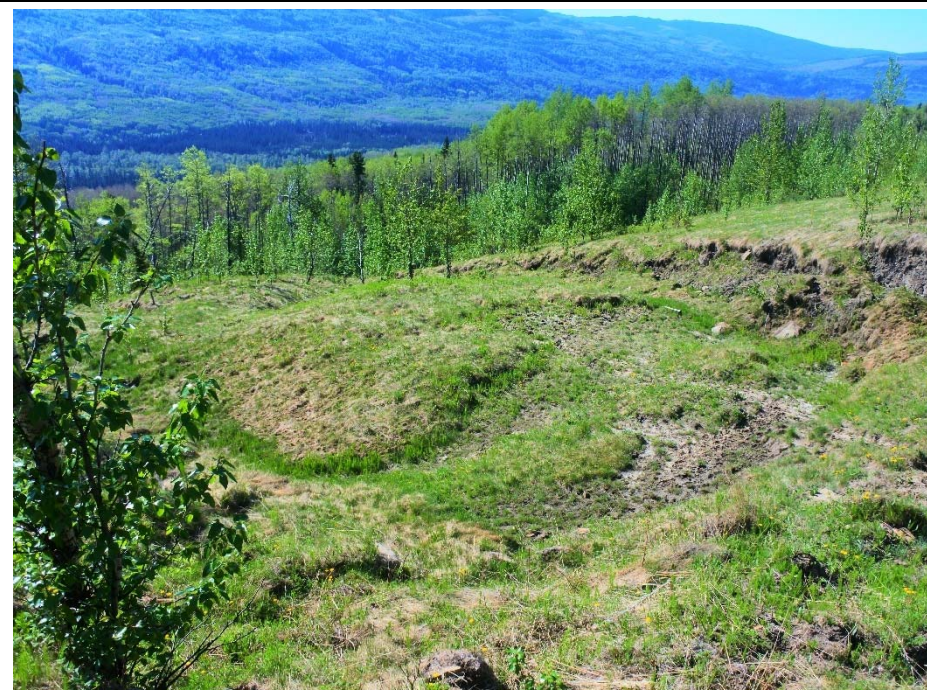
Photo 7.
Looking southwest
at the intermediate
toe area.
