**ALBERTA TRANSPORTATION
GEOHAZARD ASSESSMENT PROGRAM
PEACE REGION – GRANDE PRAIRIE DISTRICT
2019 INSPECTION**

Site Number	Location	Name	Hwy	km
GP42 Call Out	North of Grande Cache	9 km N of Wanyandie Rd	40:36	37.5
Legal Description		UTM Co-ordinates (NAD 83)		
NE16-59-6-W6		11U N 5,996,900	E 379,900

**PEACE REGION (GRANDE PRAIRIE)
(GP42) HWY 40:36, km 37.5 SLIDE**

2019 INSPECTION PLAN

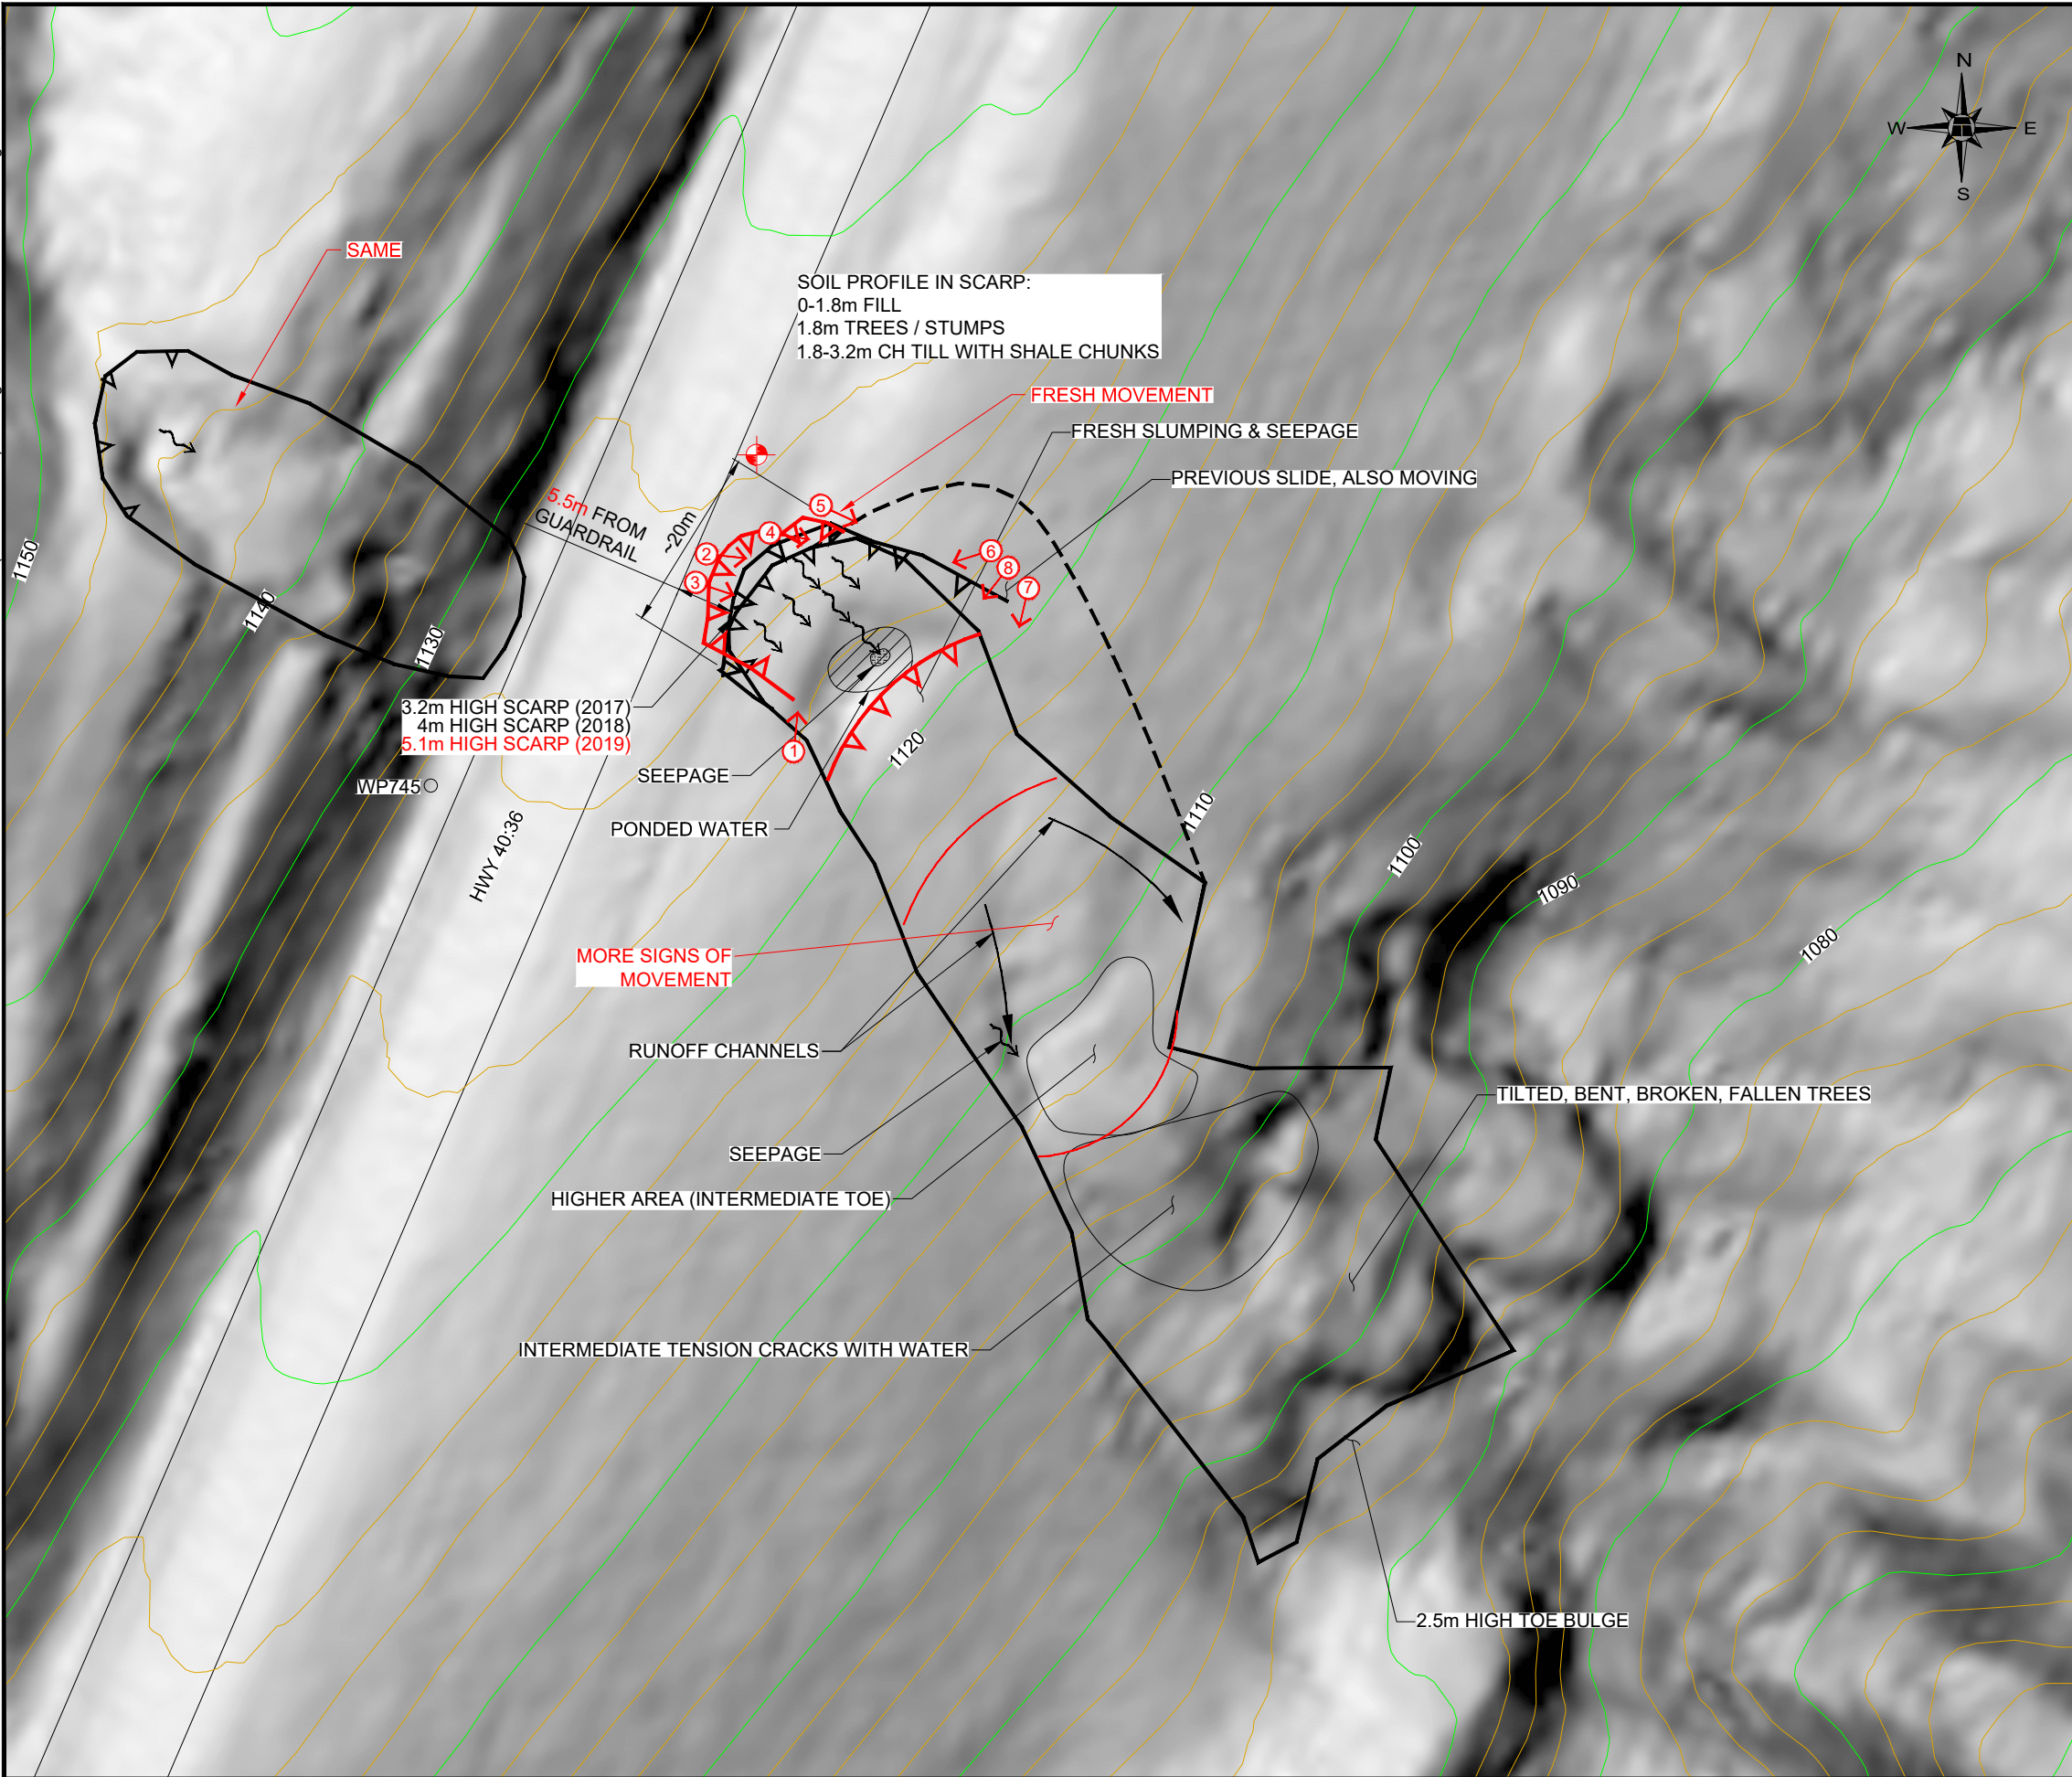
DWG No. 13353-GP42-1

Primary Site Issue:	Landslide with 5.1 m high backscarp in embankment fill on east side of highway (5.5 m from guardrail).	
Dimensions:	About ~100 m long by 50 m wide. The main scarp is approximately 20 m wide.	
Date of any remediation:		
Maintenance:		
Observations:	Description	Worse?
<input type="checkbox"/> Pavement Distress		<input type="checkbox"/>
<input checked="" type="checkbox"/> Slope Movement	The landslide occurred within the east embankment fill. The slump appears to be a shallow retrogressive slide. Fresh retrogressive movement was noted towards the northeast as the slide is closer to the guardrail. There were also minor scarps near the main body of the landslide and more signs of movement further south.	<input checked="" type="checkbox"/>
<input checked="" type="checkbox"/> Erosion	Active erosion taking place by surface water and seepage flowing down slope.	<input checked="" type="checkbox"/>

<input checked="" type="checkbox"/> Seepage	Seepage was observed from the base of the main scarp, and within intermediate tension cracks throughout the slide mass. There are preferential water runoff channels on either side of the higher lobe near center of slide mass. Water is ponding at the bottom of the main scarp (Photo 3).	<input checked="" type="checkbox"/>
<input type="checkbox"/> Bridge/Culvert Distress		<input type="checkbox"/>
<input checked="" type="checkbox"/> Other	Some backslope slumping was observed on the west (upslope) side of the highway and was in similar condition in 2019.	<input type="checkbox"/>
Instrumentation: None		
Assessment:		
<p>The slide is approximately 100 m long by 50 m wide with the main scarp approximately 20 m wide. The soils exposed in the slide scarp appeared to consist of 1.8 m of fill over clay till, with a layer of trees/stumps at the base of the fill (AT indicated there may also be a hardpan layer at ~8 m – info from the Bin Wall site). The toe bulge of the slide was approximately 2.5 m high, with many tilted/bent trees in the lower half of the slide, which suggests prior, continuous movements.</p>

It is anticipated that the slide is a retrogressive slide that was triggered by water seepage. Poor embankment materials and a relatively steep embankment slope may also have contributed to causing the slide. The northern flank of the upper slide portion appears to be an older slide that has re-activated. The main scarp appears to be retrogressing further back towards the highway (measured at 5.5 m from the guardrail) and at the current rate of retrogression could soon begin to affect the highway.

Drill 1 or 2 test holes above the main scarp on the edge or downslope of the highway to a depth of about 20 m (this would verify the depth of the hardpan layer). The test holes should be completed with piezometers (and one if possible downslope with an inclinometer). This would provide information on the soil and groundwater conditions and potential depth of slide movement at this location and confirm slope stabilization design measures.

A gabion wall (or bin wall) is recommended to be built below the highway and backfilled with granular fill. Sub-excavate the failed slide mass down to intact foundation soil above the wall location and rebuild the slope with imported 6-80 gravel to a slightly flatter 3H:1V inclination. The new fill material should be placed and compacted in thin horizontal lifts, benched into the intact slope surface to stabilize the slide area. Some of the more suitable excavated material could be used to provide a covering layer overtop the gravel and below the wall as the finished slope surface to shed runoff, with any excess removed from the site. The slide mass downslope of the wall could be completed with an armoured ditch to provide better drainage.

Option 2) – Construct a pile wall between the slide and the highway, consisting of steel H piles, or possibly concrete piles.

For either option: subdrain(s) should be installed along the base of the slide excavation (and perhaps below the upslope ditch) to drain any subsurface water that may enter the new fill zone. Also, a portion of the guardrail will have to be removed during construction and a temporary detour will likely have to be constructed on the west side of existing highway to allow two-way traffic.

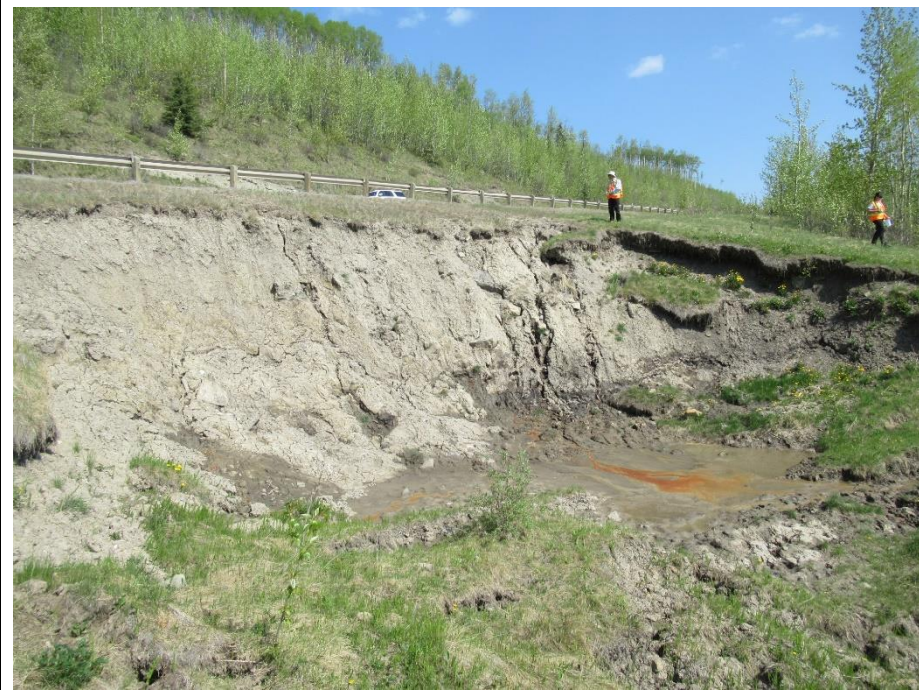
Photo 1.
Looking northeast
at the main scarp.

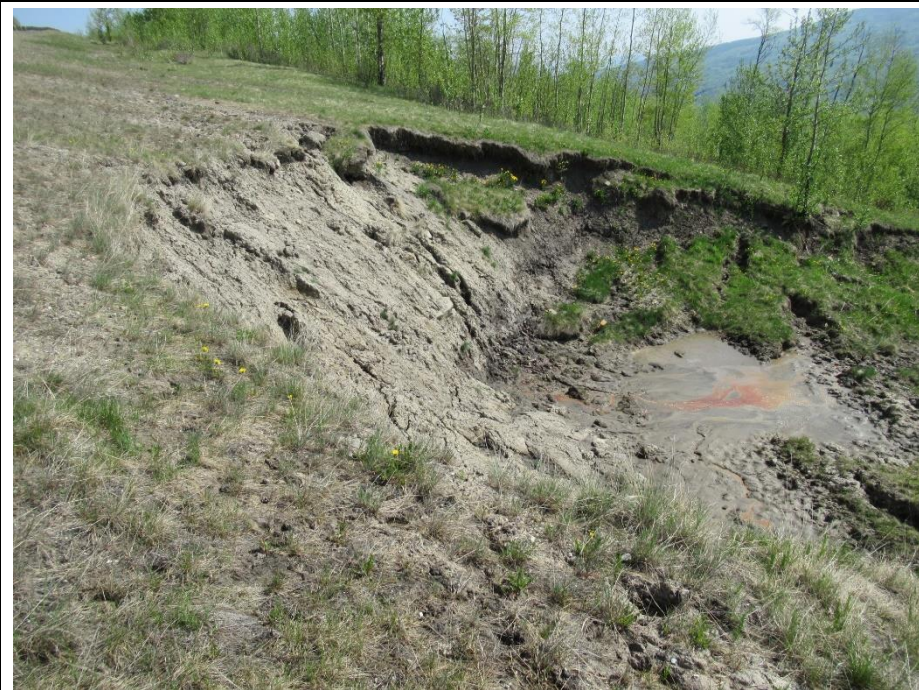
Photo 2.
Looking east at the
east flank of the
main scarp.

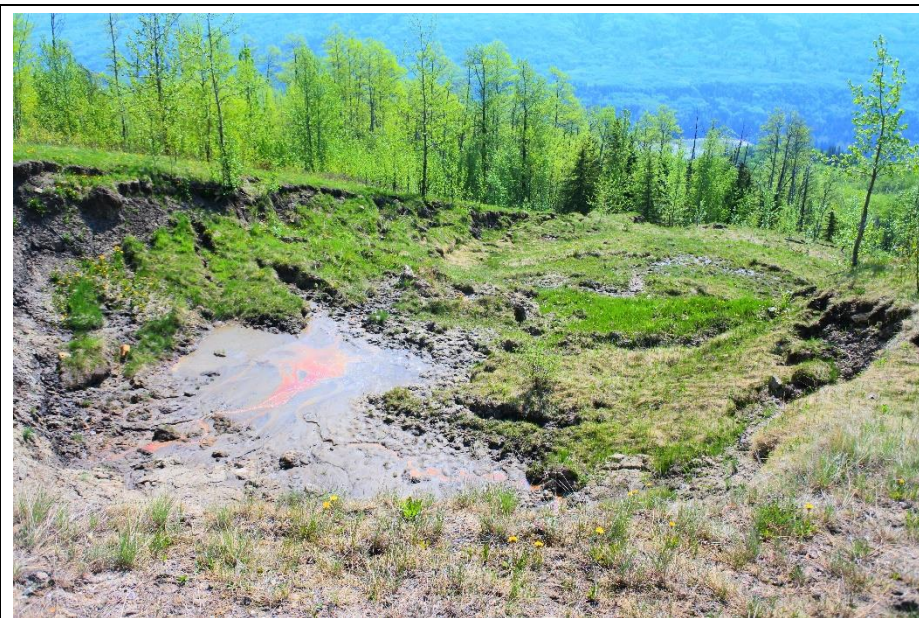
Photo 3.
Looking east at the
slide from above
the main scarp.
approached

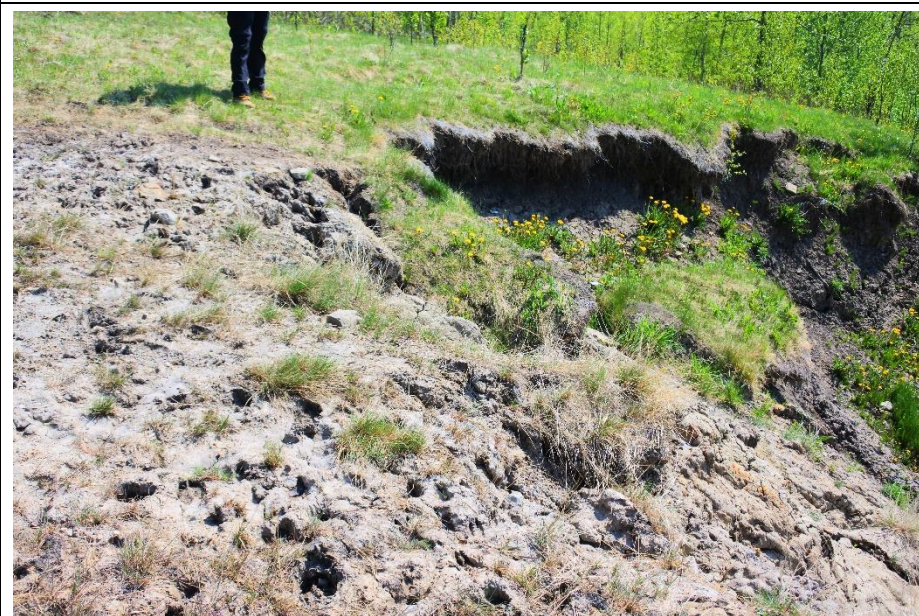
Photo 4.
Looking east at
recent tears and
sloughed material.

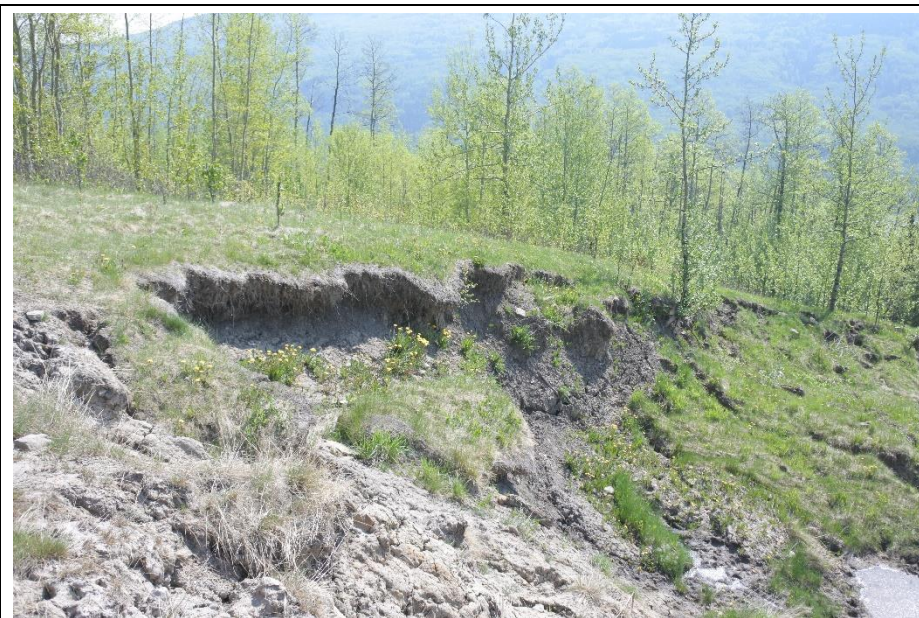
Photo 5.
Looking southeast
at area observed
with fresh
sloughing and
tears.

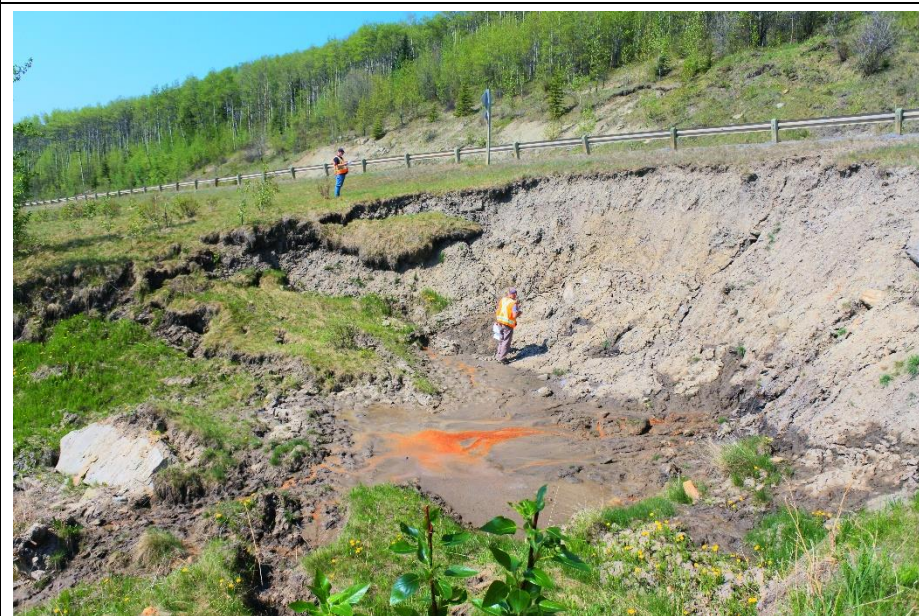
Photo 6.
Looking northwest
at the main scarp.

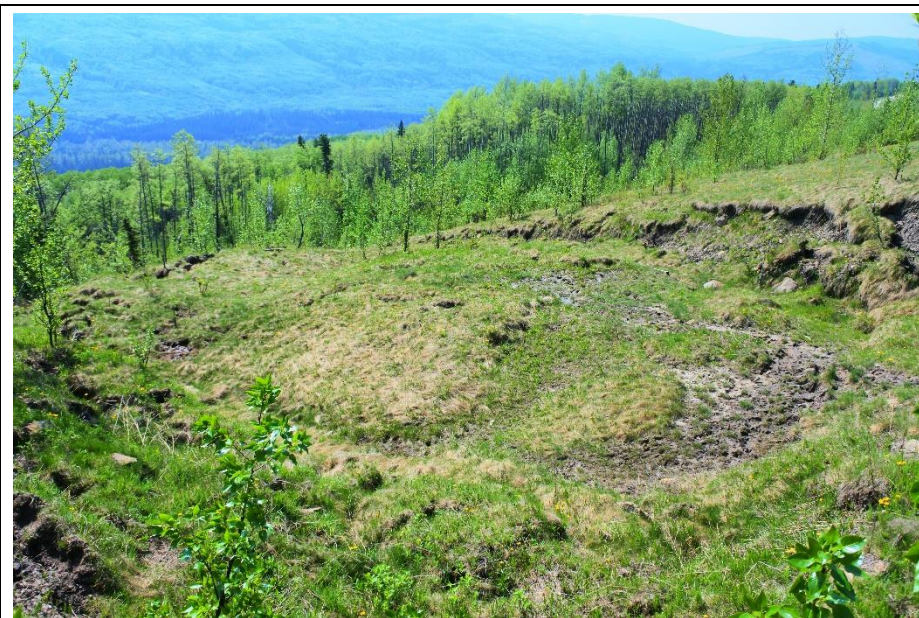
Photo 7.
Looking southwest
at the intermediate
toe area.

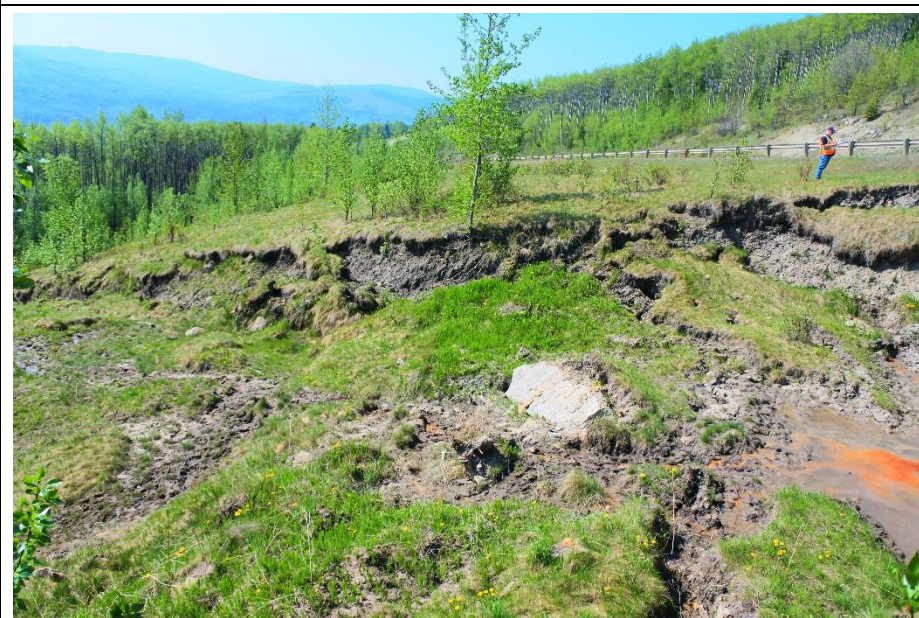
Photo 8.
Looking west at the
west flank of the
slide mass.
