SITE NUMBER AND NAME: GP042 Wanyandie Creek Embankment Slide GP050 Bin Wall Slide	HIGHWAY & KM: 40:36, 37.524 & 37.917	PREVIOUS INSPECTION DATE: GP042: May 28, 2019 GP050: May 28, 2017	INSPECTION DATE: June 2, 2025
LEGAL DESCRIPTION: NE 16-59-06-W6M SE 21-59-06-W6M	NAD 83 COORDINATES: UTM Northing Easting 11 5996900 379900 11 5997170 380027	RISK ASSESSMENT: GP042: PF: 9 CF: 2 TOTAL: 18 GP050: PF: 1 CF: 5 TOTAL: 5	
AVERAGE ANNUAL DAILY TRAFFIC (AADT): 401 (north) & 408 (south) (Reference No. 60403650, 2024)		CONTRACT MAINTENANCE AREA (CMA): 504

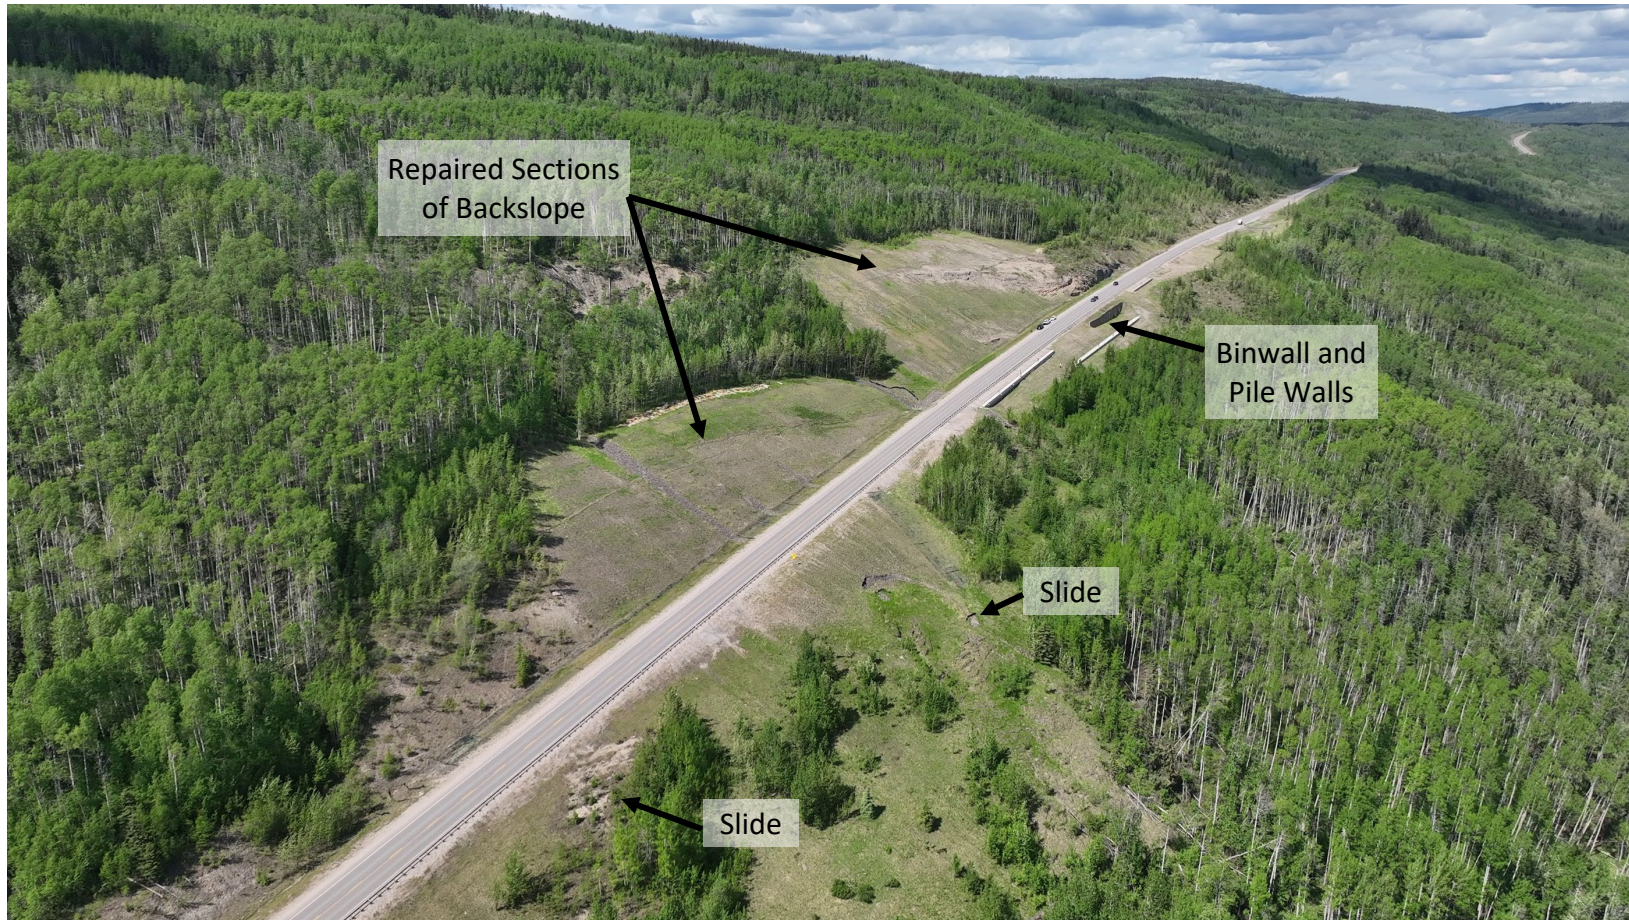
- Slide on the east side of the highway near the south end of the site continues to retrogress towards the highway (Photos 1, 6, and 7, WP048). At the time of the 2025 inspection, the slide scarp was approximately 15 m from the guardrail and 3.5 m below edge of pavement. The slide scarp is unvegetated, indicating recent movement.

Photo 1 Overview of GP042 and GP050 sites on Hwy 40:36. UAV photo taken June 2, 2025, facing north from south end of site.

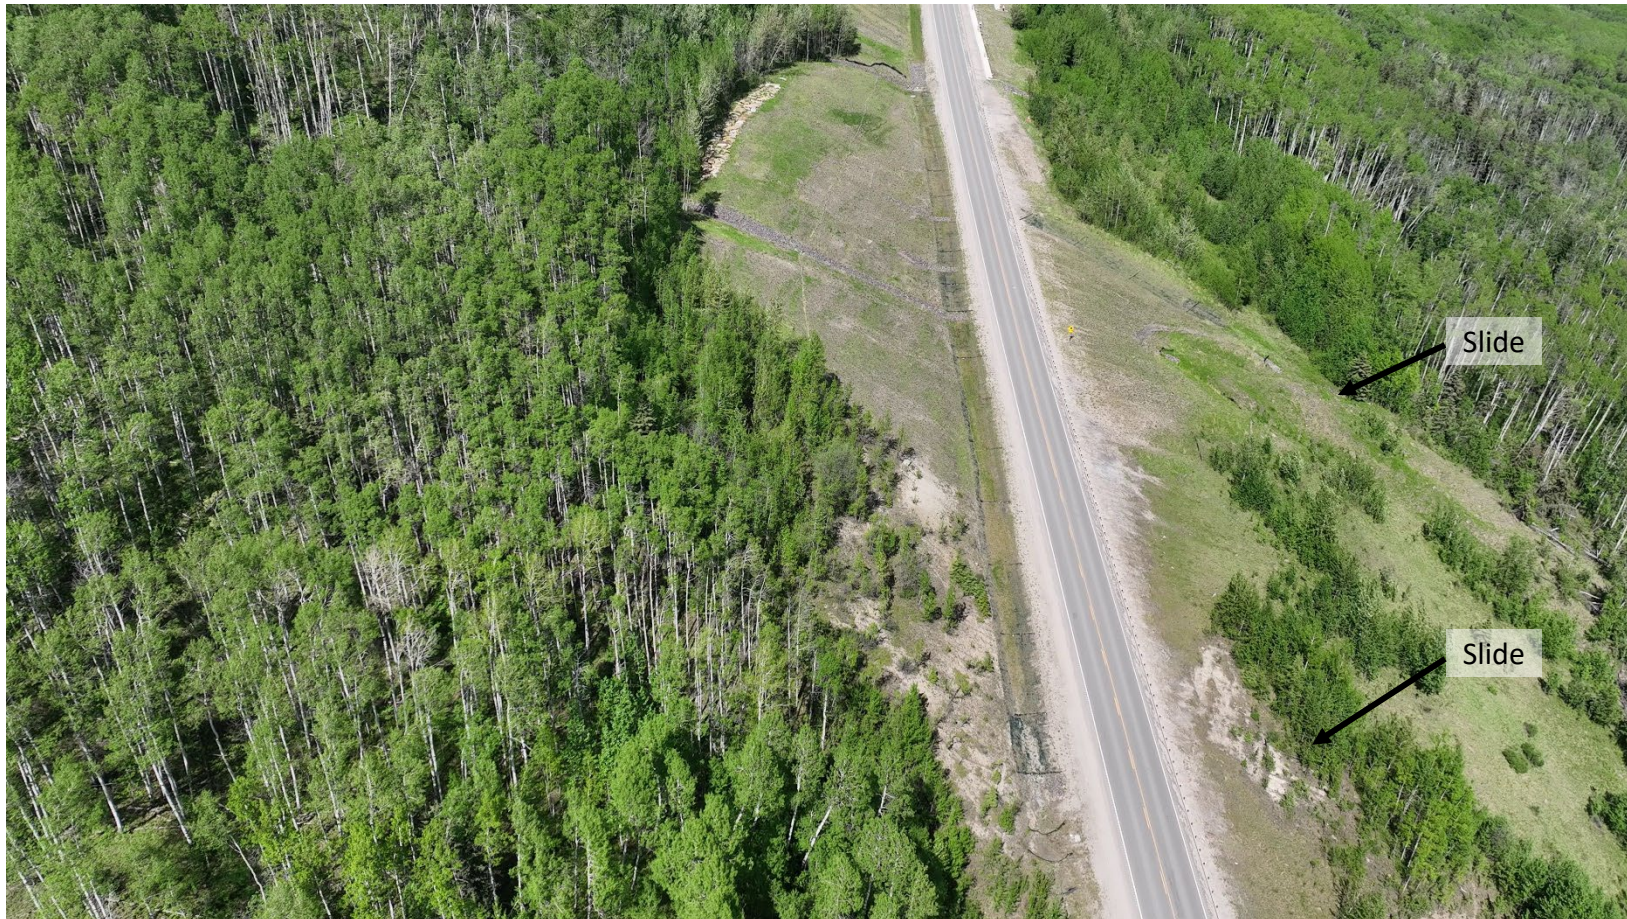
- installing three drilled cast-in-place concrete pile walls on the east side of the highway (Photos 2, and 8 through 10), with concrete walers and buried perforated pipe subdrains that discharge into riprap-lined swales, as follows:

Photo 2 South portion of site. Note slides on east (downslope) side of Hwy 40:36. UAV photo taken June 2, 2025, facing northeast.

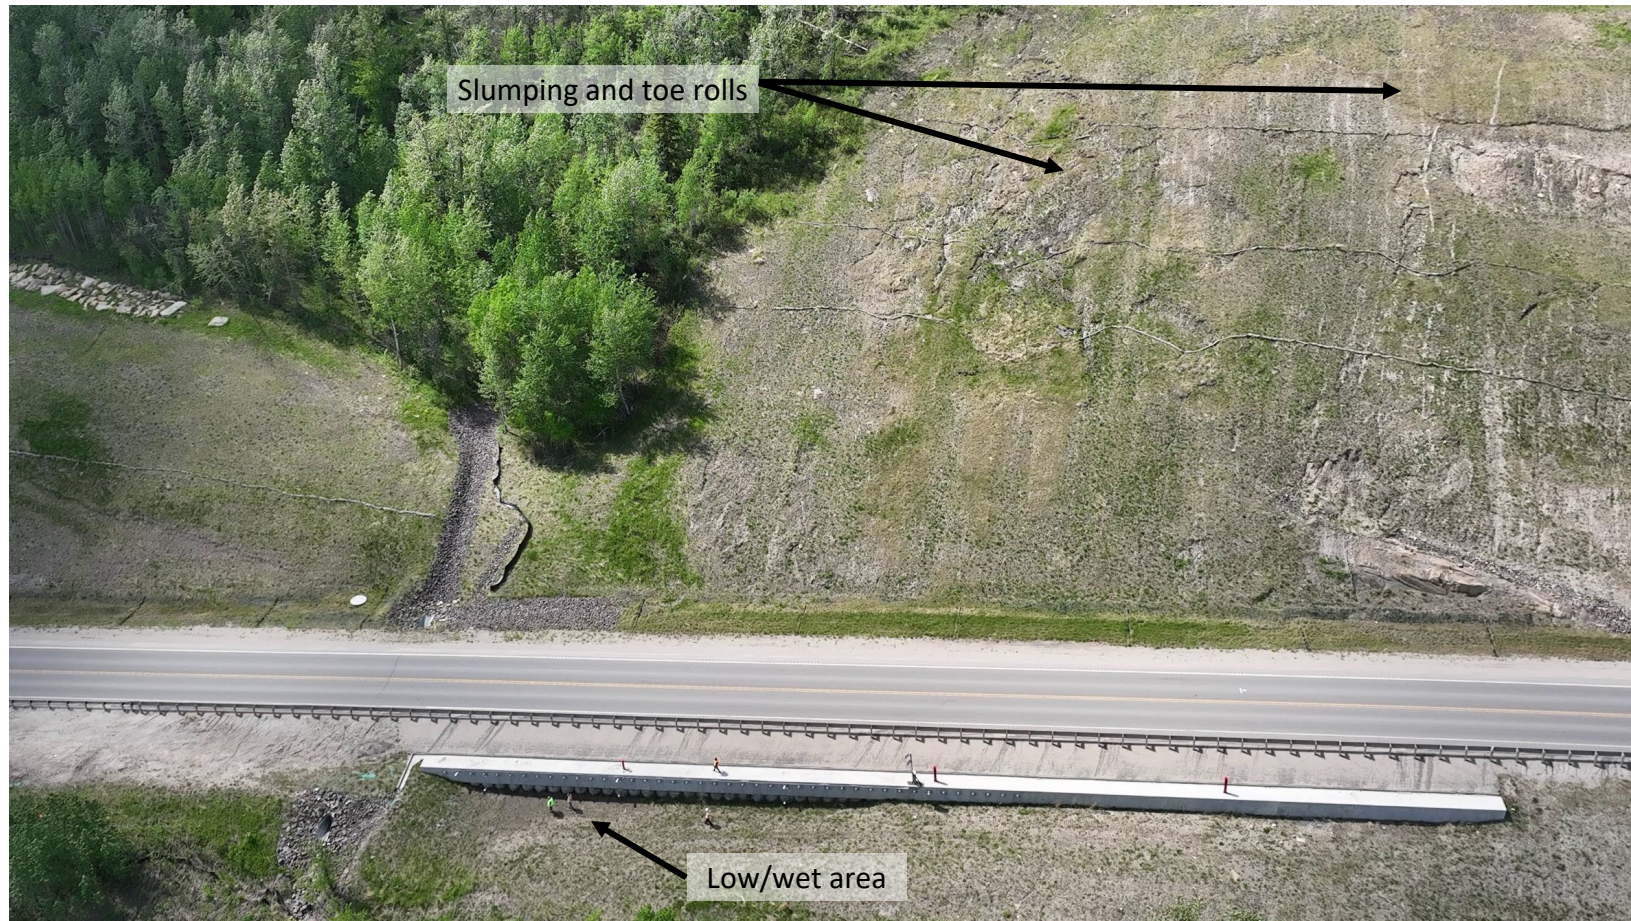
- Small shallow slumping/slope failures and toe rolls observed on backslope along west side of the highway (Photos 3, 4, and 12).
- Low area beneath the south pile wall on the east side of the highway, where there is a second row of anchors, is damp (Photos 3 and 10). Low area could have been excavated to provide access for installation of the lower row of anchors.

Photo 3 Middle portion of site. Note low wet area in front of south pile wall on east (downslope) side of Hwy 40:36, and slumping and toe rolls on west (upslope) side of Hwy 40:36. UAV photo taken June 2, 2025, facing northwest.

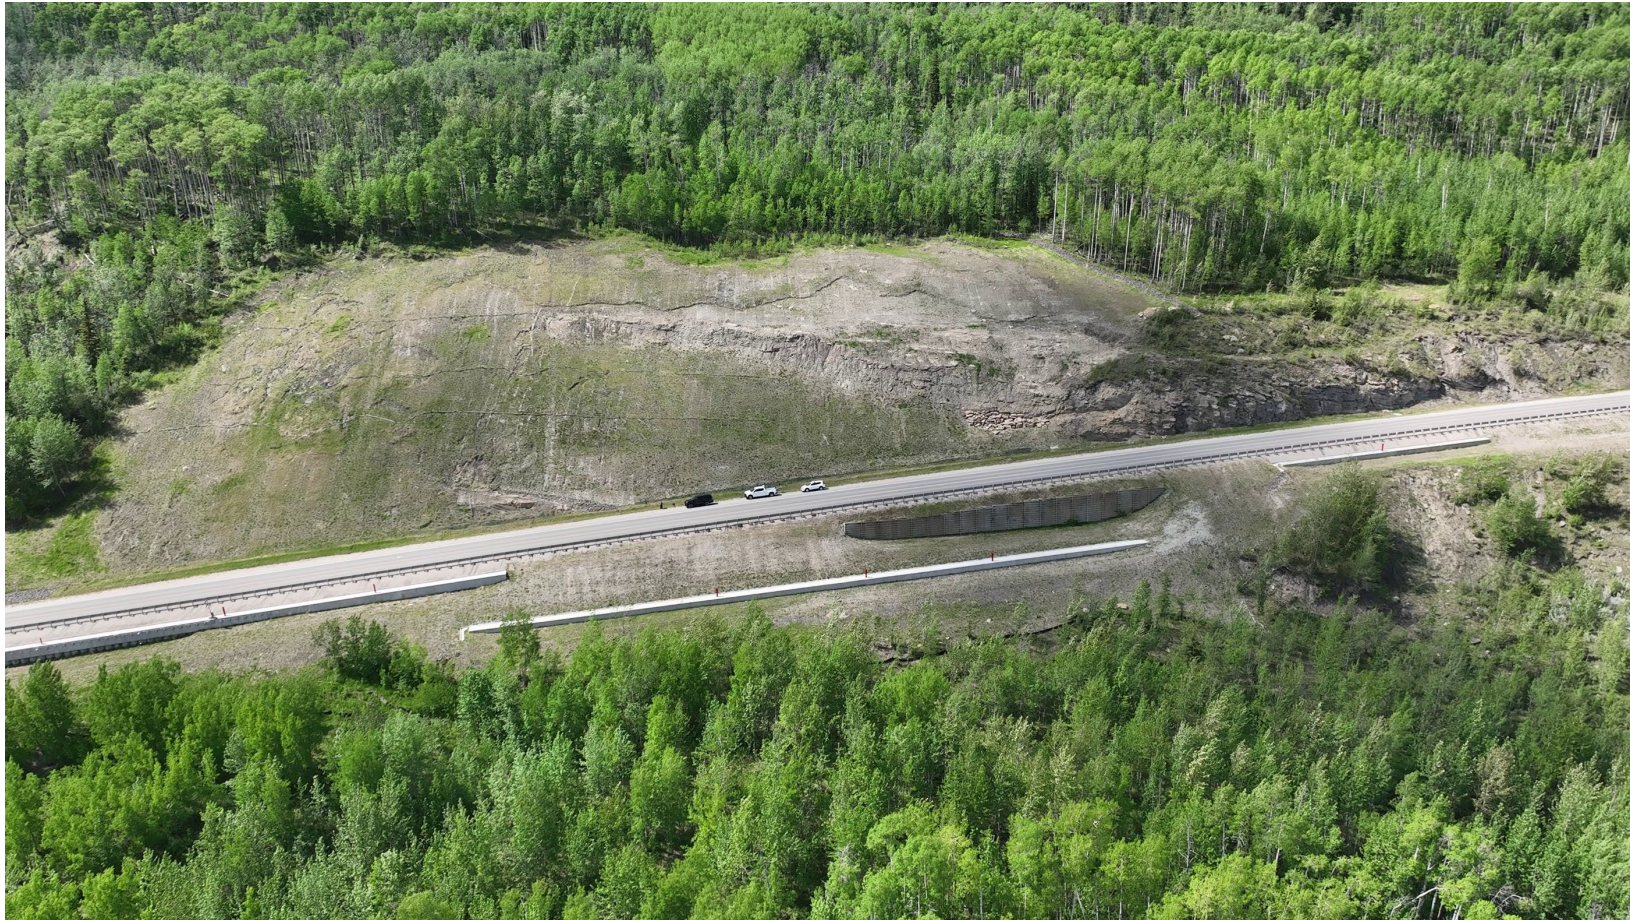
Photo 4 North portion of site. Note binwall and three pile walls on east (downslope) side of Hwy 40:36, and slumping and toe rolls on west (upslope) side of Hwy 40:36. UAV photo taken June 2, 2025, facing northwest.

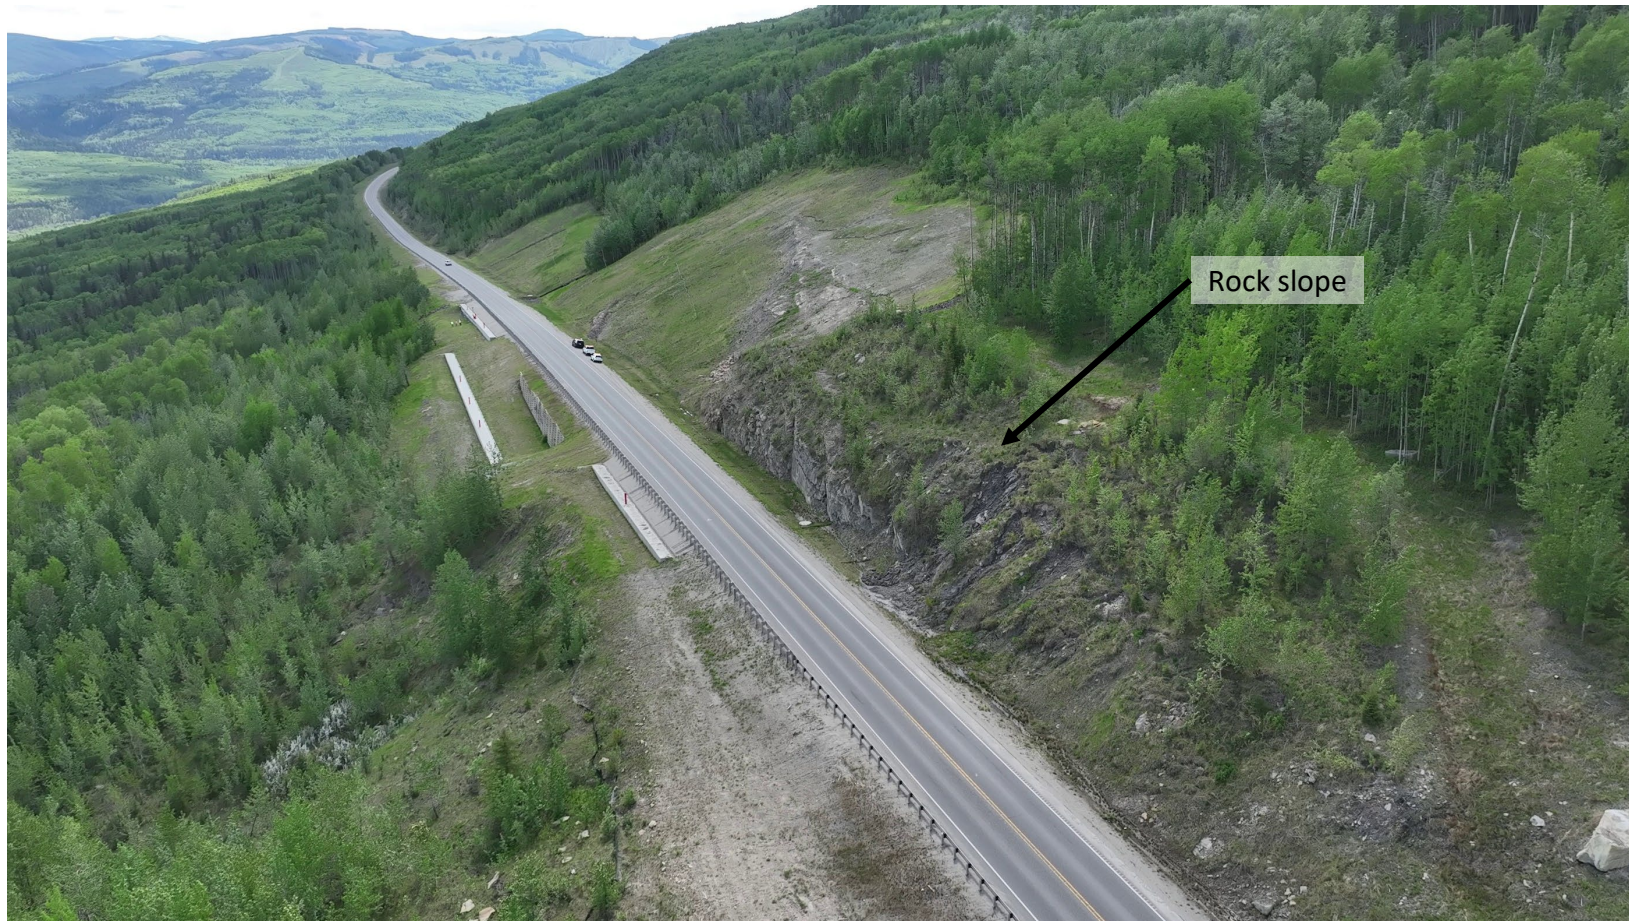
- Backslope on west side of the highway near the north end of the site consists of bedrock with a thin cover of soil (Photos 5 and 13). The soil is slumping because of saturation from seepage.

Photo 5 Overview of GP042 and GP050 sites on Hwy 40:36. Note rock slope on west (upslope) side of Hwy 40:36. UAV photo taken June 2, 2025, facing southwest from north end of site.

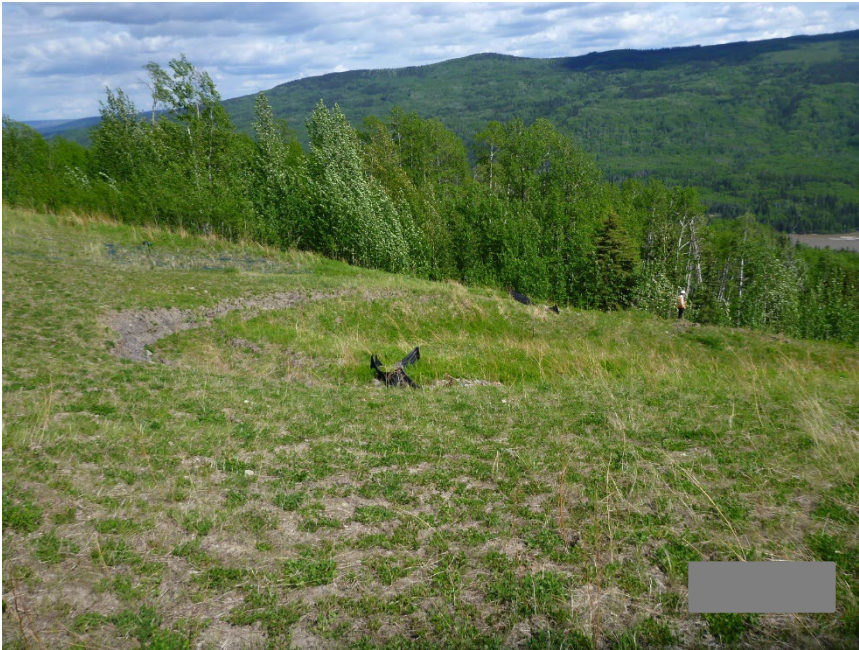
Photo 6 Slide on east (downslope) side of Hwy 40:36. Photo taken June 2, 2025, facing northeast.

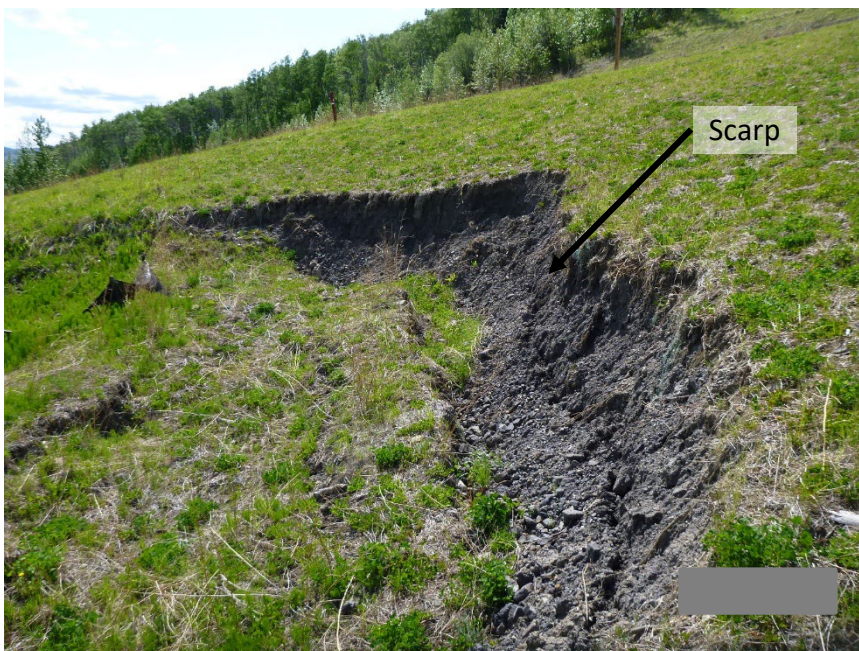
Photo 7 Slide scarp on east (downslope) side of Hwy 40:36. Note slide scarp is unvegetated indicating recent movement. Photo taken June 2, 2025, facing southwest.

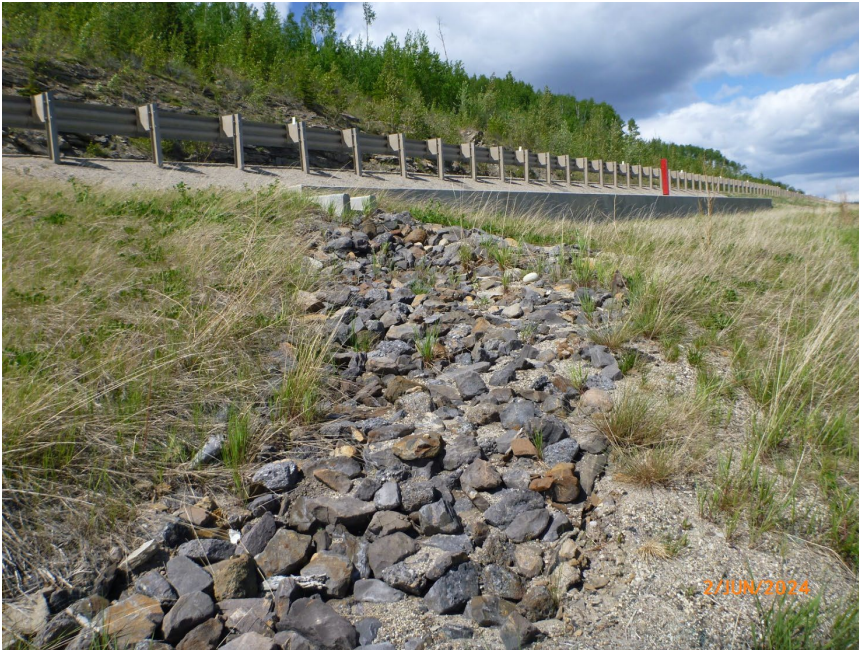
Photo 8 North pile wall on east (downslope) side of Hwy 40:36. Photo taken June 2, 2025, facing north.

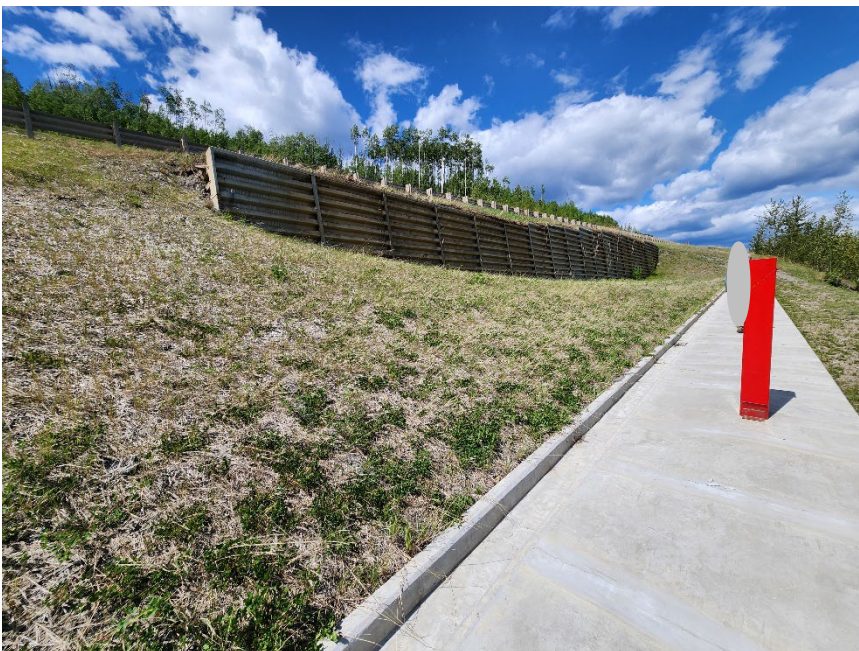
- Vegetation is beginning to re-establish where repairs were recently completed. Some trees growing through binwall (Photo 9).

Photo 9 Binwall and middle pile wall on east (downslope) side of Hwy 40:36. Photo taken June 2, 2025, facing north.

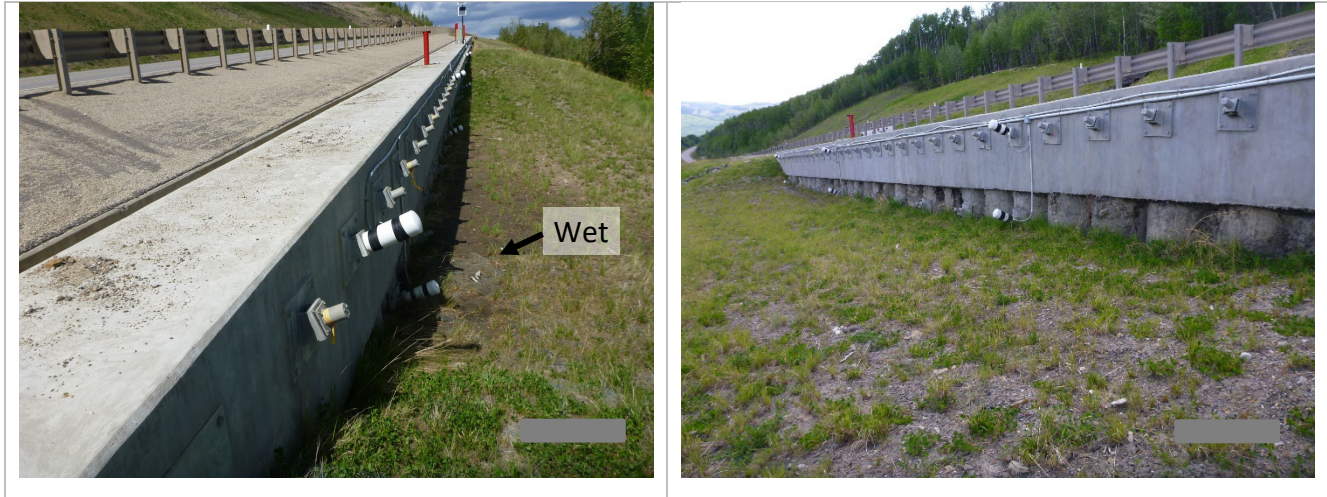
Photo 10 South pile wall on east (downslope) side of Hwy 40:36. Note low wet area in front of pile wall where there is a second row of anchors. Photos taken June 2, 2025, facing north and southwest.

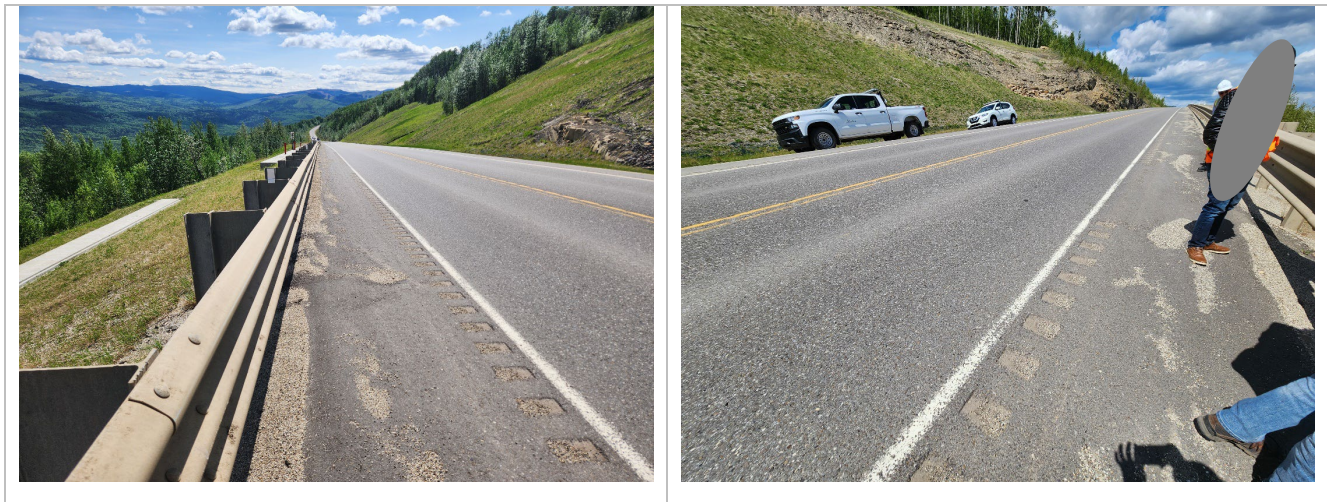
Photo 11 Pavement surface of Hwy 40:36. Photos taken June 2, 2025, facing southwest and northwest, respectively.

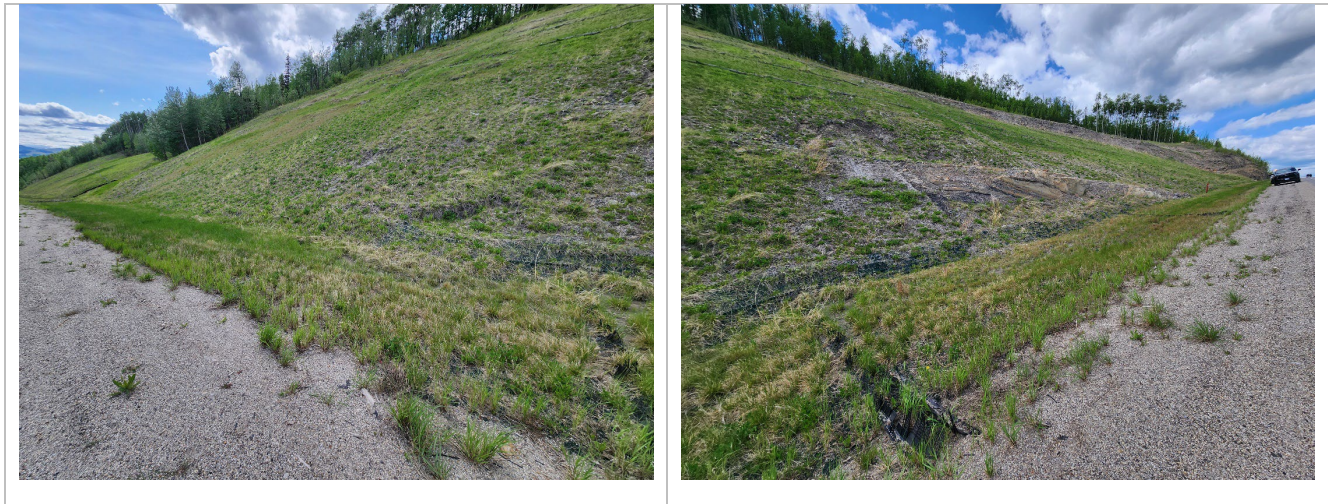
Photo 12 Backslope and ditch on west (upslope) side of Hwy 40:36. Photos taken June 2, 2025, facing southwest and northwest, respectively.

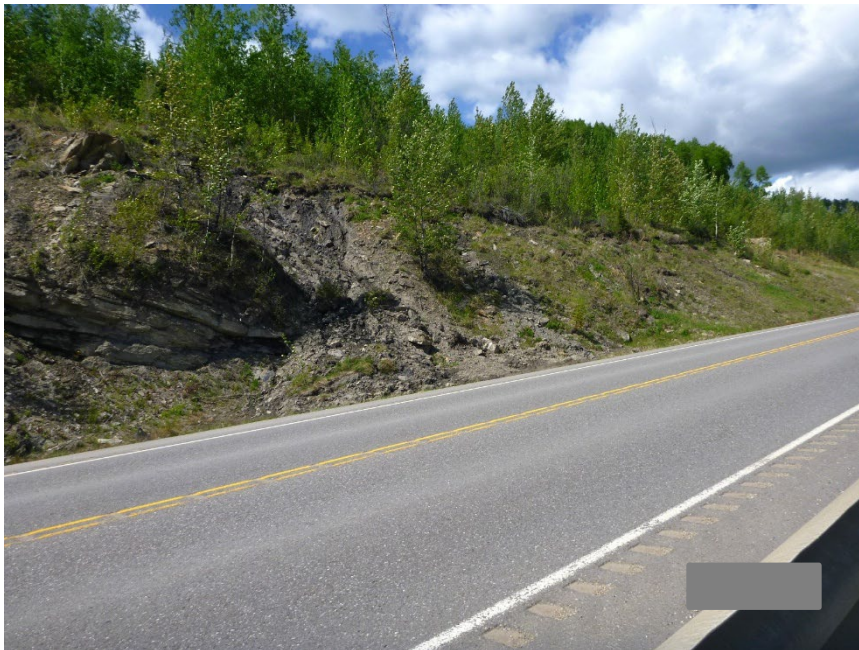
Photo 13 Rock slope along west (upslope) side of Hwy 40:36. Note thin cover of soil over bedrock, which is slumping likely due to saturation. Photo taken June 2, 2025, facing north.
