**PEACE REGION
(GRANDE PRAIRIE DISTRICT – SOUTH) GRMP**

SITE INSPECTION FORM

SITE NUMBER AND NAME: GP049 Rockfall 5.5 km South of McIntyre Mine		HIGHWAY & KM: 40:36, 8.395	PREVIOUS INSPECTION DATE: May 25, 2020	INSPECTION DATE: June 14, 2022
LEGAL DESCRIPTION: NW 29-57-08-W6M	NAD 83 COORDINATES: UTM Northing Easting 11 5981300 358436		RISK ASSESSMENT: PF: 12 CF: 4 TOTAL: 48	
AVERAGE ANNUAL DAILY TRAFFIC (AADT): 820 (north) & 1020 (south) (Reference No. 25592, 2021)			CONTRACT MAINTENANCE AREA (CMA): 504

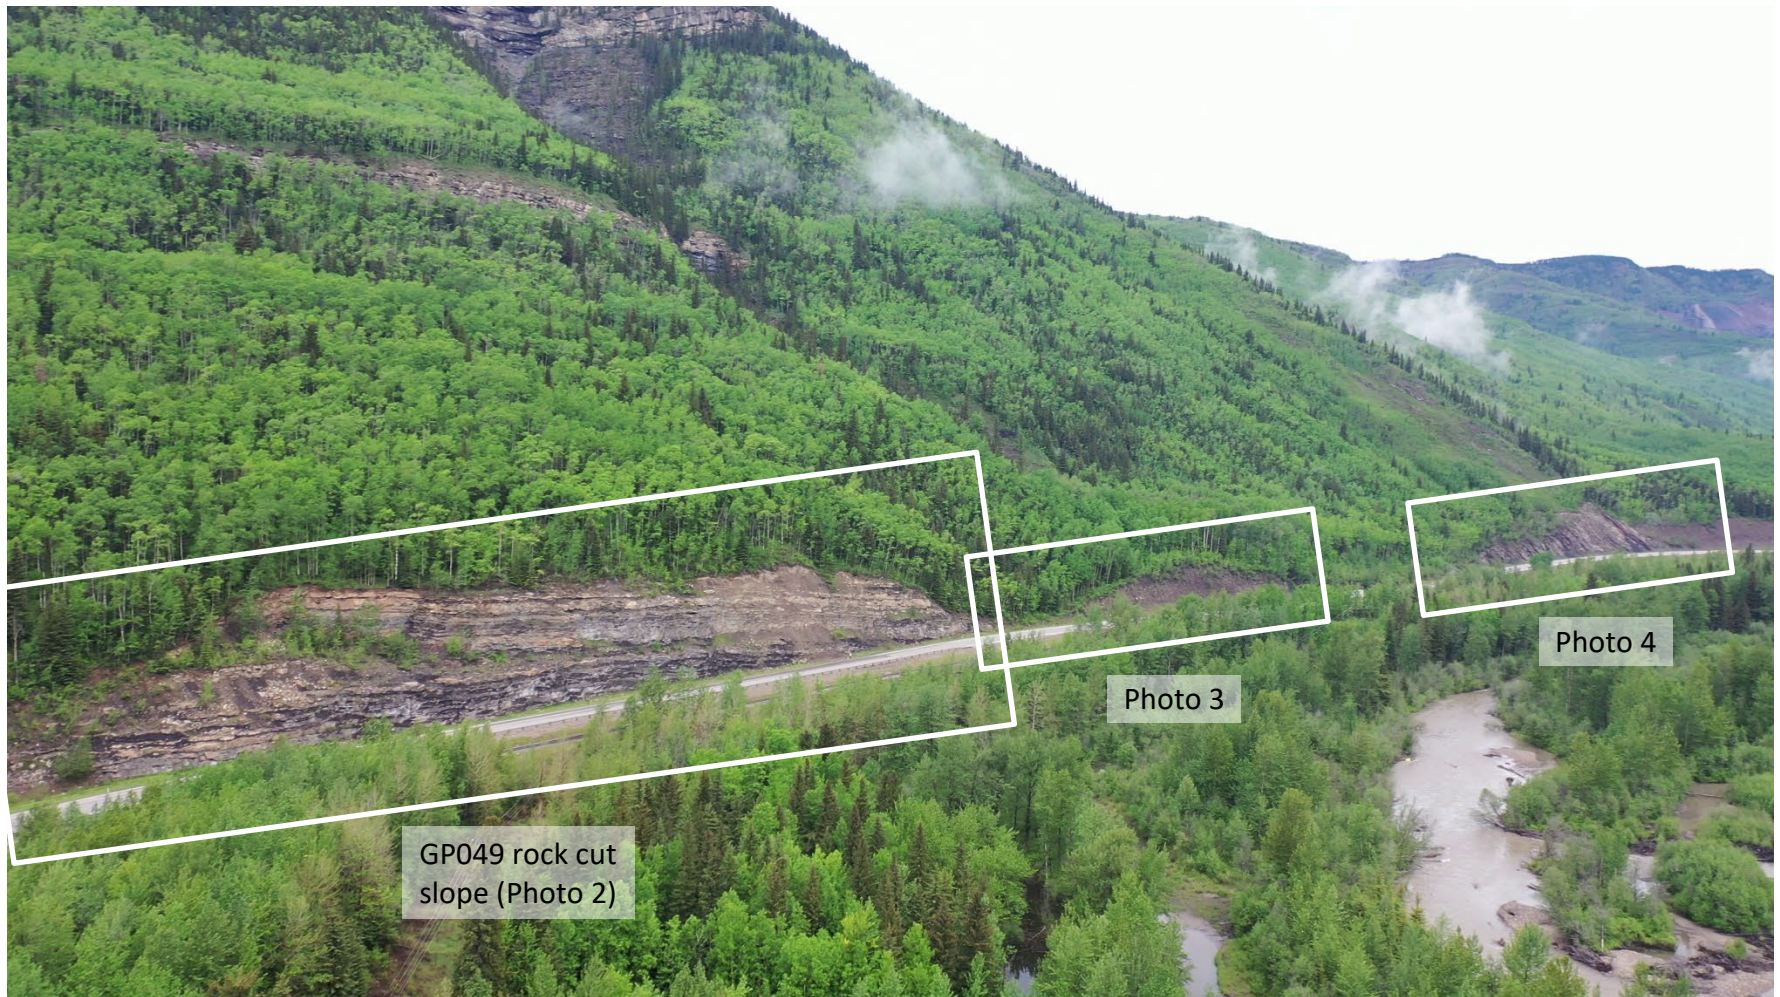
Photo 1 Overview of GP049 site on Hwy 40:36. Photo taken June 14, 2022, facing northwest.

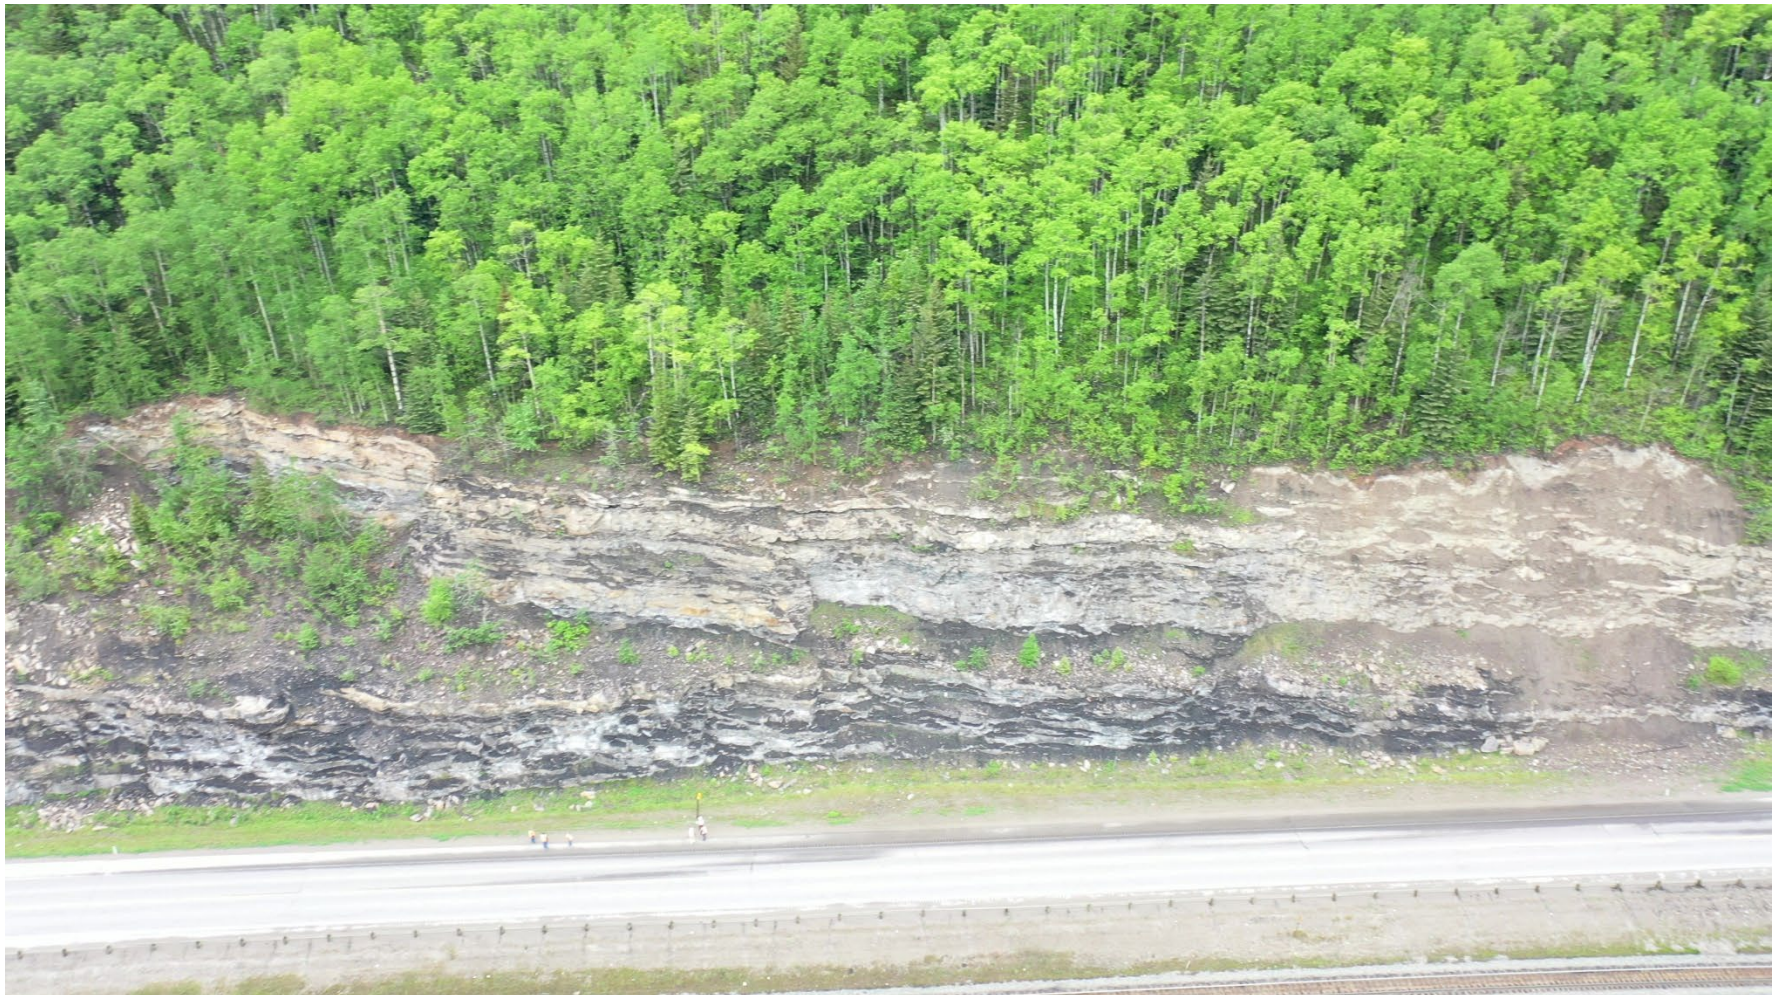
Photo 2 Rock cut slope along west side of Hwy 40:36. Note mid-slope bench and talus cones/slopes could potentially bounce/launch/roll rockfall particles out onto highway. Photo taken June 14, 2022, facing west.

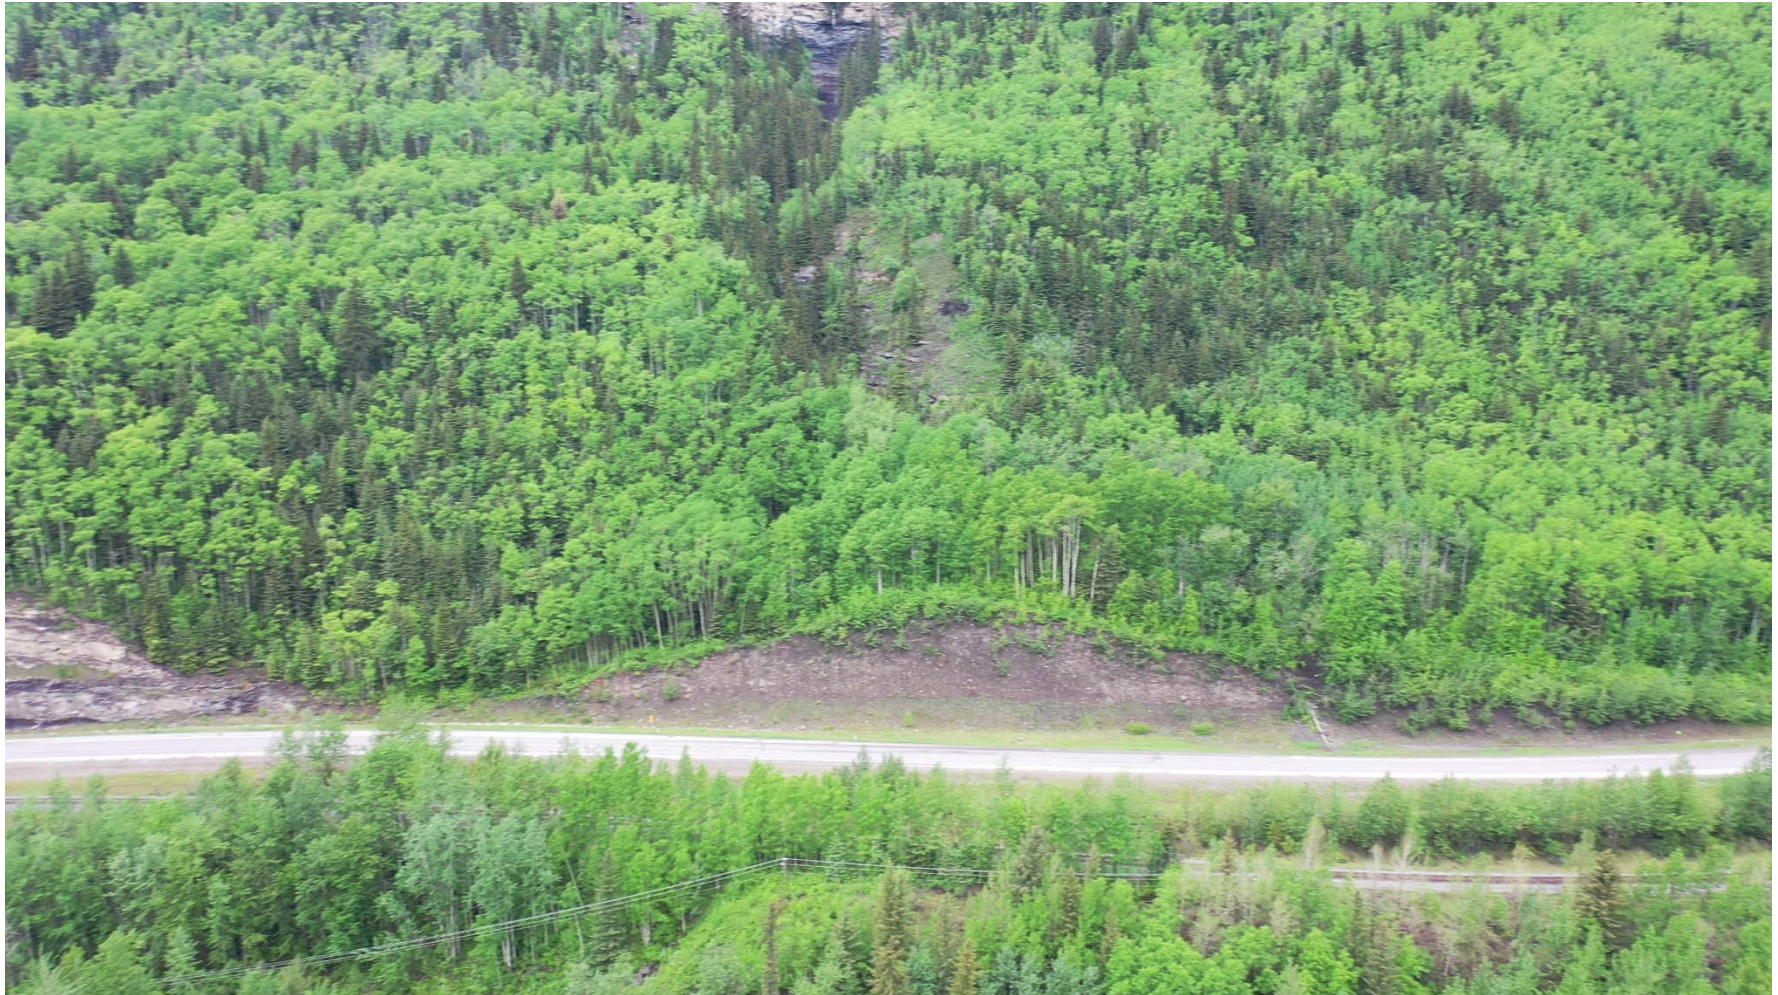
Photo 3 Cut slope along west side of Hwy 40:36 north of GP049 site. Photo taken June 14, 2022, facing west.

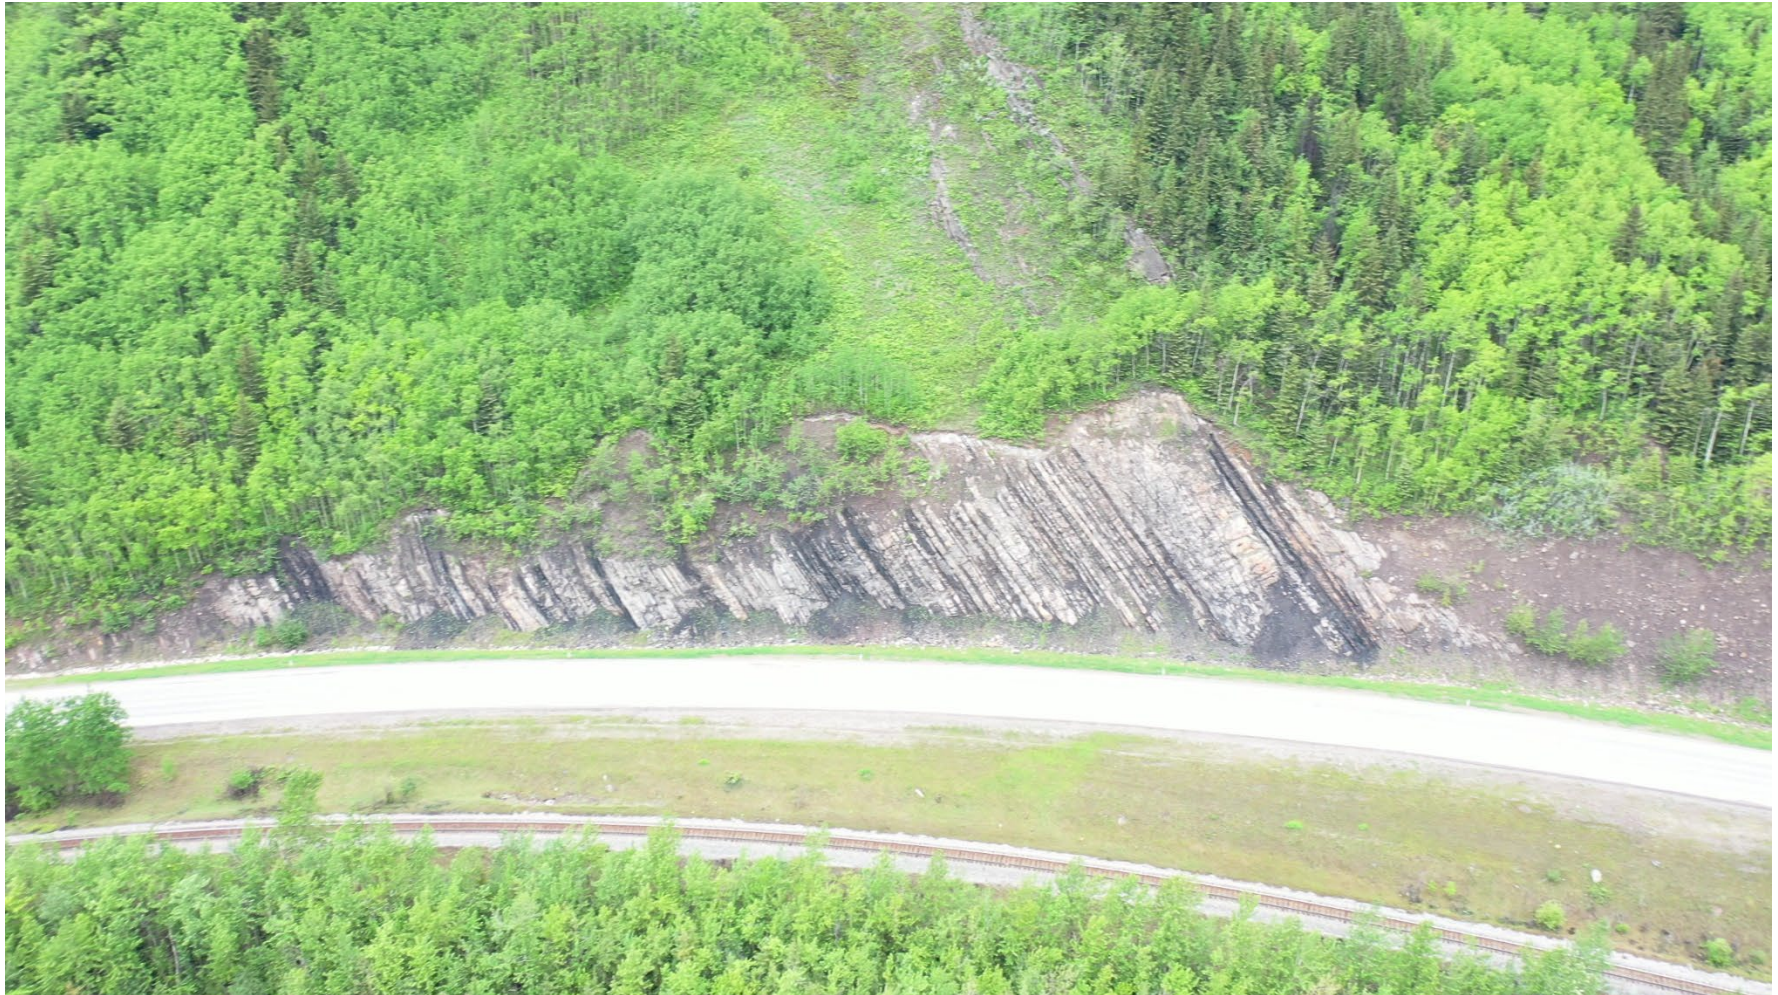
Photo 4 **Rock cut slope along west side of Hwy 40:36 north of GP049 site. Photo taken June 14, 2022, facing west.**

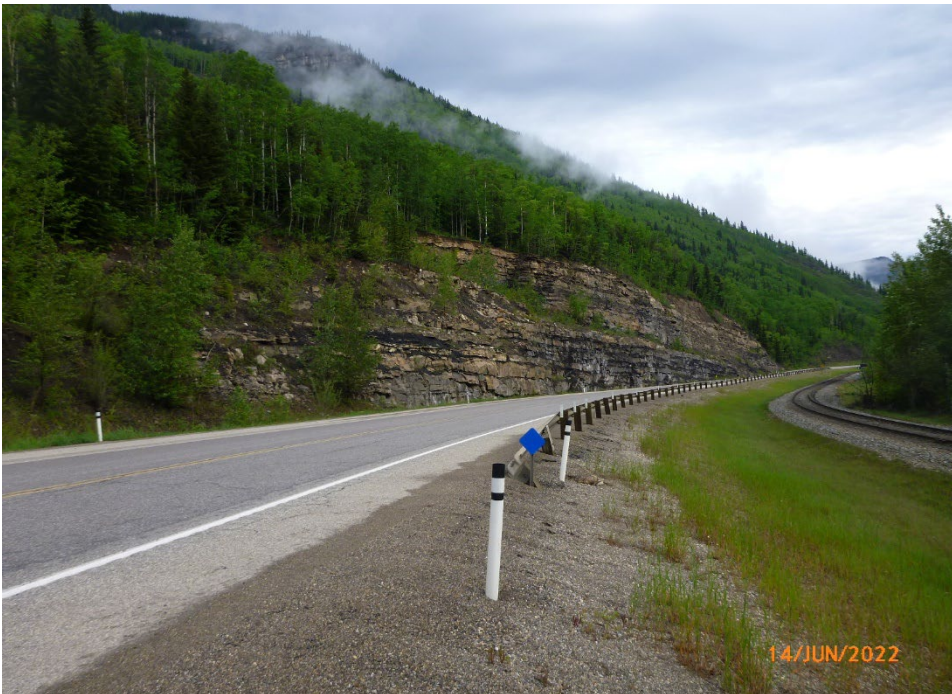
Photo 5 Rock cut slope along west side of Hwy 40:36. Photo taken June 14, 2022, facing northwest at southern site limit.

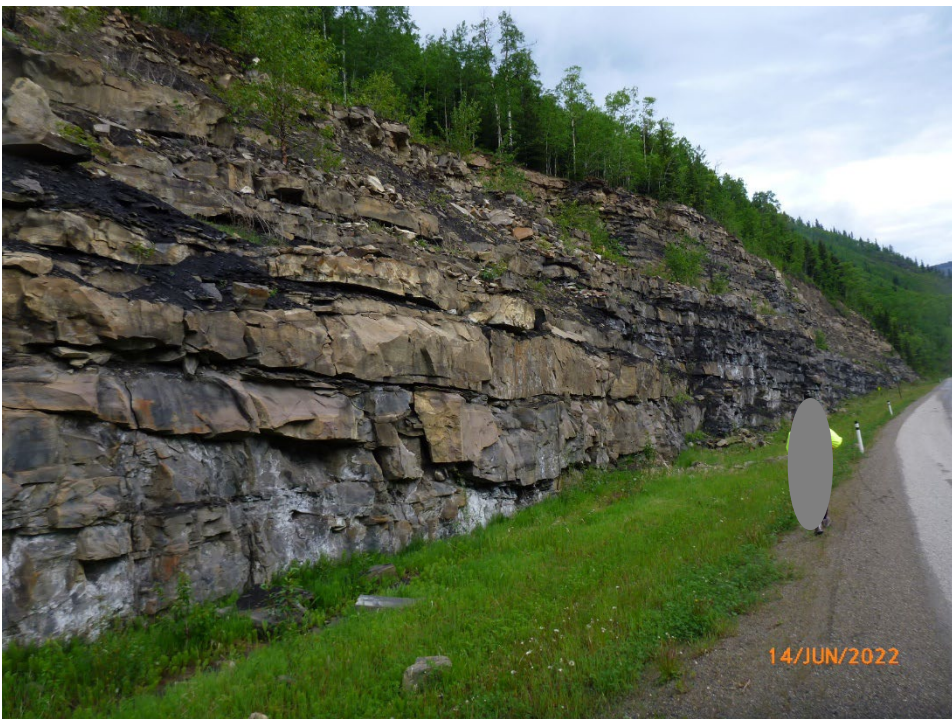
Photo 6 Near horizontal bedding of rock cut slope. Rock below mid-slope bench is massively bedded and competent. While rock above mid-slope bench is heavily fractured. Photo taken June 14, 2022, facing northwest.

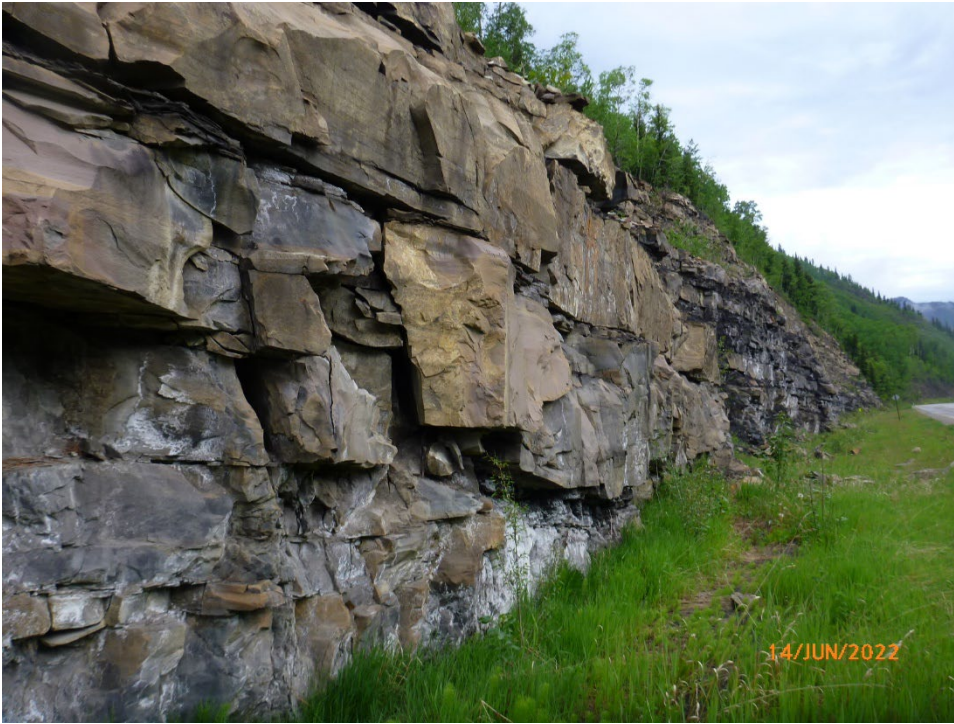
Photo 7 Overhanging blocks which have been undermined by differential weathering of coal (and other less competent materials). Photo taken June 14, 2022, facing northwest.

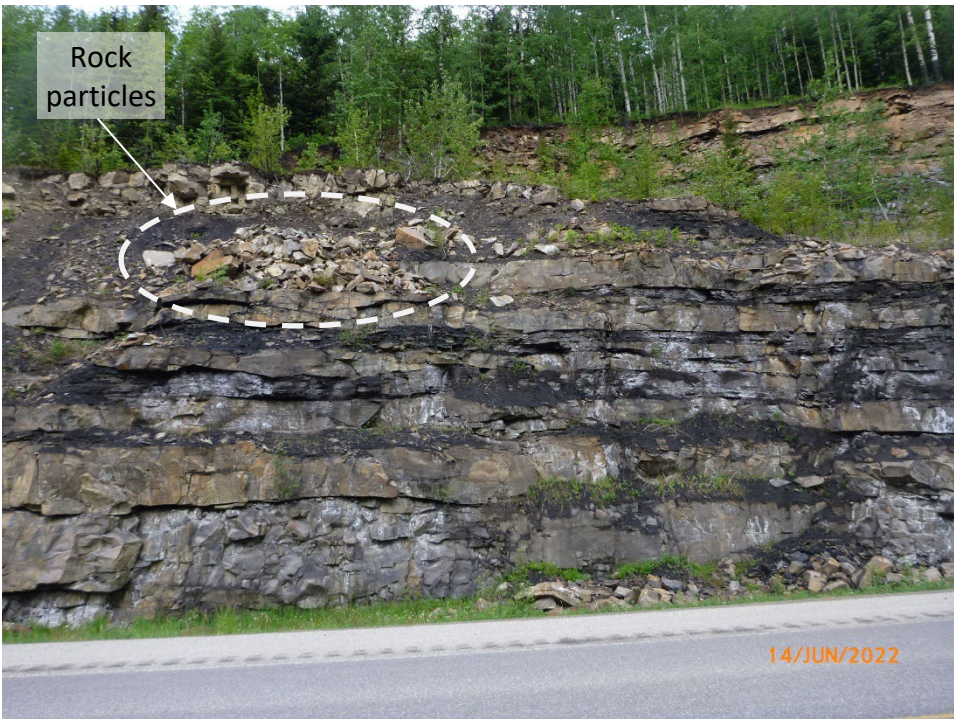
Photo 8 Talus materials and rockfall particles along mid-slope bench. Photo taken June 14, 2022, facing west.

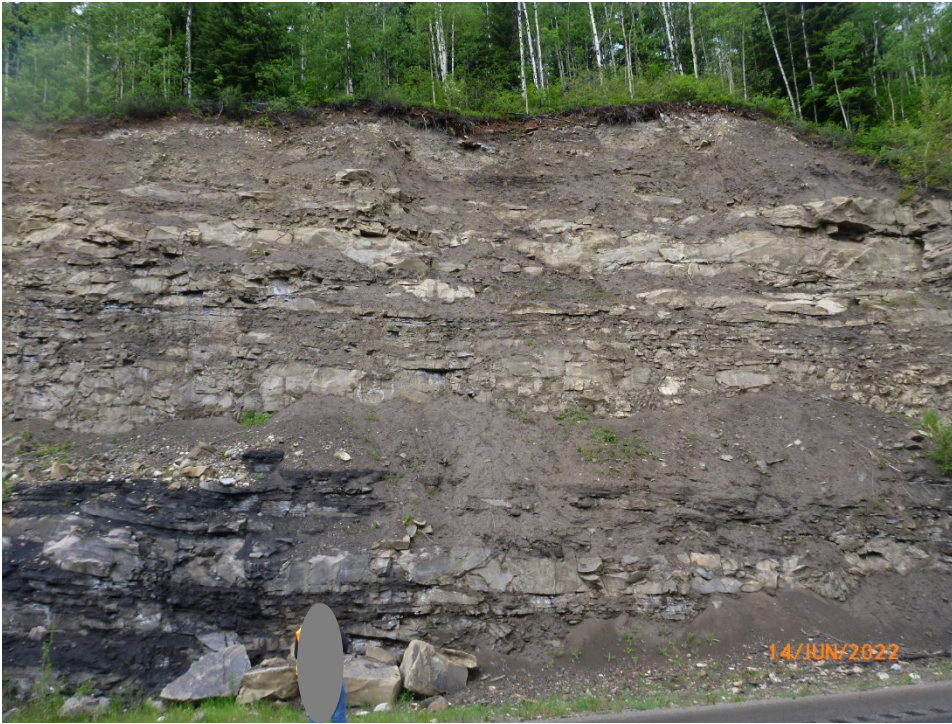
<p>Northern third of site of rock cut slope:</p> <ul style="list-style-type: none"> • The rock quality is poor, and the overburden is thicker, resulting in the accumulation of talus cones/slopes along the bedding planes and at the toe of the slope. • Four large blocks were observed at the toe of the slope, but they look like they appear to have been pushed to their current location. • Talus cones/slopes could potentially bounce/launch/roll rockfall particles out onto highway.
<p><u>Maintenance/Repair/Monitoring Recommendations:</u></p> <ul style="list-style-type: none"> • Call out completed at the GP036, GP049, and GP053 sites on July 14, 2022 after increased rockfall activity was triggered by wet weather. As part of the call out a review will be completed to determine where scaling and an attenuating mesh is needed. <ul style="list-style-type: none"> ○ Short term – Rock slope should be scaled by a high-angle specialty contractor. Scaled materials and other rockfall materials should be cleaned out of the ditch. Estimated cost: \$55,000 to \$75,000 if entire rock face scaled. ○ Long term – Rock slope should be draped in an attenuating mesh that reduces the energy of falling rocks and limits their potential to reach the highway. Estimated cost: \$190,000 to \$260,000 if entire rock face draped with mesh. • Signage (e.g., “watch for fallen rock”, no parking etc.) should be installed on either side of site warning motorists of the rockfall risk. As well as the two cut slopes approximately 300 m and 700 m north of the site as shown in Photo 1. • Upslope/west ditch approximately 5 m to 6 m wide with an approximate 4H:1V sides slope. Rockfall particles not currently impeded ditch drainage. MC reported ditch has not been cleaned in approximately three years, and previously when the ditch was full water flowed out across the highway during heavy rainfall. Continue to clean to maintain to maintain rockfall storage volume (i.e., keep ditch as wide and deep as possible to retain material within the ditch) and reduce the potential for material reaching the highway. Buried gas line below ditch limits depth that ditch can be excavated or cleaned out.

Photo 9 At northern site limit, rock quality is poor resulting in small talus cones/slopes along bedding planes and at toe of slope. Photo taken June 14, 2022, facing west.

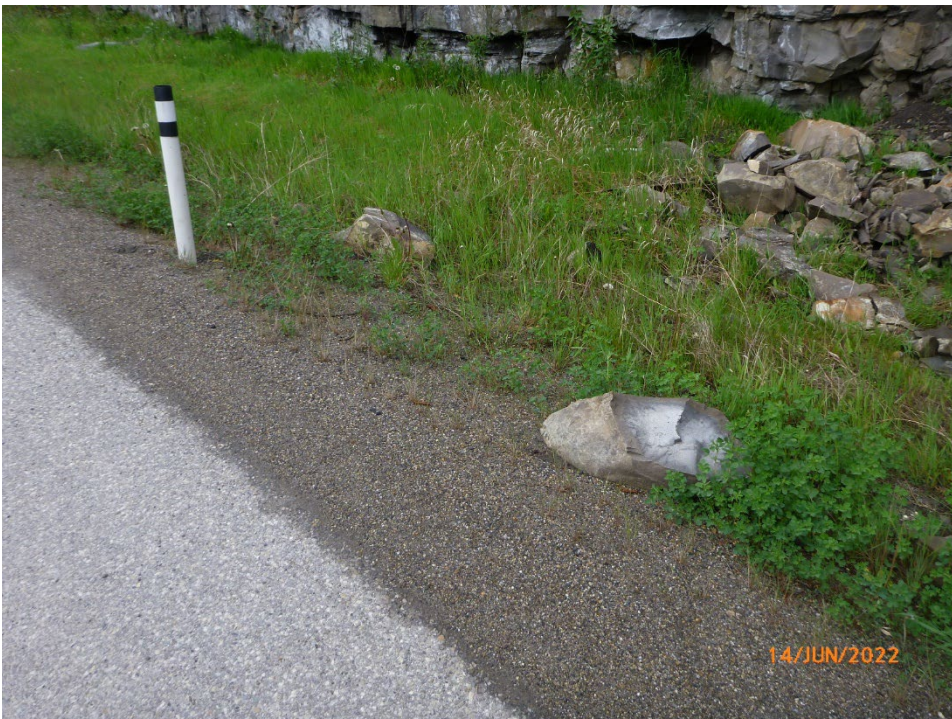
Photo 10 Rockfall particle near edge of southbound lane. Photo taken June 14, 2022 facing southwest.

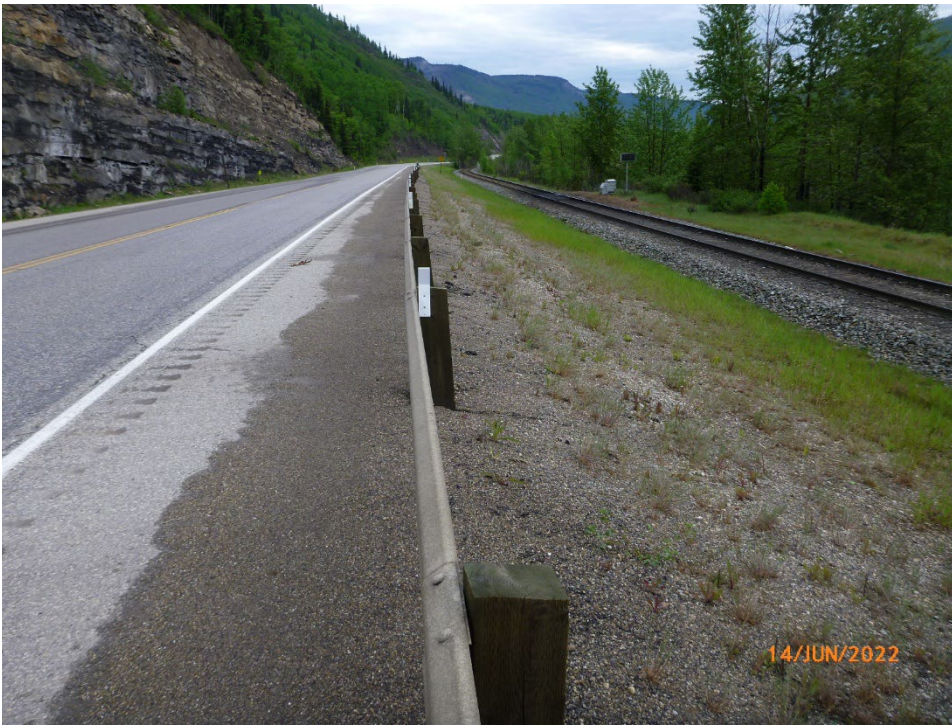
Photo 11 Pavement surface and east side of Hwy 40:36. Photo taken June 14, 2022, facing northeast.

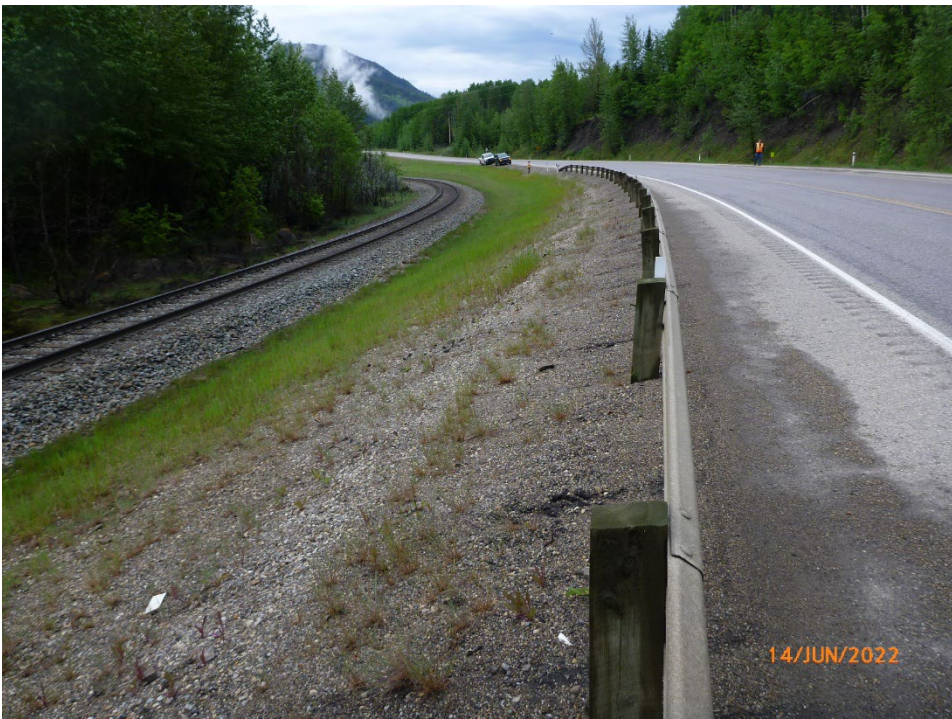
Photo 12 Pavement surface and east side of Hwy 40:36. Photo taken June 14, 2022, facing southwest.
