**ALBERTA TRANSPORTATION  
GEOHAZARD ASSESSMENT PROGRAM  
PEACE REGION – GRANDE PRAIRIE DISTRICT  
2019 CALL OUT**

<b>Site Number</b>	<b>Location</b>	<b>Name</b>	<b>Hwy</b>	<b>km</b>
Call Out	Wanyandie Creek	Bin Wall Slump	40:36	37.9
<b>Legal Description</b>		<b>UTM Co-ordinates (NAD 83)</b>		
SE21-59-6-W6		11U N 5,997,170	E 380,027

**2019 CALLOUT - HWY 40:36 KM 37.9  
WANYANDIE CREEK**

**SITE PLAN**

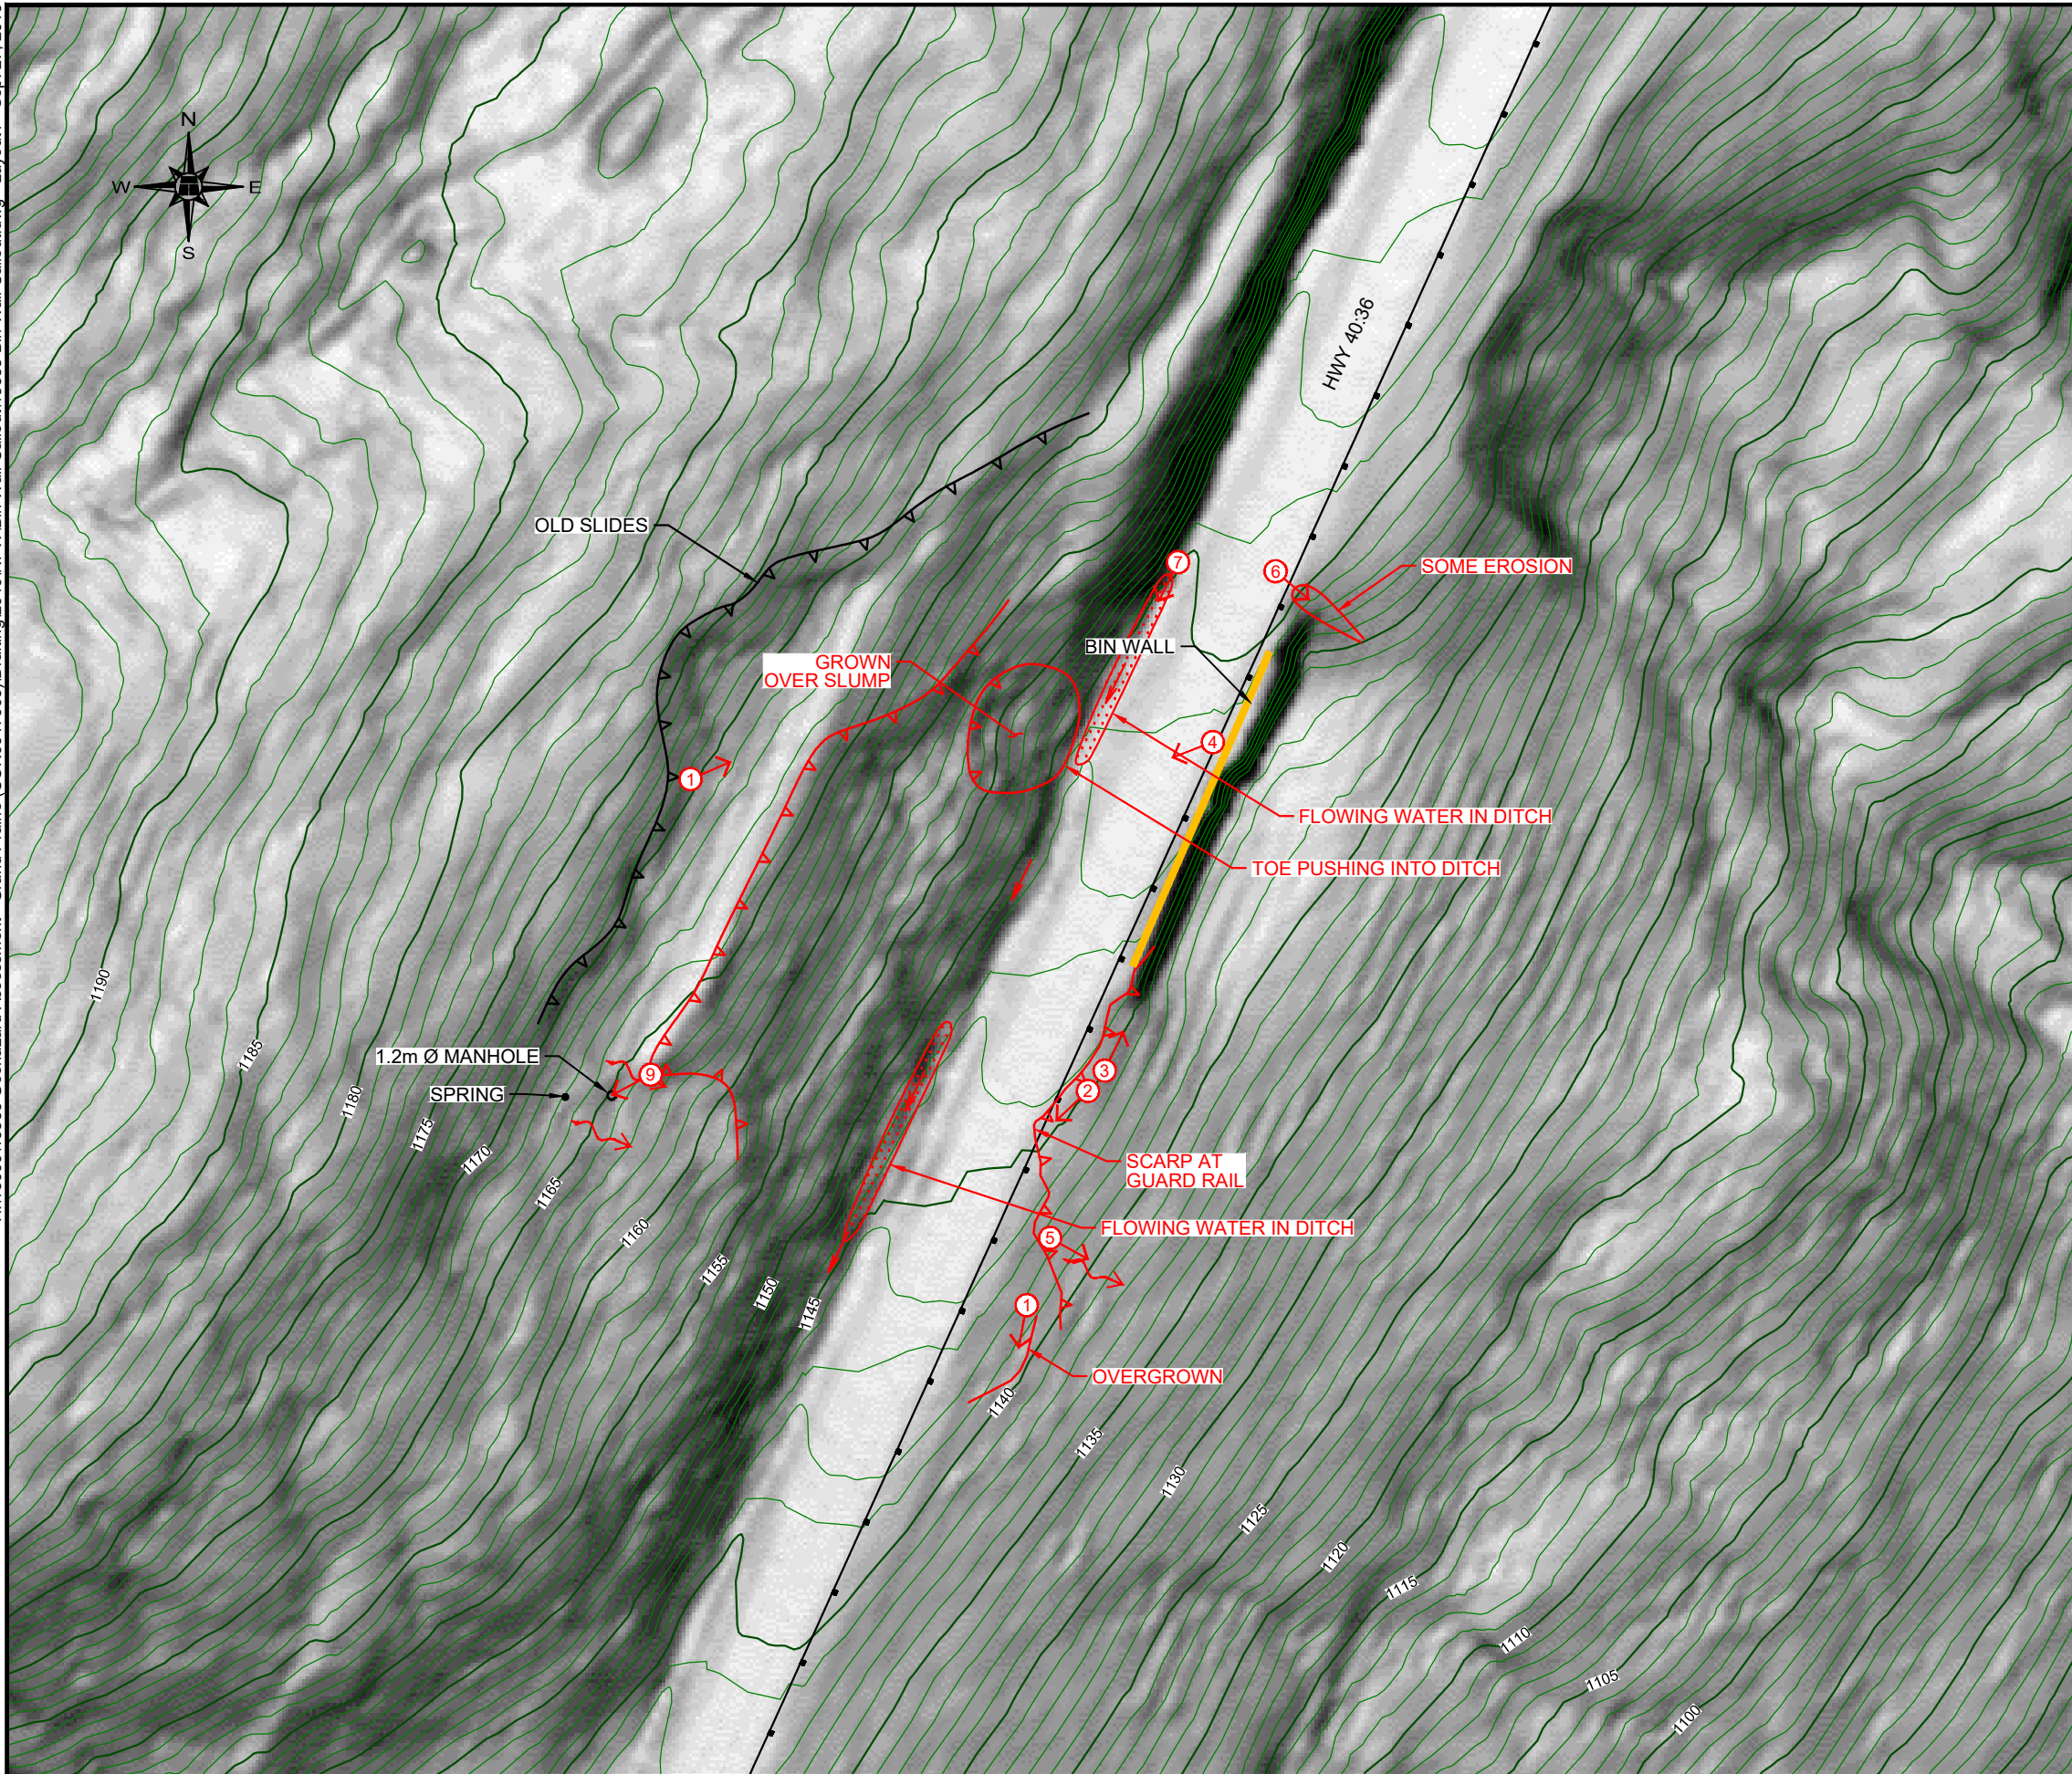
<b>Primary Site Issue:</b>	An approximate 70 m wide landslide scarp that was partially grown over was observed adjacent to the existing bin wall.	
<b>Dimensions:</b>	The approximate width of the landslide was about 70 m; however, there were no signs of a toe roll to distinguish the length.	
<b>Date of any remediation:</b>		
<b>Maintenance:</b>		
<b>Observations:</b>	<b>Description</b>	<b>Worse?</b>
<input type="checkbox"/> Pavement Distress		<input type="checkbox"/>
<input checked="" type="checkbox"/> Slope Movement	There is a scarp in the east side slope that extends about 70 m southwest from near the south side of the bin wall which extends up to the guardrail. The scarp did not appear to have fresh soil movement. There were also overgrown scarps in the west backslope observed from previous instabilities. A scarp in the backslope adjacent to the rock face outcrop has its toe roll extending into part of the upslope ditch.	<input type="checkbox"/>

<input checked="" type="checkbox"/> Erosion	Active erosion activity is occurring on the north side of the existing bin wall and some surficial erosion above scarp.	<input type="checkbox"/>
<input checked="" type="checkbox"/> Seepage	There was water flowing in the upslope ditch as well as springs and seepage noted in several areas in the backslope and in one location below the downslope scarp.	<input type="checkbox"/>
<input checked="" type="checkbox"/> Bridge/Culvert Distress		<input type="checkbox"/>
<input type="checkbox"/> Other		<input type="checkbox"/>
<b>Instrumentation:</b> None		
<b>Assessment:</b>		
<p>Slope movement occurred on the south side of the bin wall on the downslope side of the highway which was constructed at a slope of about 3H:1V. The scarp at the time of the inspection appeared to be somewhat grown over and there were also some overgrown scarps in the backslope. A manhole was observed on the bench in the backslope. From discussions with AT, horizontal drains had previously been installed from a bench in the backslope and the manhole might have been an access for cleanout.</p>

Consideration should be given to installing some more horizontal drains or French drains in the backslope area and plant some deep-rooted trees at the sliding area to help dewater the ground and improve its stability by developing a root system.

The bin wall could be extended approximately 40 m further south to protect the shoulder of the highway.

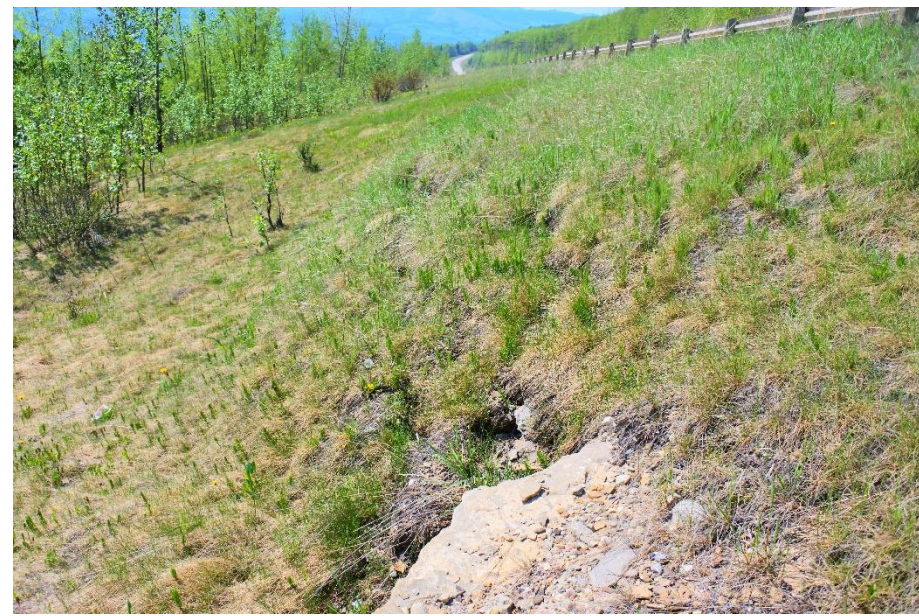
**Photo 1.**  
Looking south at  
subdued scarp  
slightly west of the  
main scarp.

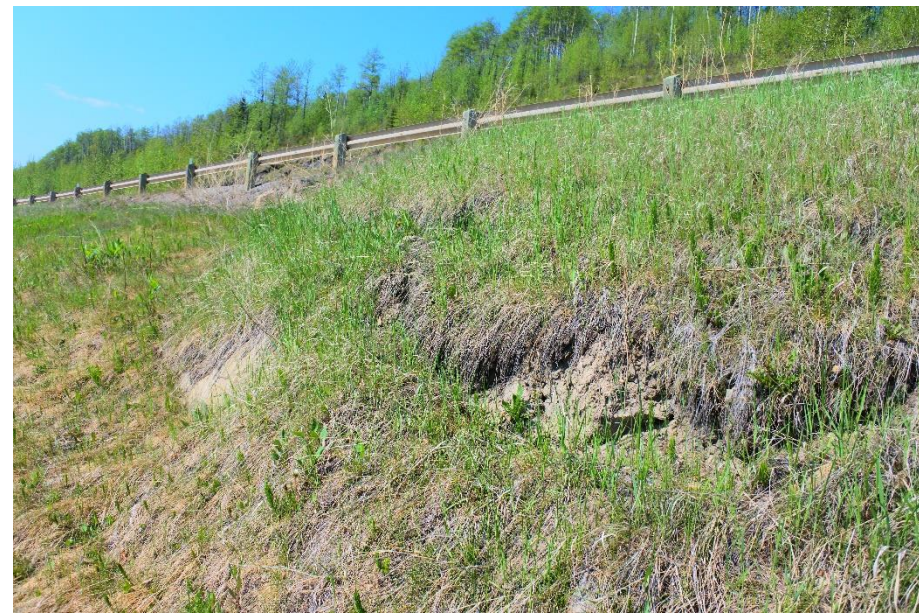
The side slope scarp does not appear to be very active; however, if the slide mass moves down it could reduce the passive support of the bin wall and could also retrogress towards the highway as the scarp currently extends up to the guardrail.

**Photo 2.**  
Looking southwest  
at scarp heading  
towards guardrail.

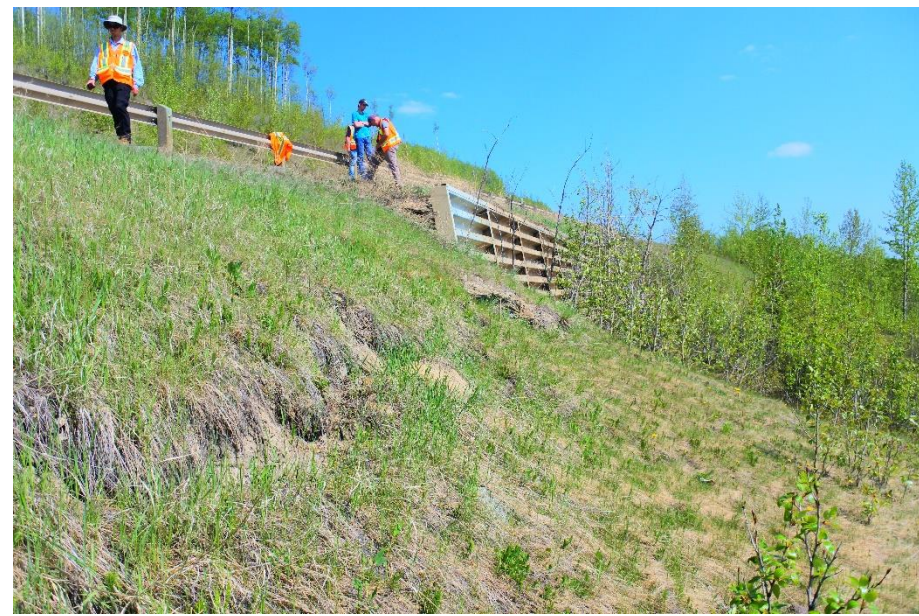
**Photo 3.**  
Looking north at  
scarp extending  
towards the bin  
wall.

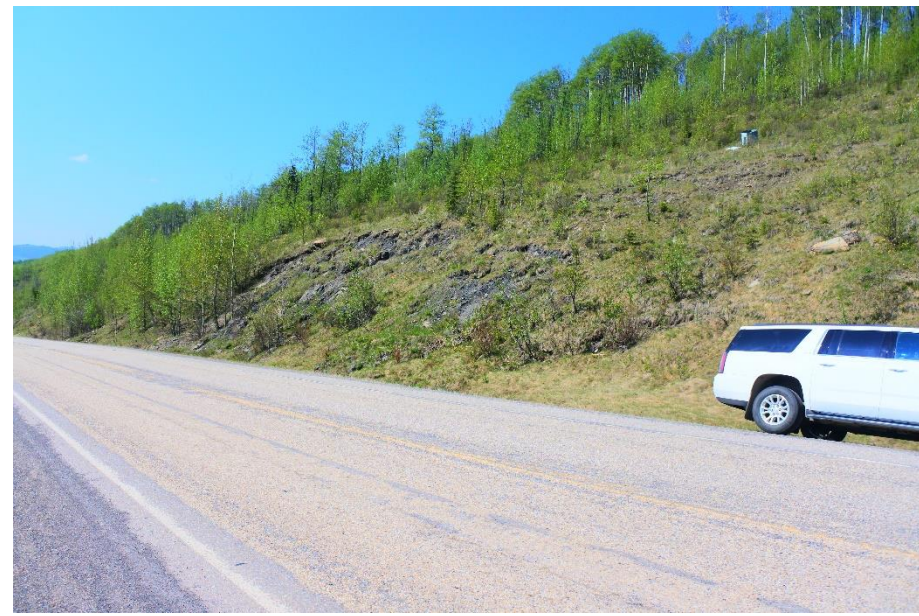
**Photo 4.**  
Looking west  
towards the  
backslope and at  
manhole.

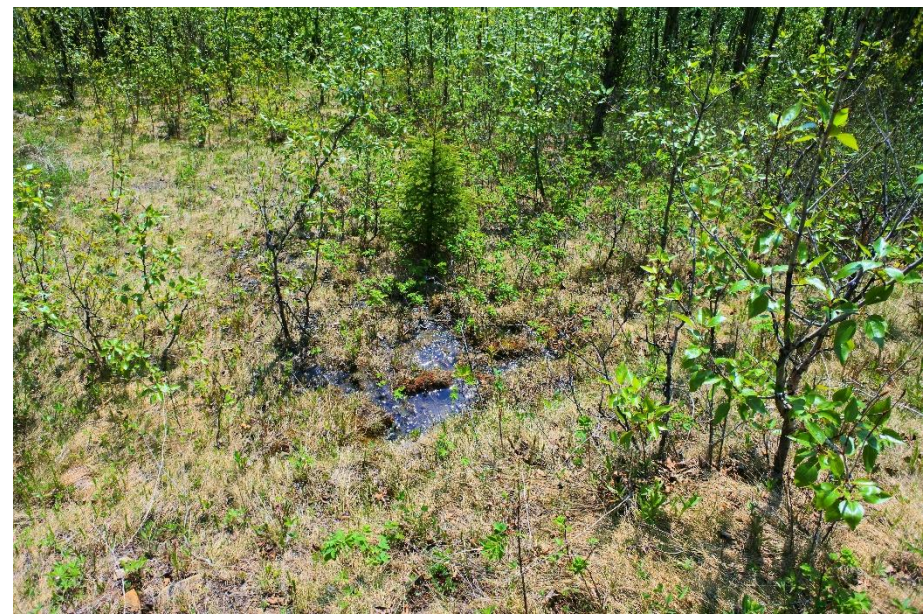
The bin wall itself looks to be in good condition and the exposed bin wall face ranges from 1.5 m to 5.5 m in height. There was seepage noted below the side slope scarp indicative of a high or at surface ground water table and springs and seepage observed in several locations in the backslope and ditch which contribute loading to area and is a driving mechanism for slope instability.

**Photo 5.**  
Looking south of  
the bin wall at  
ponded water  
downslope of  
scarp.

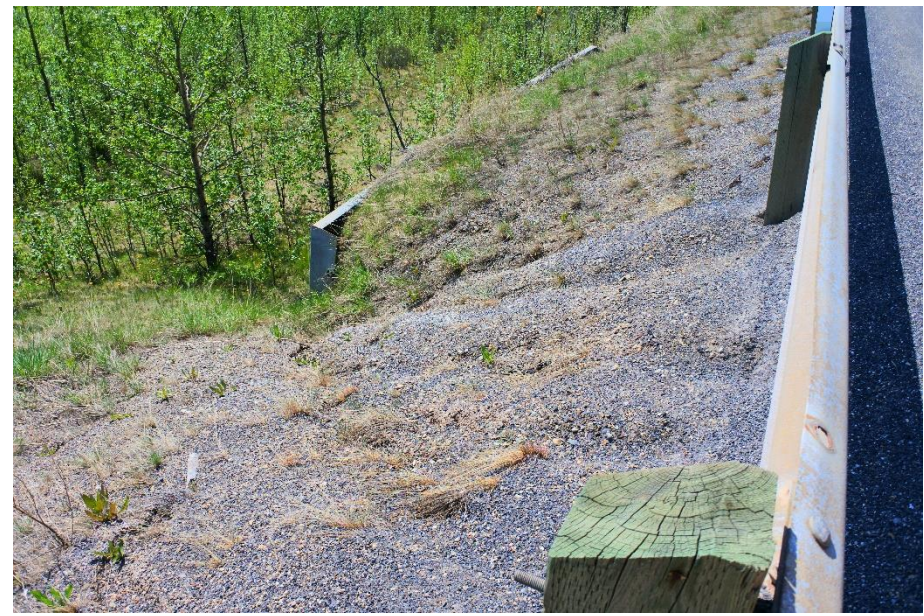
**Photo 6.**  
Looking at some  
surficial erosion  
that occurred  
above bin wall on  
north side.

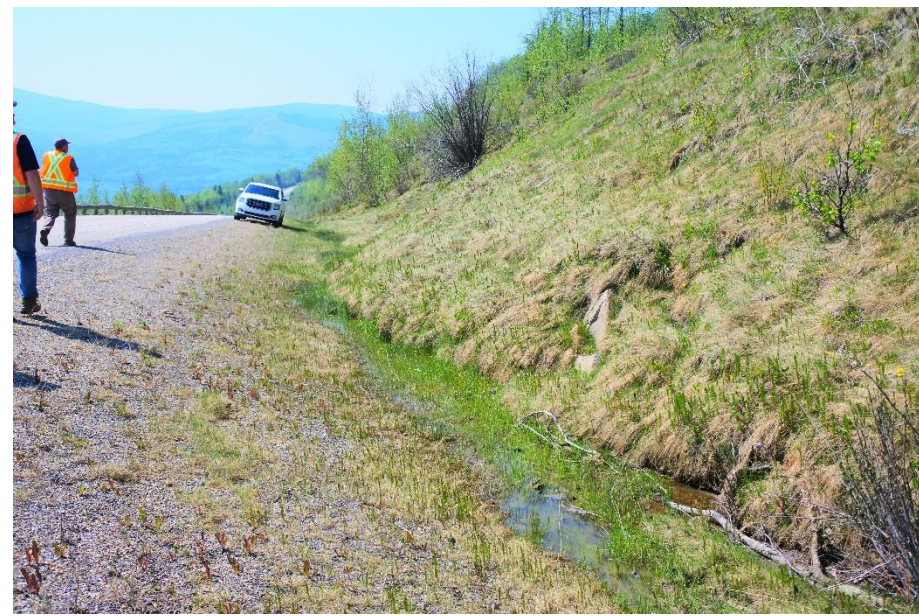
**Photo 7.**  
Looking south at  
the backslope ditch  
with water ponding.

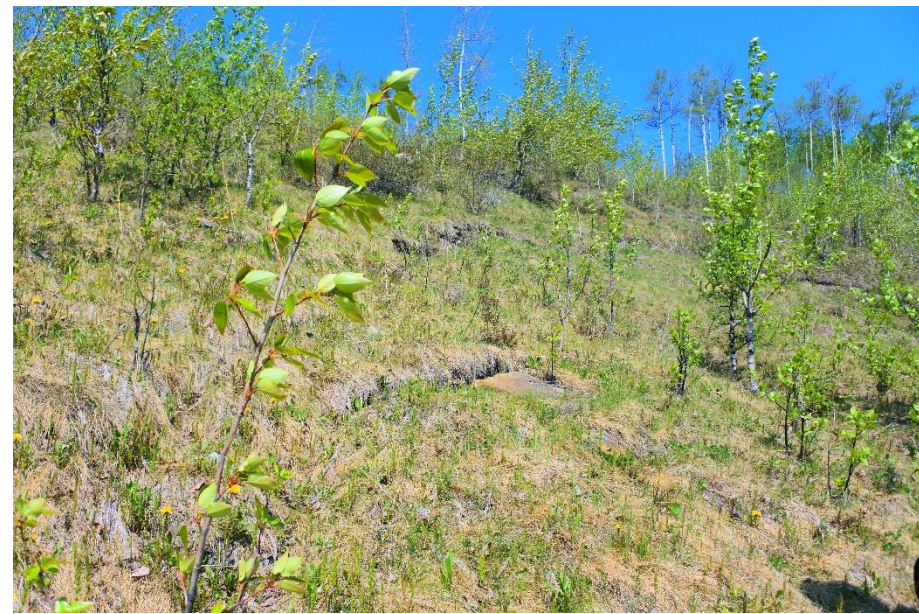
**Photo 8.**  
Backslope area  
that had overgrown  
scarps.

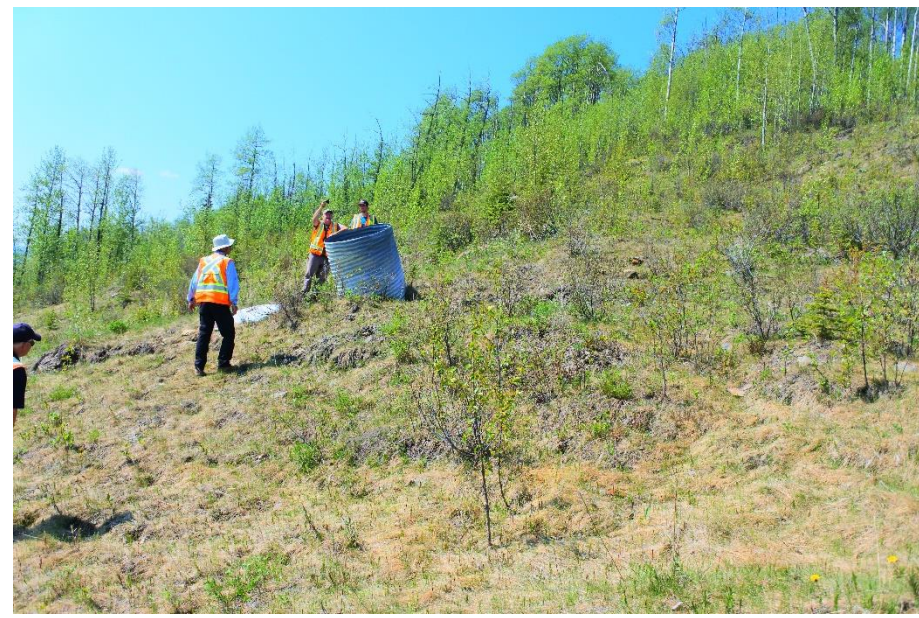
**Photo 9.**  
Backslope area  
looking towards the  
manhole.
