**ALBERTA TRANSPORTATION
GEOHAZARD ASSESSMENT PROGRAM
PEACE REGION – GRANDE PRAIRIE DISTRICT
2018 INSPECTION**

Site Number	Location	Name	Hwy	km
GP06B	N of Grande Cache	Tear Drop Slides	40:36	21.8
Legal Description		UTM Co-ordinates (NAD 83)		
NW30-58-7-W6		11U N 5,990,745	E 366,610

PEACE REGION (GRANDE PRAIRIE)
GP06B-1: HWY 40:36 TEAR DROP SLIDES

2018 INSPECTION PLAN

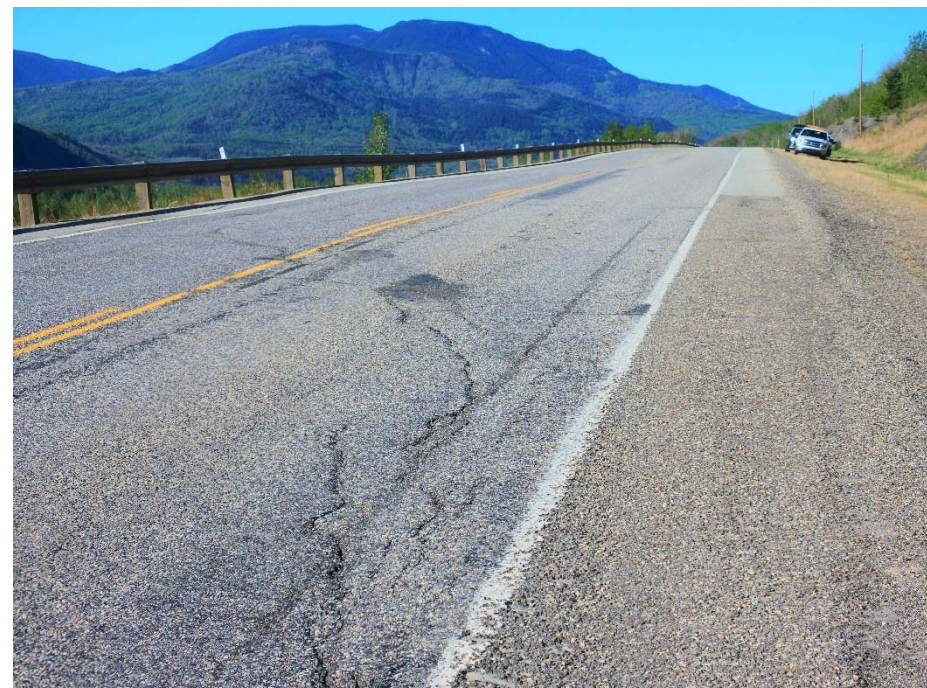
Photo 1.
Looking south along the northbound lane towards the south end of the site. Note the dip in the highway at this location.

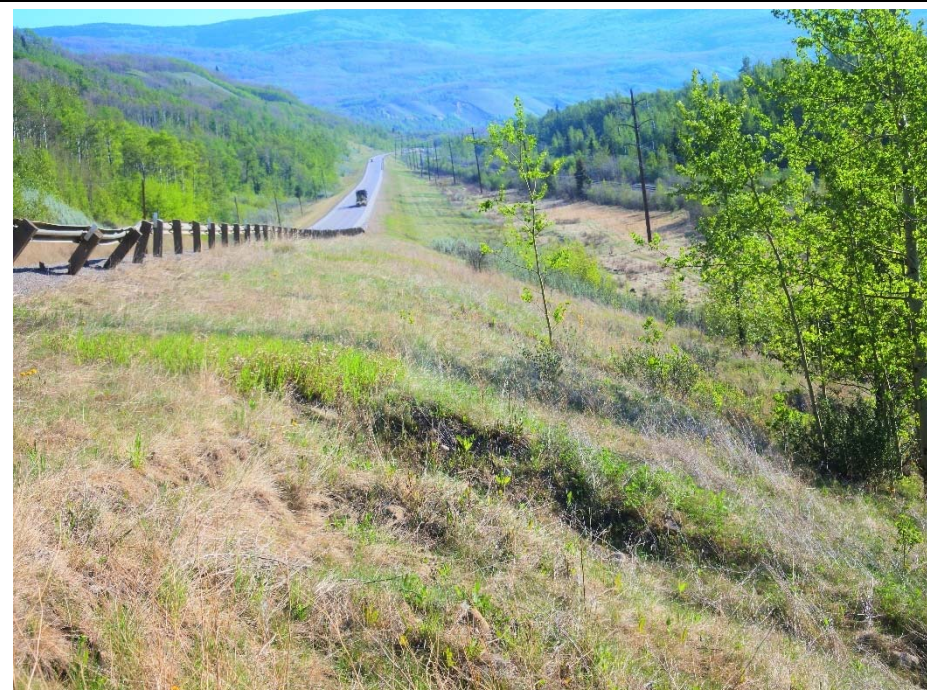
Photo 2.
Looking north along the east embankment at the South Teardrop embankment slump.

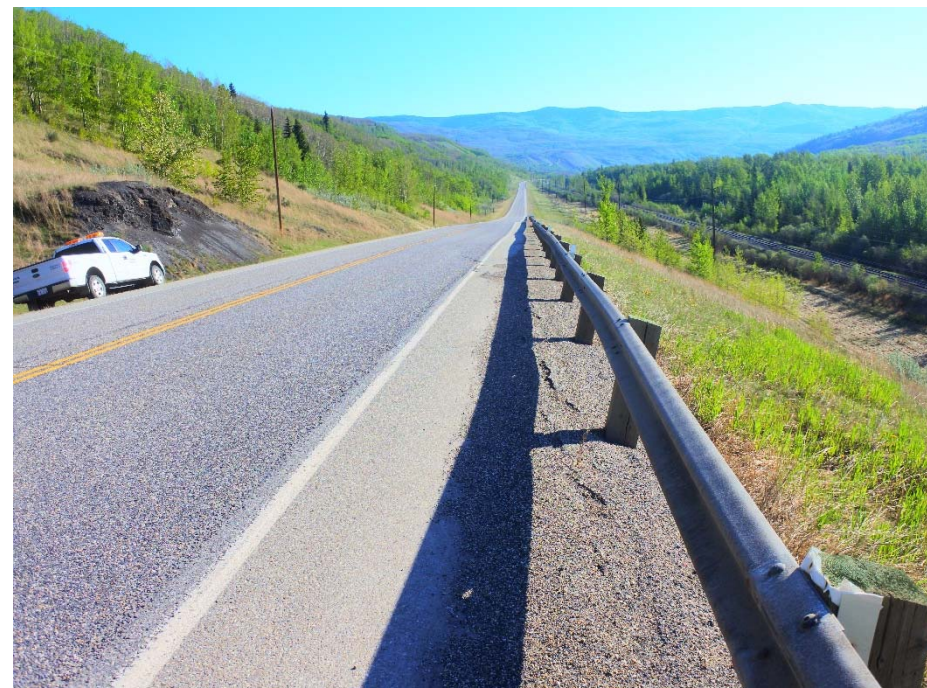
Photo 3.
Looking north along the highway at the south end of the scarp crack where it enters into shoulder

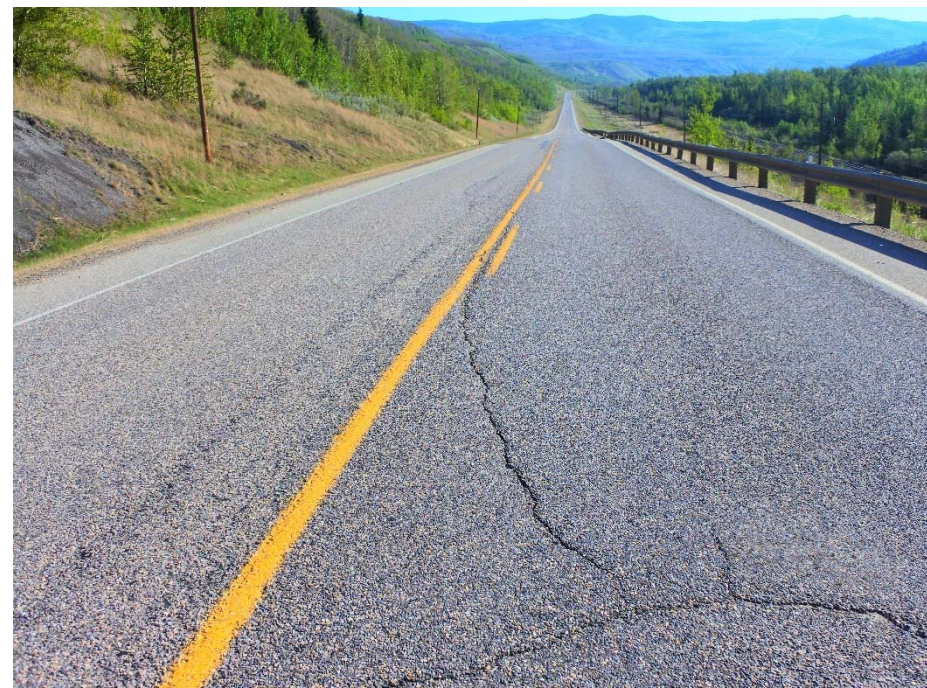
Photo 4.
Looking north along the northbound lane and guardrail at the scarp crack.

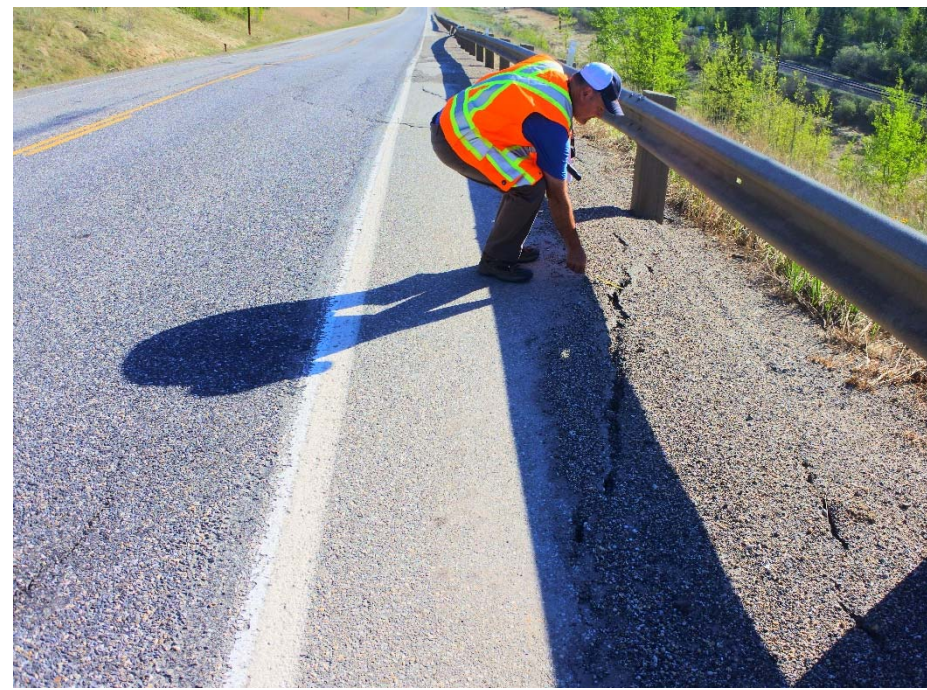
Photo 5.
Looking north along the northbound lane shoulder at where northern portion of scarp enters back into shoulder. Larger cracks observed open to 40 mm.

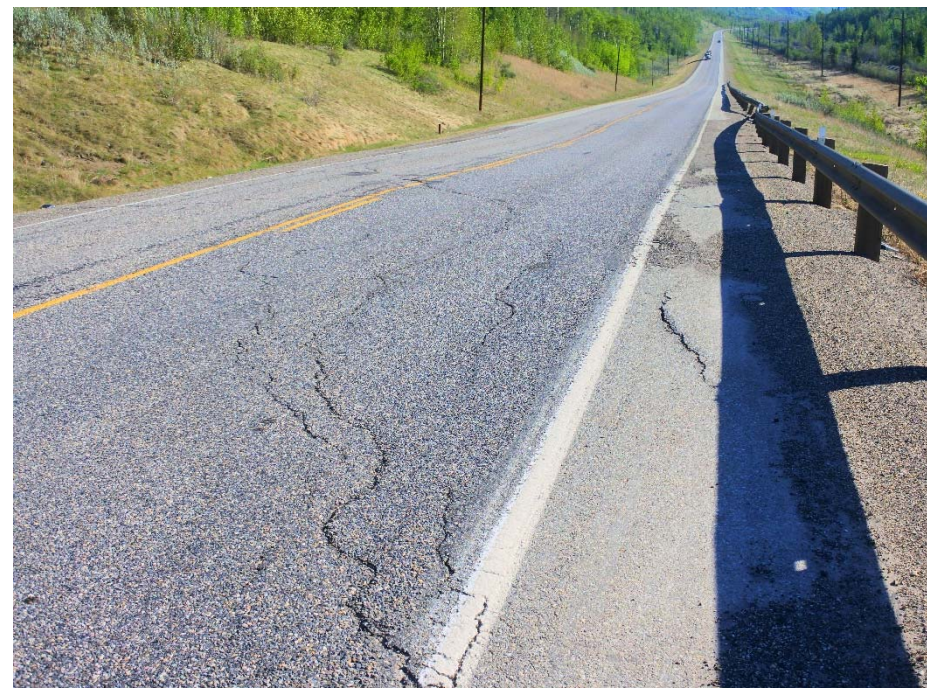
Photo 6.
Looking north along centerline at the scarp crack in the highway.

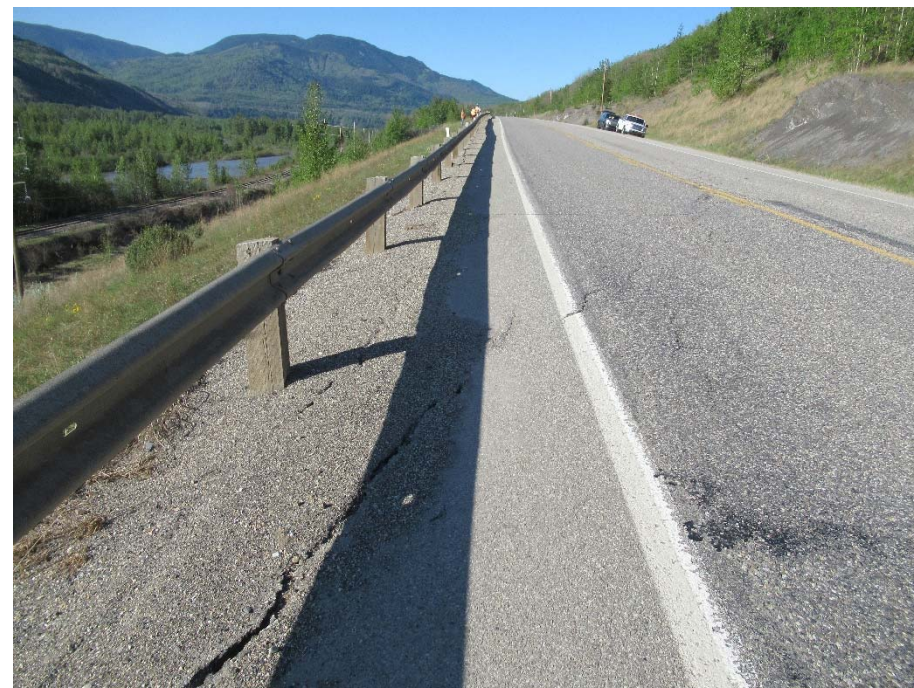
Photo 7.
Looking south
along the long
scarp crack in the
highway from near
the center of the
site.

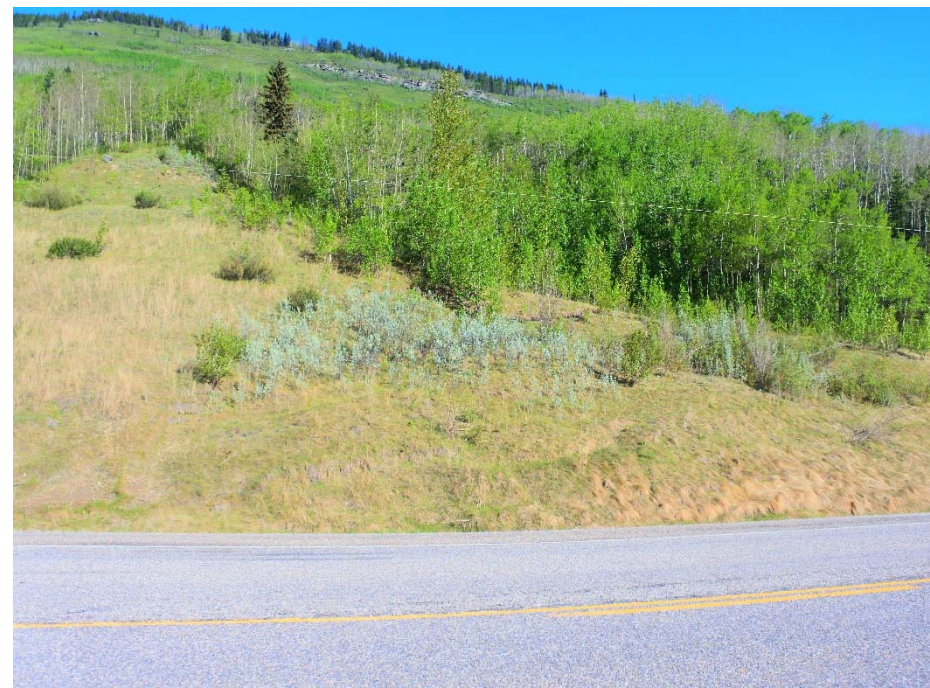
Photo 8.
Looking north at
backslope slump.

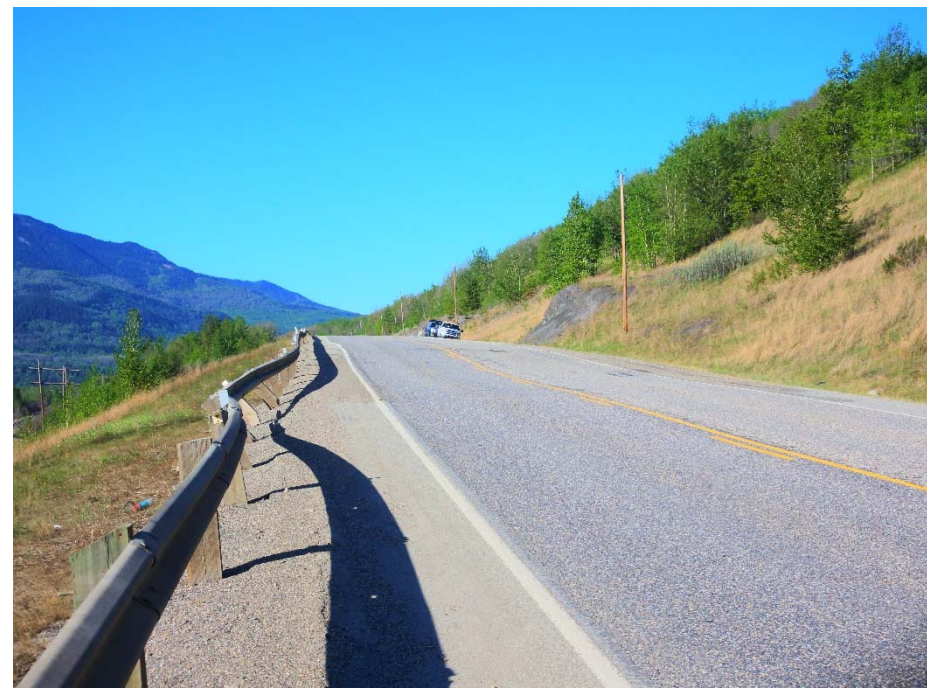
Photo 9.
Looking south at dip
in the road and
damaged guard rail.

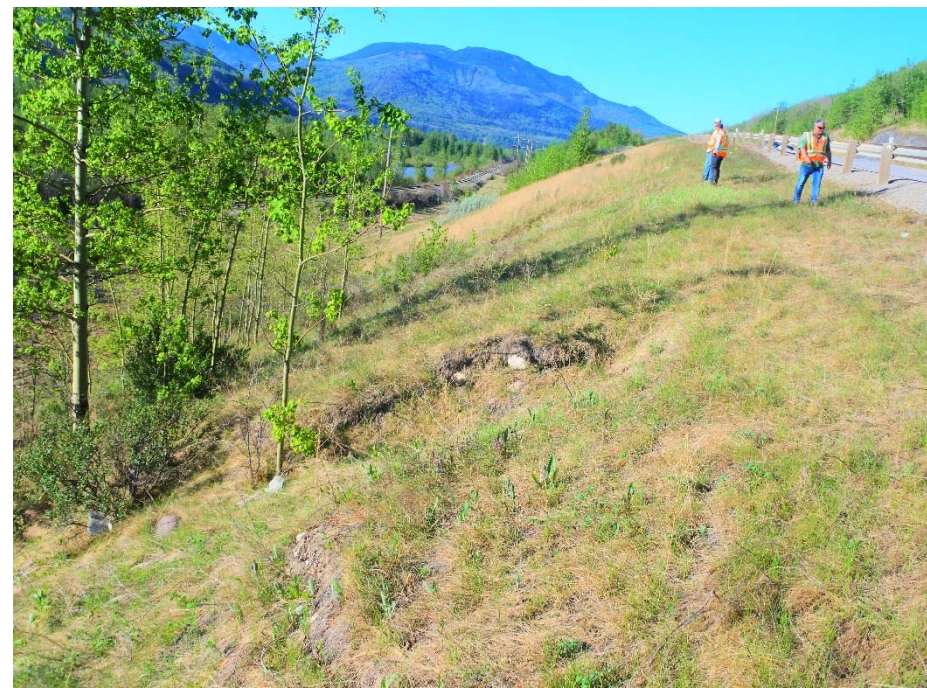
Photo 10.
Looking south
along the east
embankment at
teardrop slide
failures.
