November 30, 2022

Alberta Transportation
Main Floor, Provincial Building
9621 – 96th Avenue
Peace River, Alberta
T8S 1T4

CON0022166 Peace Region (Grande Prairie District – South) GRMP Instrumentation Monitoring Site GP006; H40:36, km 21.779 Sheep Creek Embankment (Three Teardrops Slide) Section C – 2022 Fall Readings

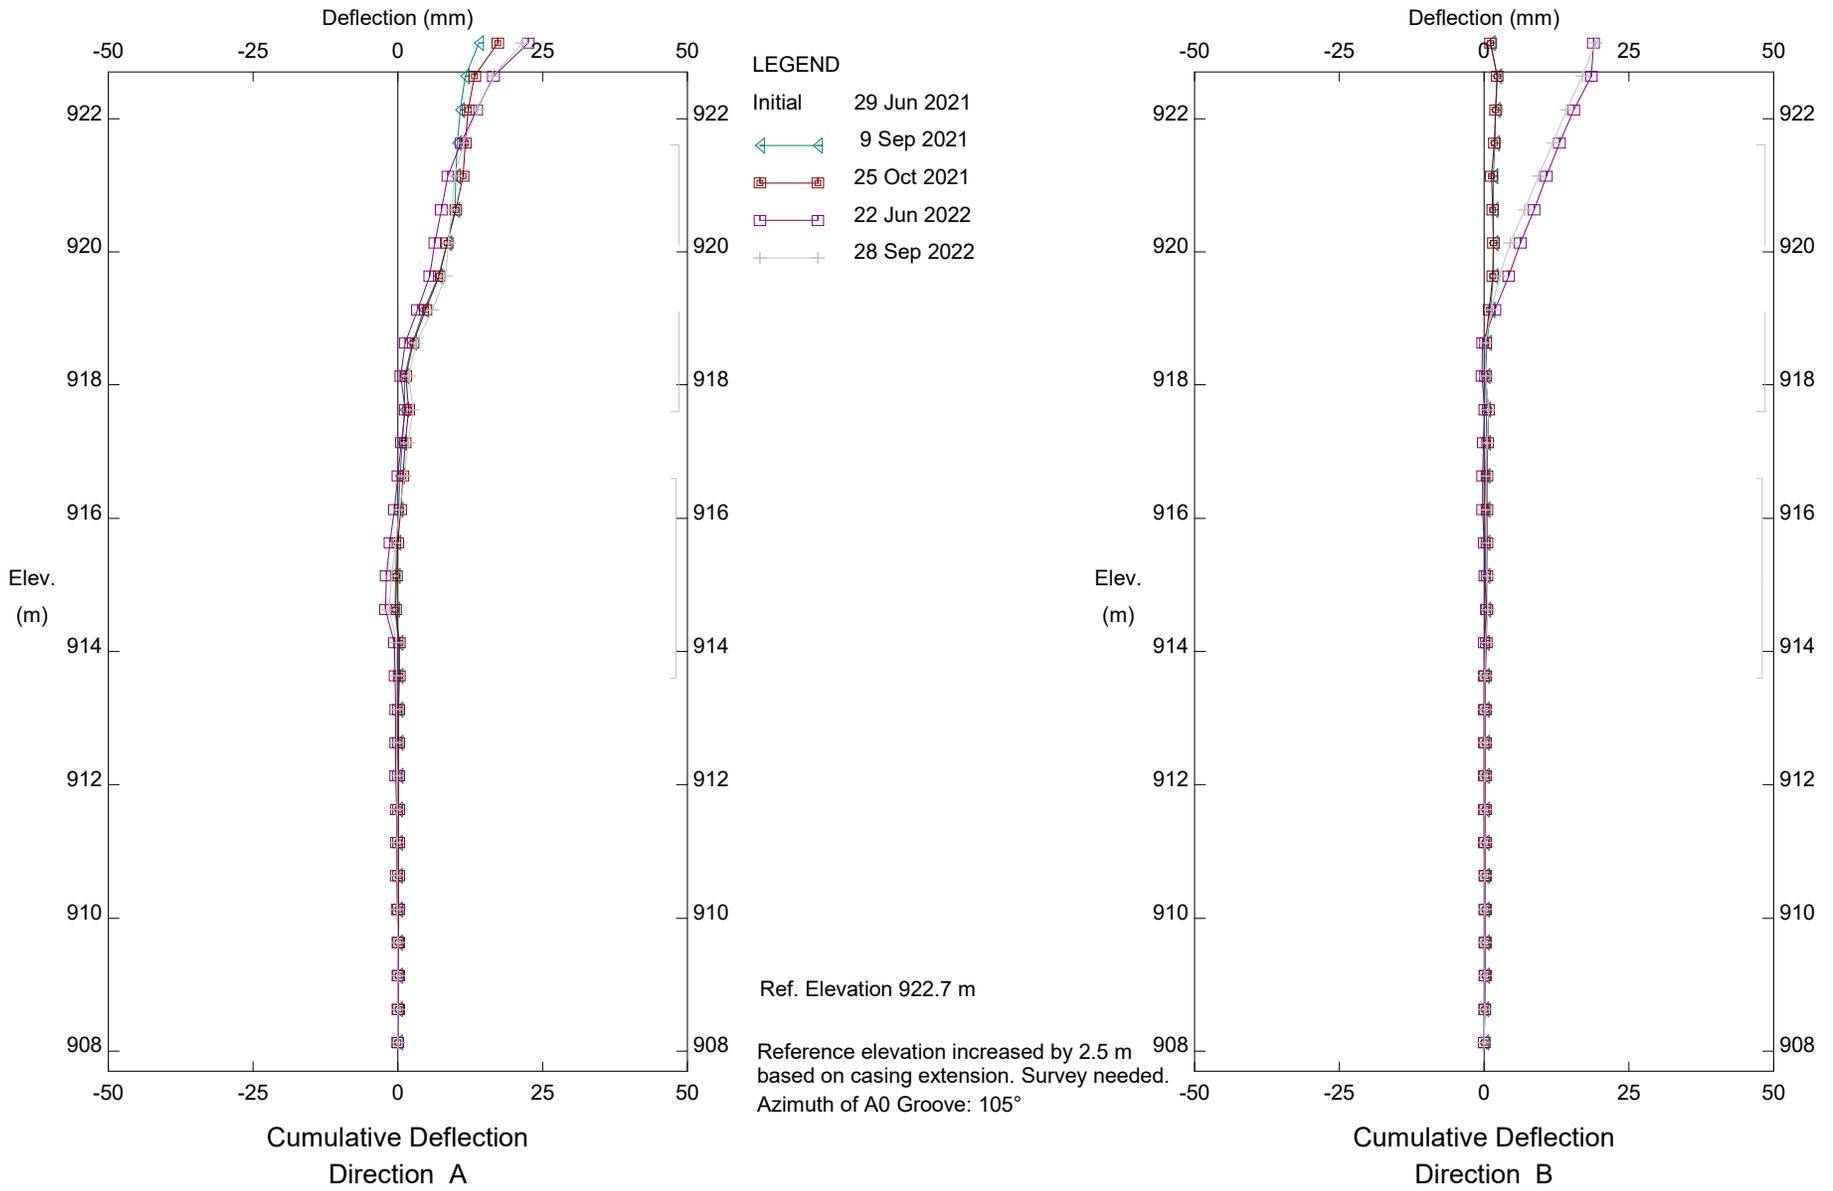
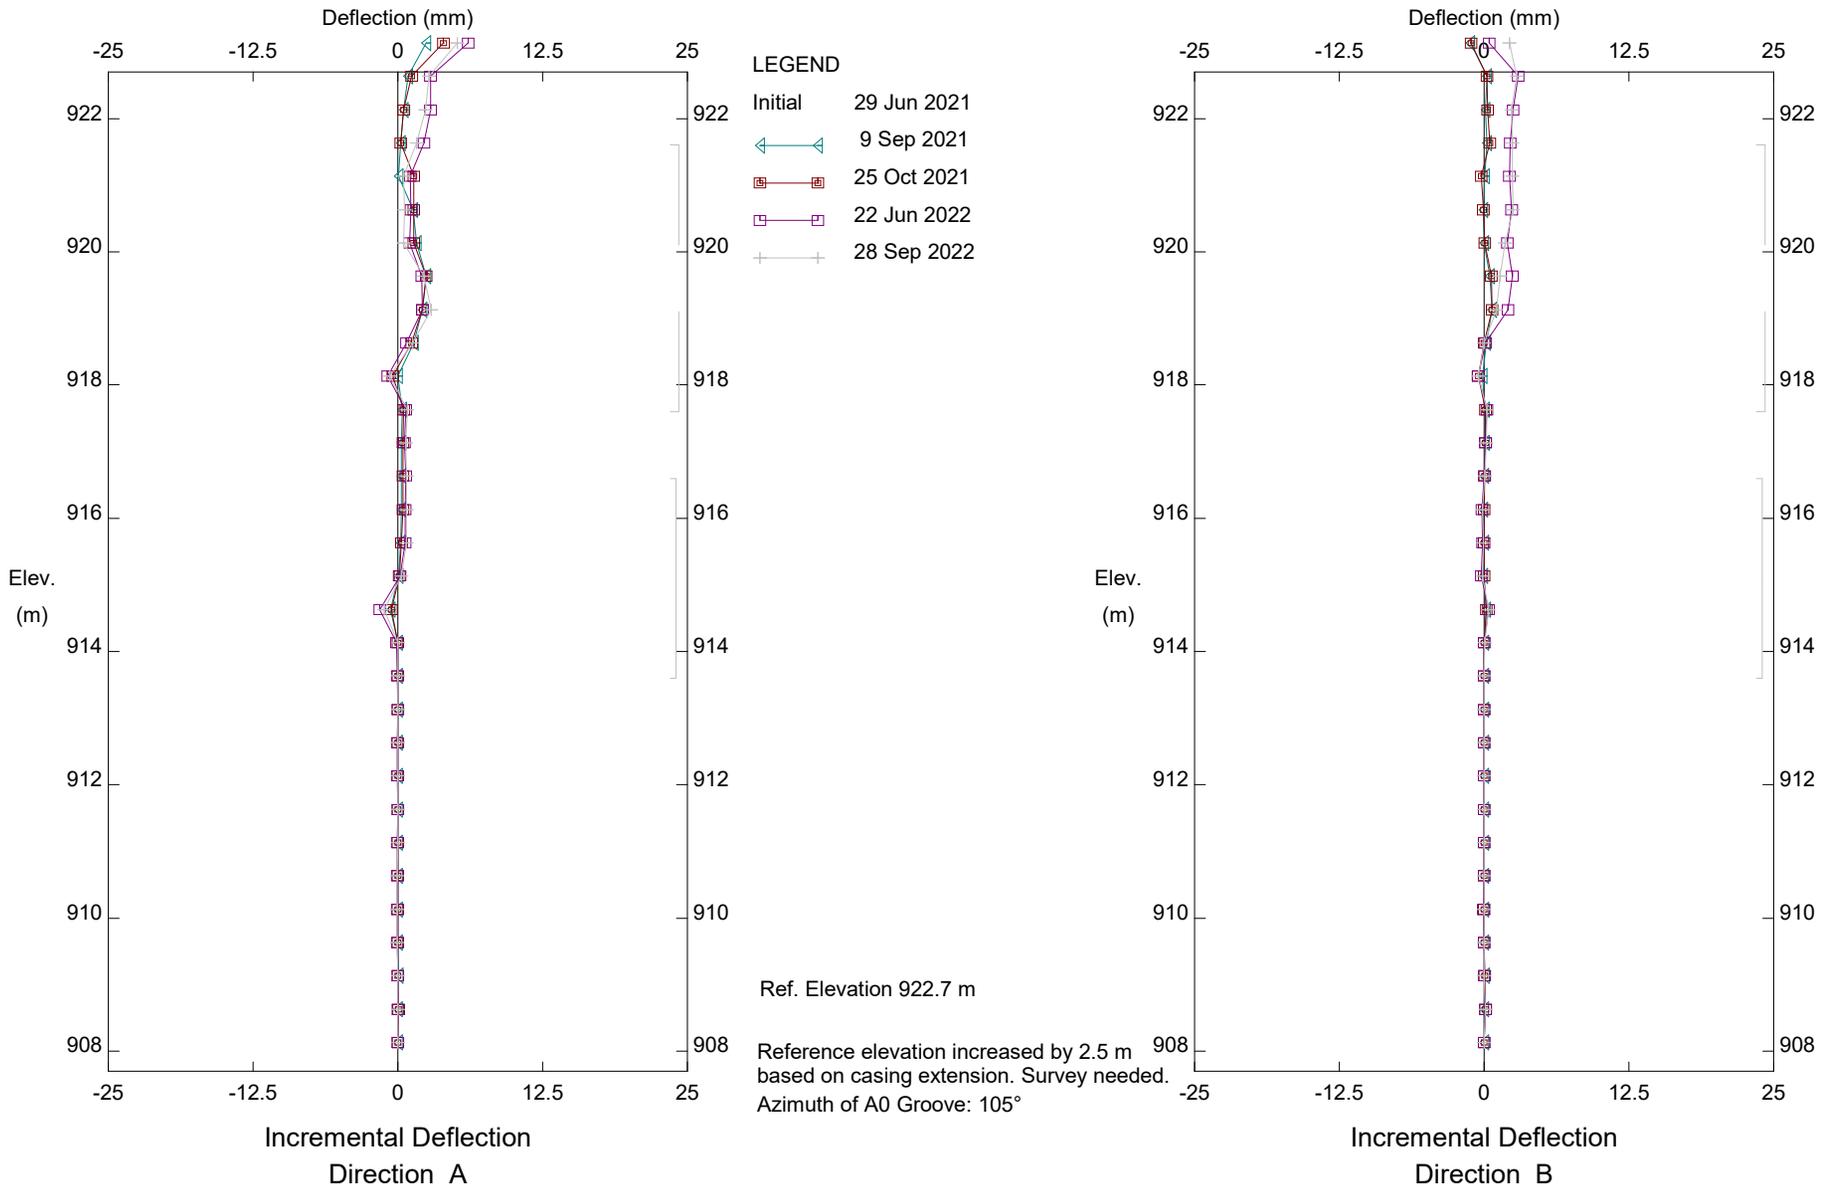
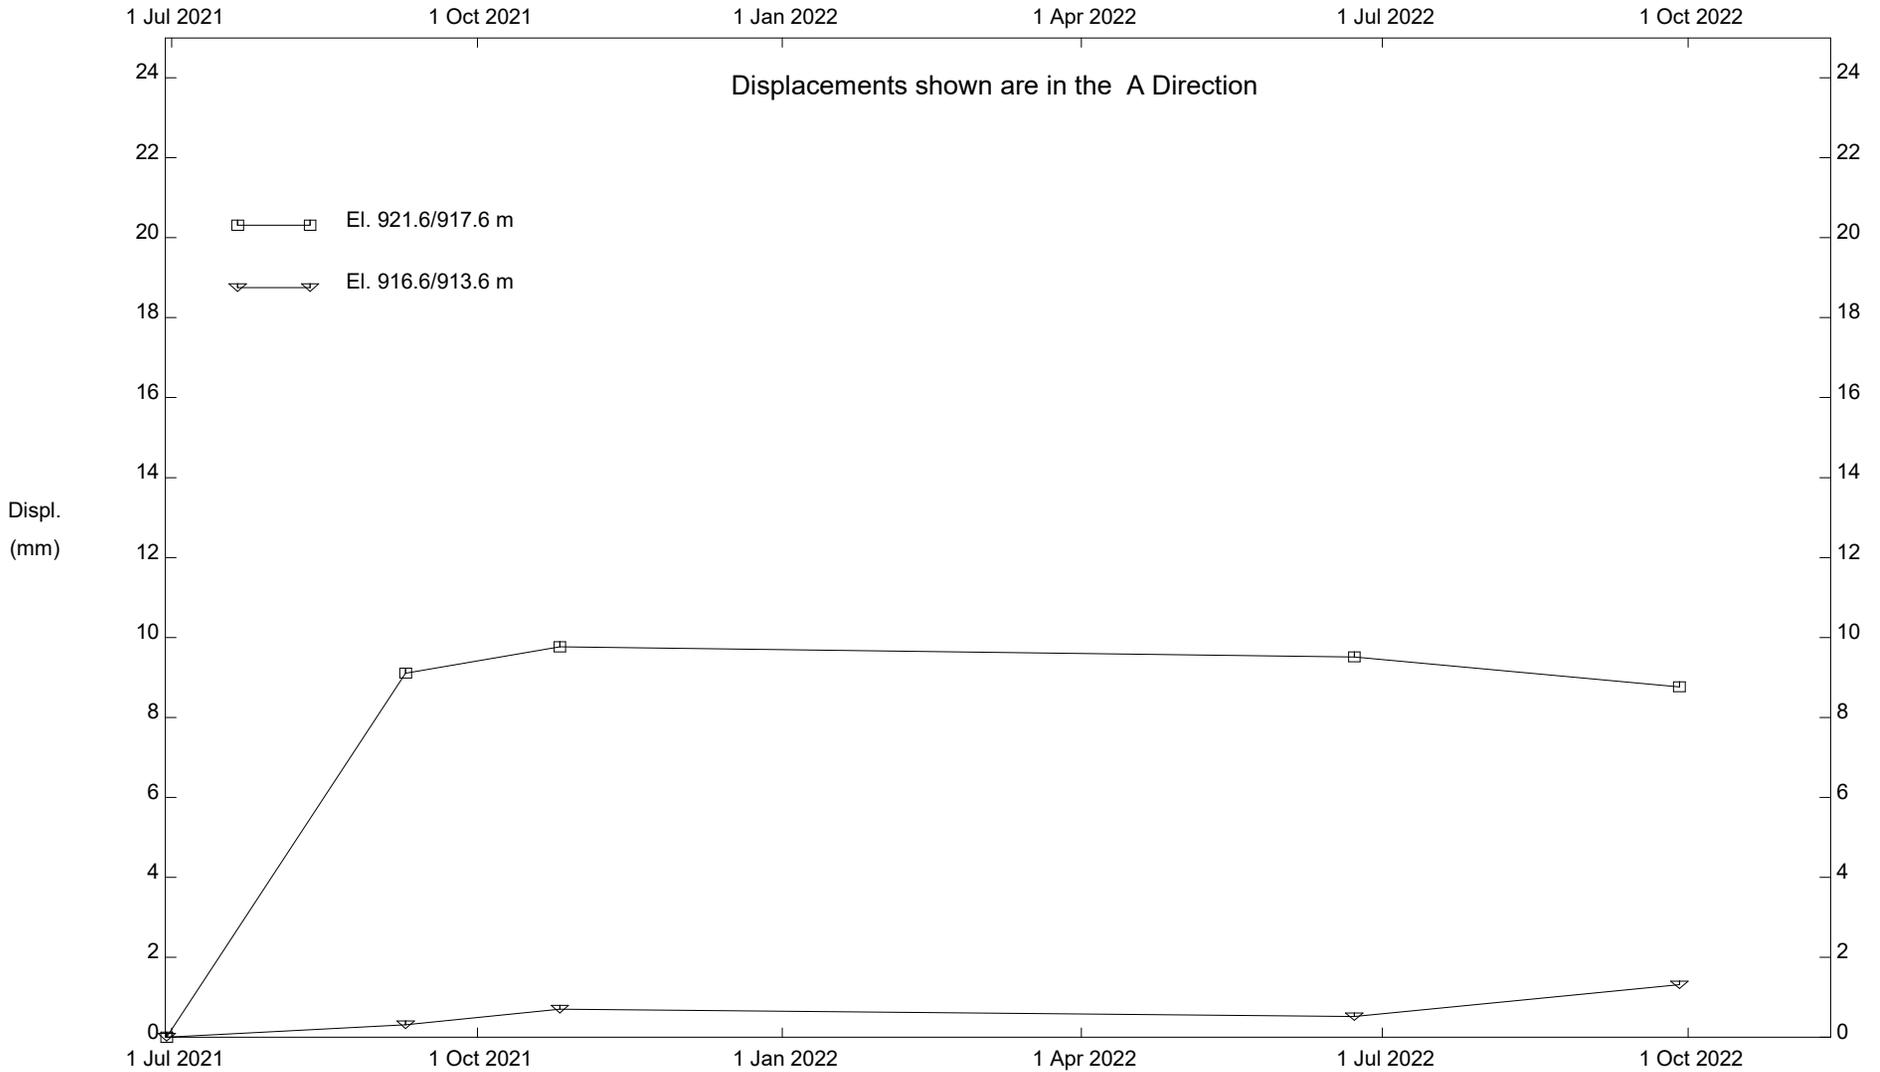
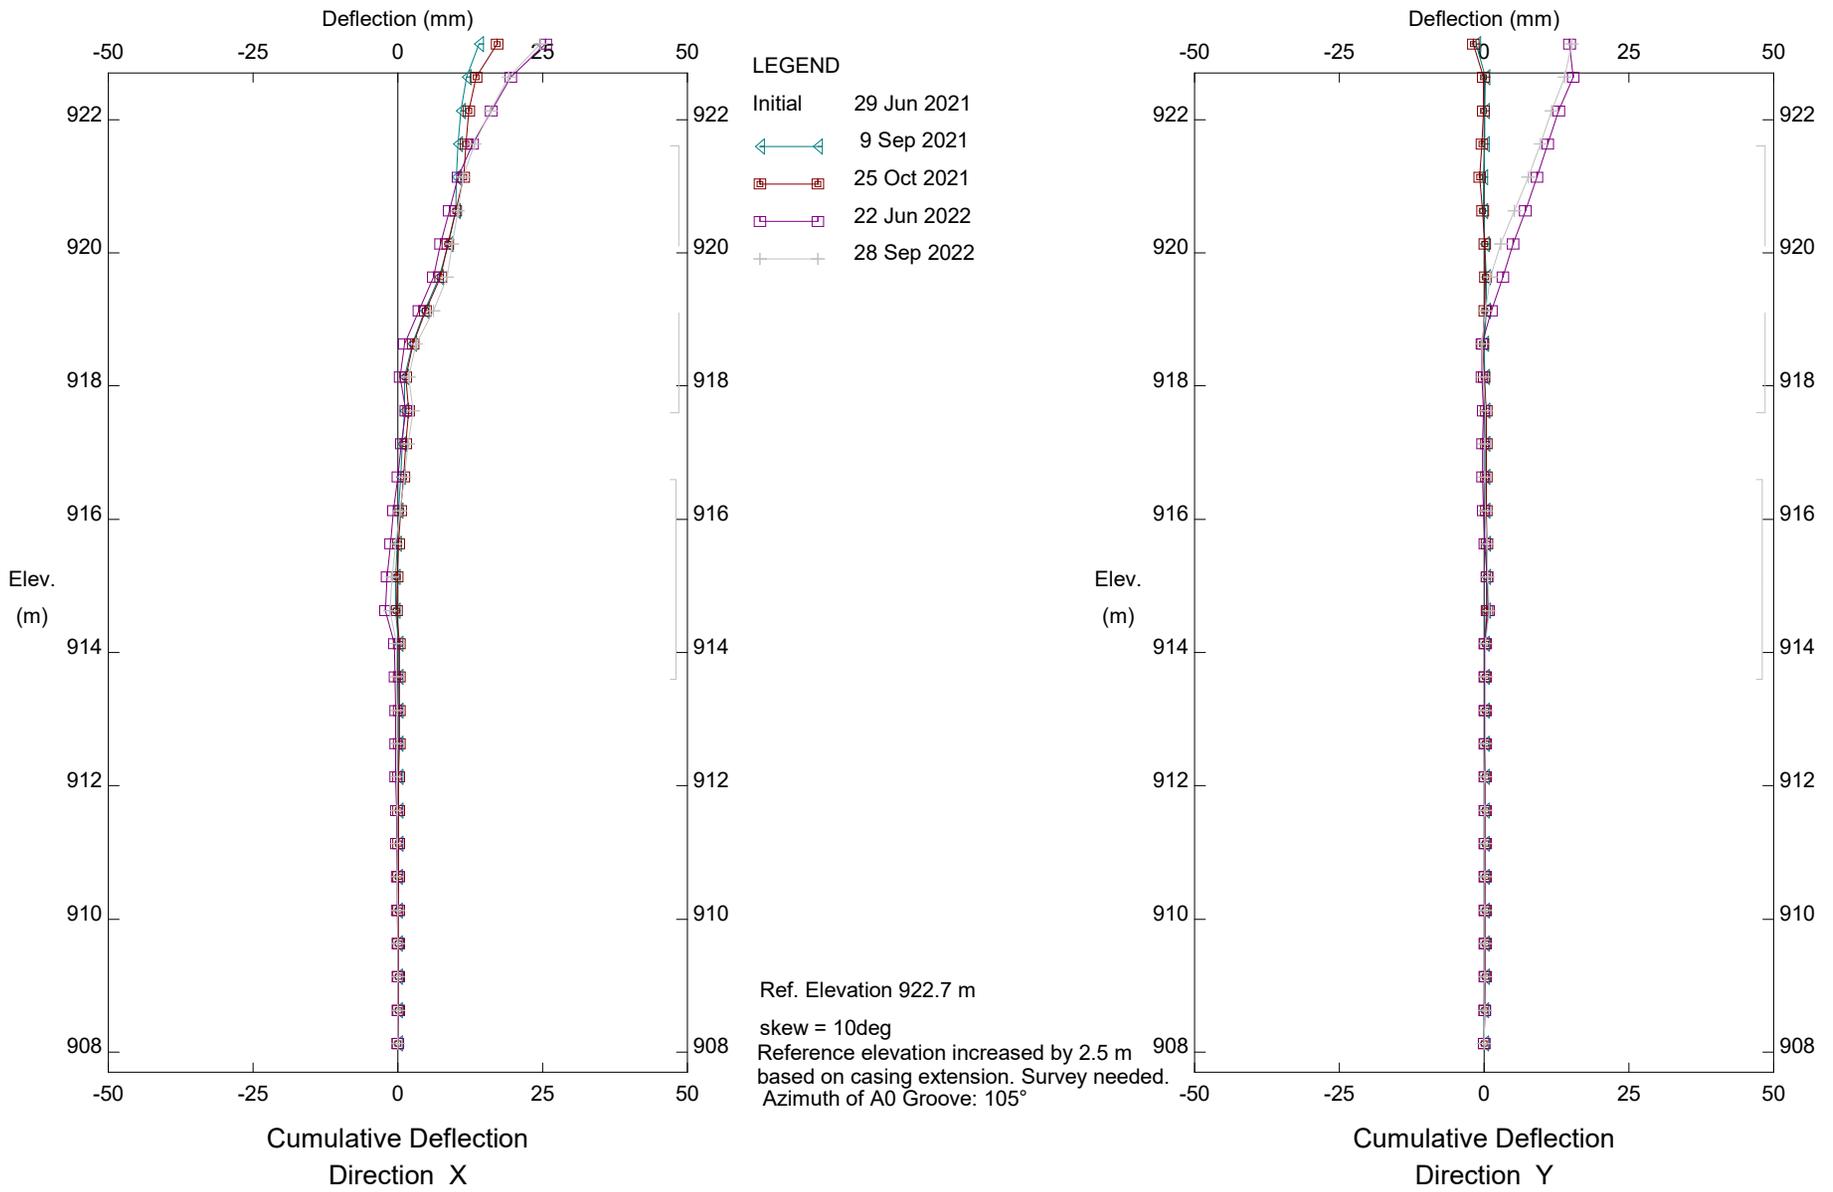
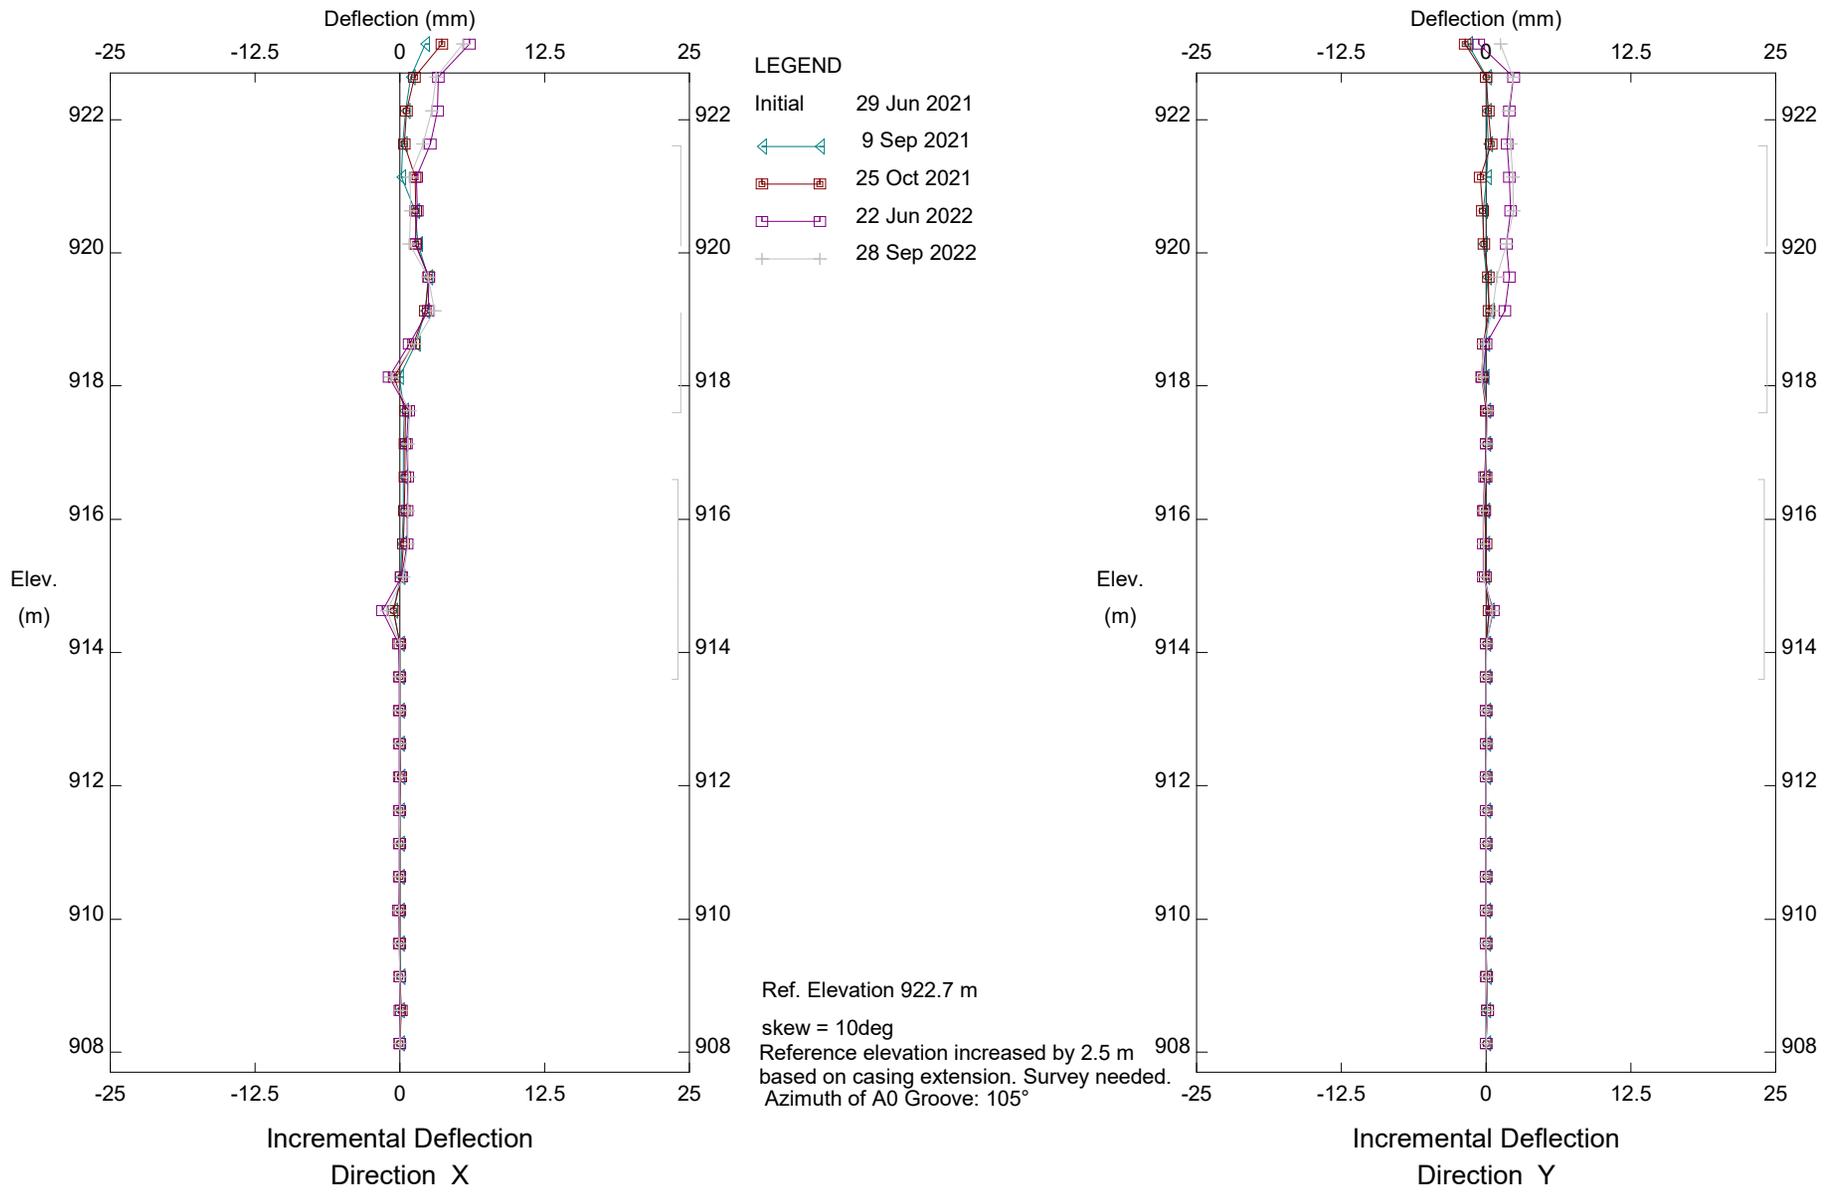
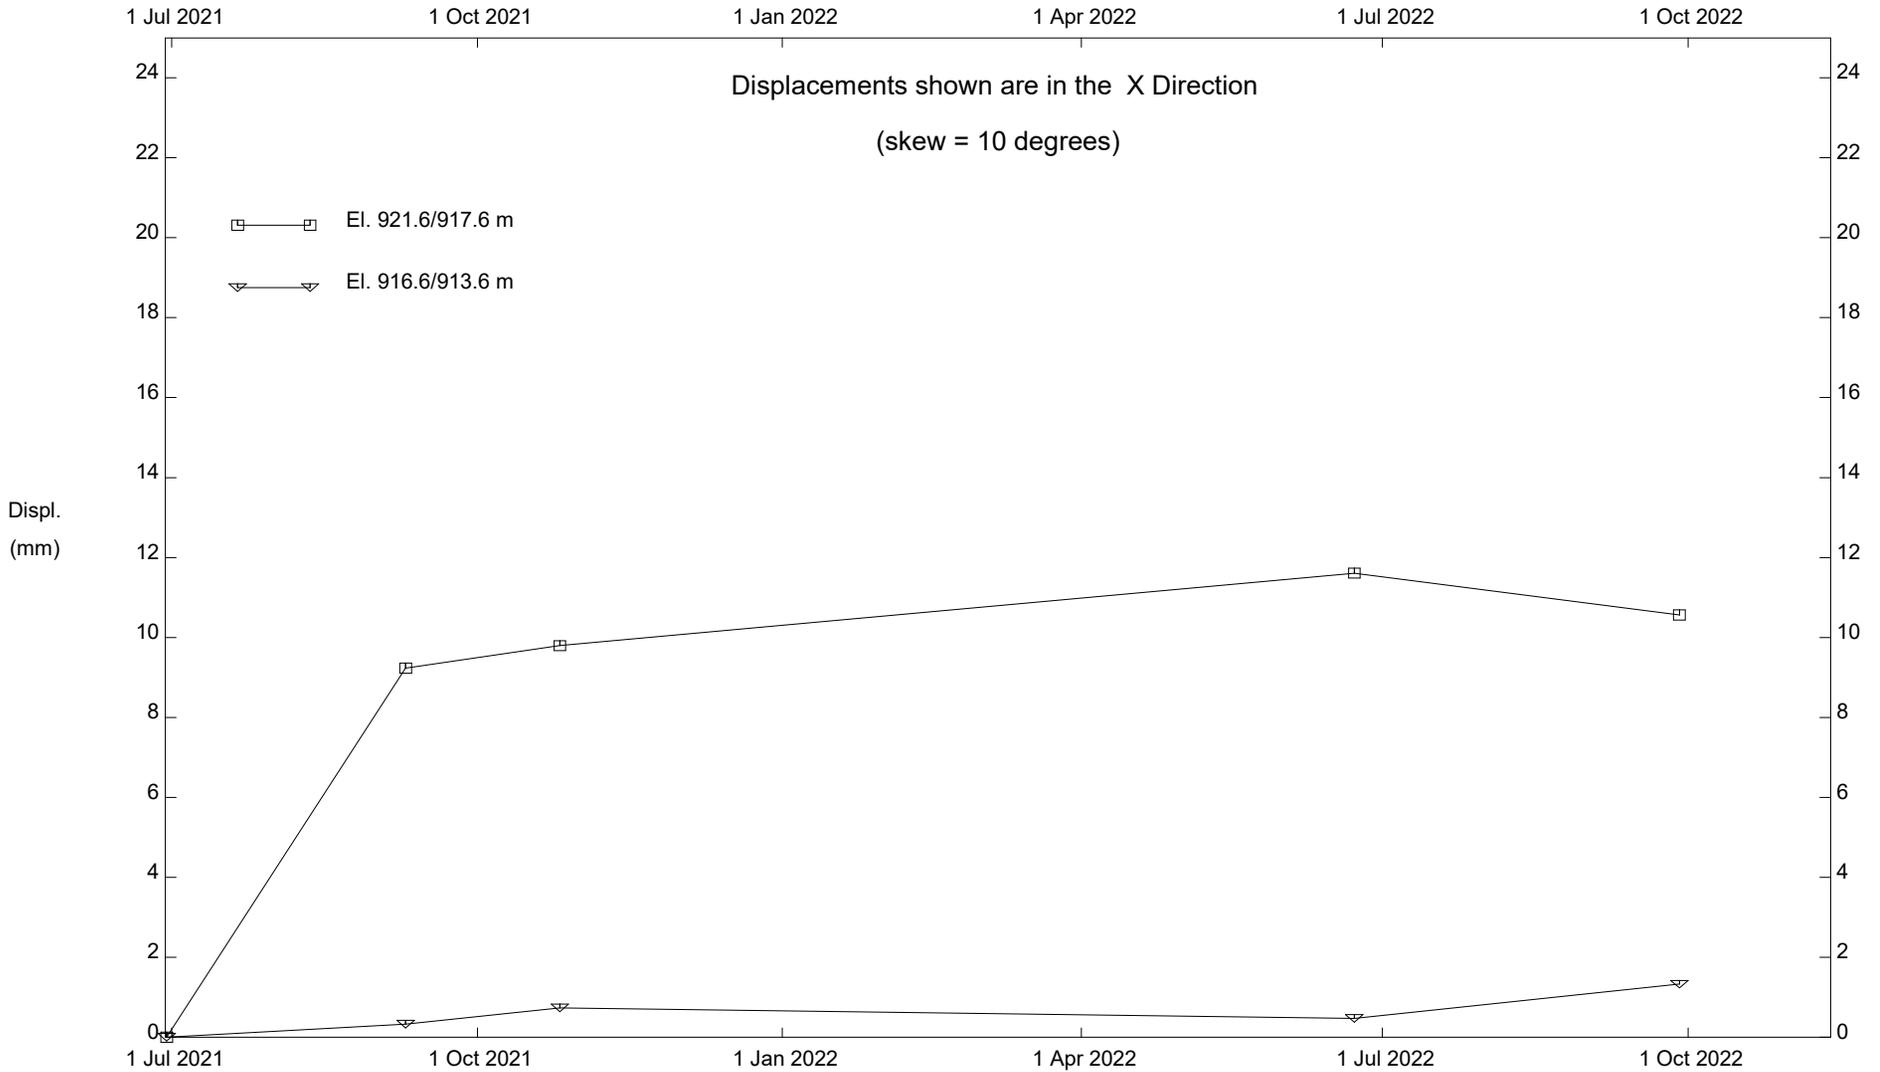
GP006; H40:36, Sheep Creek Embankment, Inclinometer SI-2
Alberta Transportation

- Large deflections that were recorded in the tops of SI-2, SI19-2, and SI19-3 to an approximate depth of 6 m, 3 m, and 4 m below ground surface, respectively. The deflections are likely due to binwall construction in late-2020. It is noted that SI-2 and SI19-2 were shortened to the binwall bench level and then later raised through the binwall fill during construction. It also appears the instruments were raised again after the previous consultant took their last reading in October 2020. The exact length of casing added is unknown but was estimated to be 2.5 m. KCB has subsequently extended the data files for SI-2 and SI19-2 by 2.5 m. The instruments were read to the adjusted depth in June and September 2022 and the data aligns with the new reading depth. Due to the large deflections recorded due to binwall construction, KCB re-initialized the SI data plots to the June 2021 readings.

Distributed movement was being recorded in SI-2 between an approximate depth of 6.1 m and 9.1 m below ground surface. However, due to a large deflection that was recorded in the top 6 m of the SI casing since late 2020, KCB re-initialized the instrument to the June 2021 reading. Since June 2021, distributed movement has been recorded in SI-2 from an approximate depth of 1.1 m to 5.1 m below ground surface (elevation 921.6 m to 917.6 m).

The movement recorded in SI-2, SI19-2, and SI19-3 between October 2020 and June 2021 can most likely be attributed to binwall construction in late-2020. Most notably in SI19-3, where a significant amount of shallow movement (approximately 498 mm) was recorded between October 2020 and June 2021. This shallow movement may be attributed to settlement as the binwall takes up load from the highway embankment, as well as deflection of the above-ground casing, since a casing protector was not installed on these instruments until fall 2022. Since the SIs were re-initialized to the June 2021 readings, approximately 12 mm and 61 mm of shallow movement has been recorded in SI-2 and SI19-3, respectively.

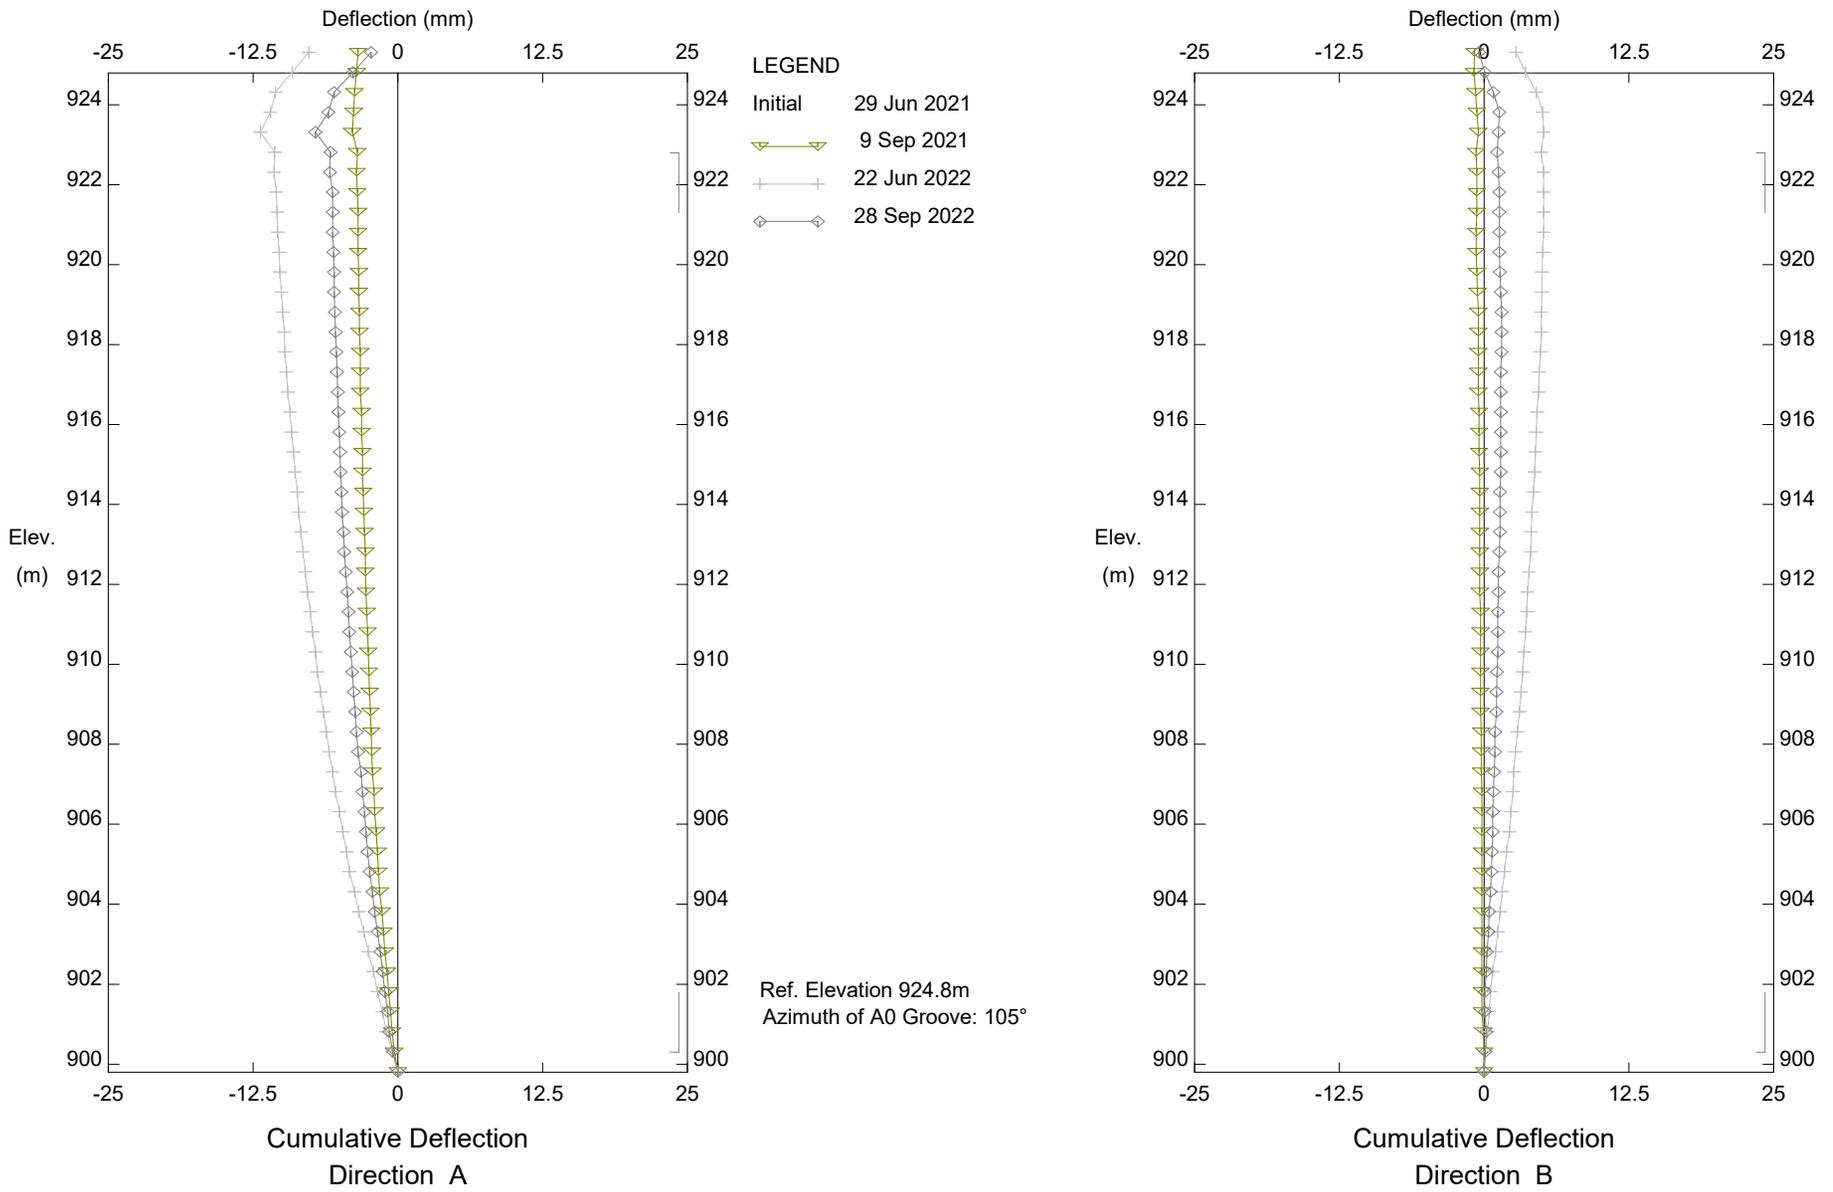
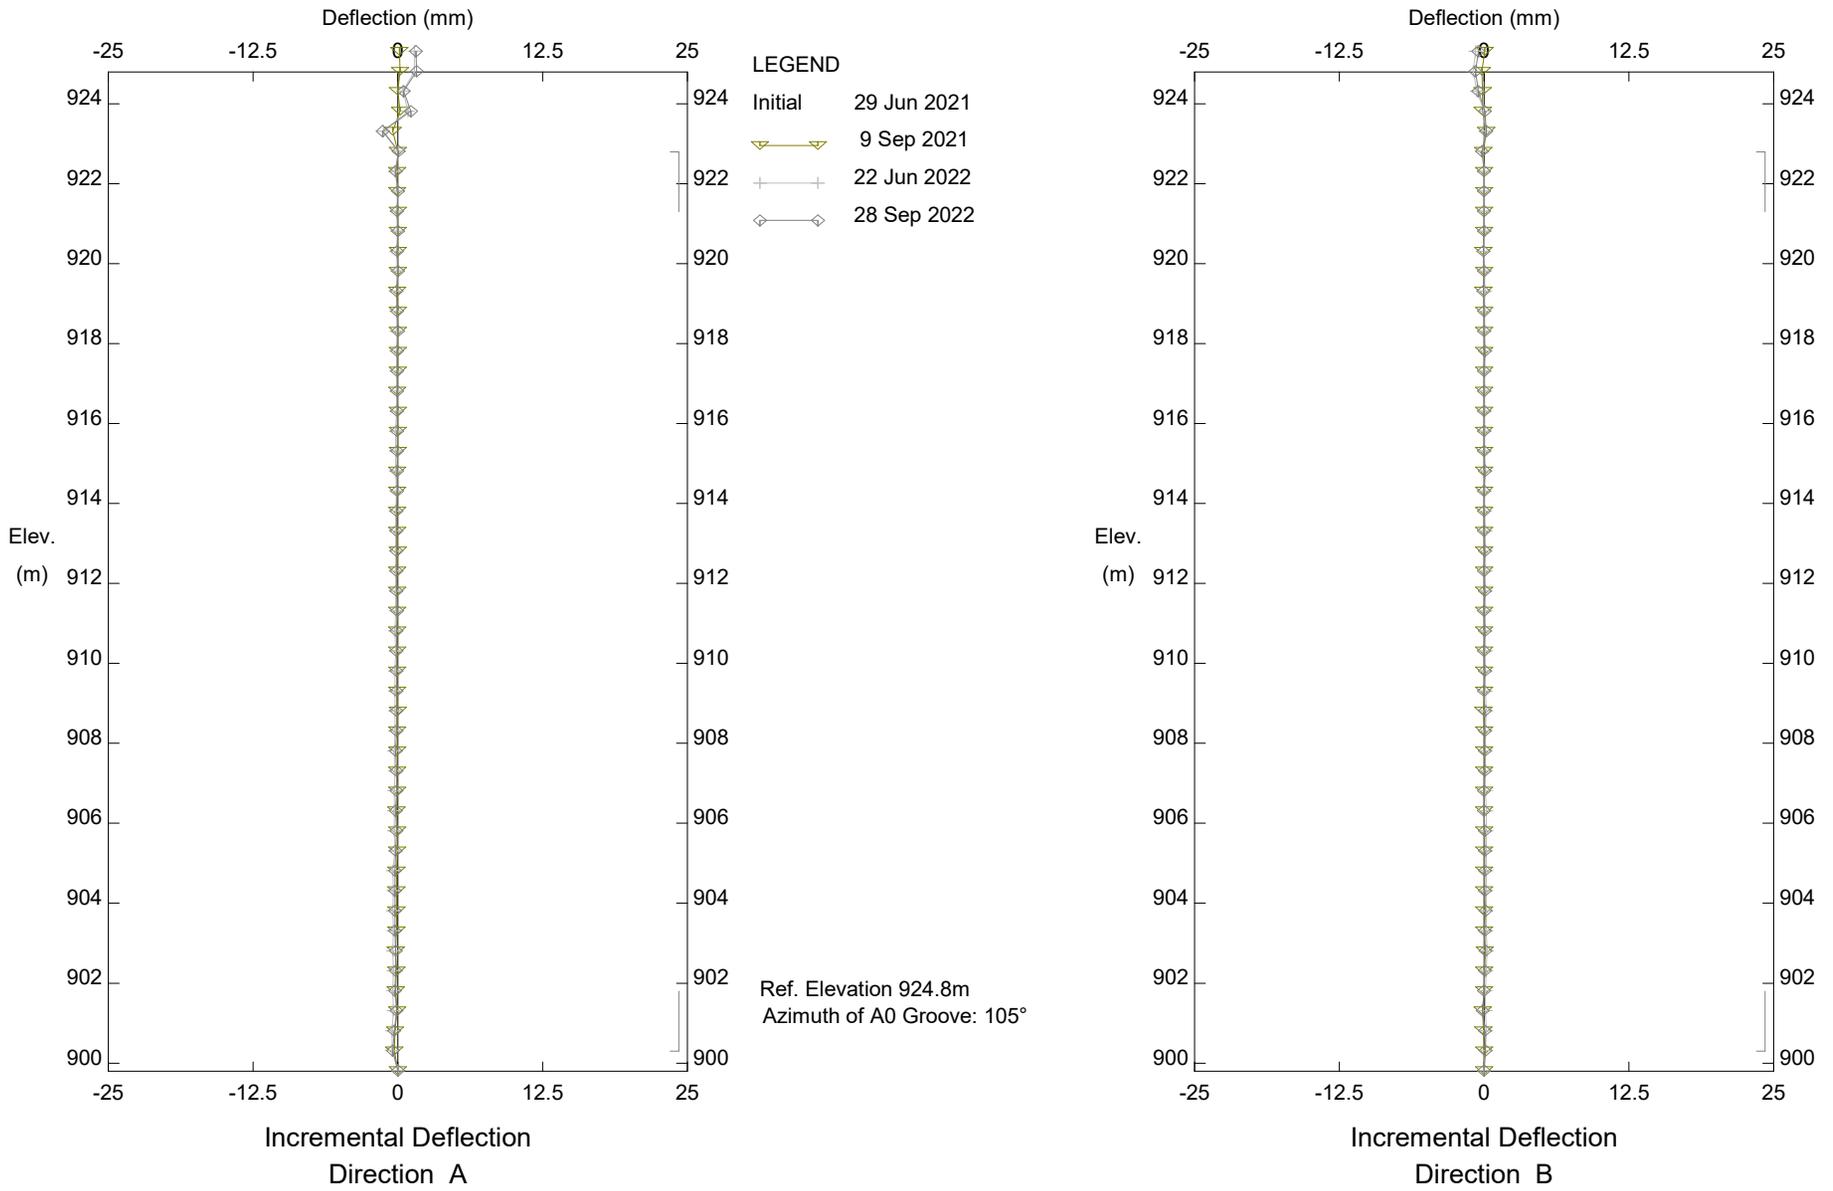
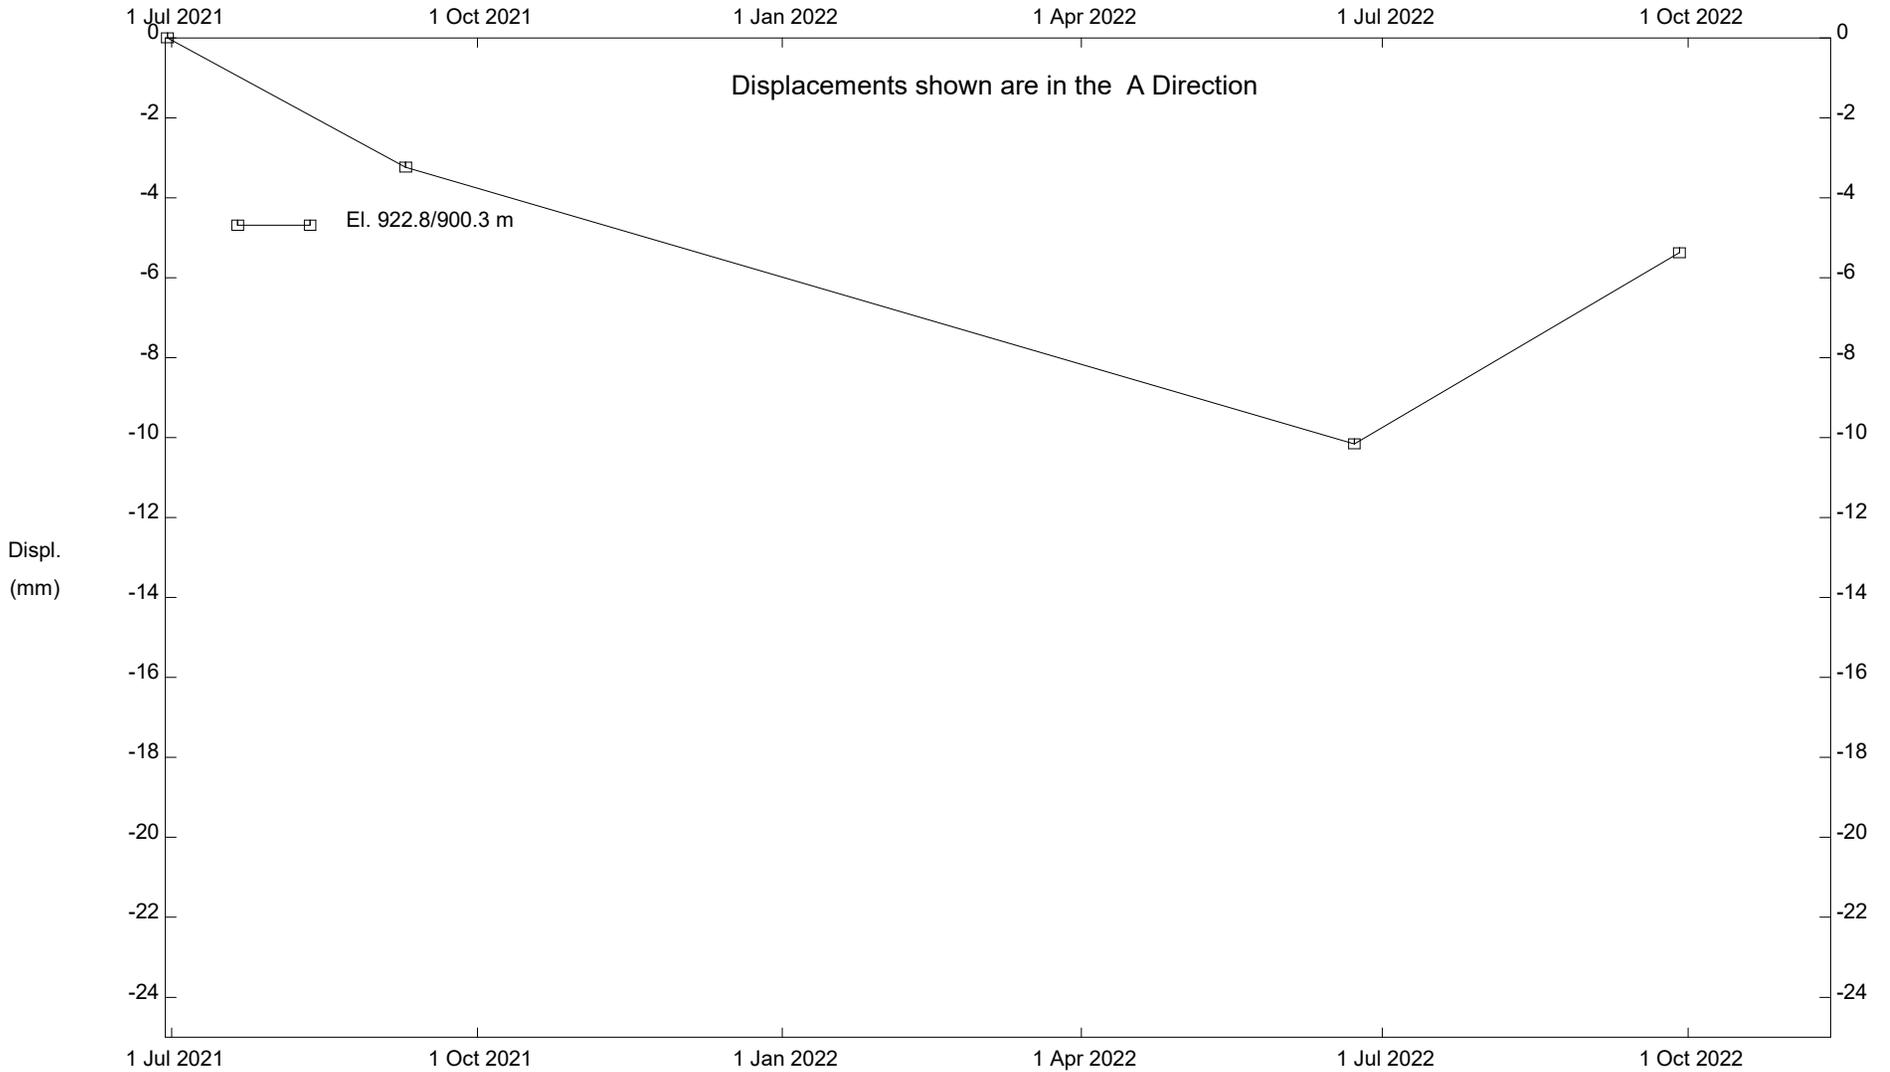
GP006; H40:36, Sheep Creek Embankment, Inclinometer SI19-1
Alberta Transportation

Distributed movement from top to bottom of casing has been recorded in SI19-1 since installation. This movement could be due to the SI not being installed deep enough or installed on enough of an angle (i.e., tilt) that complicates processing of the SI data. Based on the absolute plot for this instrument, it is tilted approximately 0.7 m and 1.5 m in the A- and B-directions, respectively.

Between the October 2021 and September 2022, negative distributed displacement has been recorded in SI19-1 and SI19-2 (from an approximate depth of 2 m and 3 m below ground surface, respectively, to bottom of casing). This movement could be due to the SI not being installed deep enough or installed on enough of an angle (i.e., tilt) that complicates processing of the SI data, which may have attributed to the discrepancy between the June and September 2022 data, or post-installation settlement/flexure of the SI casing. More data is needed to assess these movement in SI19-1 and SI19-2 to assess if these instruments need to be re-initialized.
