November 30, 2022

Alberta Transportation
Main Floor, Provincial Building
9621 – 96th Avenue
Peace River, Alberta
T8S 1T4

CON0022166 Peace Region (Grande Prairie District – South) GRMP Instrumentation Monitoring Site GP006; H40:36, km 21.779 Sheep Creek Embankment (Three Teardrops Slide) Section C – 2022 Fall Readings

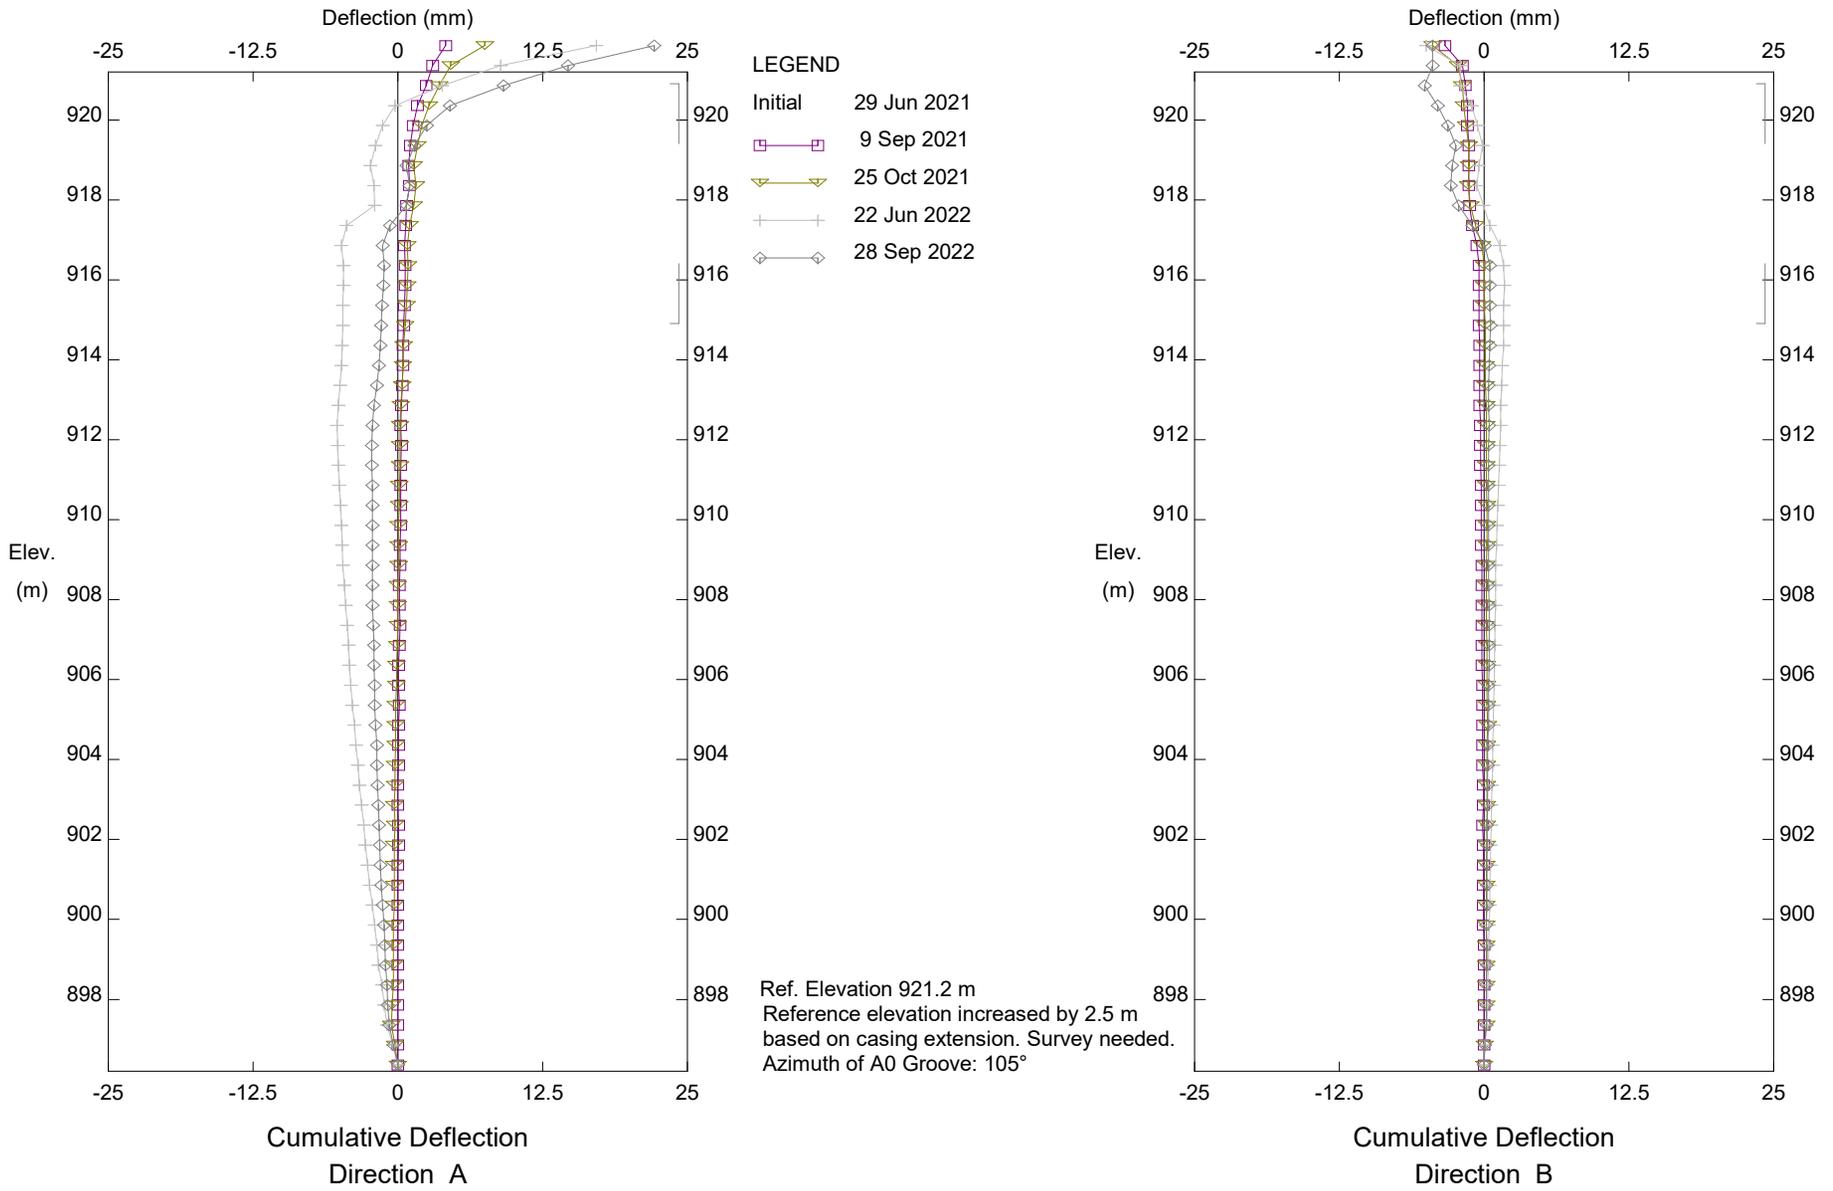
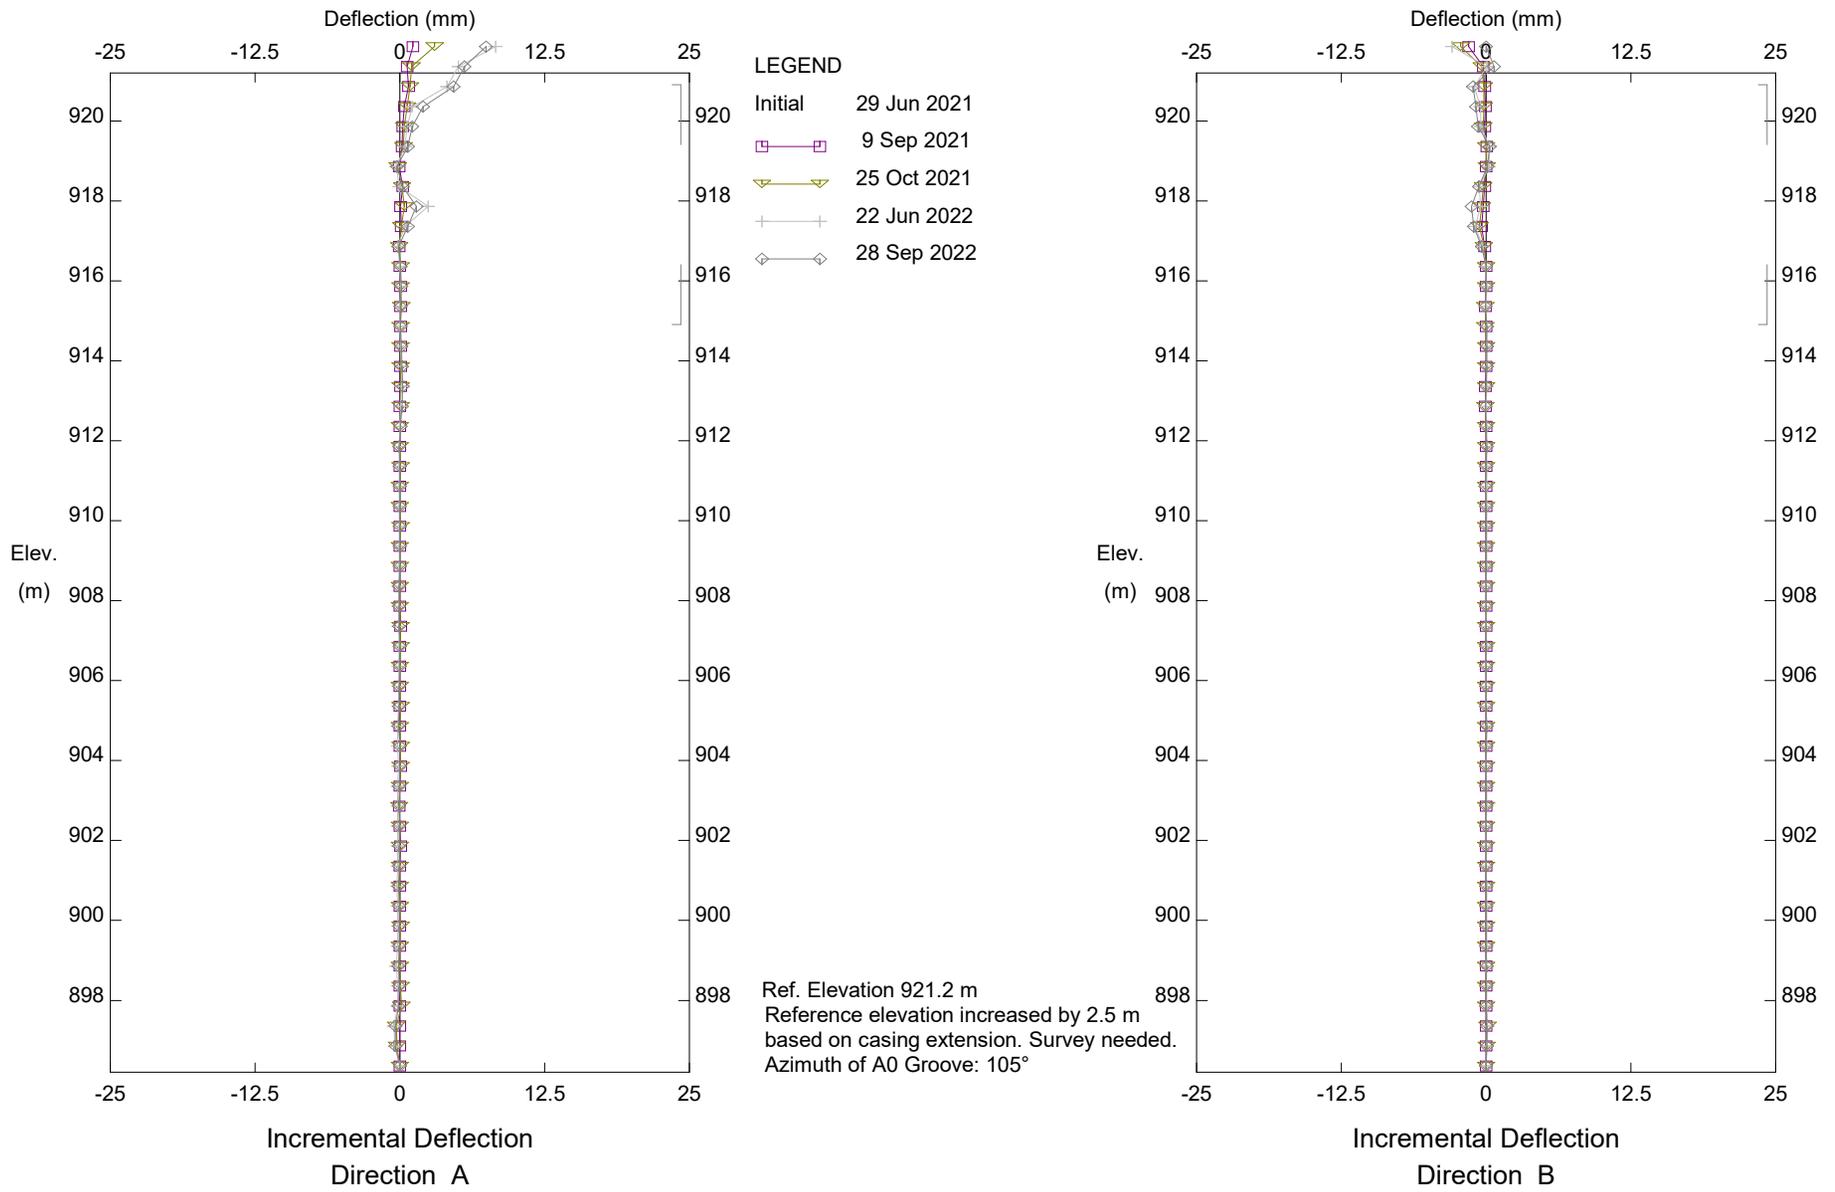
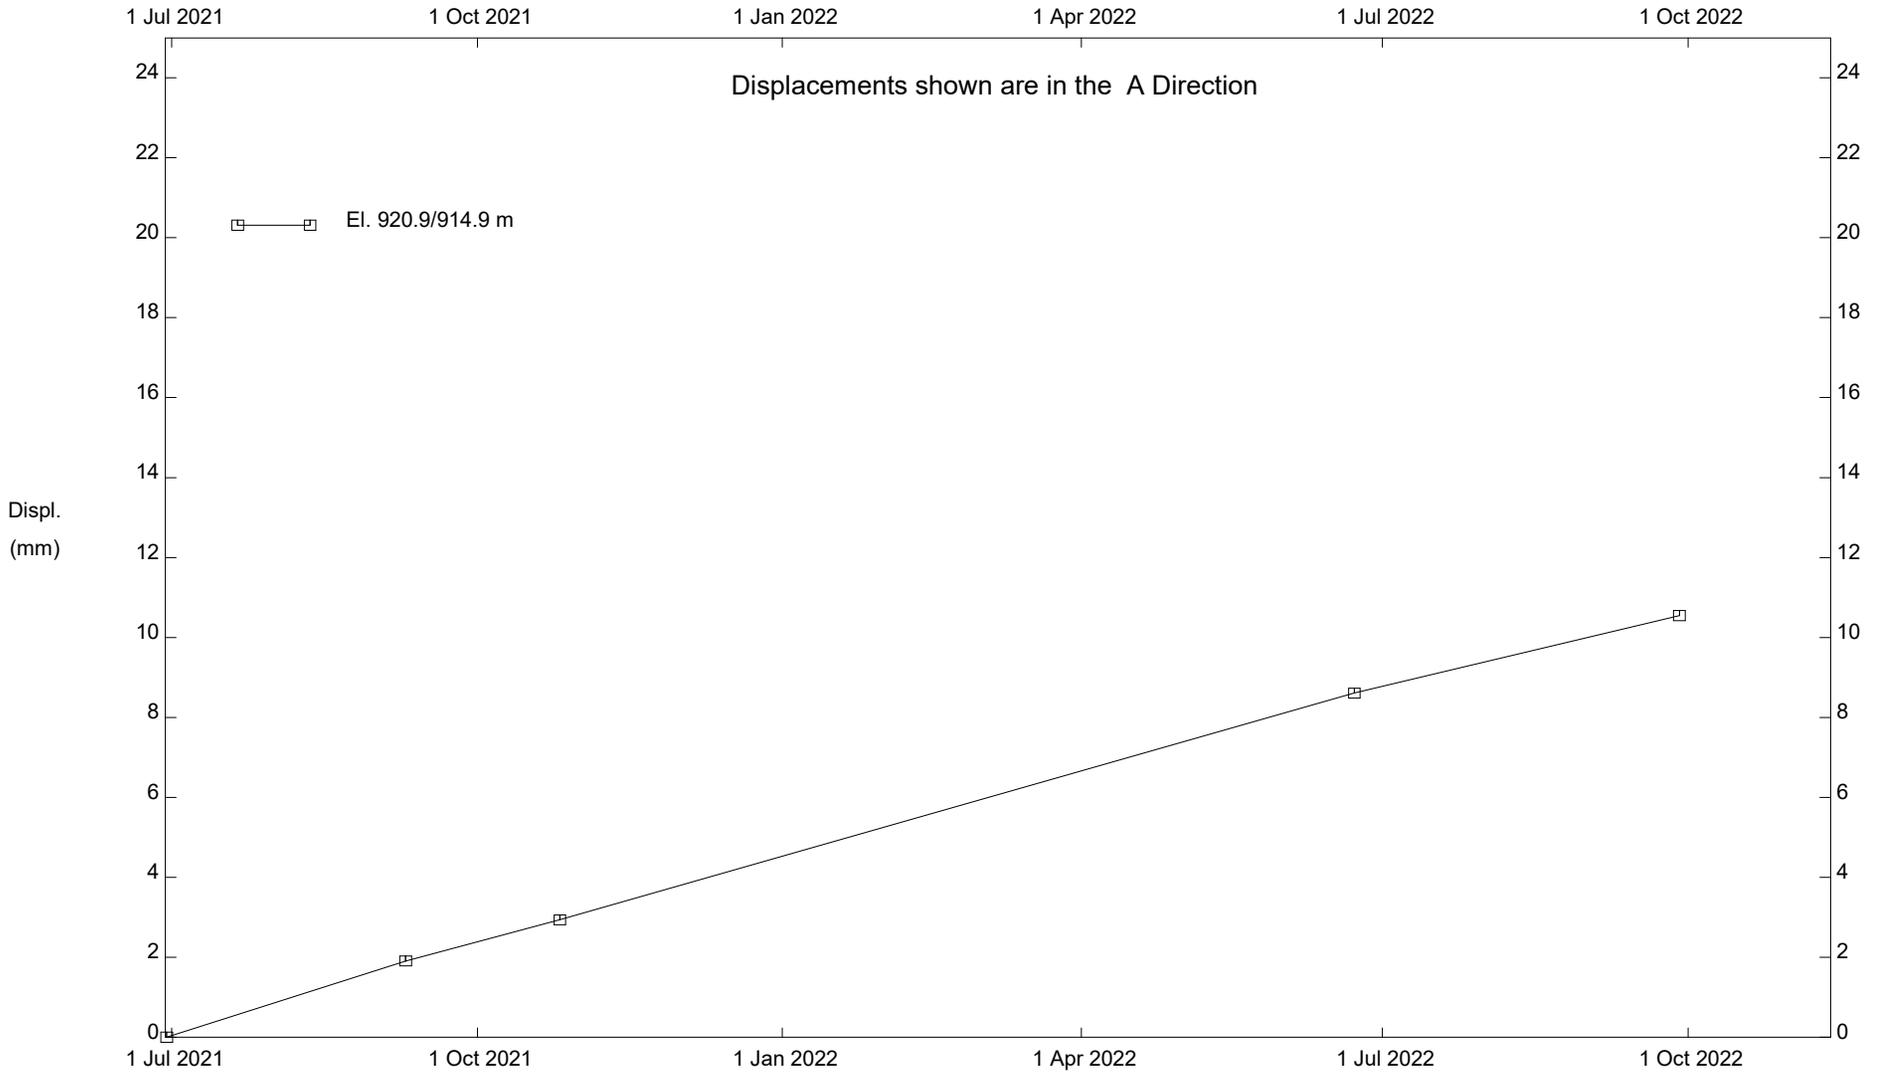
GP006; H40:36, Sheep Creek Embankment, Inclinator SI19-2
 Alberta Transportation

No discernible movement had previously (i.e., before binwall construction) been recorded in SI19-2 or SI19-3. However, since construction, large deflections have been recorded in the tops of these instruments to an approximate depth of 3 m and 2 m below ground surface, respectively. These large

deflections are believed to have been caused by cutting back (lowering) and raising the instrument casing during construction. Due to the large deflections recorded due to binwall construction, KCB re-initialized the SI data plots to the June 2021 readings.

Between October 2021 and September 2022, distributed movement has been recorded in SI19-2 from an approximate depth of 3 m below ground surface to bottom of casing. This movement could be due to the SI not being installed deep enough or installed on enough of an angle (i.e., tilt) that complicates processing of the SI data. Based on the absolute plot for this instrument, it is tilted approximately 0.9 m and 2.5 m in the A- and B-directions, respectively.

Between the October 2021 and September 2022, negative distributed displacement has been recorded in SI19-1 and SI19-2 (from an approximate depth of 2 m and 3 m below ground surface, respectively, to bottom of casing). This movement could be due to the SI not being installed deep enough or installed on enough of an angle (i.e., tilt) that complicates processing of the SI data, which may have attributed to the discrepancy between the June and September 2022 data, or post-installation settlement/flexure of the SI casing. More data is needed to assess these movement in SI19-1 and SI19-2 to assess if these instruments need to be re-initialized.

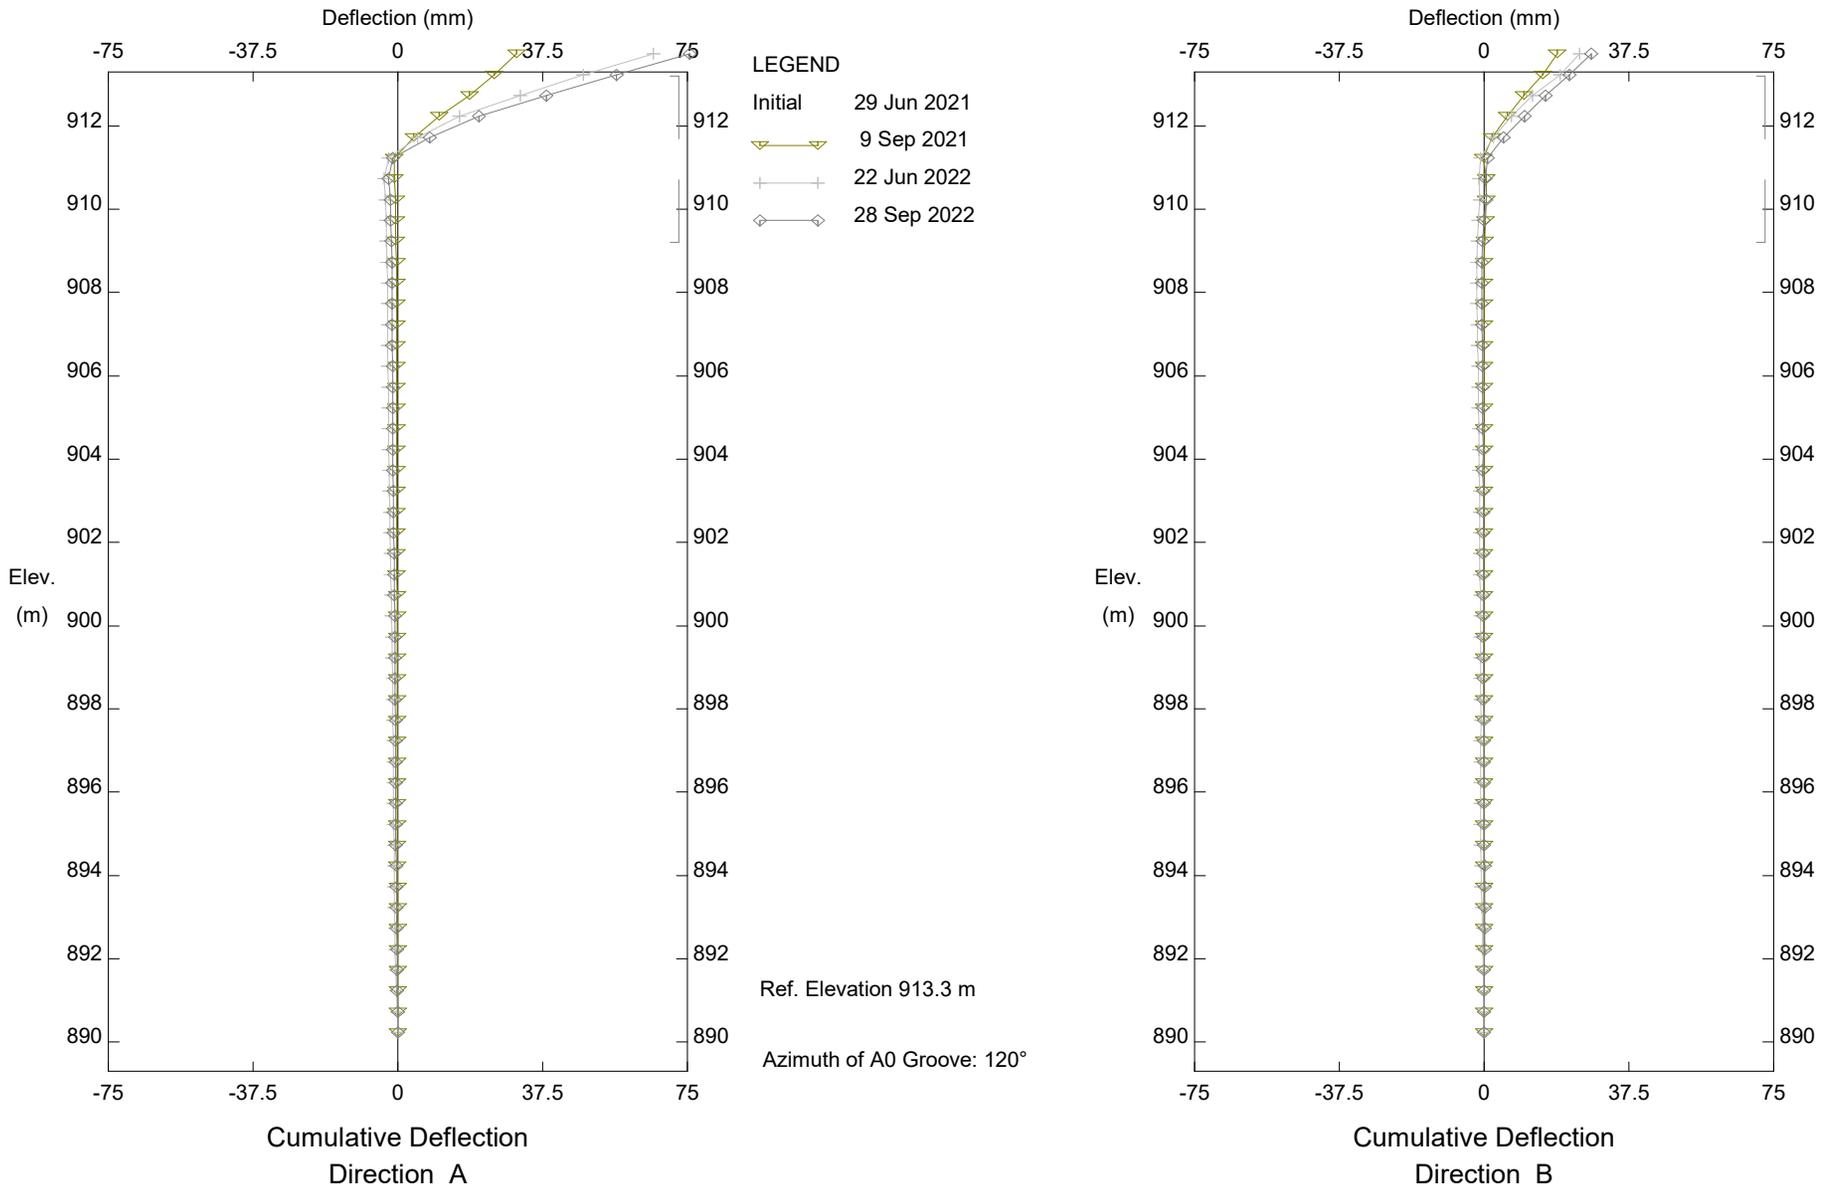
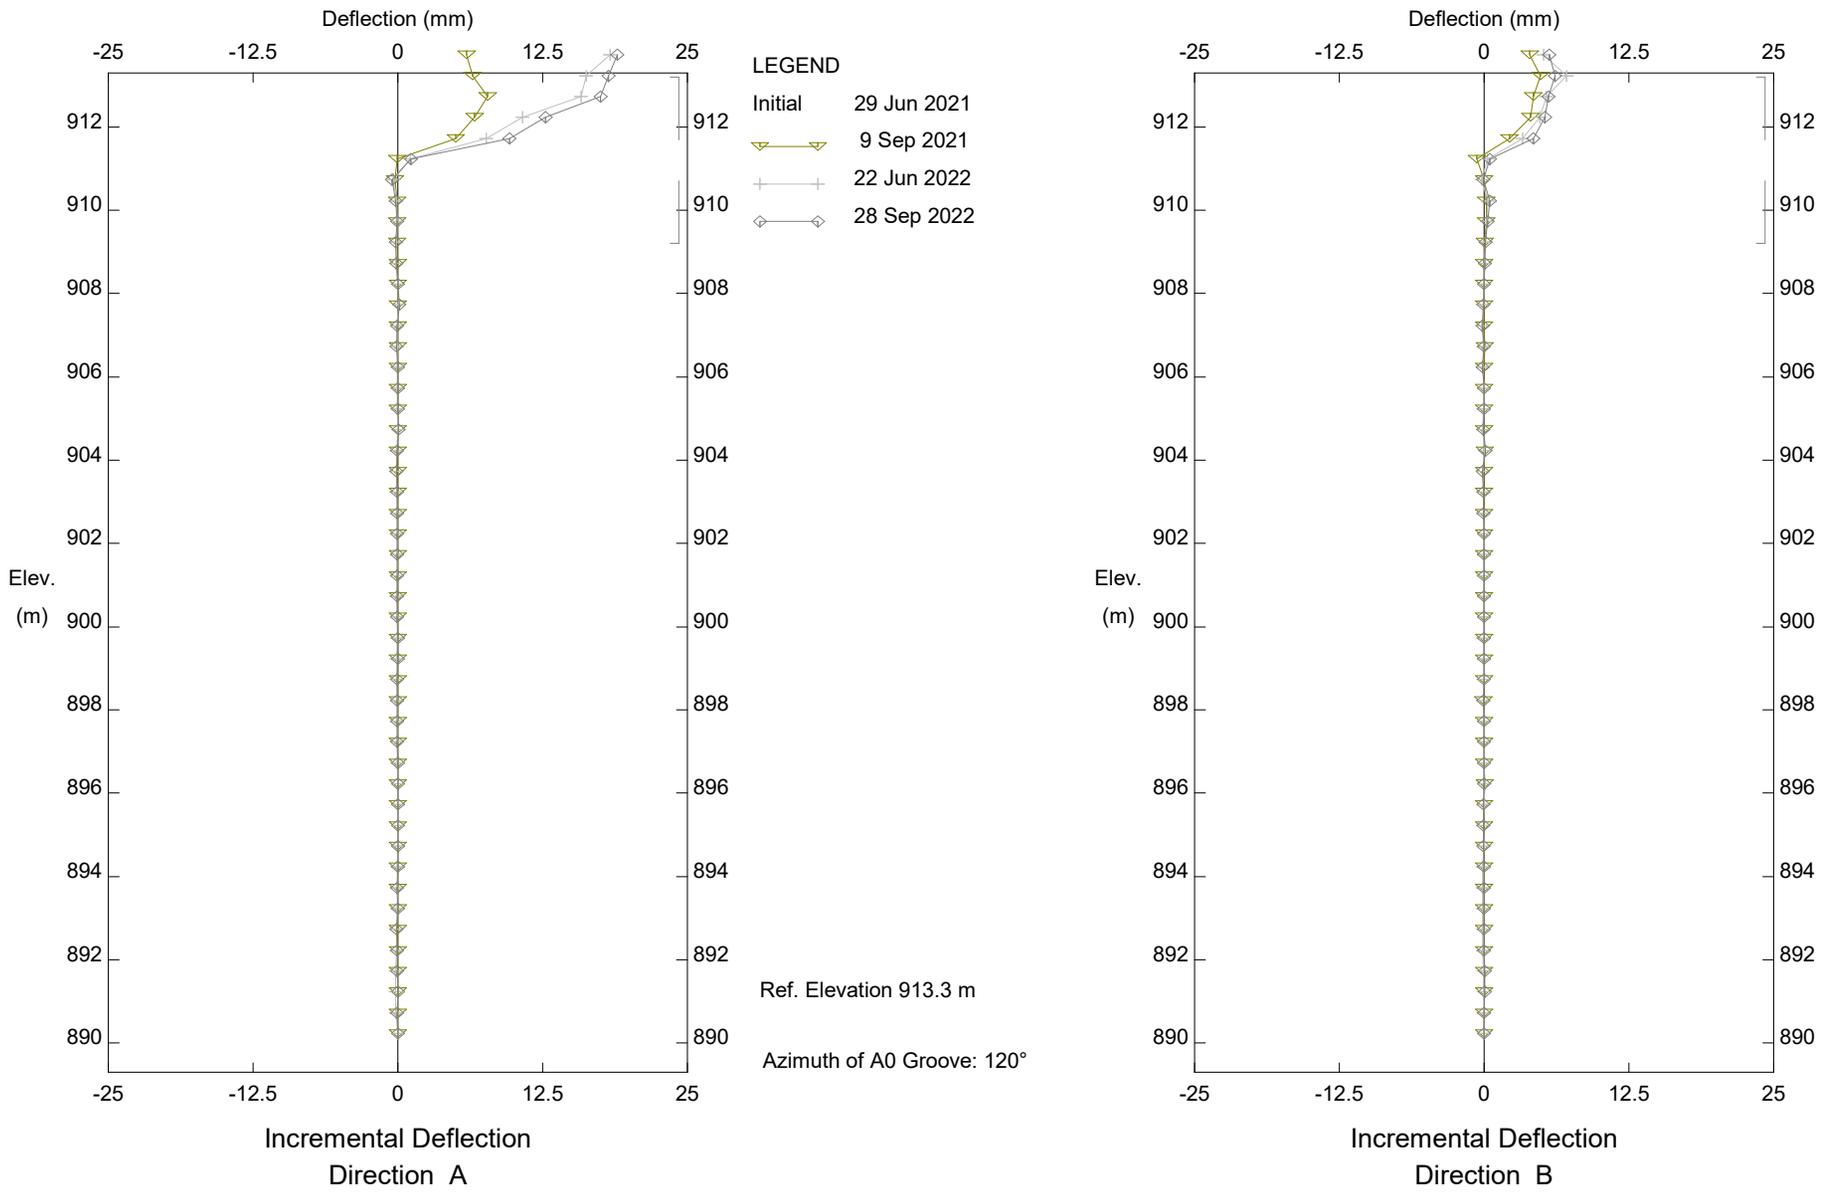
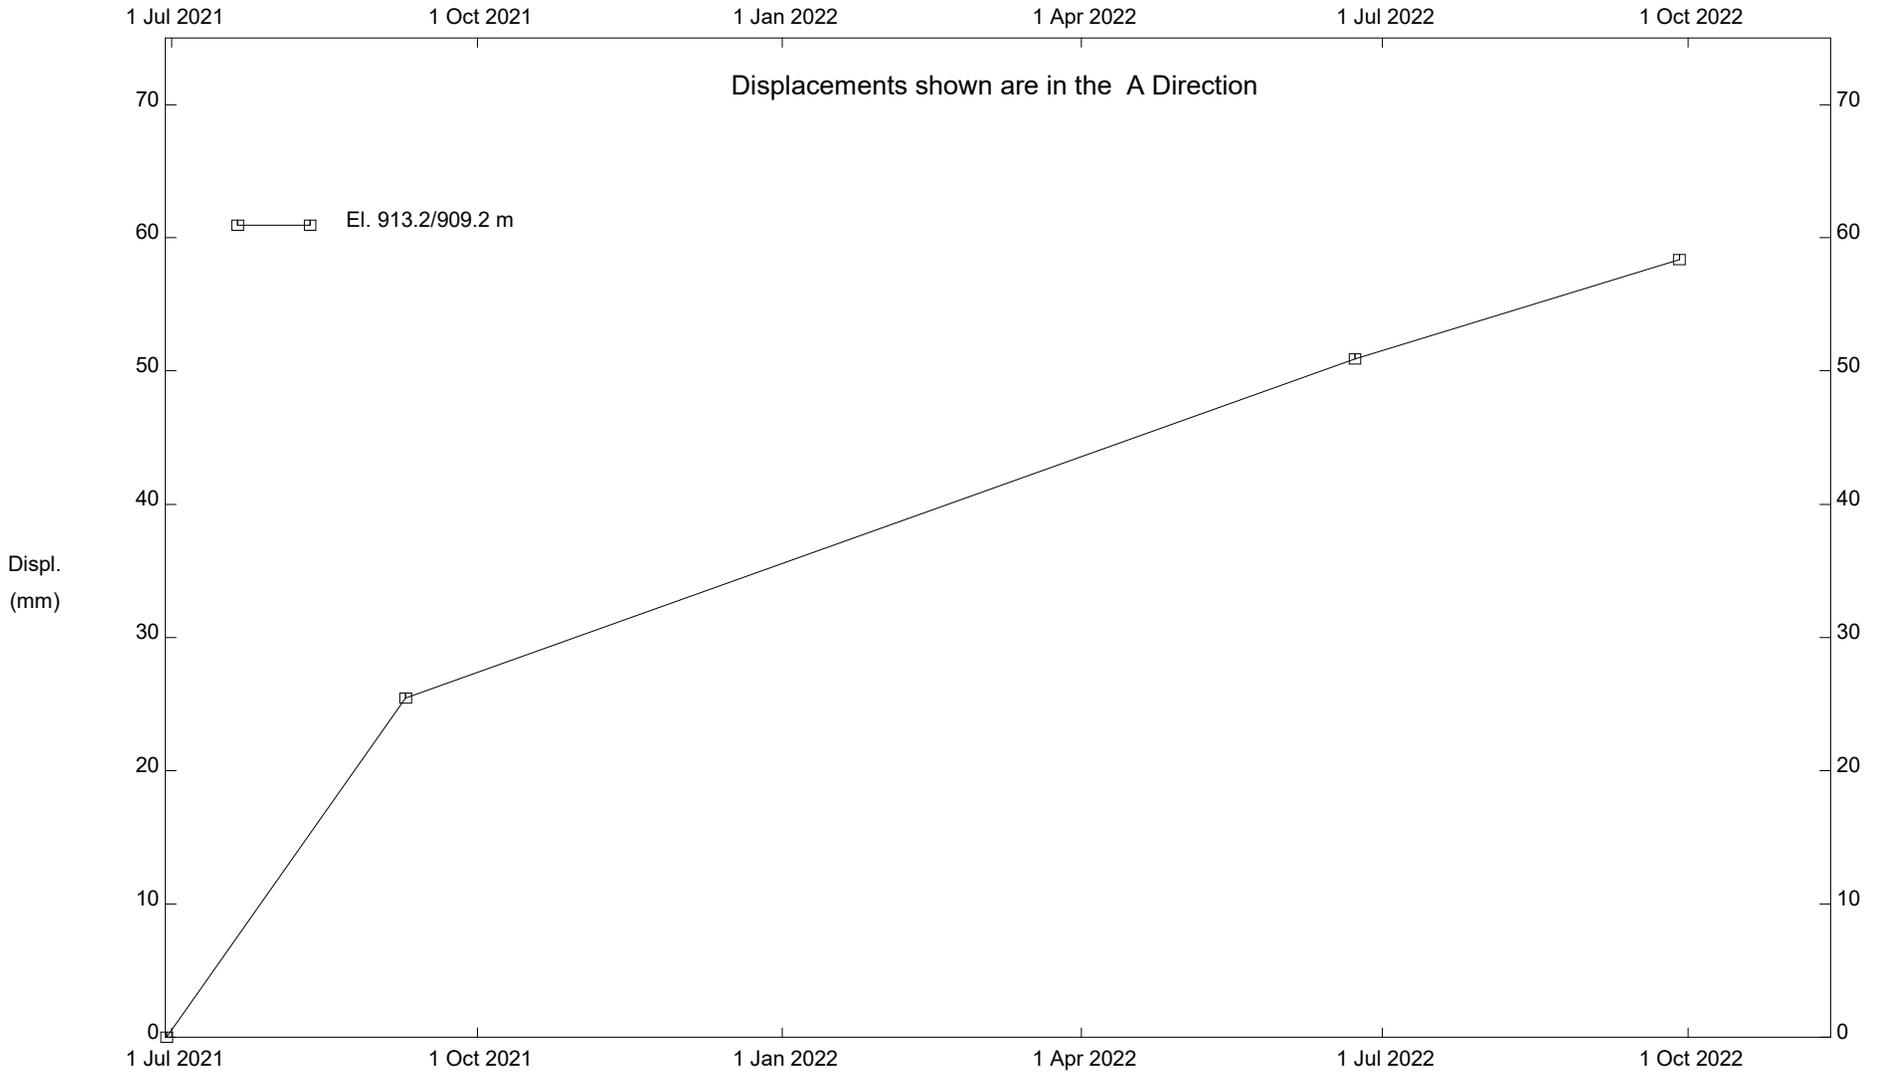
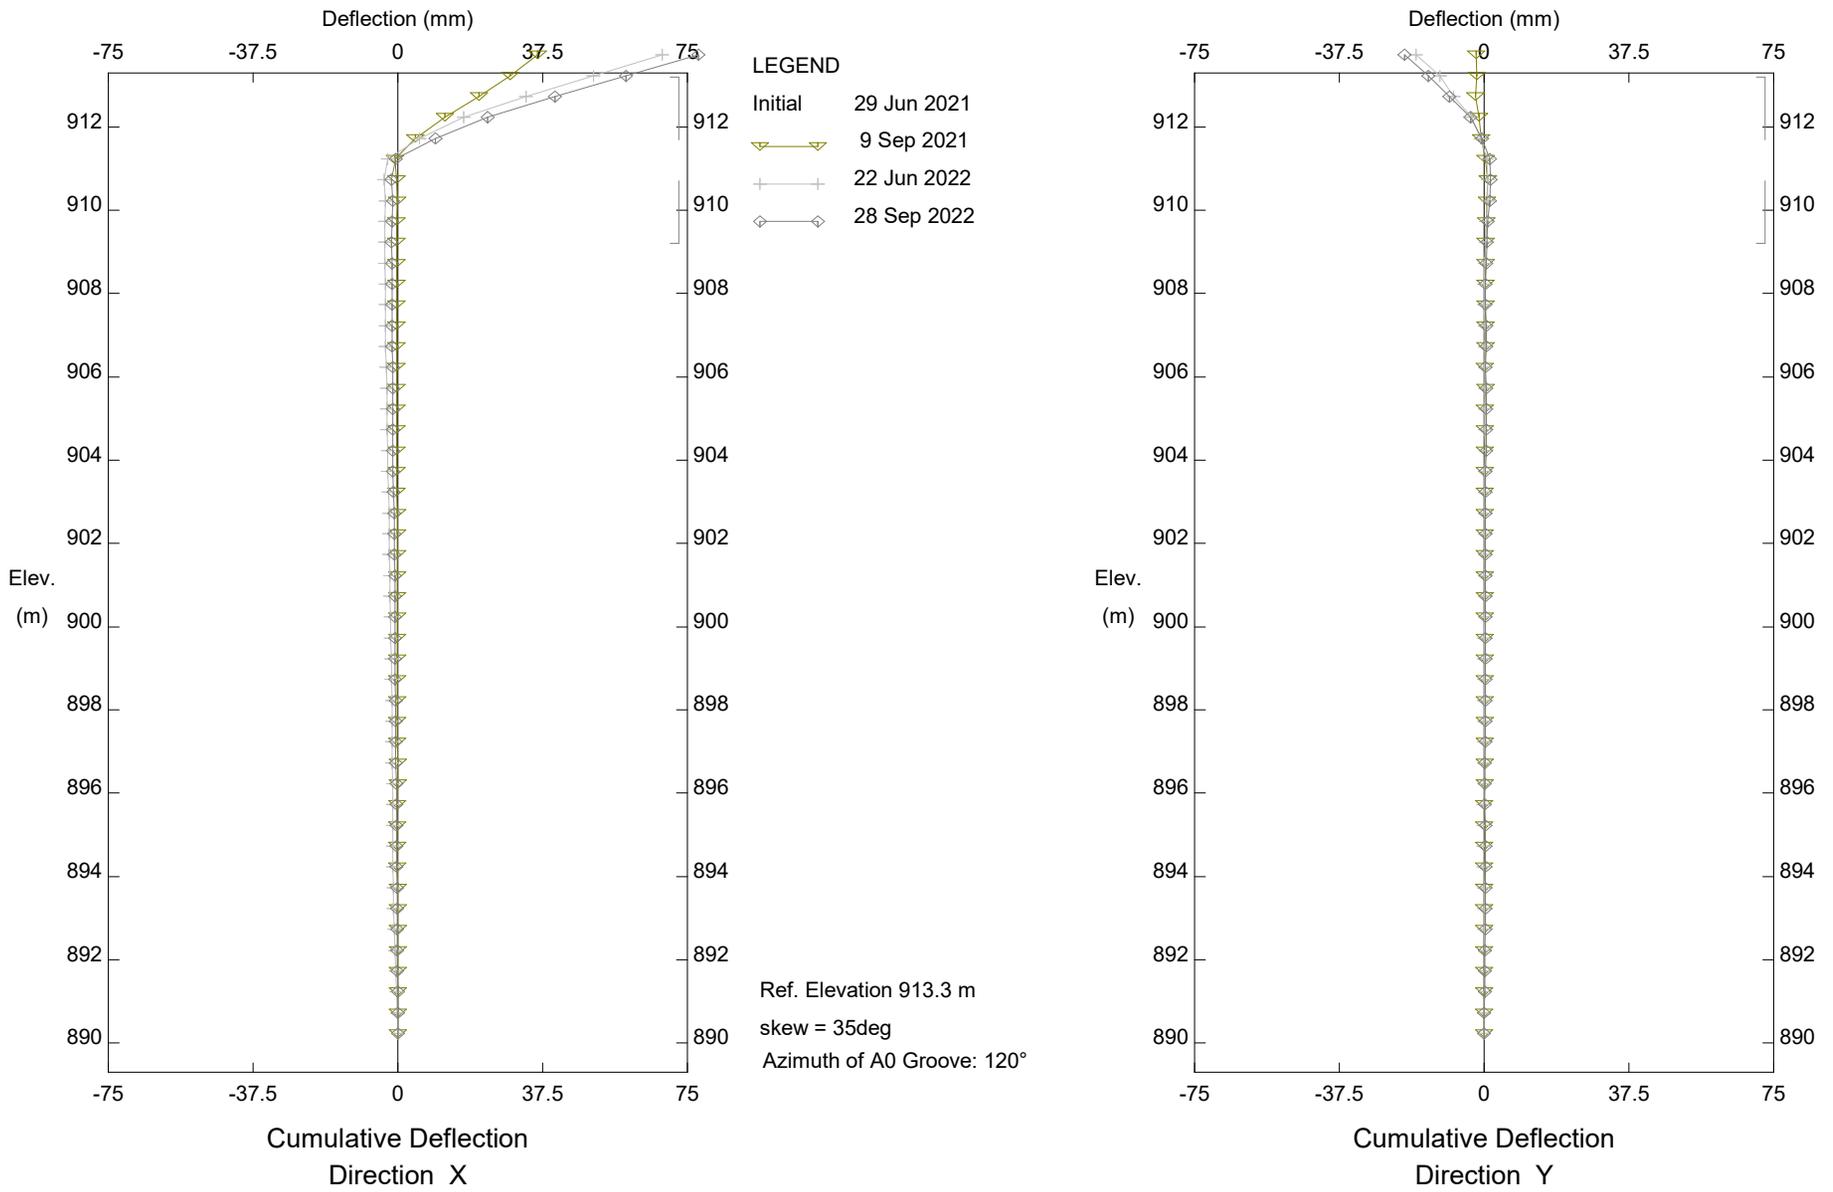
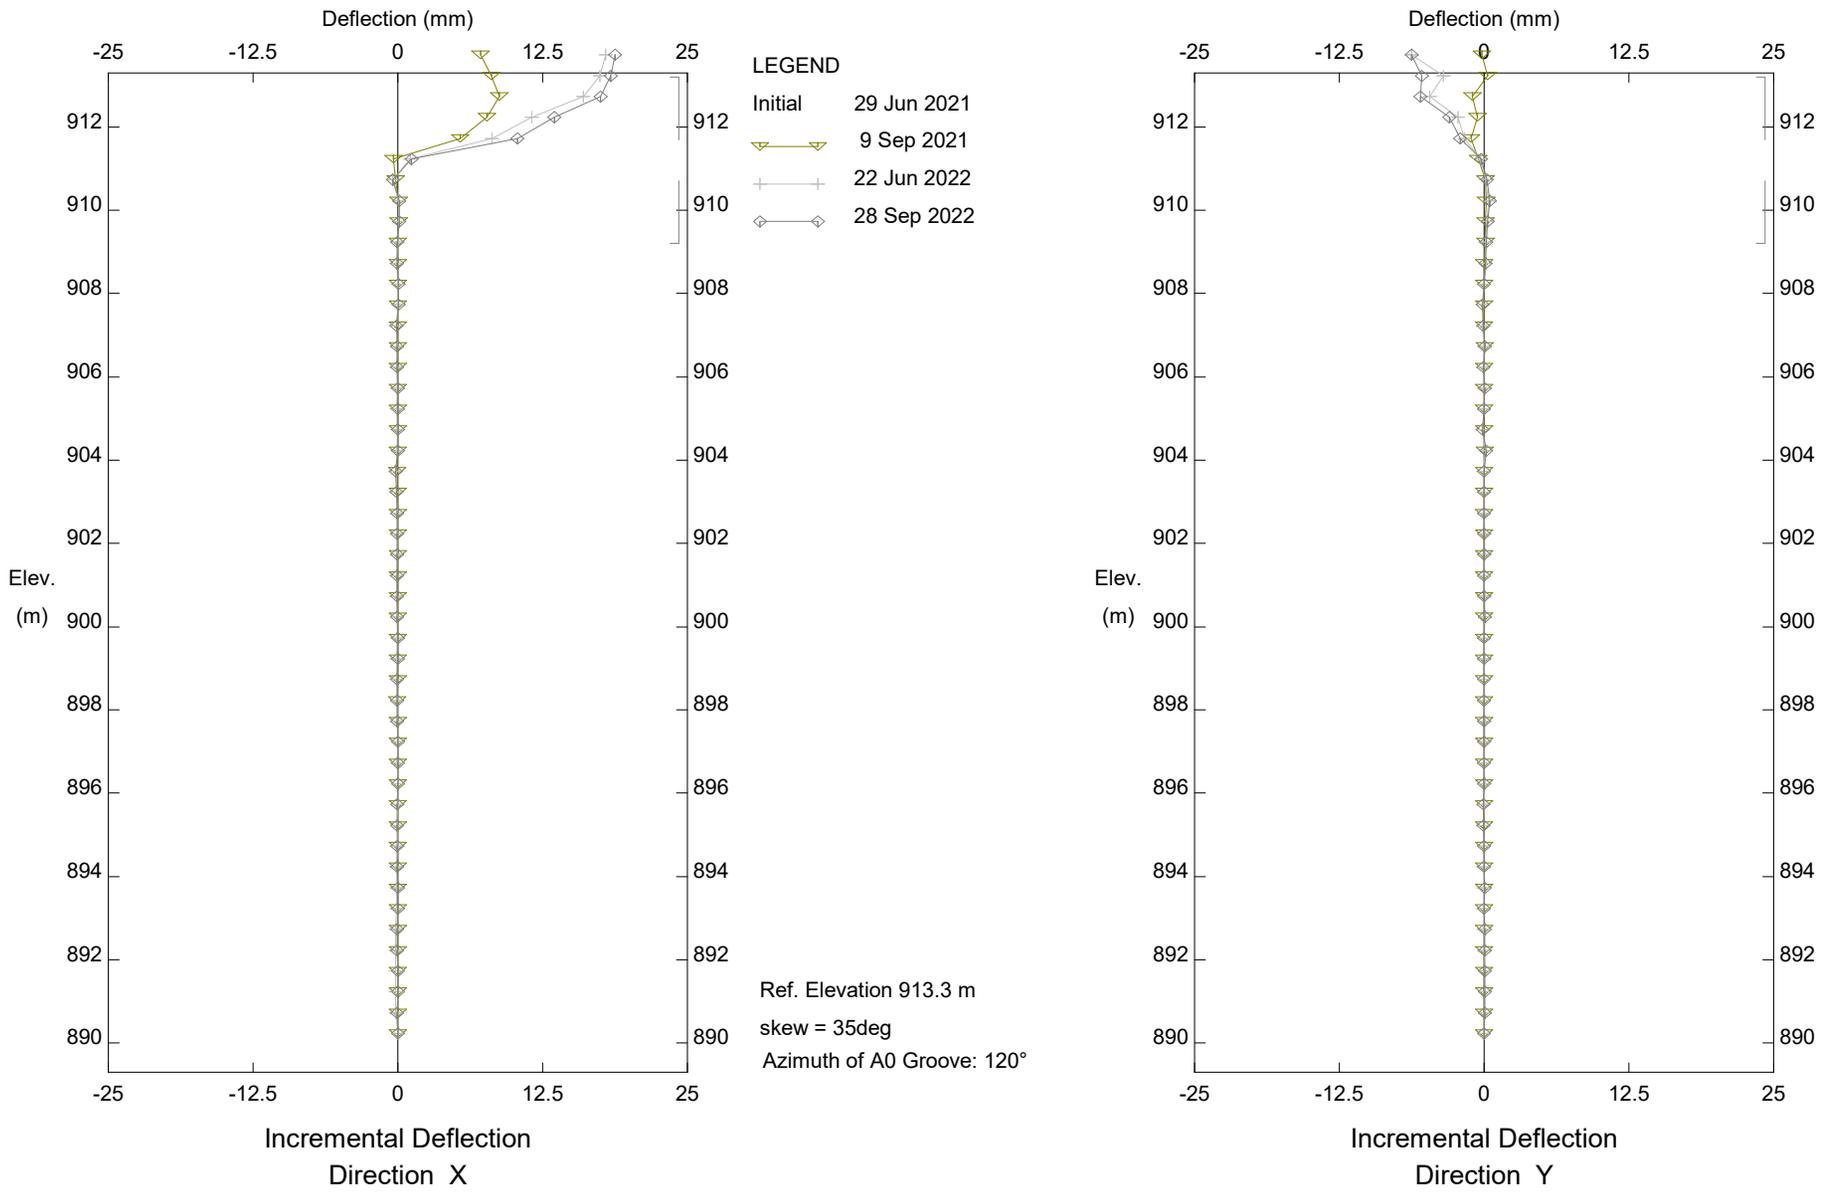
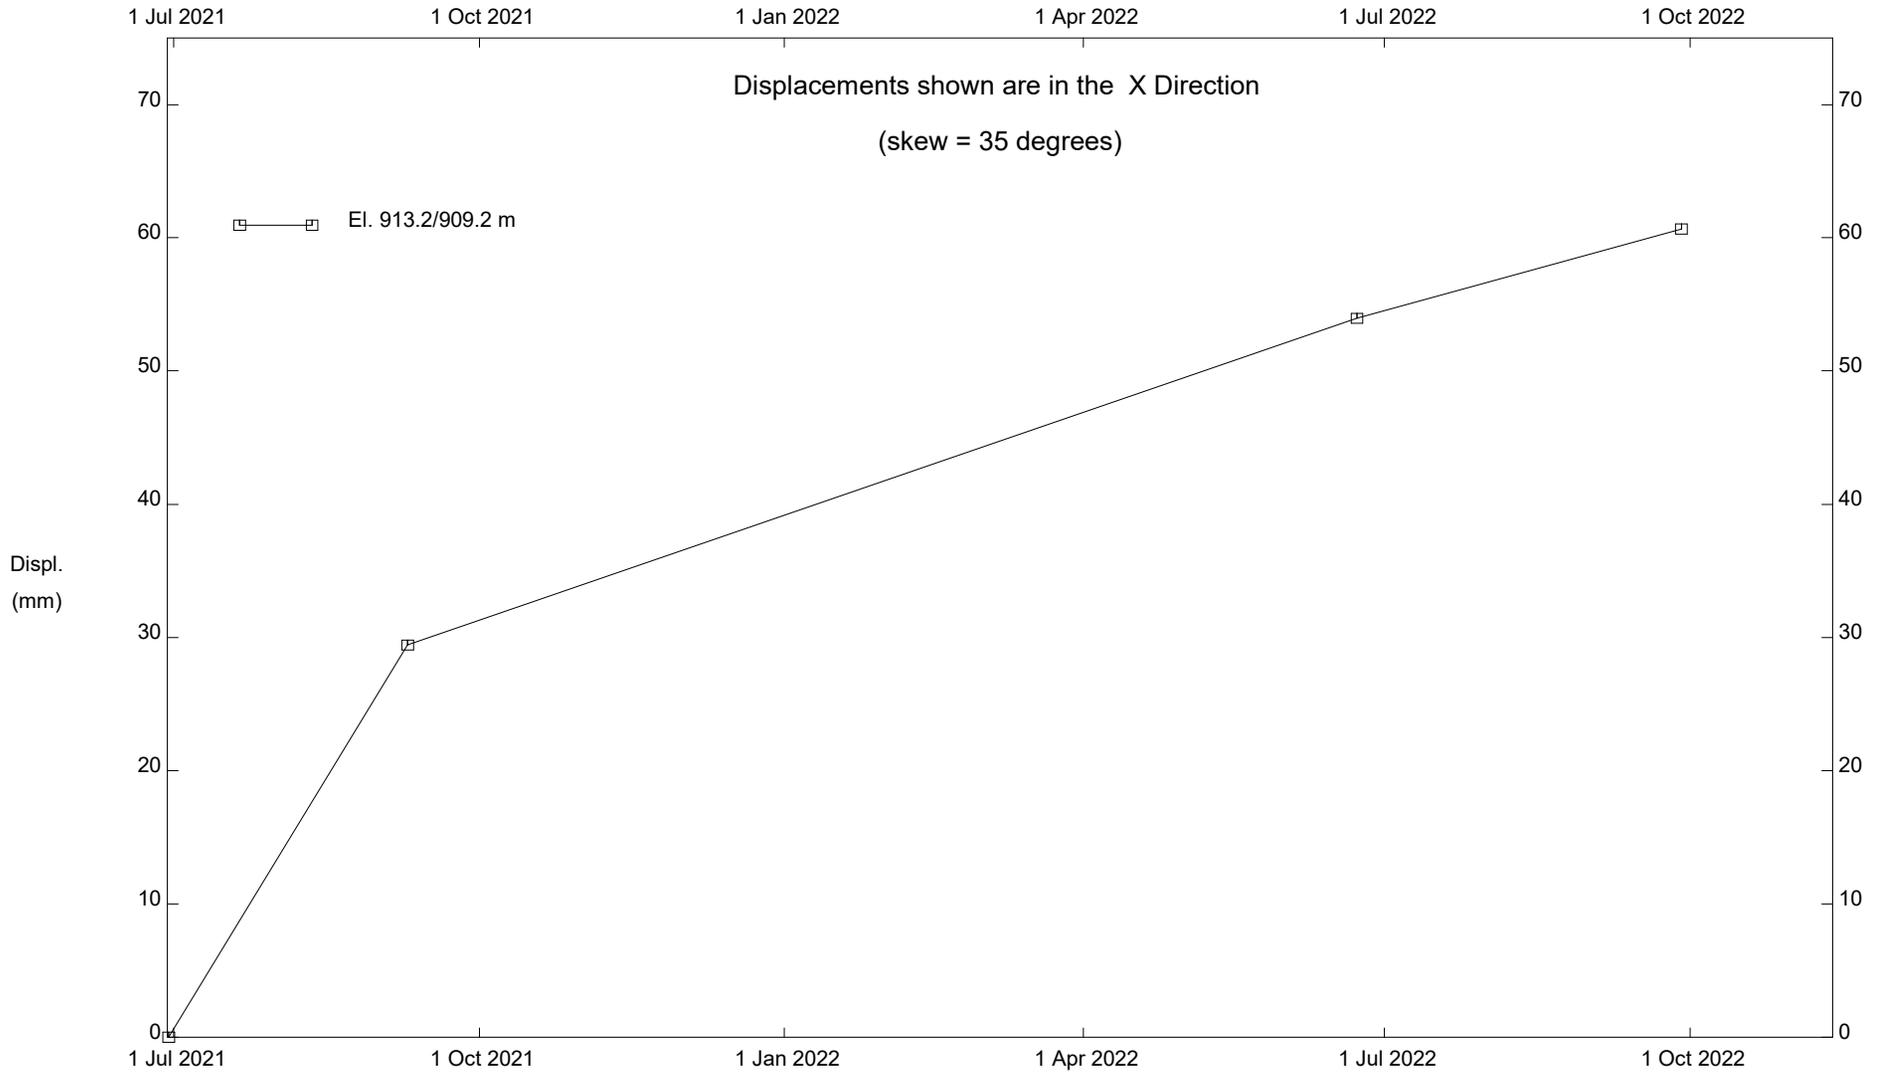
GP006; H40:36, Sheep Creek Embankment, Inclinator SI19-3
Alberta Transportation

The movement recorded in SI-2, SI19-2, and SI19-3 between October 2020 and June 2021 can most likely be attributed to binwall construction in late-2020. Most notably in SI19-3, where a significant amount of shallow movement (approximately 498 mm) was recorded between October 2020 and June 2021. This shallow movement may be attributed to settlement as the binwall takes up load from the highway embankment, as well as deflection of the above-ground casing, since a casing protector was not installed on these instruments until fall 2022. Since the SIs were re-initialized to the June 2021 readings, approximately 12 mm and 61 mm of shallow movement has been recorded in SI-2 and SI19-3, respectively.
