SITE INSPECTION FORM

SITE NUMBER AND NAME: GP006 Sheep Creek Embankment (Three Teardrops Slide)		HIGHWAY & KM: 40:36, 21.779	PREVIOUS INSPECTION DATE: July 12, 2019	INSPECTION DATE: June 14, 2022
LEGAL DESCRIPTION: NW 30-58-07-W6M	NAD 83 COORDINATES: UTM Northing Easting 11 5990716 366584		RISK ASSESSMENT: PF: 1 CF: 4 TOTAL: 4	
AVERAGE ANNUAL DAILY TRAFFIC (AADT): 396 (north) & 409 (south) (Reference No. 60403650, 2021)			CONTRACT MAINTENANCE AREA (CMA): 504

PEACE REGION
(GRANDE PRAIRIE DISTRICT – SOUTH) GRMP
SITE INSPECTION FORM

PROJECT
 PEACE REGION (GRANDE PRAIRIE DISTRICT-SOUTH)
 GEOHAZARD RISK MANAGEMENT PROGRAM

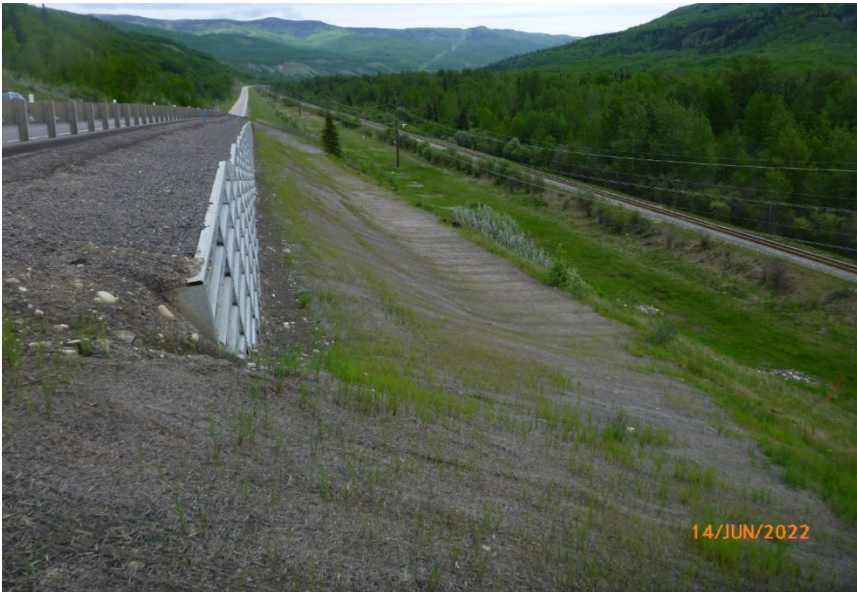
Photo 1 Binwall and mid-slope bench on downslope/east side of Hwy 40:36. Vegetation still establishing on slope and mid-slope bench. Photo taken June 14, 2022, facing northeast.

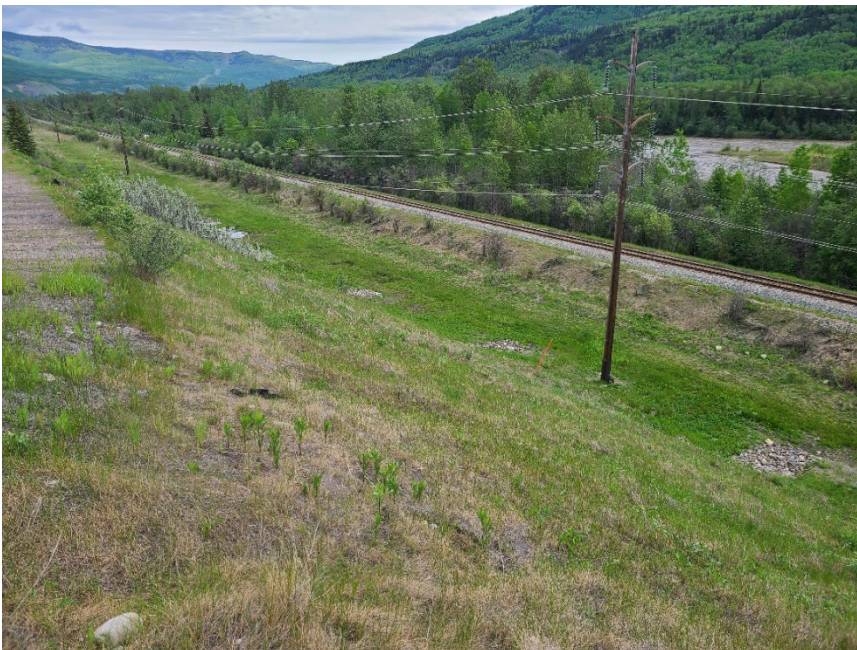
Photo 2 Toe of slope below highway and binwall. Photo taken June 14, 2022, facing northeast.

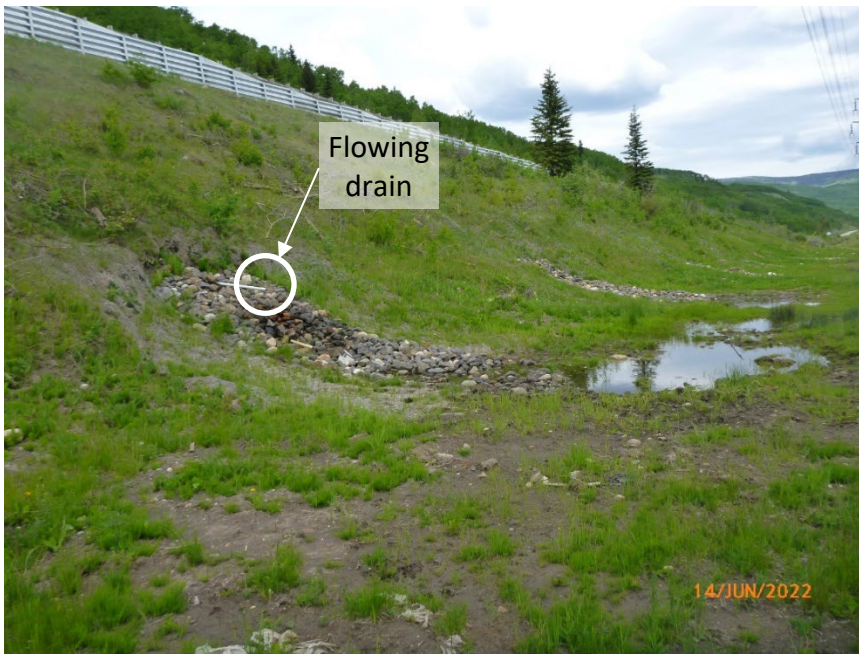
Photo 3 Outlet of horizontal drain (circled in white) flowing at WP 199. Ponded water at toe of slope below highway and binwall. Photo taken June 14, 2022 facing northwest.

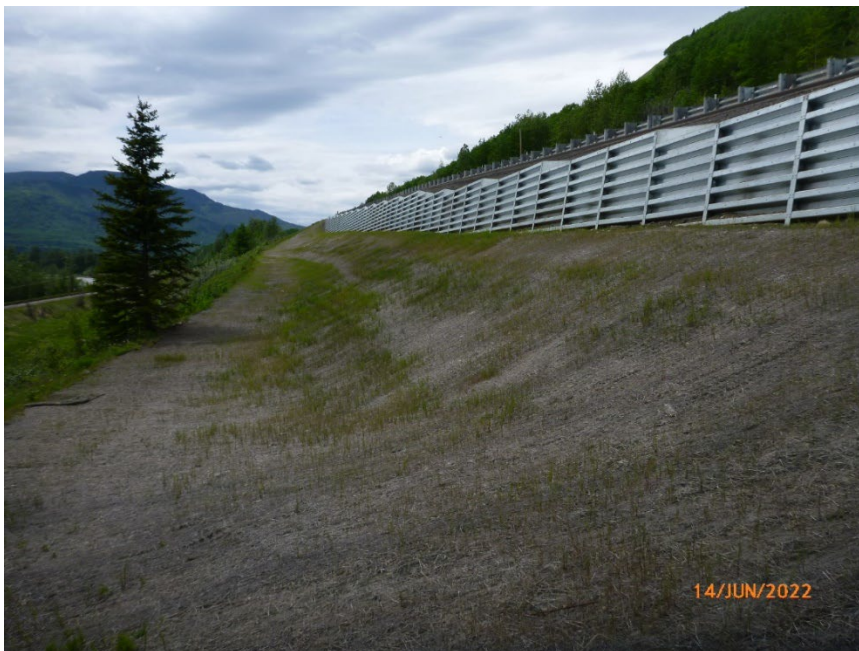
Photo 4 Binwall and mid-slope bench along downslope/east side of Hwy 40:36. Vegetation still establishing on slope and mid-slope bench. Photo taken June 14, 2022 facing southwest.

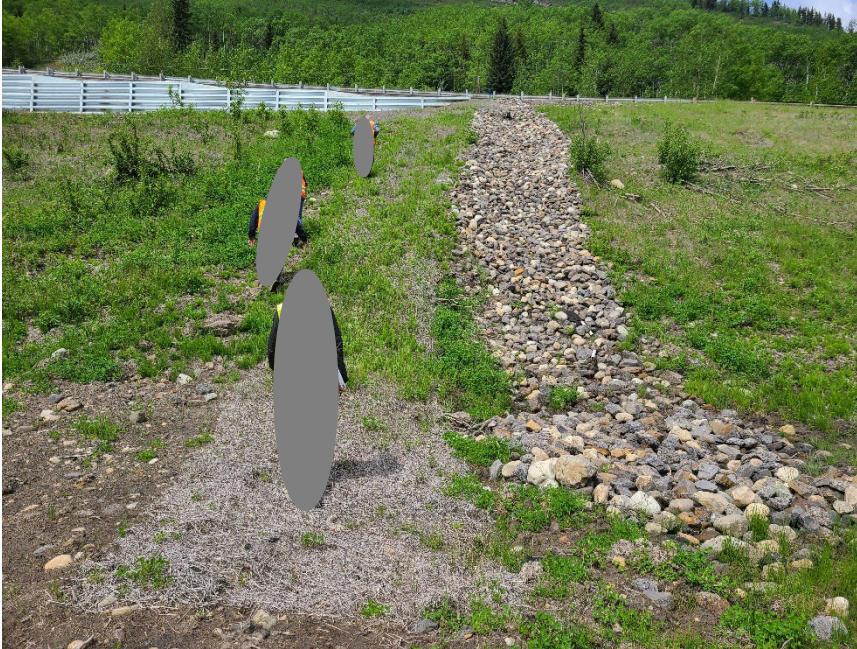
Photo 5 Riprap-lined channel at north end of binwall that conveys flows from asphalt ditch between guardrail and binwall to toe of slope. Photo taken June 14, 2022, facing northwest.

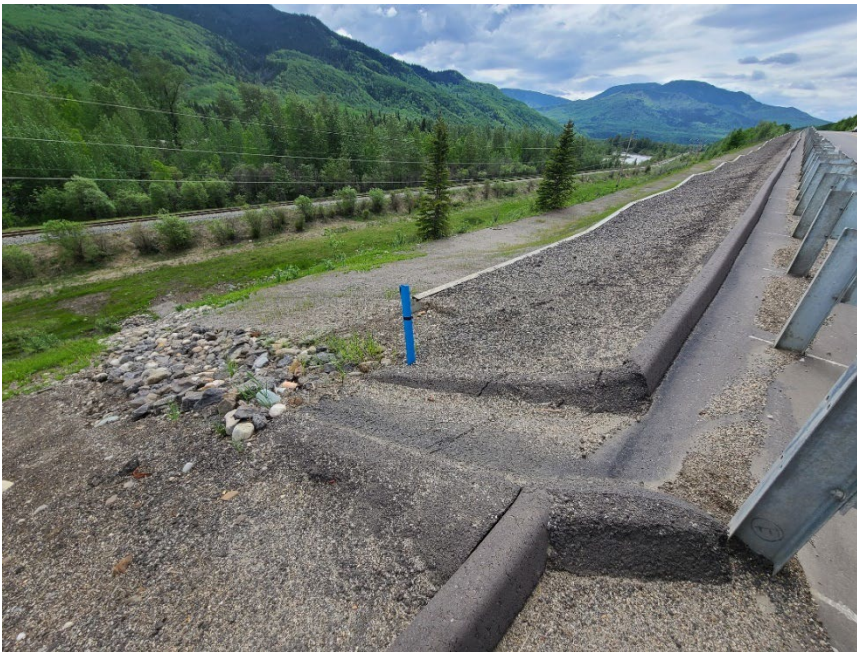
Photo 6 Connection between asphalt ditch between guardrail and binwall, and top of riprap-lined channel at north end of binwall. Photo taken June 14, 2022, facing south.

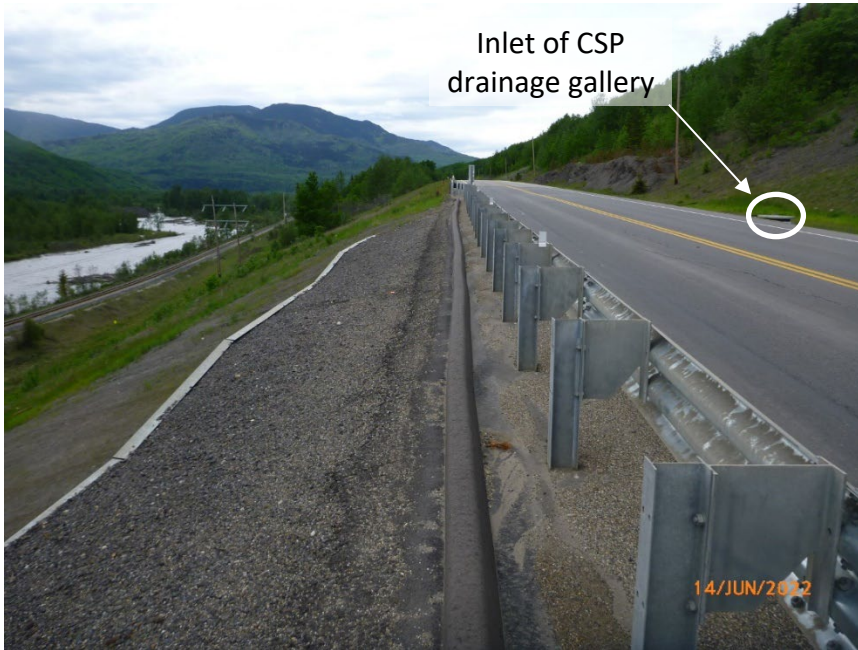
Photo 7 Asphalt ditch between guardrail and binwall. Some cracking in pavement surface of Hwy 40:36 likely due to binwall taking up load from slide mass. Inlet of CSP drainage gallery (circled in white) in upslope/west ditch of Hwy 40:36. Photo taken June 14, 2022, facing southwest.

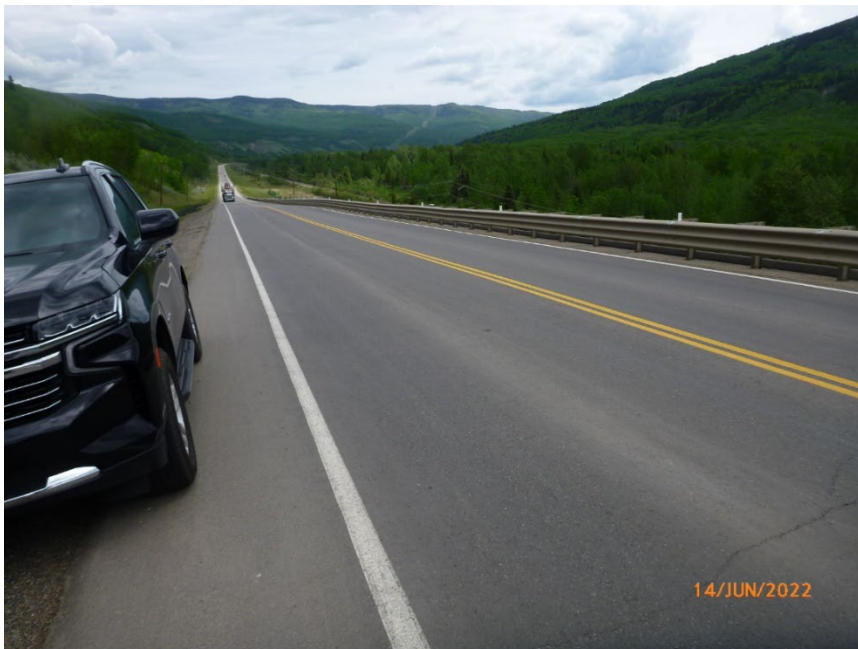
Photo 8 Some cracking in pavement surface of Hwy 40:36 likely due to binwall taking up load from slide mass. Photo taken June 14, 2022, facing north.

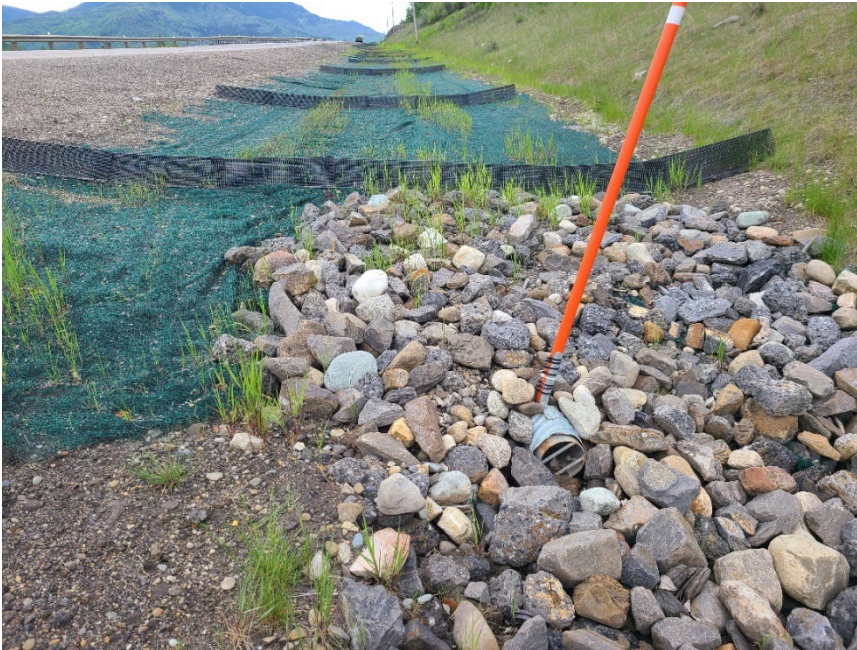
Photo 9 Check dams and outlet of CSP subdrain in upslope/west ditch of Hwy 40:36. Photo taken June 14, 2022, facing southwest.

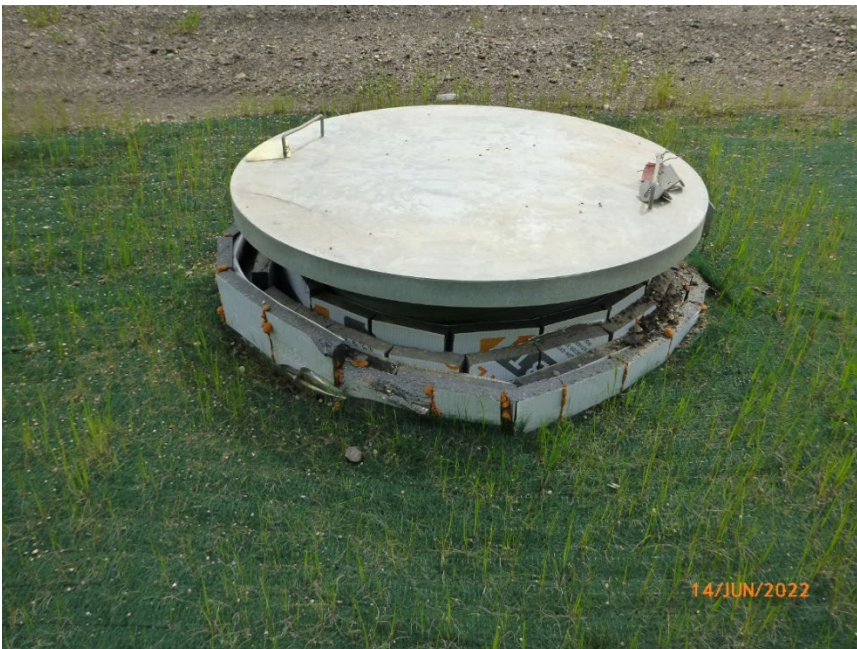
Photo 10 Inlet of CSP drainage gallery in upslope/west ditch of Hwy 40:36. Note inlet of CSP drainage gallery sticks up approximately 0.5 m above ditch bottom and is a potential roadside hazard to motorists who go off highway. Insulation around inlet is also deteriorating. Photo taken June 14, 2022, facing northeast.

COMMENTS
Vegetation still establishing on slope and mid-slope bench below highway and binwall.
A couple horizontal drains at toe of slope flowing and a few trickling. Mostly at mid to north end of binwall where wet conditions were encountered during construction. Pond of water in front of flowing drain at WP199.
Pore pressures recorded in some piezometers have decreased, which could be attributed to the installation of drains during 2020 binwall construction.
Sloughing and riprap settlement around outlets of horizontal drains at toe of slope. Conglomerate and clay shale used as riprap around outlets of horizontal drains already showing signs of deterioration.
More flow around 8-in diameter subdrain in upslope/west ditch then out drain outlet.
<u>Maintenance/Repair/Monitoring Recommendations:</u> <ul style="list-style-type: none"> • Continue to maintain and clean ditch and existing subdrain system. • Inlet of CSP drainage gallery sticks up approximately 0.5 m above ditch bottom and is a potential roadside hazard to motorists who go off the highway. Insulation around inlet is also deteriorating. A guardrail could be installed along west side of highway to protect against this roadside hazard.
