July 15, 2024

CON0022166 Peace Region (Grande Prairie District – South) GRMP Instrumentation Monitoring Site GP006; H40:36, km 21.779 Sheep Creek Embankment (Three Teardrops Slide) Section C – 2024 Spring Readings

Site Plan
 GP006 - Sheep Creek Embankment
 (Three Teardrops Slide)
 Hwy 40:36, km 21.779

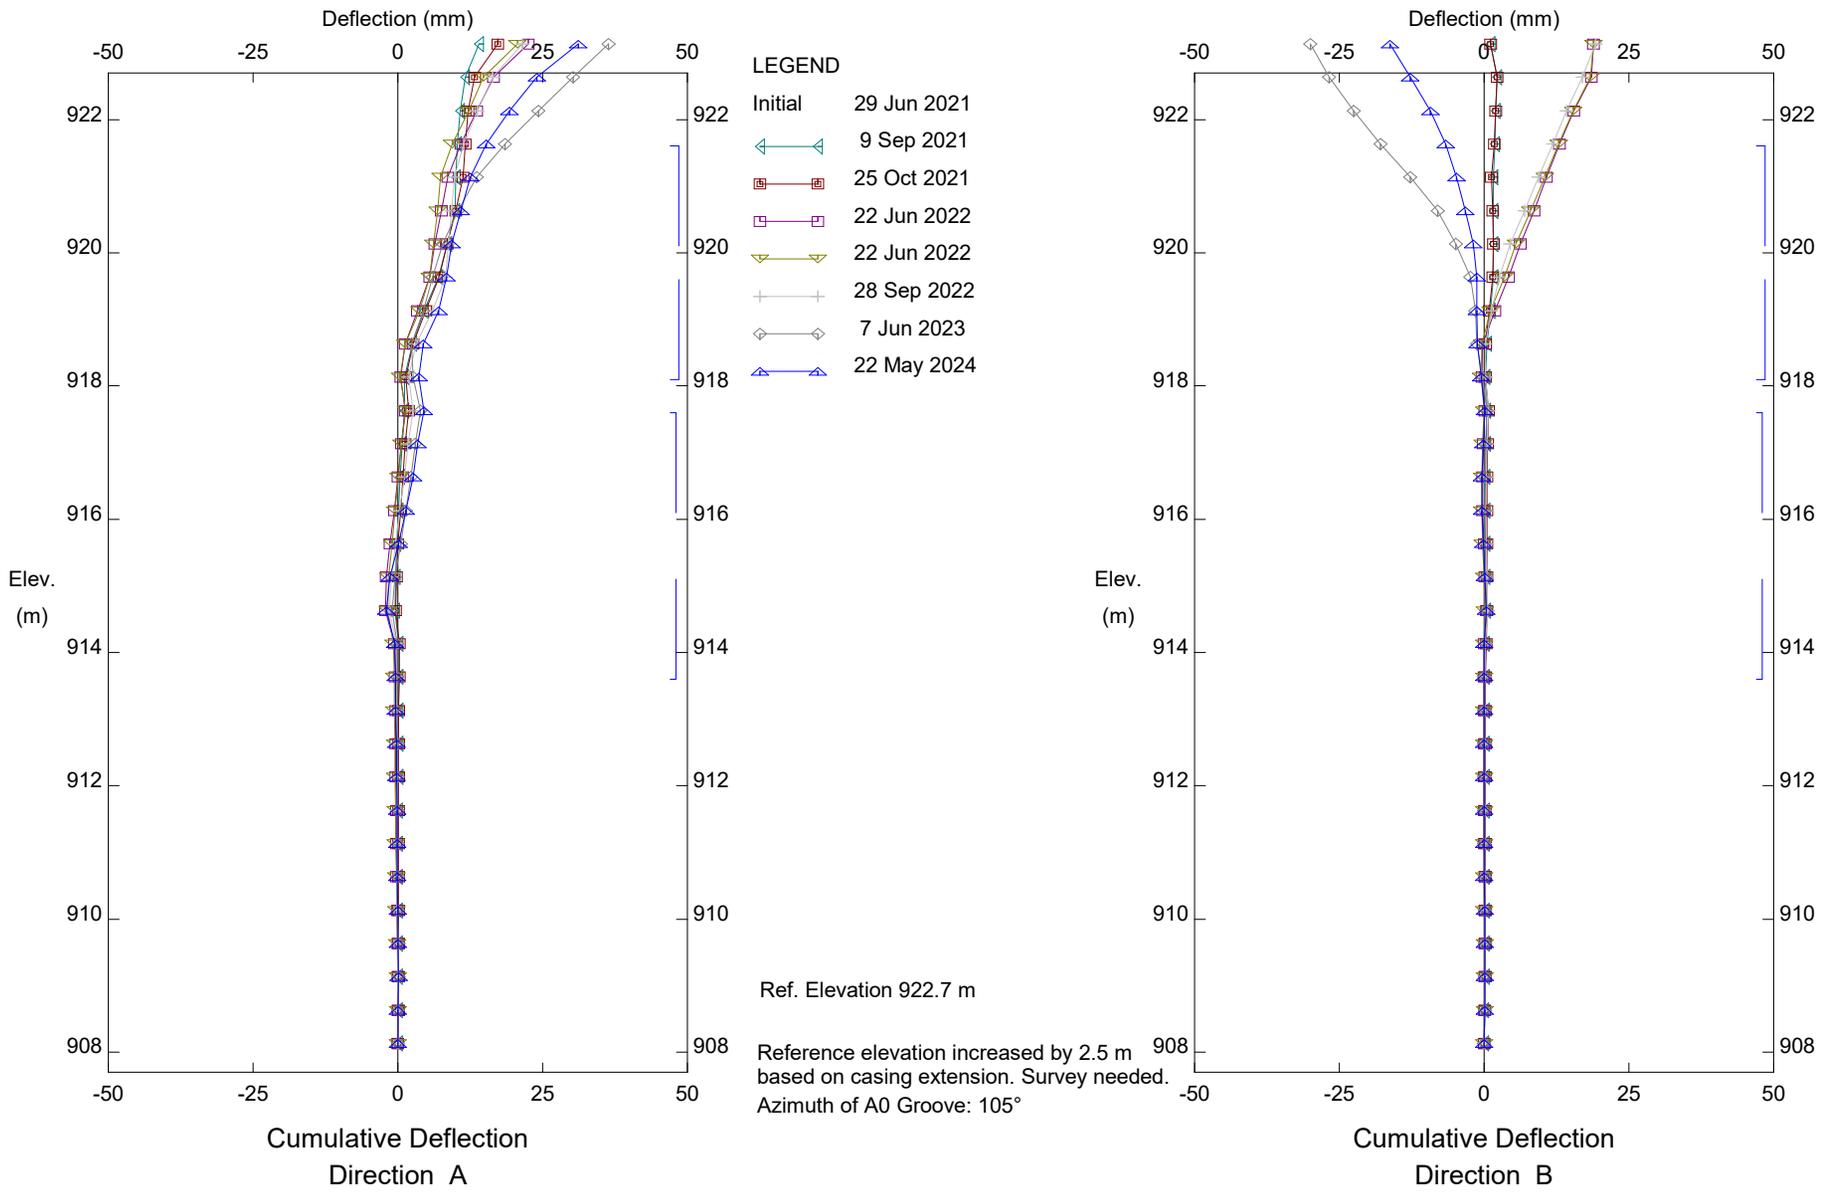
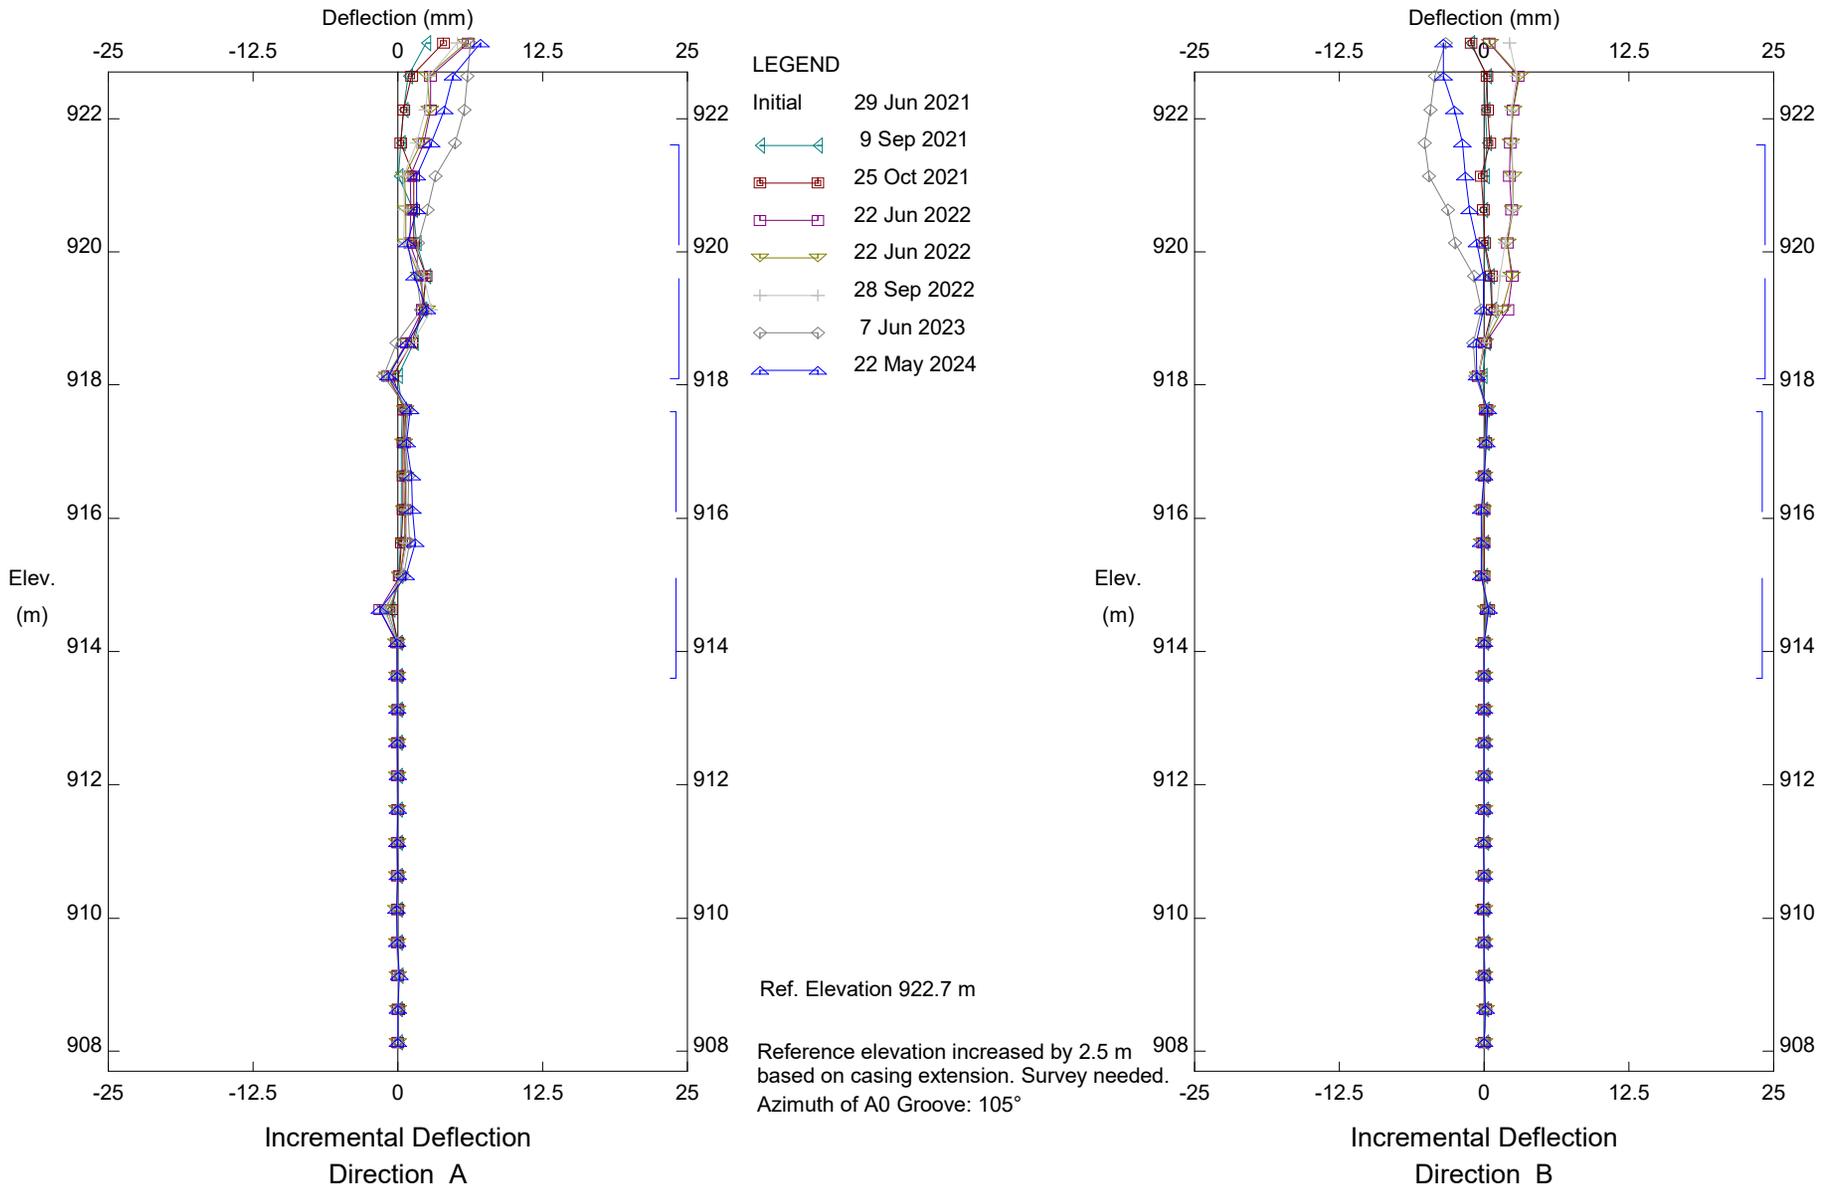
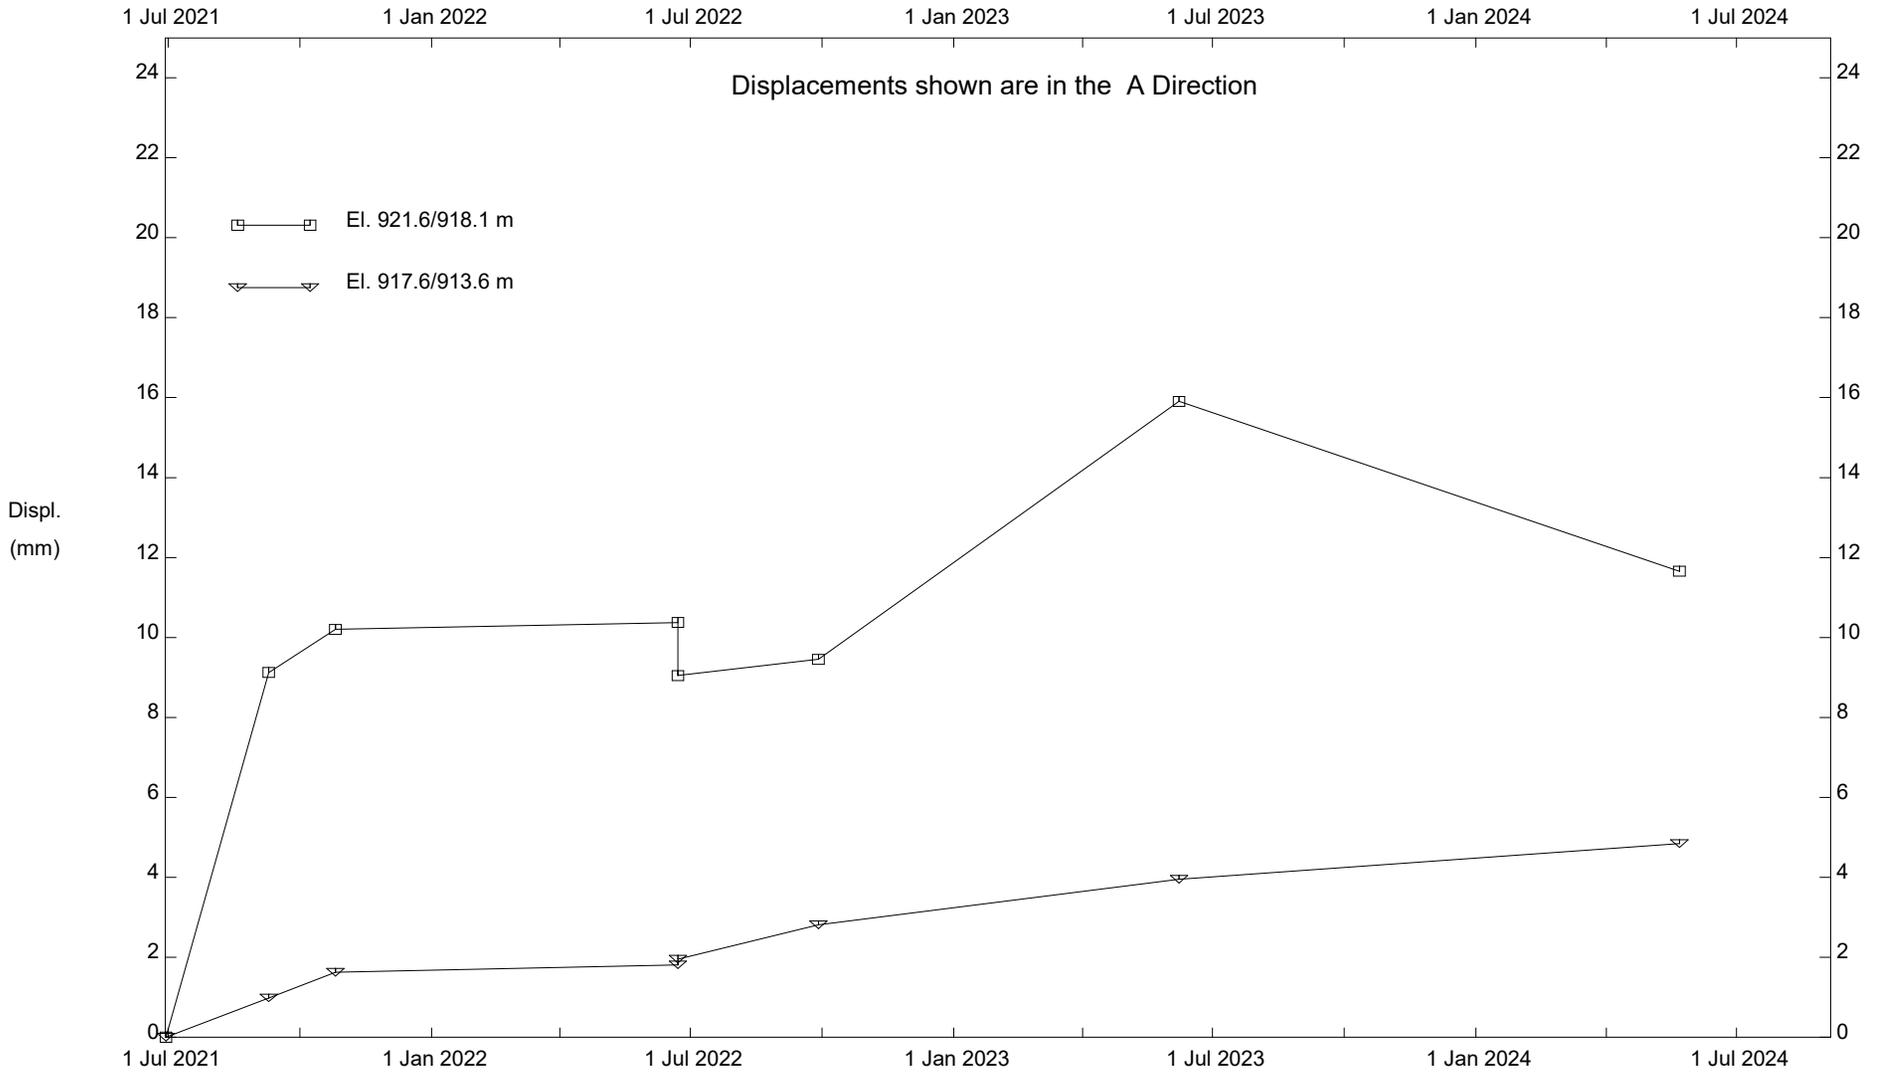
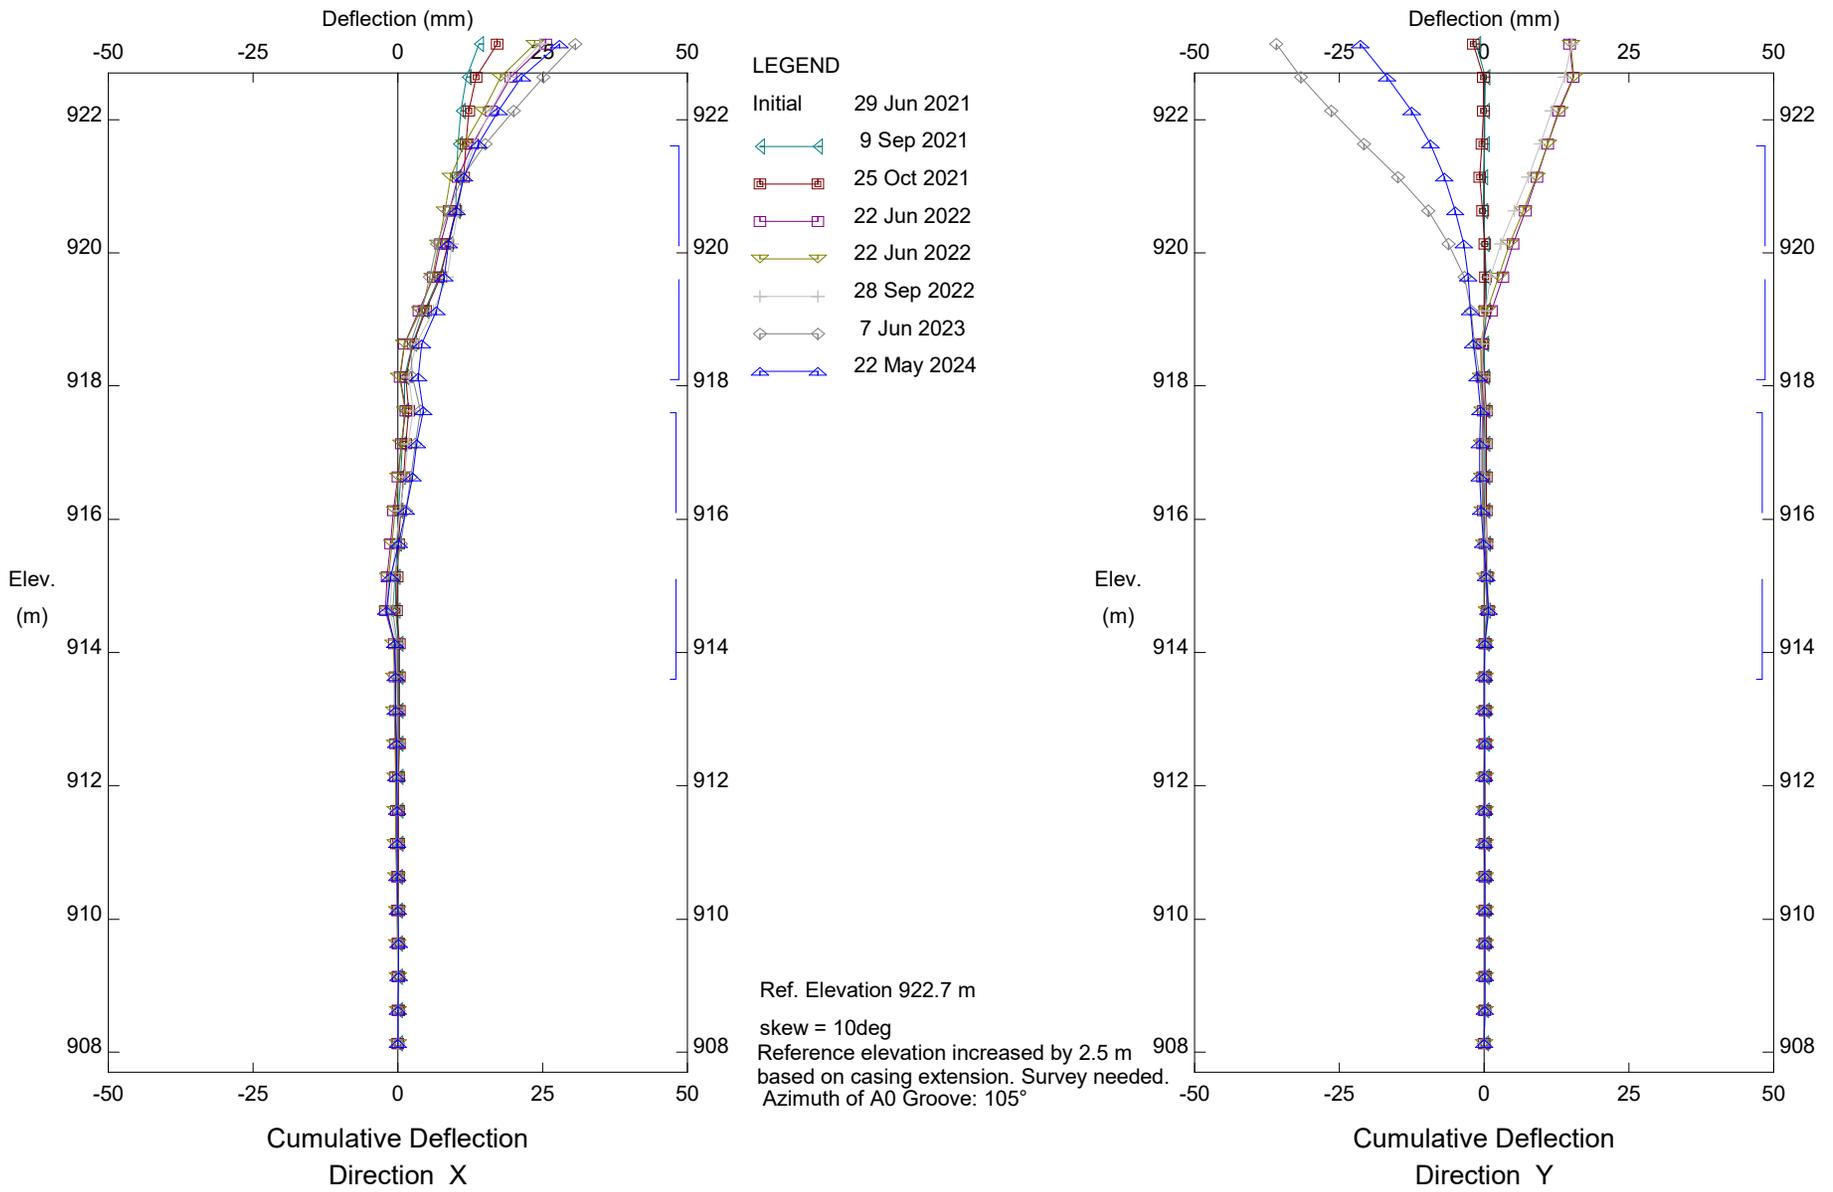
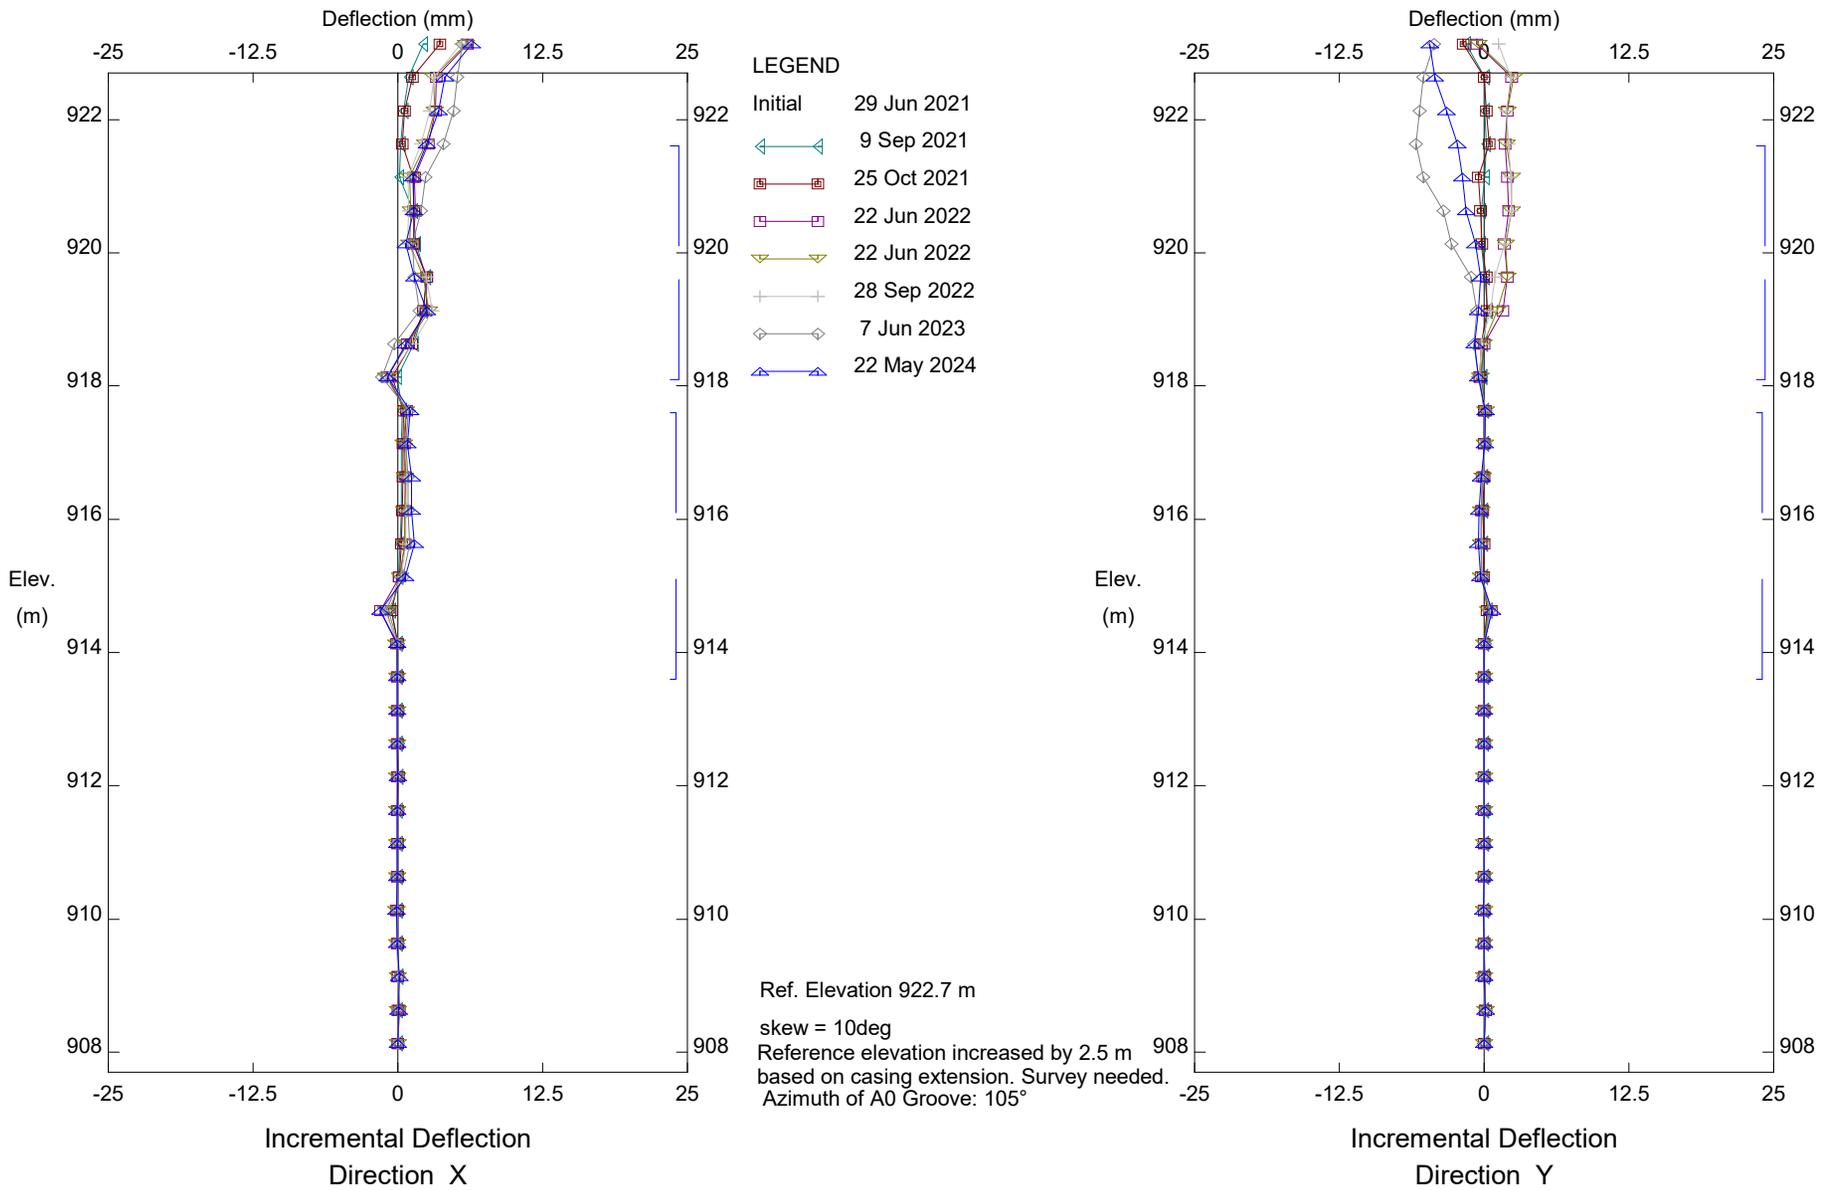
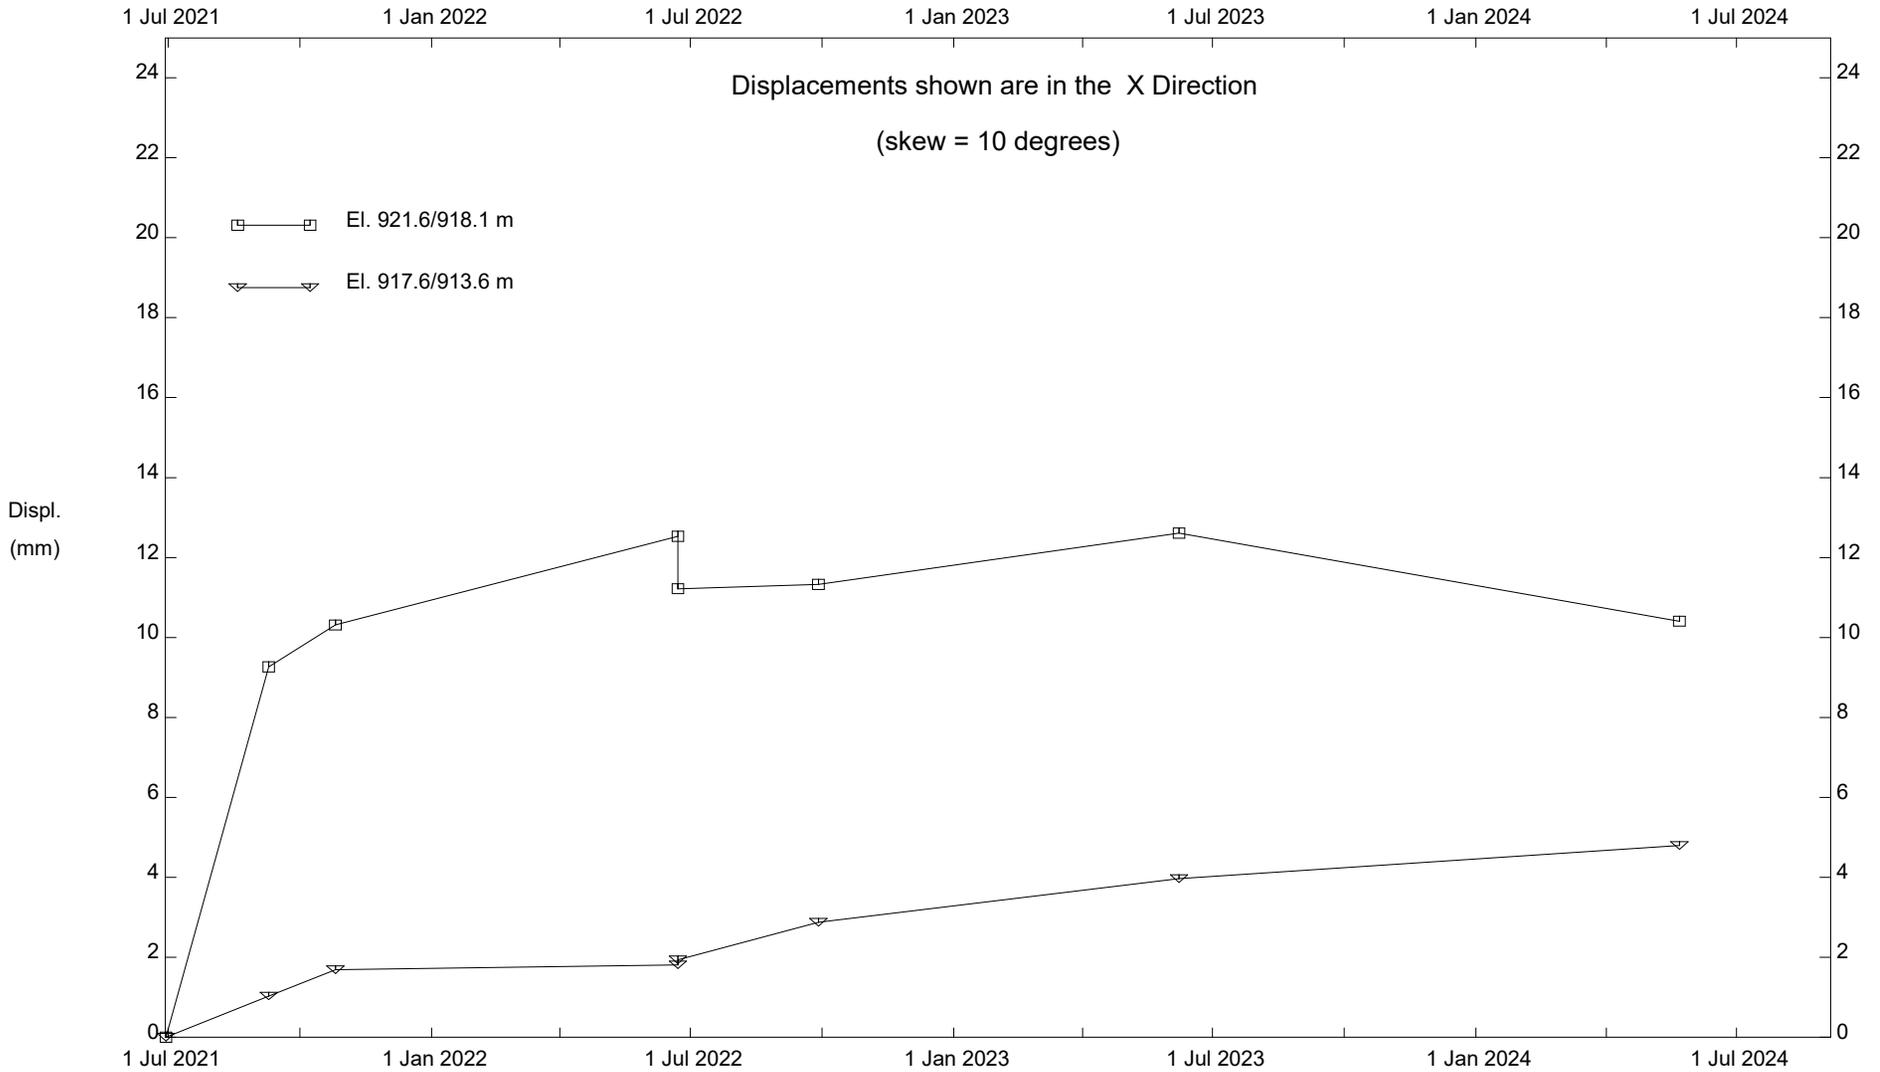
GP006; H40:36, Sheep Creek Embankment, Inclinometer SI-2

- Large deflections that were recorded in the tops of SI-2, SI19-2, and SI19-3 up to an approximate depth of 6 m below ground surface. The deflections are likely due to binwall construction in late 2020. It is noted that SI-2 and SI19-2 were shortened to the binwall bench level and then later raised through the bin wall fill during construction. It also appears the instruments were raised again after the previous consultant took their last reading in October 2020. The exact length of casing added is unknown but was estimated to be 2.5 m. KCB has subsequently extended the data files for SI-2 and SI19-2 by 2.5 m. The instruments have been read to the adjusted depth since June 2022, and the data aligns with the new reading depth. Due to the large deflections, KCB re-initialized the SI data plots to the June 2021 readings. It is noted that the data for SI19-2 is noisy and difficult to interpret, and the instrument may need to be re-initialized again. Based on the absolute plot, SI19-2 is tilted approximately 1.0 m and 2.4 m in the A- and B-directions, respectively.

Distributed movement was being recorded in the A-direction of SI-2 between an approximate depth of 6.1 m and 9.1 m below ground surface. However, due to a large deflection that was recorded in the top 6 m of the SI casing since late 2020, KCB re-initialized the instrument to the June 2021 reading. Since June 2021, distributed movement has continued to be recorded in SI-2 from ground surface to an approximate depth of 9.1 m below ground surface.

A relatively large amount of displacement has been recorded in the B-direction (approximately 20 mm to 30 mm) of SI-2 from ground surface to an approximate depth of 5.1 m. The direction of movement varies from positive to negative indicating the displacement may be attributed to movement in the fill placed in 2020, or seasonal temperature fluctuations (i.e., frost penetration). More data is needed to assess the movement trend recorded in SI-2.

The movement recorded in SI-2, SI19-2, and SI19-3 since October 2020 can most likely be attributed to binwall construction in late 2020. Most notably in SI19-3, where a significant amount (approximately 583 mm) of shallow movement has been recorded since October 2020. This shallow movement may be attributed to settlement as the bin wall takes loading from the highway embankment, as well as deflection of the above-ground casing, since casing protectors were not installed for these instruments. Since the SIs were re-initialized to the June 2021 readings, between approximately 12 mm and 85 mm of shallow movement has been recorded in these instruments. Overall, the rate of movement recorded in these instruments is beginning to slow, but ongoing pavement surface distress, including cracking and settlement, has been observed behind the binwall.
