July 15, 2024

CON0022166 Peace Region (Grande Prairie District – South) GRMP Instrumentation Monitoring Site GP006; H40:36, km 21.779 Sheep Creek Embankment (Three Teardrops Slide) Section C – 2024 Spring Readings

Site Plan
 GP006 - Sheep Creek Embankment
 (Three Teardrops Slide)
 Hwy 40:36, km 21.779

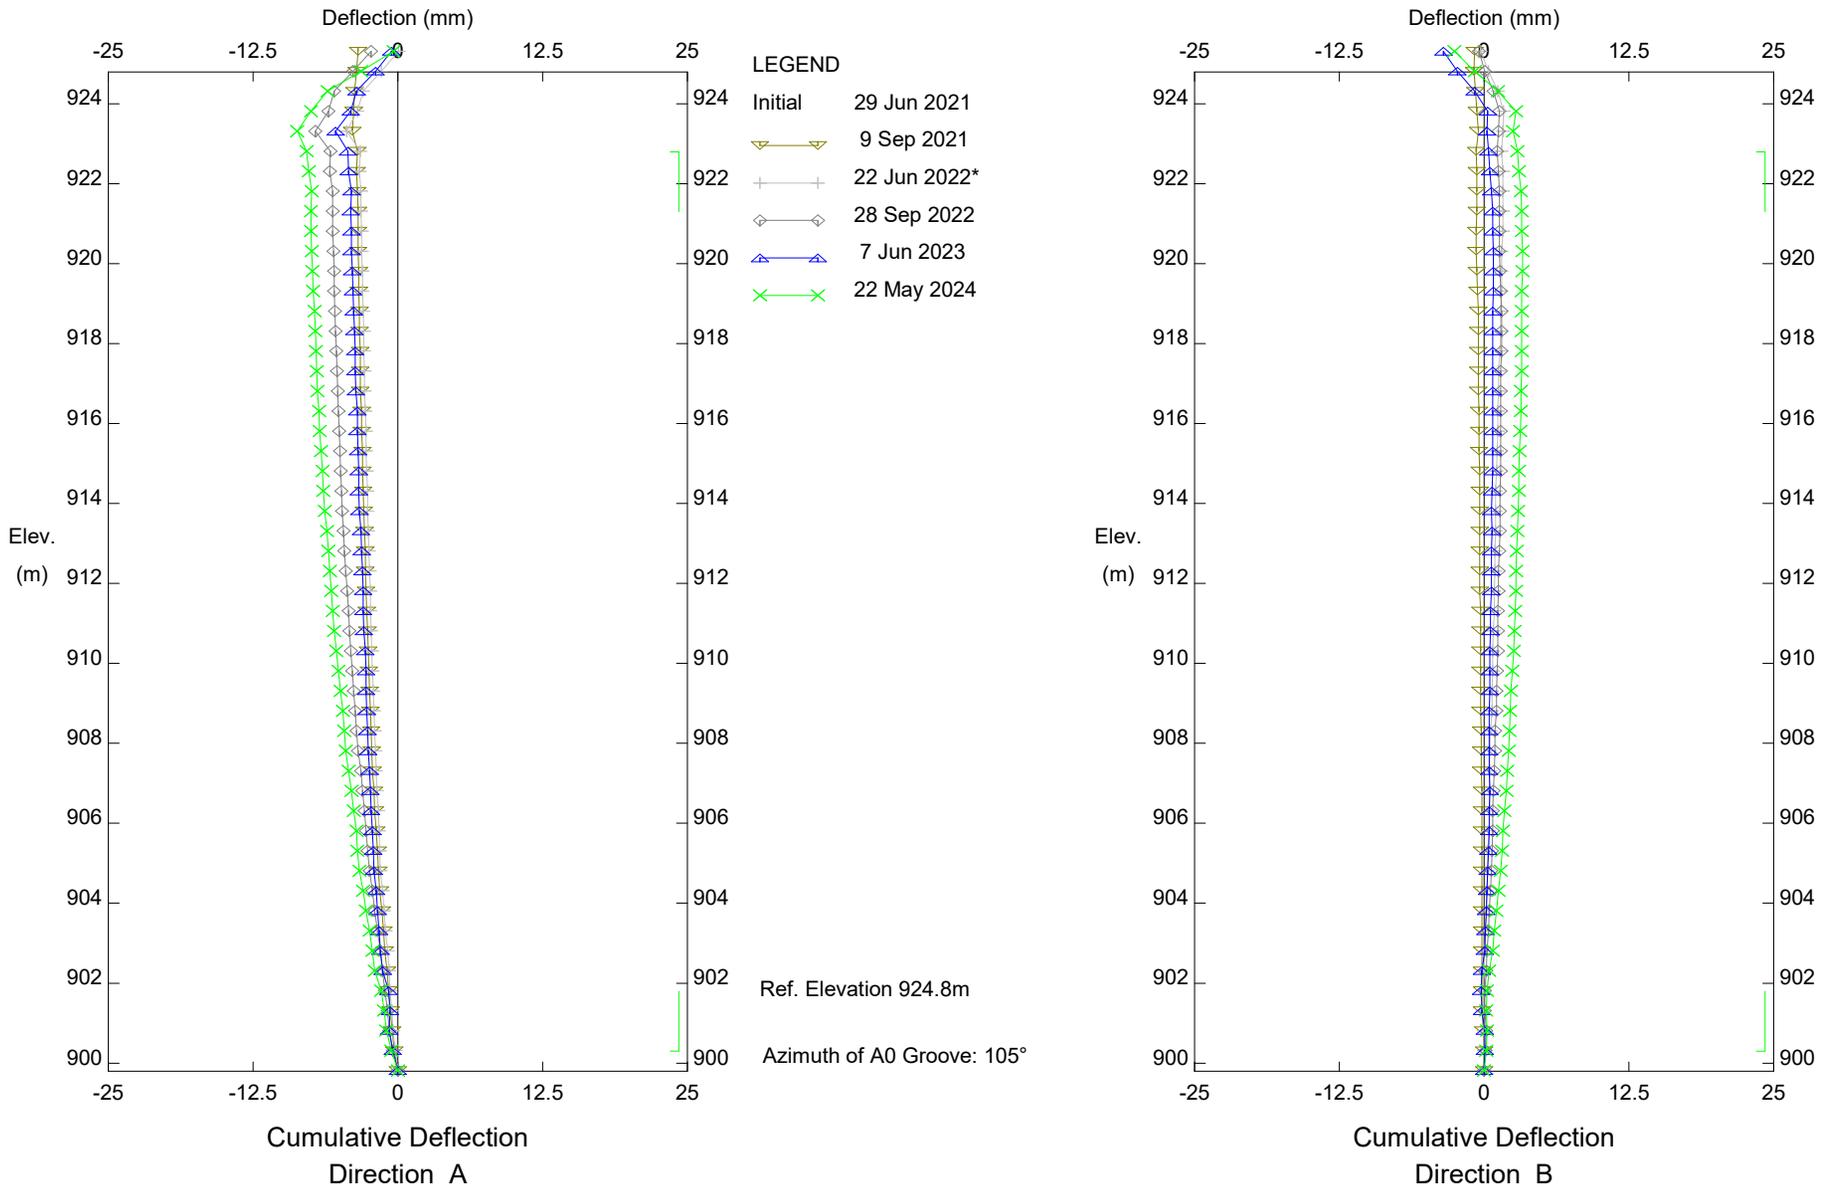
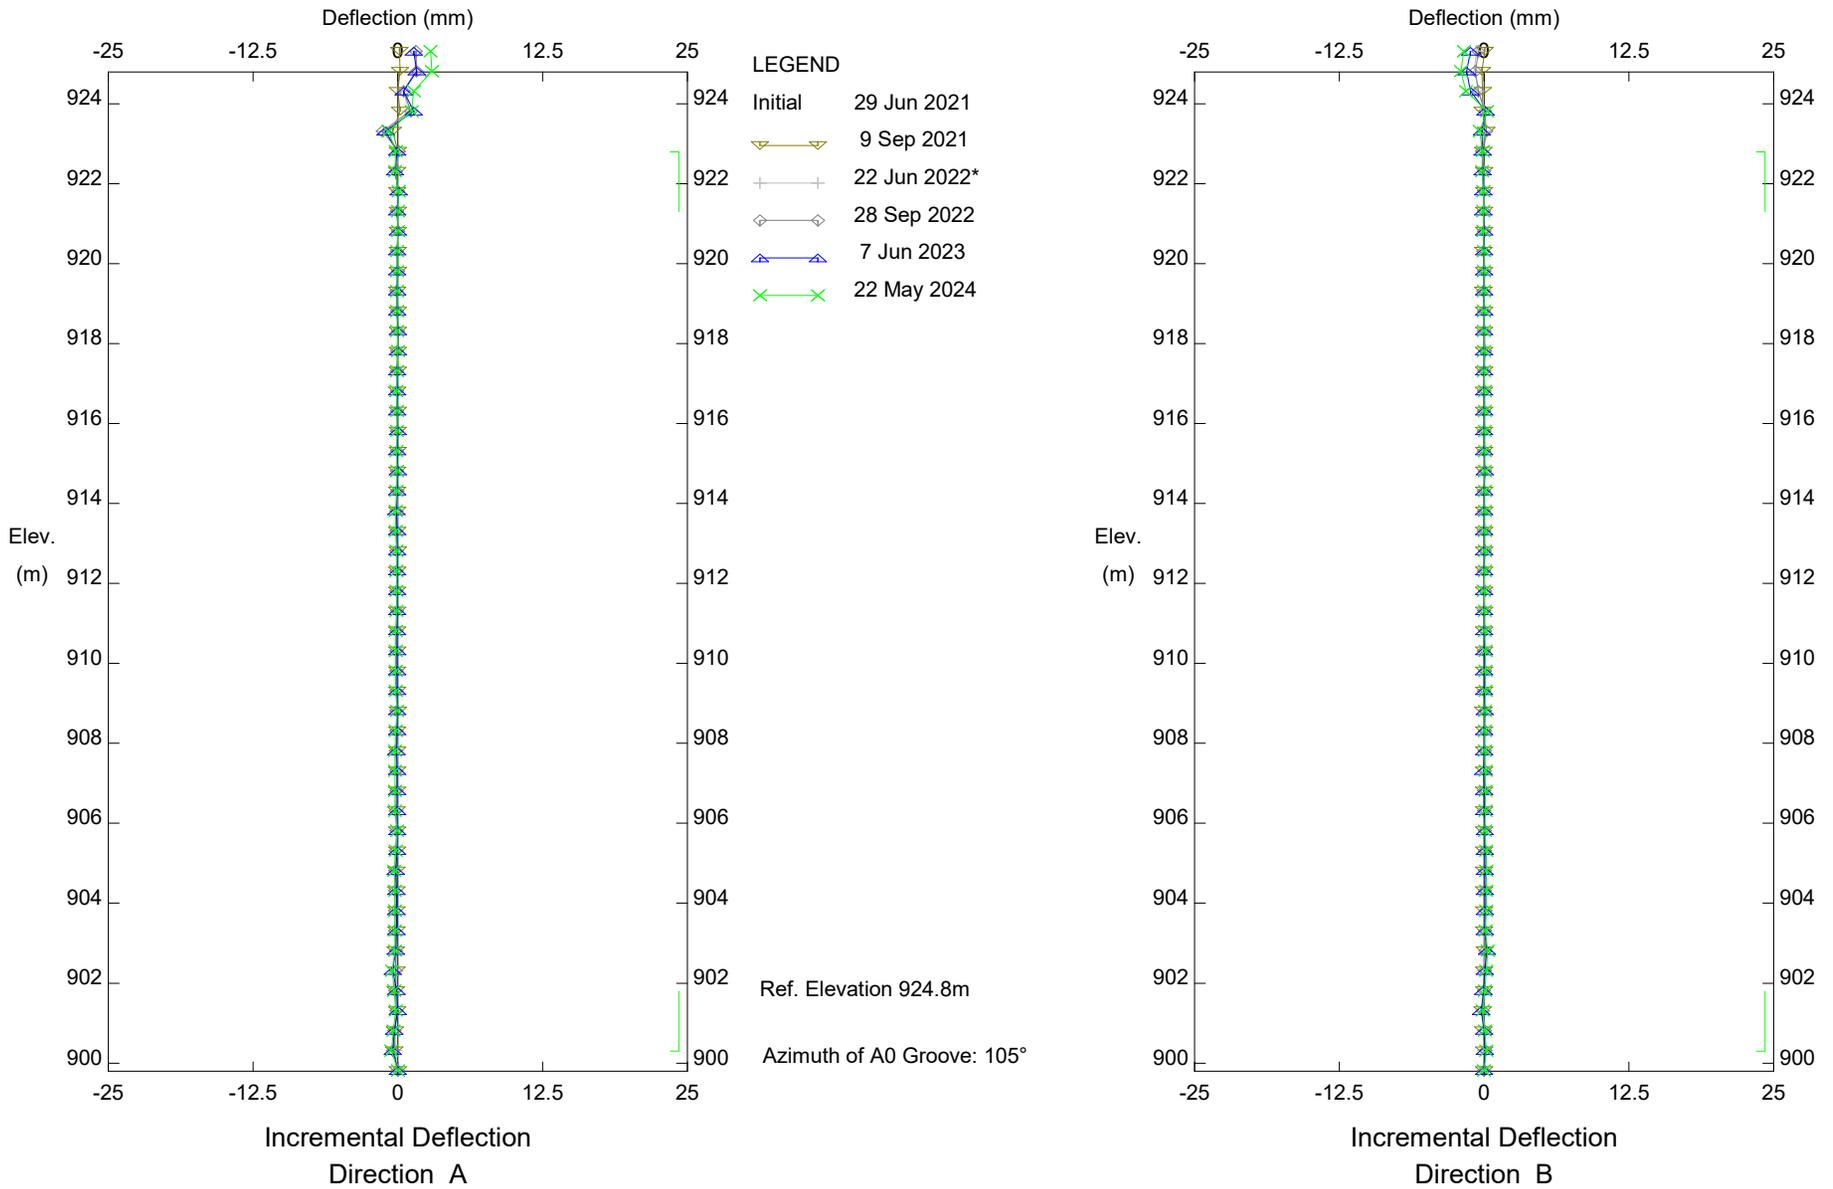
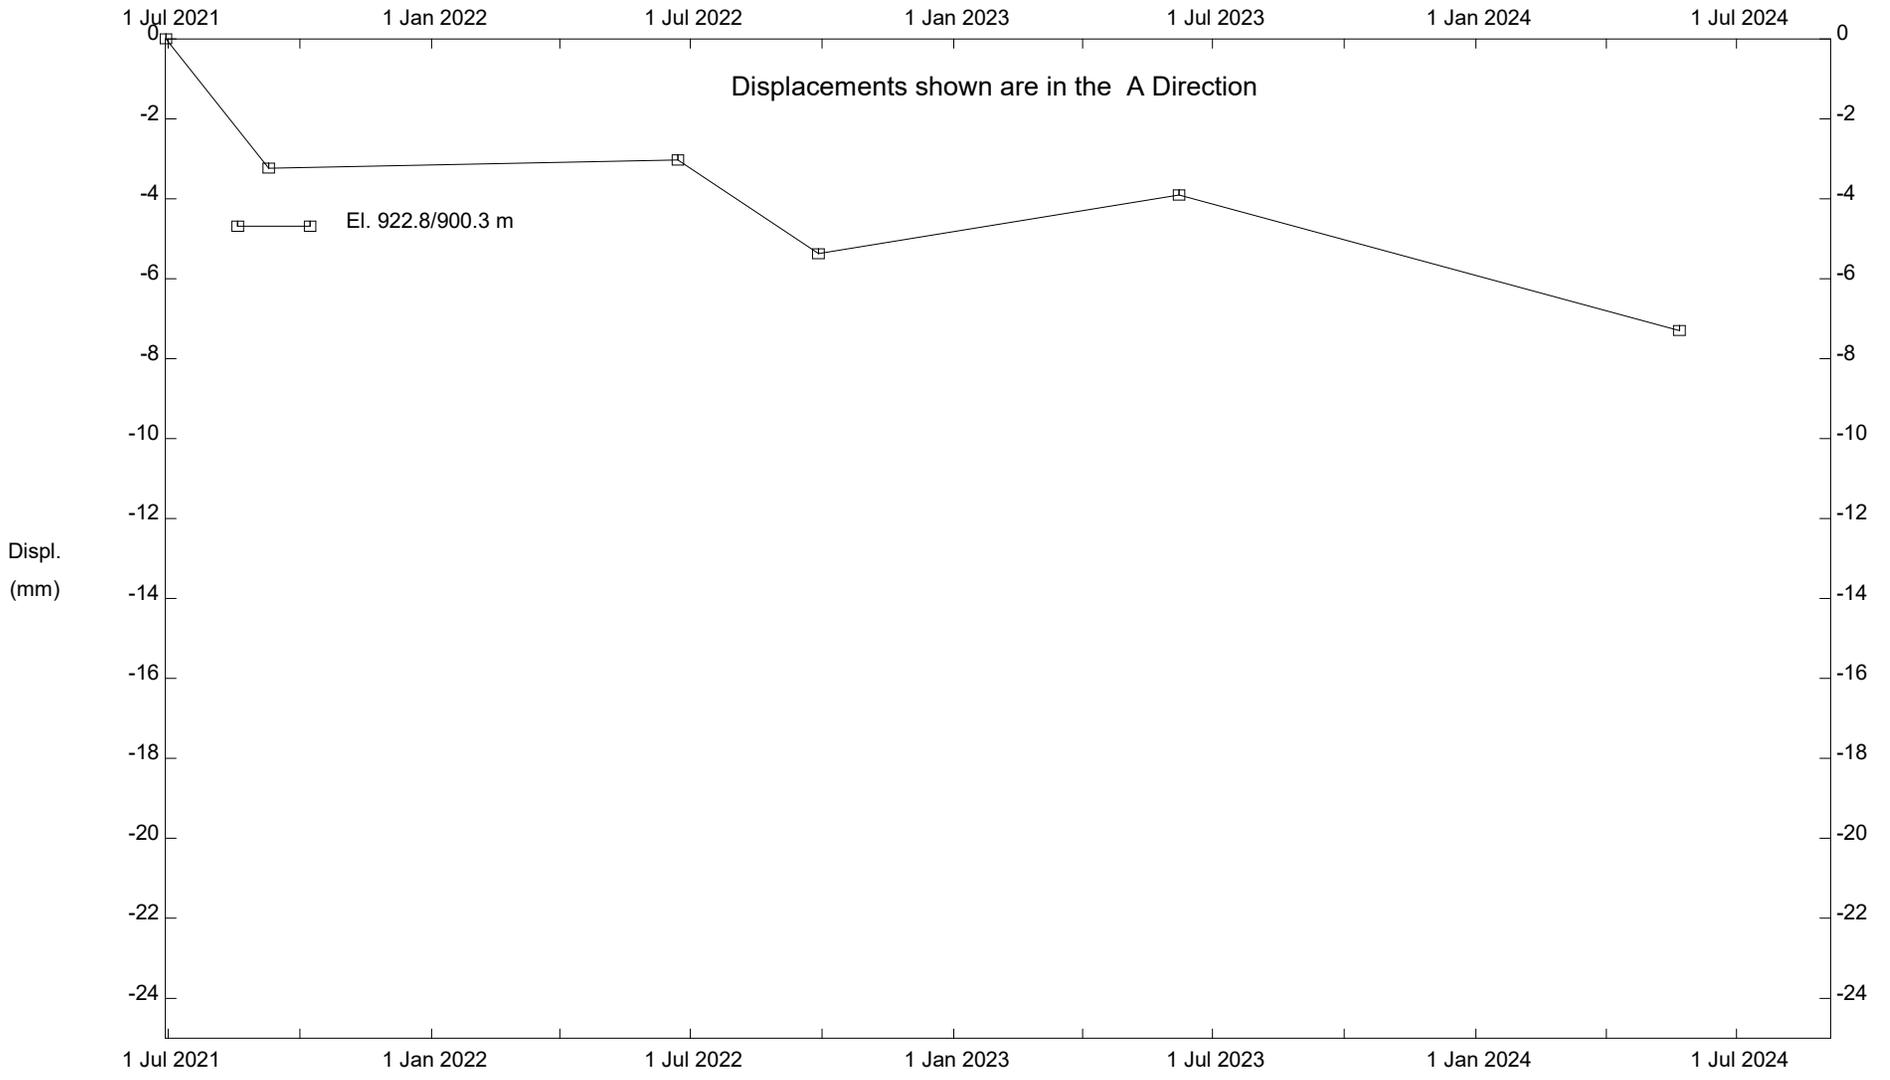
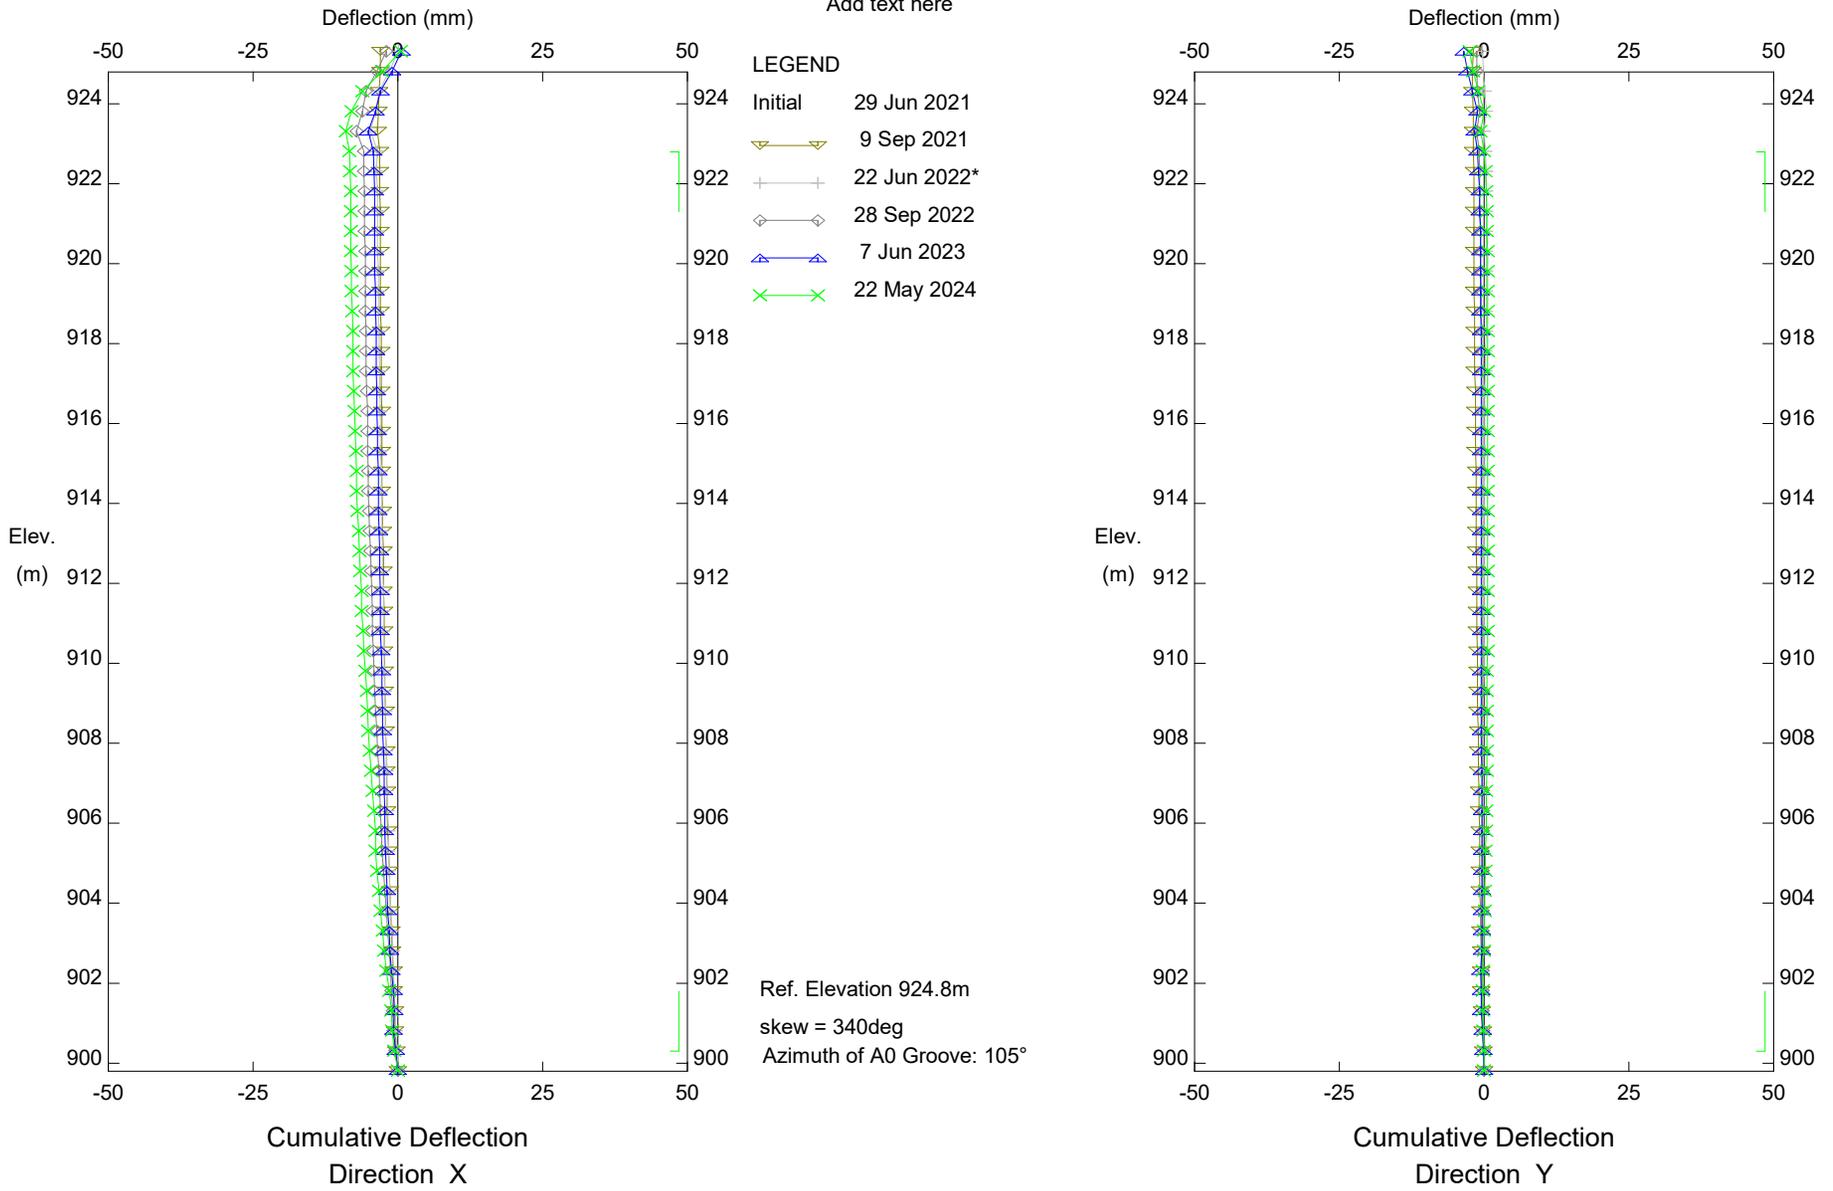
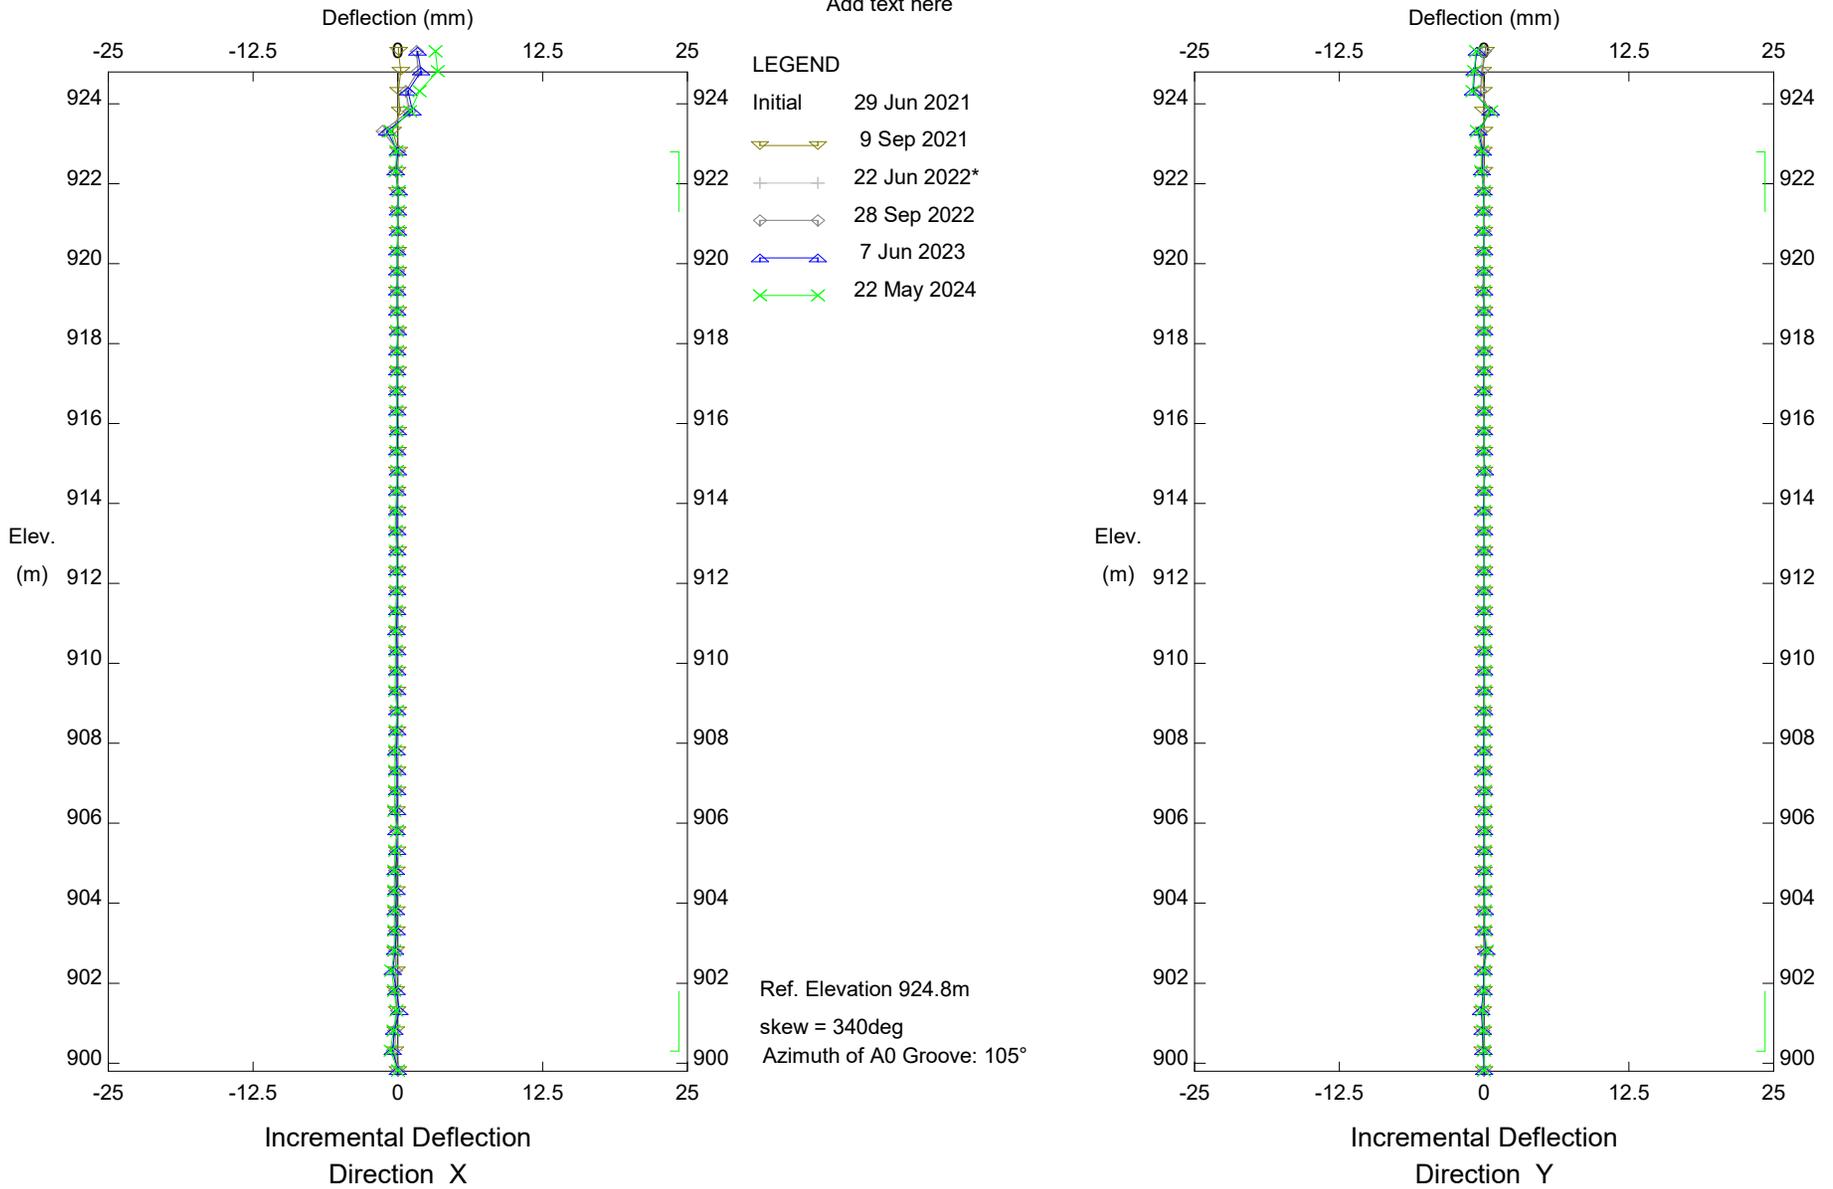
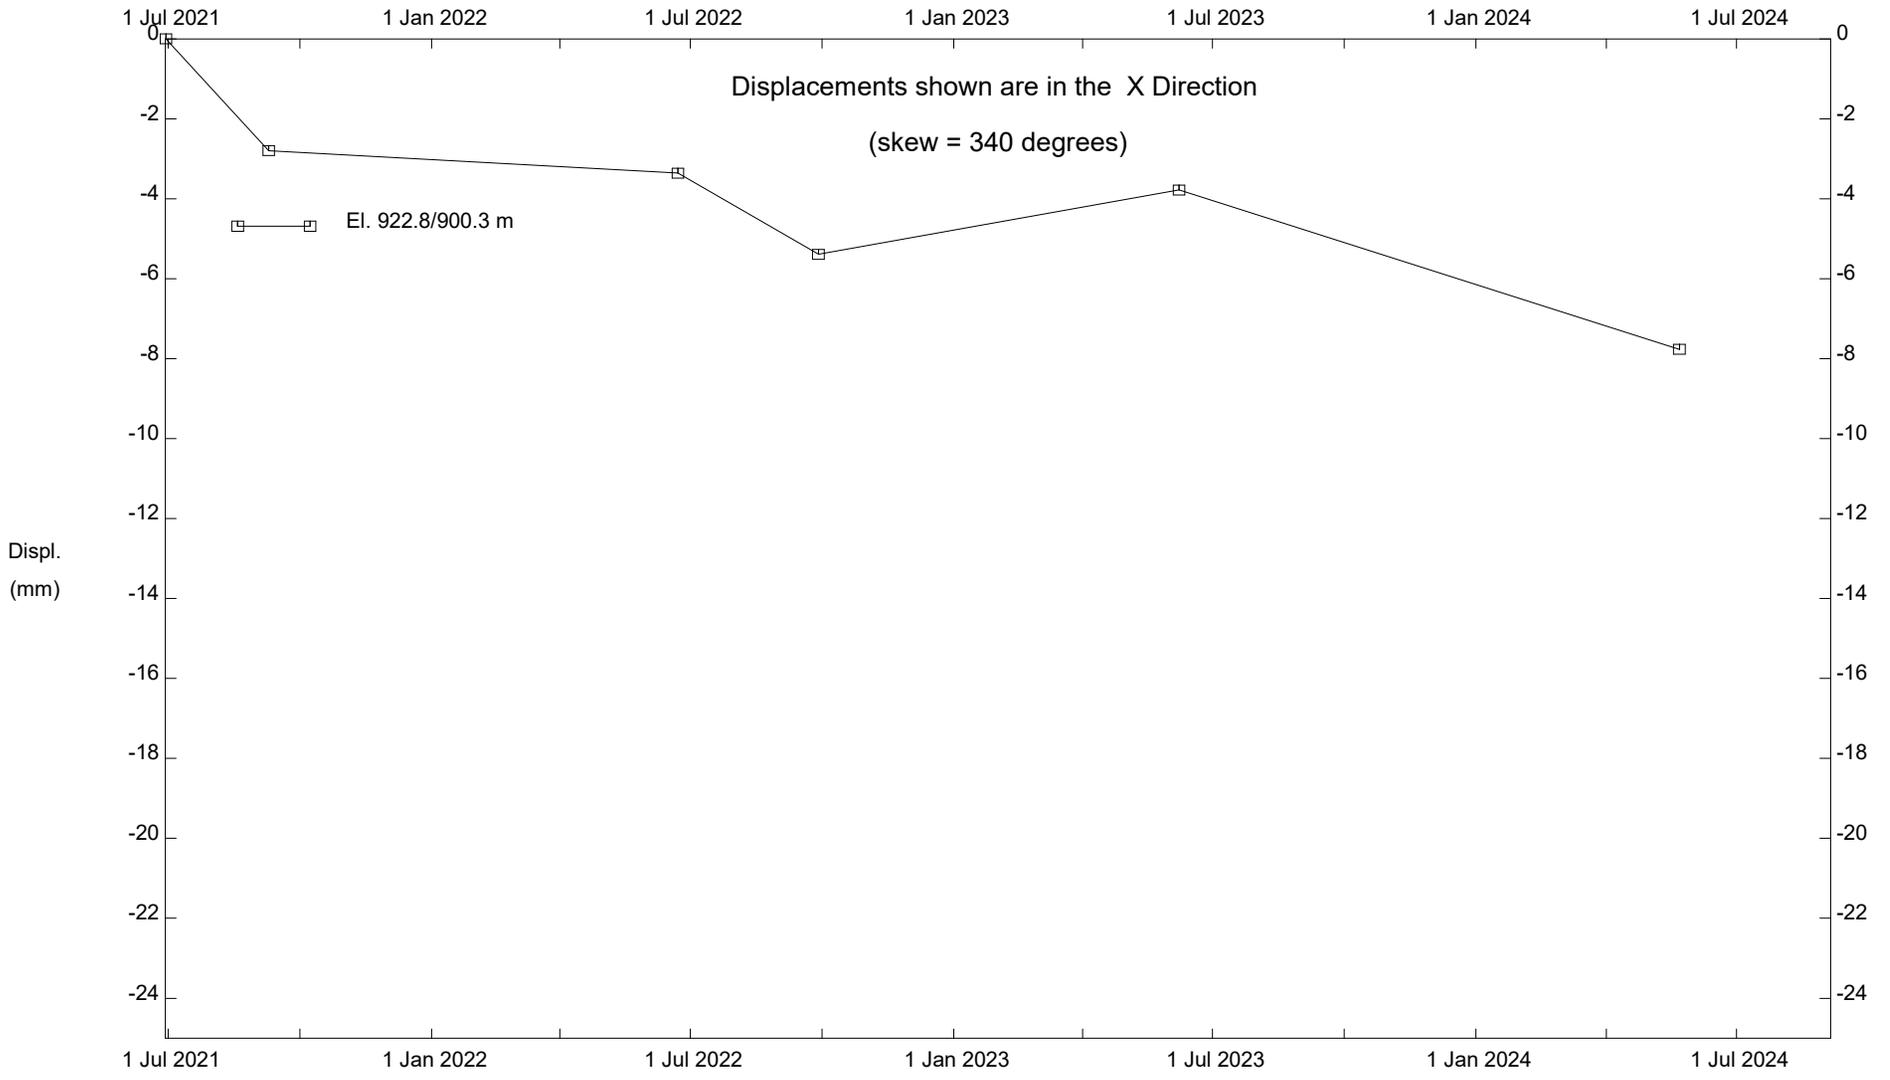
GP006; H40:36, Sheep Creek Embankment, Inclinator SI19-1

Distributed movement from top to bottom of casing has been recorded in SI19-1 since installation, including negative distributed movement recorded since October 2021 from an approximate depth of 4 m below ground surface to the bottom of the instrument. This movement could be due to the SI not being installed deep enough or installed on enough of an angle (i.e., tilt) that complicates processing of the SI data. Based on the absolute plot for this instrument, it is tilted approximately 0.7 m and 1.5 m in the A- and B-directions, respectively.

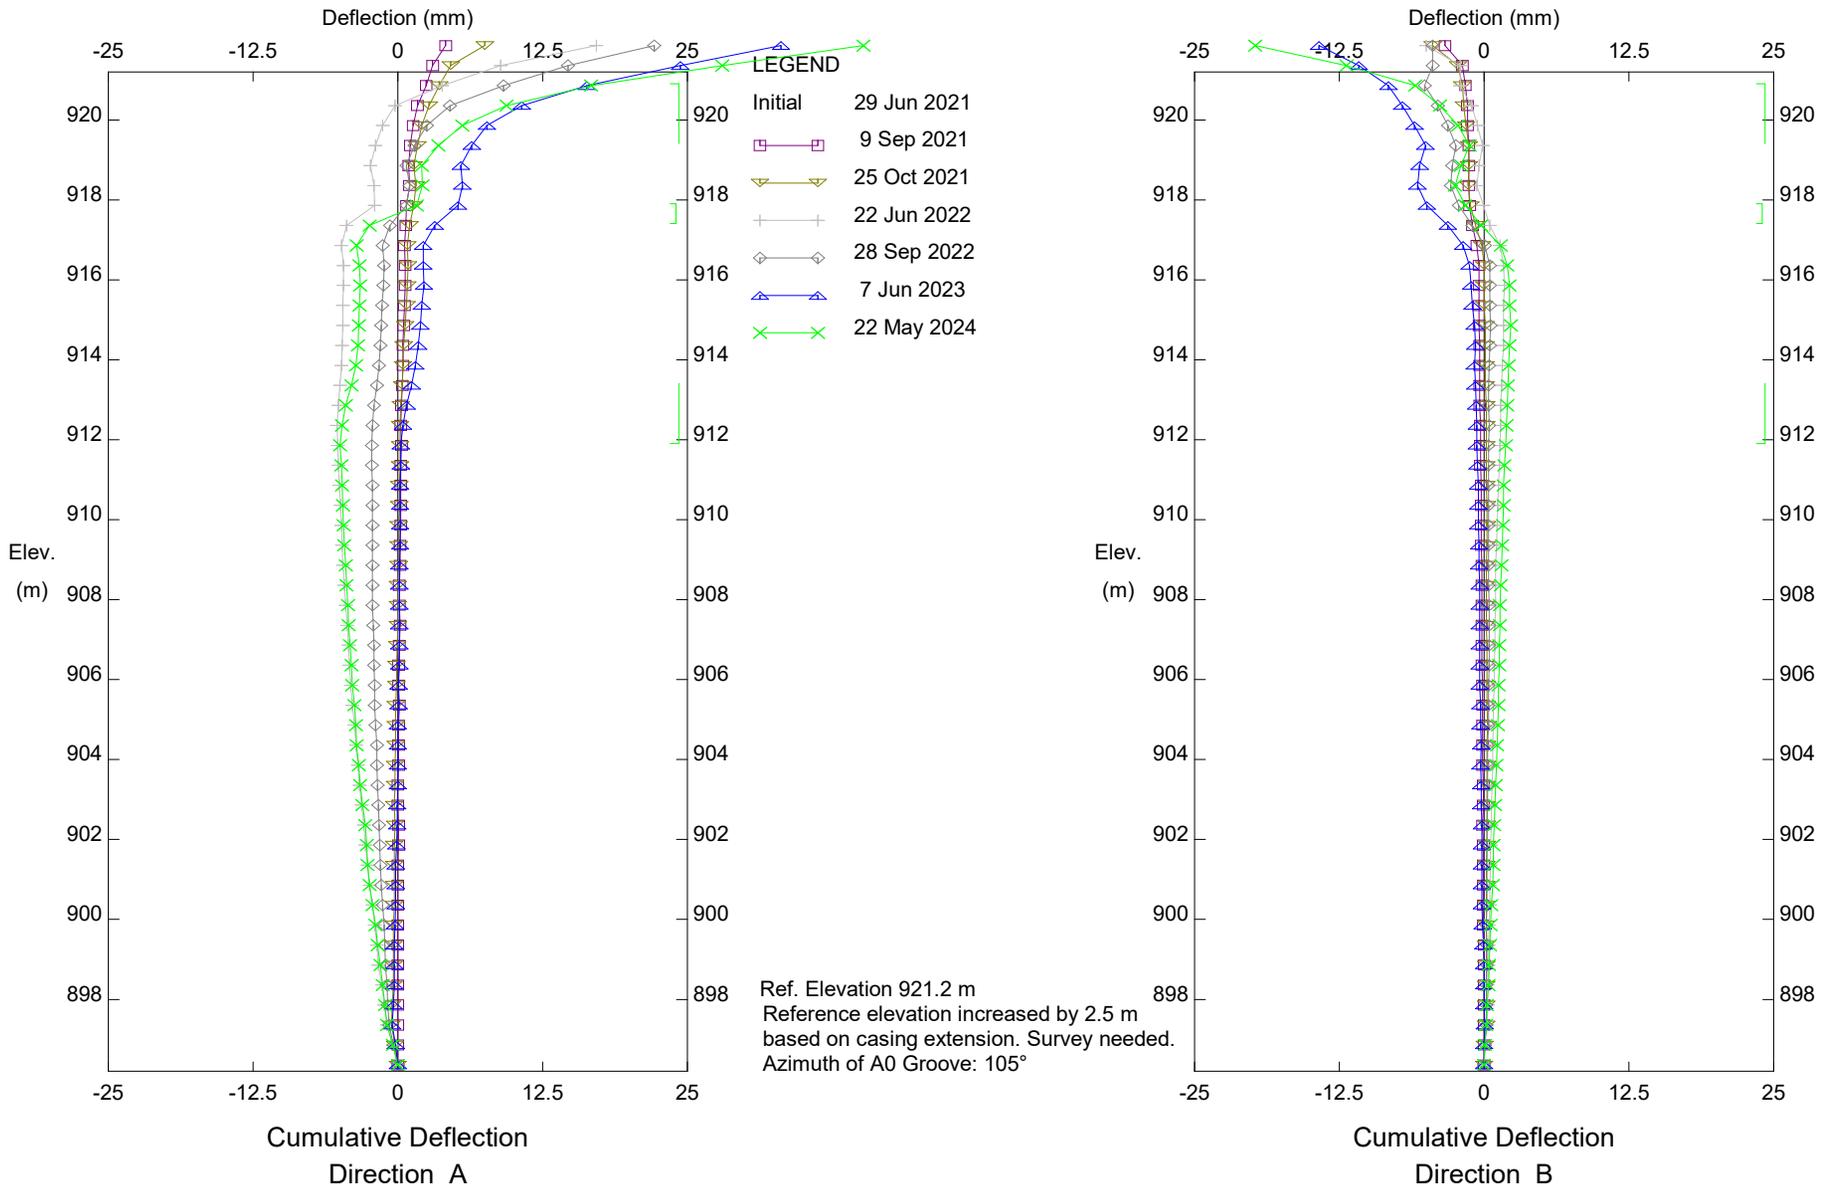
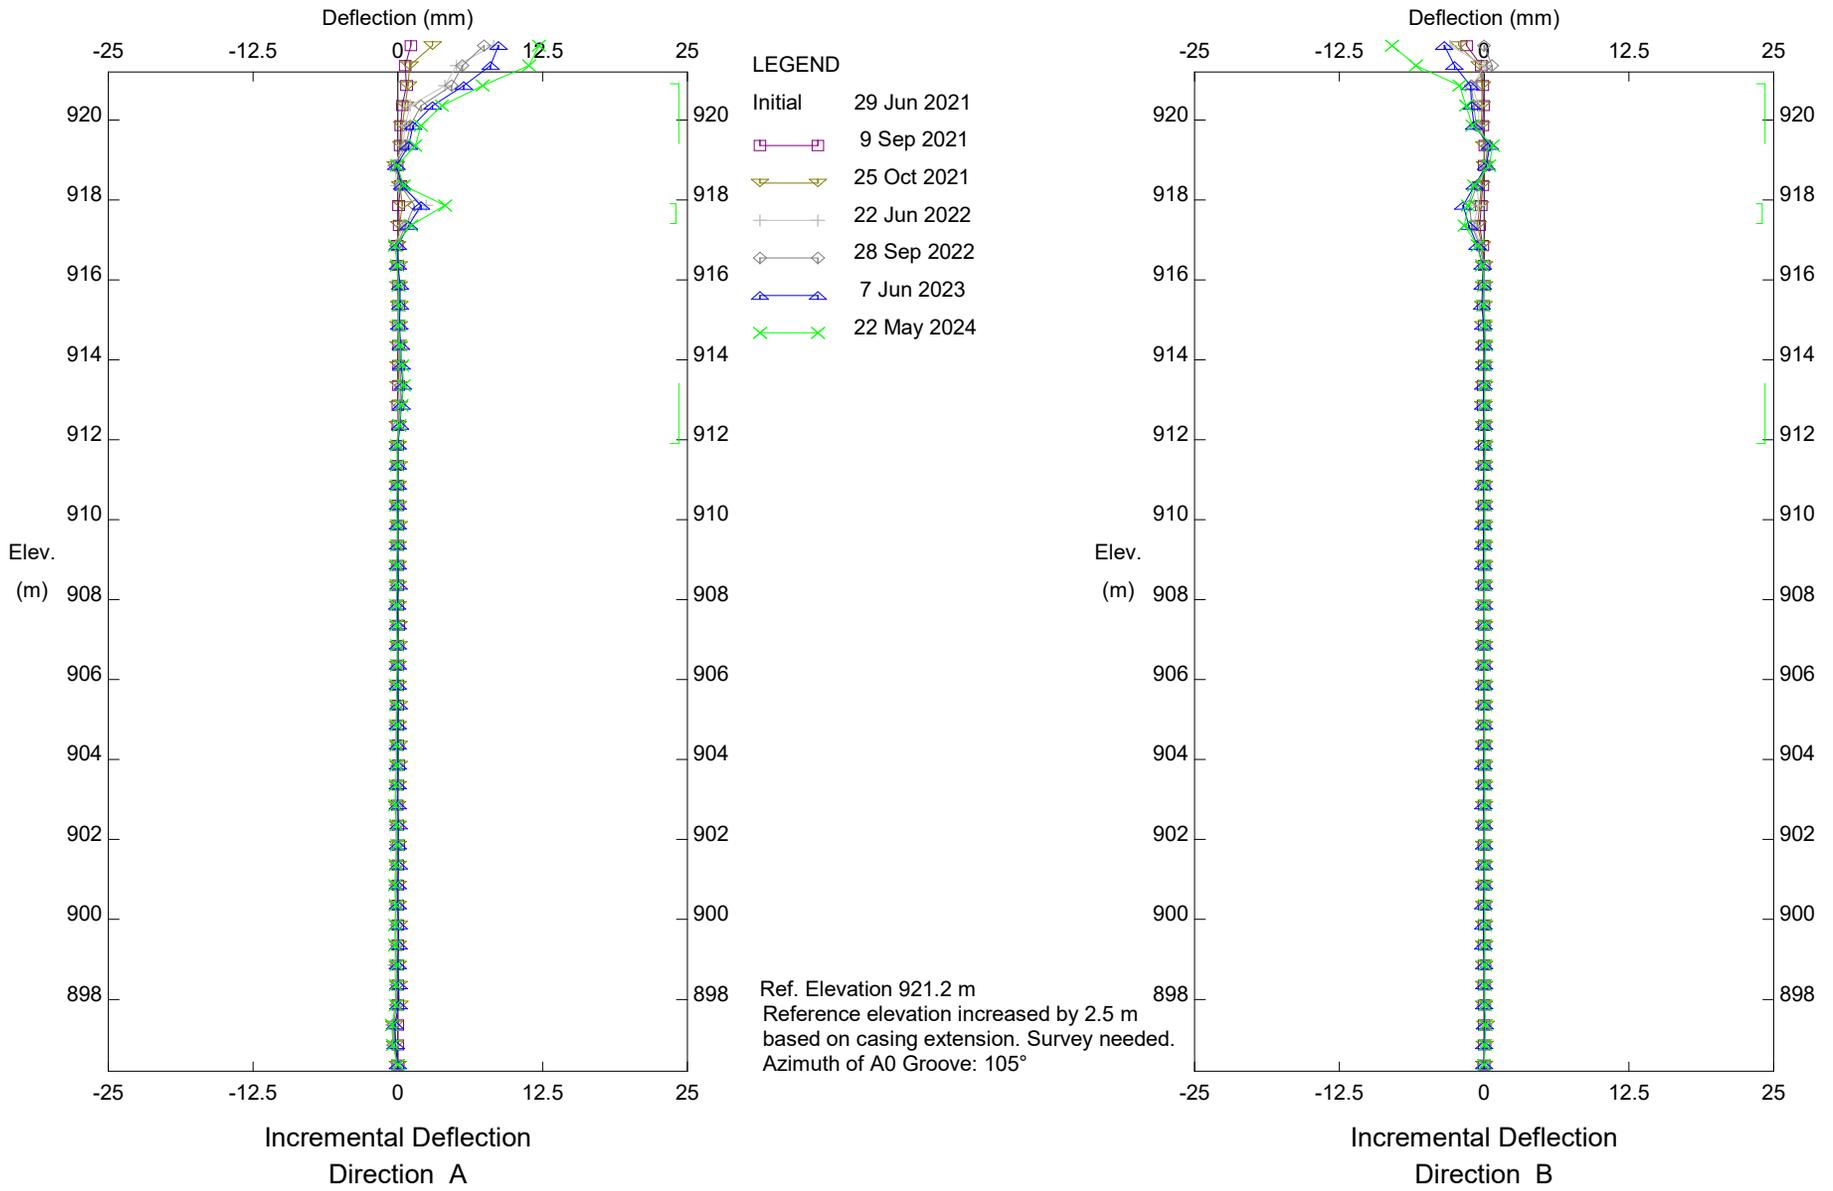
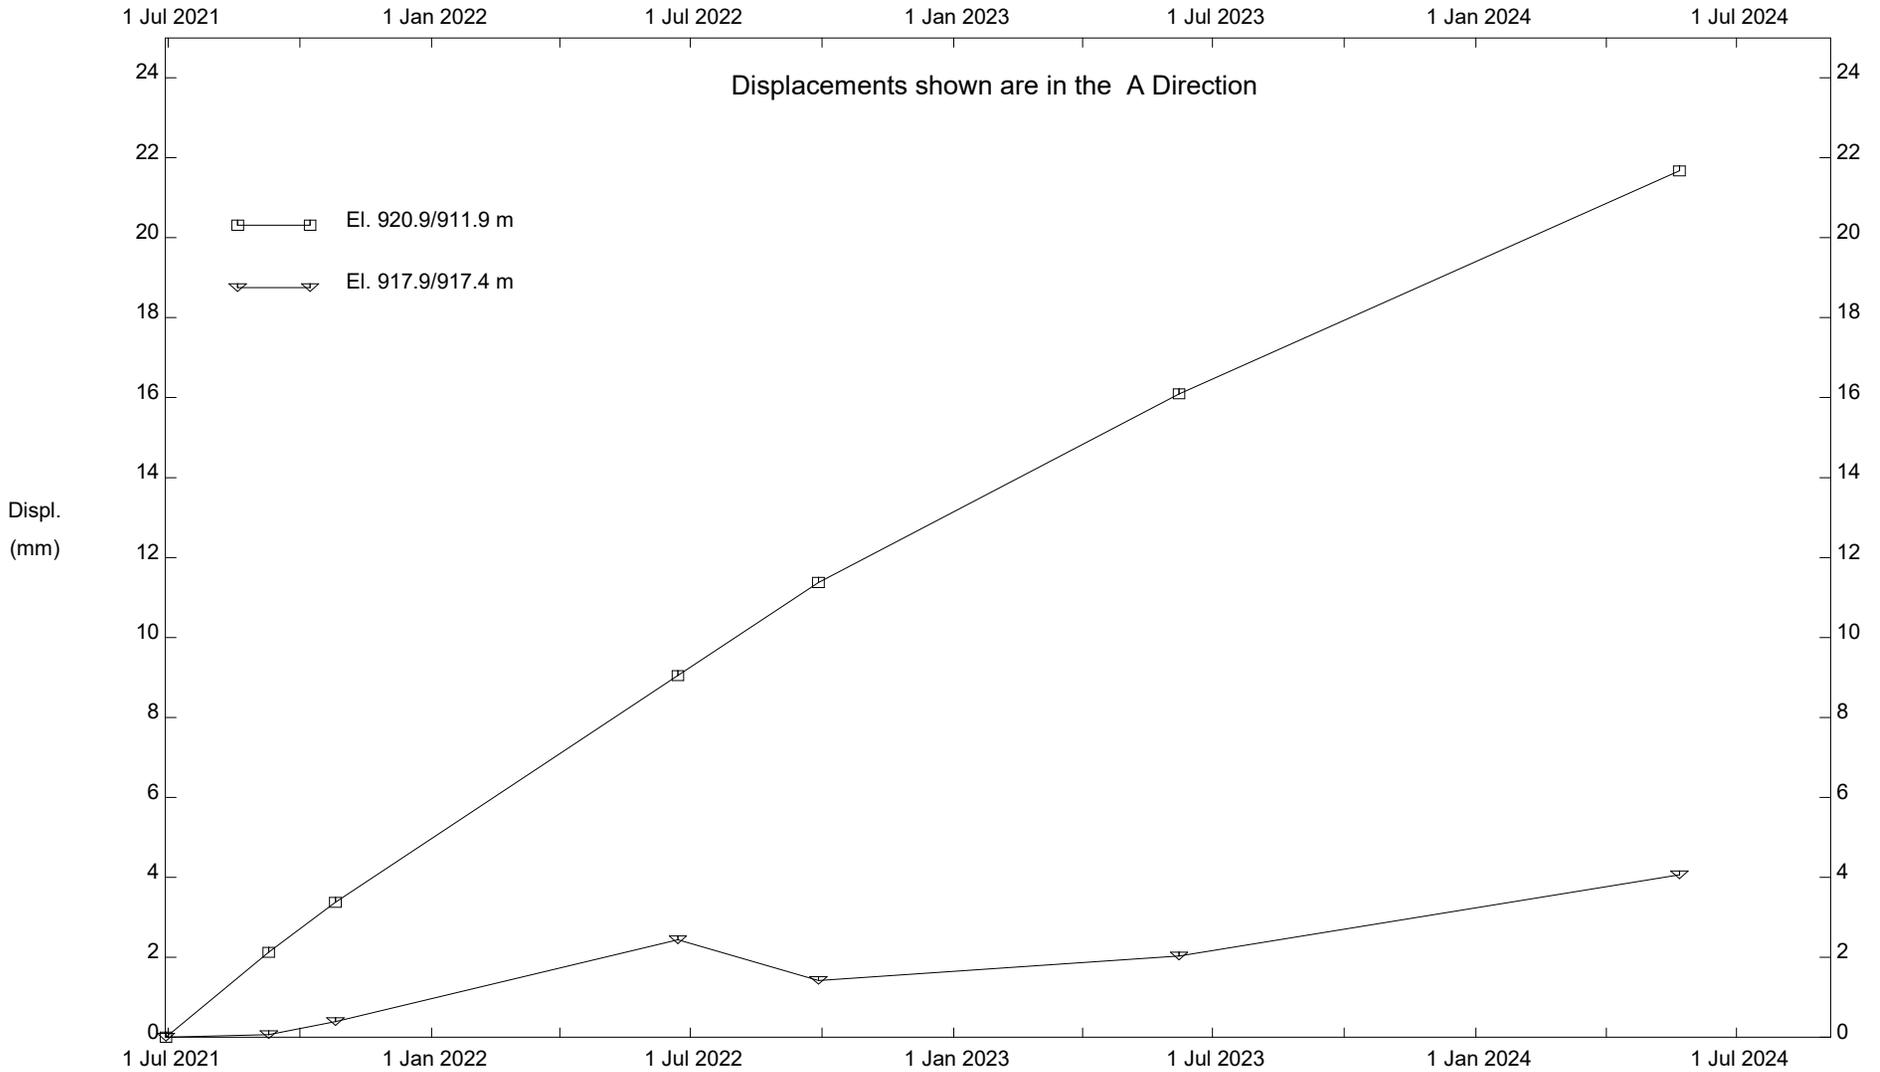
GP006; H40:36, Sheep Creek Embankment, Inclinometer SI19-2

No discernible movement had previously (i.e., before bin wall construction) been recorded in SI19-2 or SI19-3. However, since construction, large deflections have been recorded in the tops of these instruments to an approximate depth of 4 m below ground surface. These large deflections are believed to have been caused by cutting back (lowering) and raising the instrument casing during construction. KCB re-initialized the SI data plots to the June 2021 readings because these large deflections were complicating review of the SI data and potentially masking smaller movements that may be occurring. Since June 2021, distributed movement has been recorded in SI19-2 and SI19-3 up to an approximate depth of 9.3 m and 2.5 m, respectively. Since June 2022, some discrete movement has been recorded in SI19-2 at an approximate depth of 3.5 m below ground surface.

The movement recorded in SI-2, SI19-2, and SI19-3 since October 2020 can most likely be attributed to binwall construction in late 2020. Most notably in SI19-3, where a significant amount (approximately 583 mm) of shallow movement has been recorded since October 2020. This shallow movement may be attributed to settlement as the bin wall takes loading from the highway embankment, as well as deflection of the above-ground casing, since casing protectors were not installed for these instruments. Since the SIs were re-initialized to the June 2021 readings, between approximately 12 mm and 85 mm of shallow movement has been recorded in these instruments. Overall, the rate of movement recorded in these instruments is beginning to slow, but ongoing pavement surface distress, including cracking and settlement, has been observed behind the binwall.
