July 15, 2024

CON0022166 Peace Region (Grande Prairie District – South) GRMP Instrumentation Monitoring Site GP006; H40:36, km 21.779 Sheep Creek Embankment (Three Teardrops Slide) Section C – 2024 Spring Readings

Site Plan
 GP006 - Sheep Creek Embankment
 (Three Teardrops Slide)
 Hwy 40:36, km 21.779

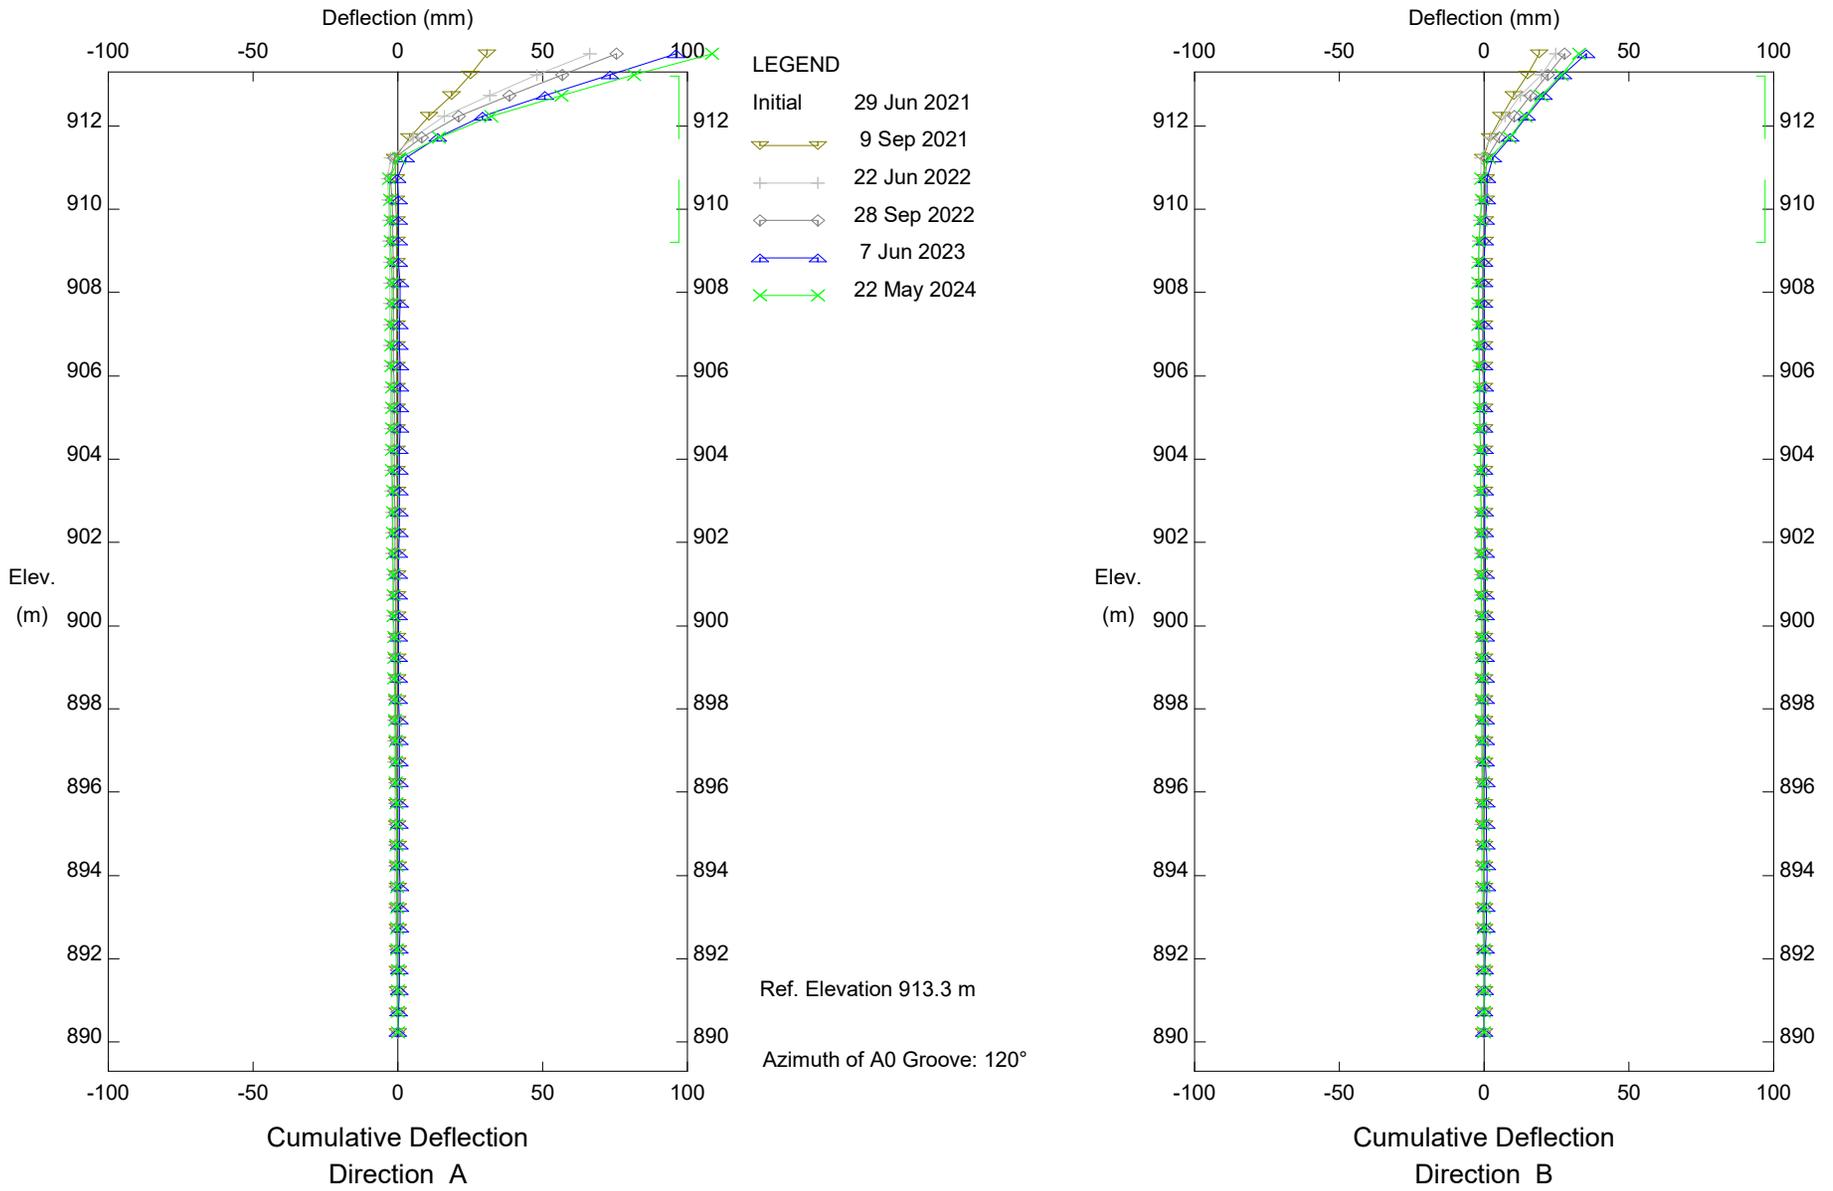
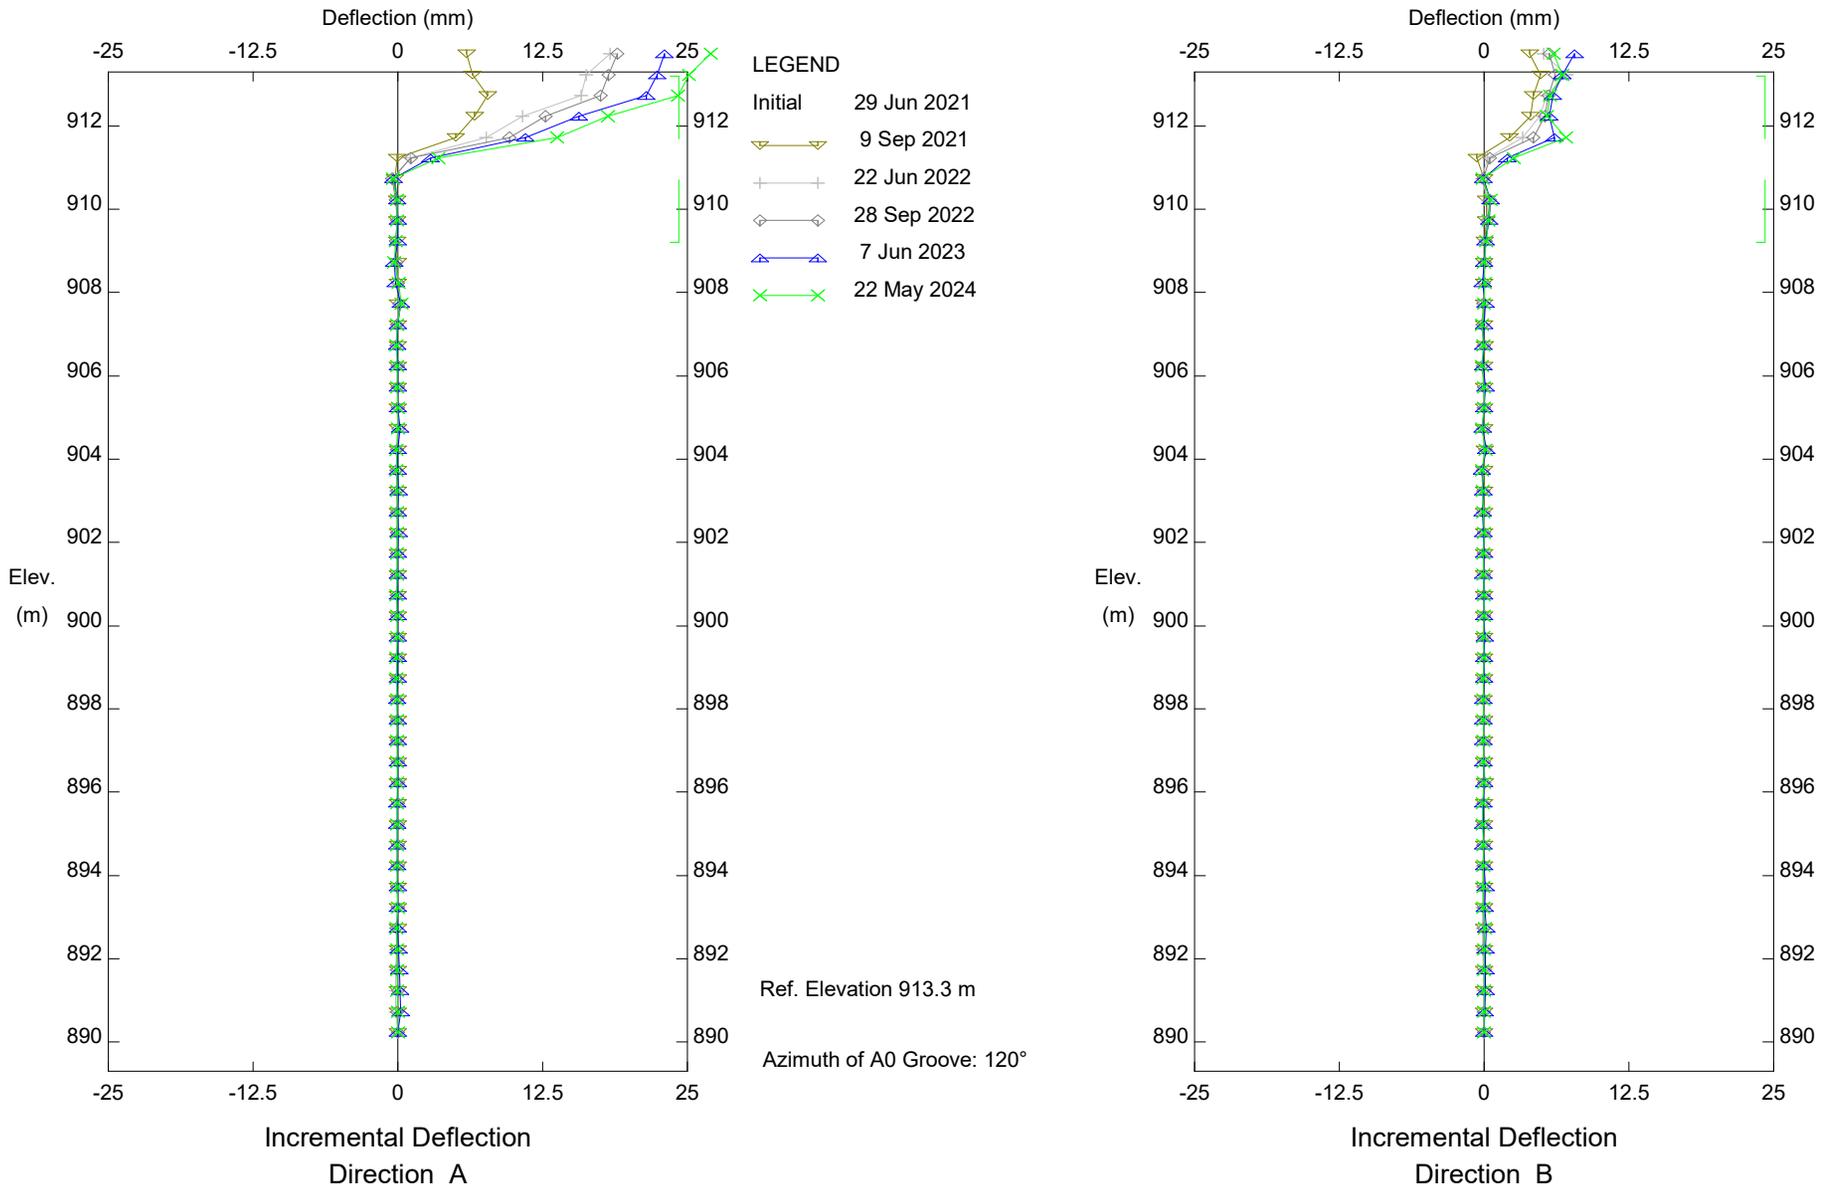
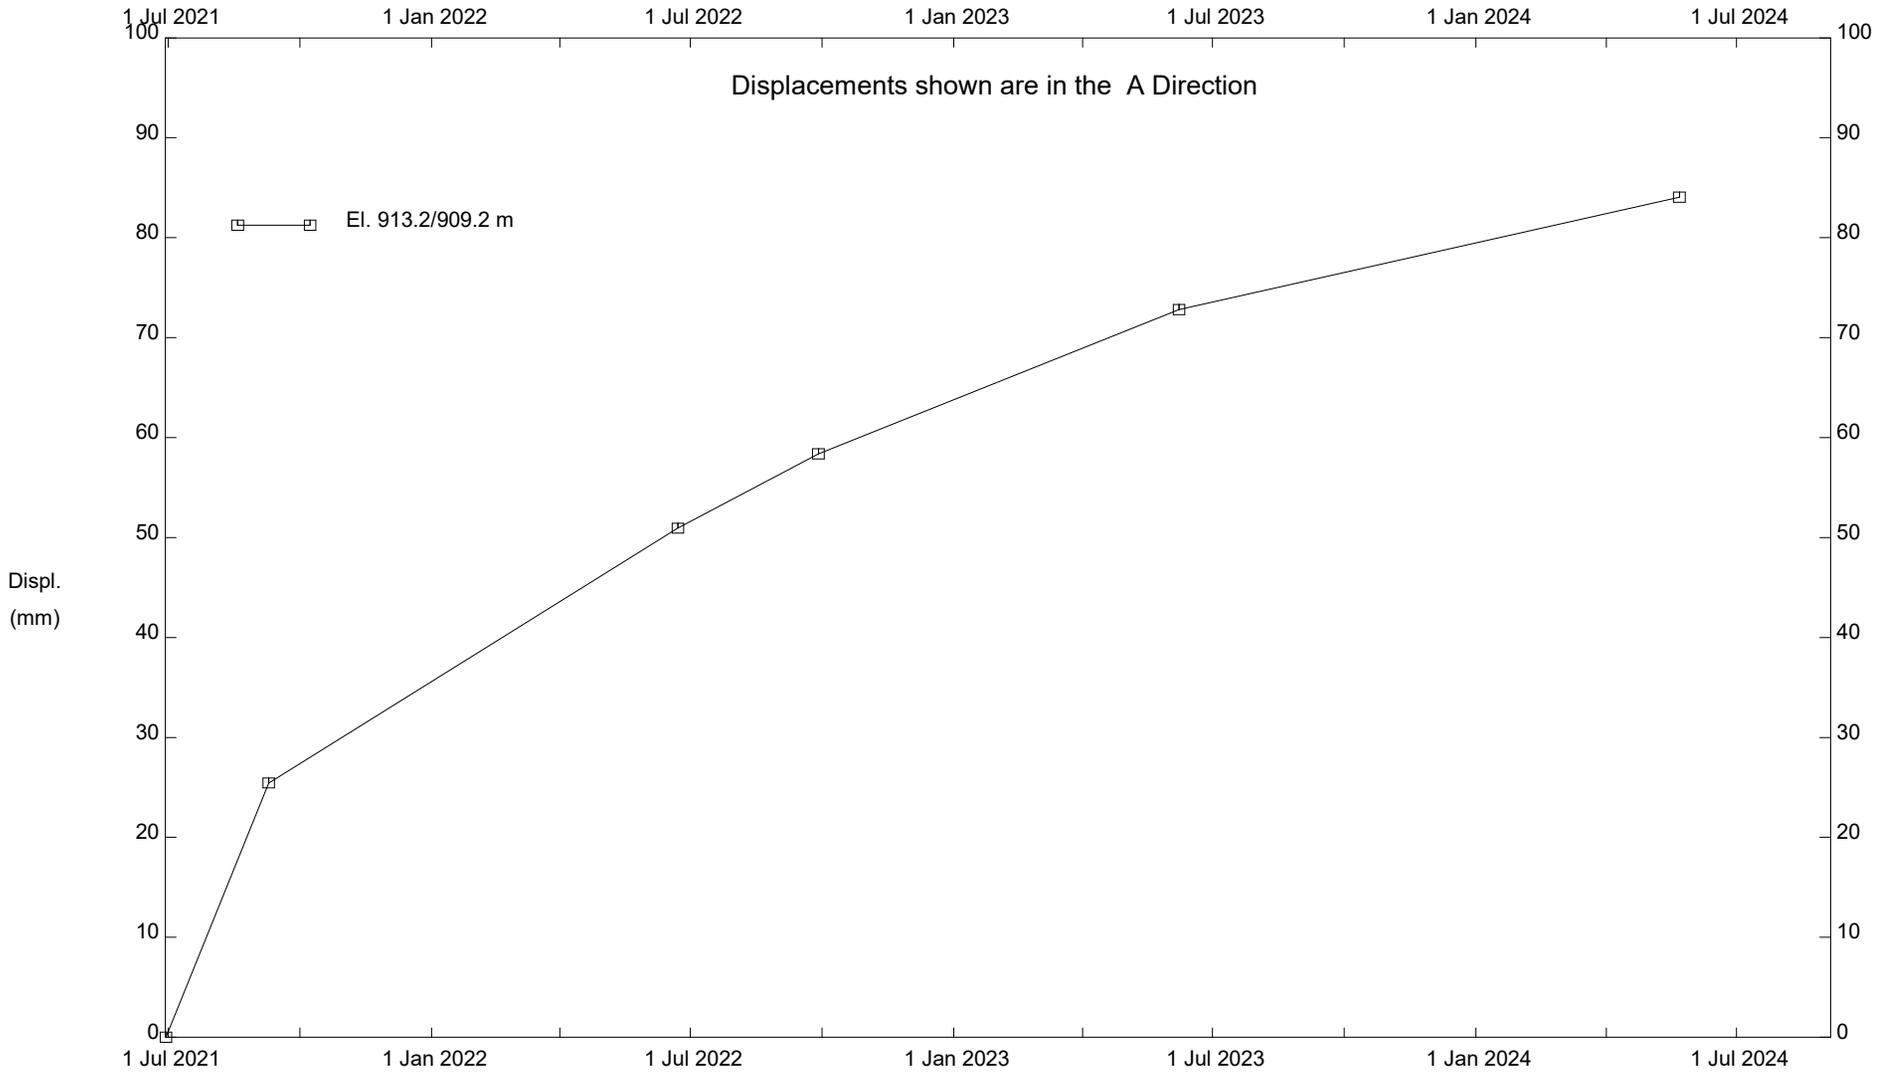
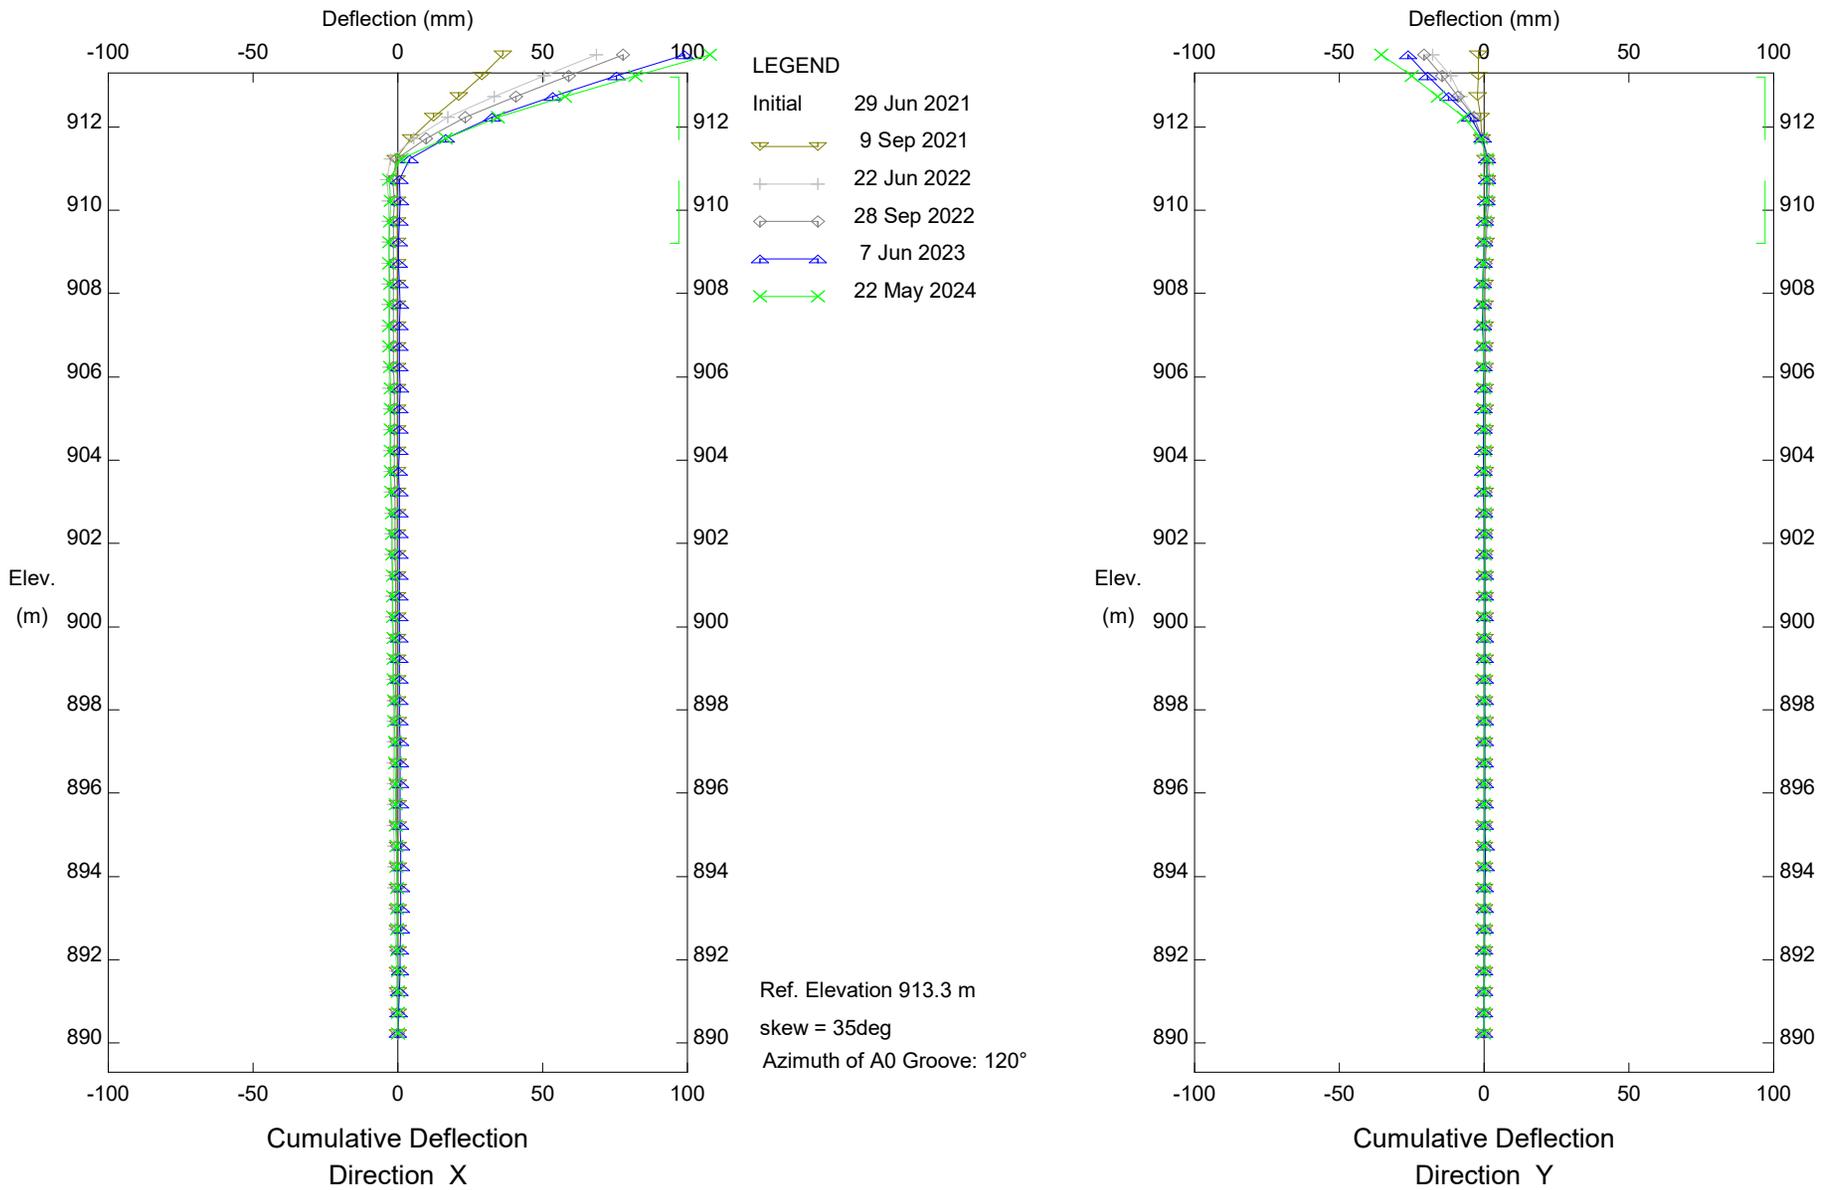
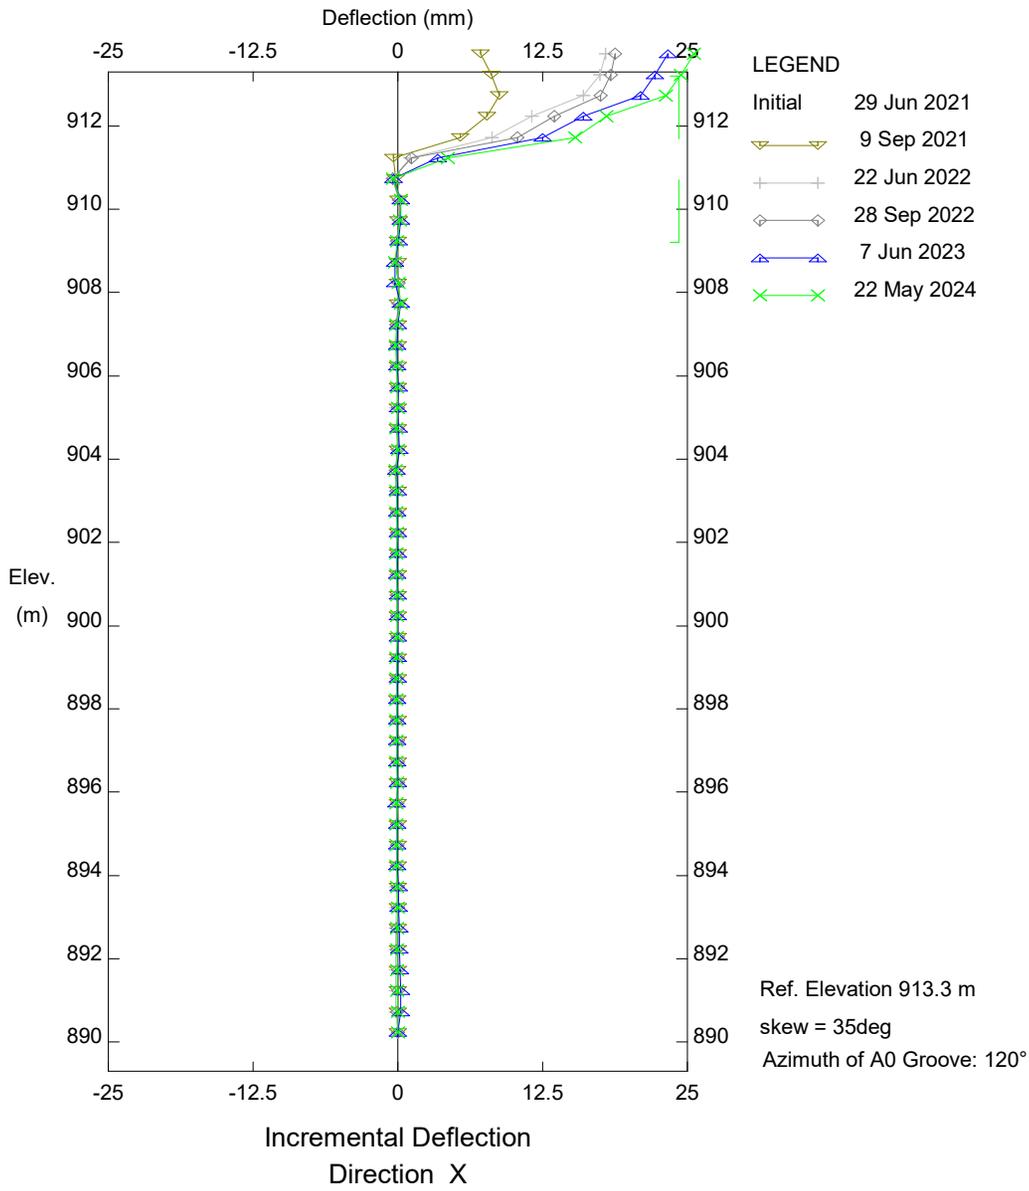
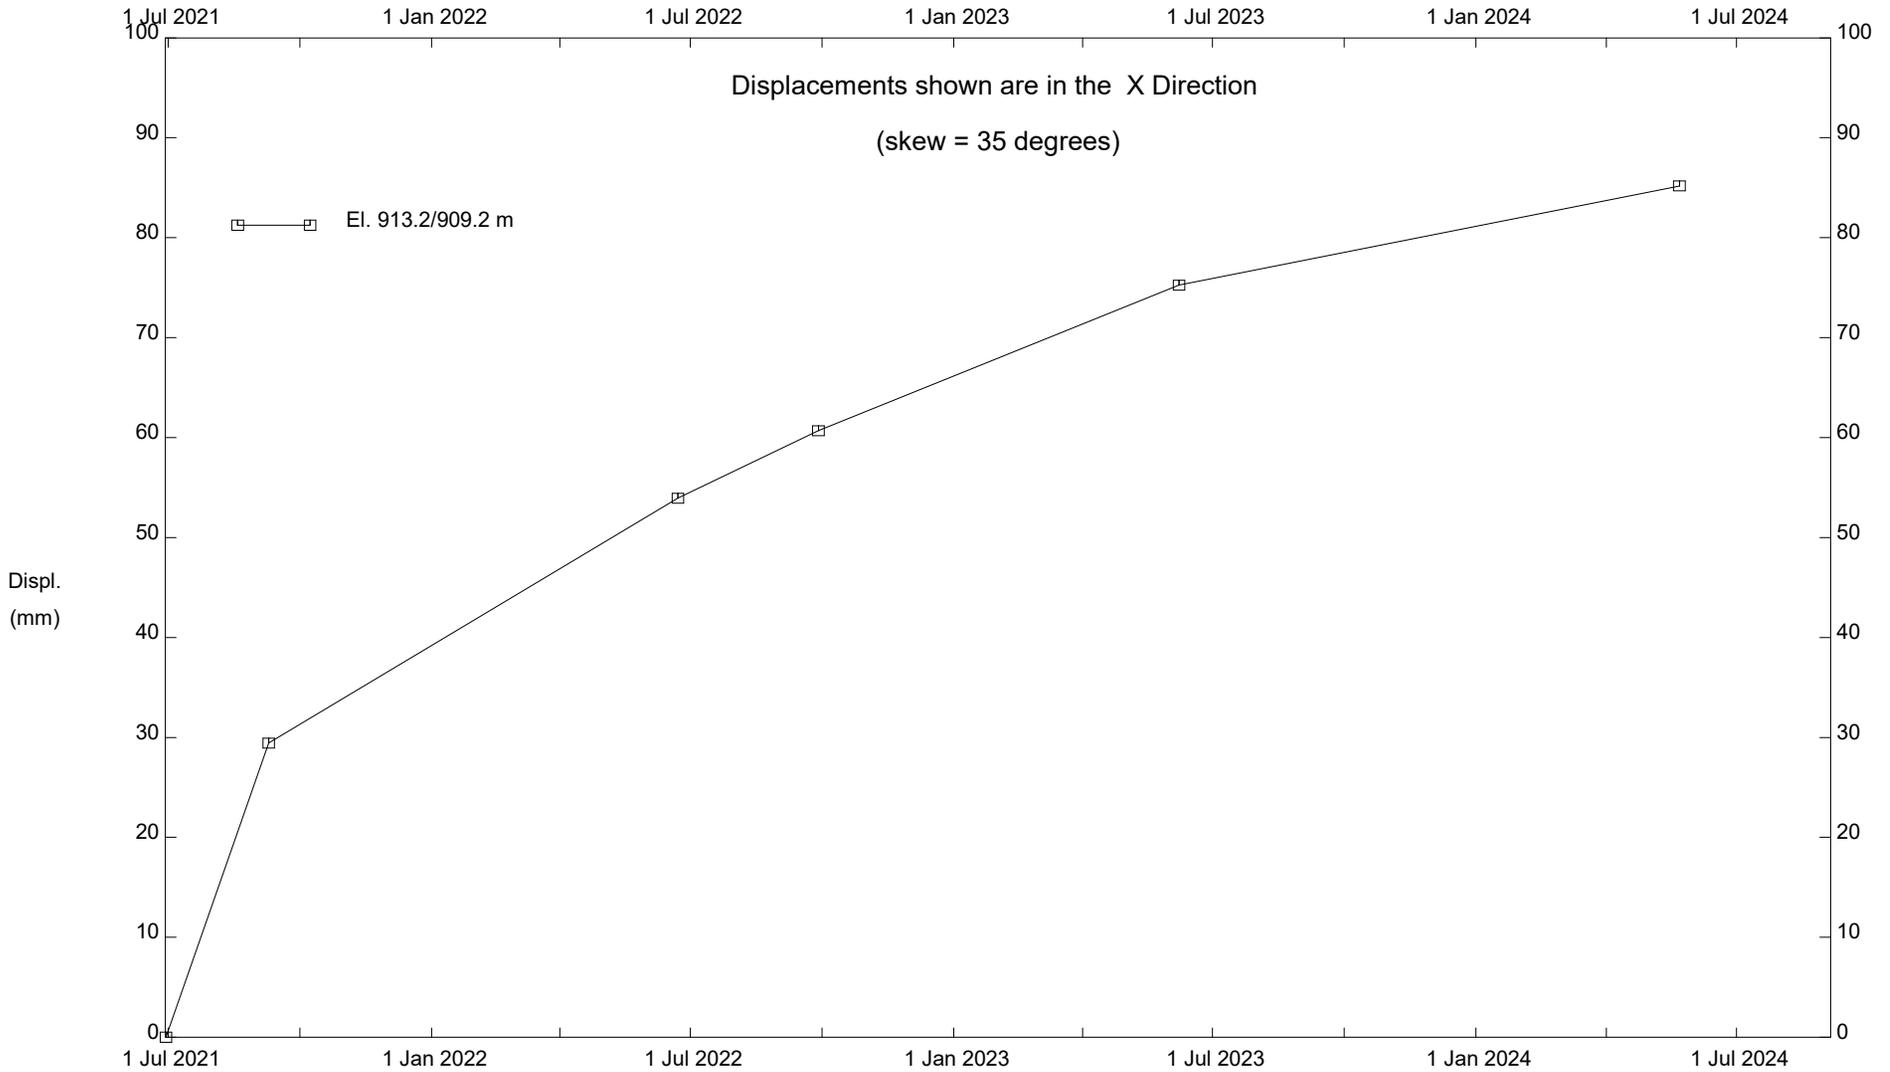
GP006; H40:36, Sheep Creek Embankment, Inclinometer SI19-3

No discernible movement had previously (i.e., before bin wall construction) been recorded in SI19-2 or SI19-3. However, since construction, large deflections have been recorded in the tops of these instruments to an approximate depth of 4 m below ground surface. These large deflections are believed to have been caused by cutting back (lowering) and raising the instrument casing during construction. KCB re-initialized the SI data plots to the June 2021 readings because these large deflections were complicating review of the SI data and potentially masking smaller movements that may be occurring. Since June 2021, distributed movement has been recorded in SI19-2 and SI19-3 up to an approximate depth of 9.3 m and 2.5 m, respectively. Since June 2022, some discrete movement has been recorded in SI19-2 at an approximate depth of 3.5 m below ground surface.

The movement recorded in SI-2, SI19-2, and SI19-3 since October 2020 can most likely be attributed to binwall construction in late 2020. Most notably in SI19-3, where a significant amount (approximately 583 mm) of shallow movement has been recorded since October 2020. This shallow movement may be attributed to settlement as the bin wall takes loading from the highway embankment, as well as deflection of the above-ground casing, since casing protectors were not installed for these instruments. Since the SIs were re-initialized to the June 2021 readings, between approximately 12 mm and 85 mm of shallow movement has been recorded in these instruments. Overall, the rate of movement recorded in these instruments is beginning to slow, but ongoing pavement surface distress, including cracking and settlement, has been observed behind the binwall.
