July 15, 2025

CON0022166 Peace Region (Grande Prairie District – South) GRMP Instrumentation Monitoring Site GP006; H40:36, km 21.779 Sheep Creek Embankment (Three Teardrops Slide) Section C – 2025 Spring Readings

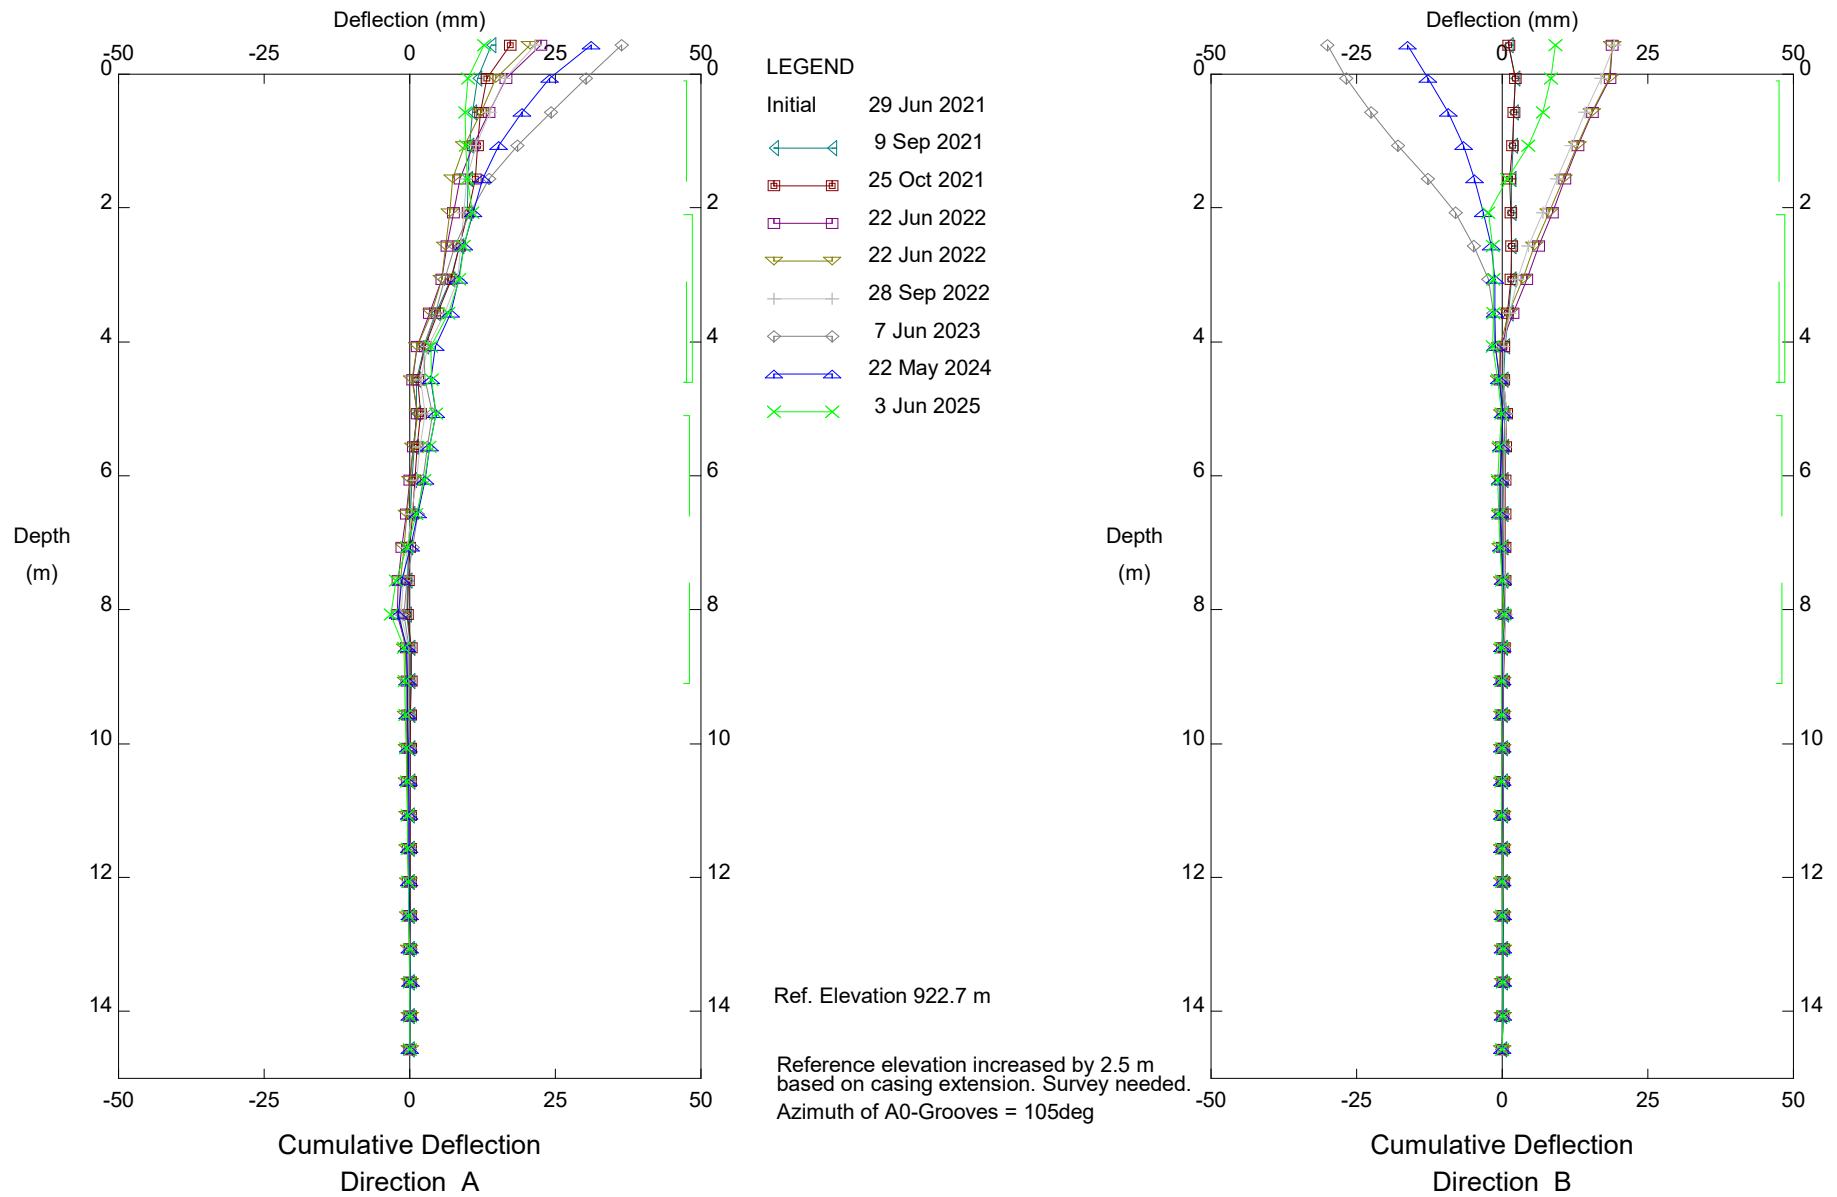
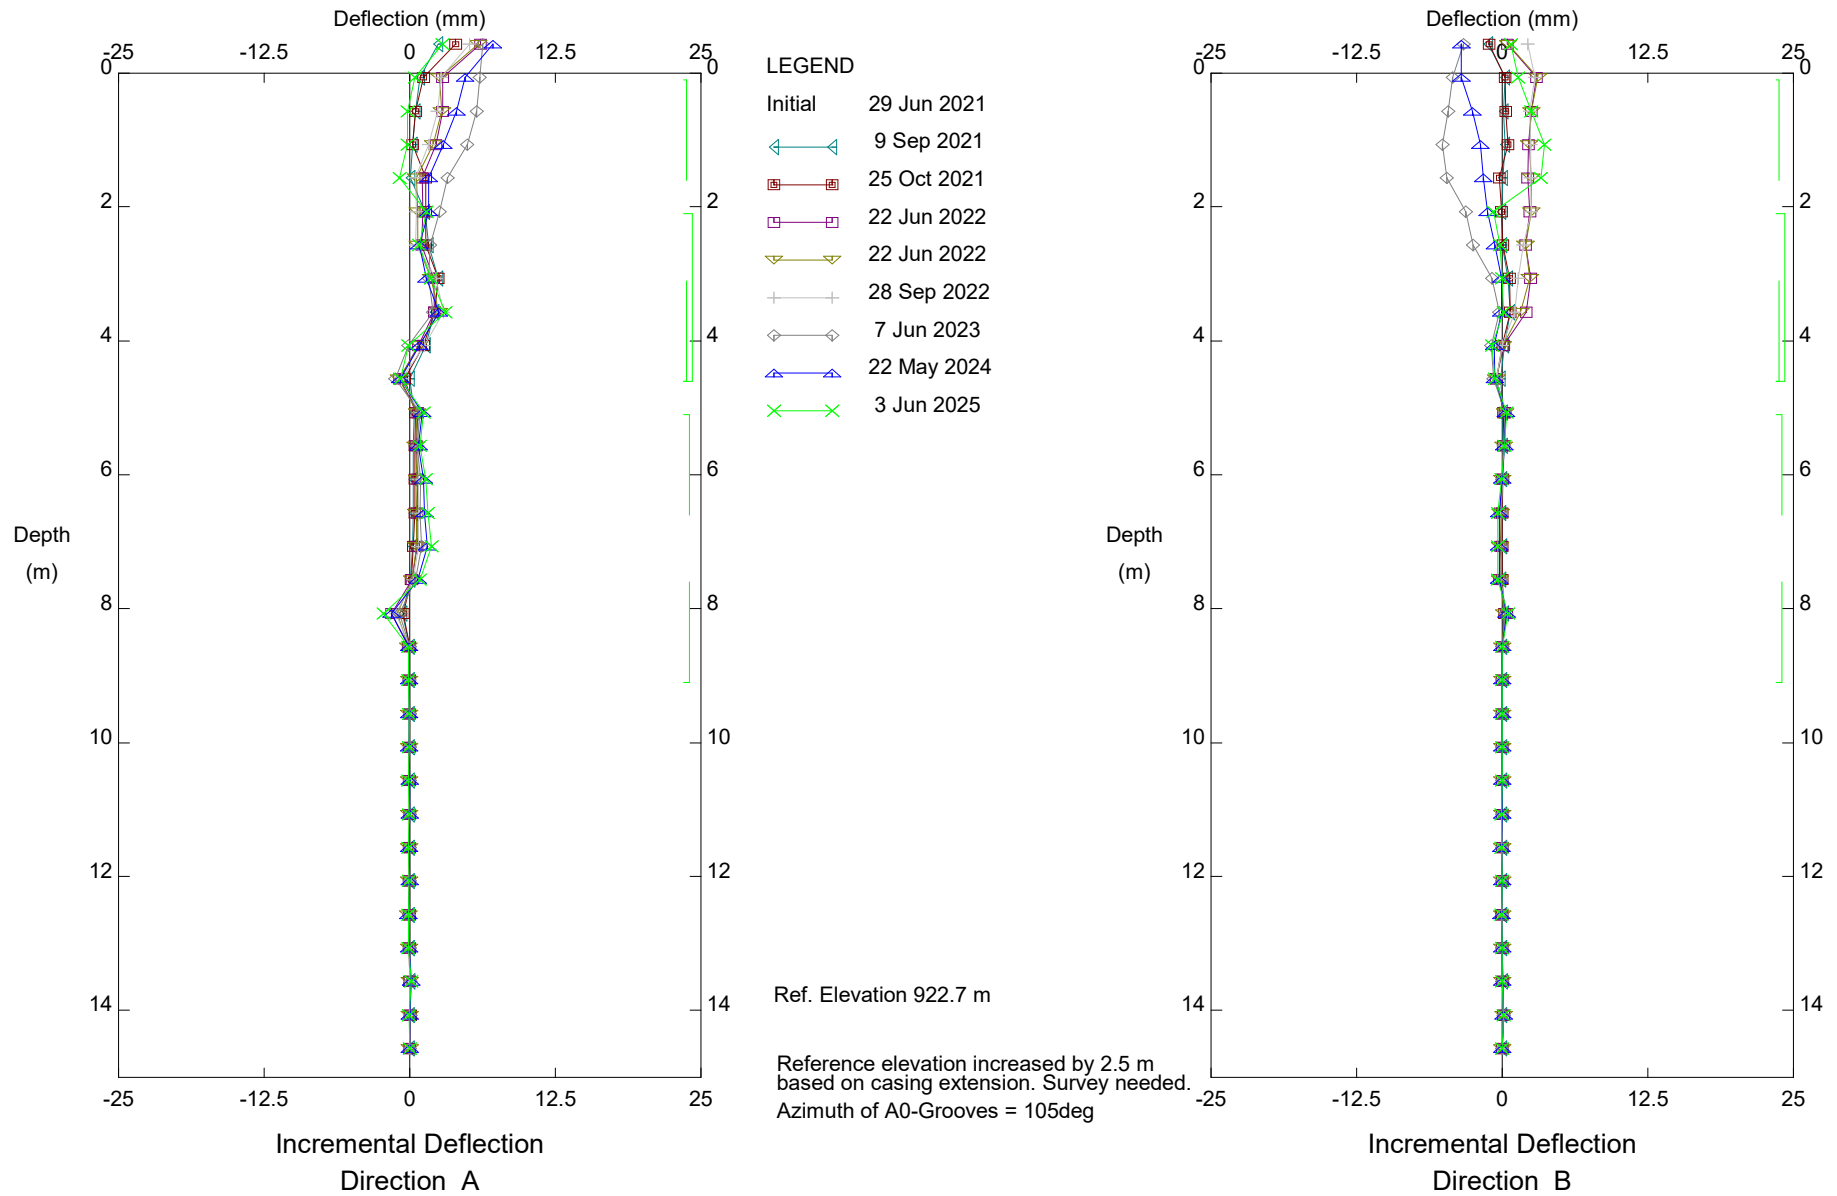
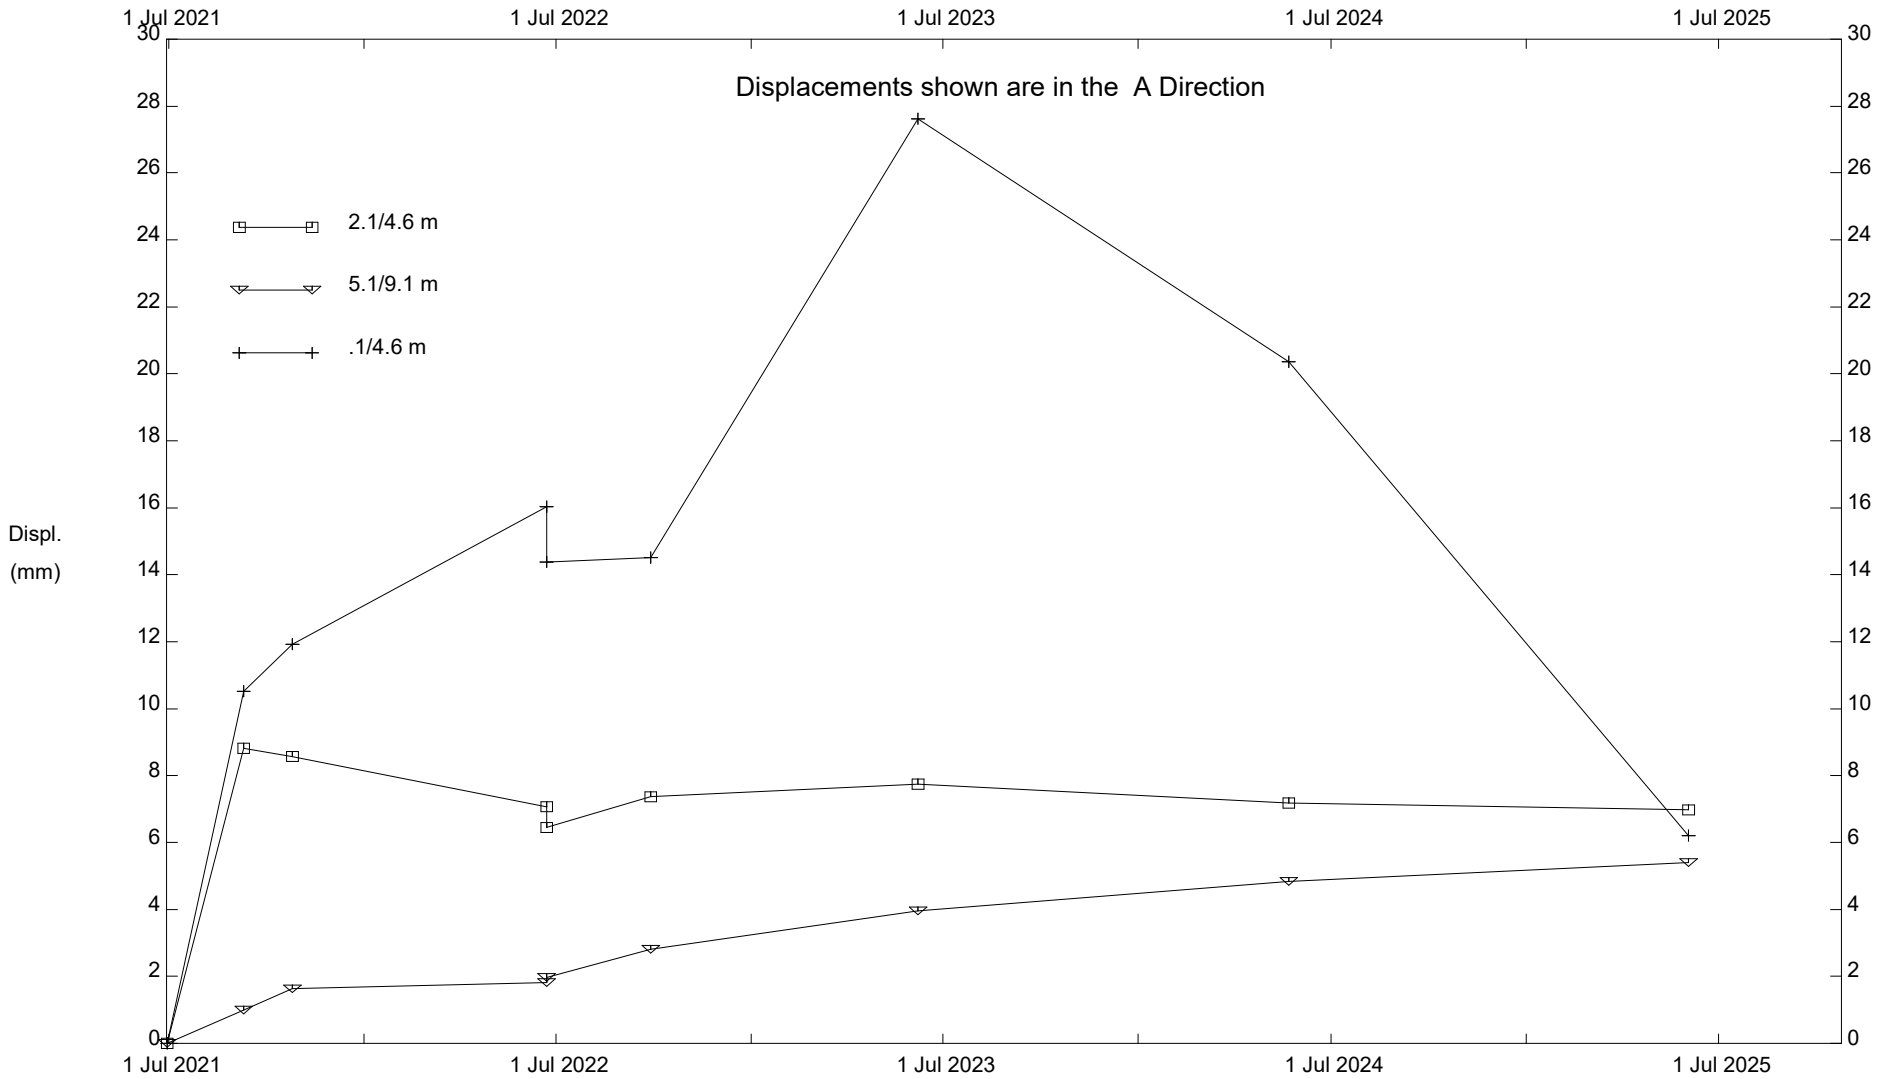
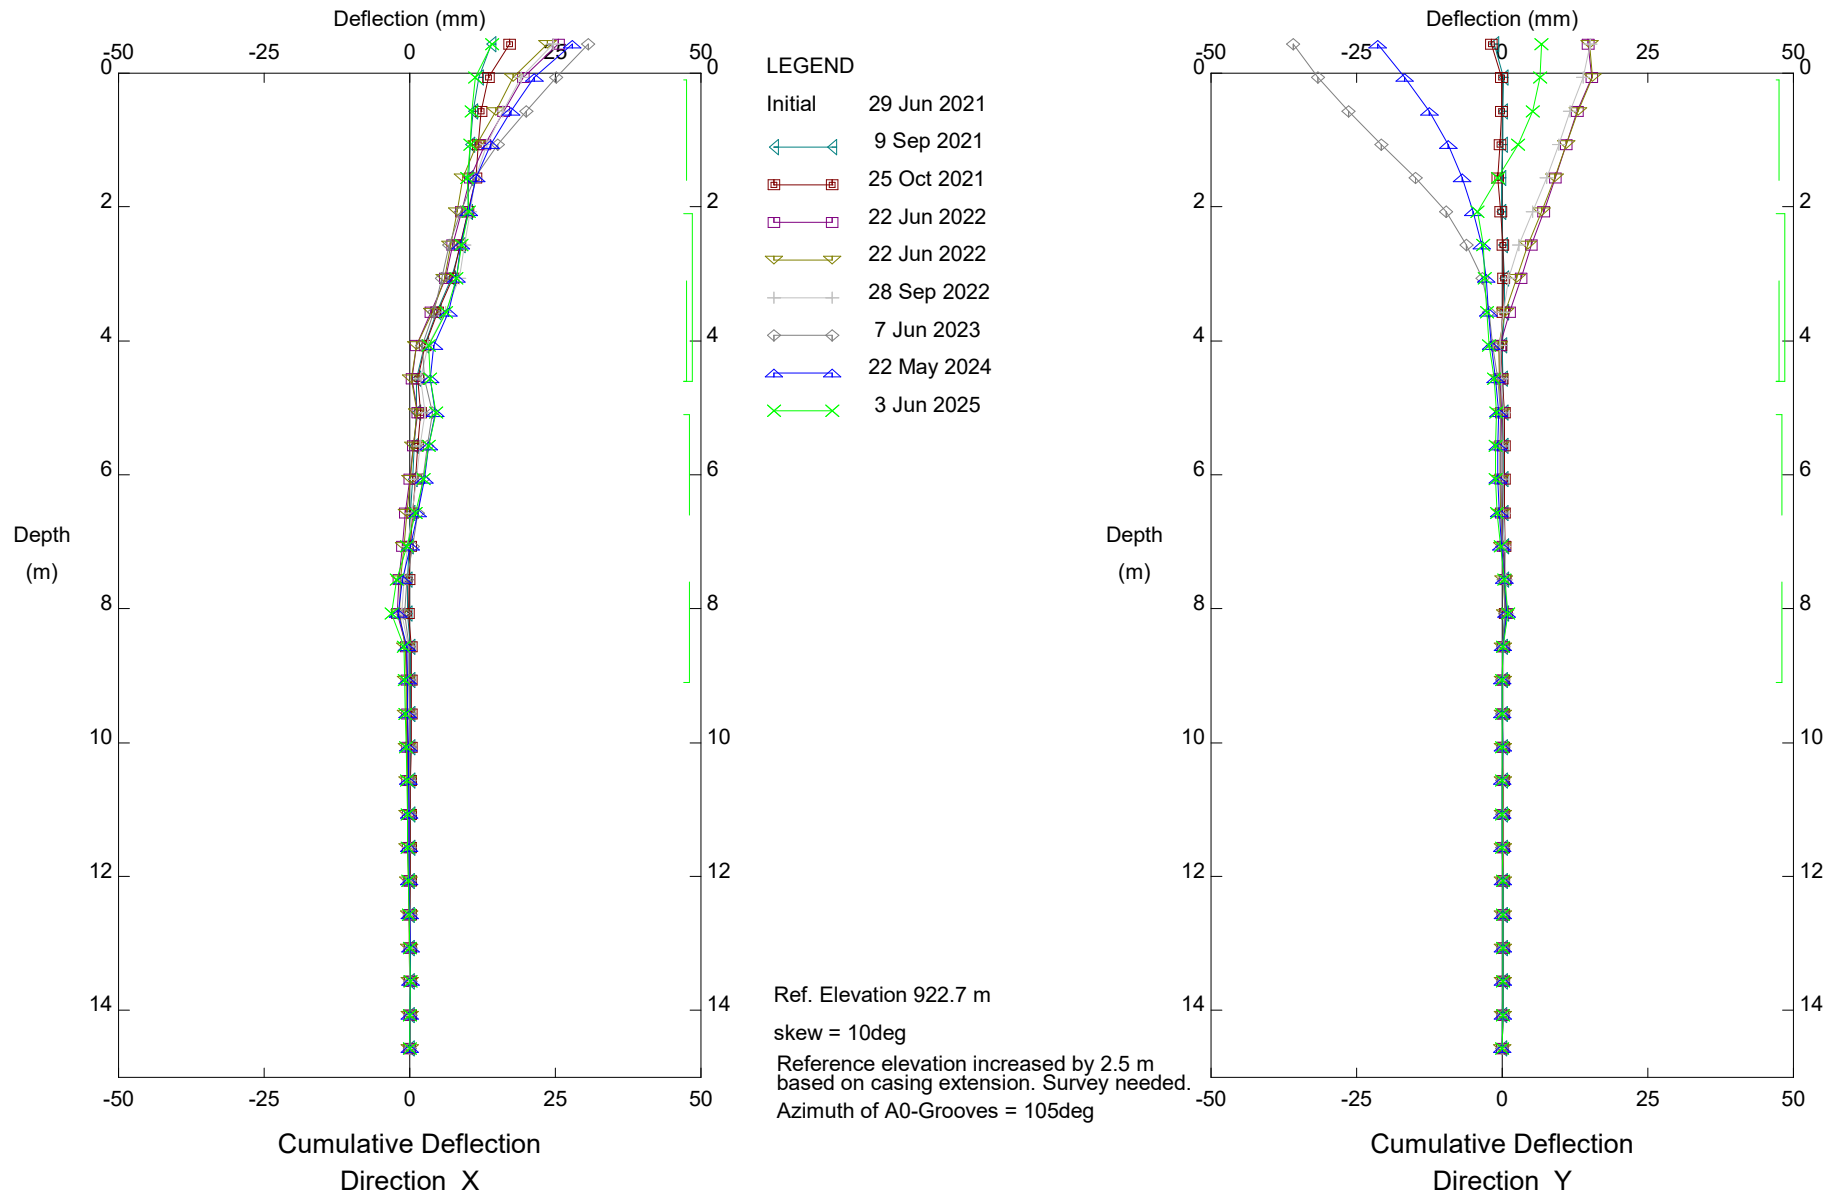
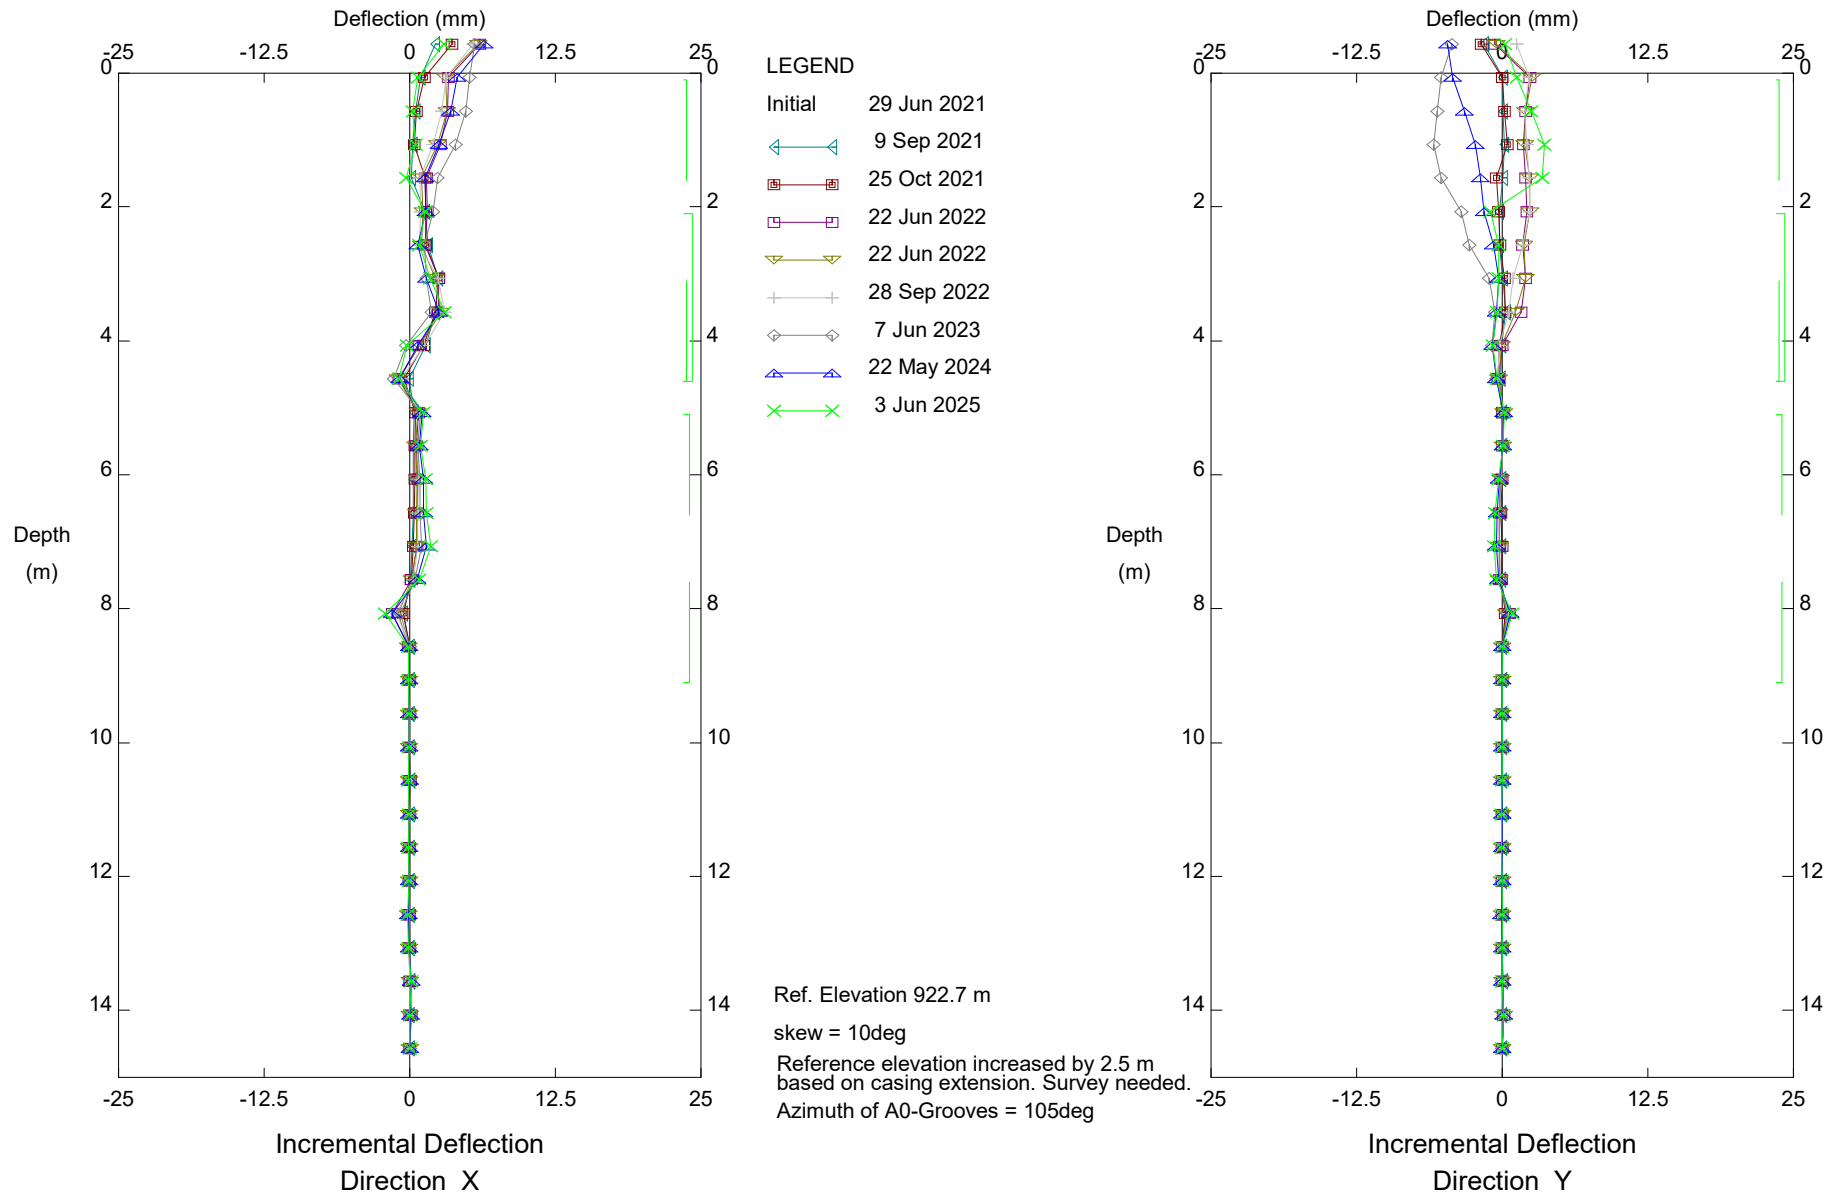
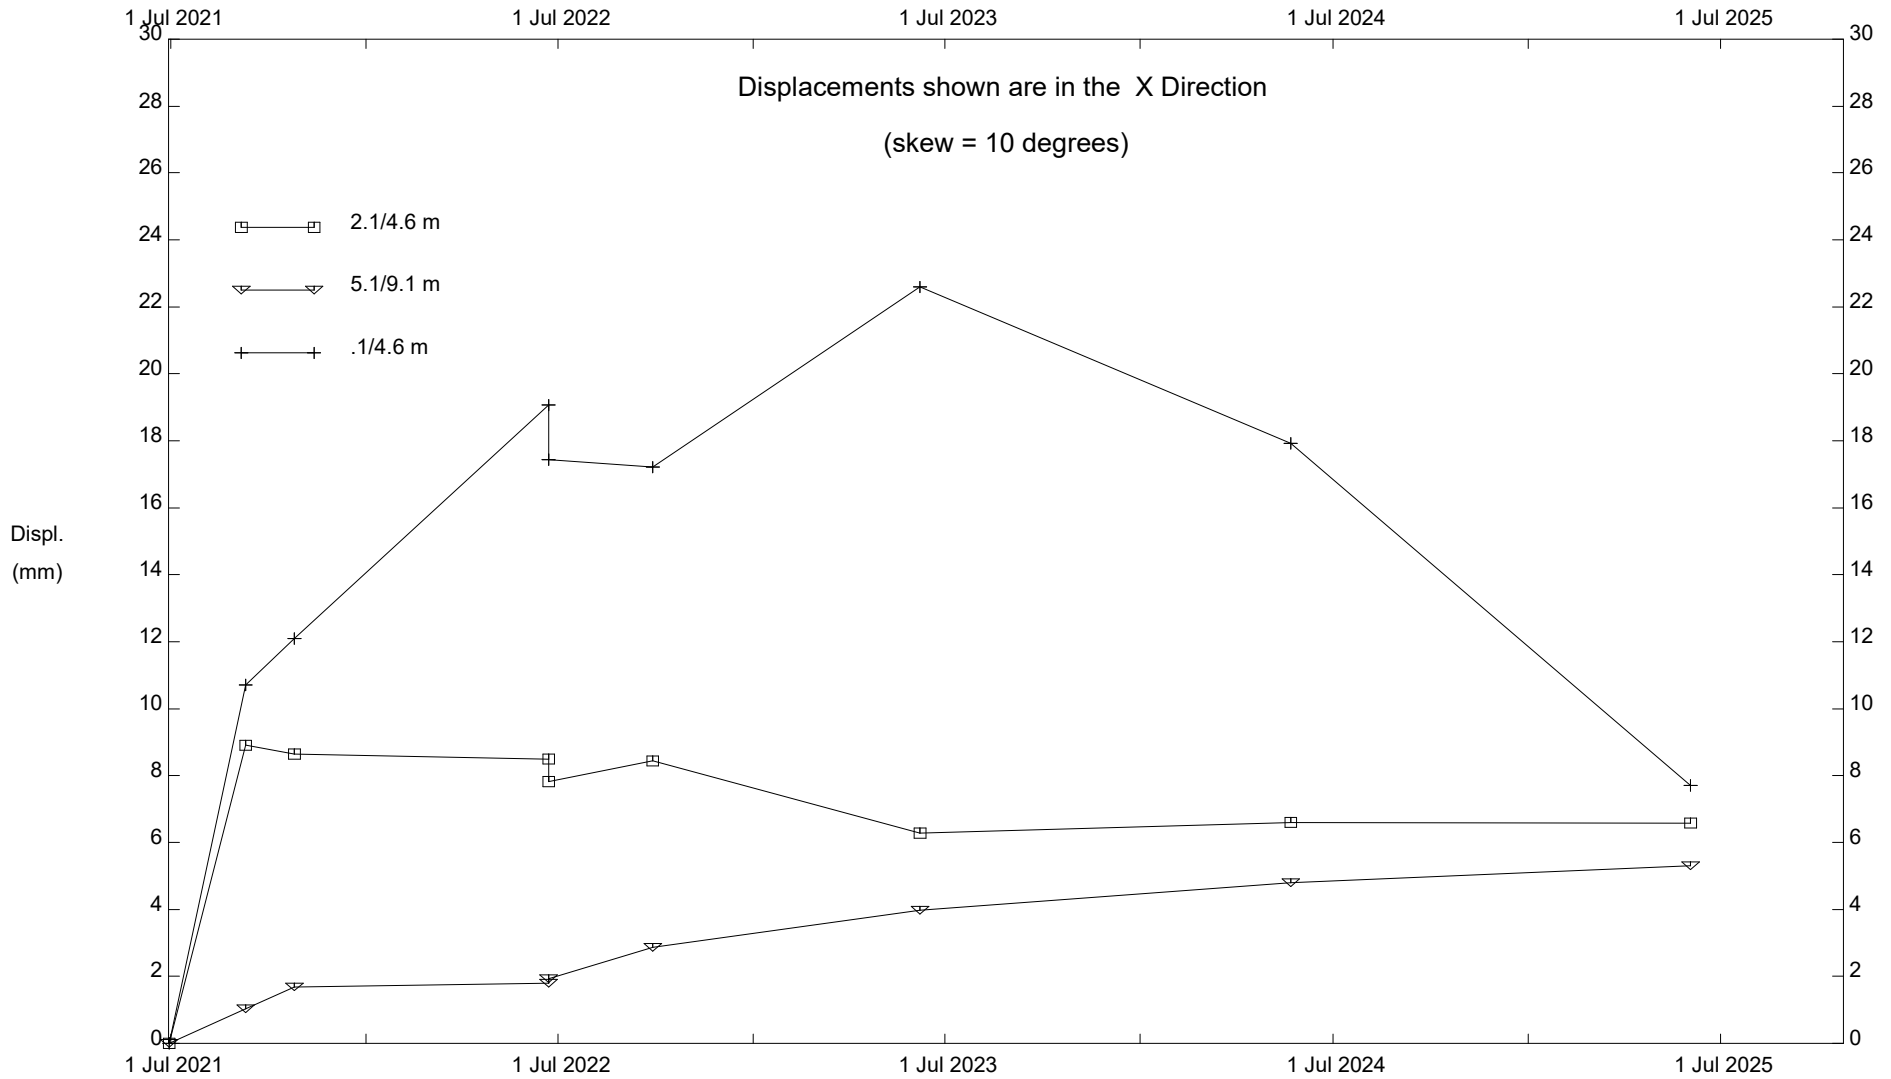
- Large deflections that were recorded in the tops of SI-2, SI19-2, and SI19-3 up to an approximate depth of 6 m below ground surface. The deflections are likely due to binwall construction in late 2020. It is noted that SI-2 and SI19-2 were shortened to the binwall bench level and then later raised through the bin wall fill during construction. It also appears the instruments were raised again after the previous consultant took their last reading in October 2020. The exact length of casing added is unknown but was estimated to be 2.5 m. KCB has subsequently extended the data files for SI-2 and SI19-2 by 2.5 m. The instruments have been read to the adjusted depth since June 2022, and the data aligns with the new reading depth. Due to the large deflections, KCB re-initialized the SI data plots to the June 2021 readings. It is noted that the data for SI19-2 is noisy and difficult to interpret, and the instrument may need to be re-initialized again. Based on the absolute plot, SI19-2 is tilted approximately 1.0 m and 2.4 m in the A- and B-directions, respectively.

Distributed movement was being recorded in the A-direction of SI-2 between an approximate depth of 6.1 m and 9.1 m below ground surface. However, due to a large deflection that was recorded in the top 6 m of the SI casing since late 2020, KCB re-initialized the instrument to the June 2021 reading. Since June 2021, distributed movement has continued to be recorded in SI-2 from ground surface to an approximate depth of 9.1 m below ground surface.

A relatively large amount of displacement (up to approximately 30 mm) has been recorded in the B-direction of SI-2 from ground surface to an approximate depth of 5.1 m. The direction of movement varies from positive to negative indicating the displacement may be attributed to movement in the fill placed in 2020, or seasonal temperature fluctuations (i.e., frost penetration).
