July 15, 2025

CON0022166 Peace Region (Grande Prairie District – South) GRMP Instrumentation Monitoring Site GP006; H40:36, km 21.779 Sheep Creek Embankment (Three Teardrops Slide) Section C – 2025 Spring Readings

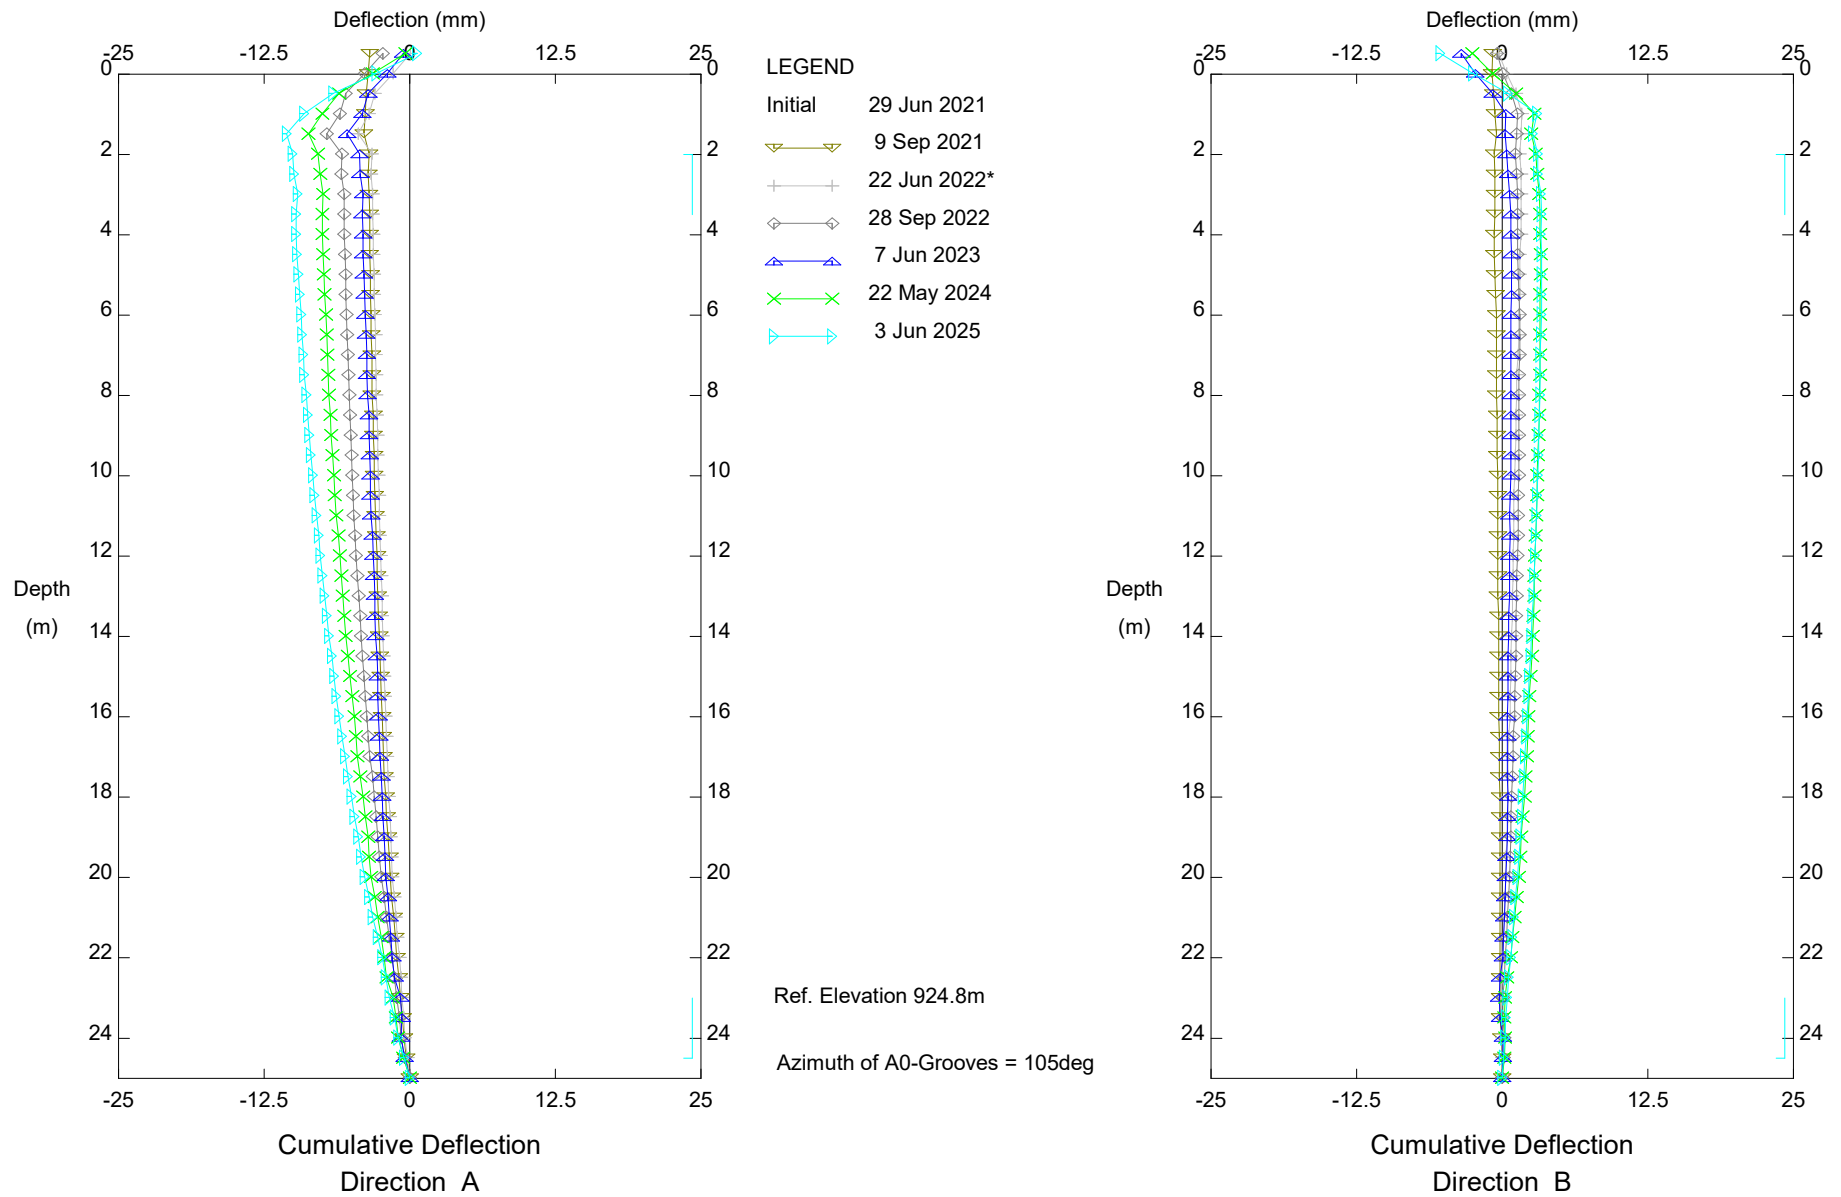
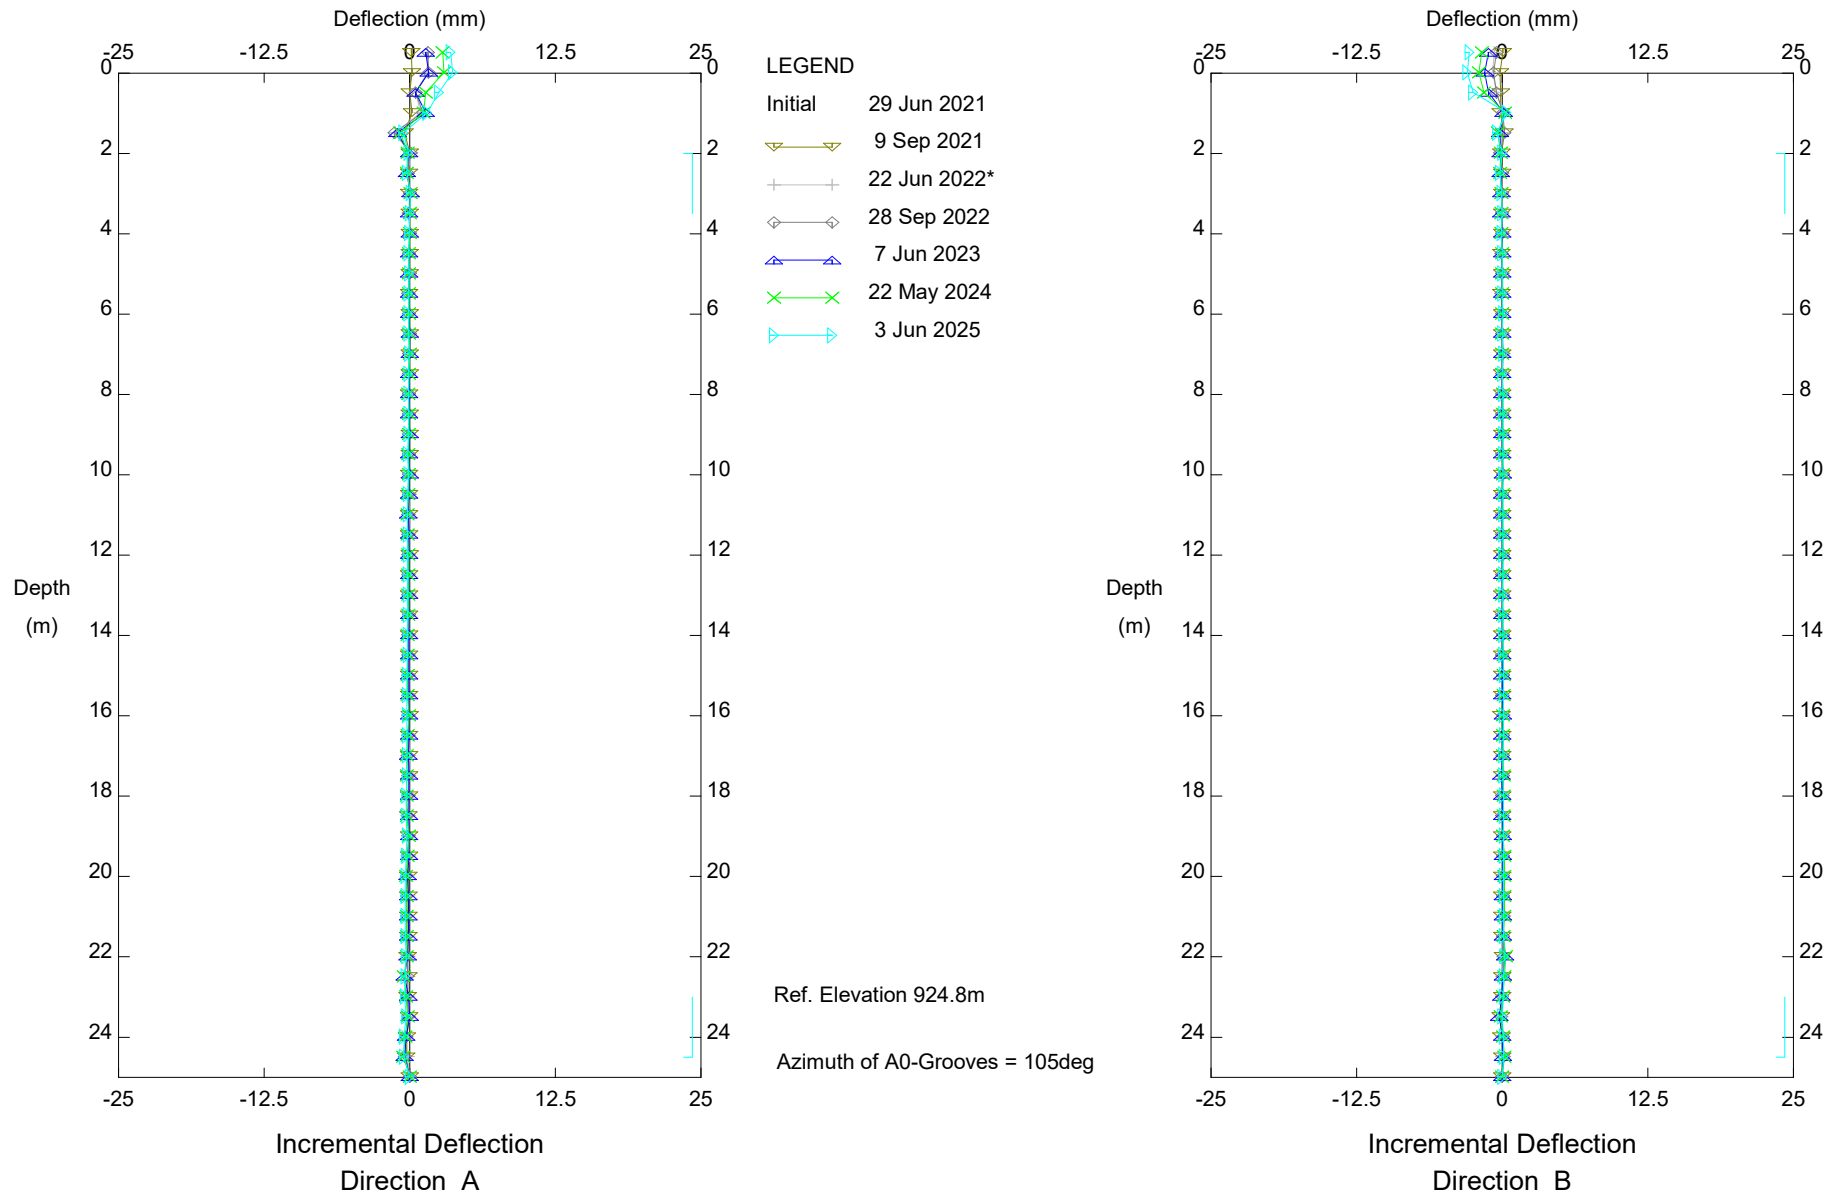
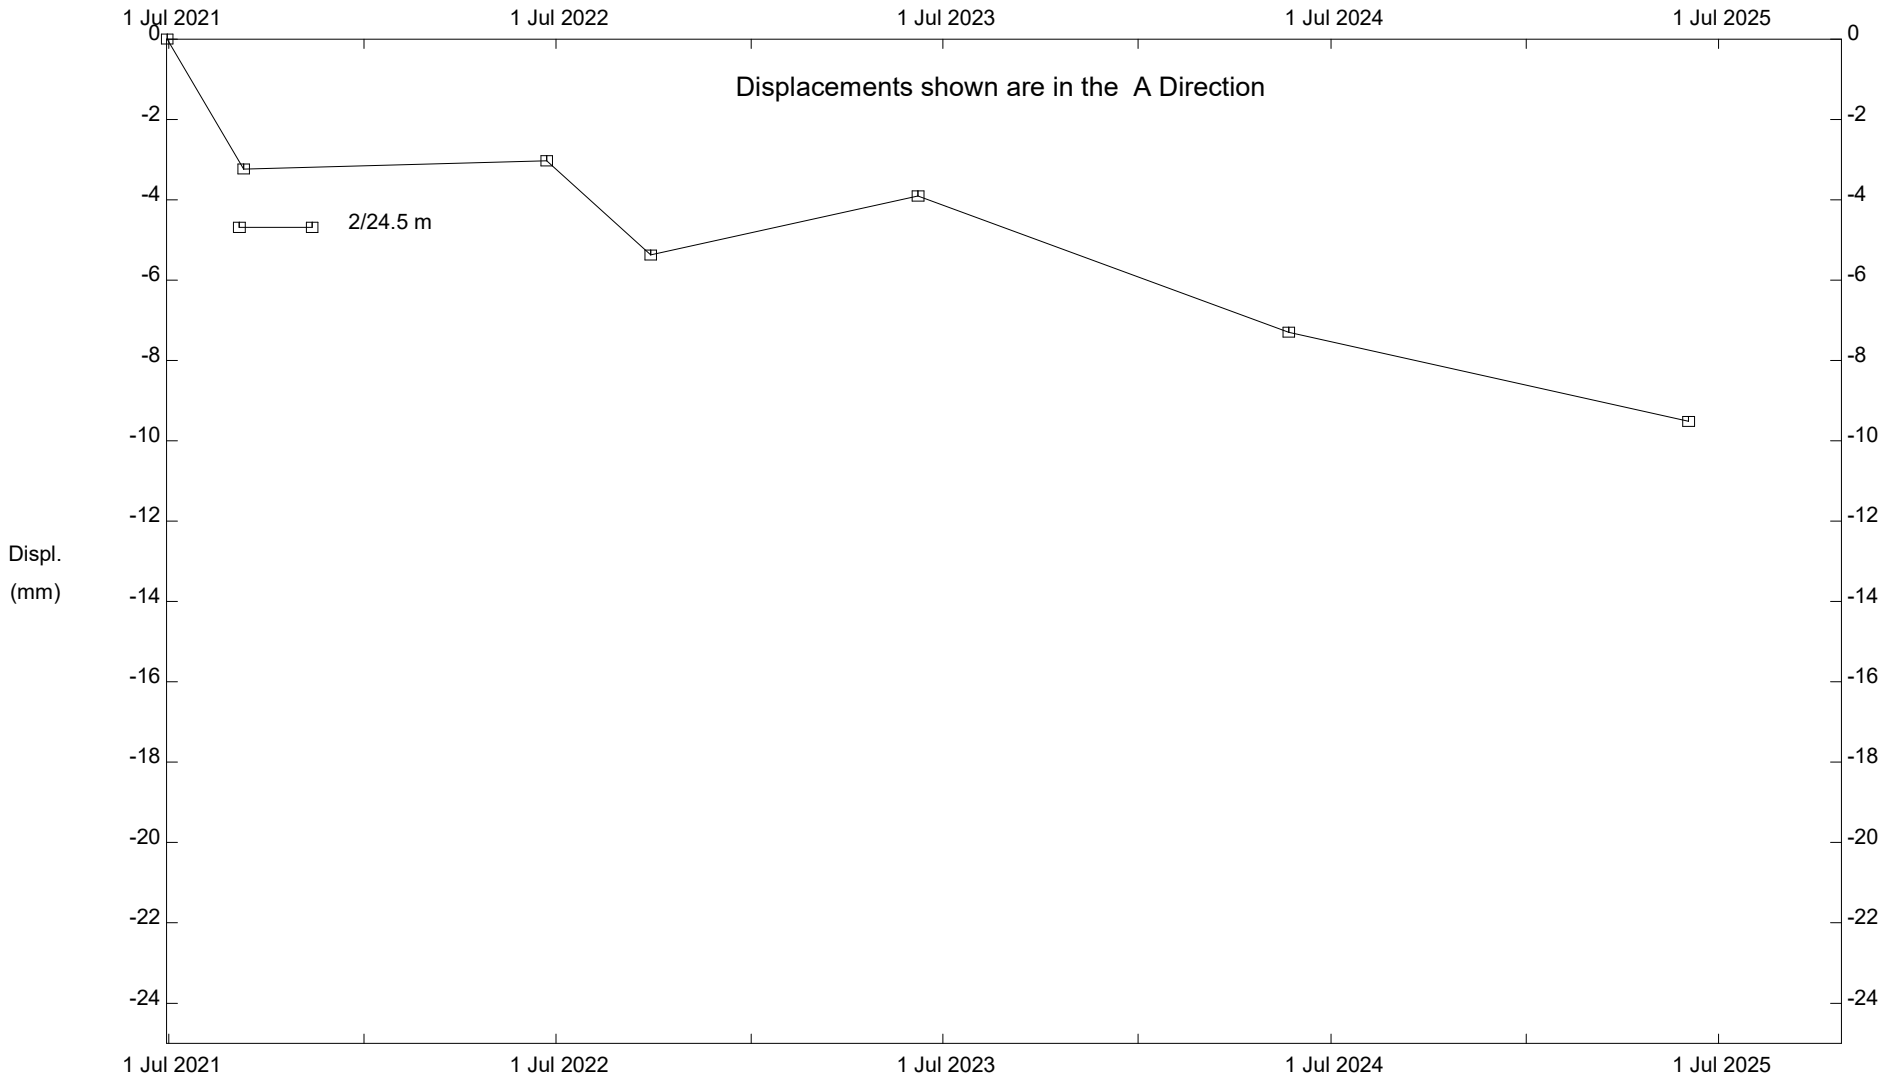
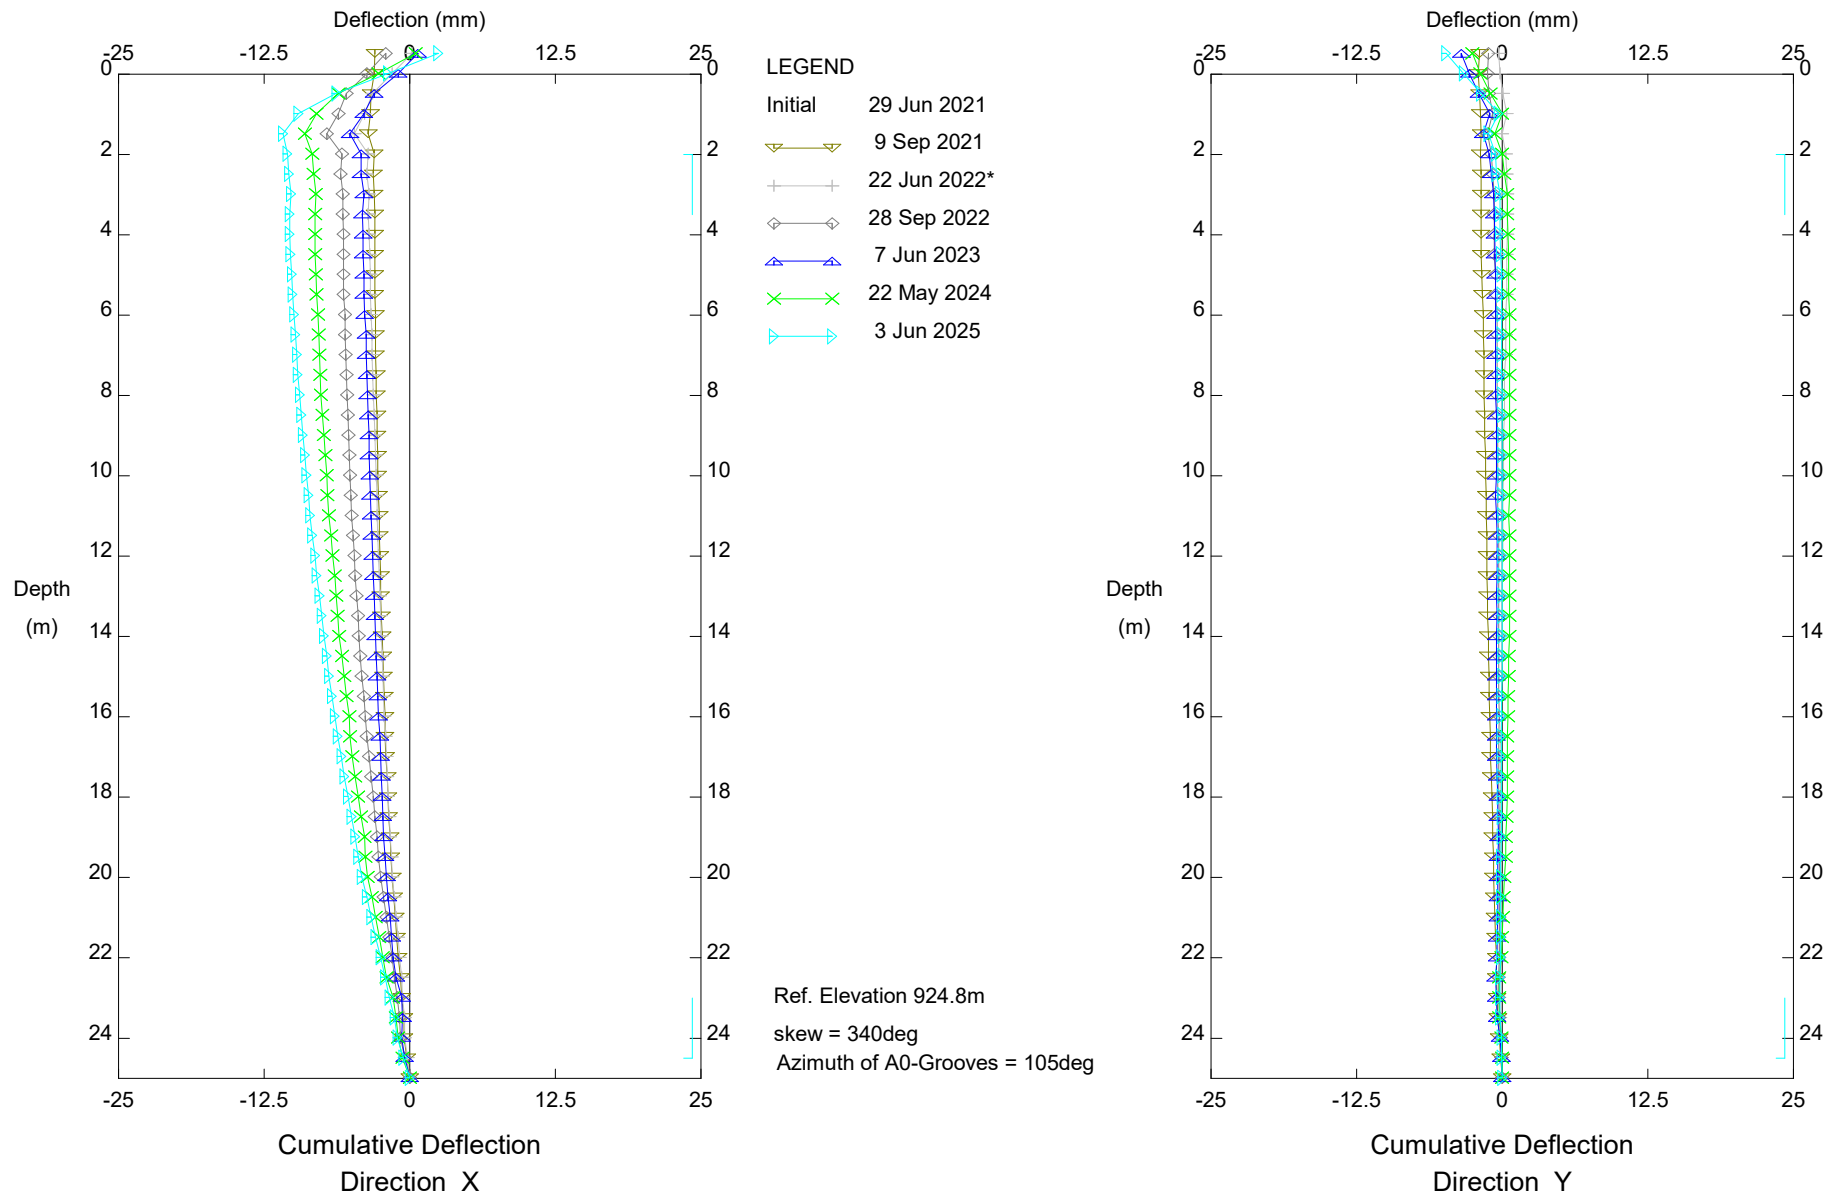
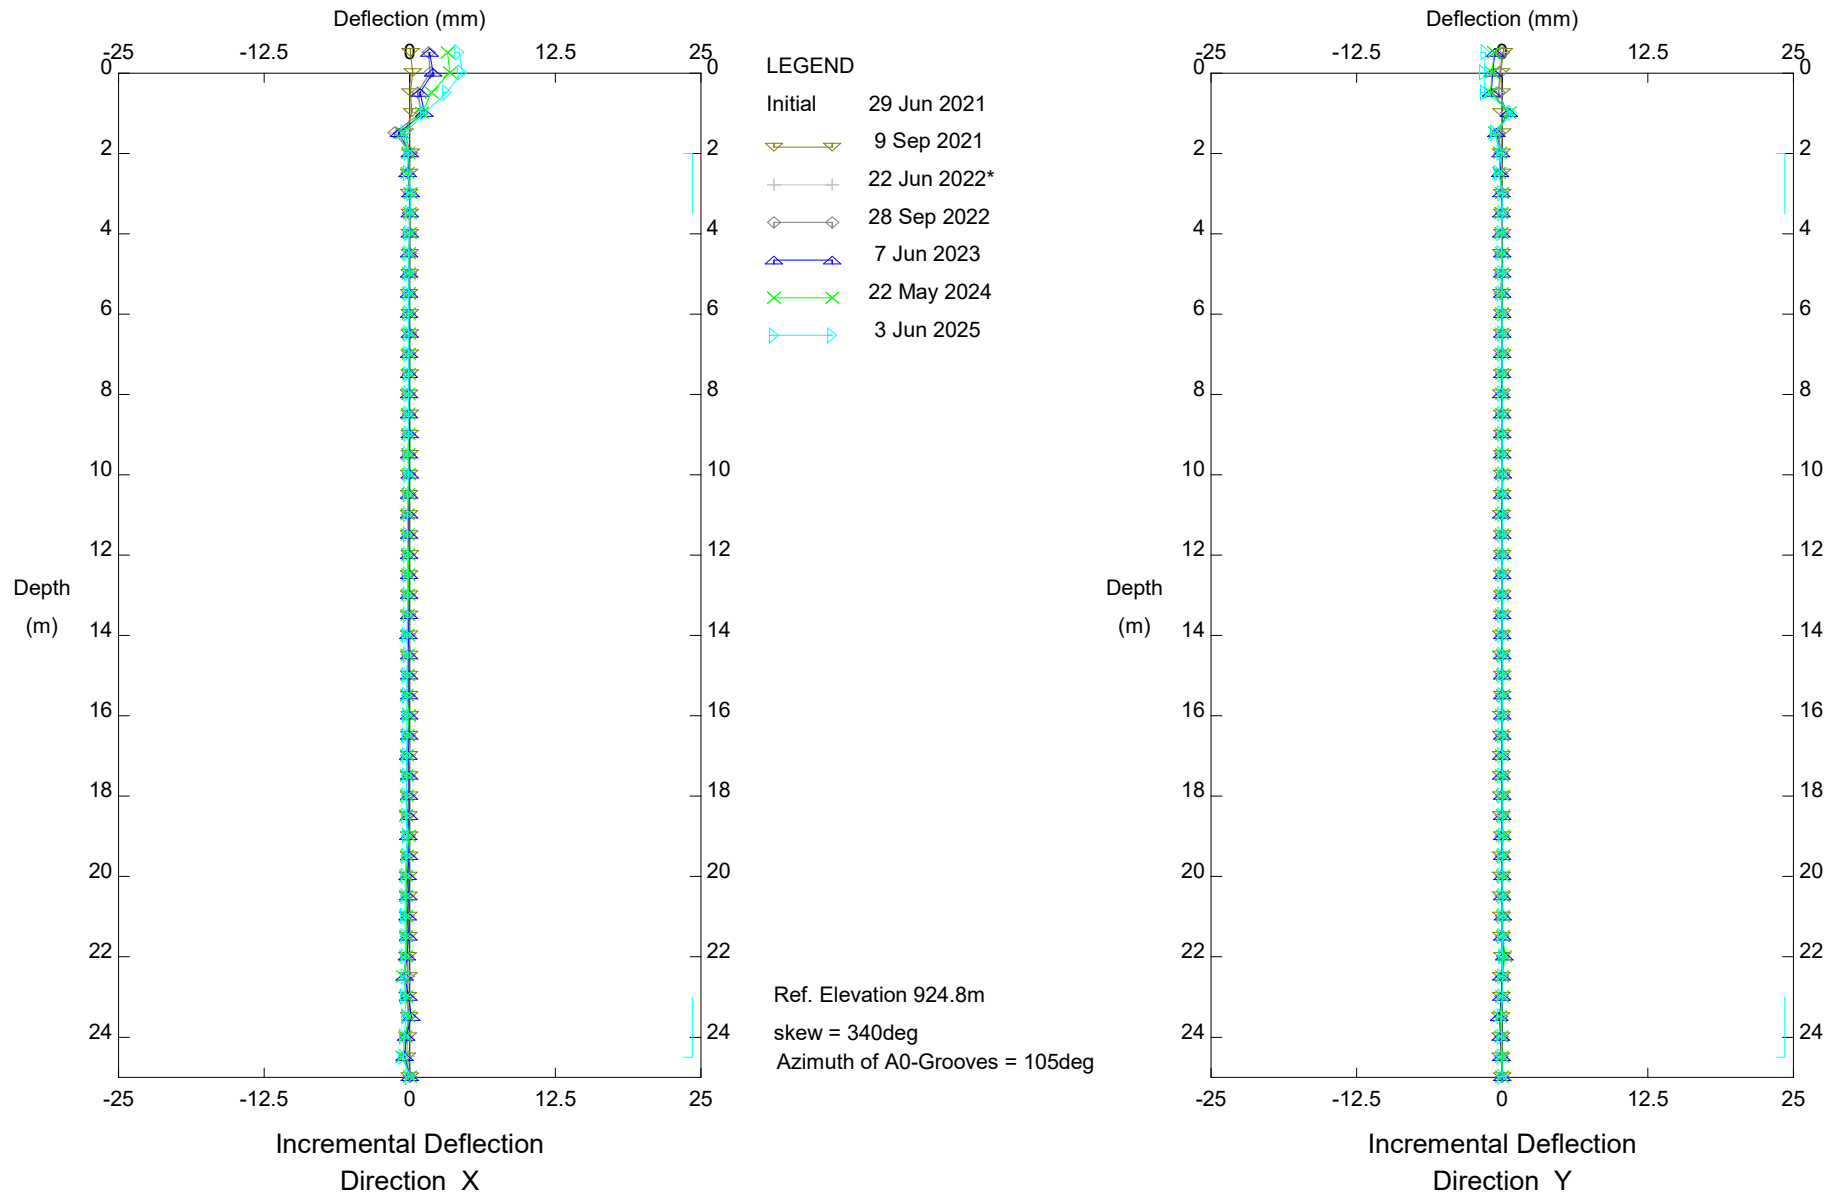
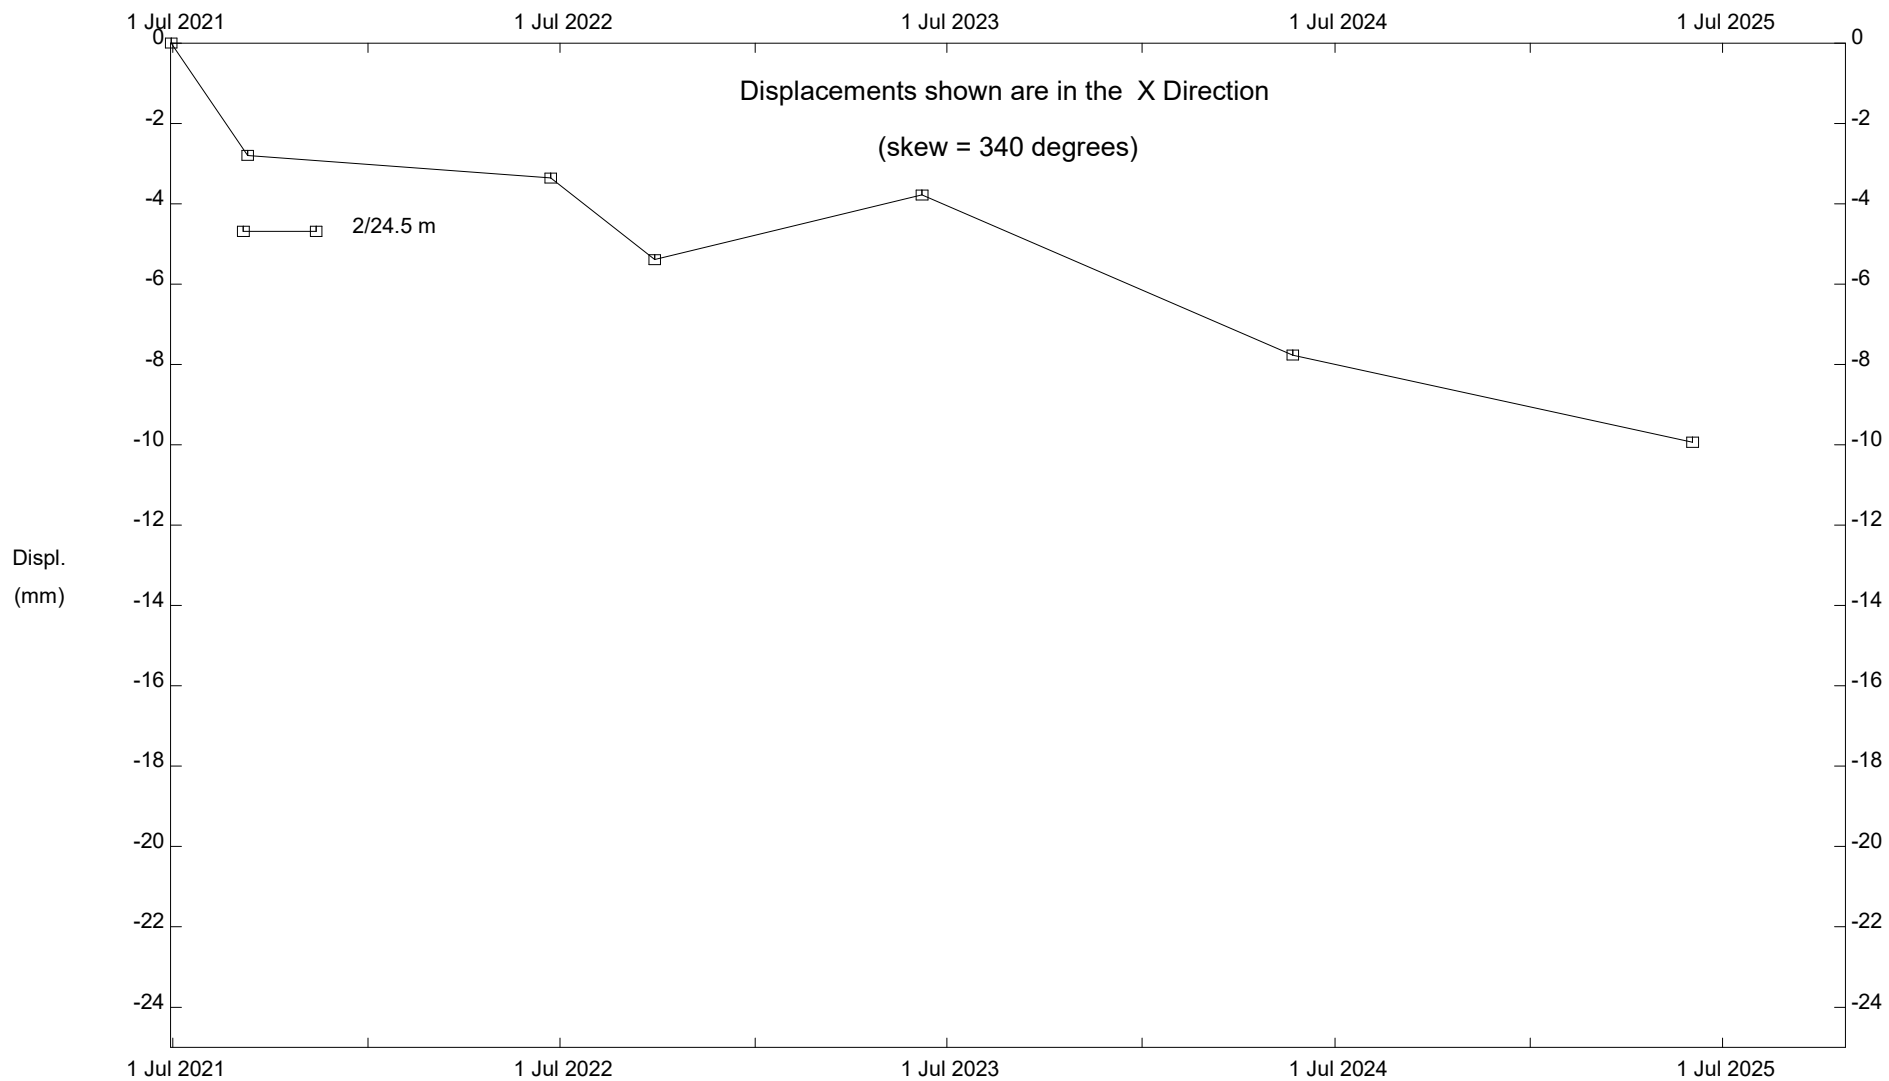
Distributed movement from top to bottom of casing has been recorded in SI19-1 since installation, including negative distributed movement recorded since October 2021 from an approximate depth of 2 m below ground surface to the bottom of the instrument. This movement could be due to the SI not being installed deep enough or installed on enough of an angle (i.e., tilt) that complicates processing of the SI data. Based on the absolute plot for this instrument, it is tilted approximately 0.7 m and 1.5 m in the A- and B-directions, respectively. Movement may also be within the accuracy of the SI reading equipment.

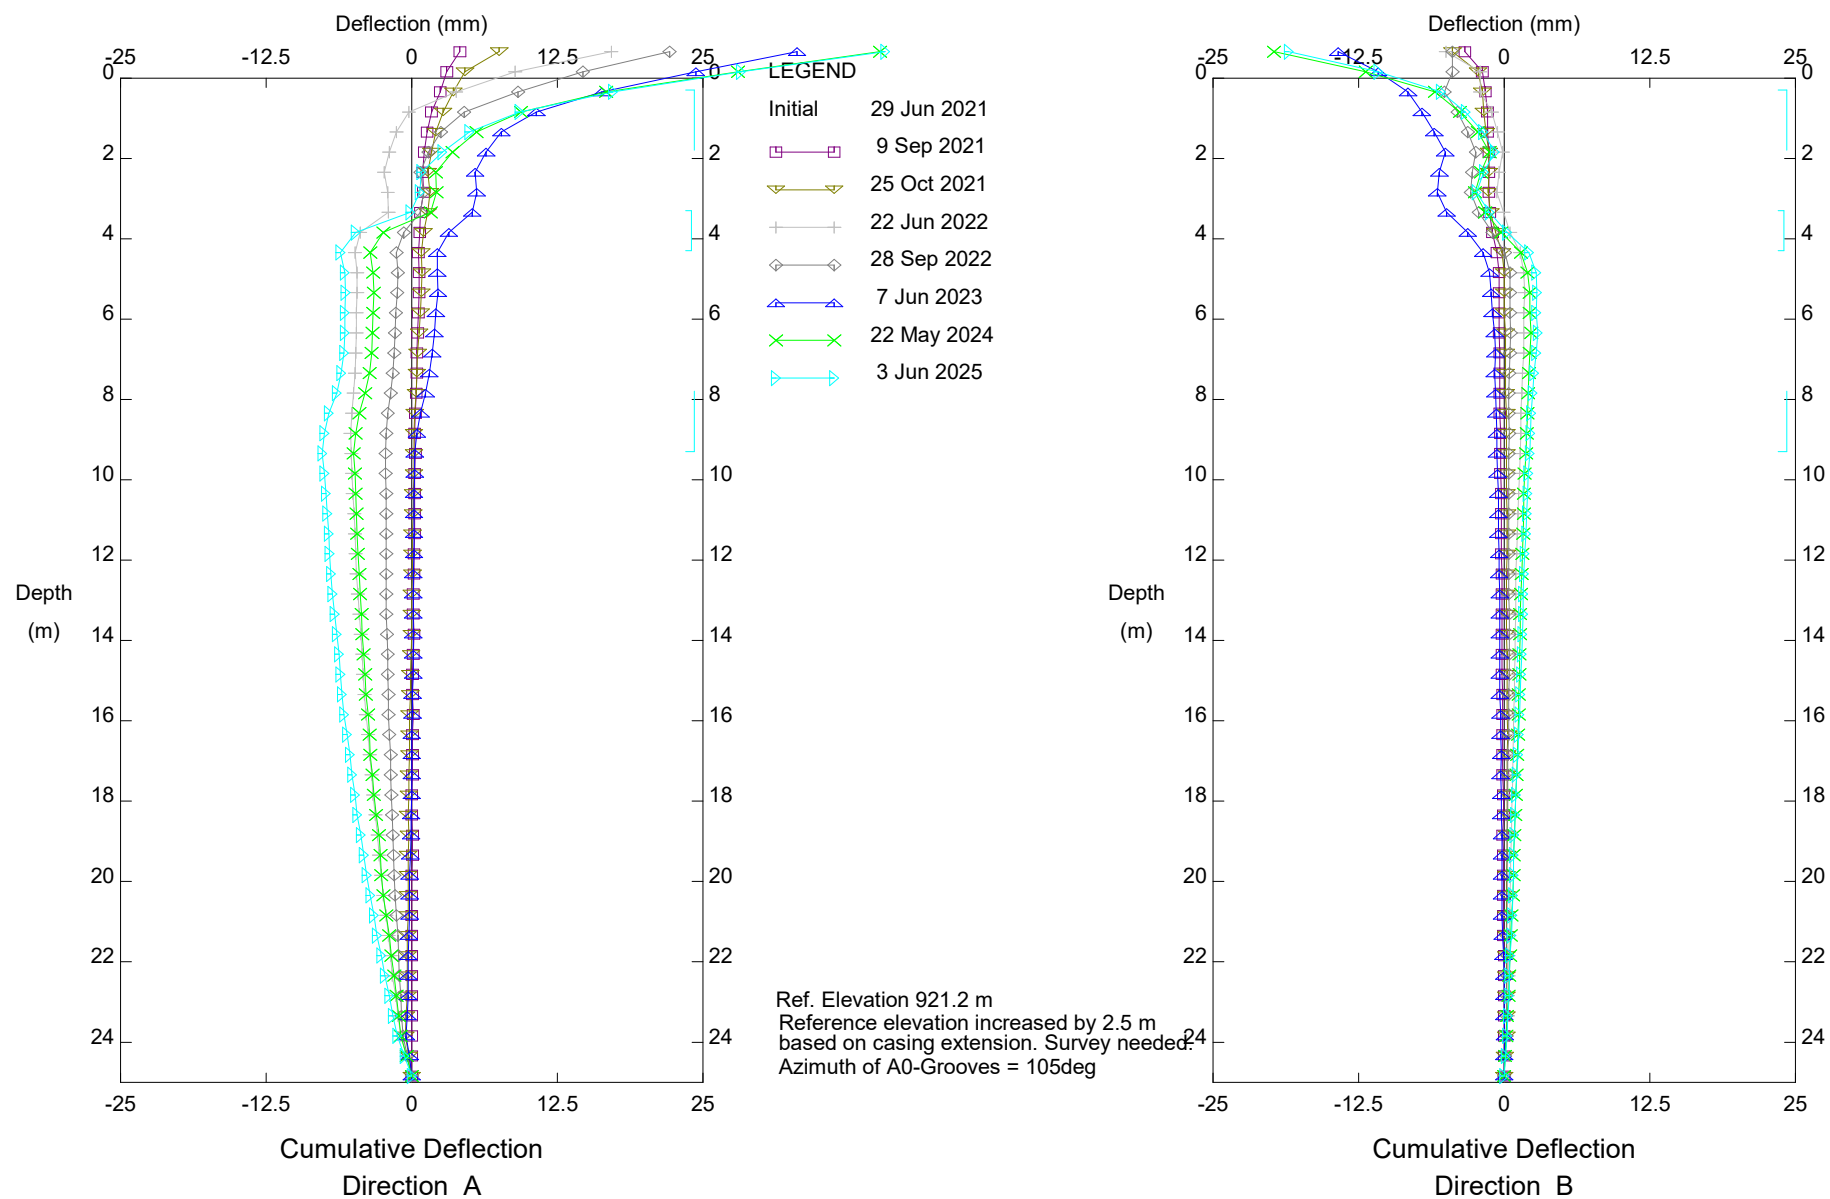
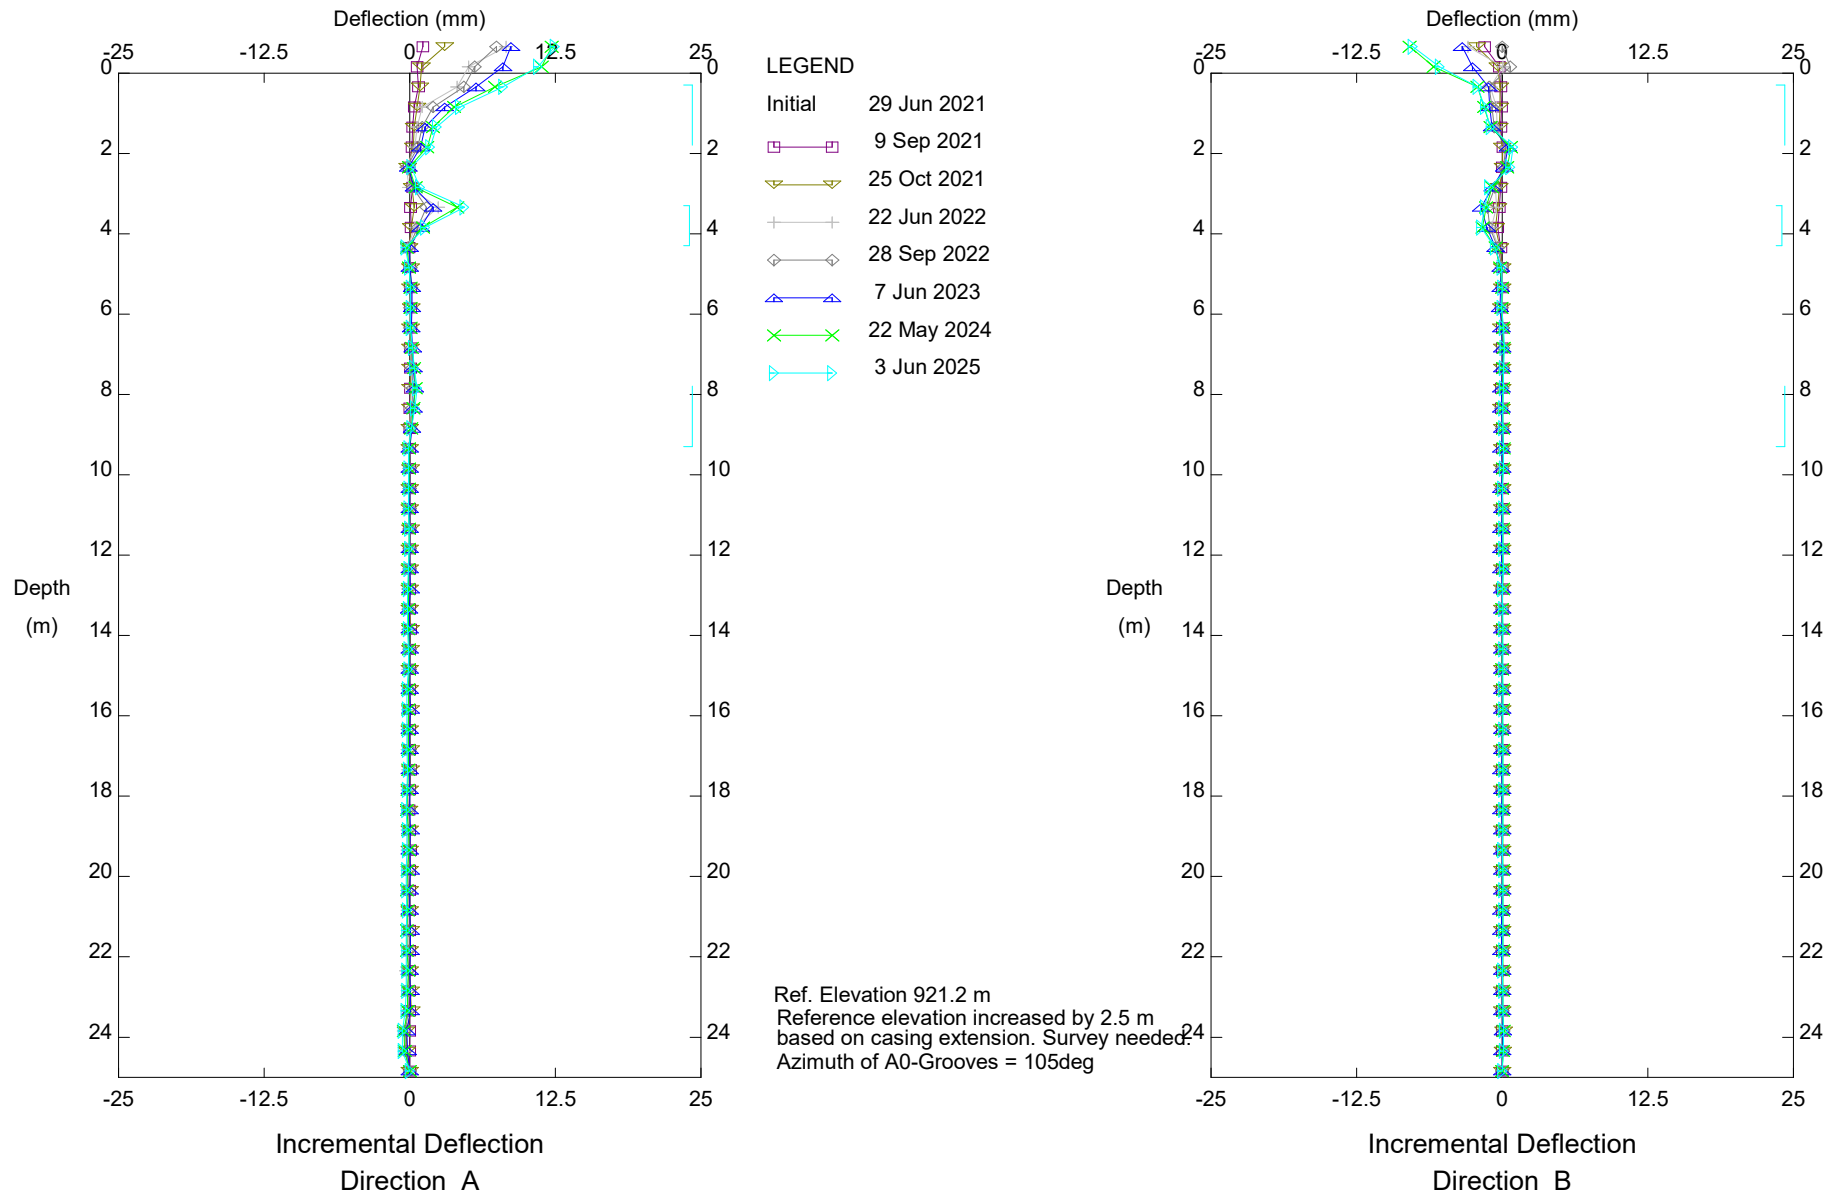
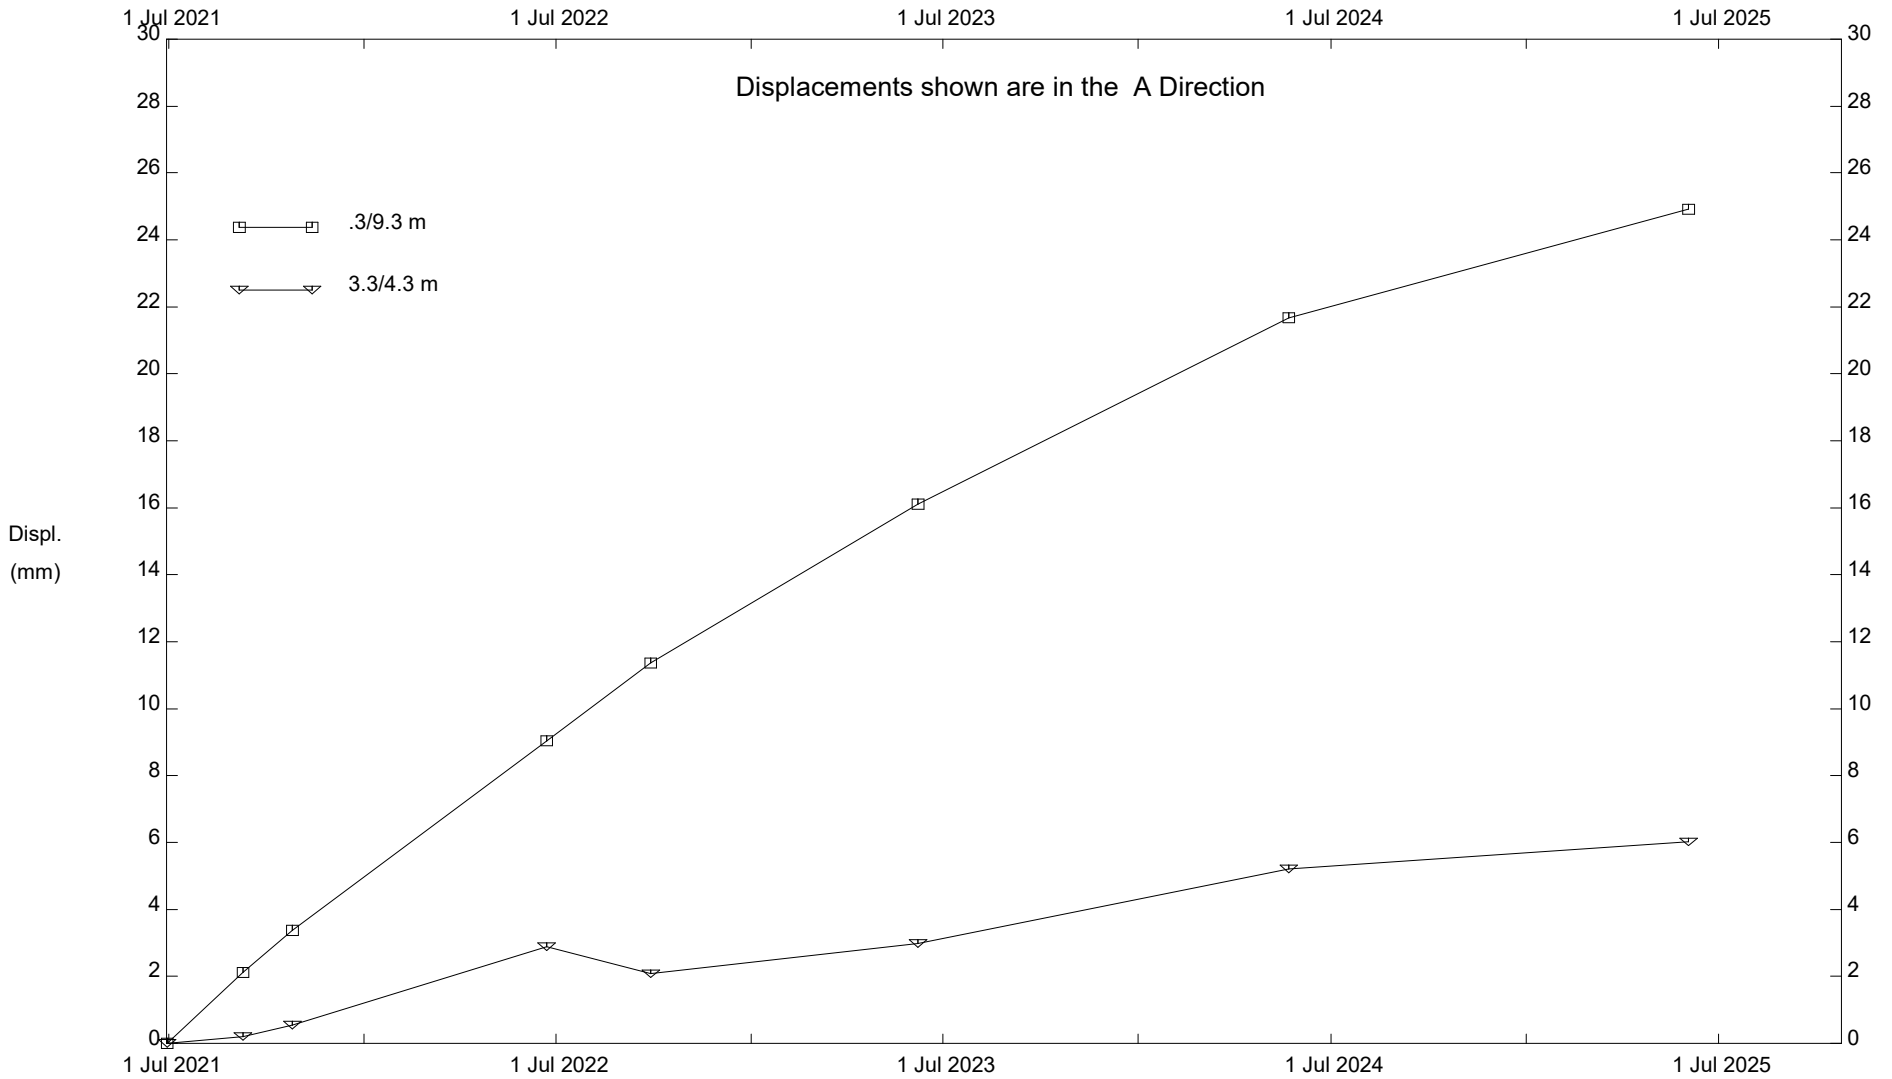
No discernible movement had previously been recorded in SI19-2 or SI19-3 before bin wall construction. However, since construction, large deflections have been recorded in the tops of these instruments to an approximate depth of 2 m below ground surface. These large deflections are believed to have been caused by cutting back (lowering) and raising the instrument casing during construction. KCB re-initialized the SI data plots to the June 2021 readings because these large deflections were complicating review of the SI data and potentially masking smaller movements that may be occurring. Since June 2021, distributed movement has been recorded in SI19-2 and SI19-3 up to an approximate depth of 9.3 m and 2.6 m, respectively. Since June 2022, some discrete movement has also been recorded in SI19-2 at an approximate depth of 3.5 m below ground surface.
