July 15, 2025

CON0022166 Peace Region (Grande Prairie District – South) GRMP Instrumentation Monitoring Site GP006; H40:36, km 21.779 Sheep Creek Embankment (Three Teardrops Slide) Section C – 2025 Spring Readings

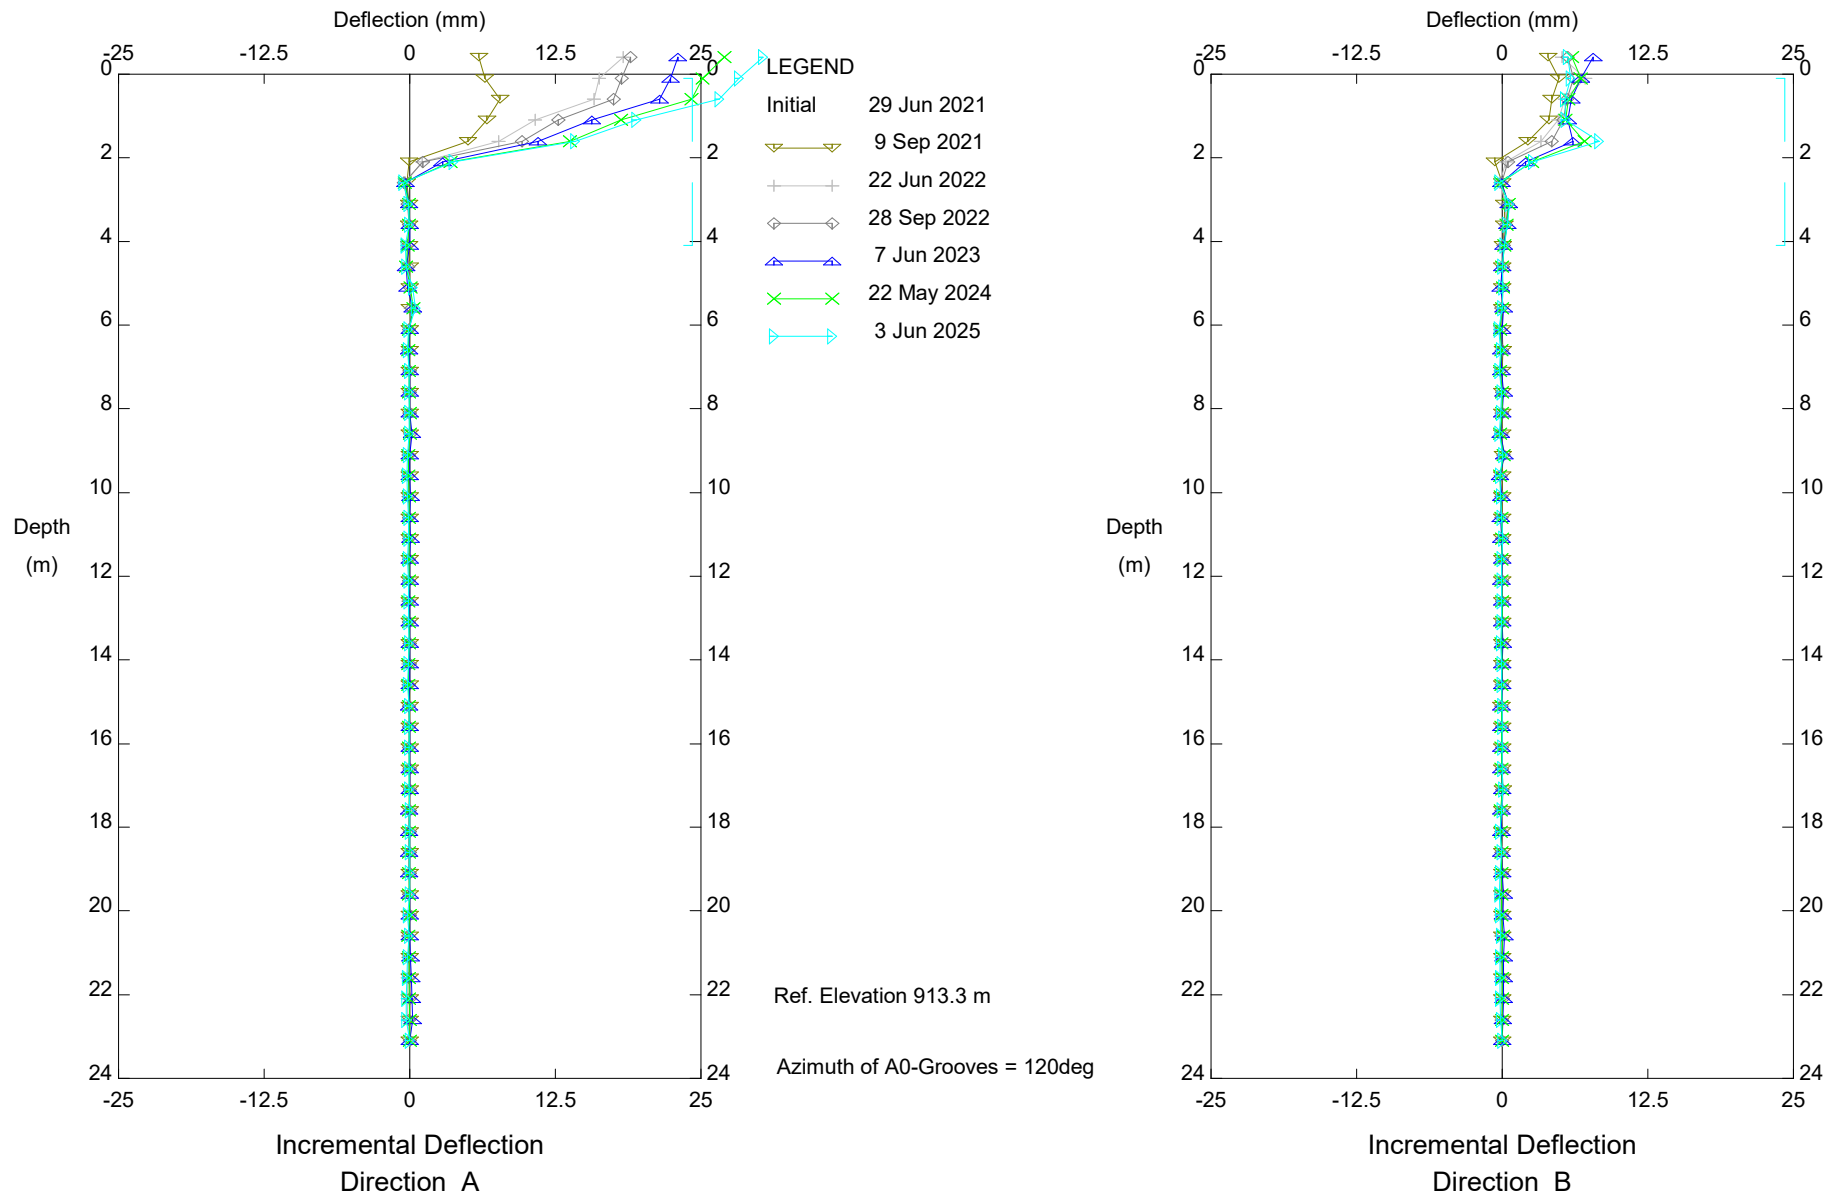
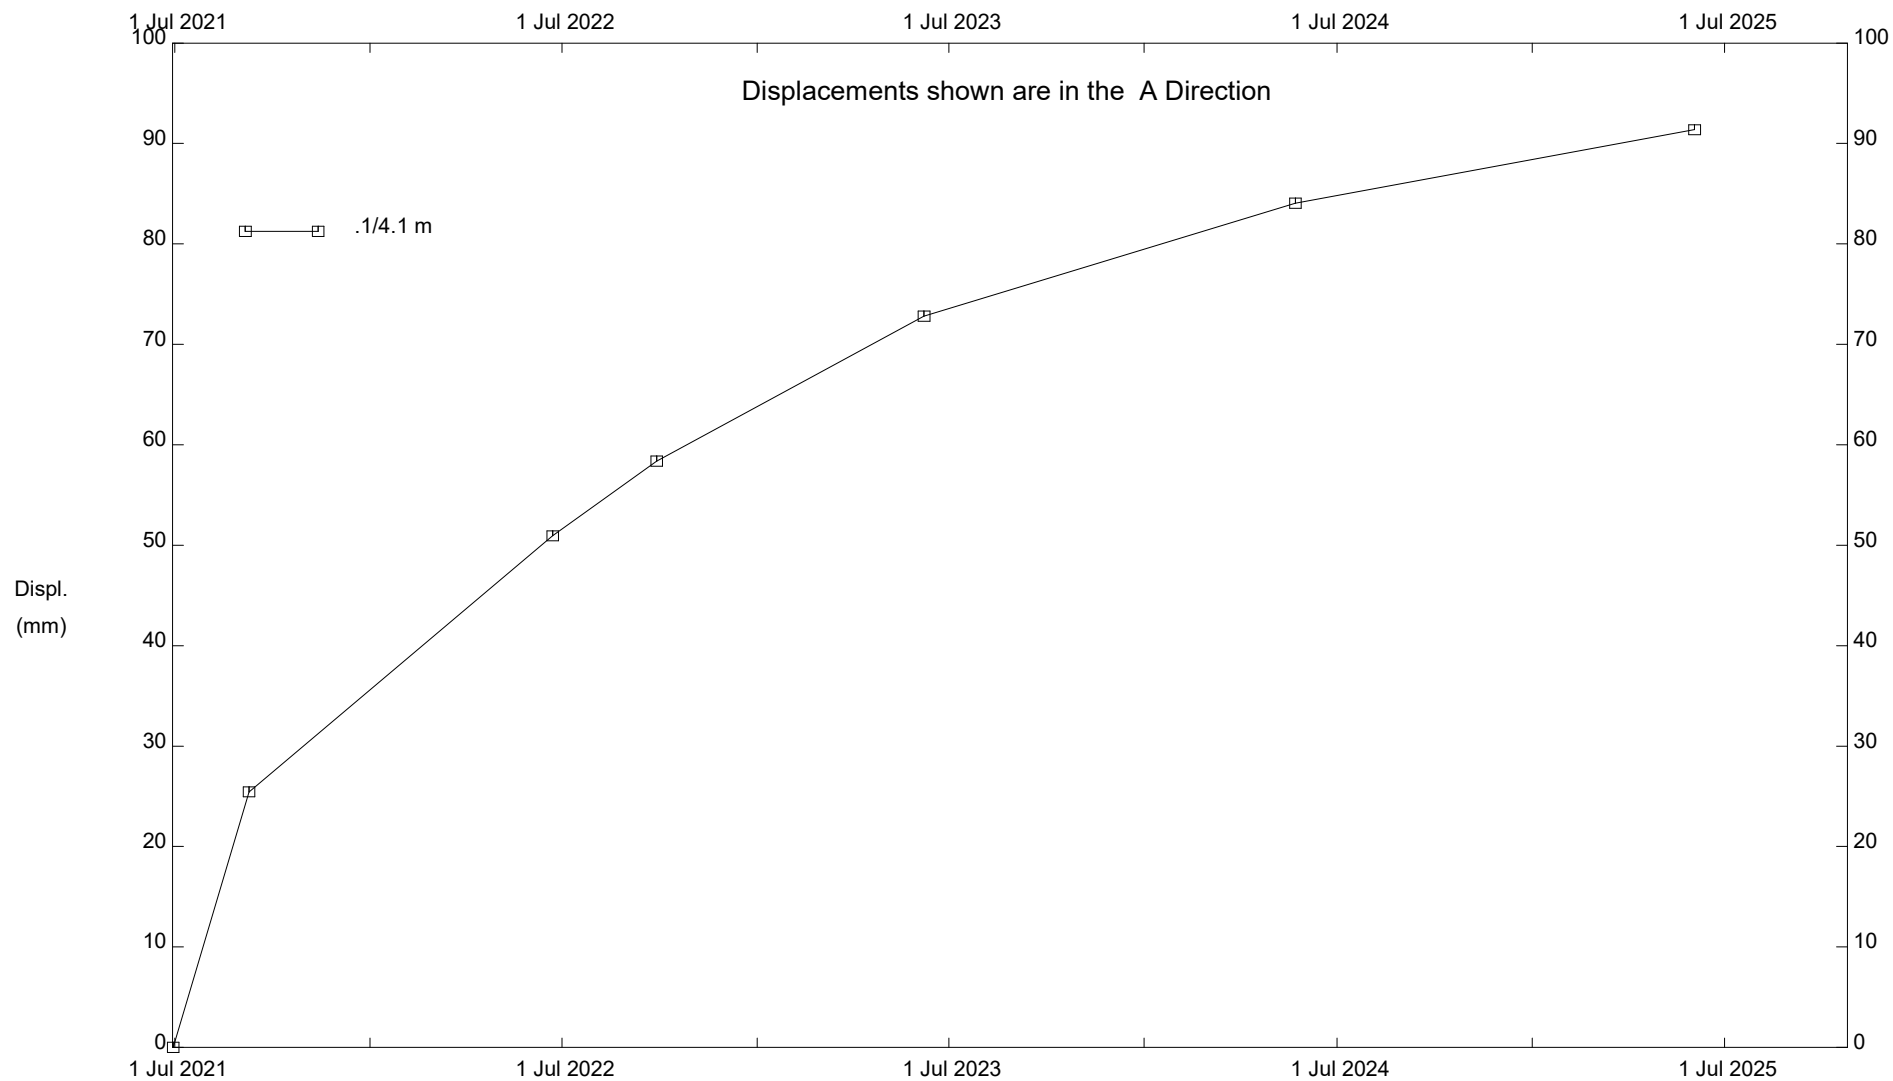
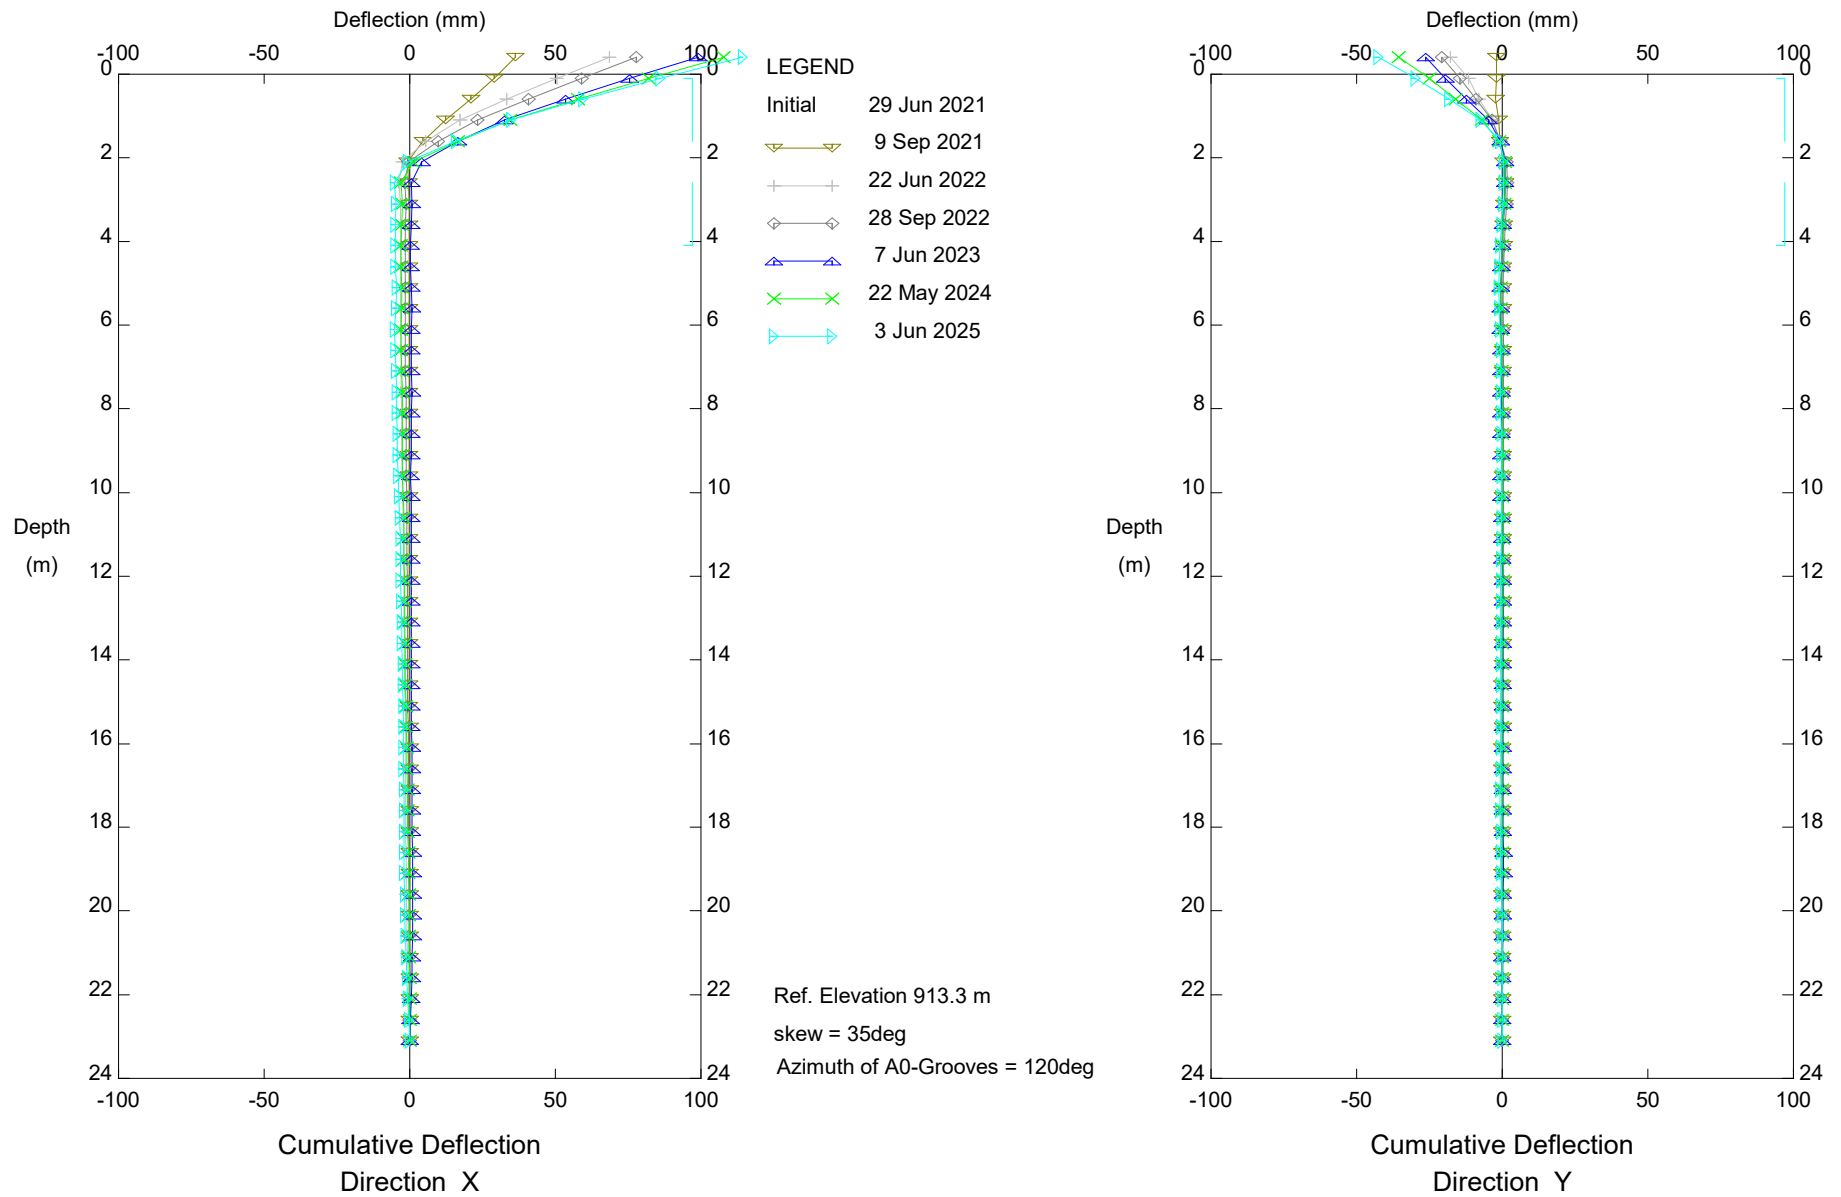
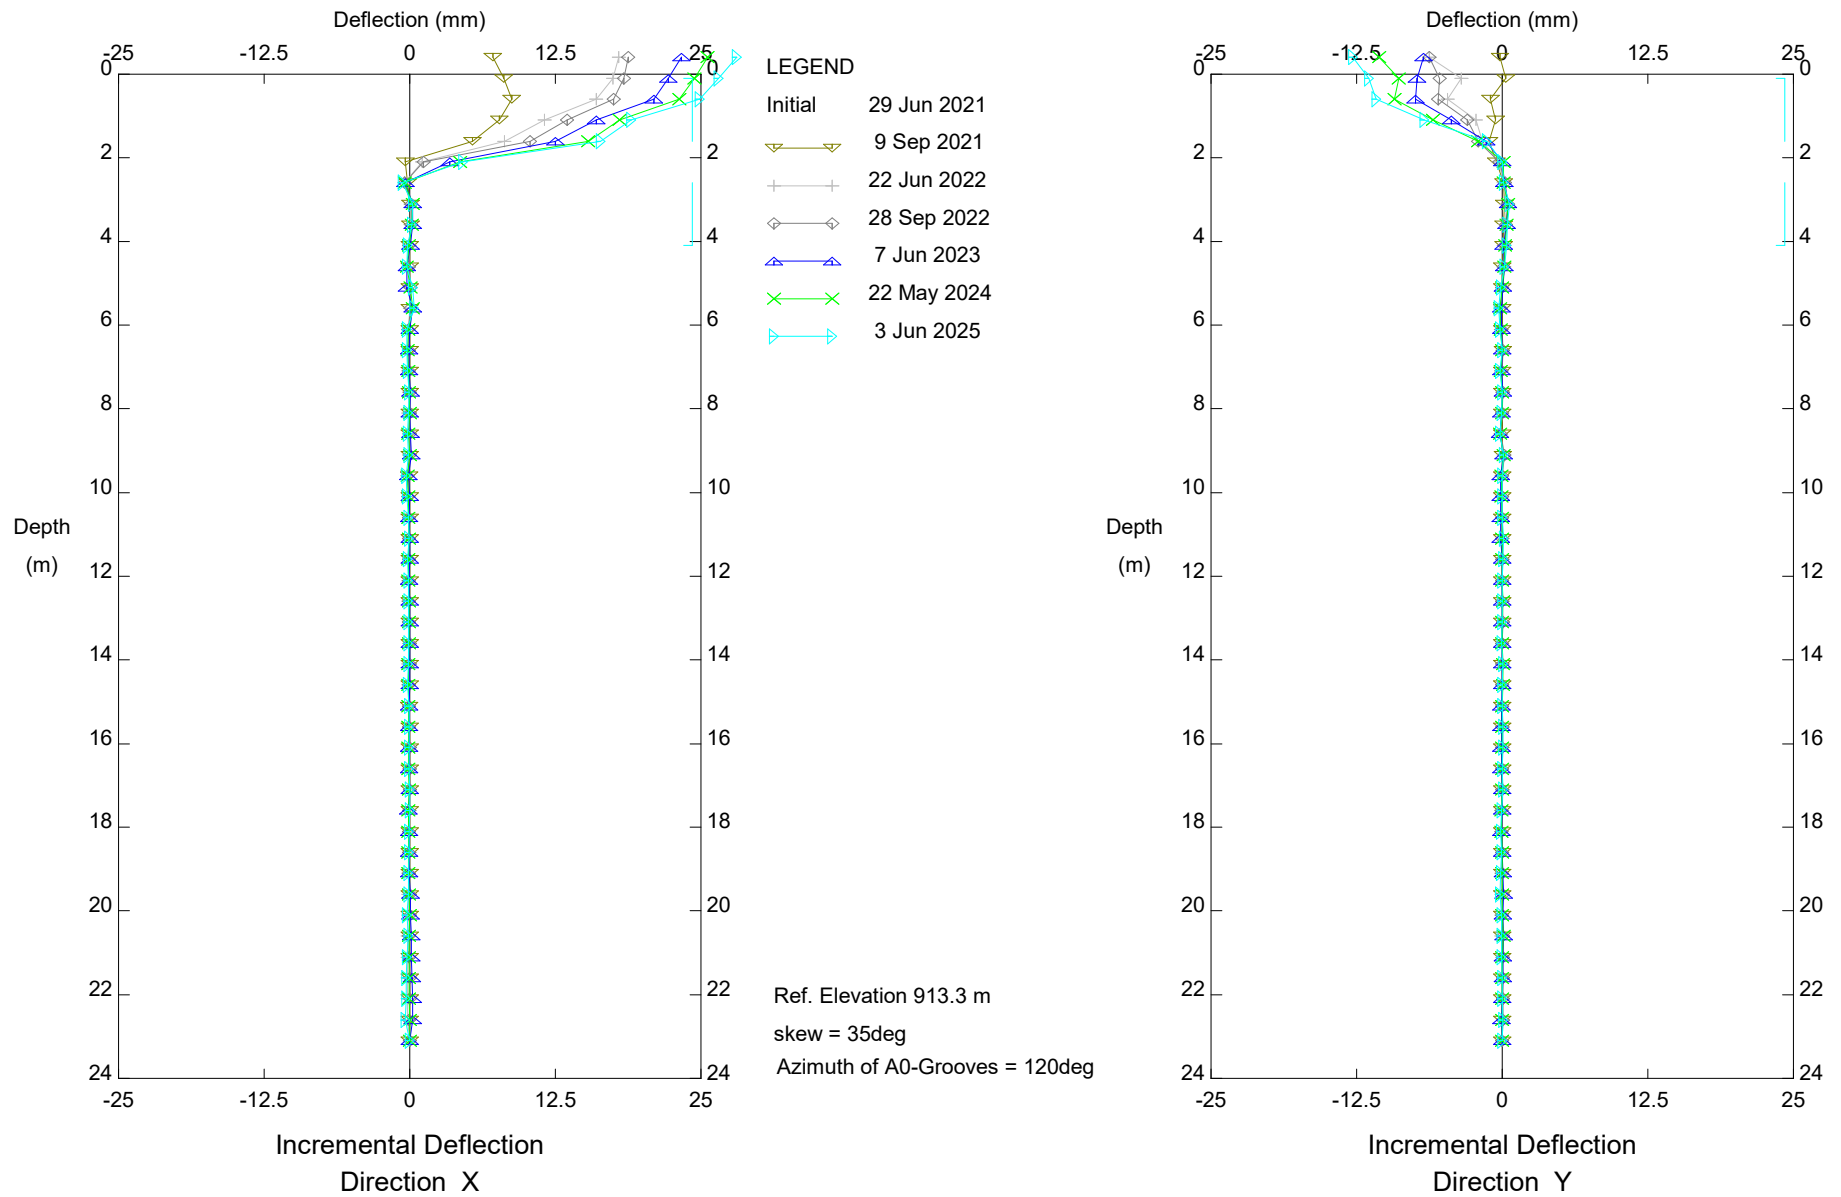
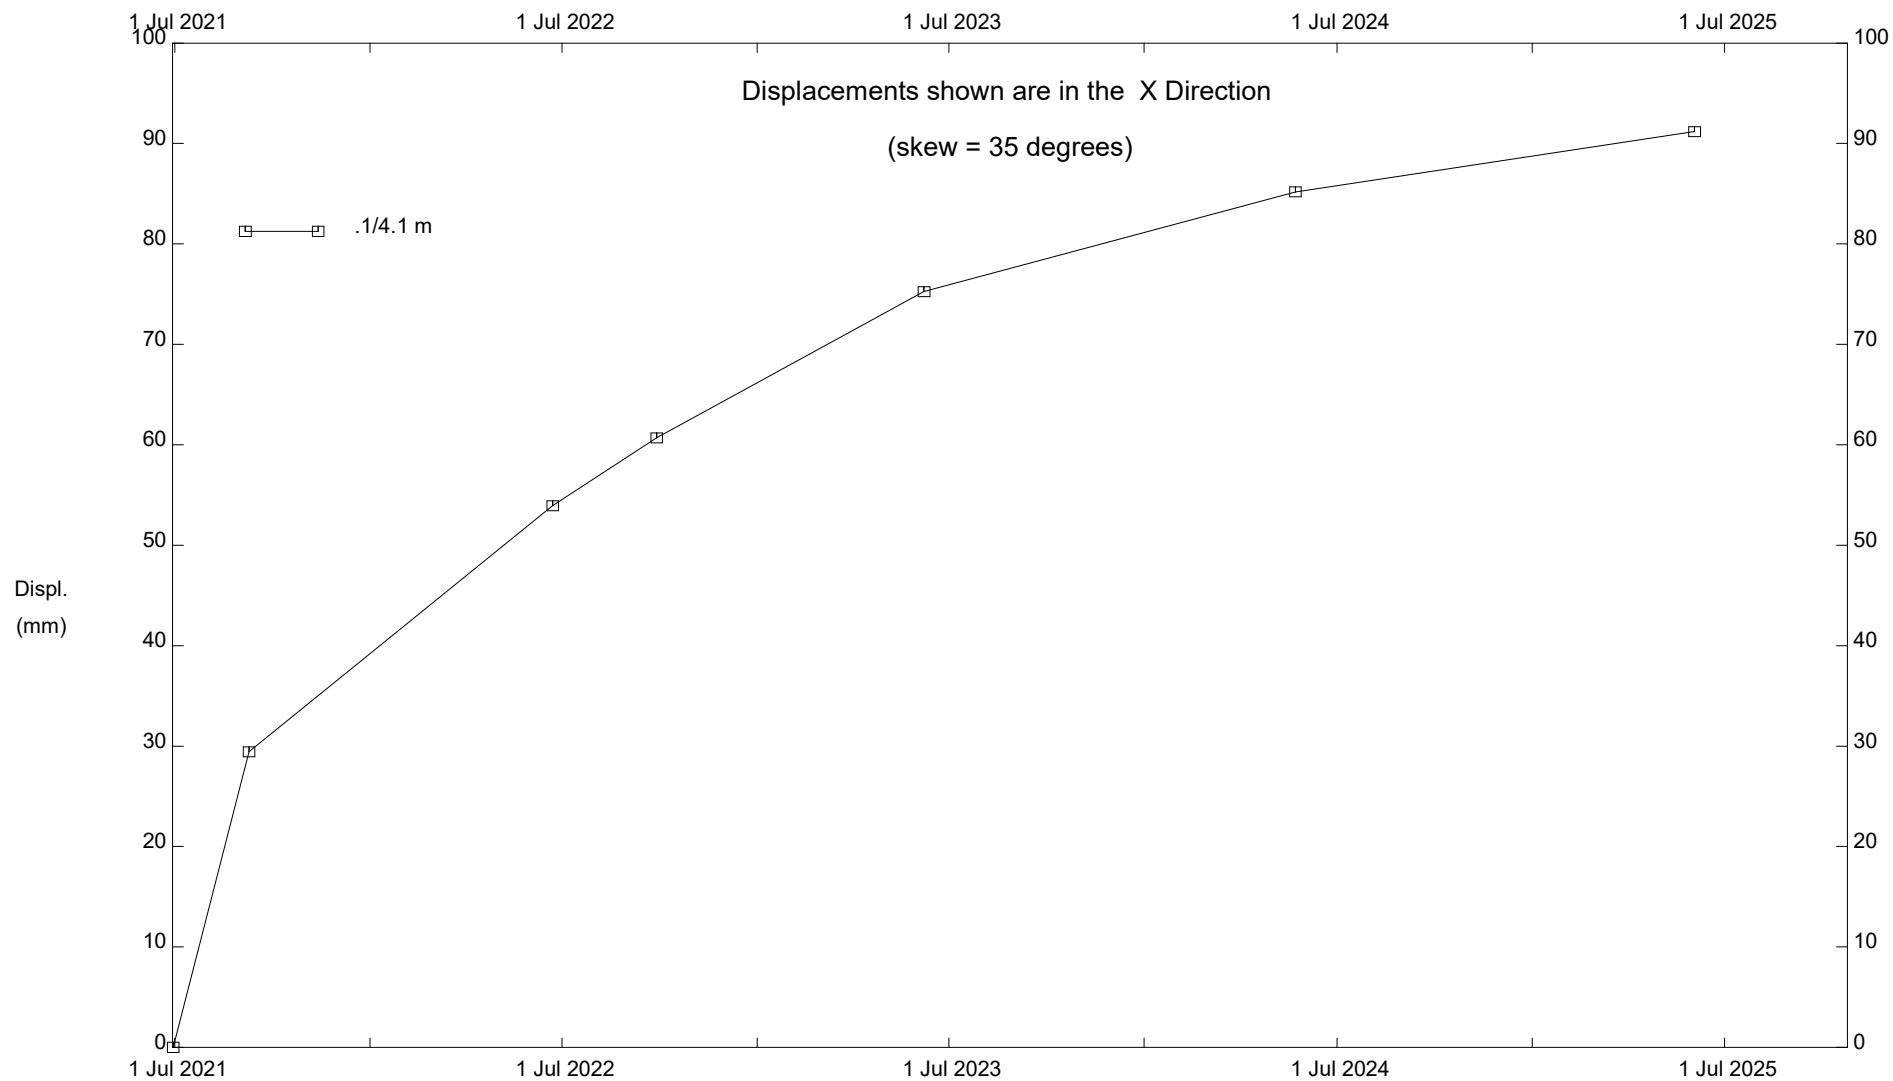
The movement recorded in SI-2, SI19-2, and SI19-3 since October 2020 can most likely be attributed to binwall construction in late 2020. Most notably in SI19-3, where a significant amount (approximately 589 mm) of shallow movement has been recorded since October 2020. This shallow movement may be attributed to settlement as the bin wall takes loading from the highway embankment, as well as deflection of the above-ground casing, since casing protectors were not installed for these instruments. Since the SIs were re-initialized to the June 2021 readings, between approximately 23 mm and 91 mm of shallow movement has been recorded in these instruments.

Data cannot be reliably obtained from SI-4 located in the west highway ditch (SI probe wheels keep coming out of both the A and B-direction casing grooves), so the instrument will no longer be read. KCB does not recommend replacing SI-4 at this time because SI19-3, which is installed deeper on the east side of the highway near SI-4, is still active and indicates repair work completed in 2020 (binwall with mid-slope bench and drainage) has mitigated slide movements. If movements were to increase and begin to impact the highway or if SI19-3 were to become inoperable, additional deeper SIs could be considered.
