SITE NUMBER AND NAME: <b>GP007 Wanyandie Road</b>		HIGHWAY & KM: 40:36, 29.339	PREVIOUS INSPECTION DATE: May 26, 2020	INSPECTION DATE: <b>July 20, 2021</b>
LEGAL DESCRIPTION: NW 02-59-07-W6M	NAD 83 COORDINATES: UTM Northing Easting 11 5993890 372875		RISK ASSESSMENT: PF: 13 CF: 7 TOTAL: 91	
AVERAGE ANNUAL DAILY TRAFFIC (AADT): 429 (north) & 453 (south) (Reference No. 60403650)			CONTRACT MAINTENANCE AREA (CMA): 504

PROJECT	GRANDE PRAIRIE SOUTH REGION GEOHAZARD RISK MANAGEMENT PROGRAM	
TITLE	Site Plan GP007 - Wanyandie Road Hwy 40:36, km 29.339	
SCALE	PROJECT No.	FIG No.
1:4,000	A05116A01	1

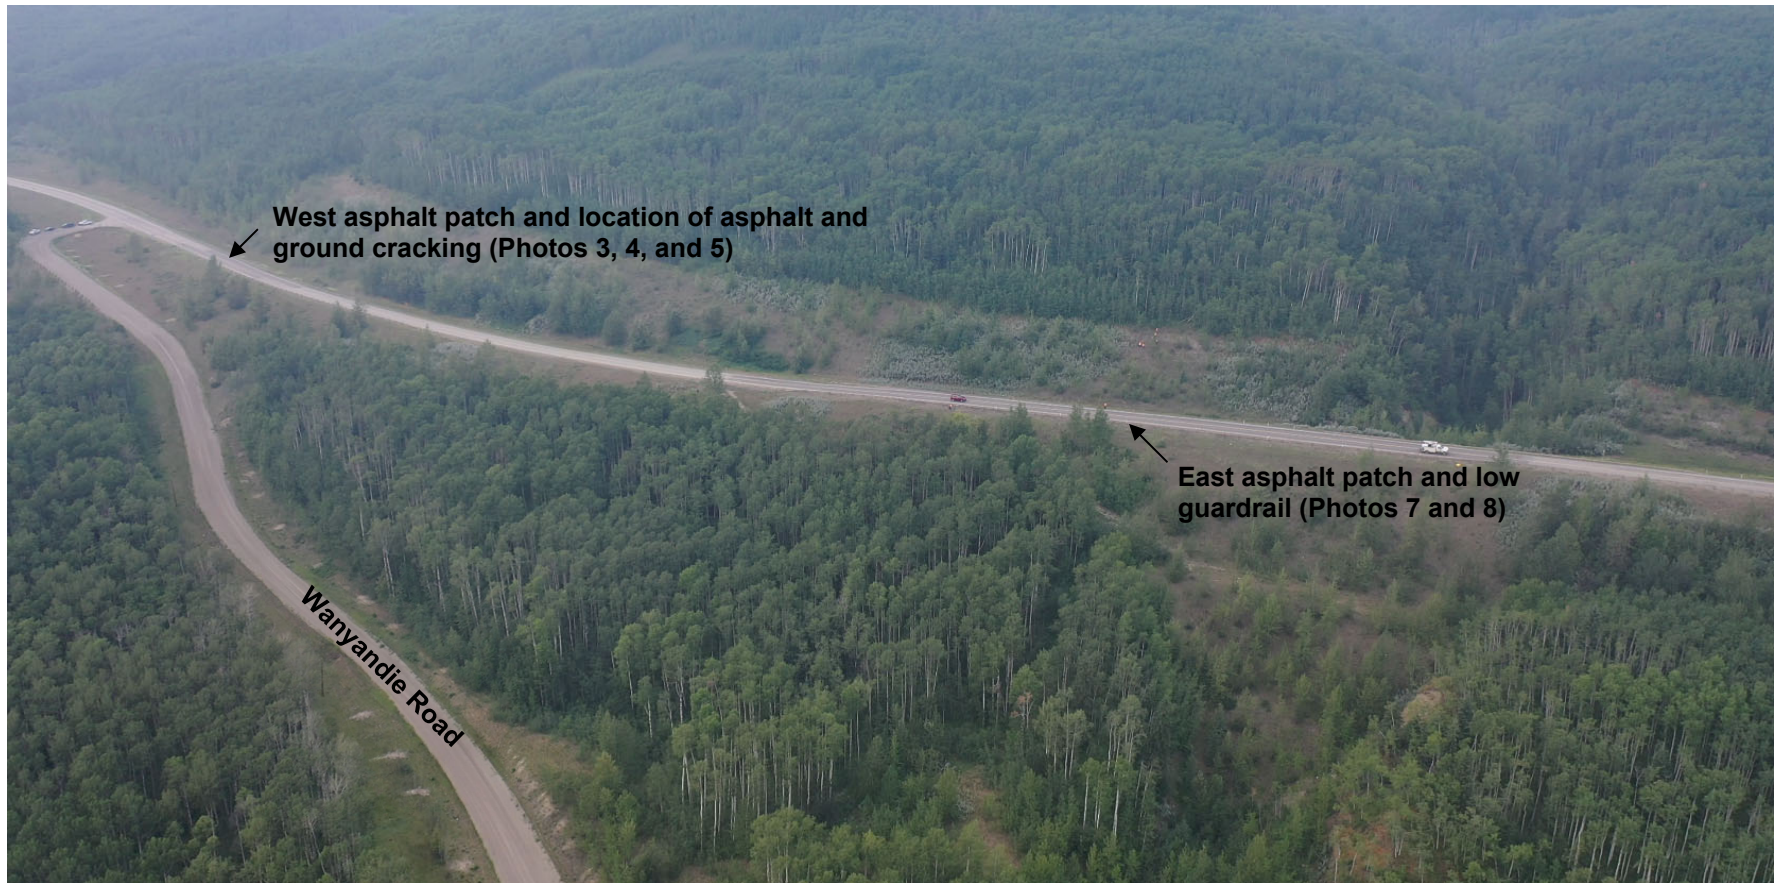
**Photo 1** Overview of the GP007 site, highlighting the east and west patches, and areas of asphalt cracking and settlement.  
Photo taken July 20, 2021 facing northwest.

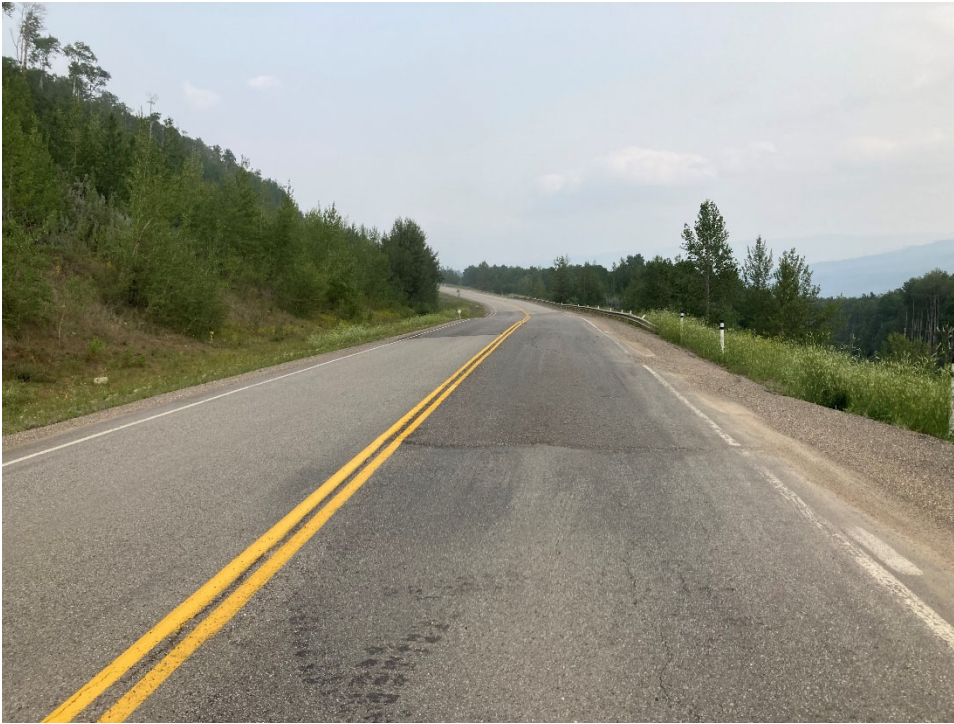
**Photo 2** Lower (west) patch located just east of Wanyandie Road. Photo taken July 20, 2021 facing northeast.

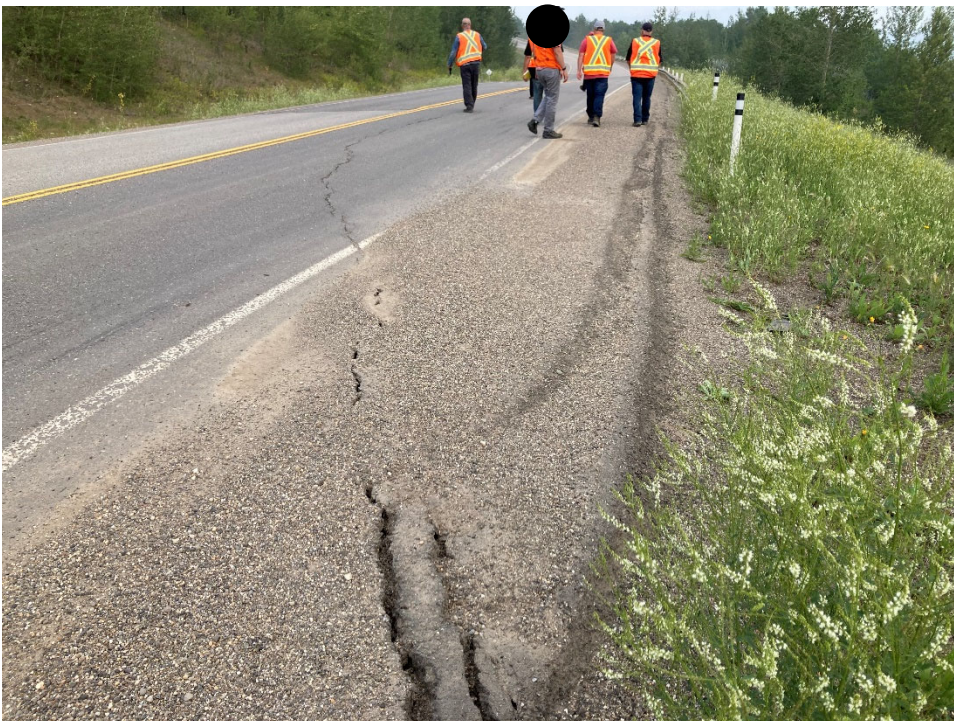
**Photo 3** Asphalt cracking observed in the south (northbound) lane that extends from the edge of the highway to the centreline. Photo taken July 20, 2021 facing northeast.

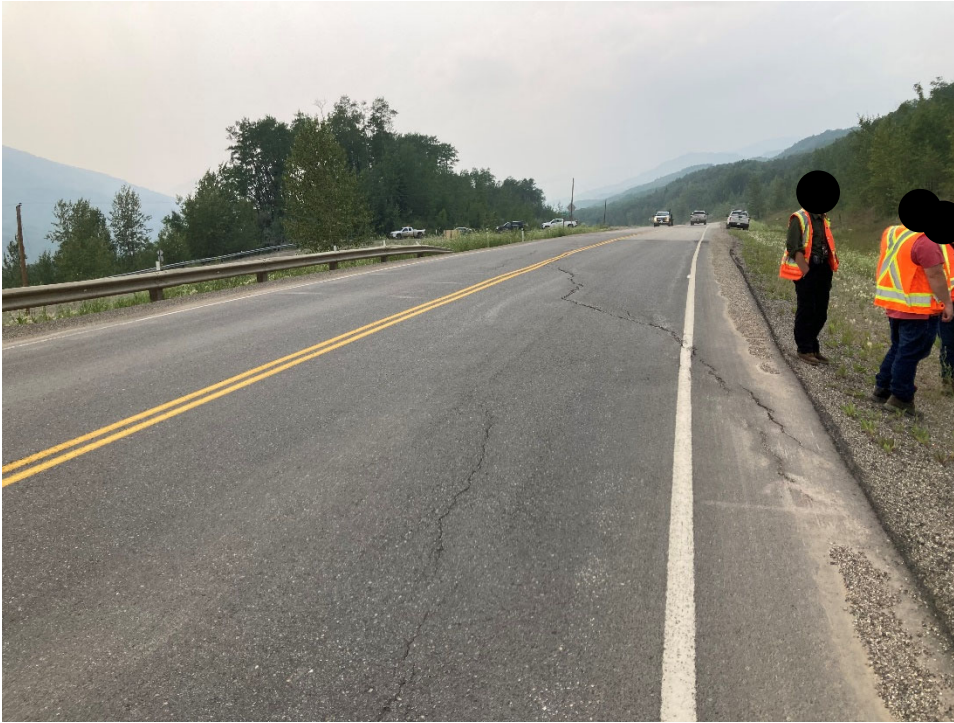
**Photo 4** Asphalt cracking at the west flank of the slide in the north (southbound) lane that extends from the edge of the asphalt to the centreline. Photo taken July 20, 2021 facing southwest.

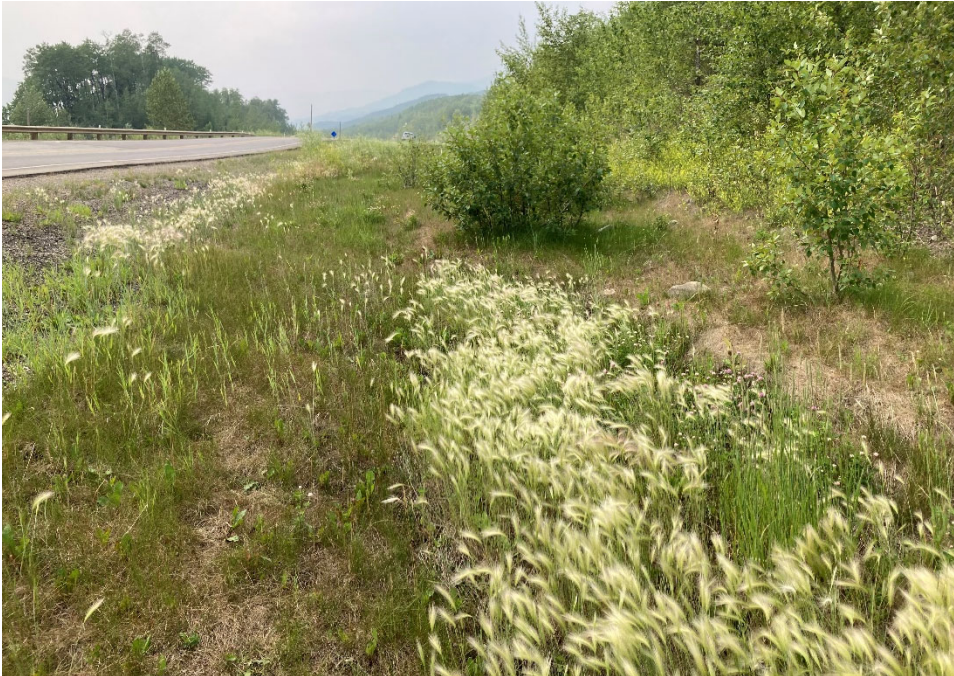
**Photo 5** Ground cracking observed in the north (southbound) ditch that may be the backscarp of the slide (obscured by vegetation). Photo taken July 20, 2021 facing southwest.

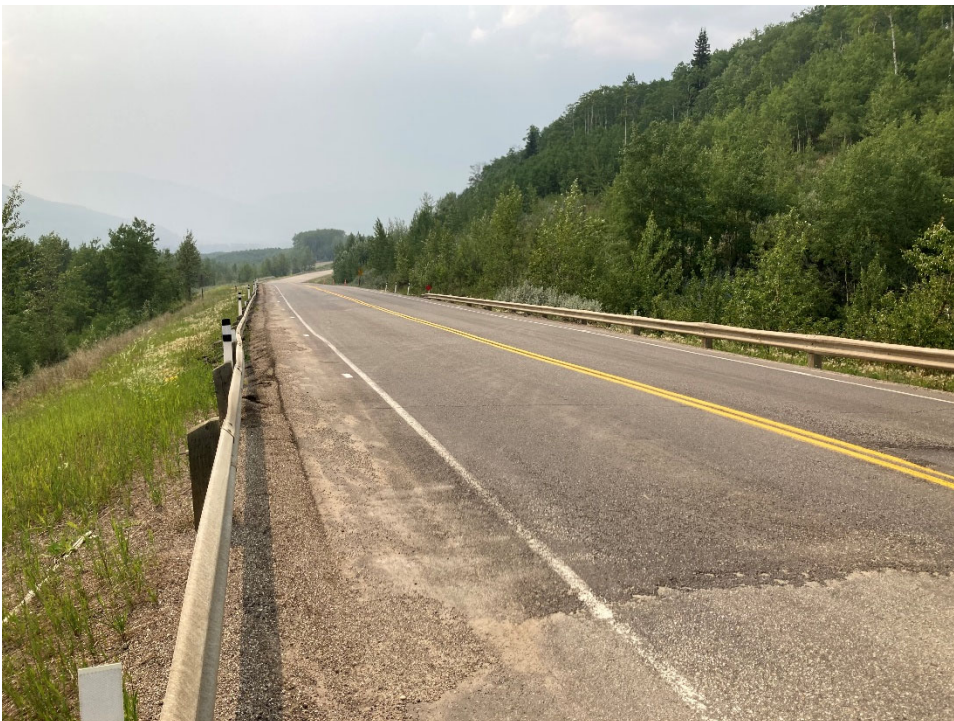
**Photo 6** Asphalt patch near the east extent of the site that is typically repaved on an annual basis. Photo taken July 20, 2021 facing southwest.

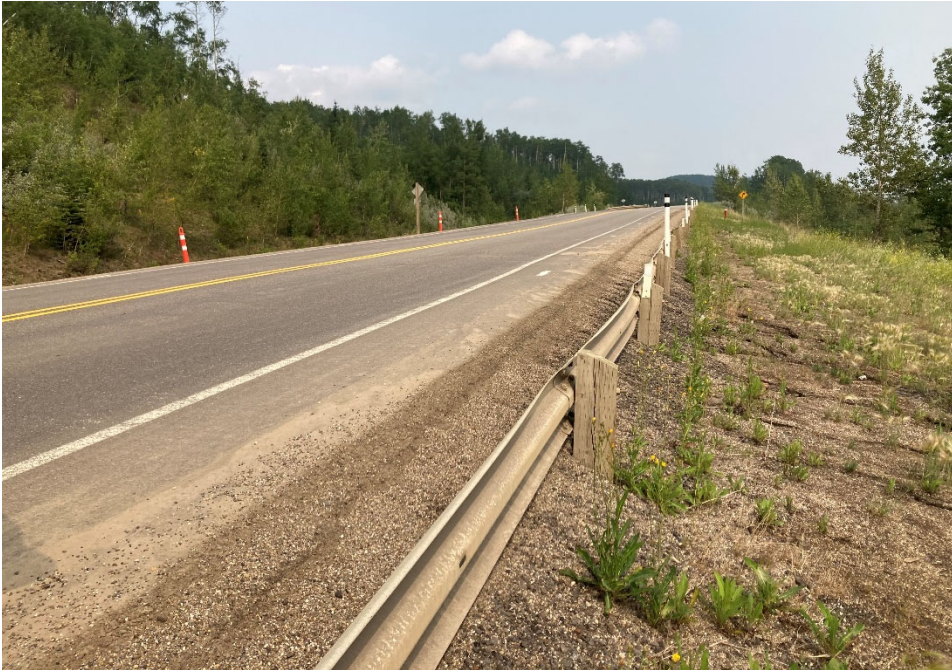
**Photo 7** An area near the east extent of the site (west of the high embankment fill) that is regularly patched, where the asphalt surface is close to the top of the guardrail (WP101). Photo taken July 20, 2021 facing northeast.

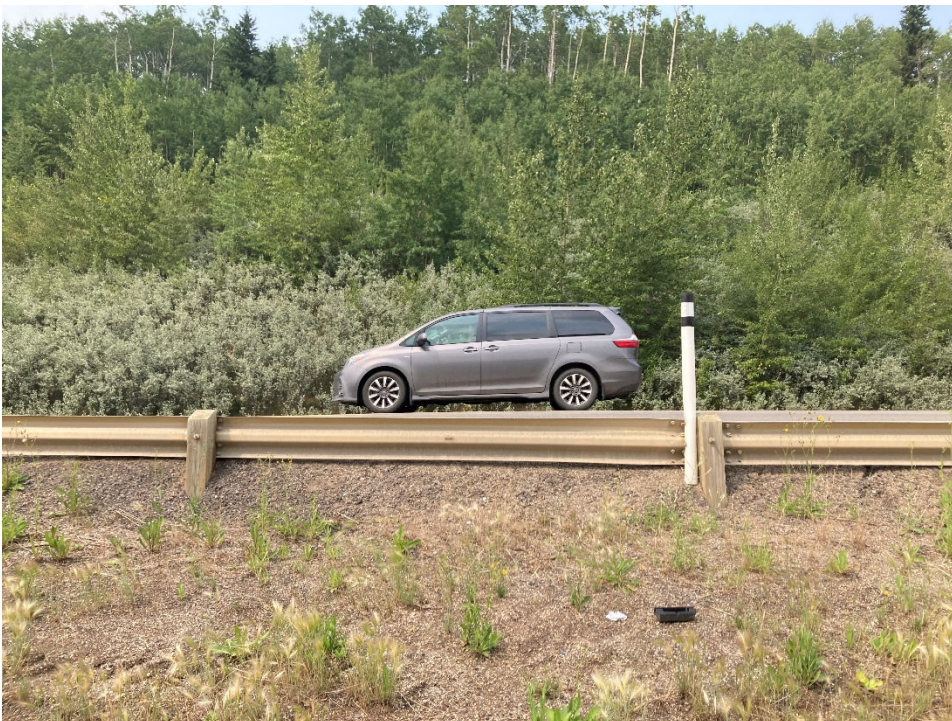
**Photo 8** An area of the site that is regularly patched (shown in Photo 7) where the asphalt surface is near the top of the guardrail. Photo taken July 20, 2021 facing north.
