November 30, 2022

Alberta Transportation
Main Floor, Provincial Building
9621 – 96th Avenue
Peace River, Alberta
T8S 1T4

CON0022166 Peace Region (Grande Prairie District – South) GRMP Instrumentation Monitoring Site GP007; H40:36, km 29.339 Wanyandie Road Slide Section C – 2022 Fall Readings

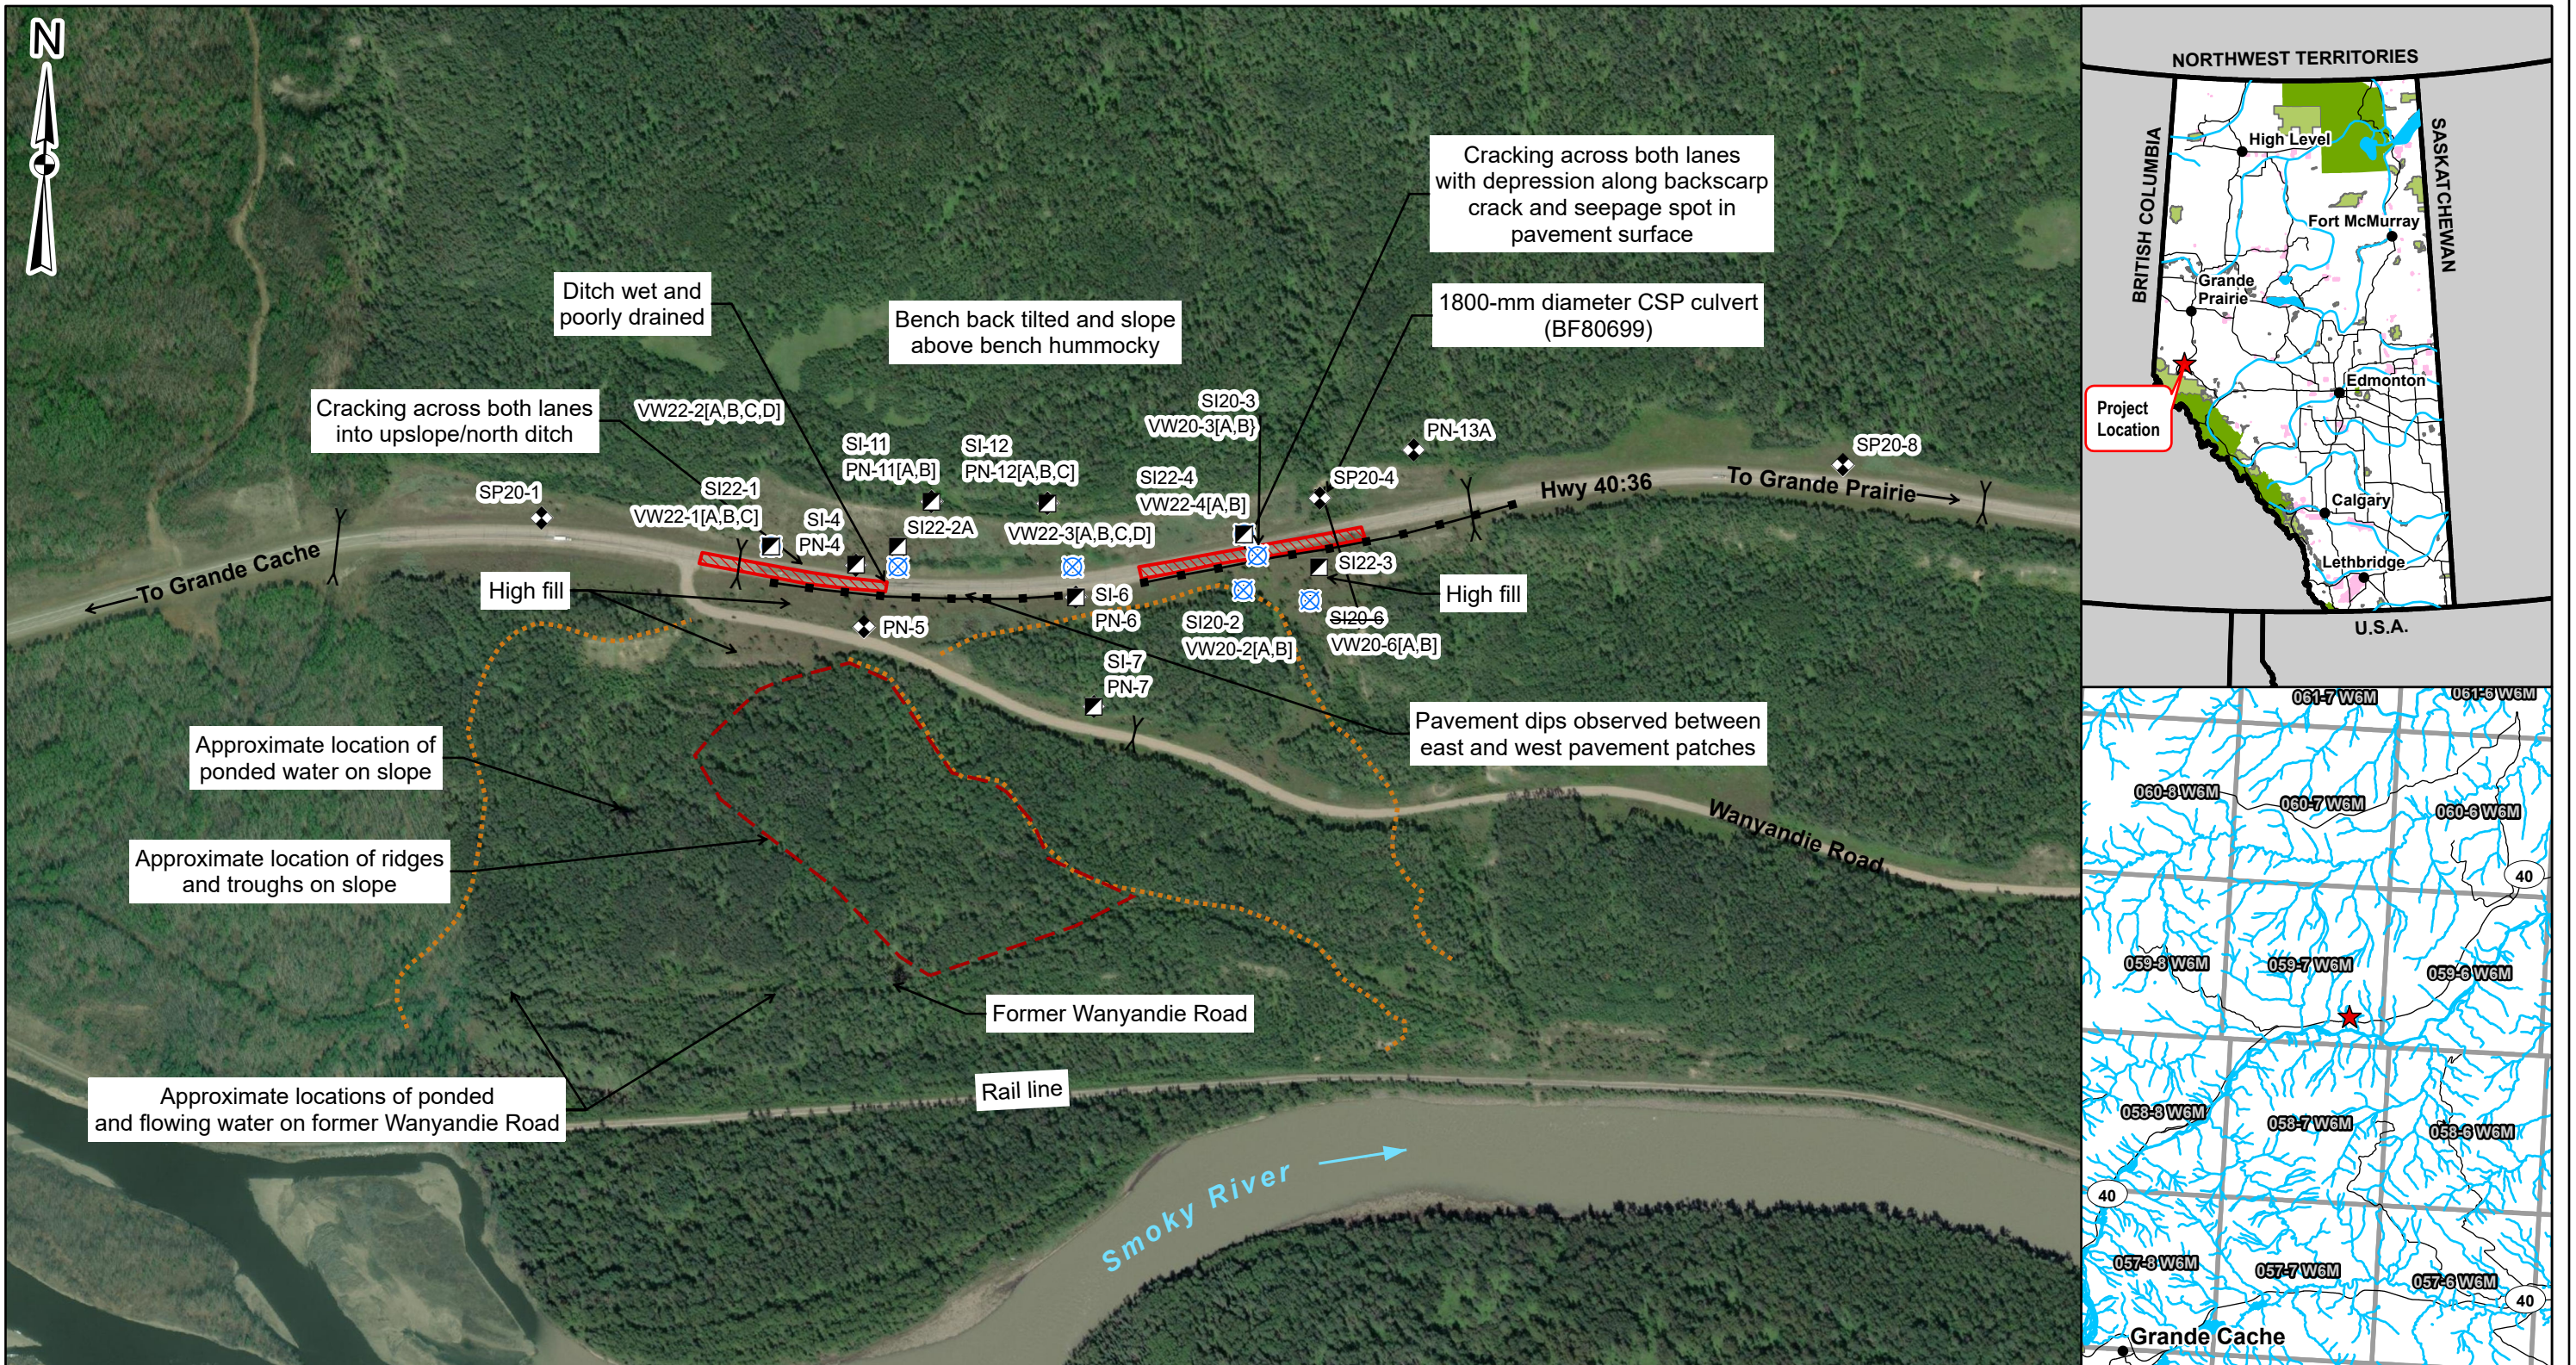
Based on the surface expression of the 2005 bare-earth LiDAR data and historic air photos, the most active slide terrain is located downslope of Hwy 40:36 and Wanyandie Road at the western site limit as shown in Figure 1. KCB hiked to this area during our March 2022 site reconnaissance and the 2022 Section B inspection with AT. A series of ridges and troughs were observed, which could be the result of blocks sliding and eroding overtime with vegetation growth, becoming more rounded. The direction of movement recorded in SI98-2 and SI98-5 was towards the area of ridges and troughs before they sheared.

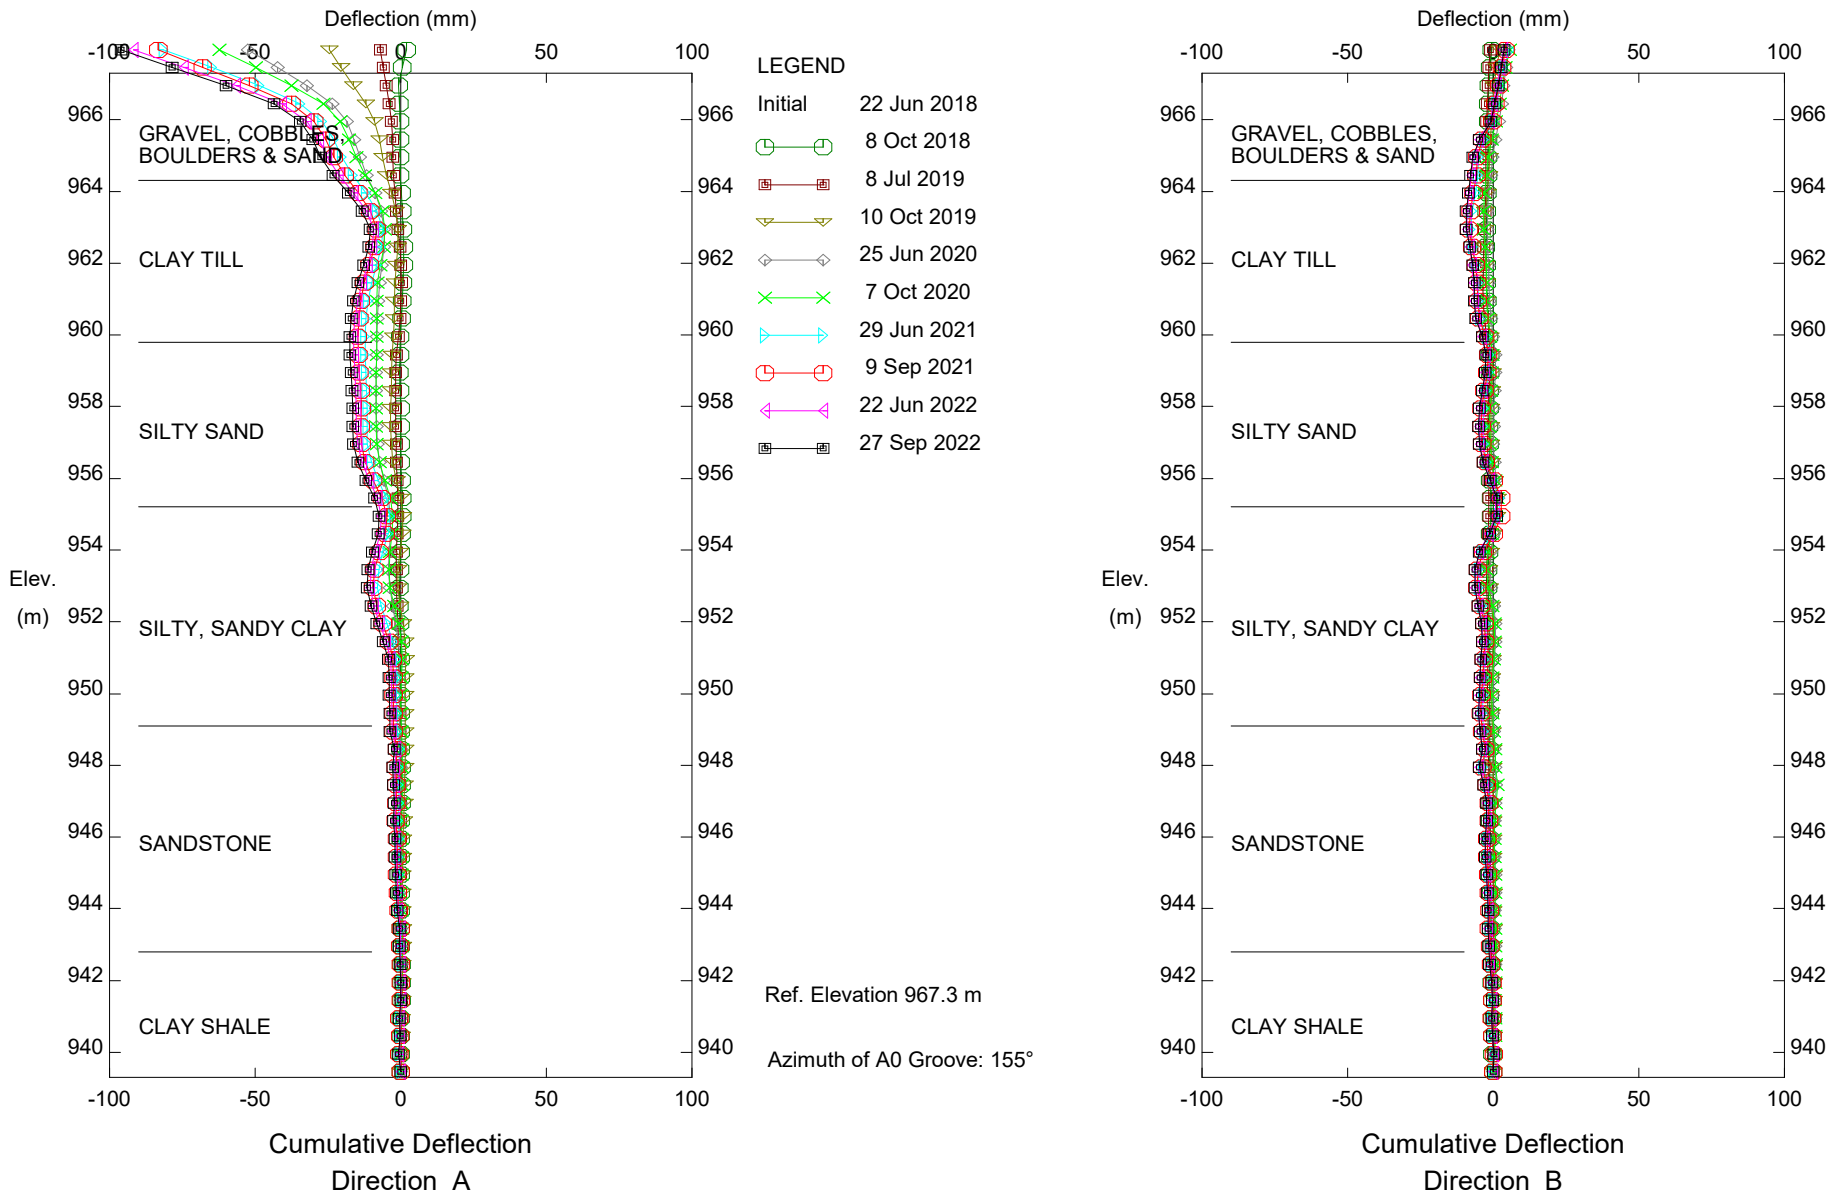
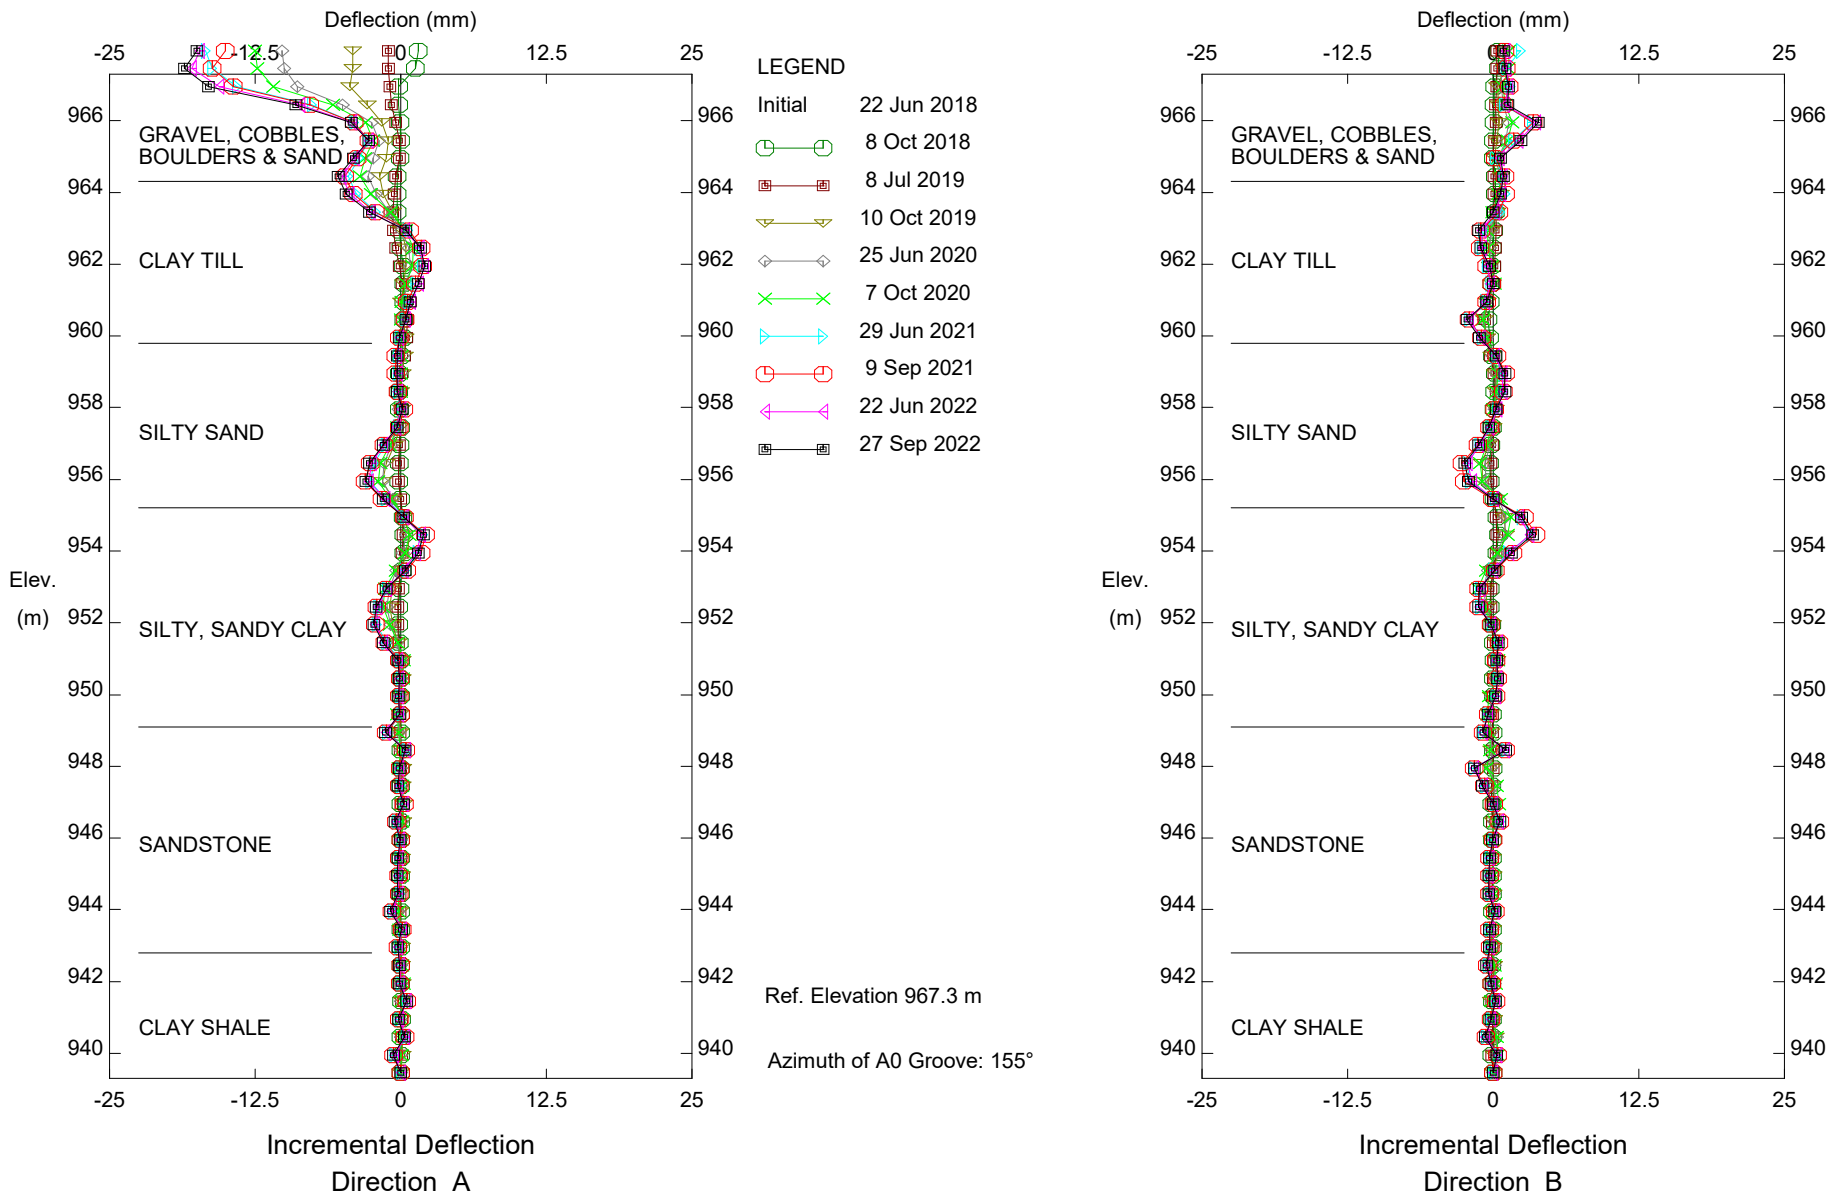
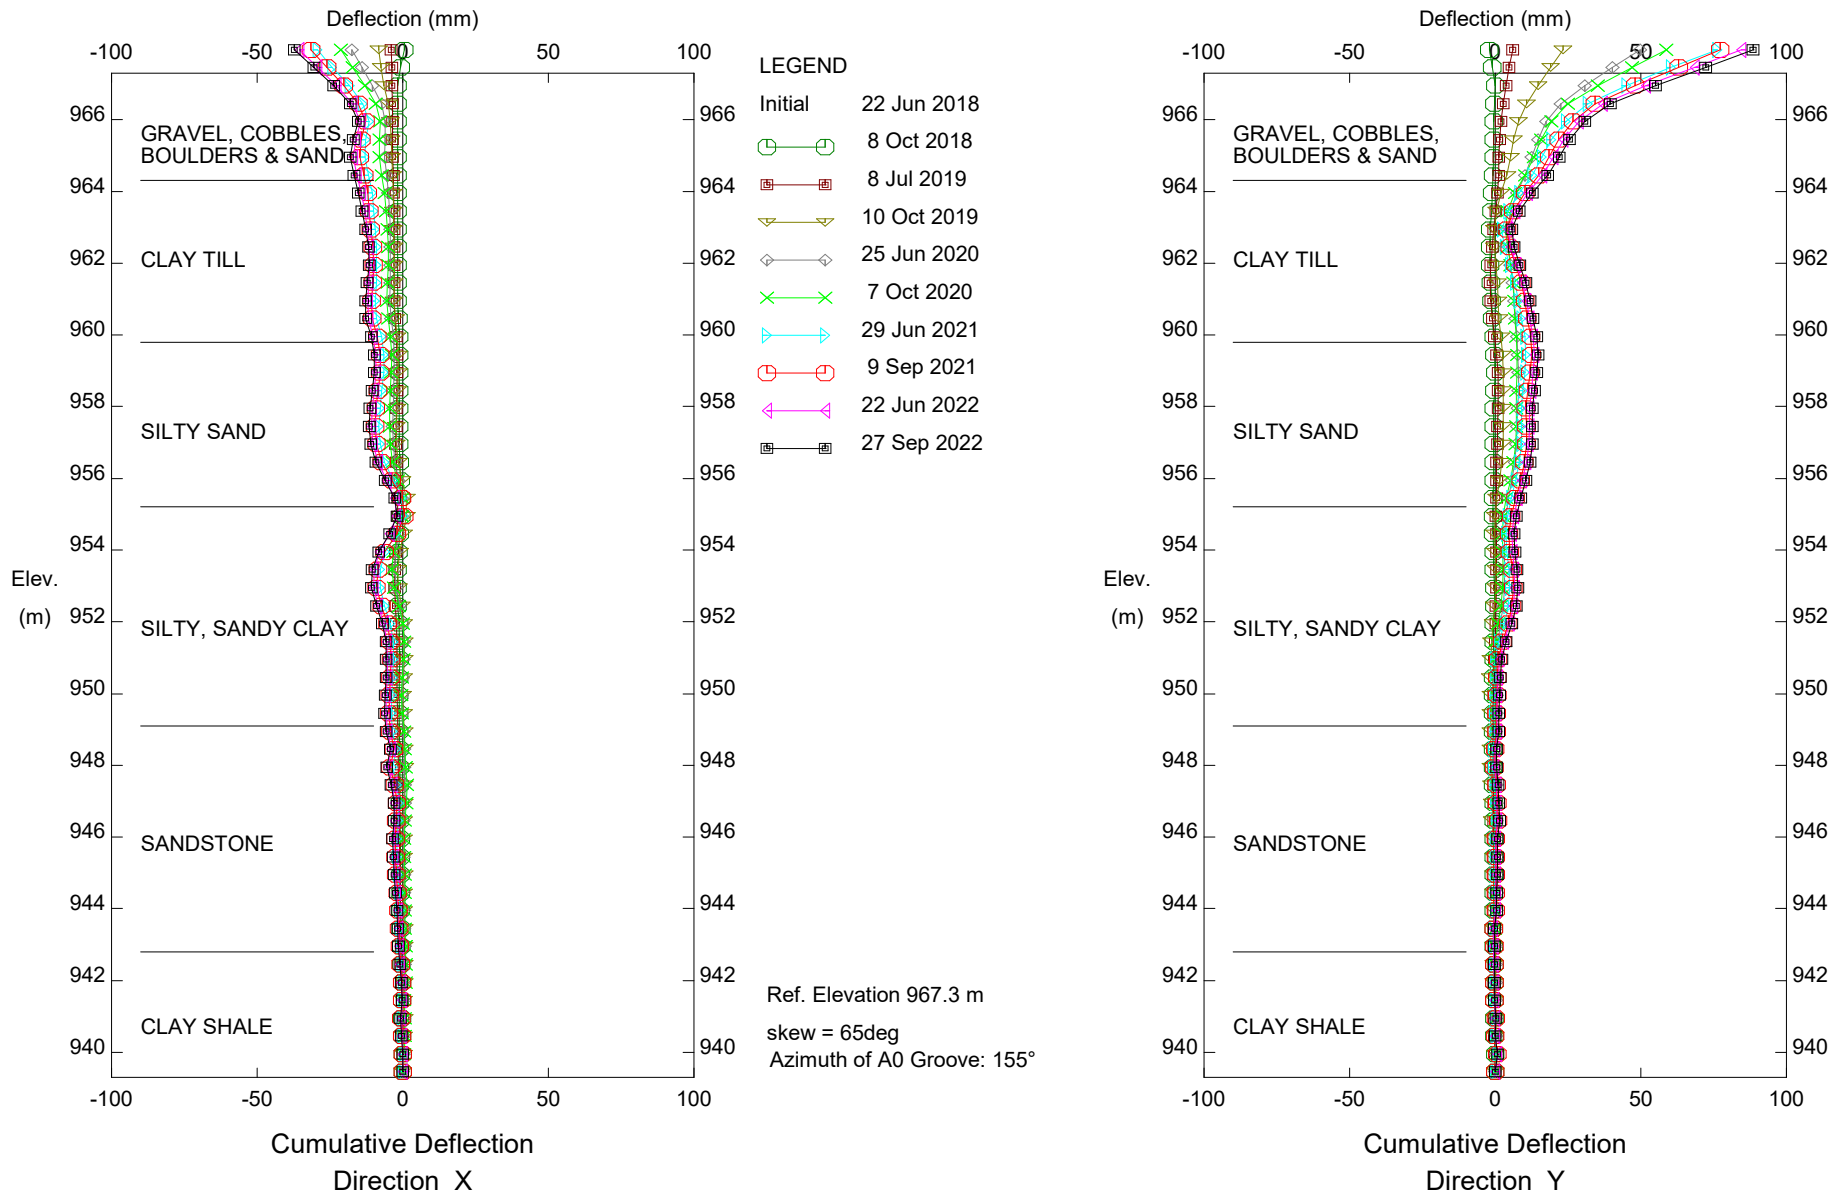
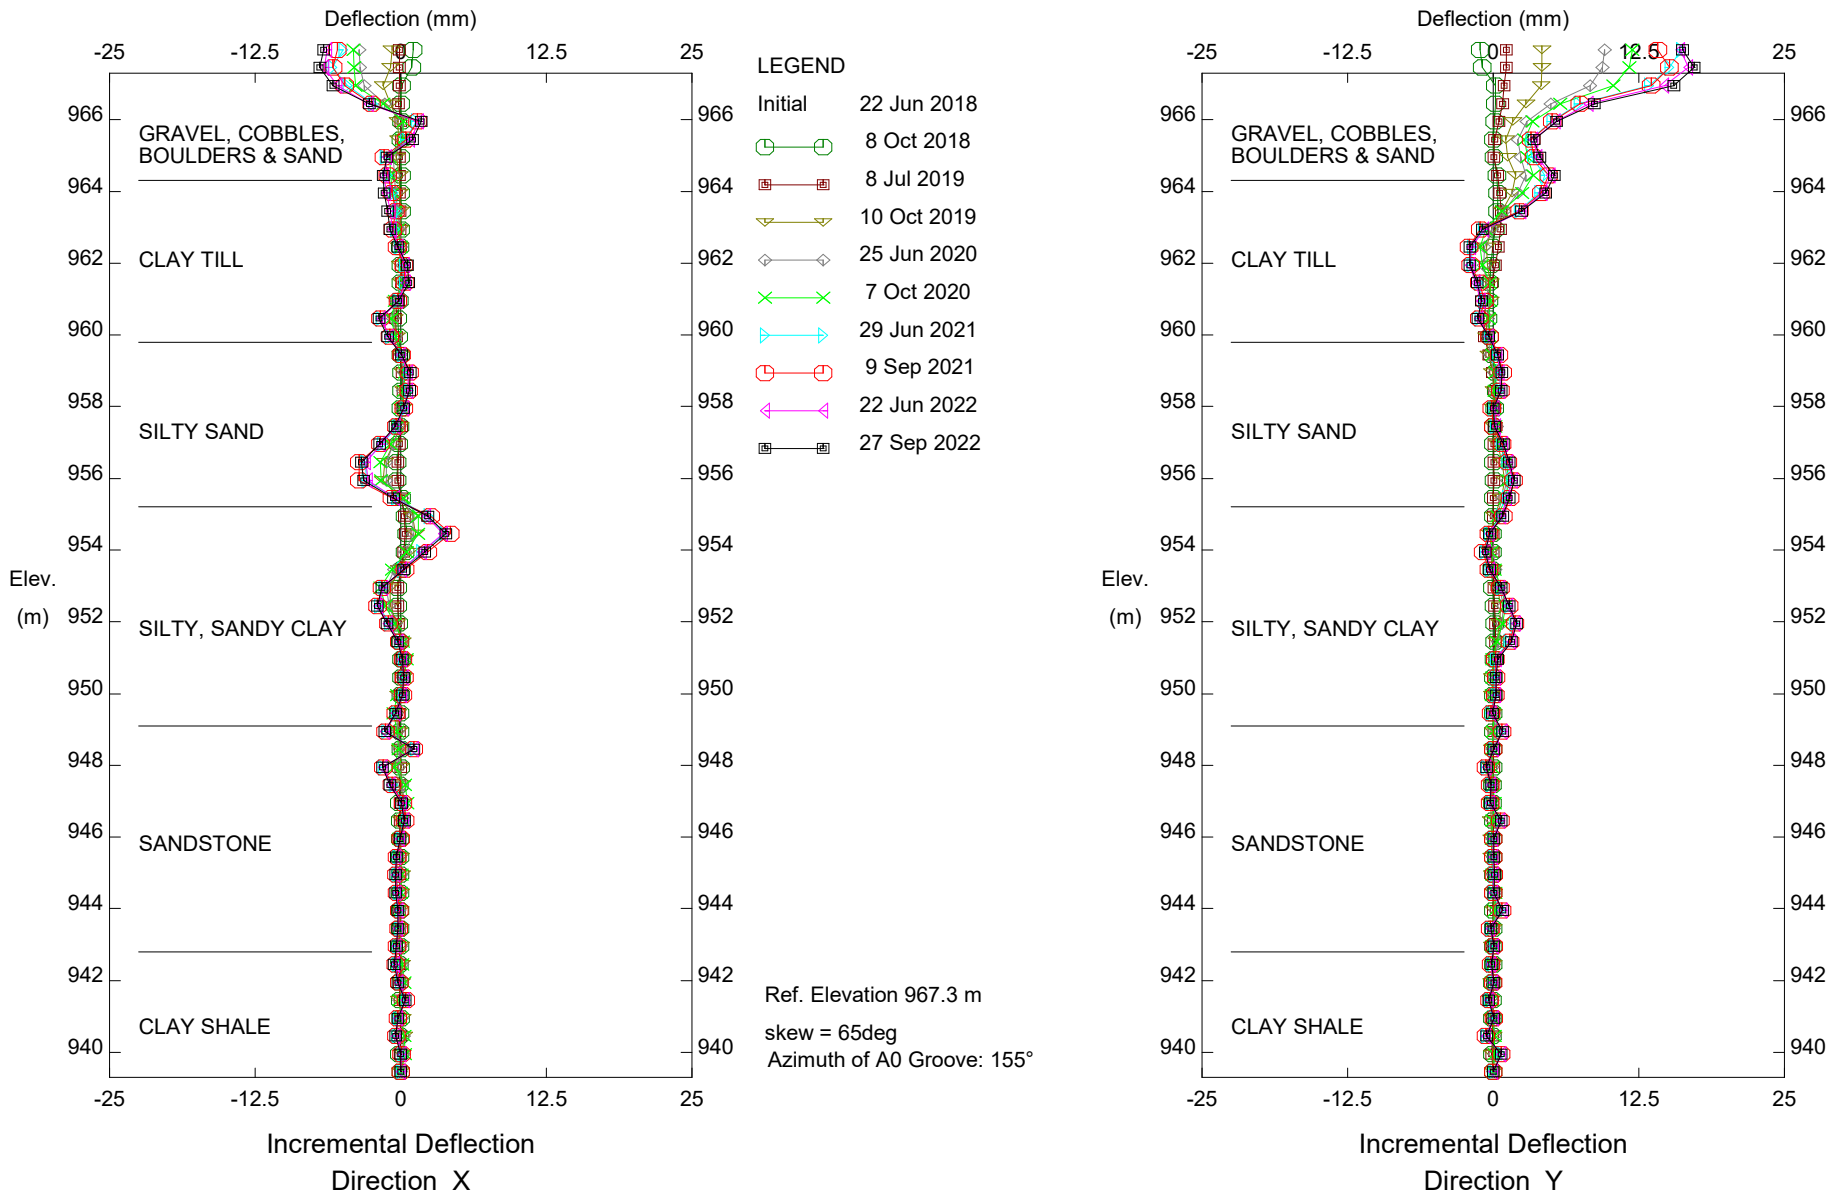
GP007; H40:36, Wanyandie Road Slide, Inclinometer SI98-06

It is noted that the data for SI98-6 and SI98-12 is noisy and difficult to interpret. Based on the absolute plots for these instruments, SI98-6 has kinks in the casing at an approximate depth of 11.9 m and 13.9 m below ground surface, and SI98-12 is tilted approximately 1.5 m in the A-direction. SI98-12 has also been re-sleeved twice (i.e., had a small diameter casing installed in it) (dates unknown). KCB will continue to assess if re-initialization is needed to reduce reading noise in these instruments.
