November 30, 2022

Alberta Transportation
Main Floor, Provincial Building
9621 – 96th Avenue
Peace River, Alberta
T8S 1T4

CON0022166 Peace Region (Grande Prairie District – South) GRMP Instrumentation Monitoring Site GP007; H40:36, km 29.339 Wanyandie Road Slide Section C – 2022 Fall Readings

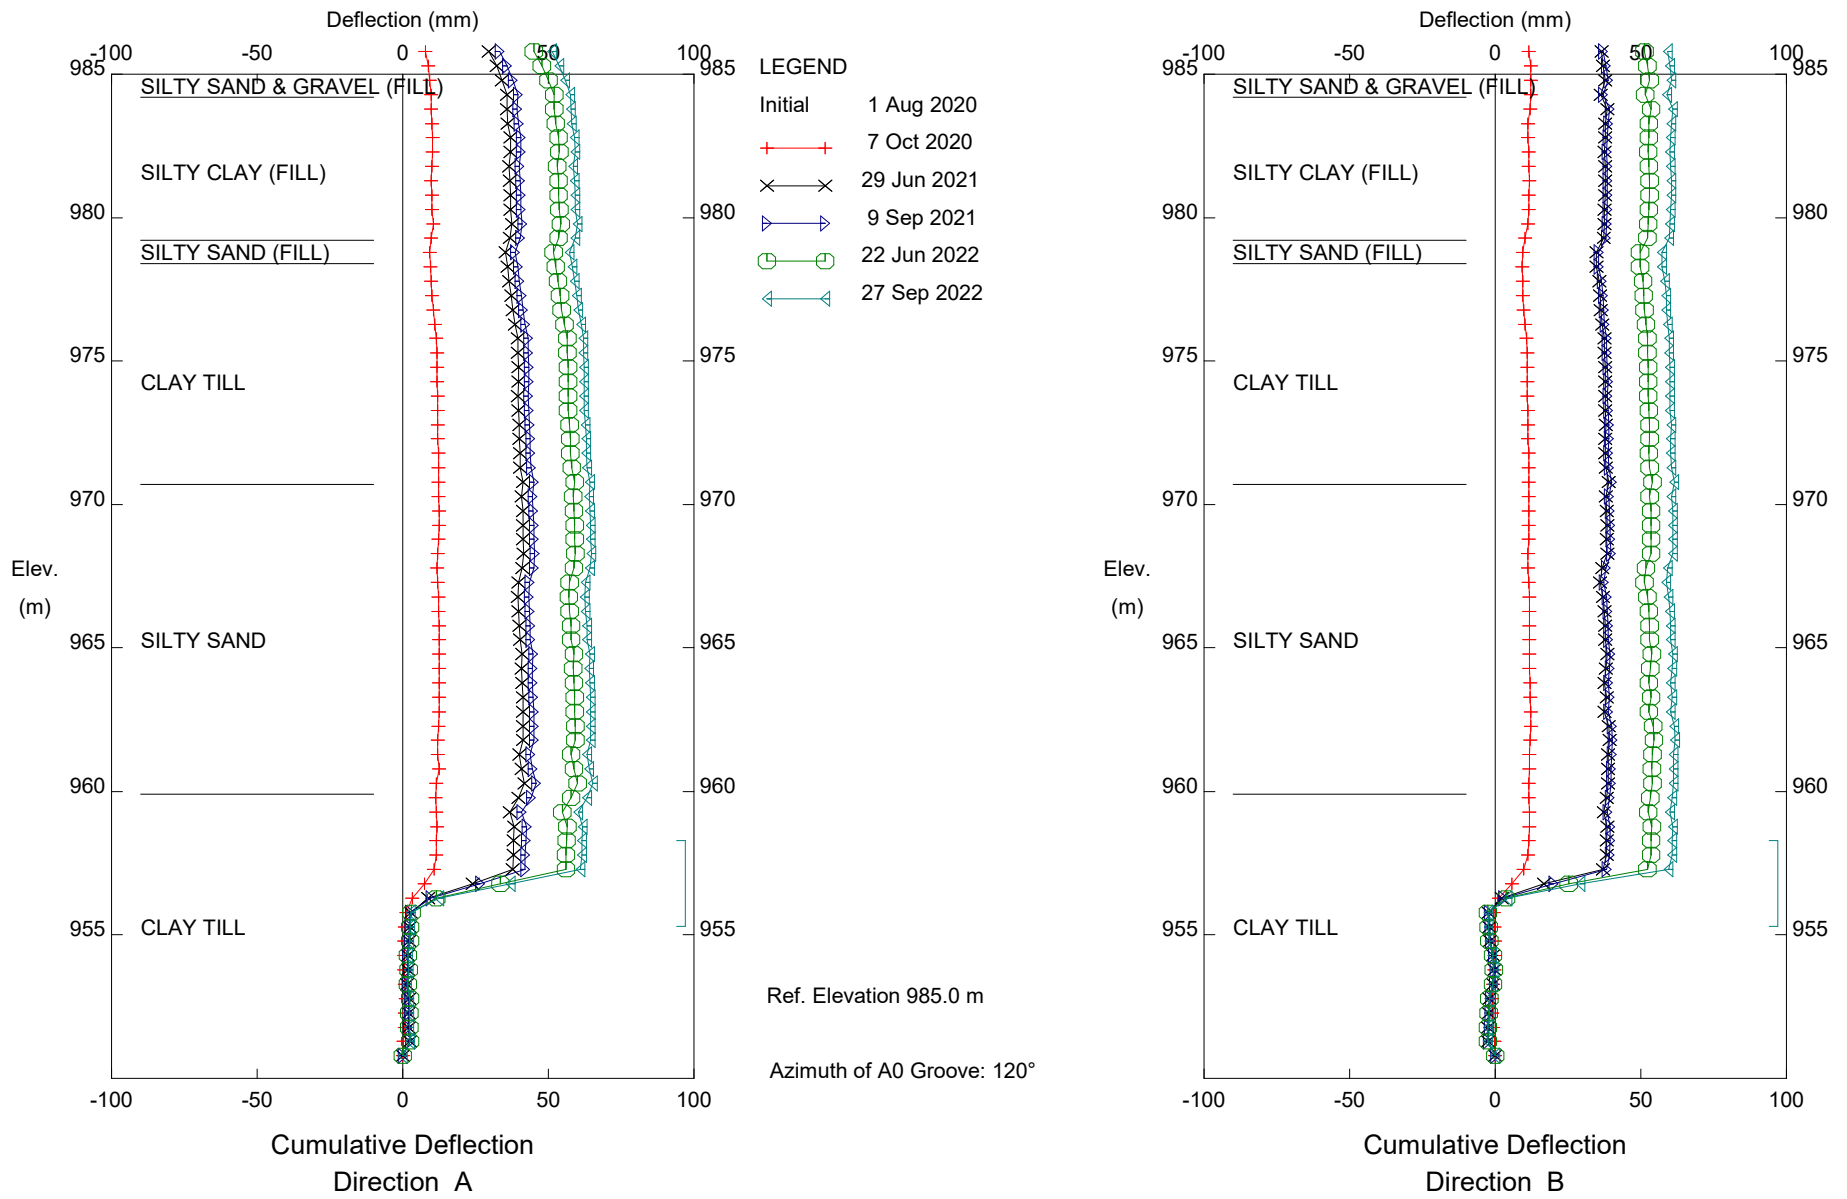
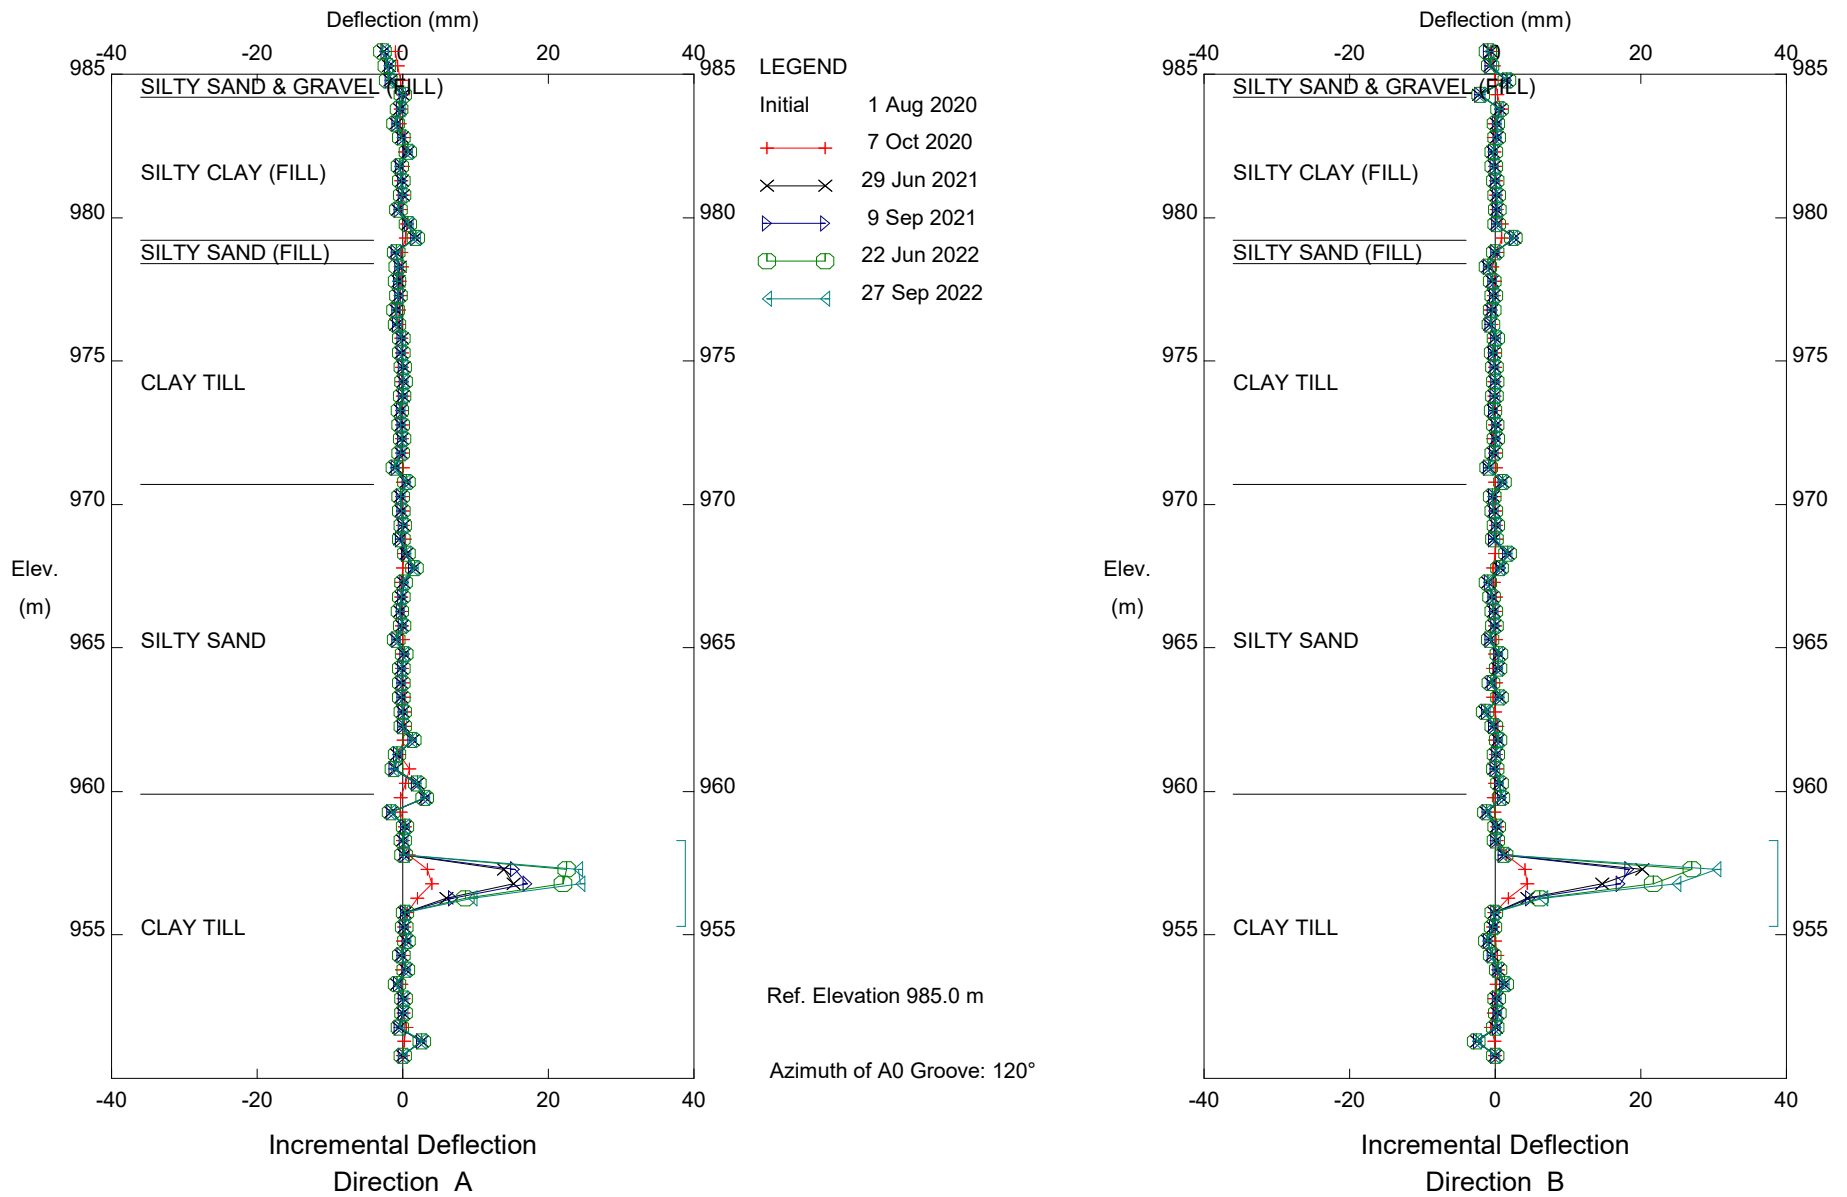
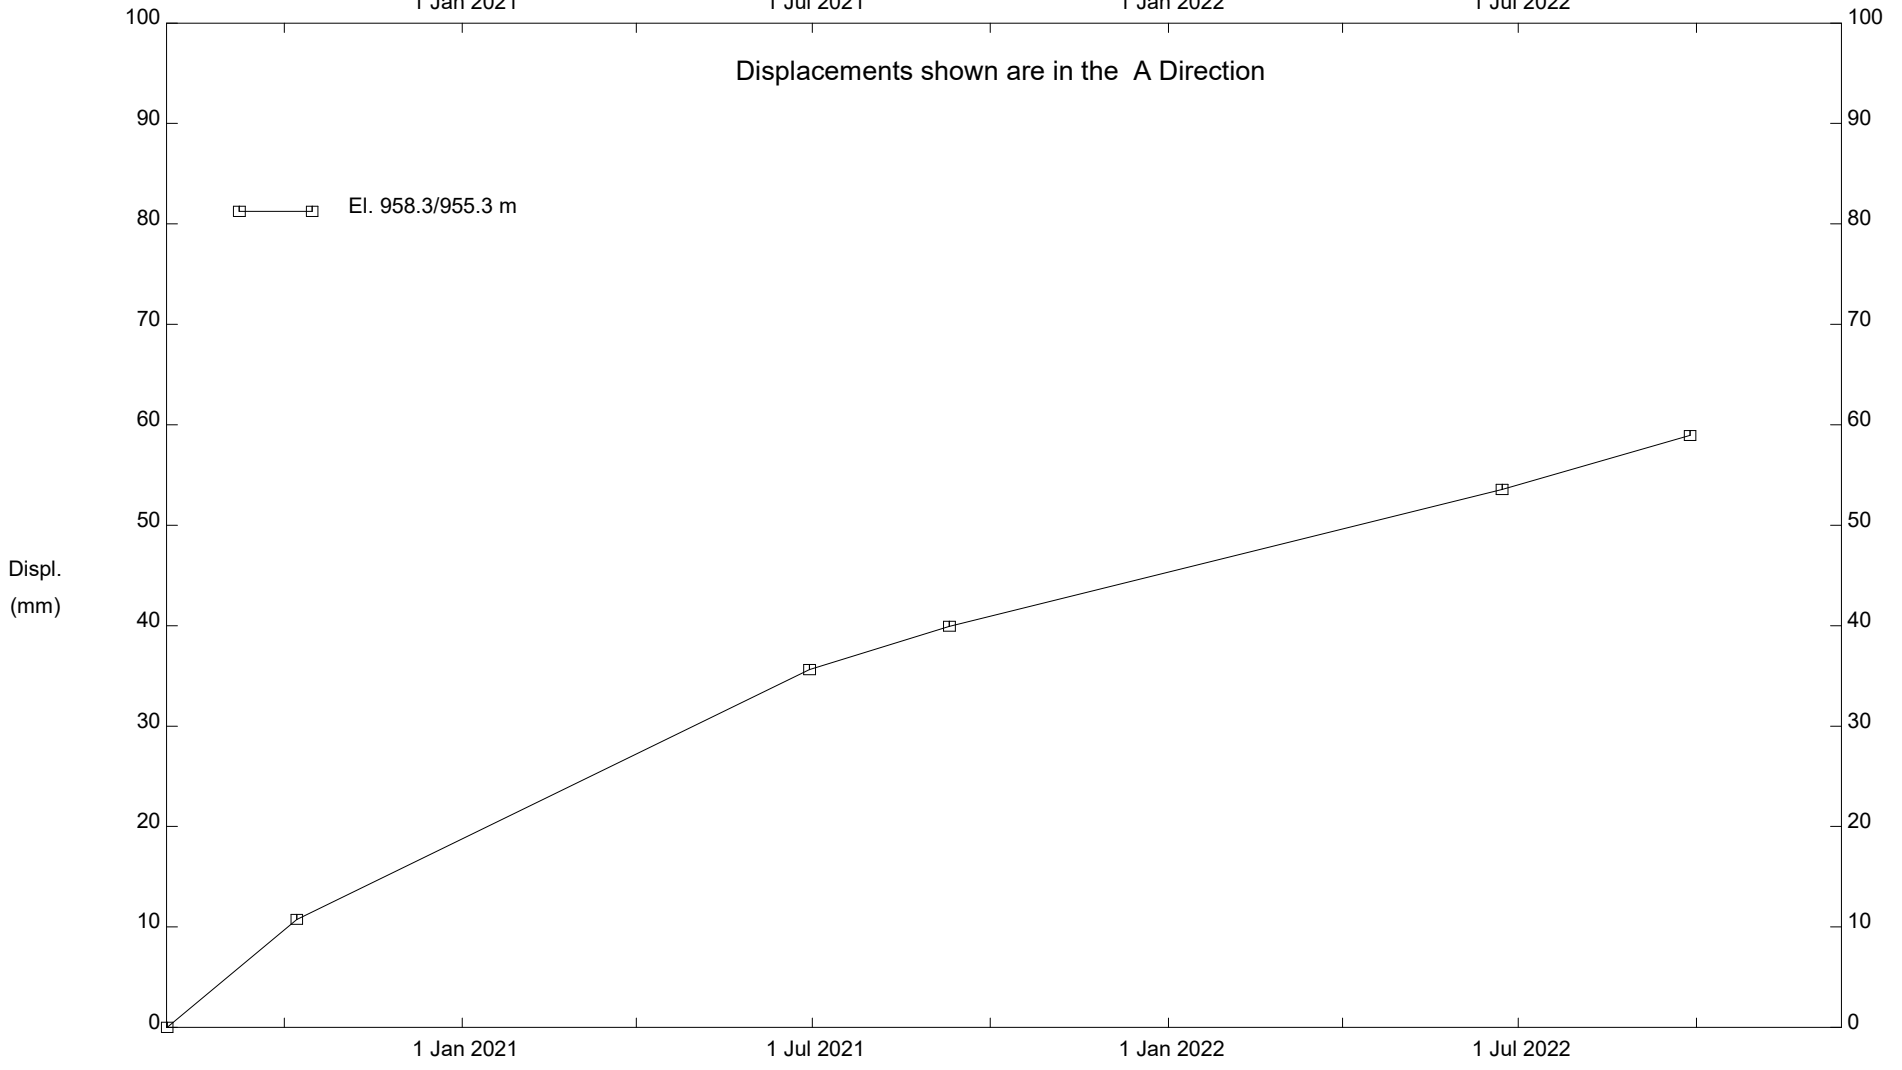
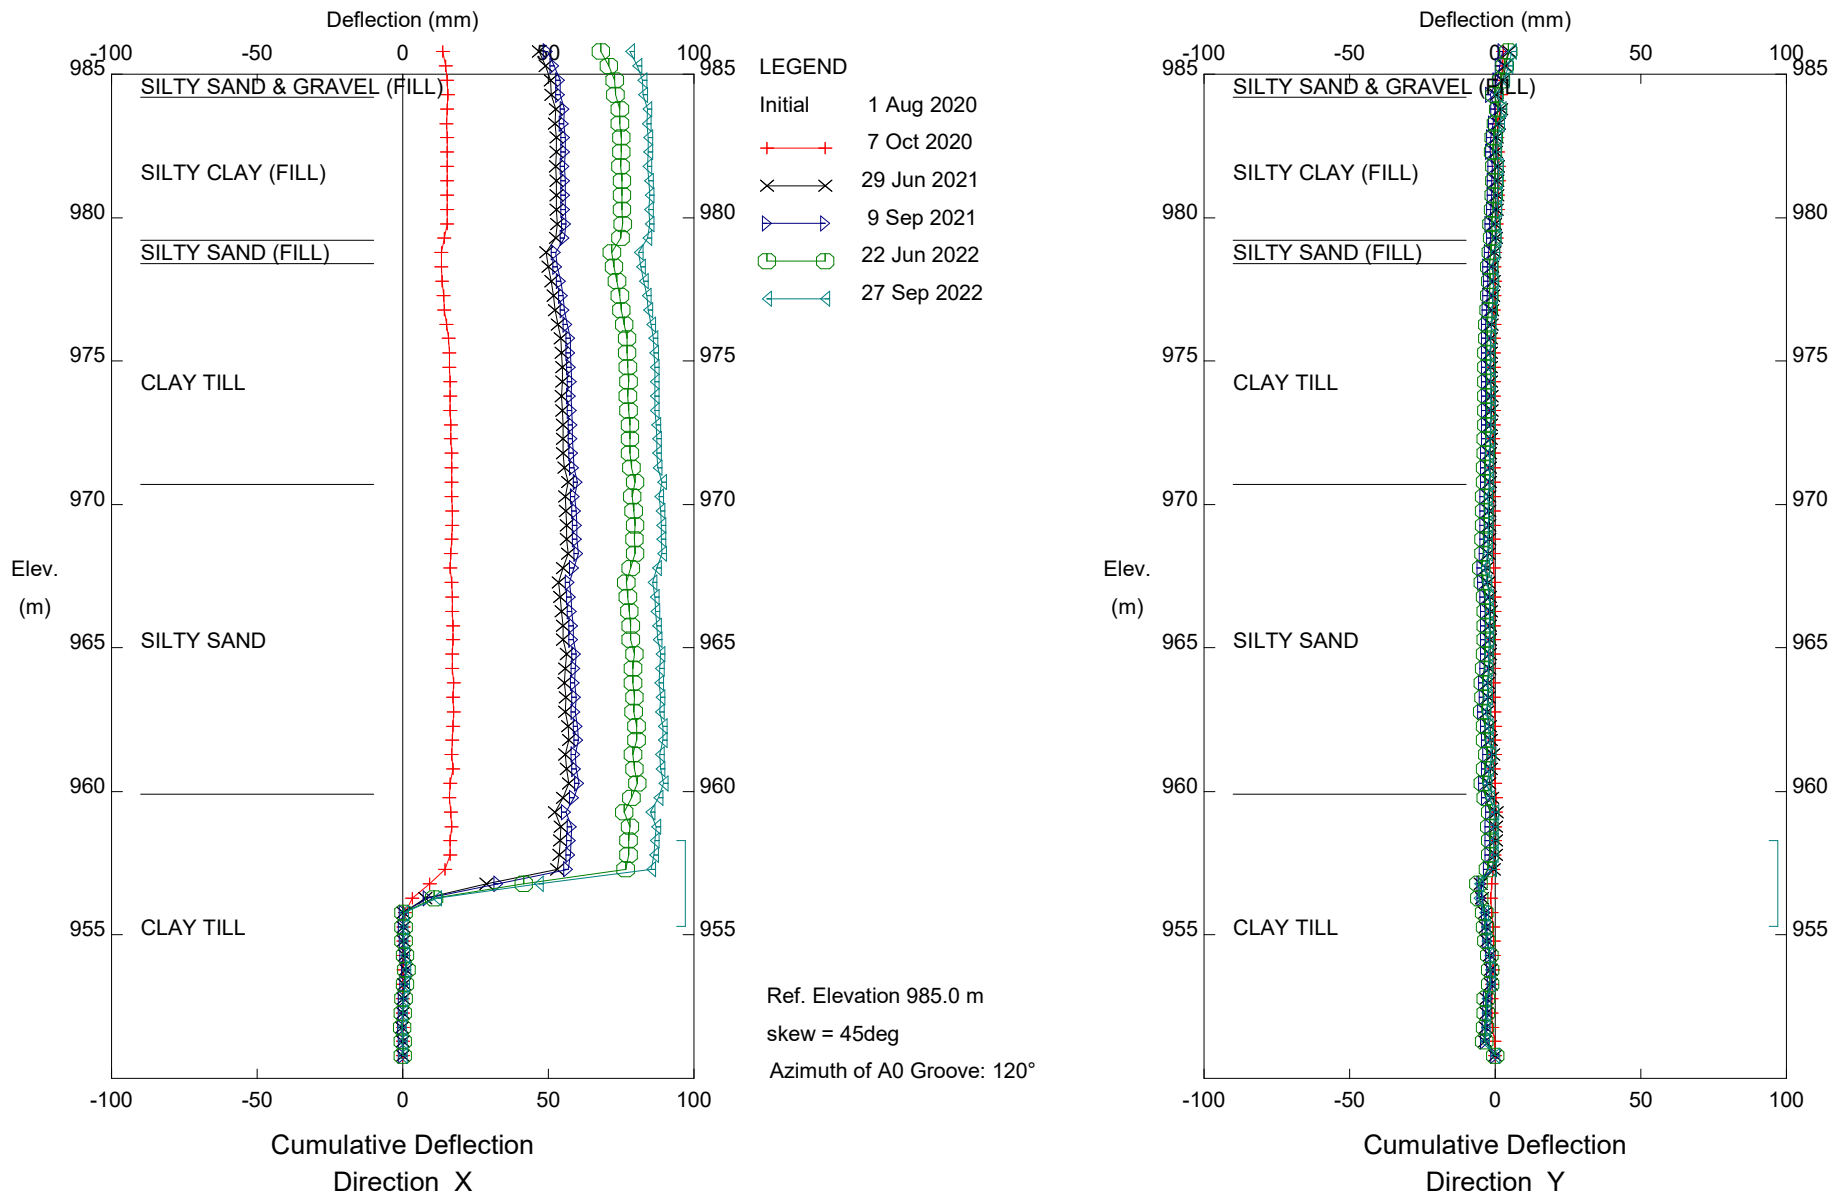
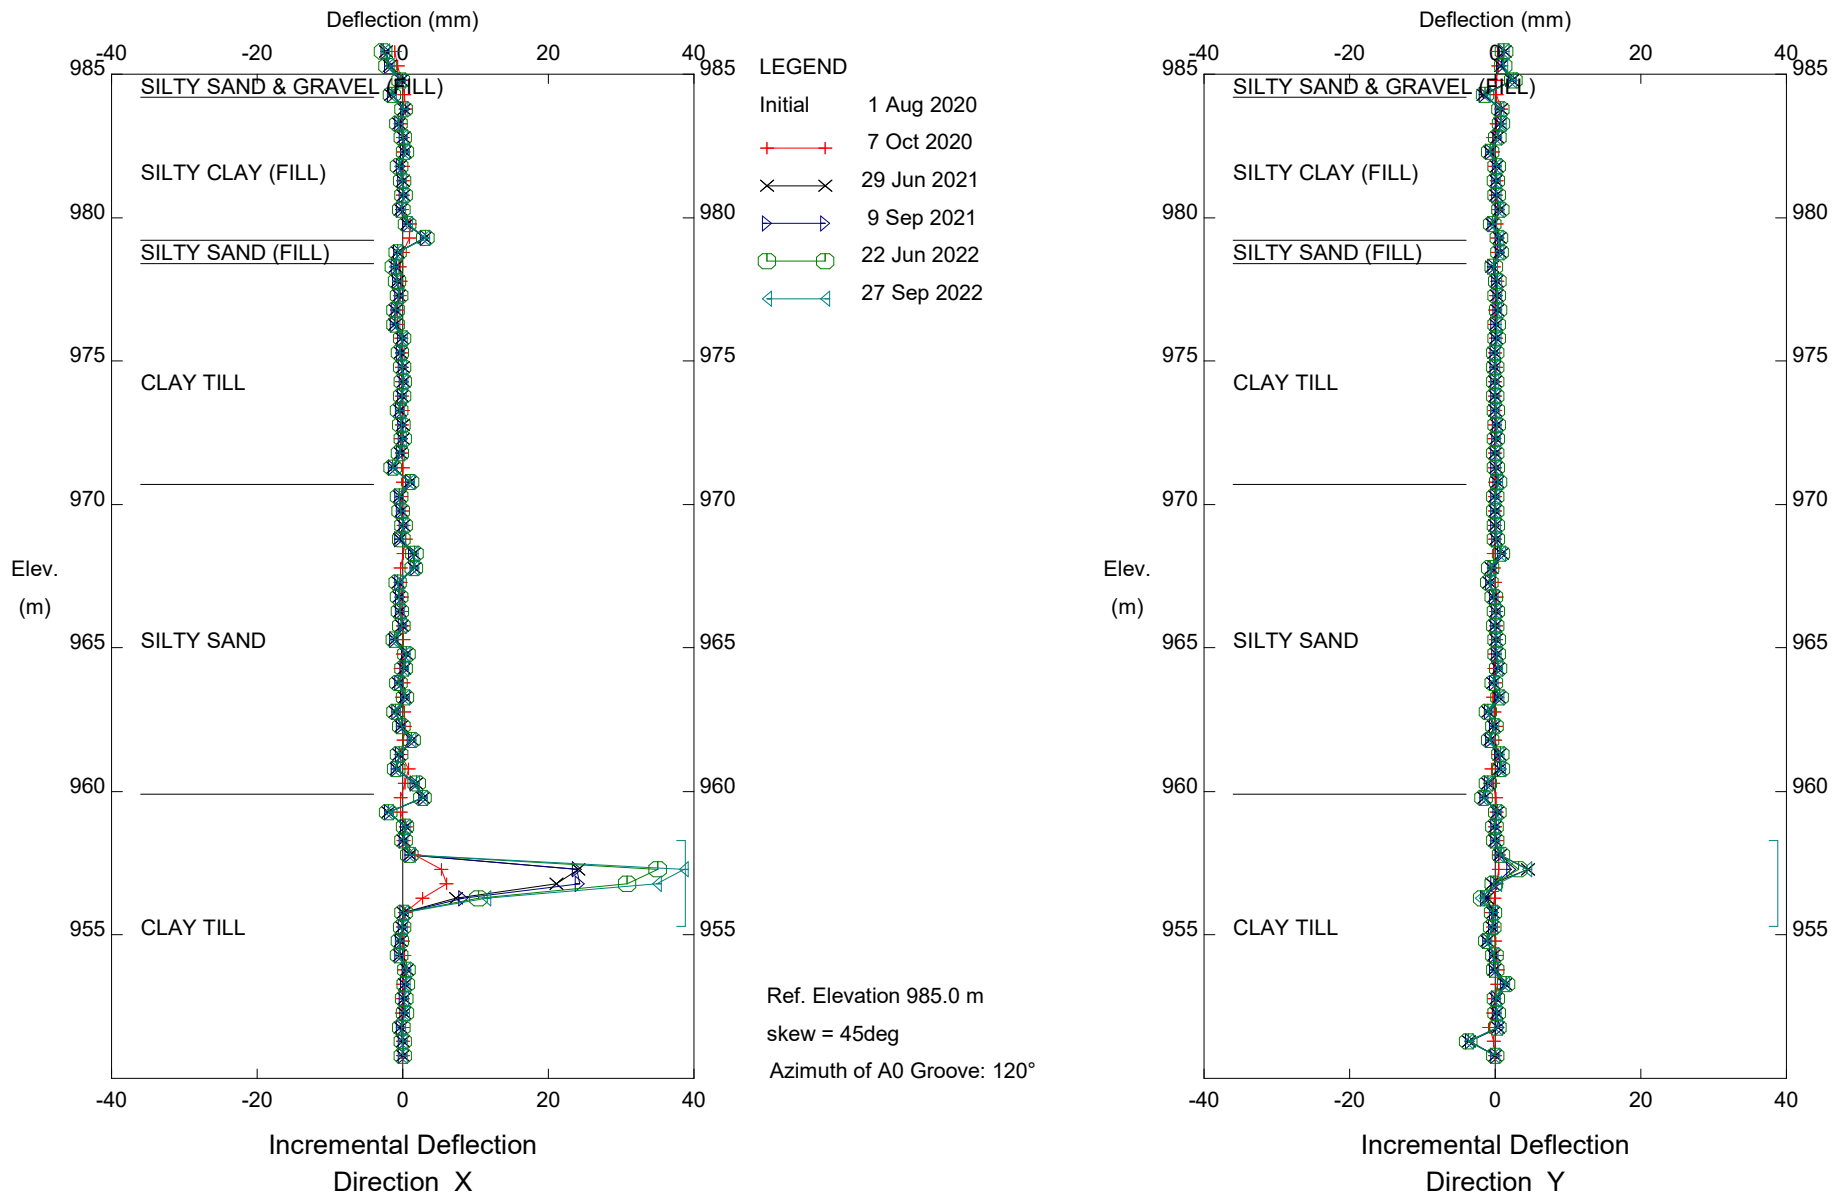
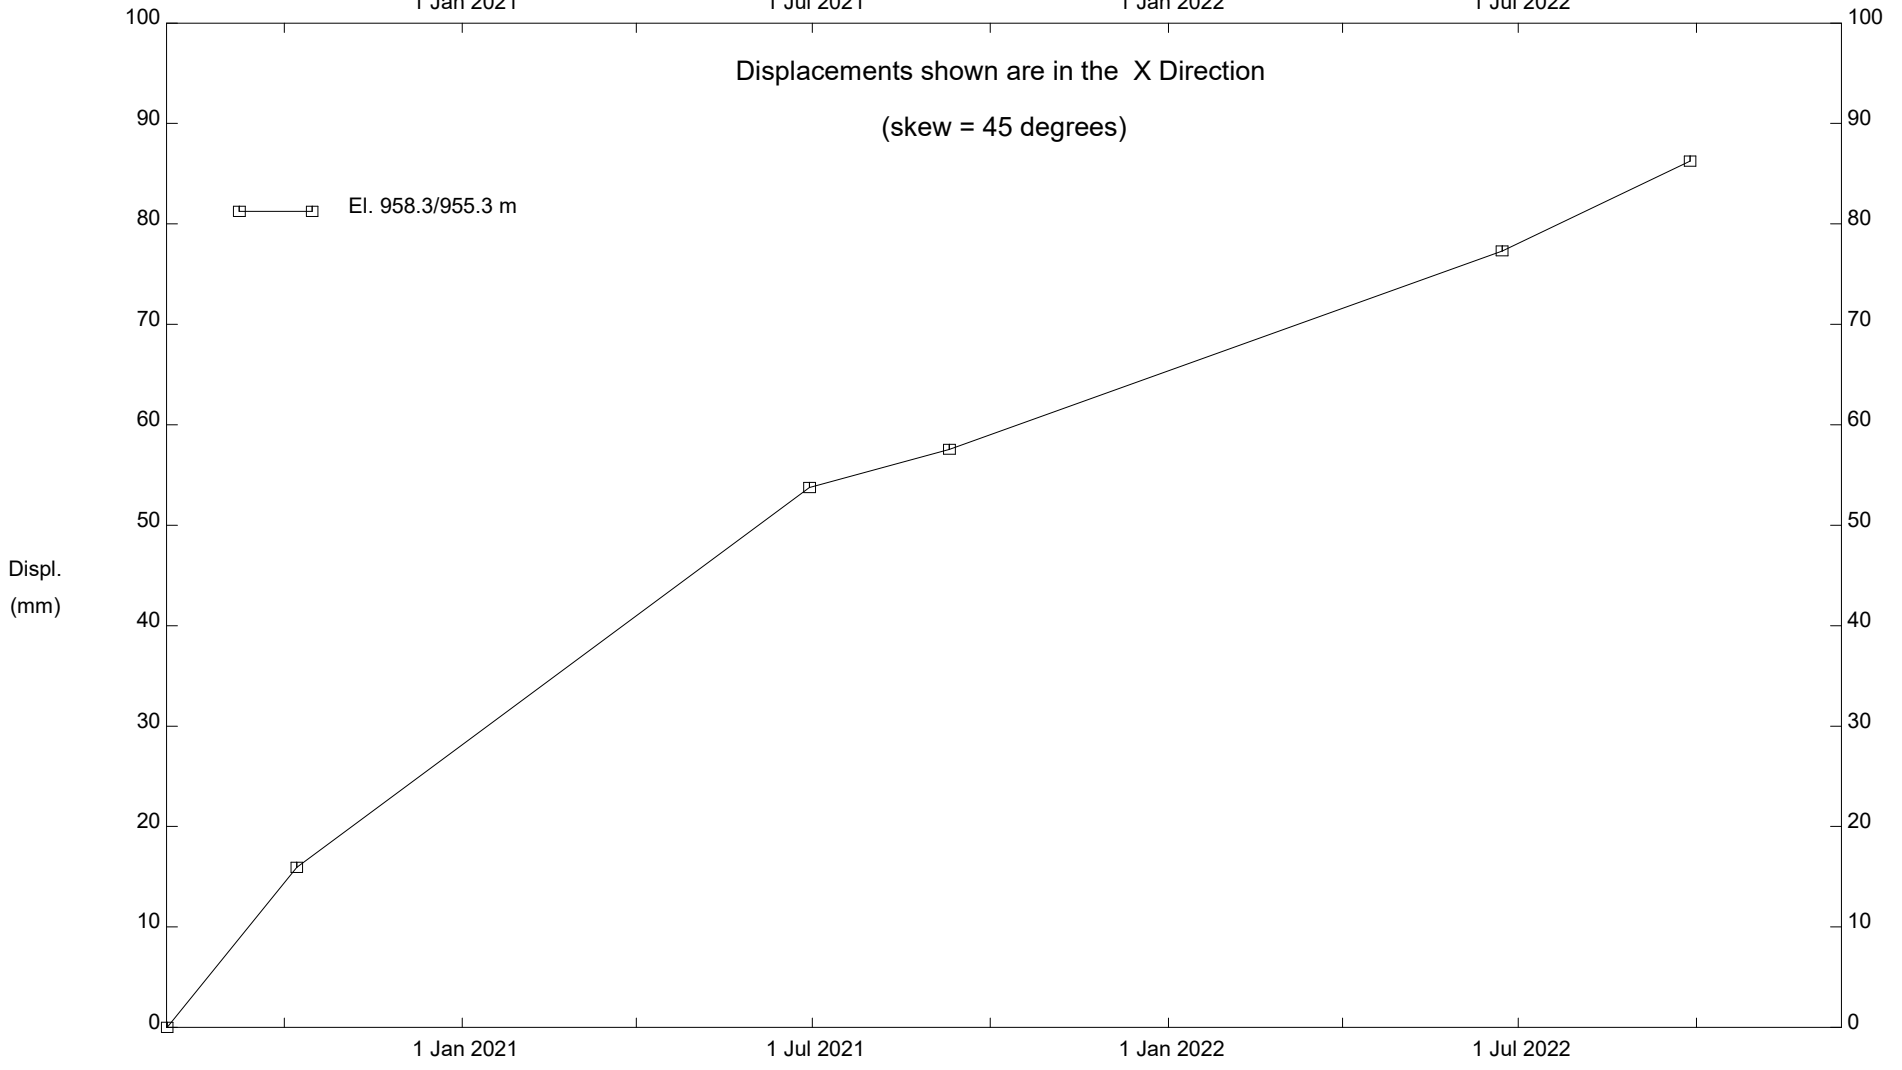
GP007; H40:36, Wanyandie Road Slide, Inclinometer SI20-02

Movement is/was being recorded in both the A- and B-directions of SI20-2, SI20-3, and SI20-6 (now inoperable) with an overall resultant towards the south to southeast. The movement appears to be in response to high fill placement at this location in the ravine on the east side of the site. Alternatively, the size of the area of valley-wall instability could be such that natural slope movements have A- and B-direction components due to the shape of the basal failure plane, potentially more stable zones, or other unknown factors. Since these instruments were terminated in clay till (not bedrock) a deeper SI (SI22-04) was installed by KCB in 2022 into bedrock to assess if deeper movements are occurring at this location. No discernible movement has been recorded in SI22-04. This instrument has only been read once since installation and more data is needed to assess movement trends. Given the rate of discrete movement being recorded in SI20-2 and SI20-3, KCB anticipates that these instruments could shear soon and become inoperable.
