November 30, 2022

Alberta Transportation
Main Floor, Provincial Building
9621 – 96th Avenue
Peace River, Alberta
T8S 1T4

CON0022166 Peace Region (Grande Prairie District – South) GRMP Instrumentation Monitoring Site GP007; H40:36, km 29.339 Wanyandie Road Slide Section C – 2022 Fall Readings

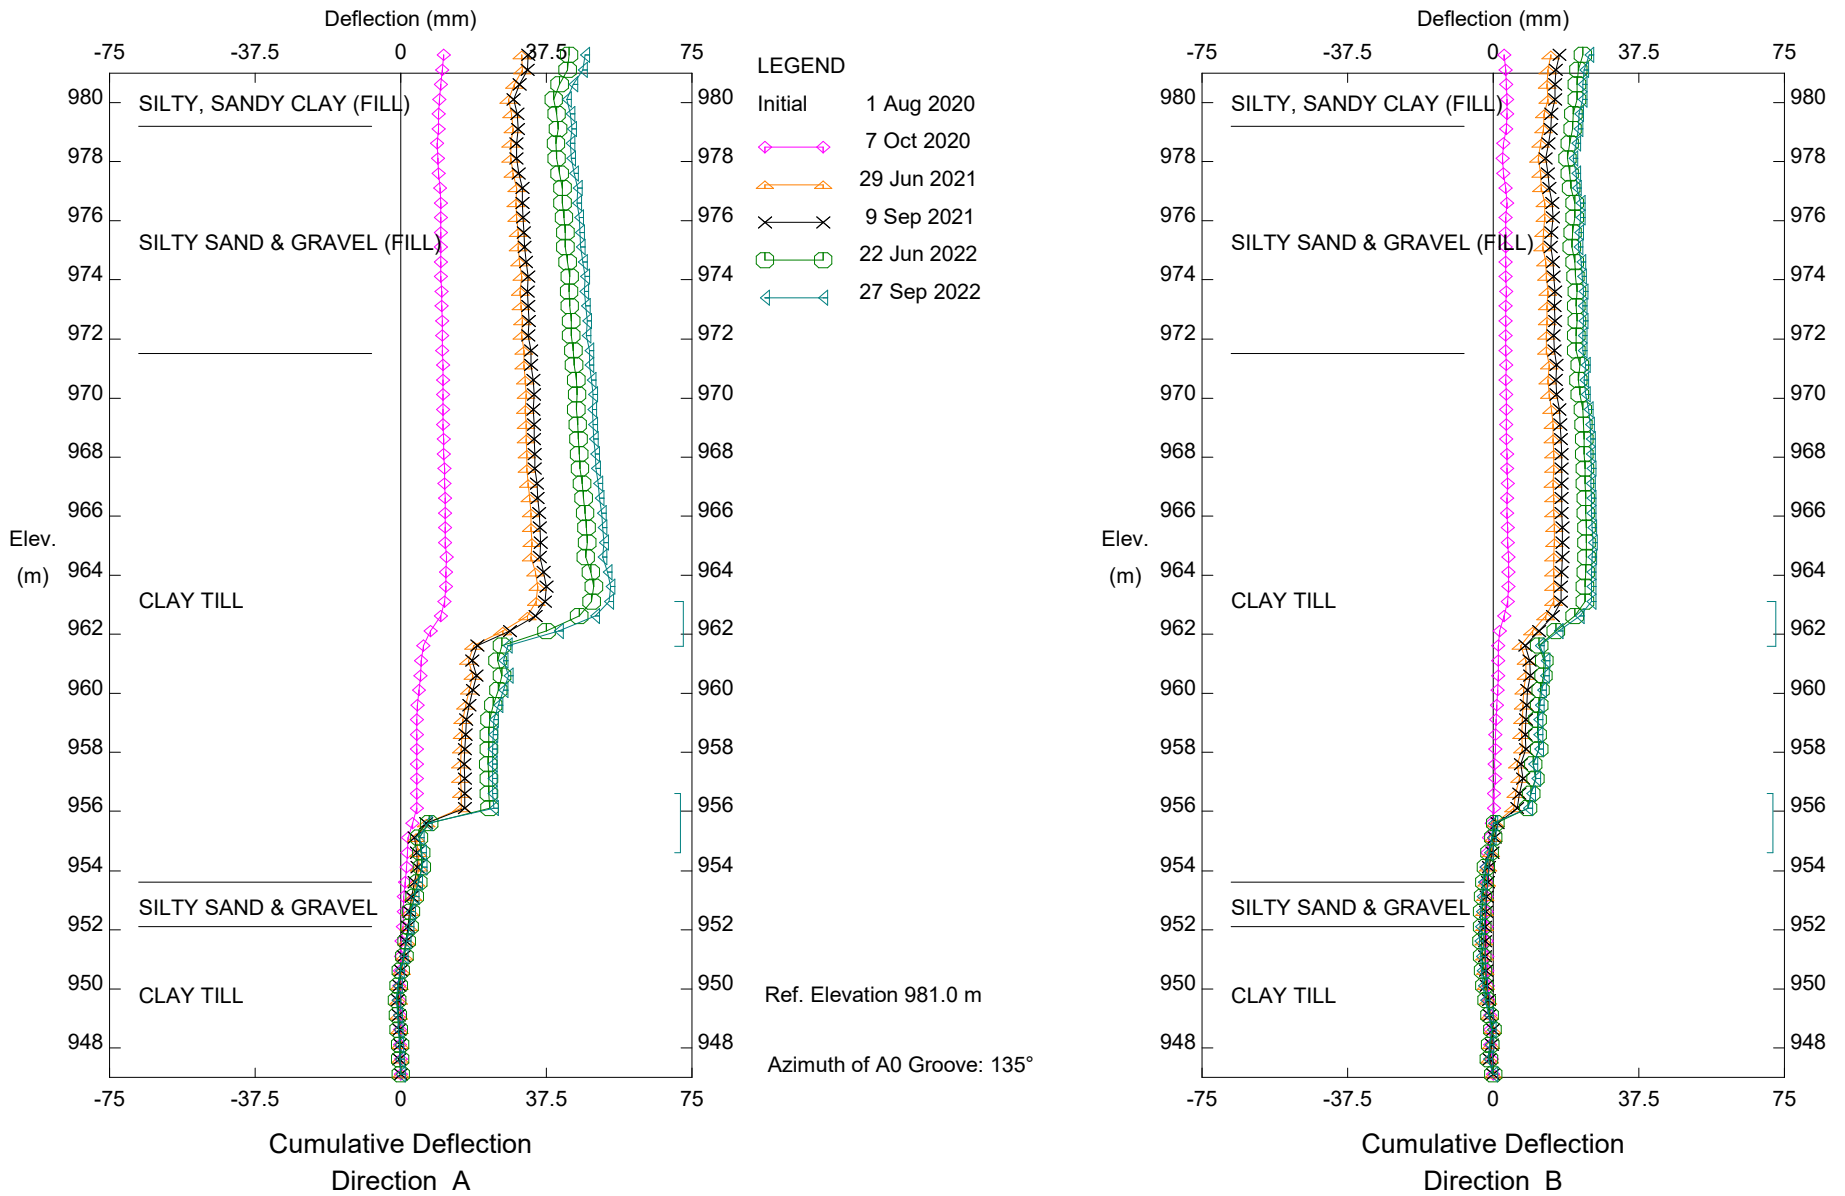
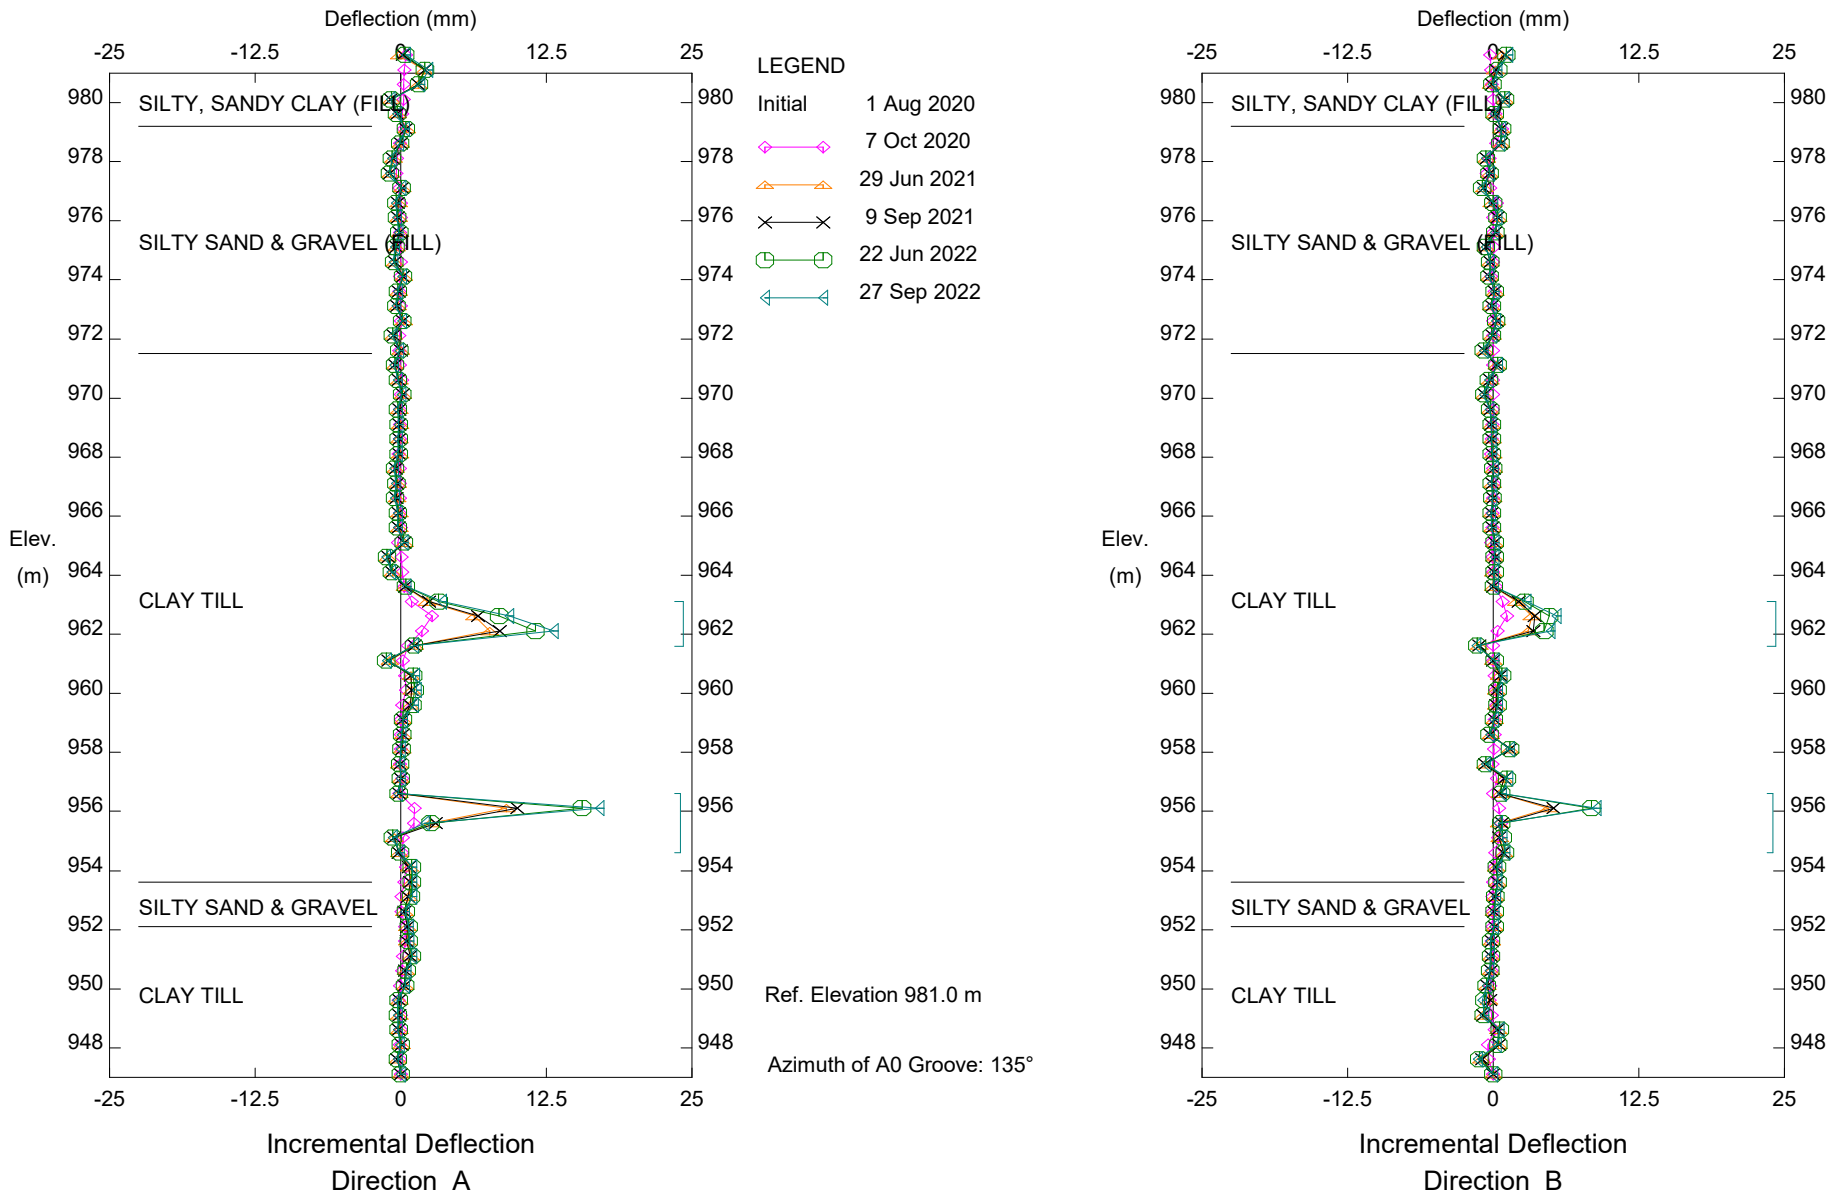
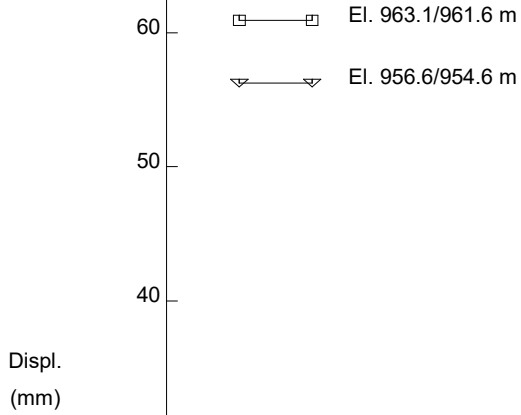
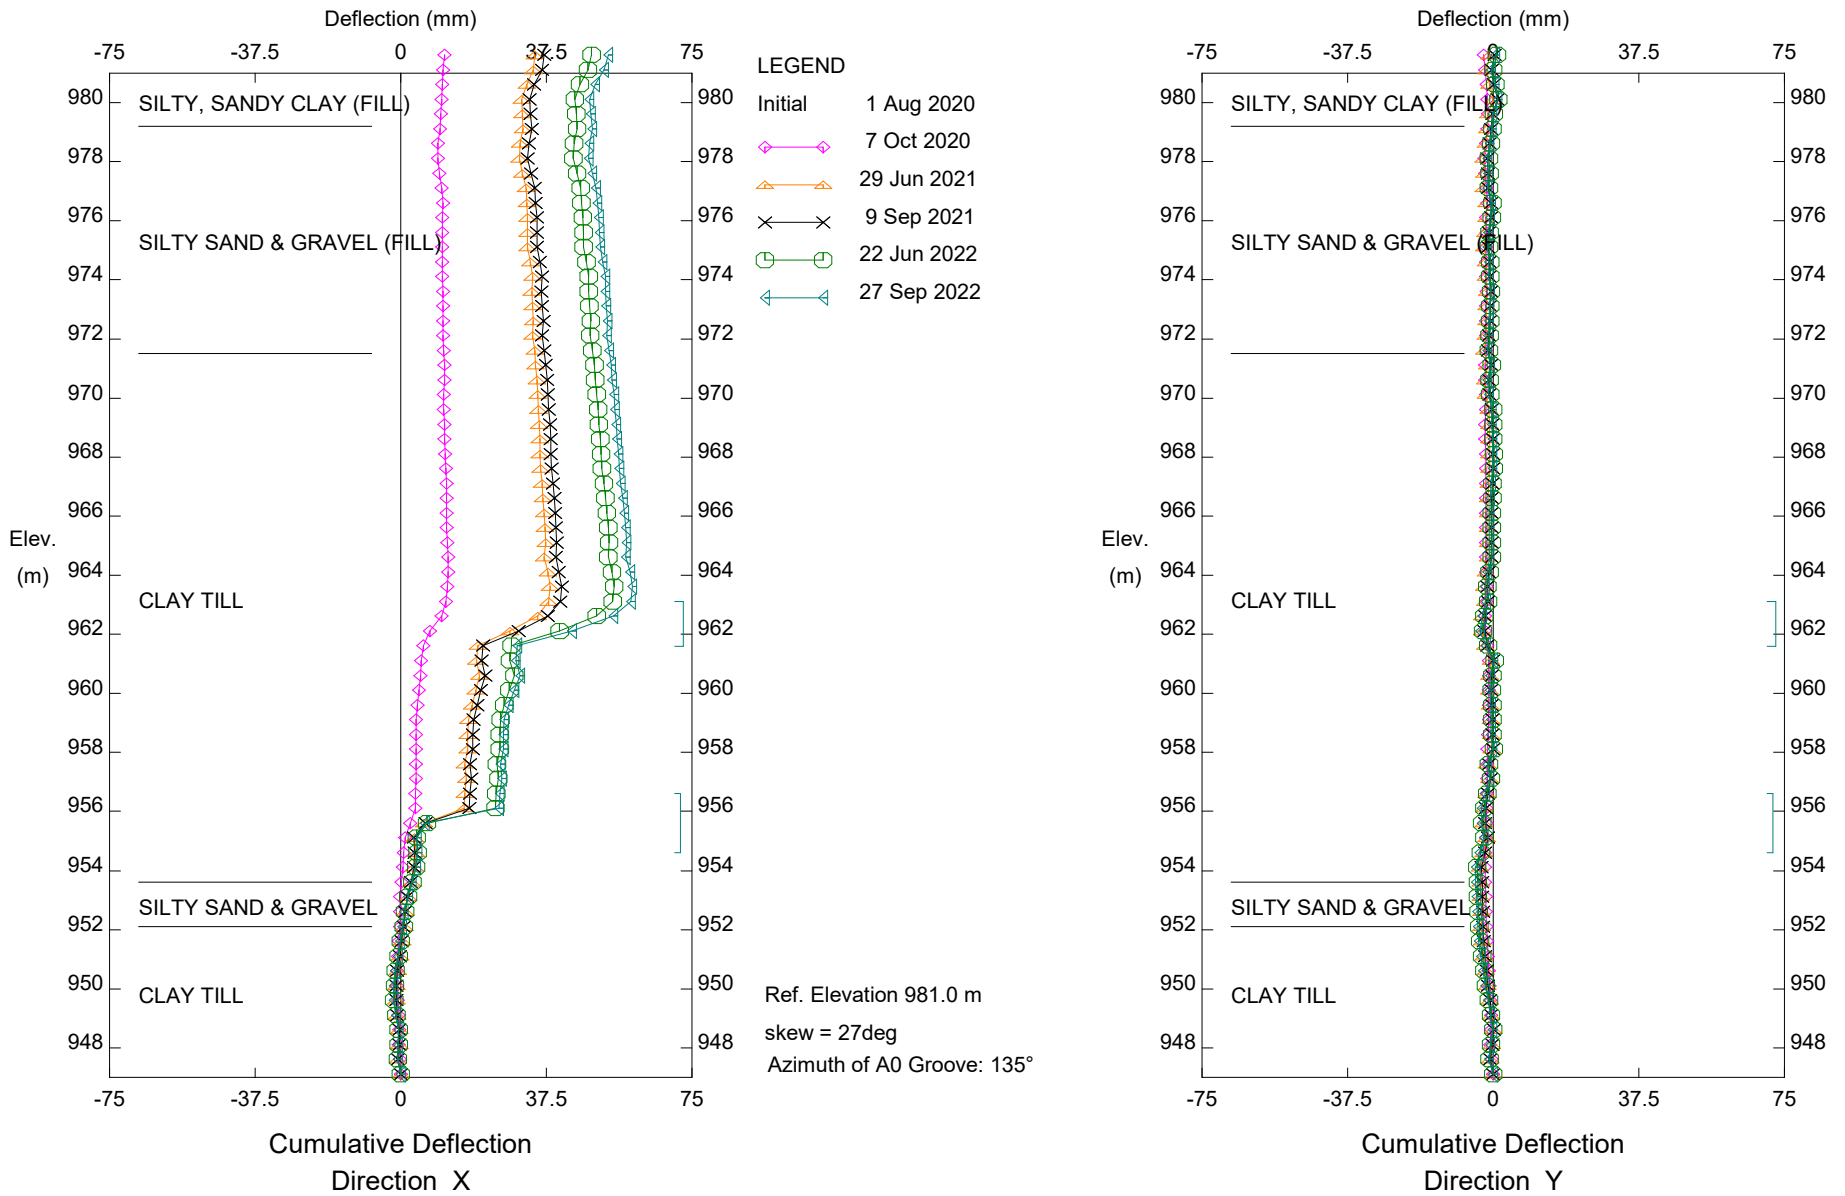
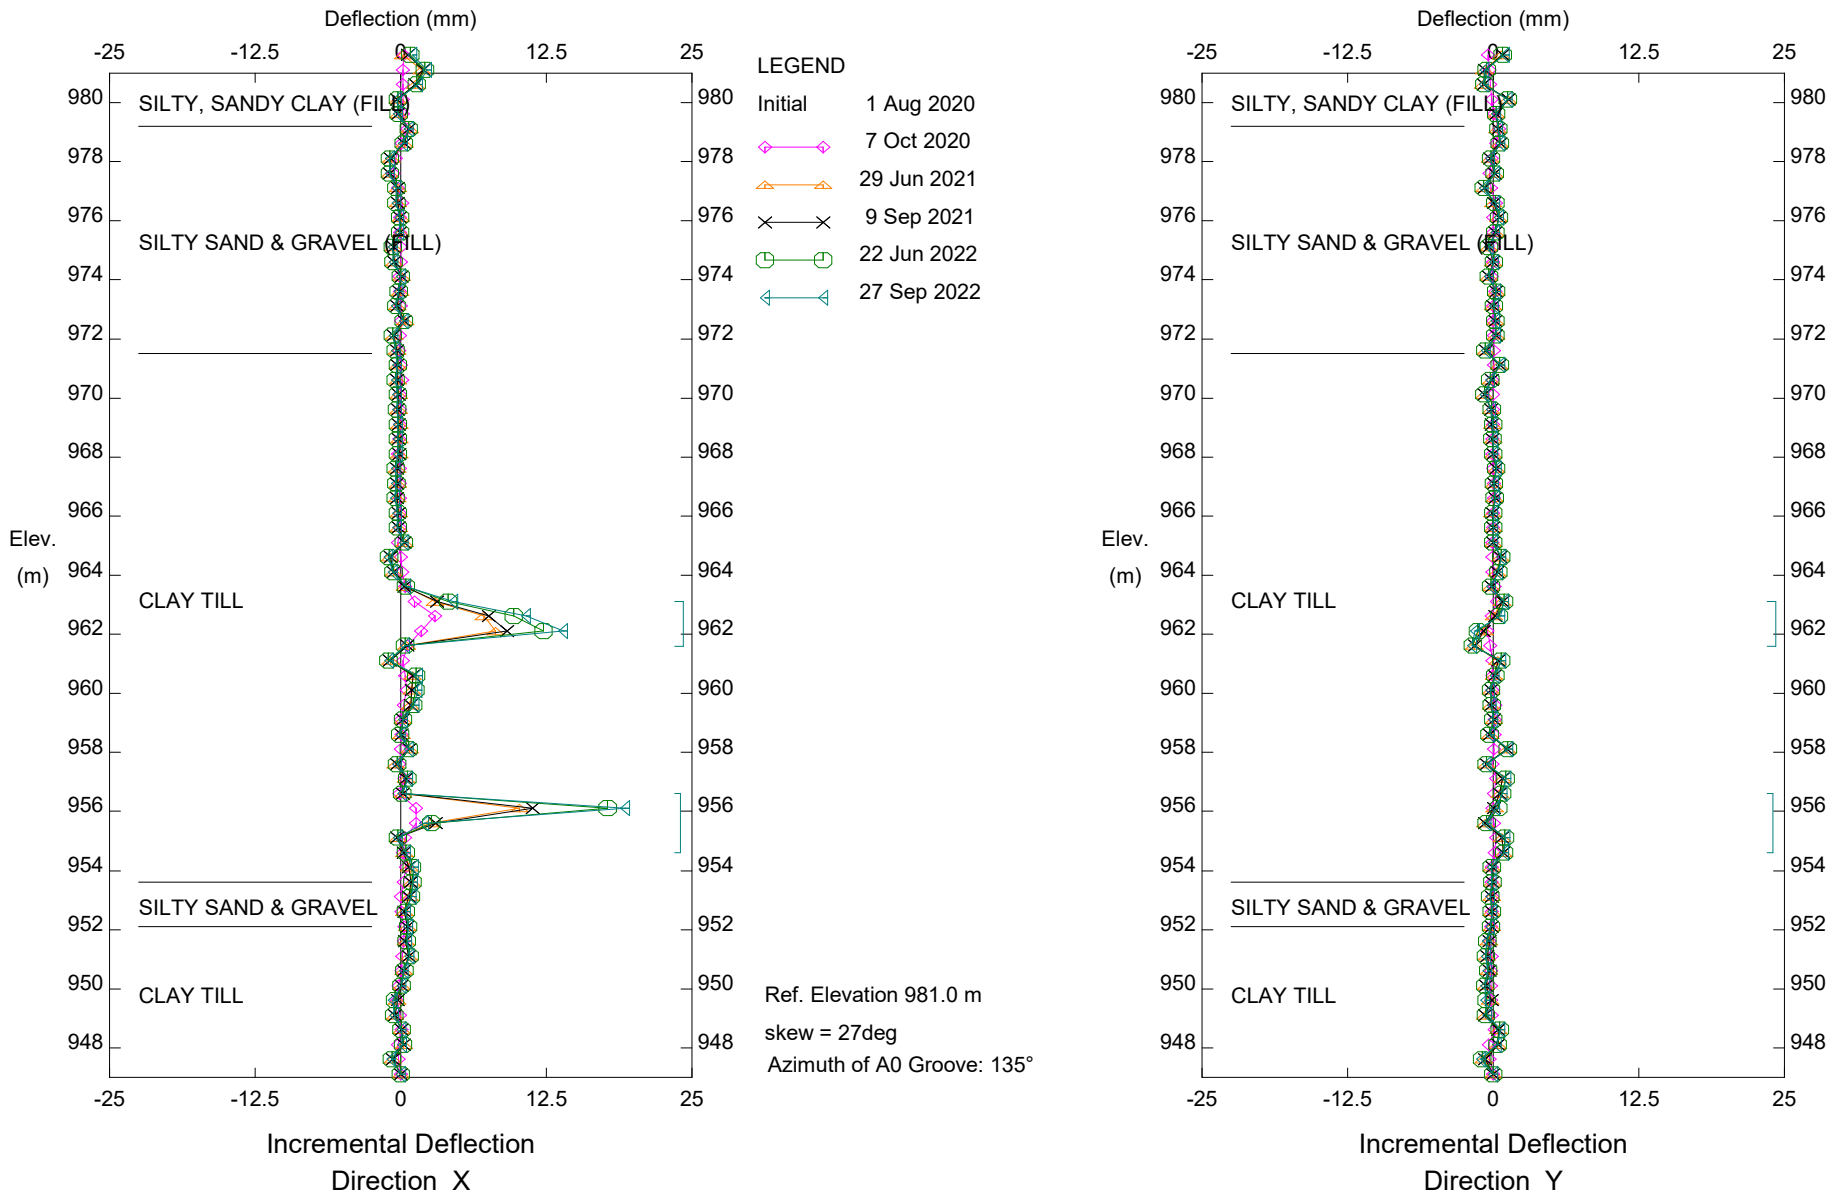
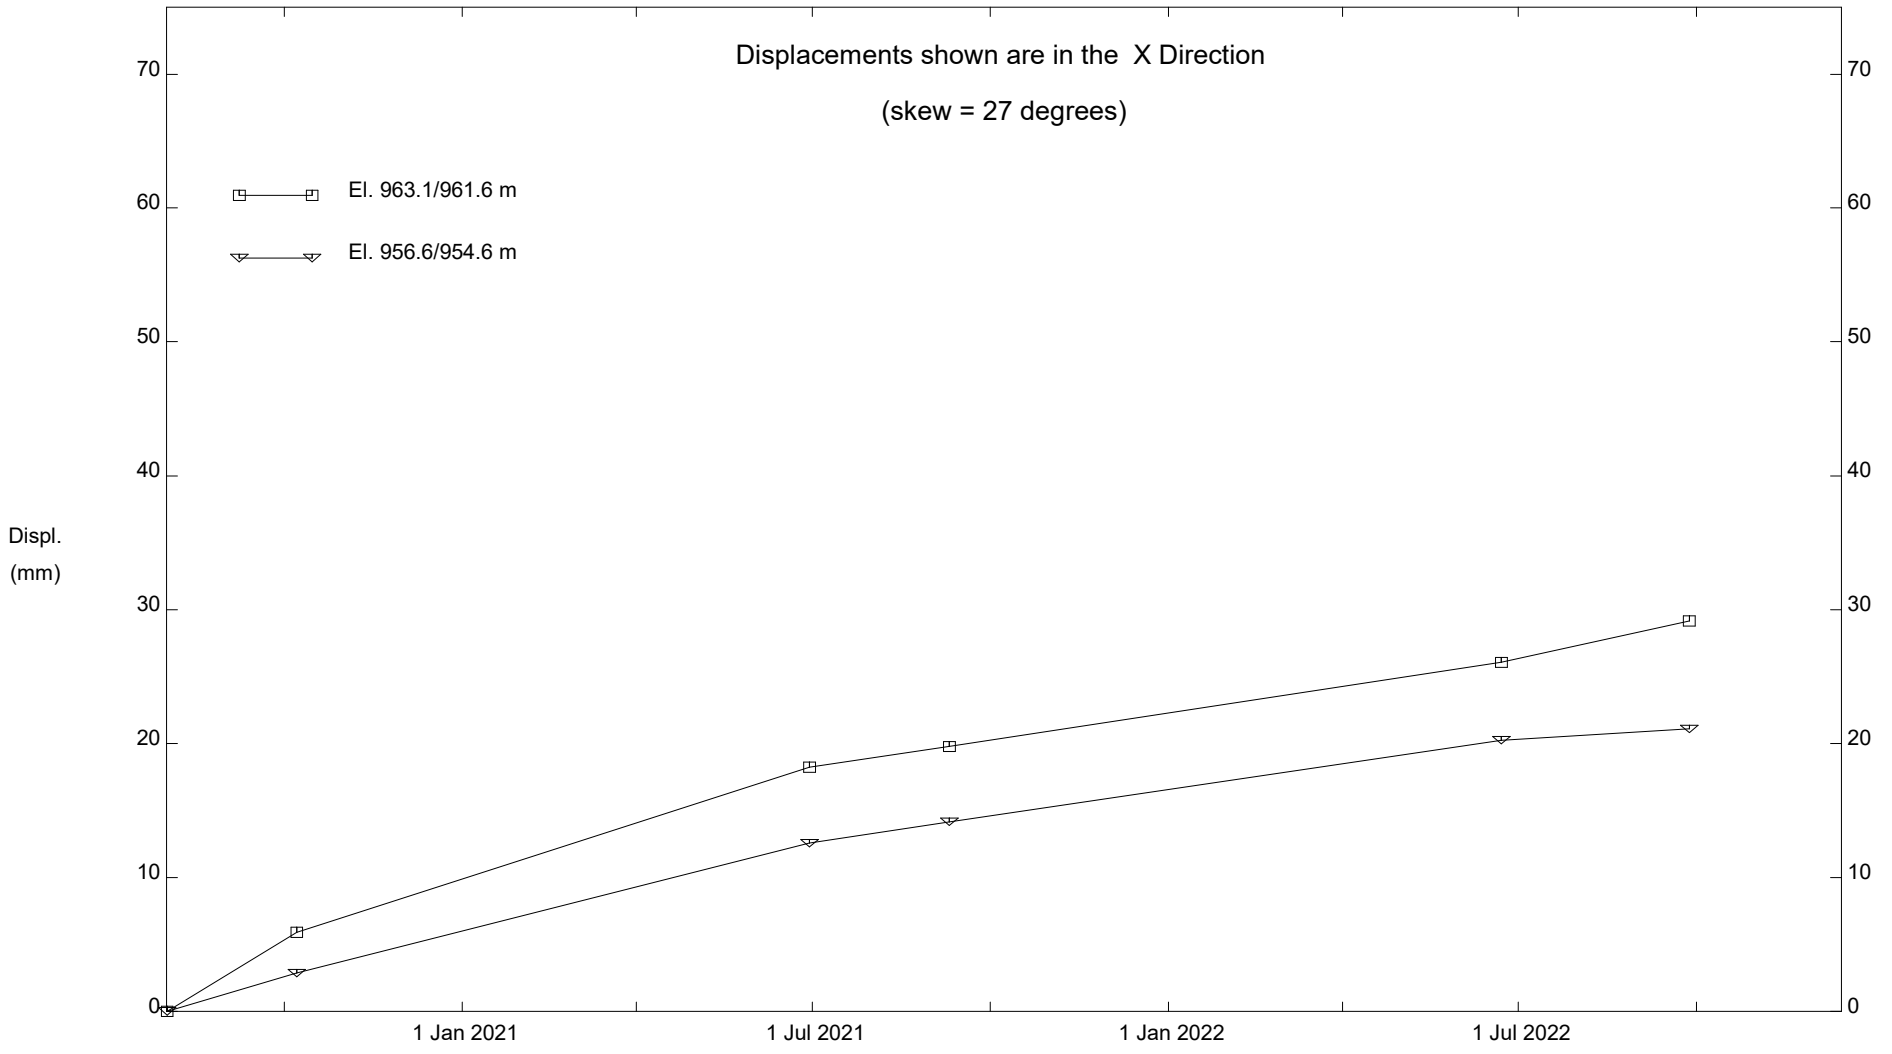
GP007; H40:36, Wanyandie Road Slide, Inclinometer SI20-03

Movement is/was being recorded in both the A- and B-directions of SI20-2, SI20-3, and SI20-6 (now inoperable) with an overall resultant towards the south to southeast. The movement appears to be in response to high fill placement at this location in the ravine on the east side of the site. Alternatively, the size of the area of valley-wall instability could be such that natural slope movements have A- and B-direction components due to the shape of the basal failure plane, potentially more stable zones, or other unknown factors. Since these instruments were terminated in clay till (not bedrock) a deeper SI (SI22-04) was installed by KCB in 2022 into bedrock to assess if deeper movements are occurring at this location. No discernible movement has been recorded in SI22-04. This instrument has only been read once since installation and more data is needed to assess movement trends. Given the rate of discrete movement being recorded in SI20-2 and SI20-3, KCB anticipates that these instruments could shear soon and become inoperable.

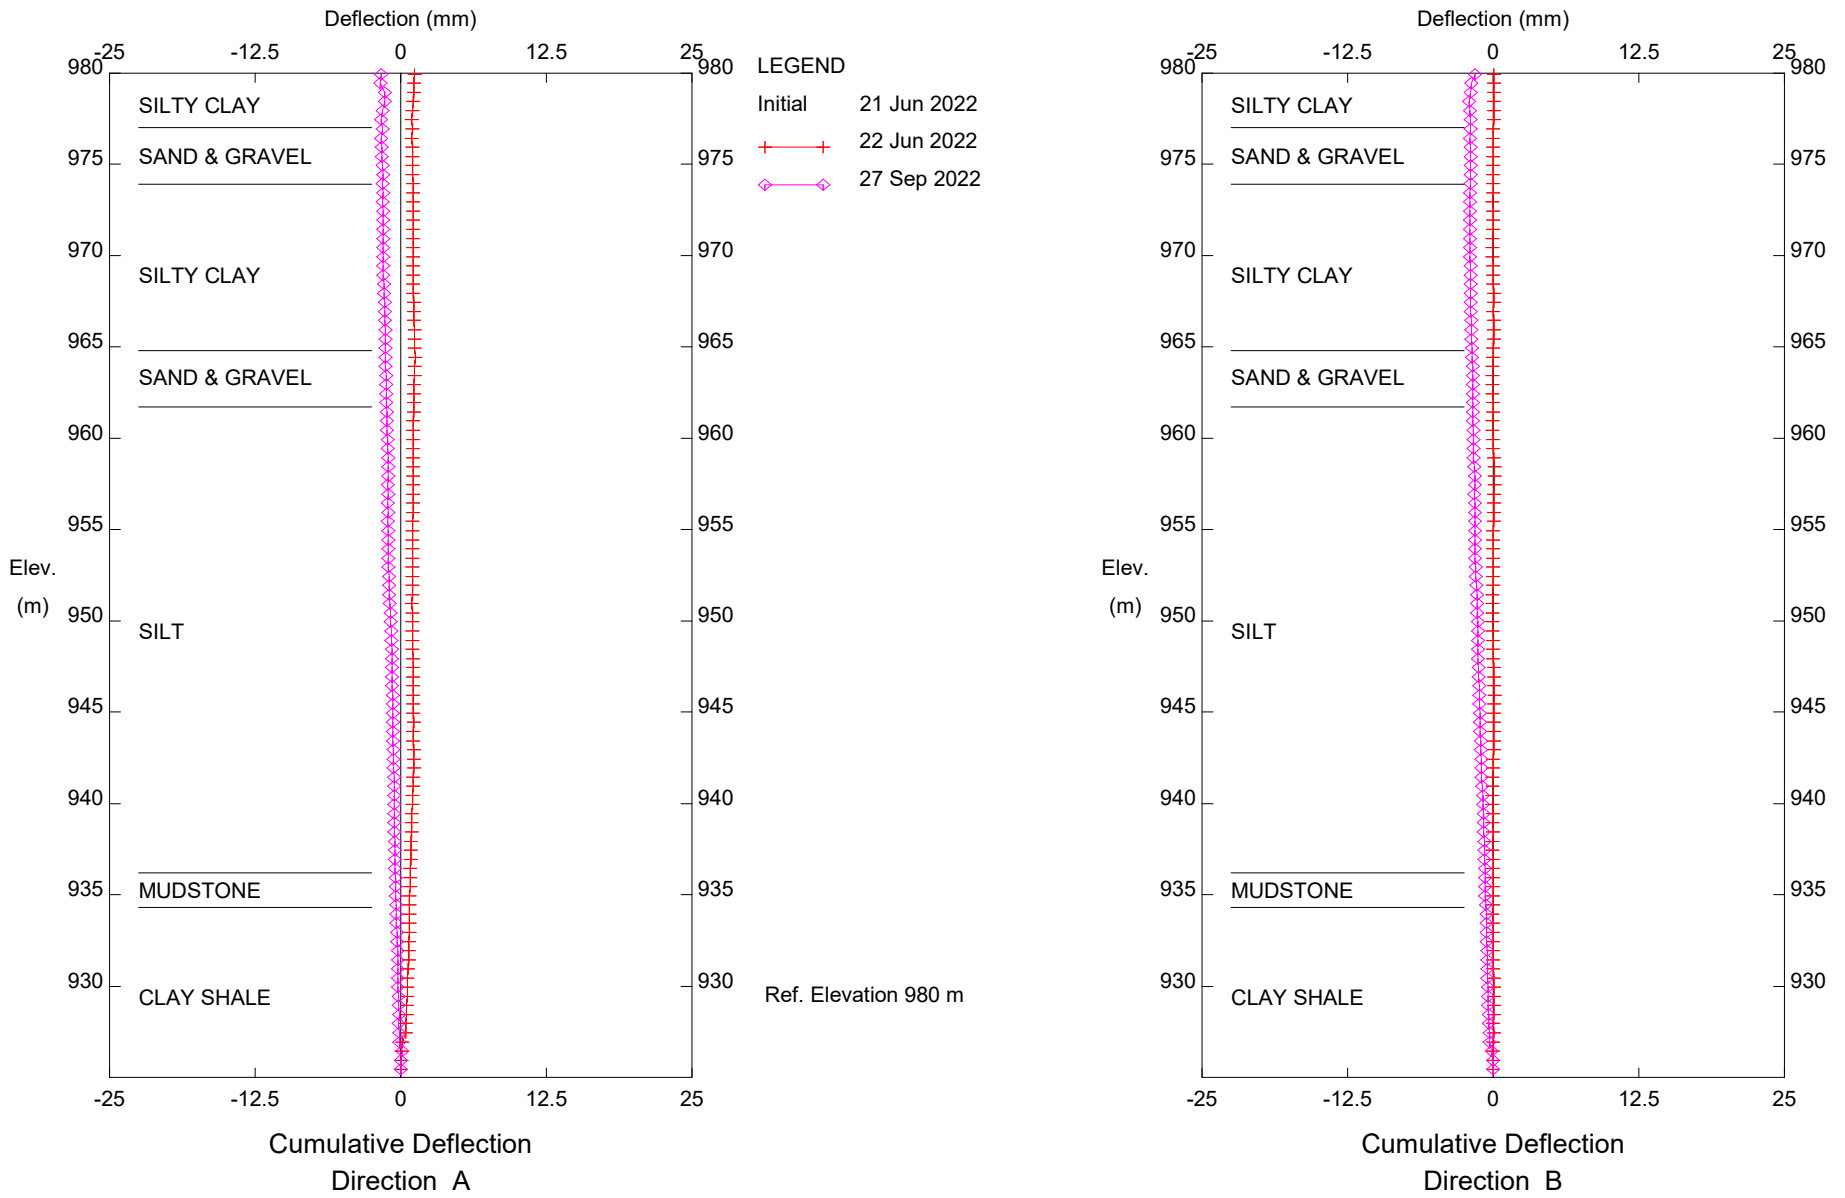
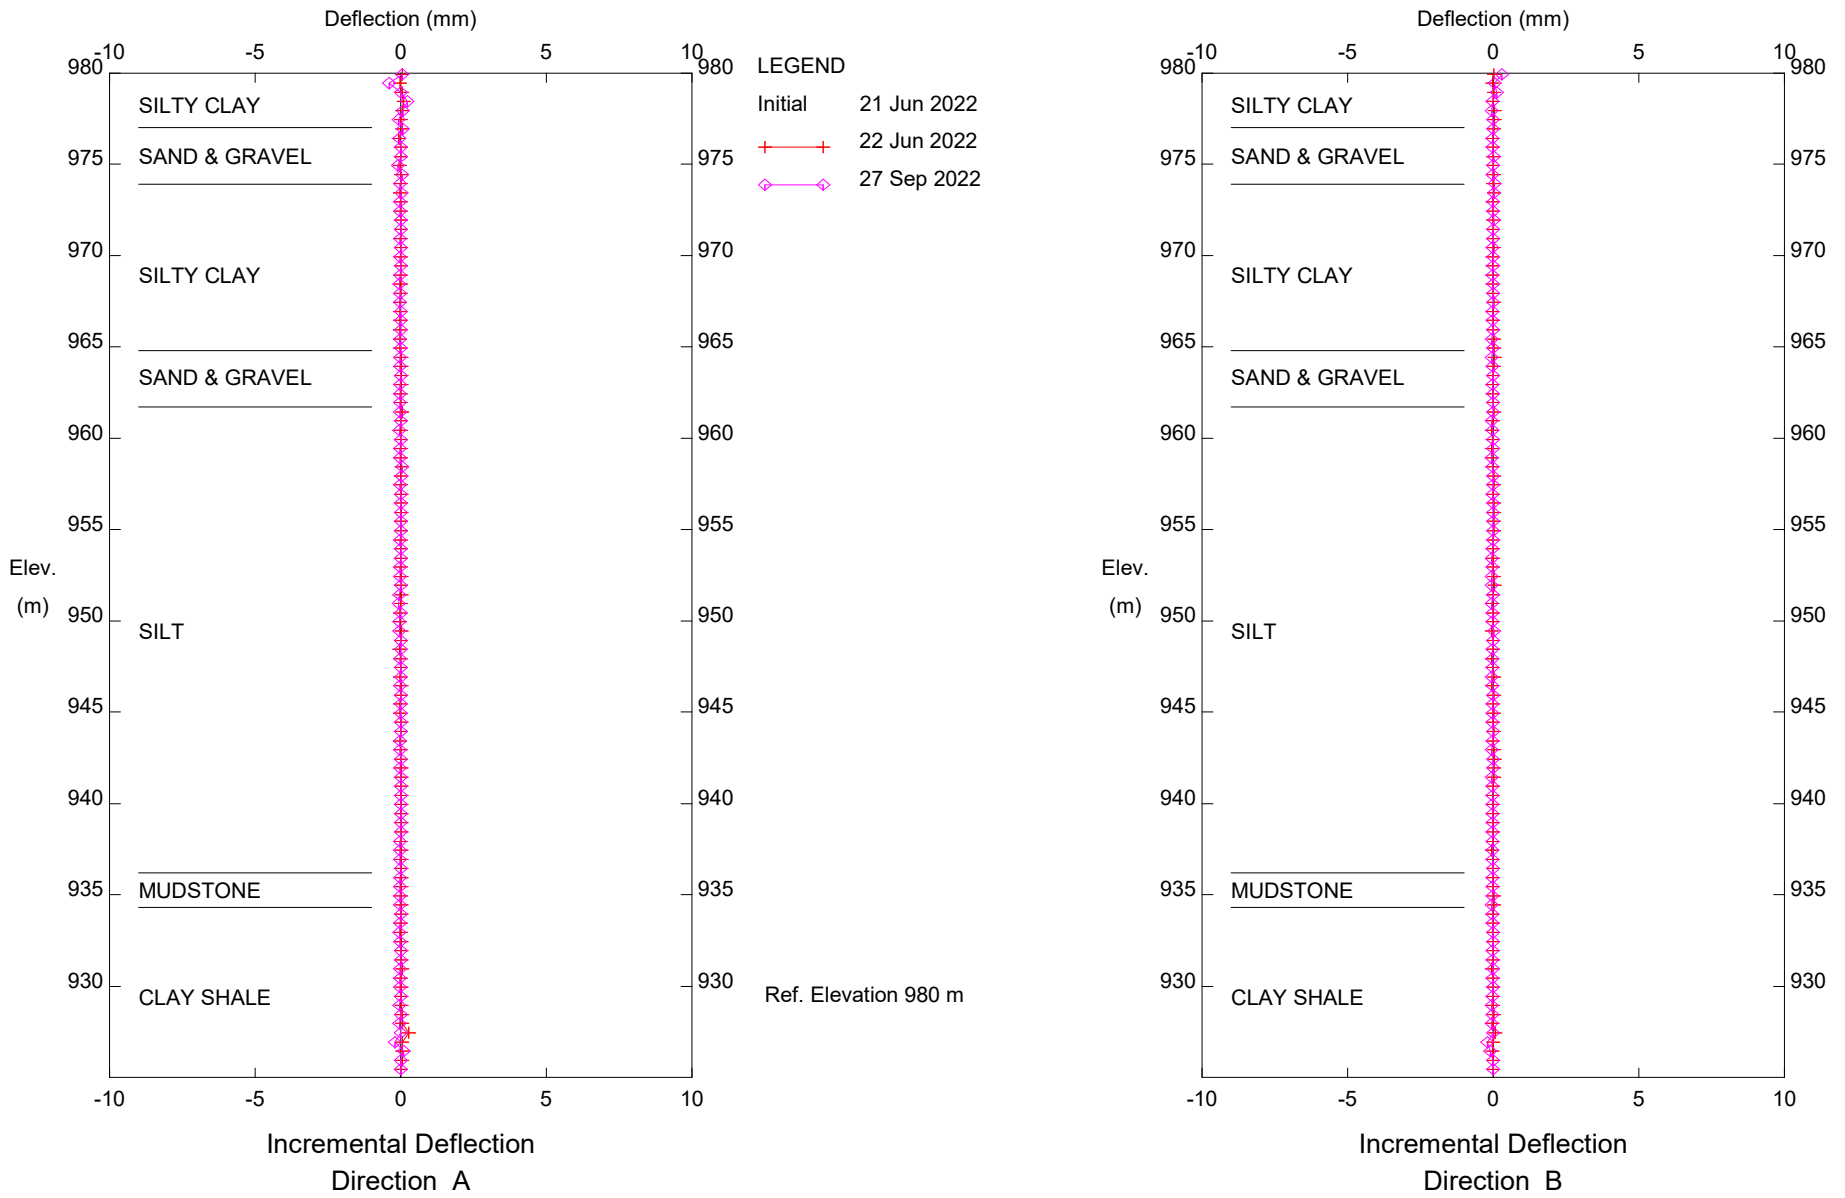
GP007; H40:36, Wanyandie Road Slide, Inclinometer SI22-04

In May 2022, a deeper SI (SI22-04) was installed to assess if a deeper failure plane was present at the eastern extent of the site. SI22-04 has recorded no discernible movement since installation. However, this instrument has only been read once since initialization. More data is needed to assess the movement trend for this instrument.

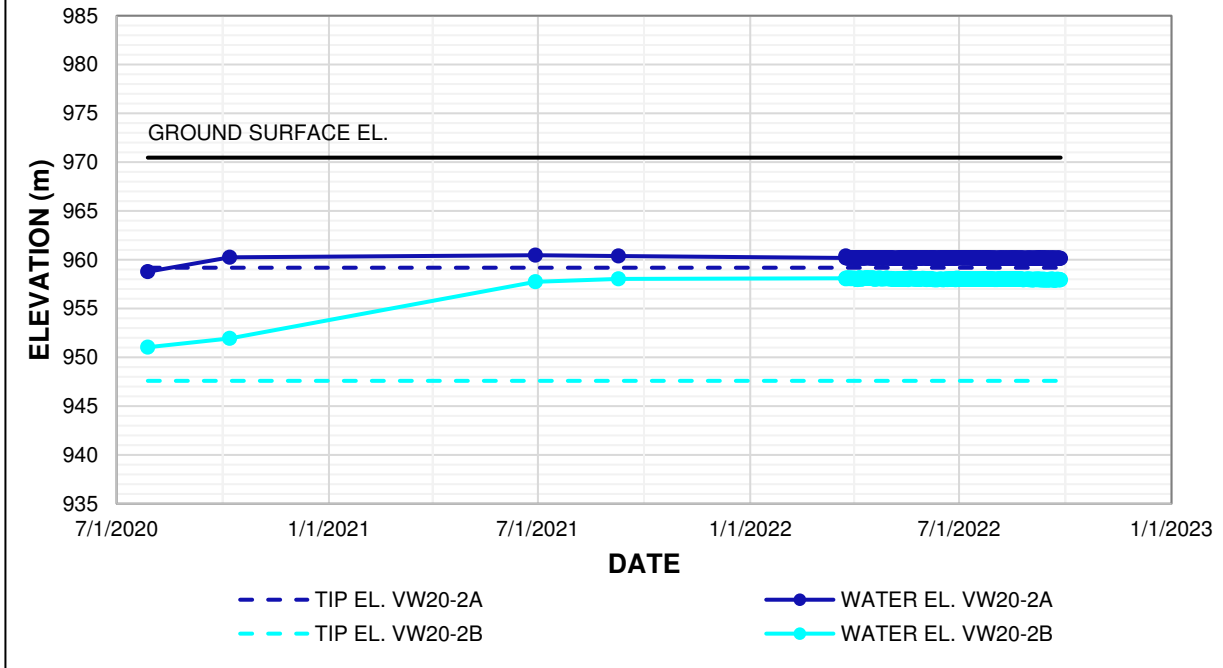
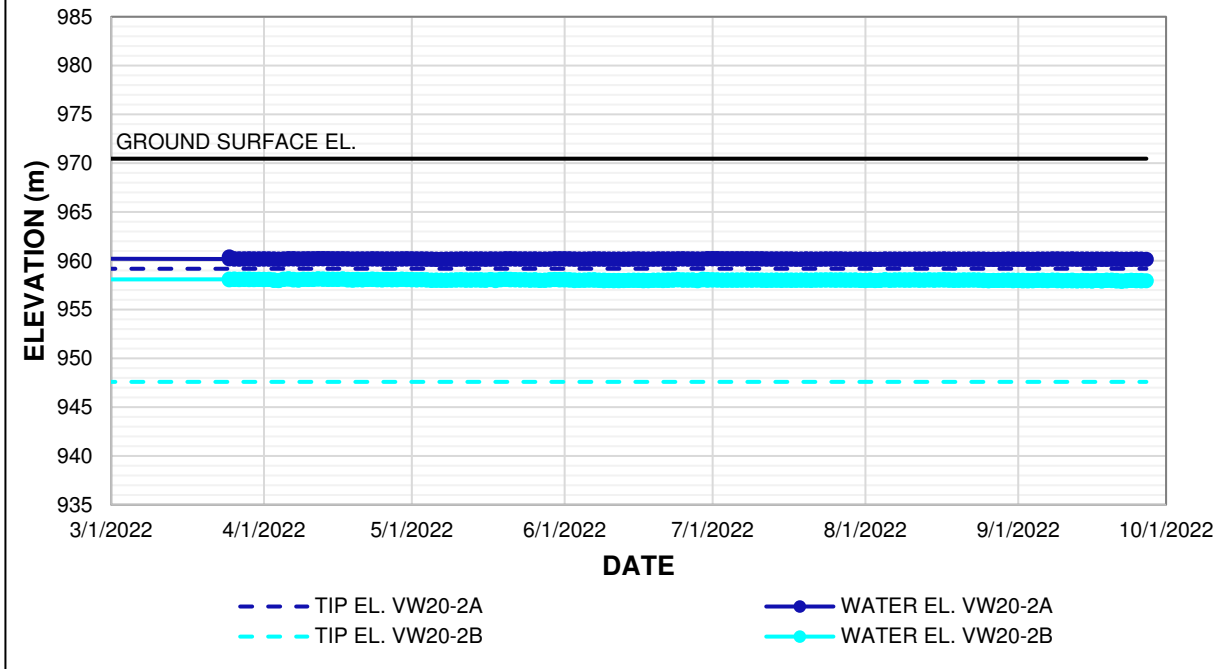
VW20-2A AND 2B (JUL. 28, 2020 TO CURRENT)

The porewater pressures/water levels recorded in the SPs, VWPs and PNs were steady (± 0.3 m) or decreasing, and consistent with previous readings for these instruments. It is noted that the porewater pressure recorded in VW20-2B increased 6.7 m between July 2020 (installation) and June 2021. The instrument was likely reaching equilibrium from the grout backfill after installation in July 2020. Pore pressure monitored by VW20-2B has been steady since July 2021. Porewater pressures monitored by VW22-1A/B/C, VW22-2A/B/C/D, VW22-3A/B/C/D, and VW22-04A/B remain steady since the data loggers first started recording data in mid May 2022. The grout may be muting the instruments response to changing water levels, or the water level variations are too rapid to be recorded by the data loggers. KCB can increase the reading frequency of the data logger (currently set to record data every 12-hours). Leveloggers could be installed in the SPs on site (e.g., TH20-04) in an attempt to capture short-term water level fluctuations (i.e., seasonal variations or in response to heavy or prolonged precipitation or infiltration due to freshet).

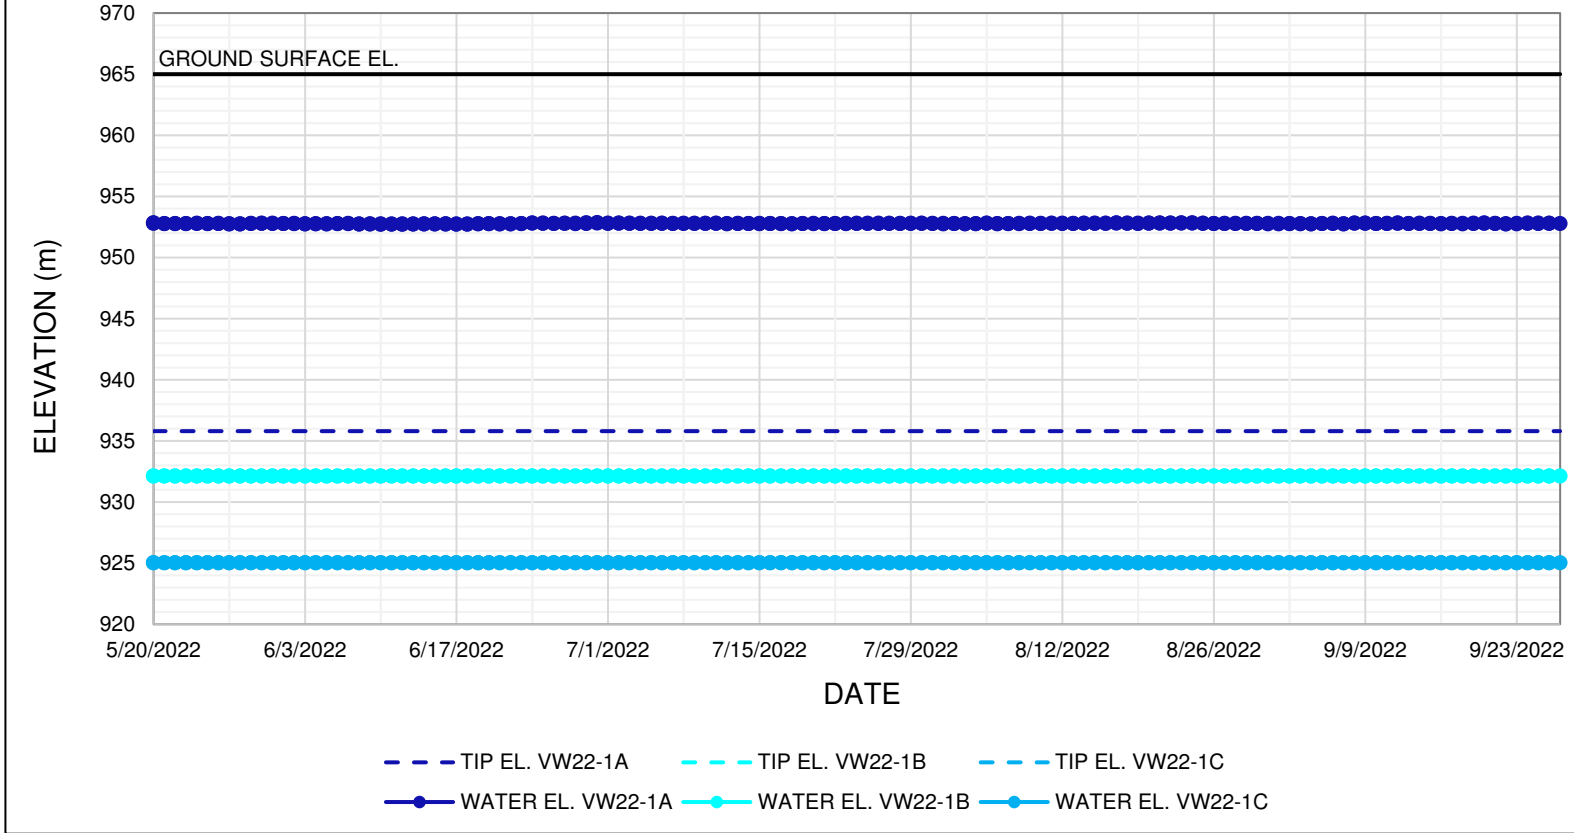
VW22-1A, 1B, AND 1C

VWP22-1B/C have been dry since installation and are installed in bedrock (siltstone and sandstone, respectively). VW22-1B was installed near a possible shear zone observed near the top of the siltstone unit. VW22-2D and -3D have been dry since installation and are both installed in clay shale.
