**PEACE REGION  
(GRANDE PRAIRIE DISTRICT – SOUTH) GRMP**

**SITE INSPECTION FORM**

| <b>SITE NUMBER AND NAME:</b><br>GP007 Wanyandie Road Slide | | <b>HIGHWAY &amp; KM:</b><br>40:36, 29.339 | <b>PREVIOUS INSPECTION DATE:</b><br>July 20, 2021 | <b>INSPECTION DATE:</b><br><b>June 14, 2022</b> |

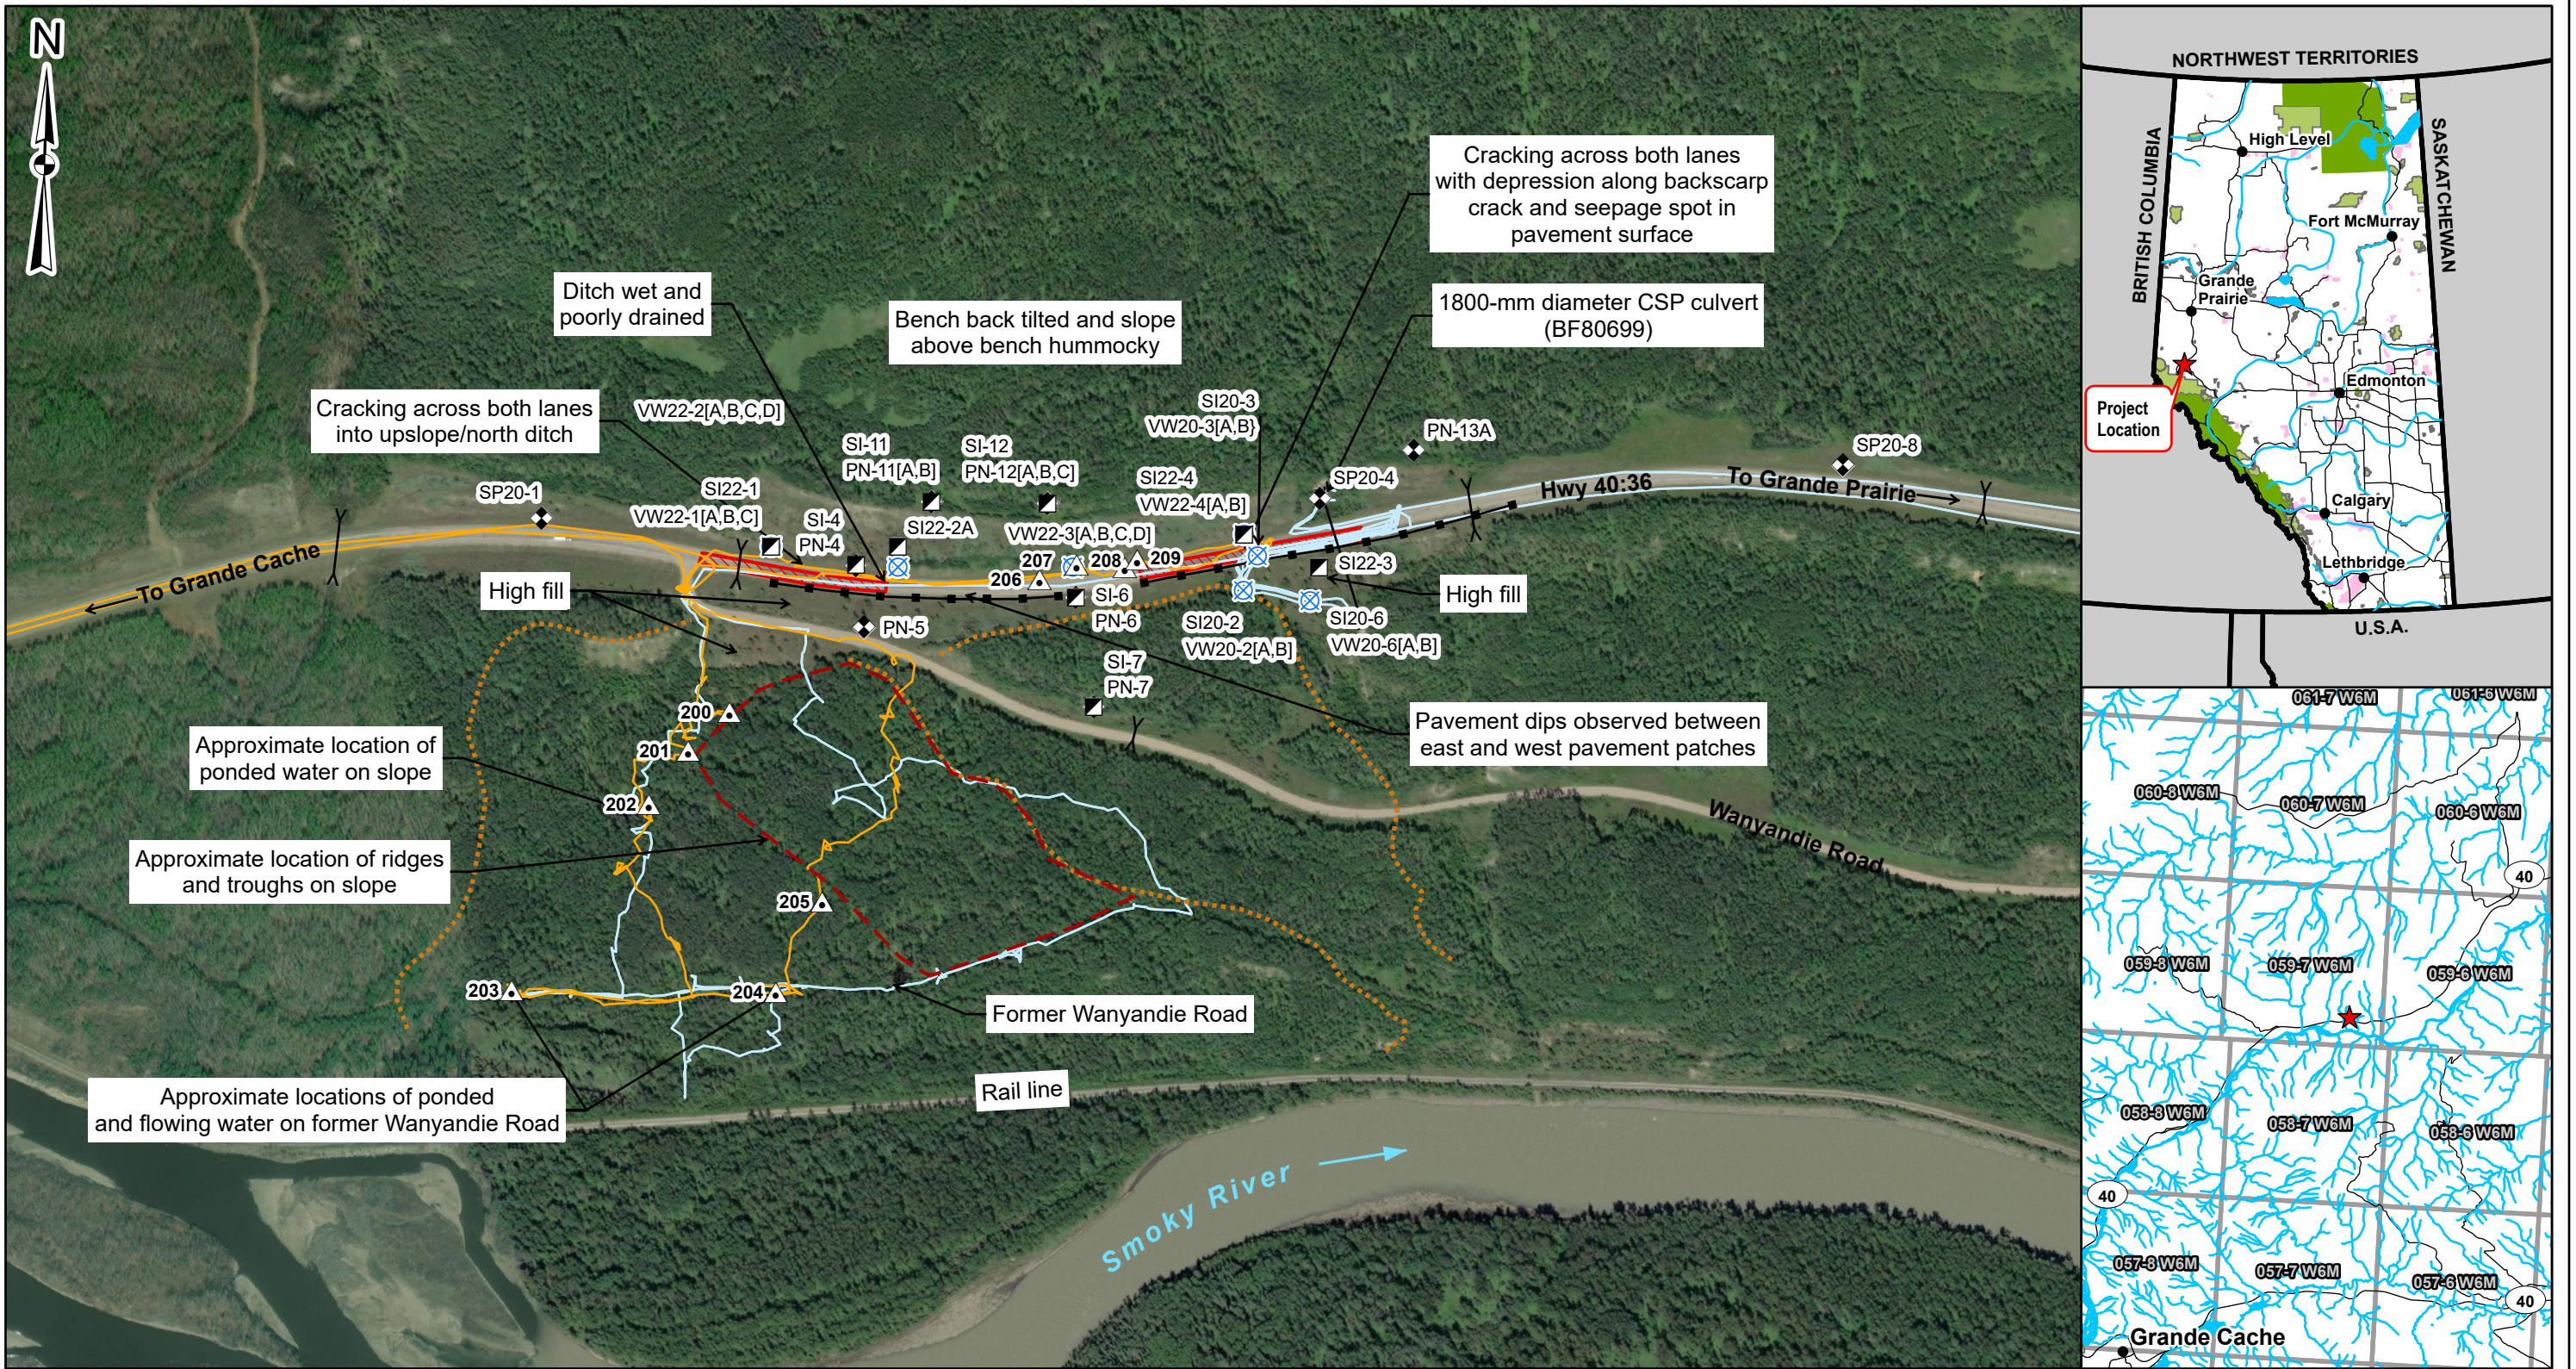
SCALE 1:6,000 PROJECT No. A05116A01 FIG No. 1

TITLE  
 Site Plan  
 GP007 - Wanyandie Road Slide  
 Hwy 40:36, km 29.339

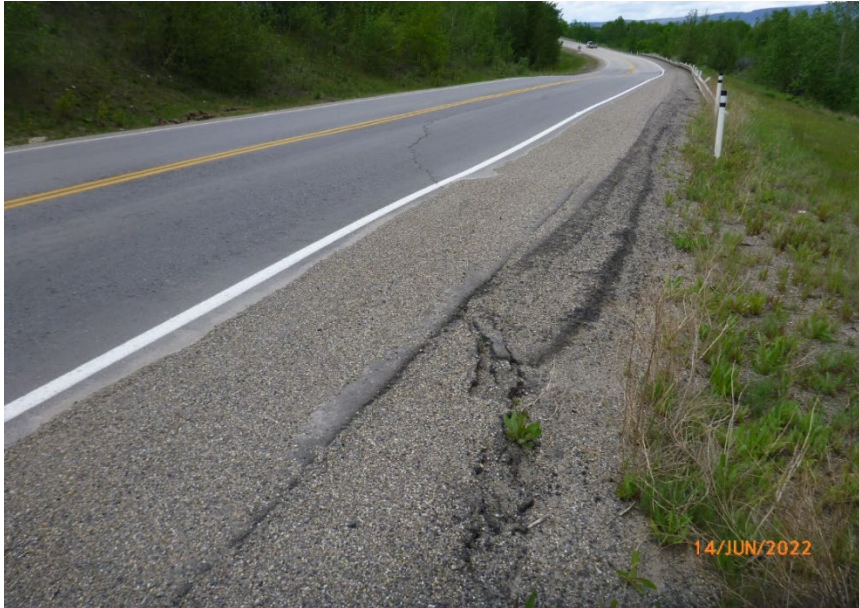
- At western site limit: cracking extends across both lanes through recent pavement patch into upslope/north ditch. Long linear depression (approximately 100 m deep, 5 m long) in pavement surface appears to indicate there is a void forming below pavement surface.
- At eastern site limit: cracking across both lanes through recent pavement patch to north shoulder at WP209. Depression along backscarp crack. Some skid marks in northbound lane before depression. Seepage spot in pavement surface of southbound lane. SI20-06 downslope of this sheared between the fall of 2021 and spring of 2022 readings.

**Photo 1** Cracking in recent pavement patch of Hwy 40:36 near western site limit. Photo taken June 14, 2022, facing northwest.

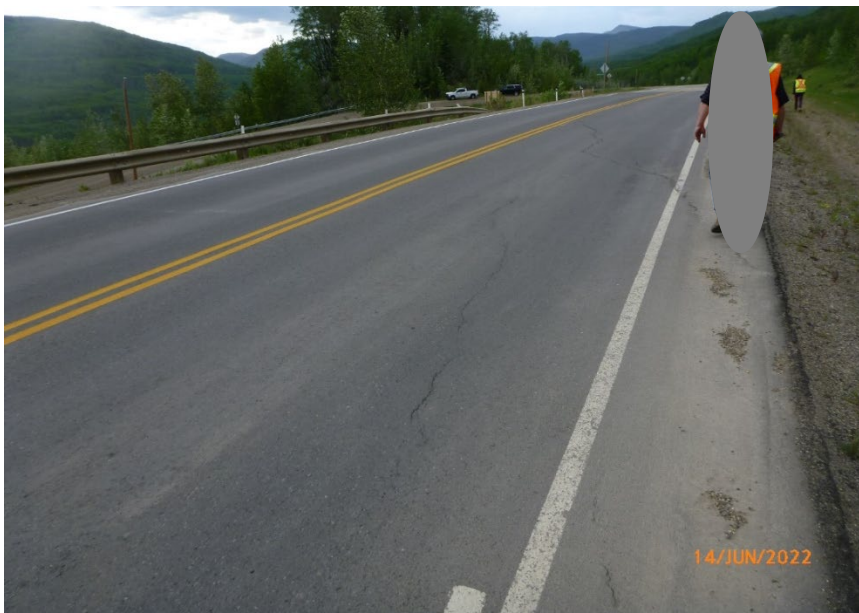
**Photo 2** Cracking in recent pavement patch of Hwy 40:36 near western site limit. Photo taken June 14, 2022, facing southwest towards intersection with Wanyandie Road.

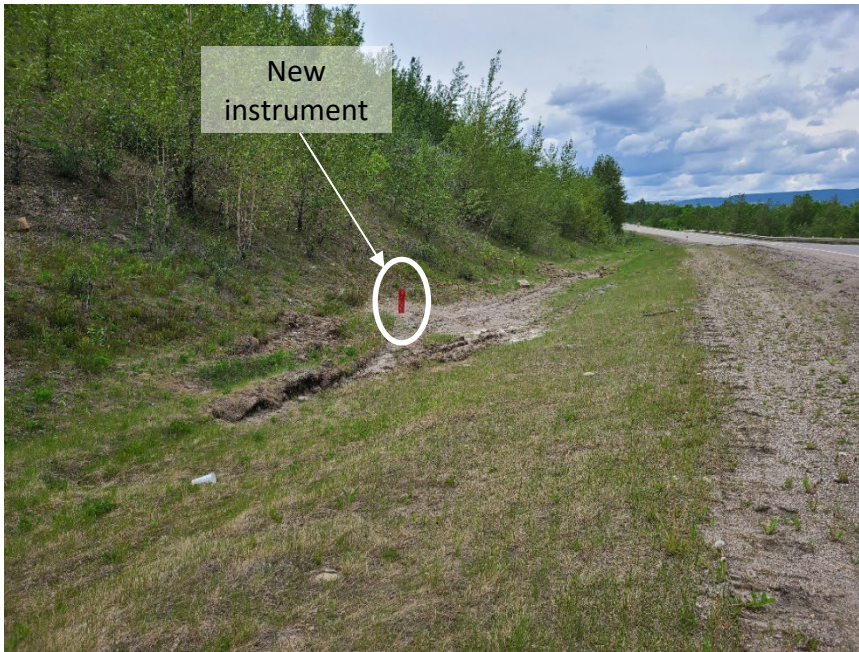
**Photo 3** New instrument (circled in white) installed in upslope/north ditch of Hwy 40:36. Photo taken June 14, 2022, facing east.

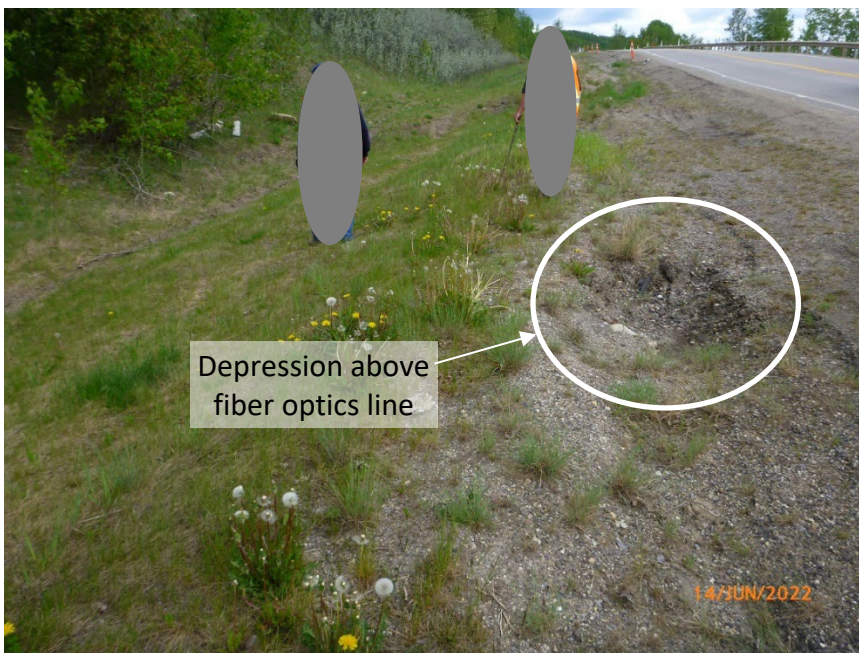
Sinkholes observed at WP206 and WP208 along fiber optics line.

**Photo 4** Sinkhole along fiber optics line (circled in white) in upslope/north ditch of Hwy 40:36 at WP208. Photo taken June 14, 2022, facing east.

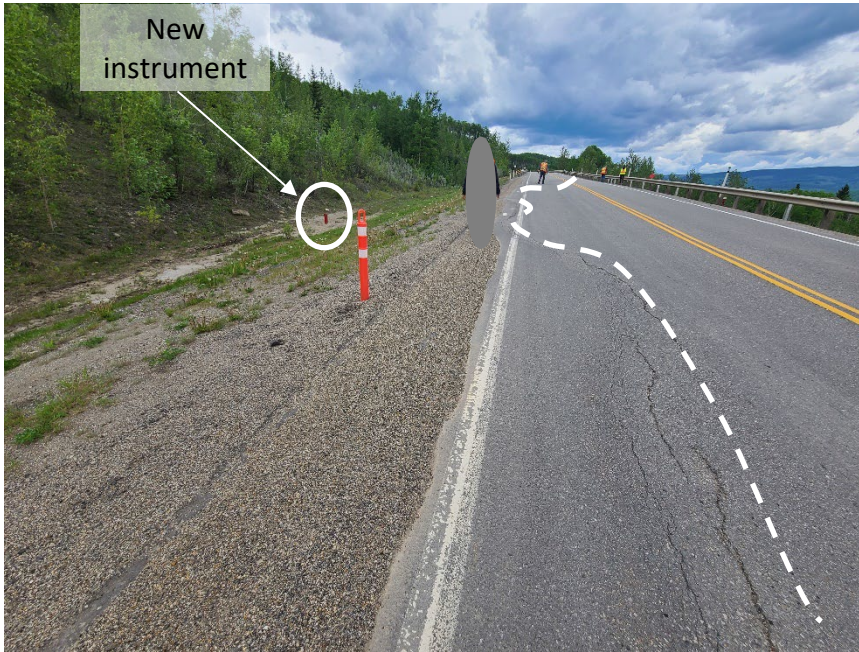
**Photo 5** Cracking, and depression (indicated with dotted white line) along backscarp crack in recent pavement patch of Hwy 40:36 near eastern site limit. New instrument (circled in white) installed in upslope/north highway ditch. Photo taken June 14, 2022, facing east

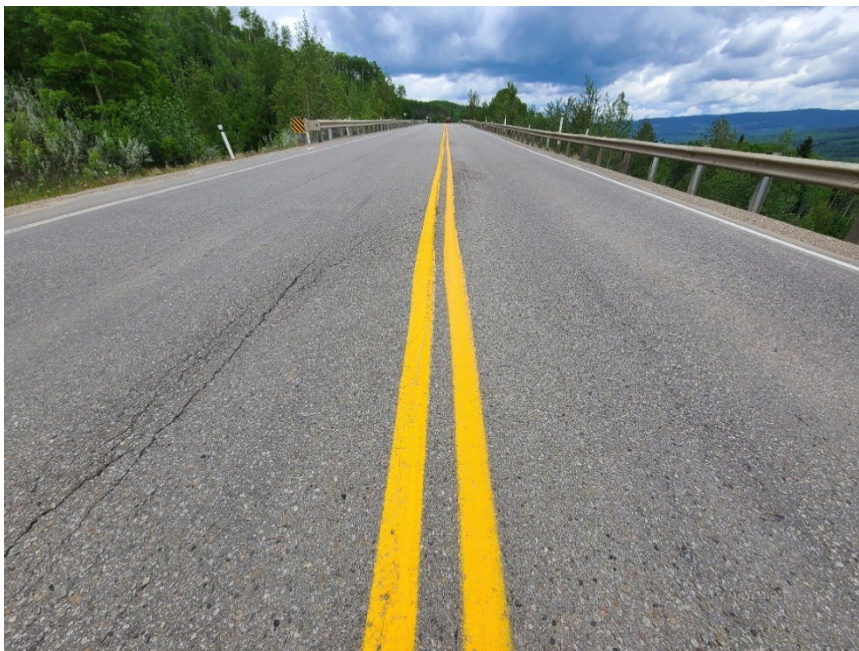
**Photo 6** Cracking, and depression along backscarp crack in recent pavement patch of Hwy 40:36 near eastern site limit. Photo taken June 14, 2022, facing east.

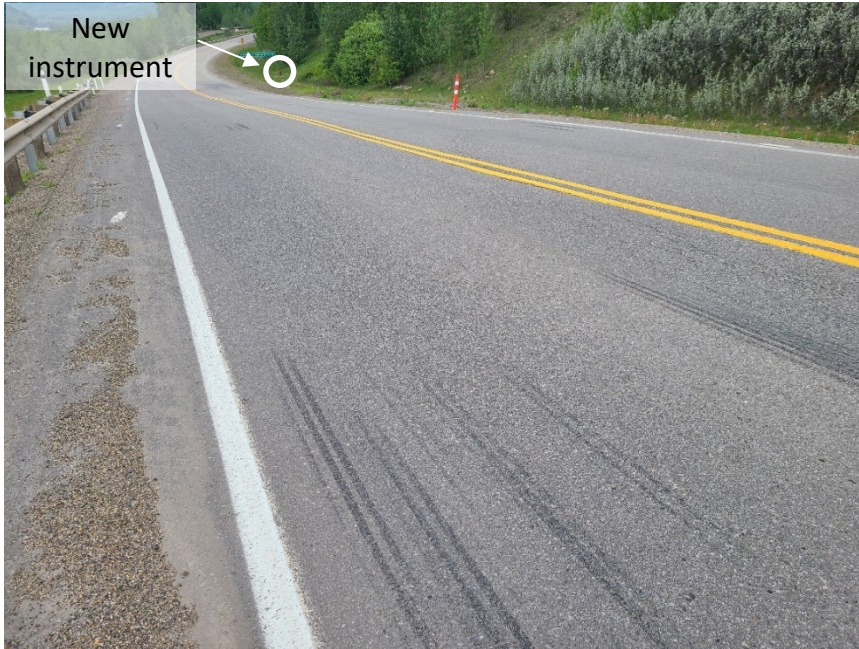
**Photo 7** Skid marks in northbound lane of Hwy 40:36 before depression in pavement surface at eastern site limit. New instrument (circled in white) installed in upslope/north highway ditch. Photo taken June 14, 2022, facing west.

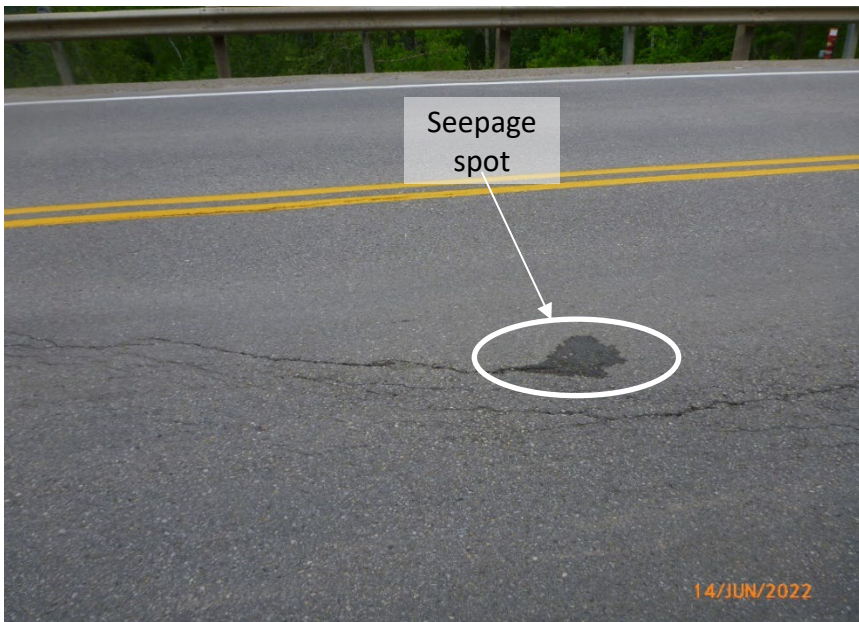
| ITEM | CONDITION EXISTS | | DESCRIPTION AND LOCATION | NOTICABLE CHANGE FROM LAST INSPECTION | |
|---|---|---|---|---|---|
| Seepage | X | | At western site limit: upslope/north ditch is wet and poorly drained. Pondered water and seepage also observed downslope/south of Hwy 40:36 as described below.<br>At eastern site limit: seepage spot observed in (southbound) lane. | | X |

**Photo 8** Seepage spot (circled in white) in southbound lane of Hwy 40:36 at eastern site limit. Photo taken June 14, 2022, facing south.

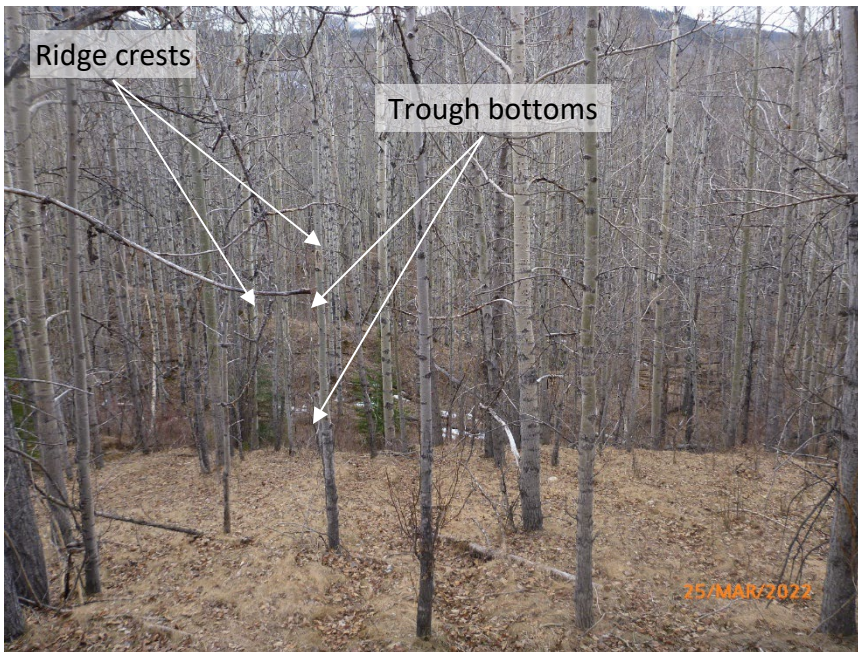
- A series of ridges and troughs on the slope, which are visible in historic air photos and the bare-earth LiDAR data. It was discussed that the ridges and troughs could be the result of blocks sliding and eroding overtime becoming more dome shaped. Possible toe located at WP201, but generally no pattern to ridges and troughs. One big ridge to east of WP205.
- A pond of water located on the mid-slope at WP202. As well as other wet spots on the slope, and ponded and flowing water on former Wanyandie Road at WP203 and 204. Note pore pressures/water levels recorded in PN-3, located along former Wanyandie Road near WP204, were above ground surface before the instrument became inoperable in 2011.

**Photo 9** Ridges and trough between Hwy 40:36 and former Wanyandie Road. Photo taken March 25, 2022, facing south.

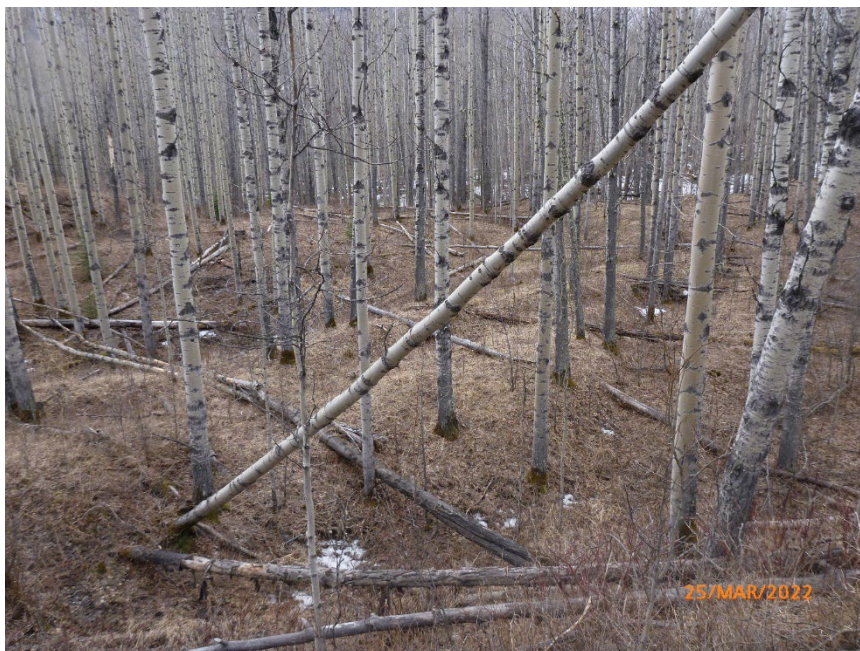
**Photo 10** Ridges and troughs between Hwy 40:36 and former Wanyandie Road. Photo taken March 25, 2022, facing south.

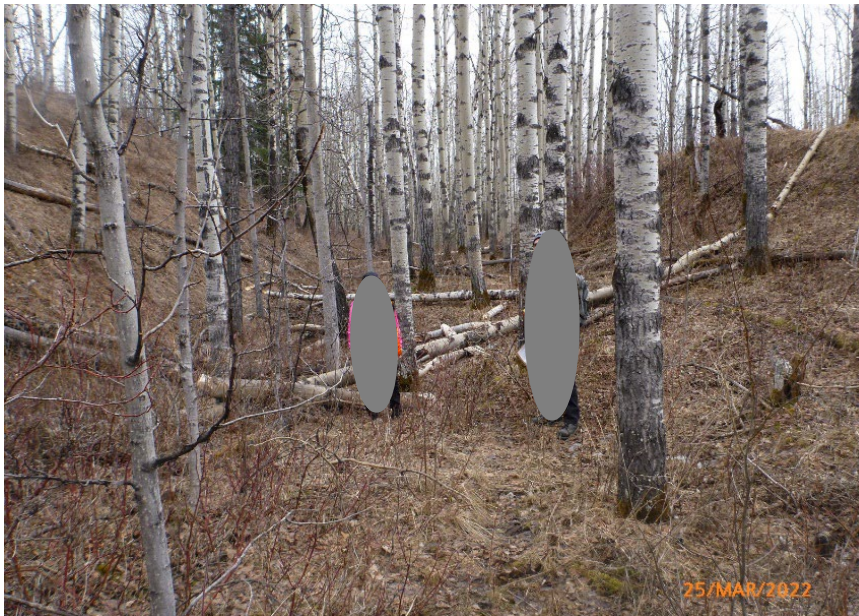
**Photo 11** Ridges and trough between Hwy 40:36 and former Wanyandie Road. Photo taken March 25, 2022, facing east.

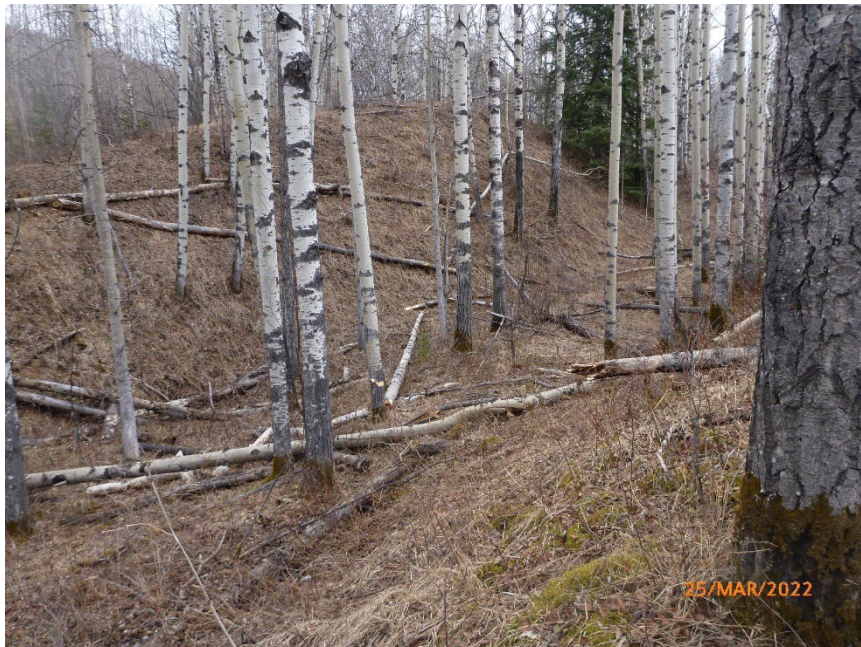
**Photo 12** Ridge and trough between Hwy 40:36 and former Wanyandie Road. Photo taken March 25, 2022.

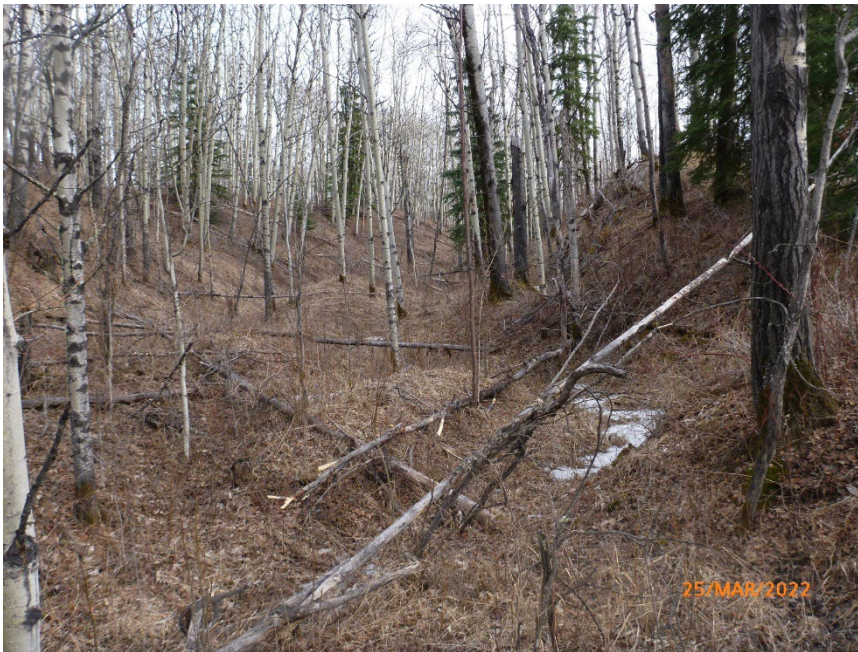
**Photo 13** Ridges and troughs between Hwy 40:36 and former Wanyandie Road. Photo taken March 25, 2022, facing south.

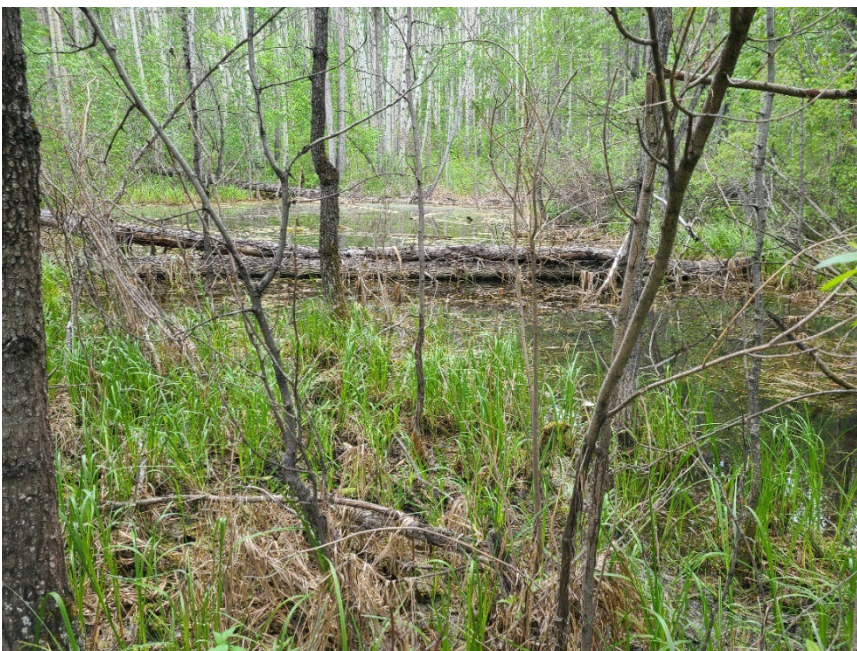
**Photo 14** Pond of water on mid-slope between Hwy 40:36 and former Wanyandie Road at WP202. Photo taken June 14, 2022, facing south.

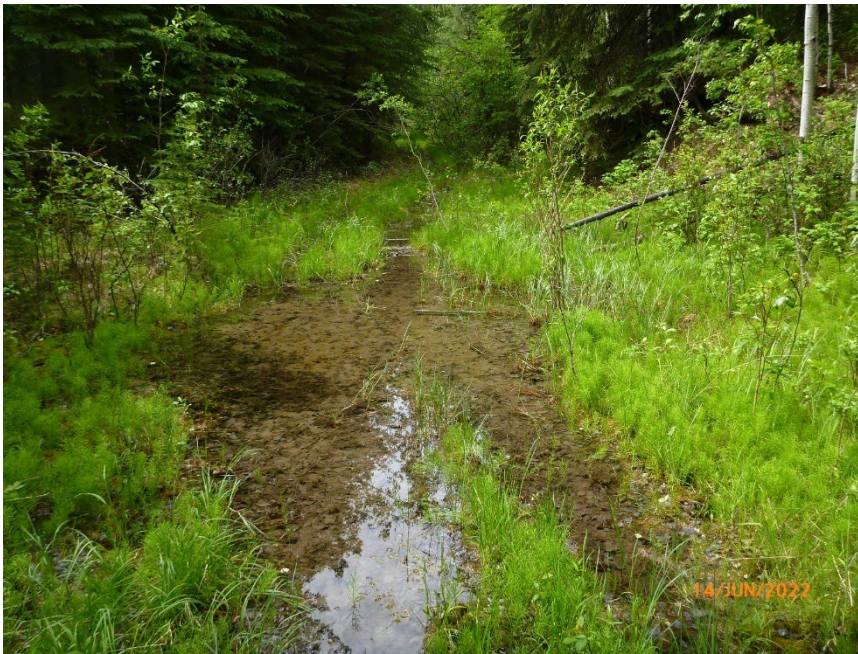
**Photo 15** Ponded water on former Wanyandie Road near western slide flank at WP203. Photo taken June 14, 2022, facing west.

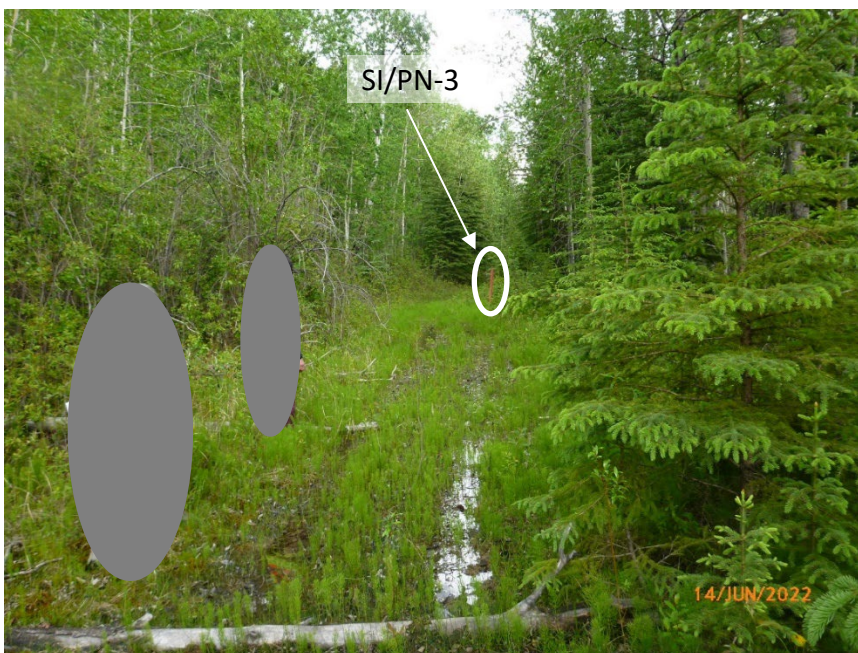
**Photo 16** Ponded and flowing water on former Wanyandie Road near SI/PN-3 (inoperable) (circled in white) at WP204. Photo taken June 14, 2022, facing east.
