November 28, 2025

Alberta Transportation and Economic Corridors
Main Floor, Provincial Building
9621 – 96th Avenue
Peace River, Alberta
T8S 1T4

**CON0022166 Peace Region (Grande Prairie District – South) GRMP Instrumentation Monitoring
Site GP007; H40:36, km 29.339 Wanyandie Road Slide
Section C – 2025 Fall Readings**

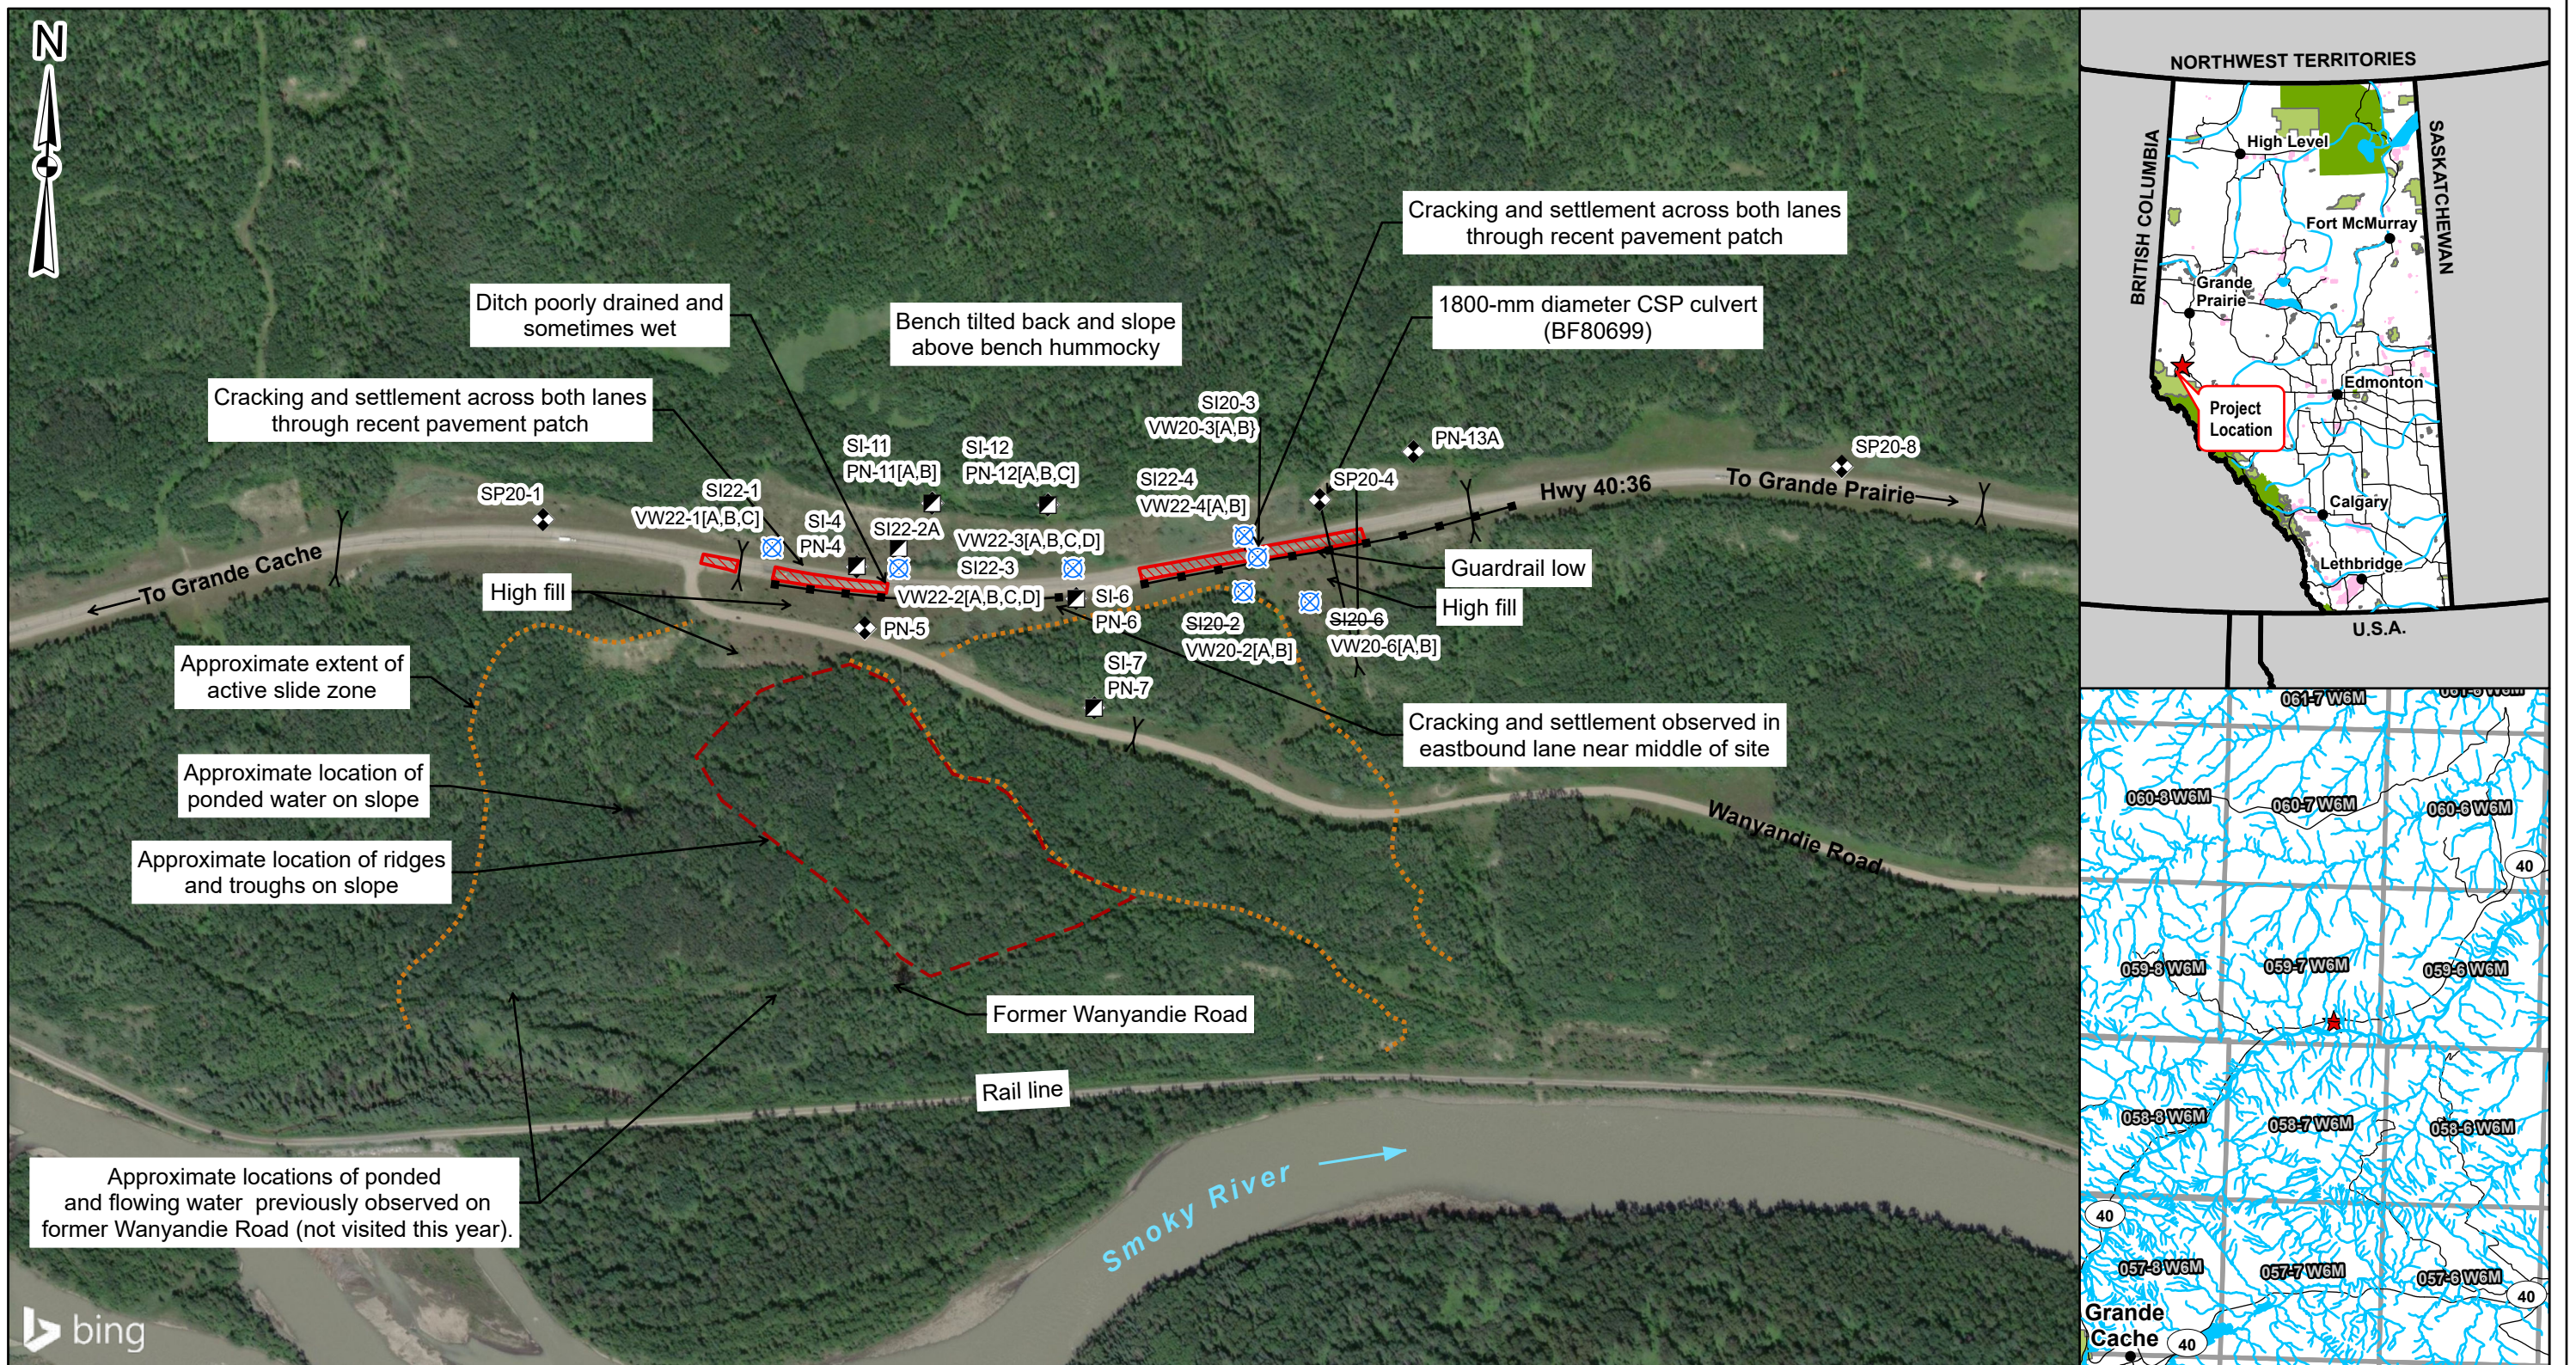
The geohazard at the GP007 site consists of a deep-seated landslide (or nested slide) along the north valley slope of the Smoky River.

Based on the surface expression of the 2005 bare-earth LiDAR data and historic air photos, the landslide appears most active downslope of Hwy 40:36 and Wanyandie Road at the west end of the site as shown on Figure 1. Ridges and troughs have been observed by KCB in this area and the area between Hwy 40:36 and Wanyandie Road, which could be the result of blocks sliding and eroding overtime with vegetation growth, becoming more rounded. The direction of movement recorded in SI98-2 and SI98-5 (before shearing) was towards the area of ridges and troughs downslope of Hwy 40:36 and Wanyandie Road.

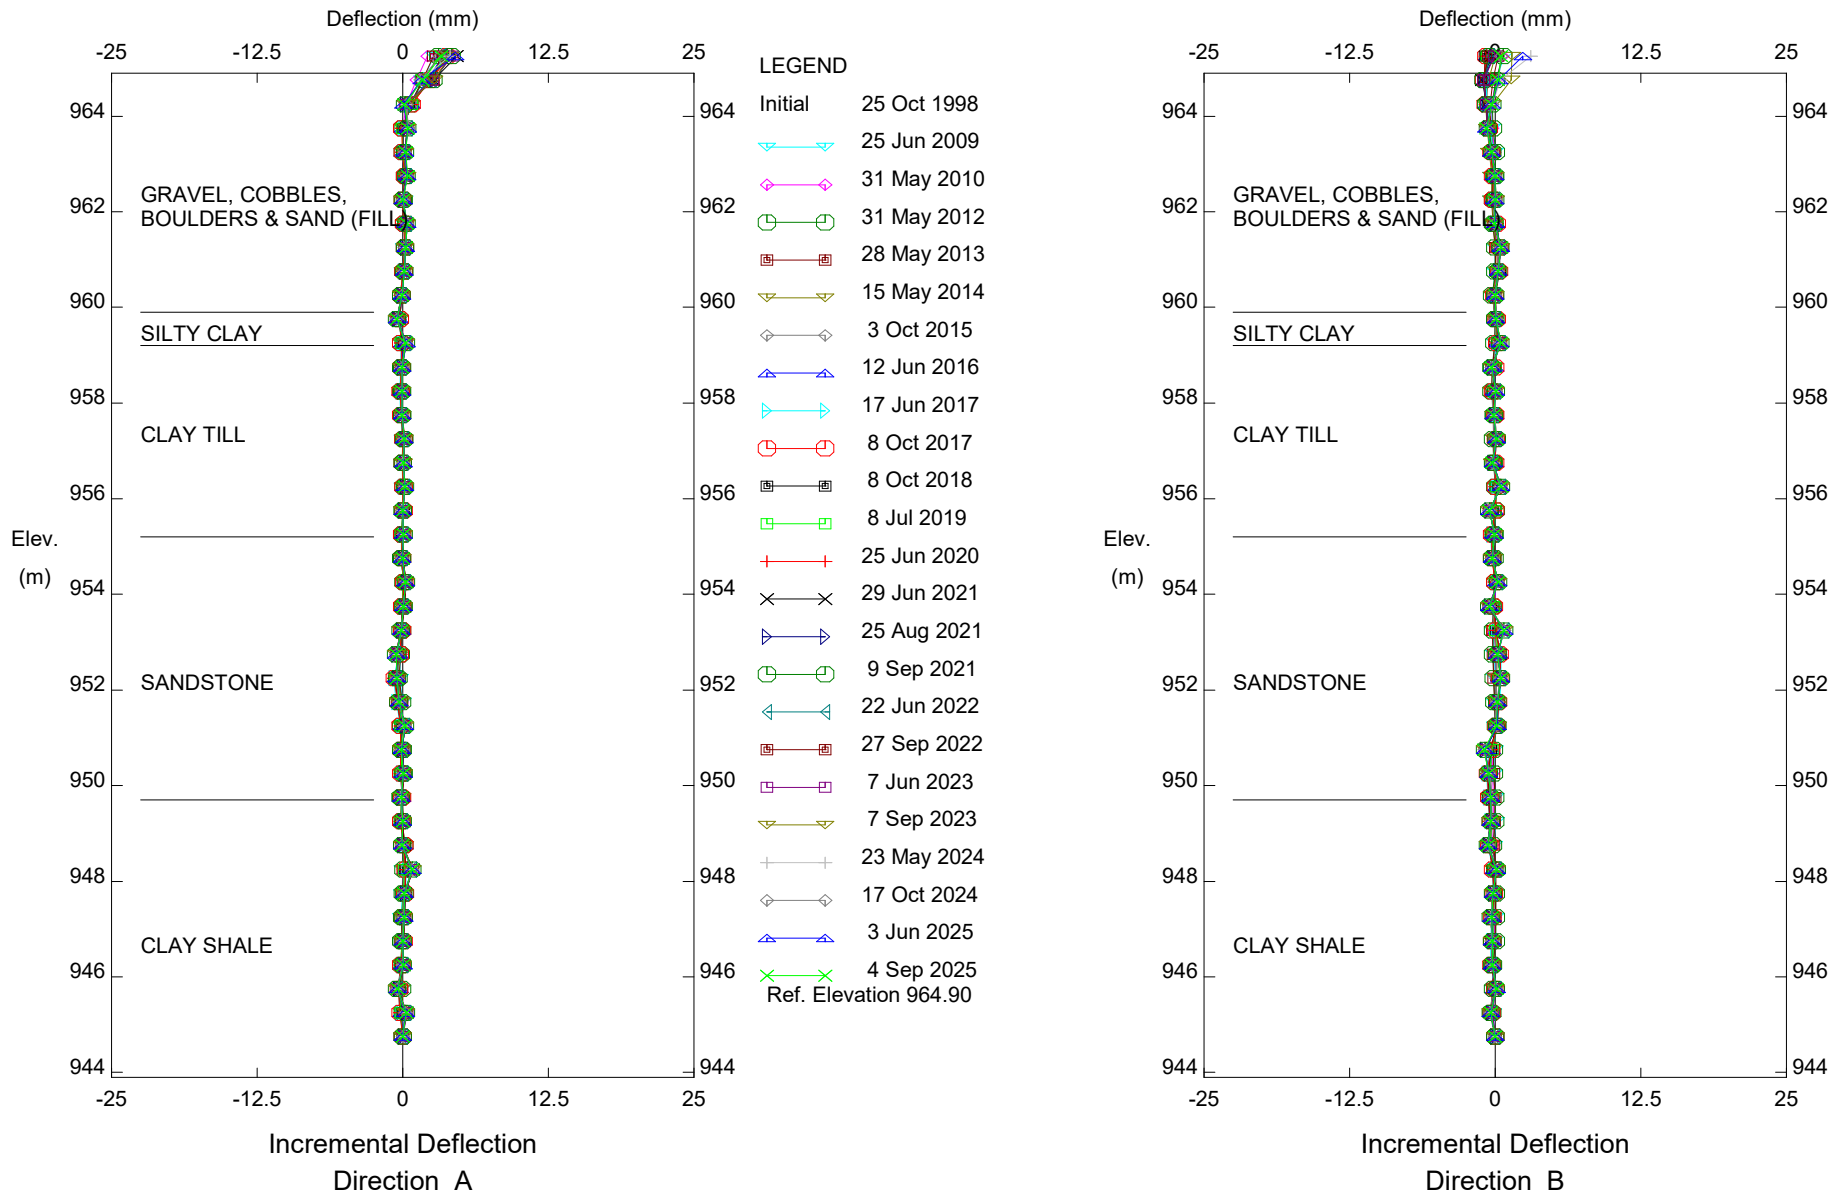
GP007; H40:36, Wanyandie Road Slide, Inclinator SI98-04

At the west end of the site, discrete movement (i.e., movement occurring on a defined failure plane) was recorded in SI98-2 and SI98-5 before the instruments sheared at approximate depths of 21.5 mbgs and 22.0 mbgs, respectively. SI98-2 was located along the south (eastbound) shoulder of the highway and SI98-5 was located below the highway along Wanyandie Road. No discernible movement has been recorded in SI98-4, which is still operable and located upslope of SI98-5 in the north (westbound) highway ditch. However, as discussed in Section 1.1, SI98-4 may not have been installed deep enough. In May 2022, a deeper SI (SI22-1) was installed adjacent to SI98-4. A “kink” has been recorded in SI22-1 at an approximate depth of 6.3 mbgs to 9.8 mbgs (elevation 958.7 m to 955.2 m), in a zone of softer material observed during drilling, which may indicate post-installation casing settlement/flexure.

Overall, the data recorded in SI98-4 and SI22-1 does not reflect the pavement distress (cracking and settlement) observed near the west end of the site and these instruments.

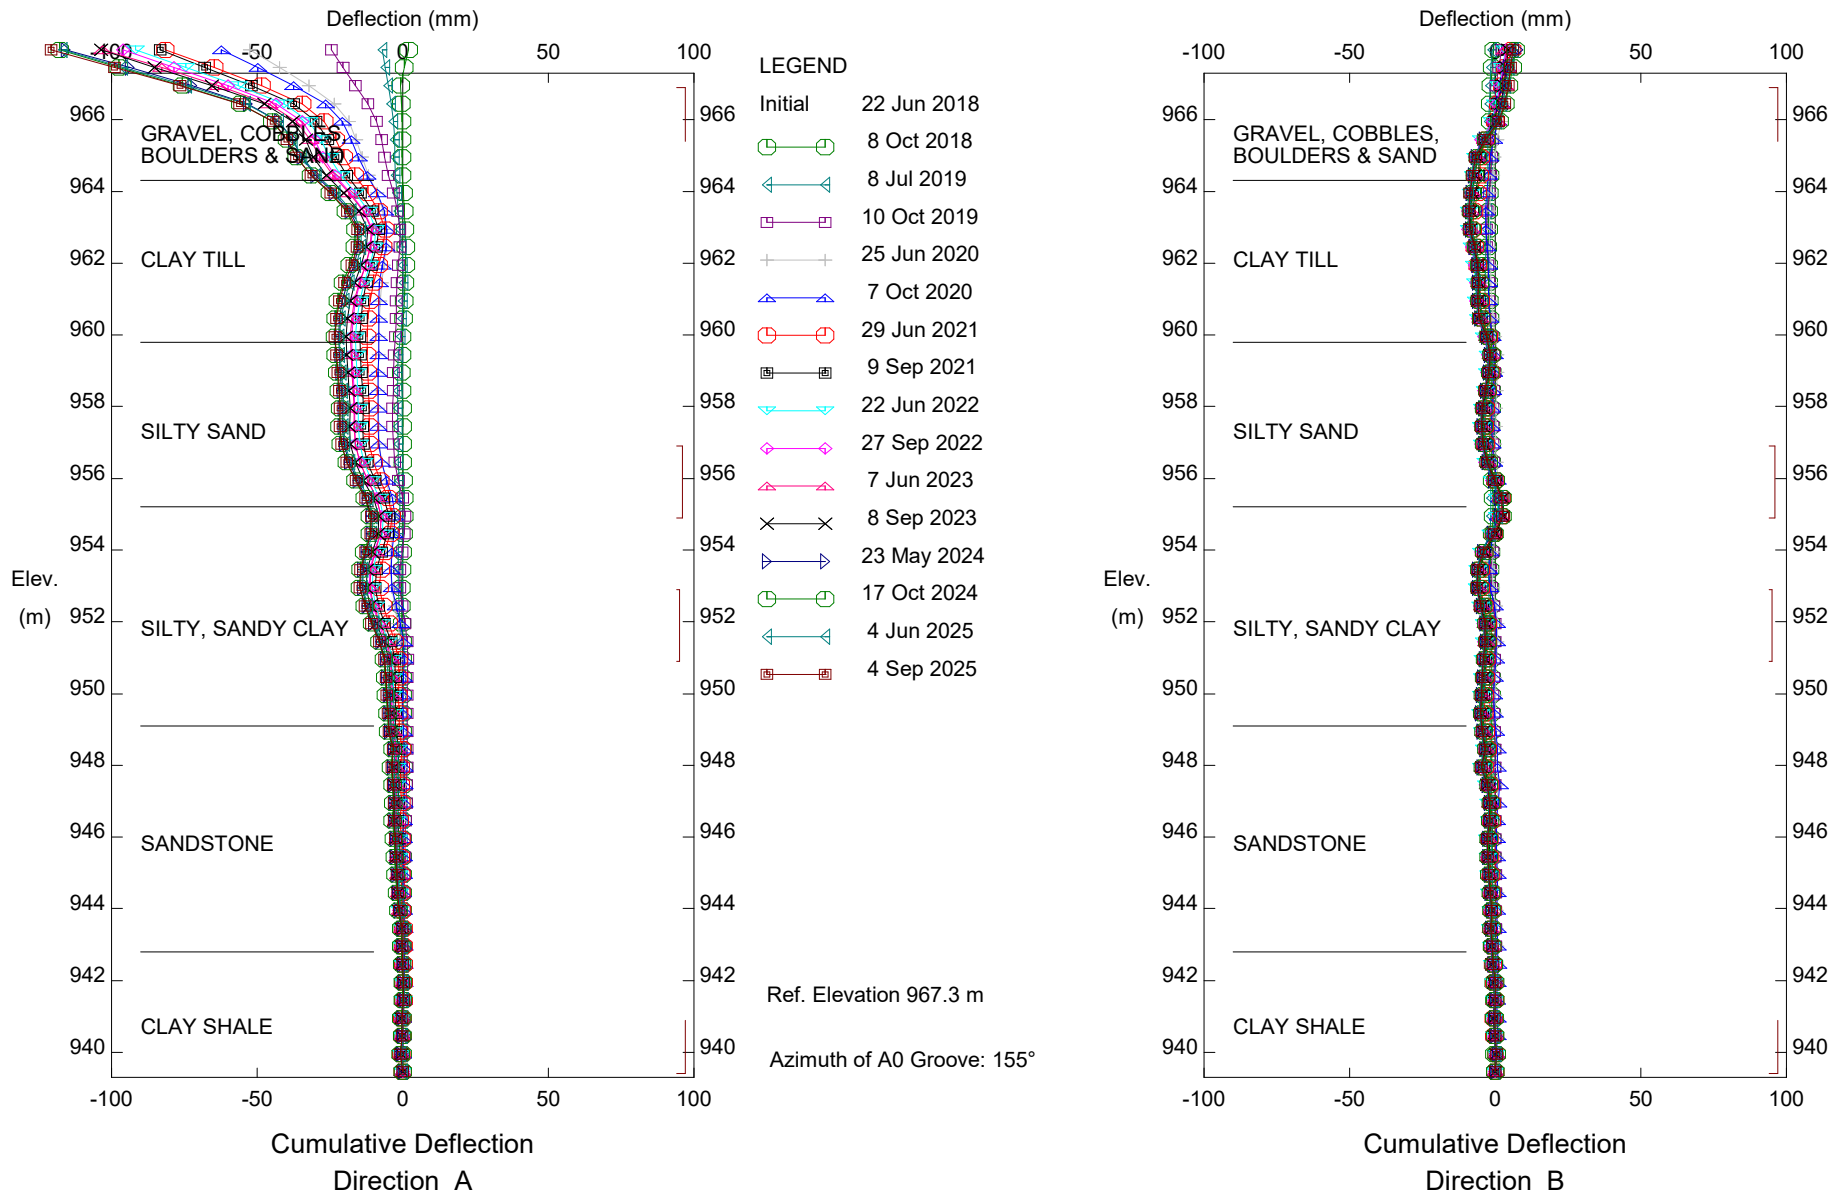
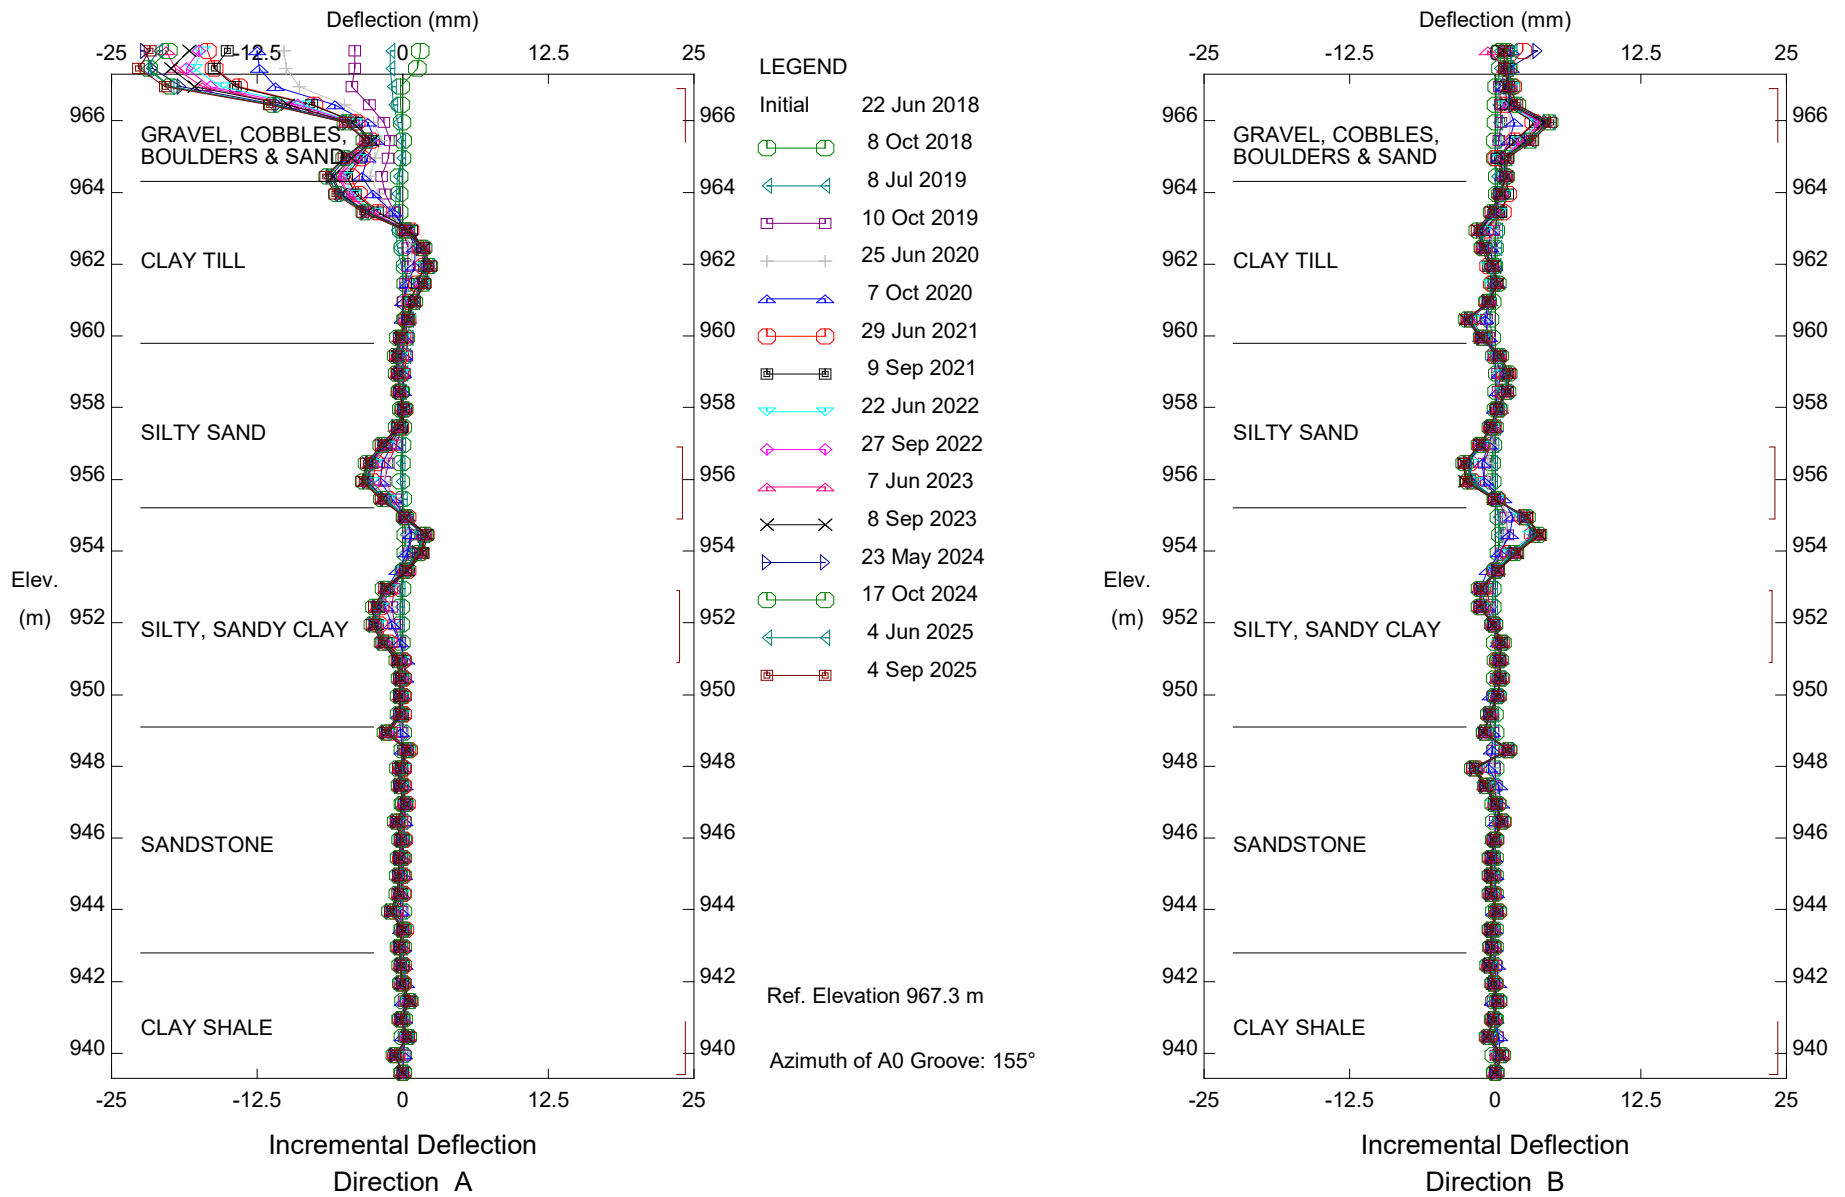
GP007; H40:36, Wanyandie Road Slide, Inclinometer SI98-06

It is noted that the data for SI98-6, SI98-7, SI03-11, SI03-12, and SI22-4 is noisy and difficult to interpret. Based on the absolute plots for these instruments, SI98-6 has kinks in the casing at an approximate depth of 11.9 m and 13.9 m below ground surface (mbgs), SI98-7, SI03-11 and SI03-12 are tilted approximately 1.2 m to 1.5 m in the A direction, and SI22-4 is titled 1.7 m in the B-direction. SI98-12 has also been re-sleeved twice (i.e., had a small-diameter casing installed in it) (dates unknown).

Overall, the data recorded in SI-6, SI22-2, and SI22-3 does not reflect the increased pavement distress (cracking and settlement) observed near the middle of the site and these instruments since fall 2024.

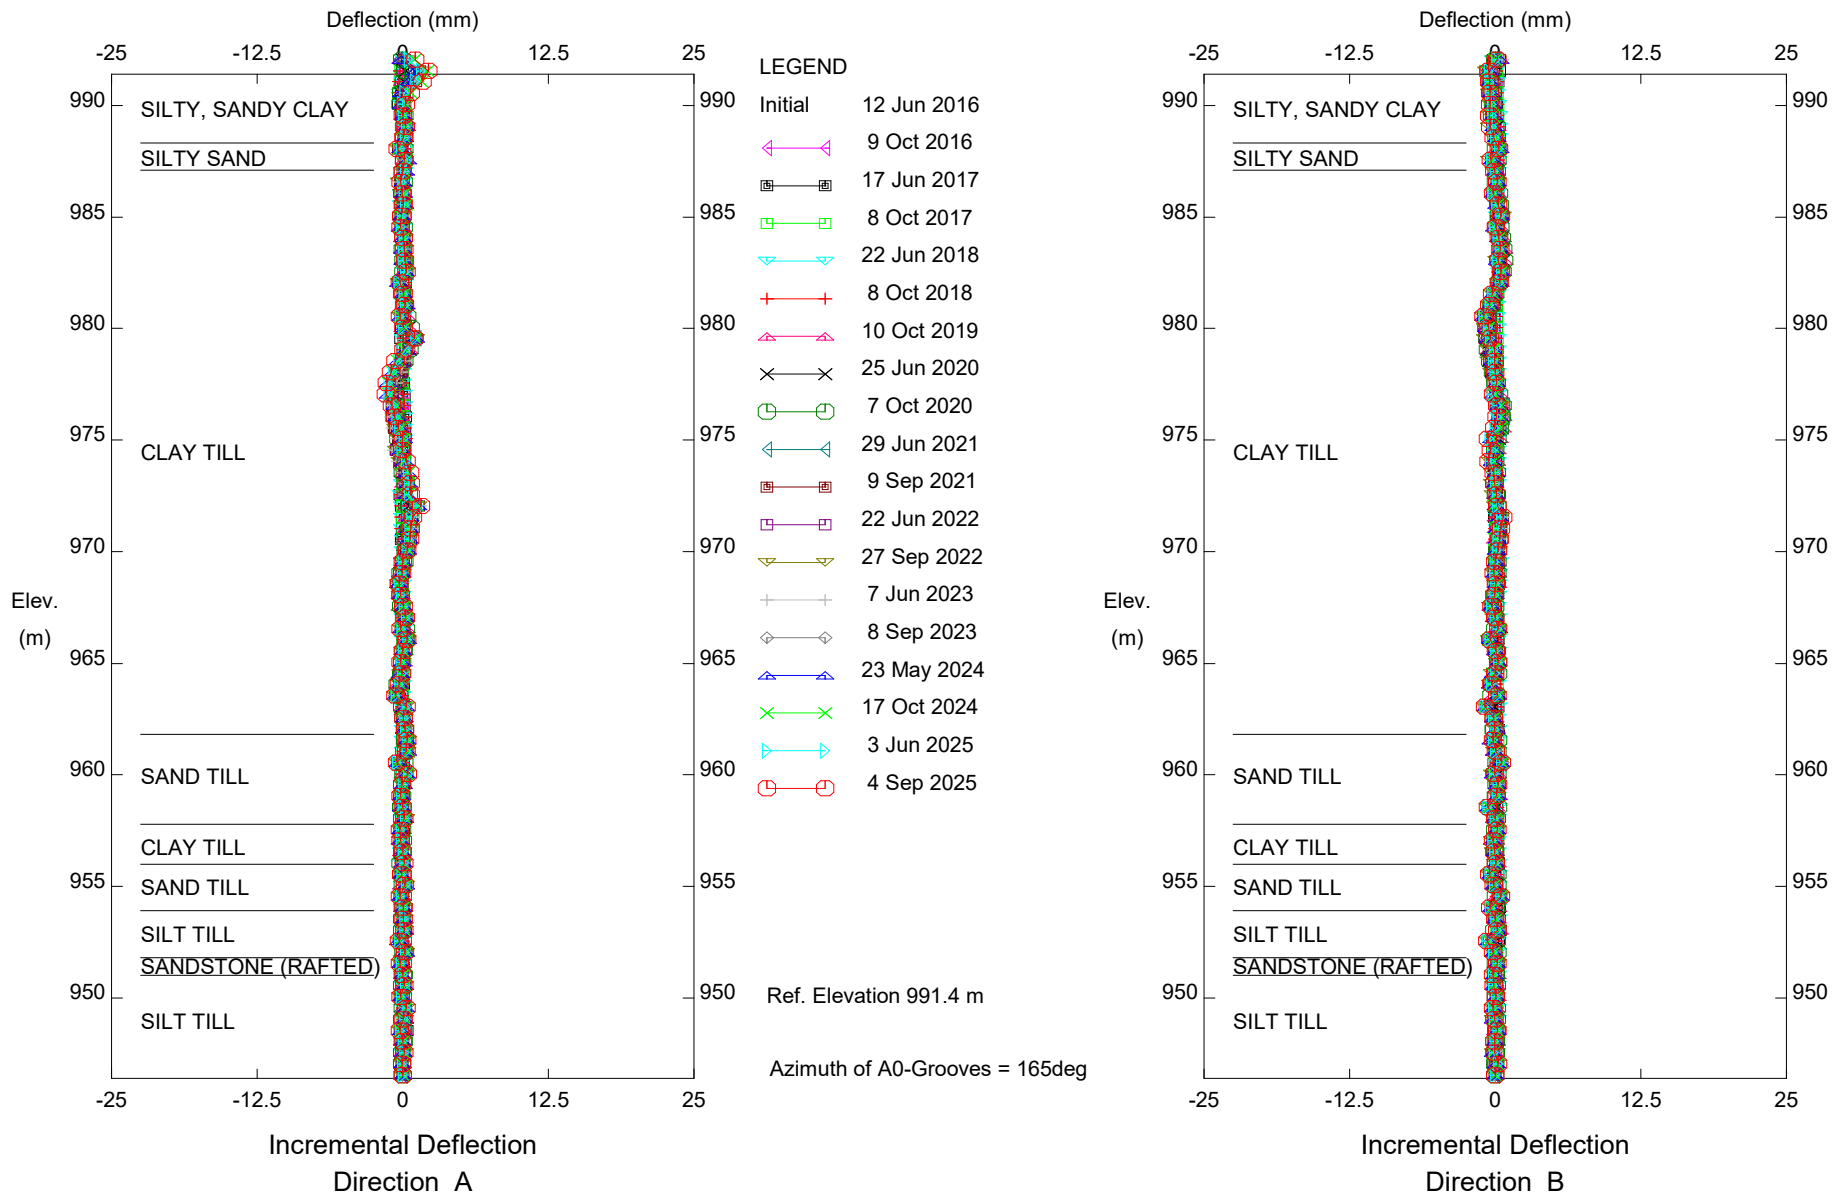
GP007; H40:36, Wanyandie Road Slide, Inclinometer SI03-12

SI03-12 ³	May 24, 2007 (Jun. 12, 2016)				991.4	N/A – No discernible discrete movement recorded, but some potential post-installation casing settlement/flexure recorded.								
SI22-1	Jun. 22, 2022				965.0	N/A – No discernible discrete movement recorded, but some potential post-installation casing settlement/flexure recorded.								
SI22-2	Jun. 22, 2022	Jun. 03, 2025	Jul. 02, 2025		966.0	6.6 – 10.6	A-direction	N/A		18.0	0.1	20.8	0.4	0.1
SI22-3	Jun. 21, 2022	N/A – No discernible movement recorded.			971.0	N/A – No discernible movement recorded, but some potential post-installation casing settlement/flexure recorded								
SI22-4 ³	Jun. 21, 2022	Oct. 17, 2024			980.0	2.6 – 53.6	X-Direction, 230°	N/A		10.1	-6.5	46.5	-8.2	-54.7

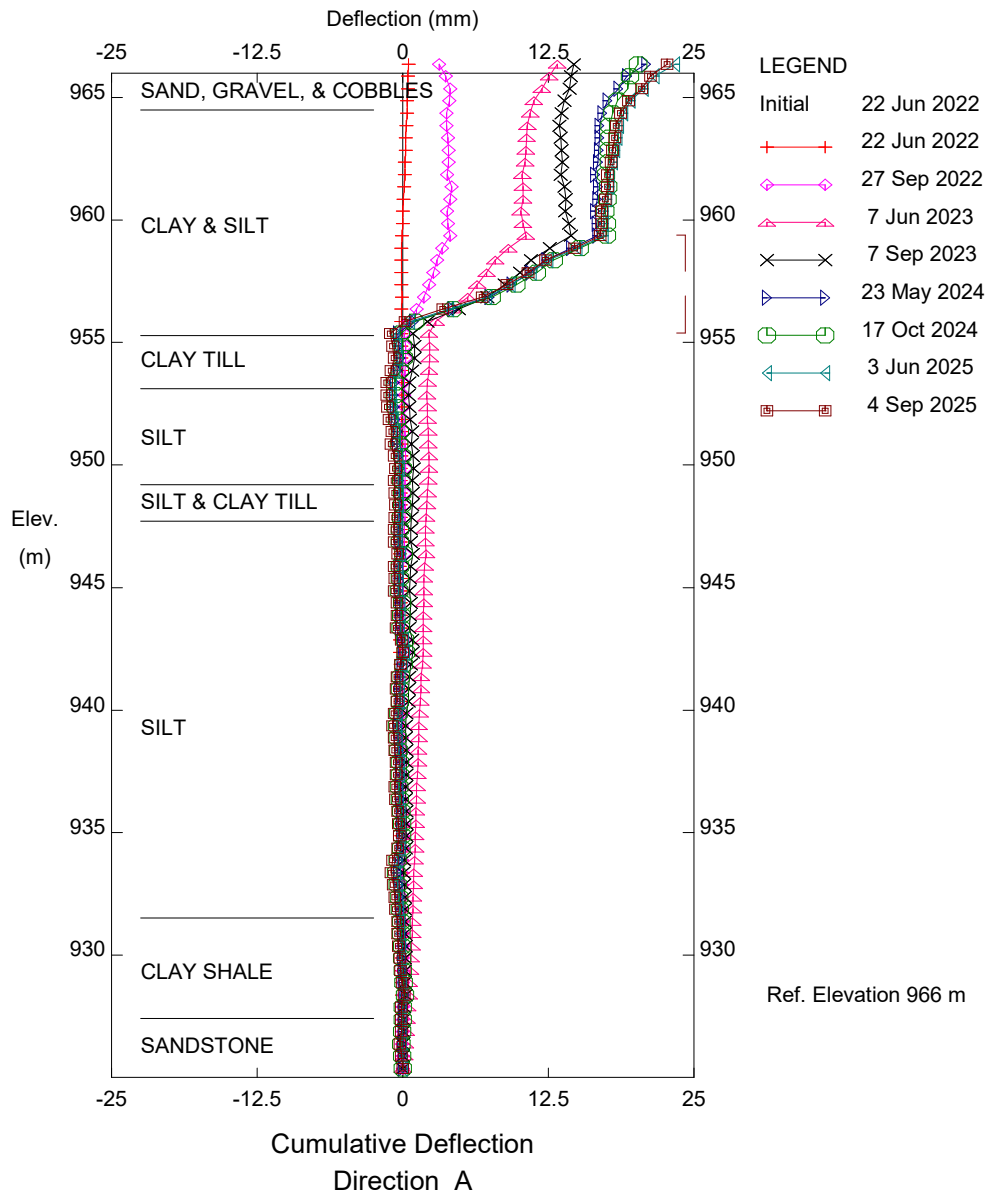
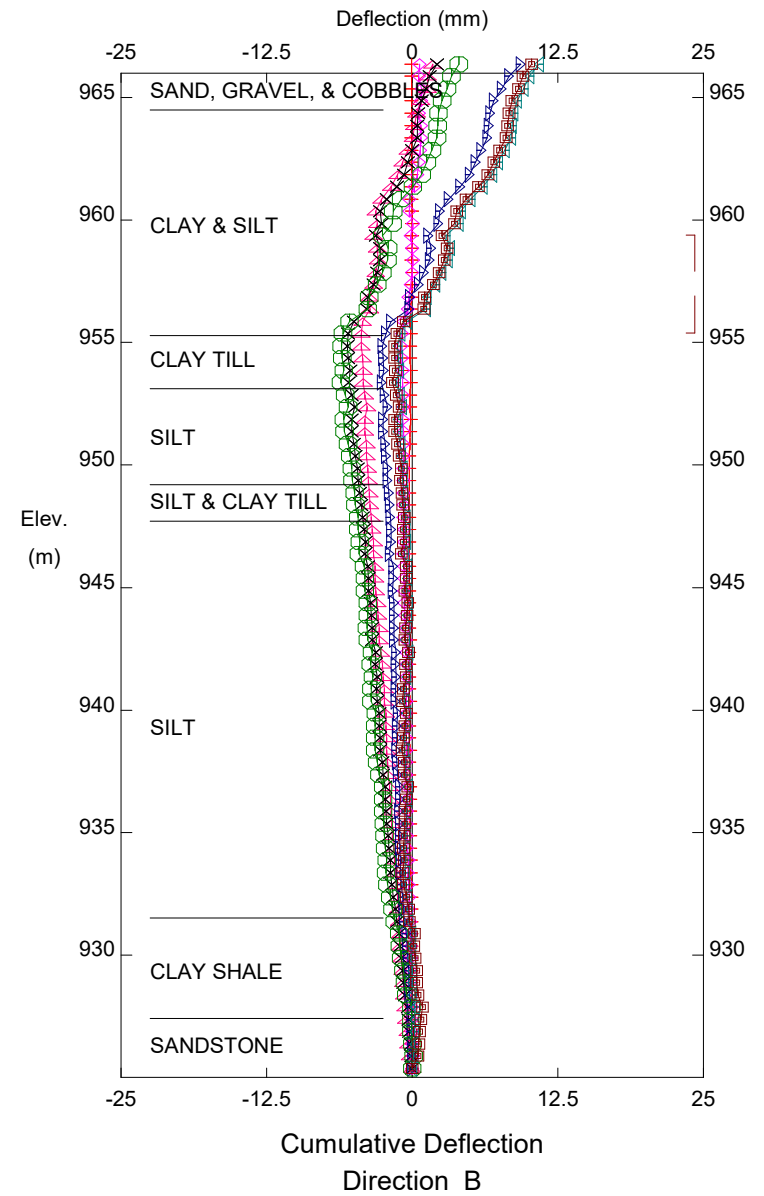
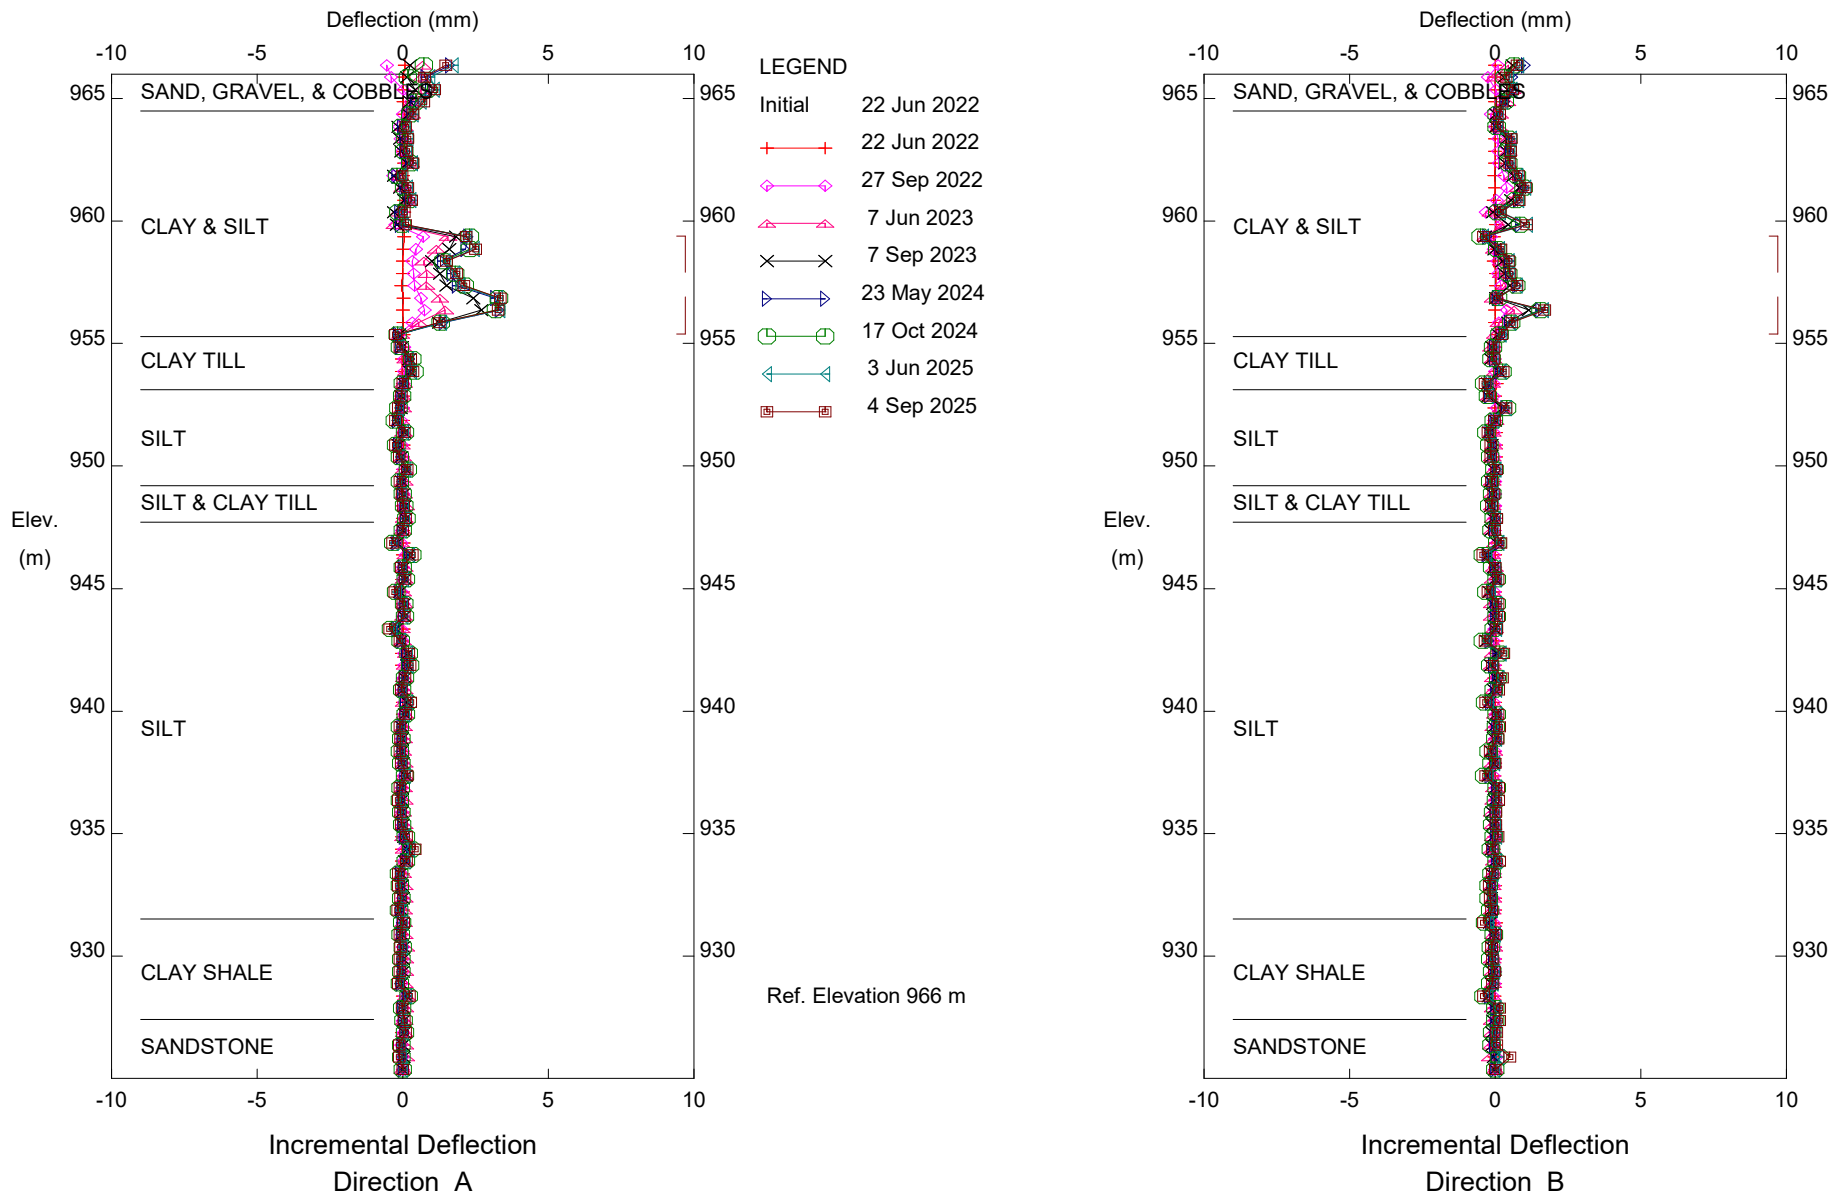
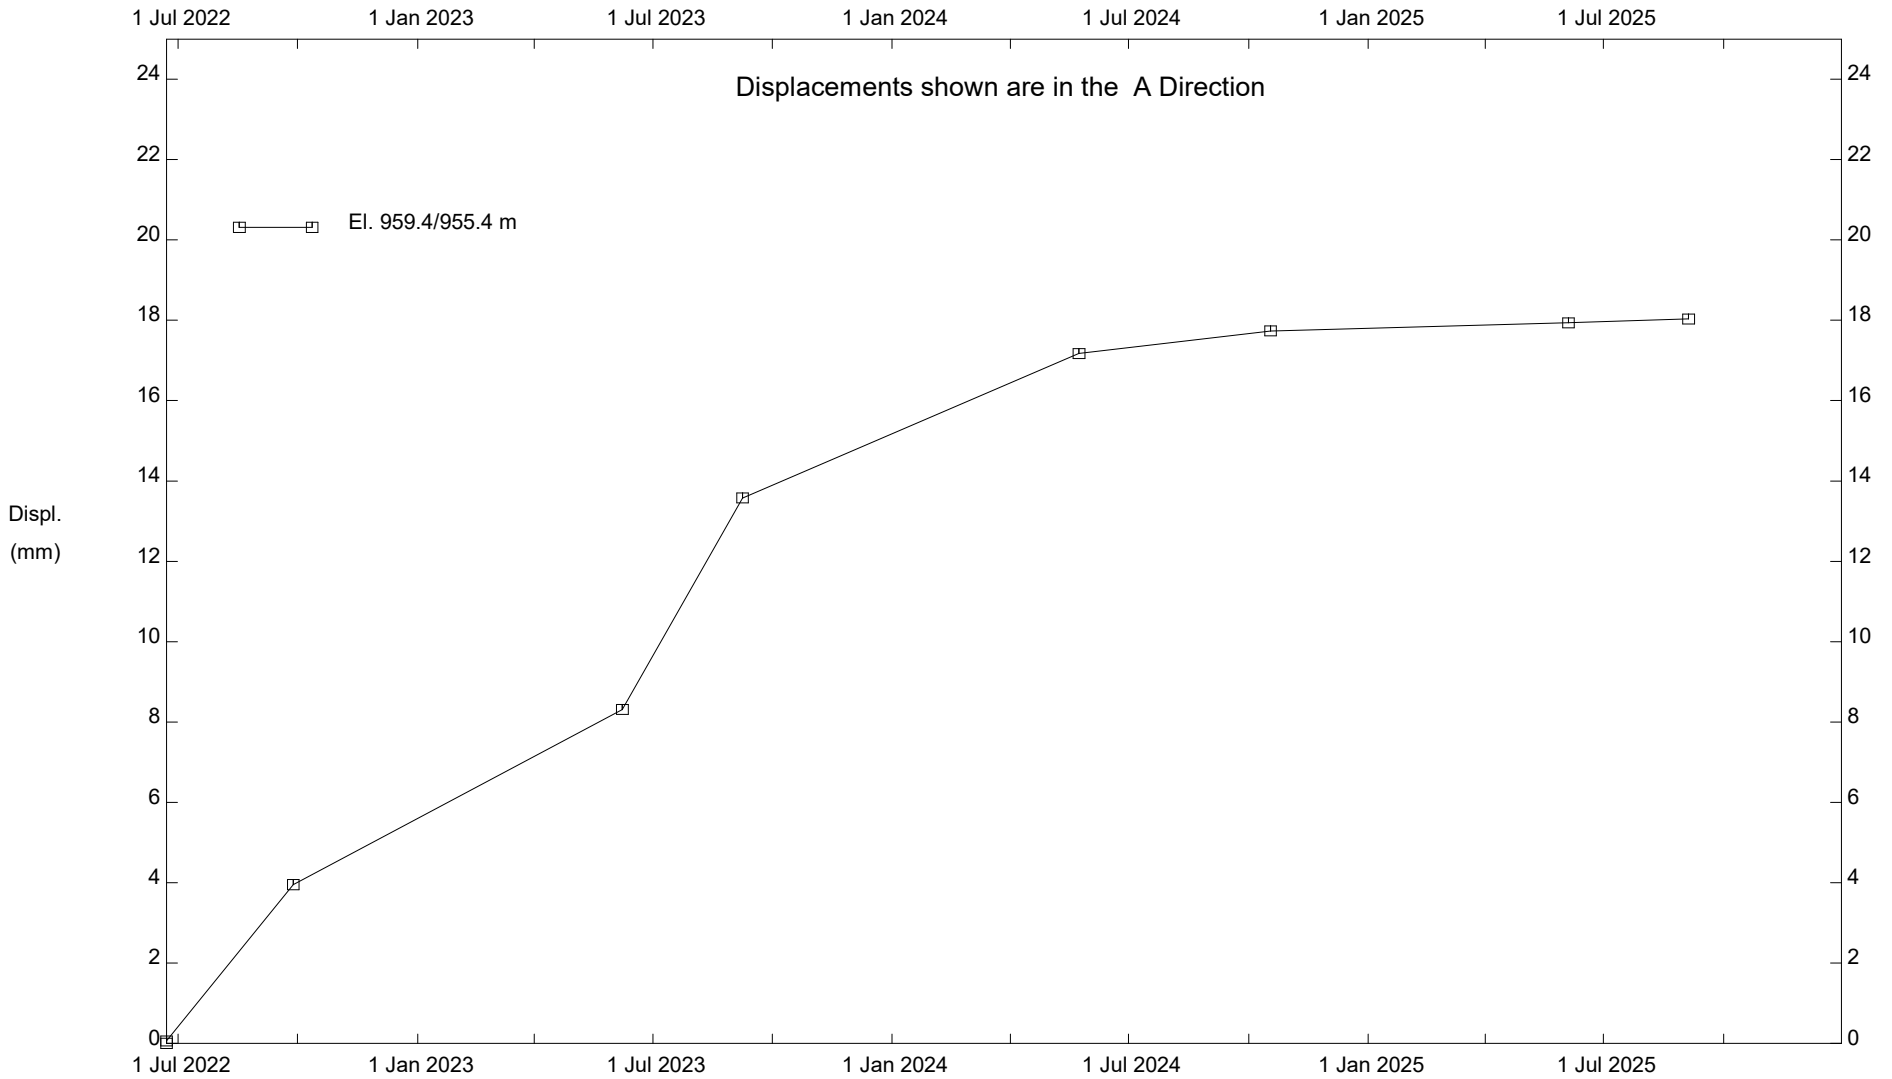
GP007; H40:36, Wanyandie Road Slide, Inclinometer SI22-02

As discussed in Section 1.1, SI98-6, SI03-11, and SI03-12 may not have been installed deep enough. In May 2022, two deeper SIs (SI22-2 and SI22-3) were installed in the north highway ditch to assess if deeper movements are occurring near the middle of the site. Distributed movement has been recorded in SI22-2 from an approximate depth of 6.6 mbgs to 10.6 mbgs (elevation 959.4 m to 955.4 m), which is confined to the colluvium/till unit, and post-installation casing settlement/flexure has been recorded in SI22-3 to an approximate depth of 12 mbgs, which may be caused by grout loss in a more granular zone in the colluvium unit. It is noted that data recorded in SI22-3 is fluctuating with negative displacement sometimes being recorded.
