November 28, 2025

Alberta Transportation and Economic Corridors
Main Floor, Provincial Building
9621 – 96th Avenue
Peace River, Alberta
T8S 1T4

**CON0022166 Peace Region (Grande Prairie District – South) GRMP Instrumentation Monitoring
Site GP007; H40:36, km 29.339 Wanyandie Road Slide
Section C – 2025 Fall Readings**

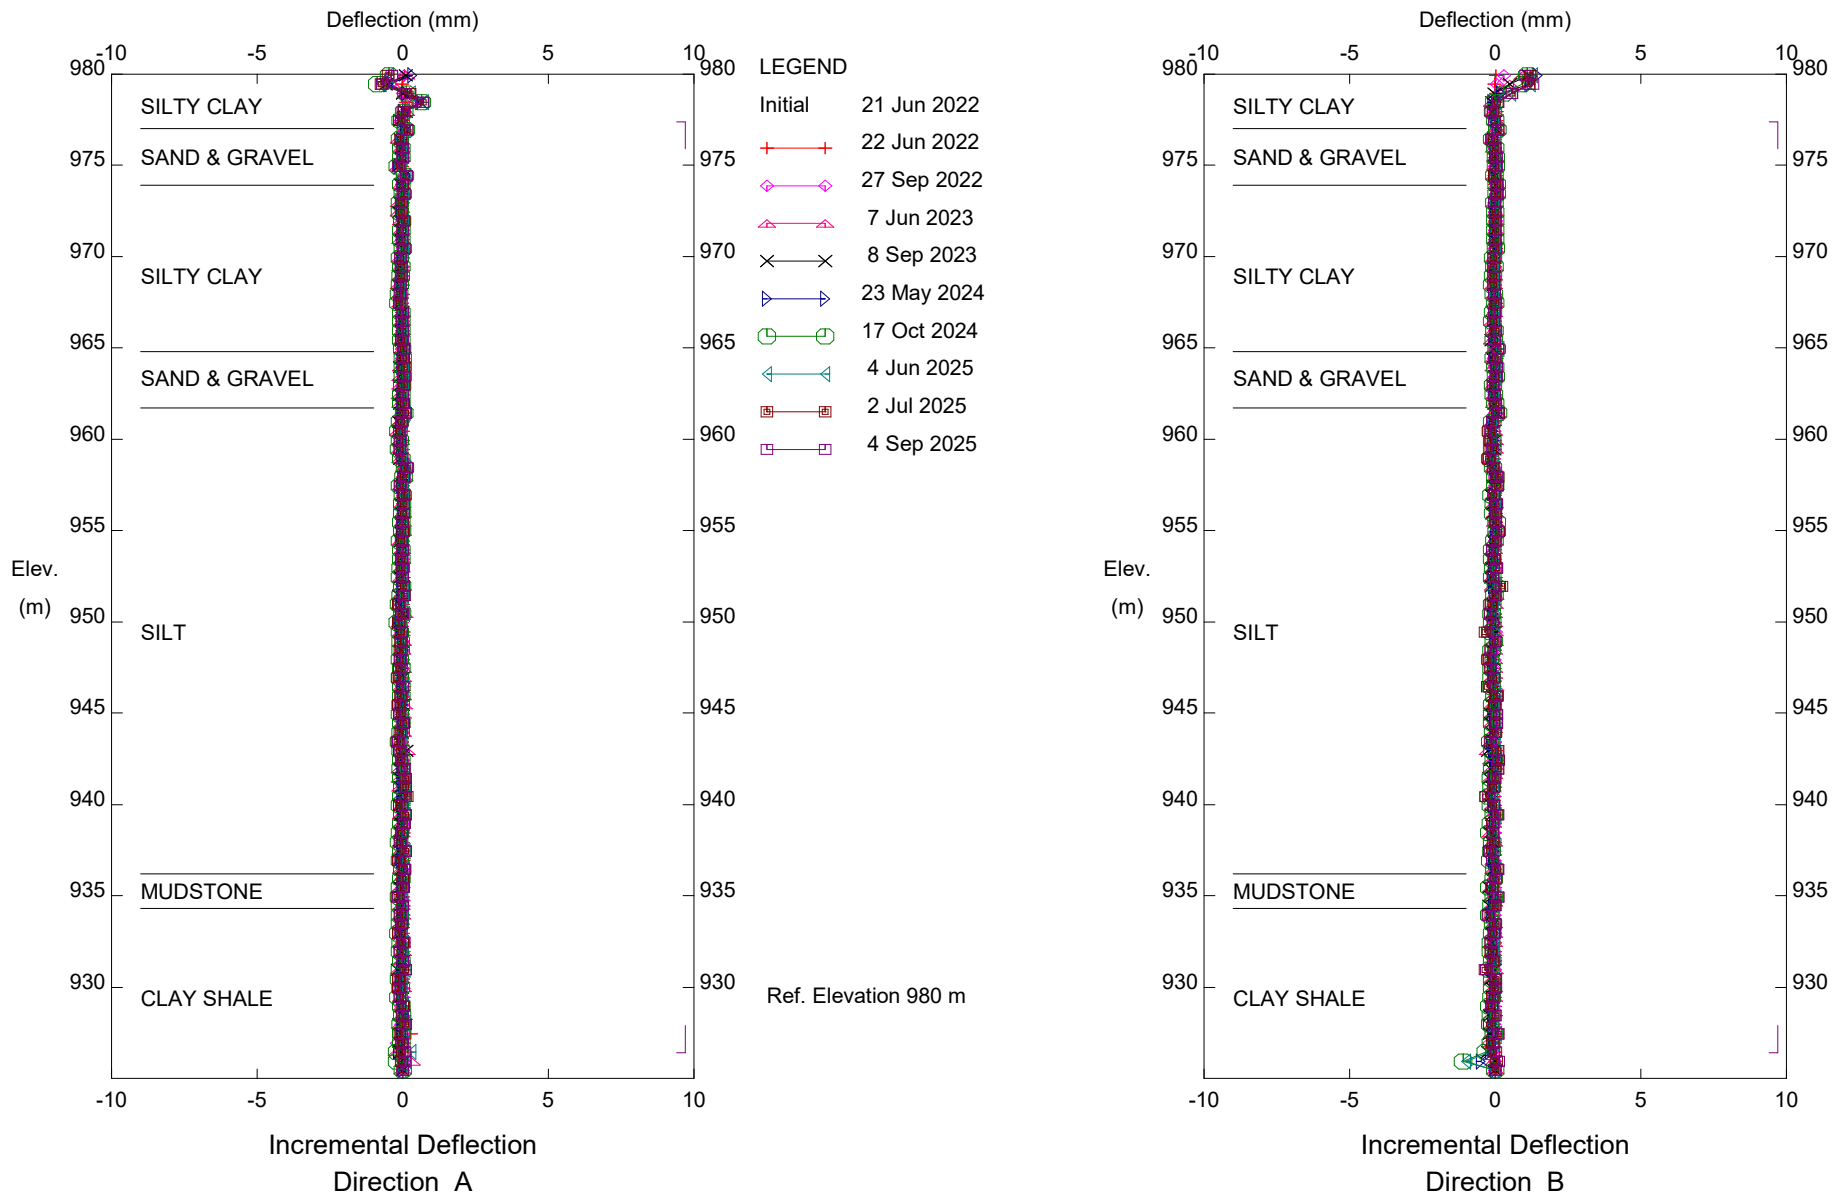
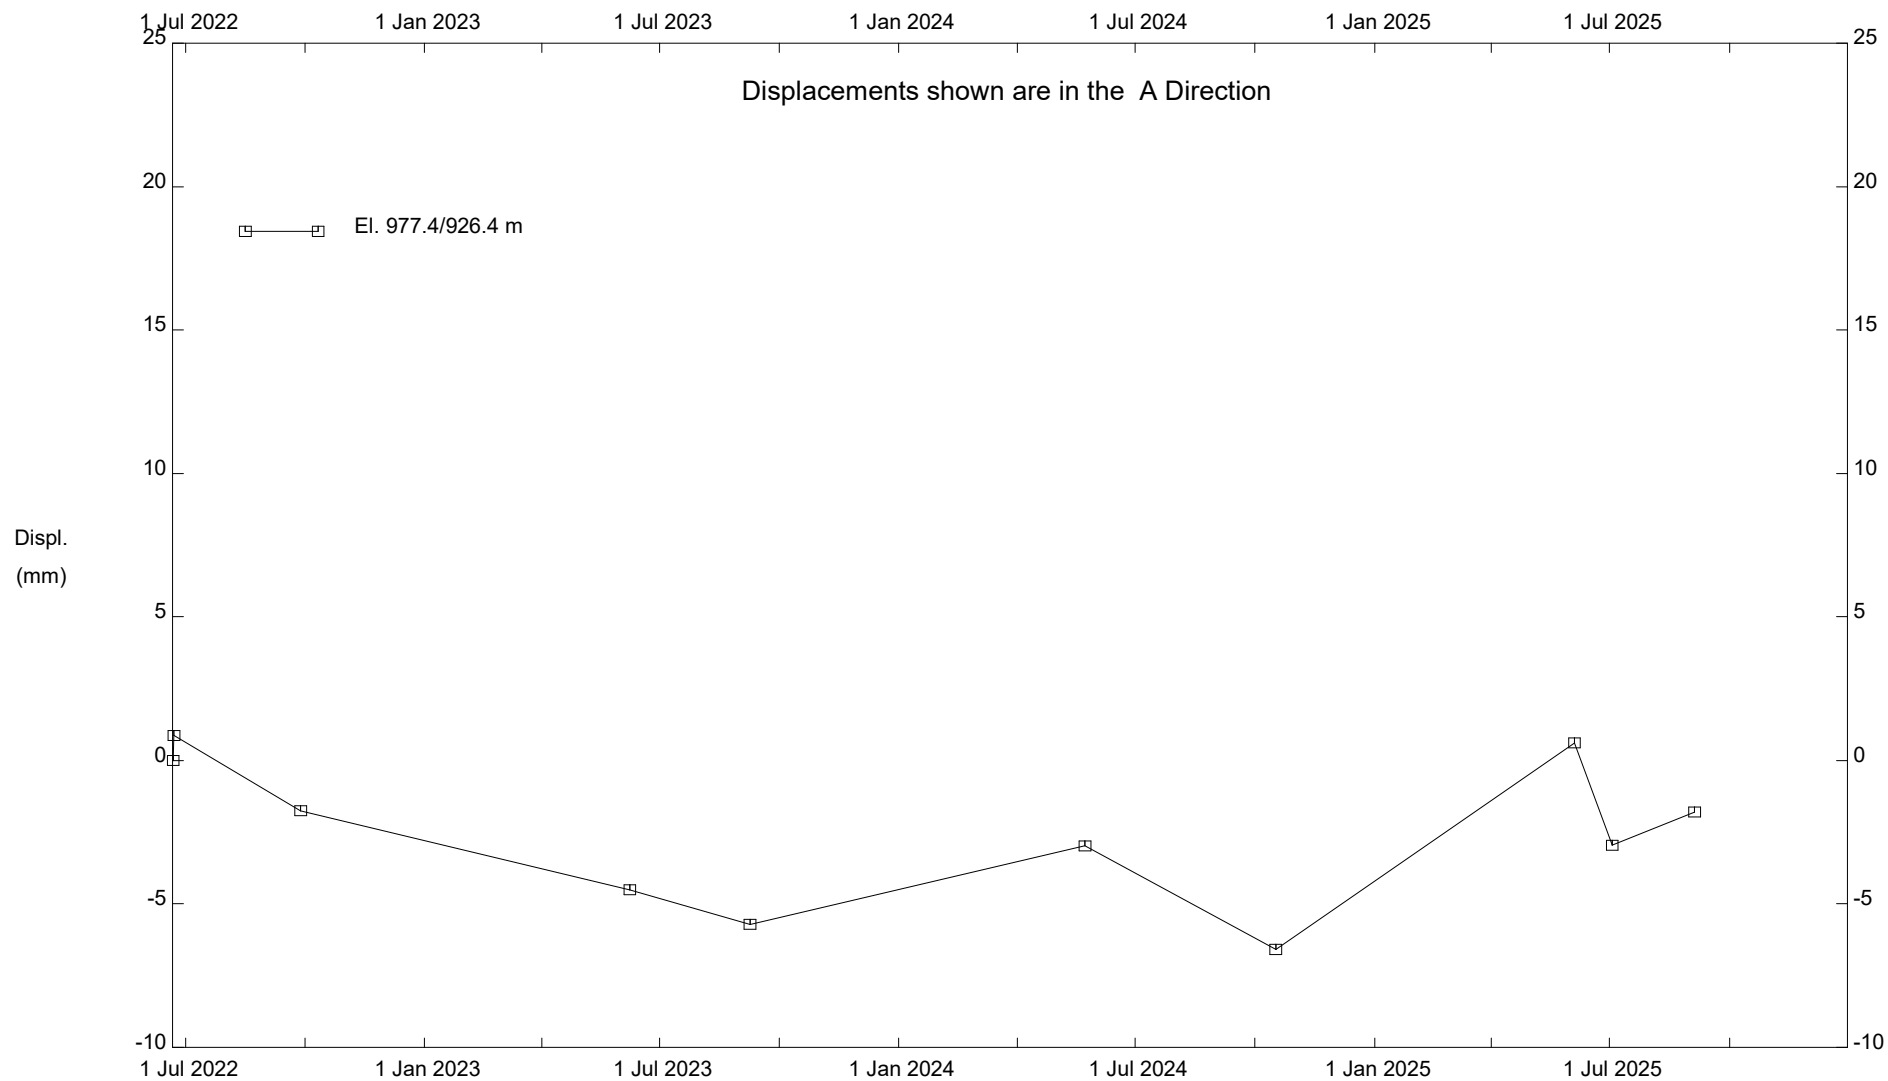
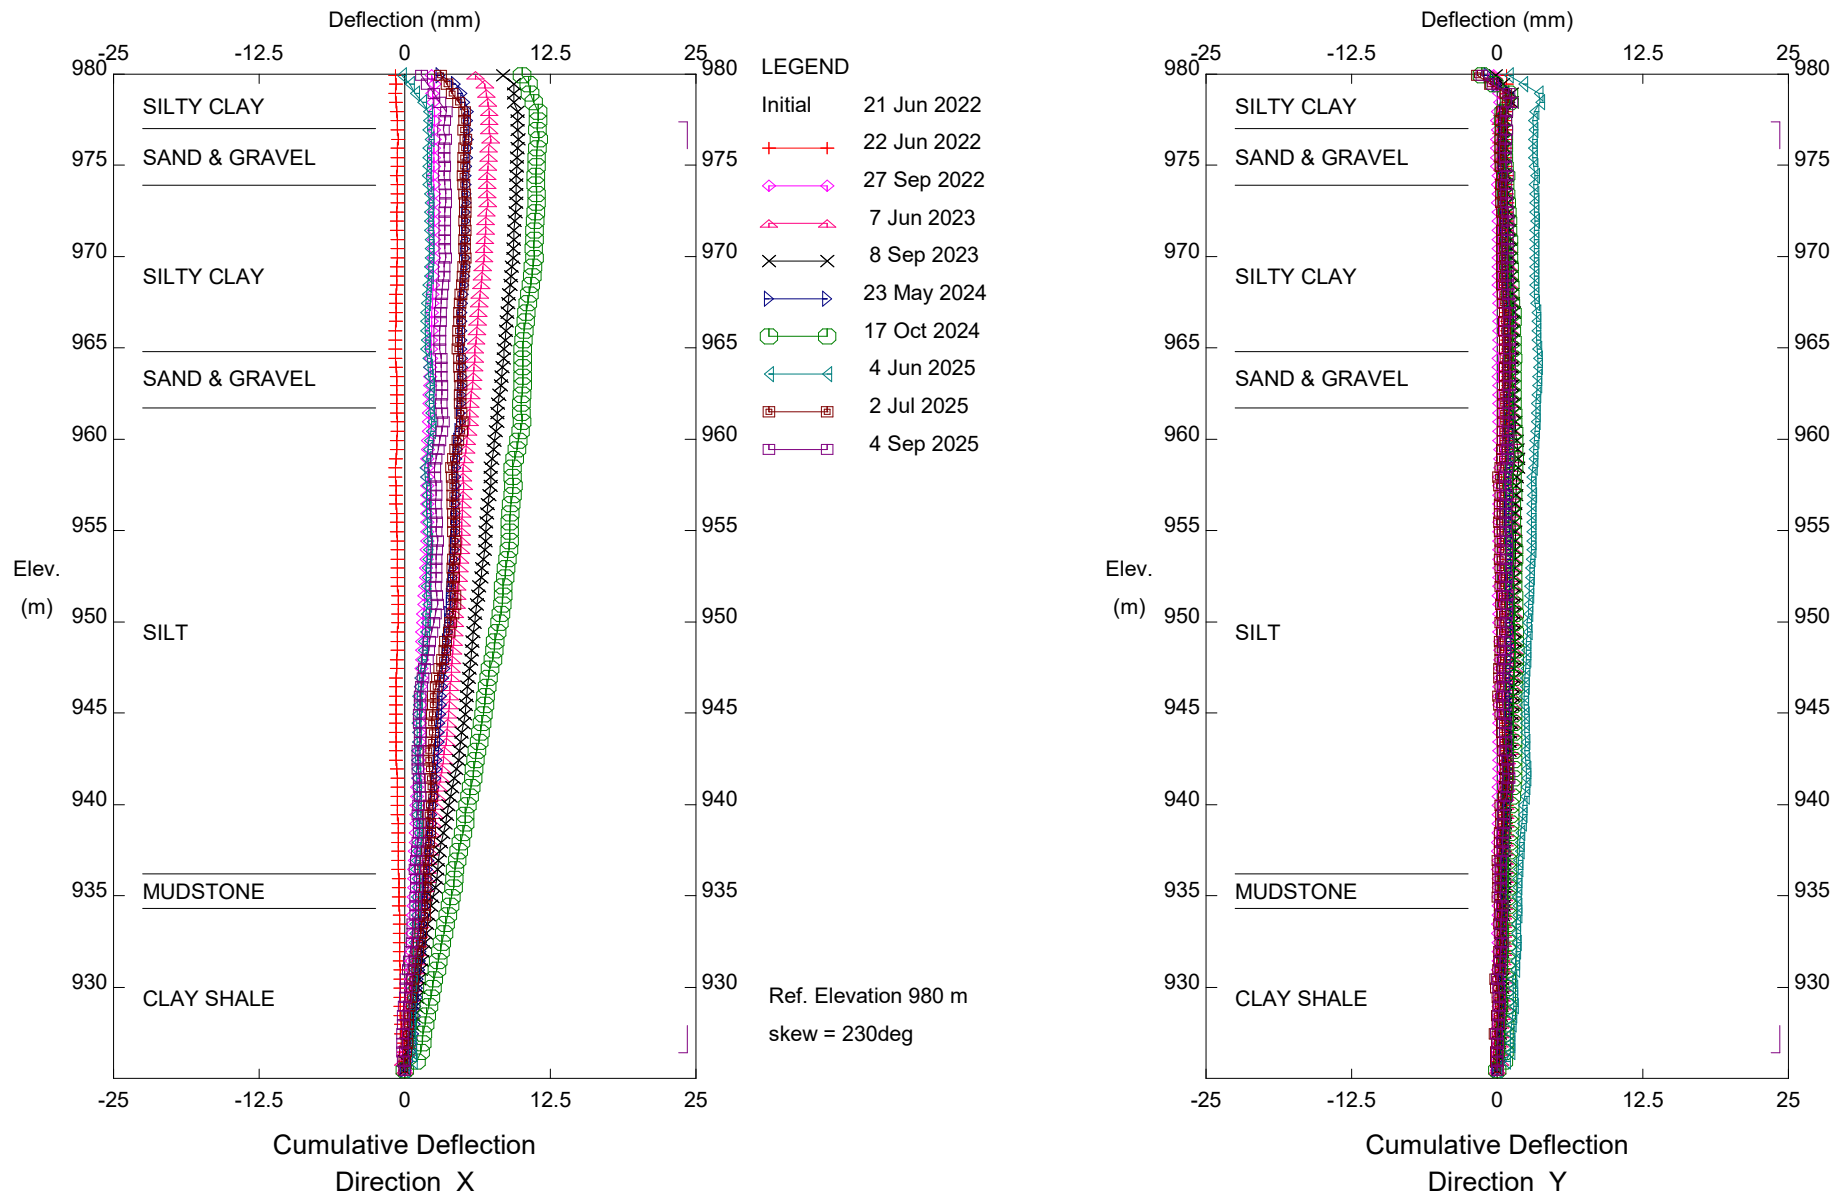
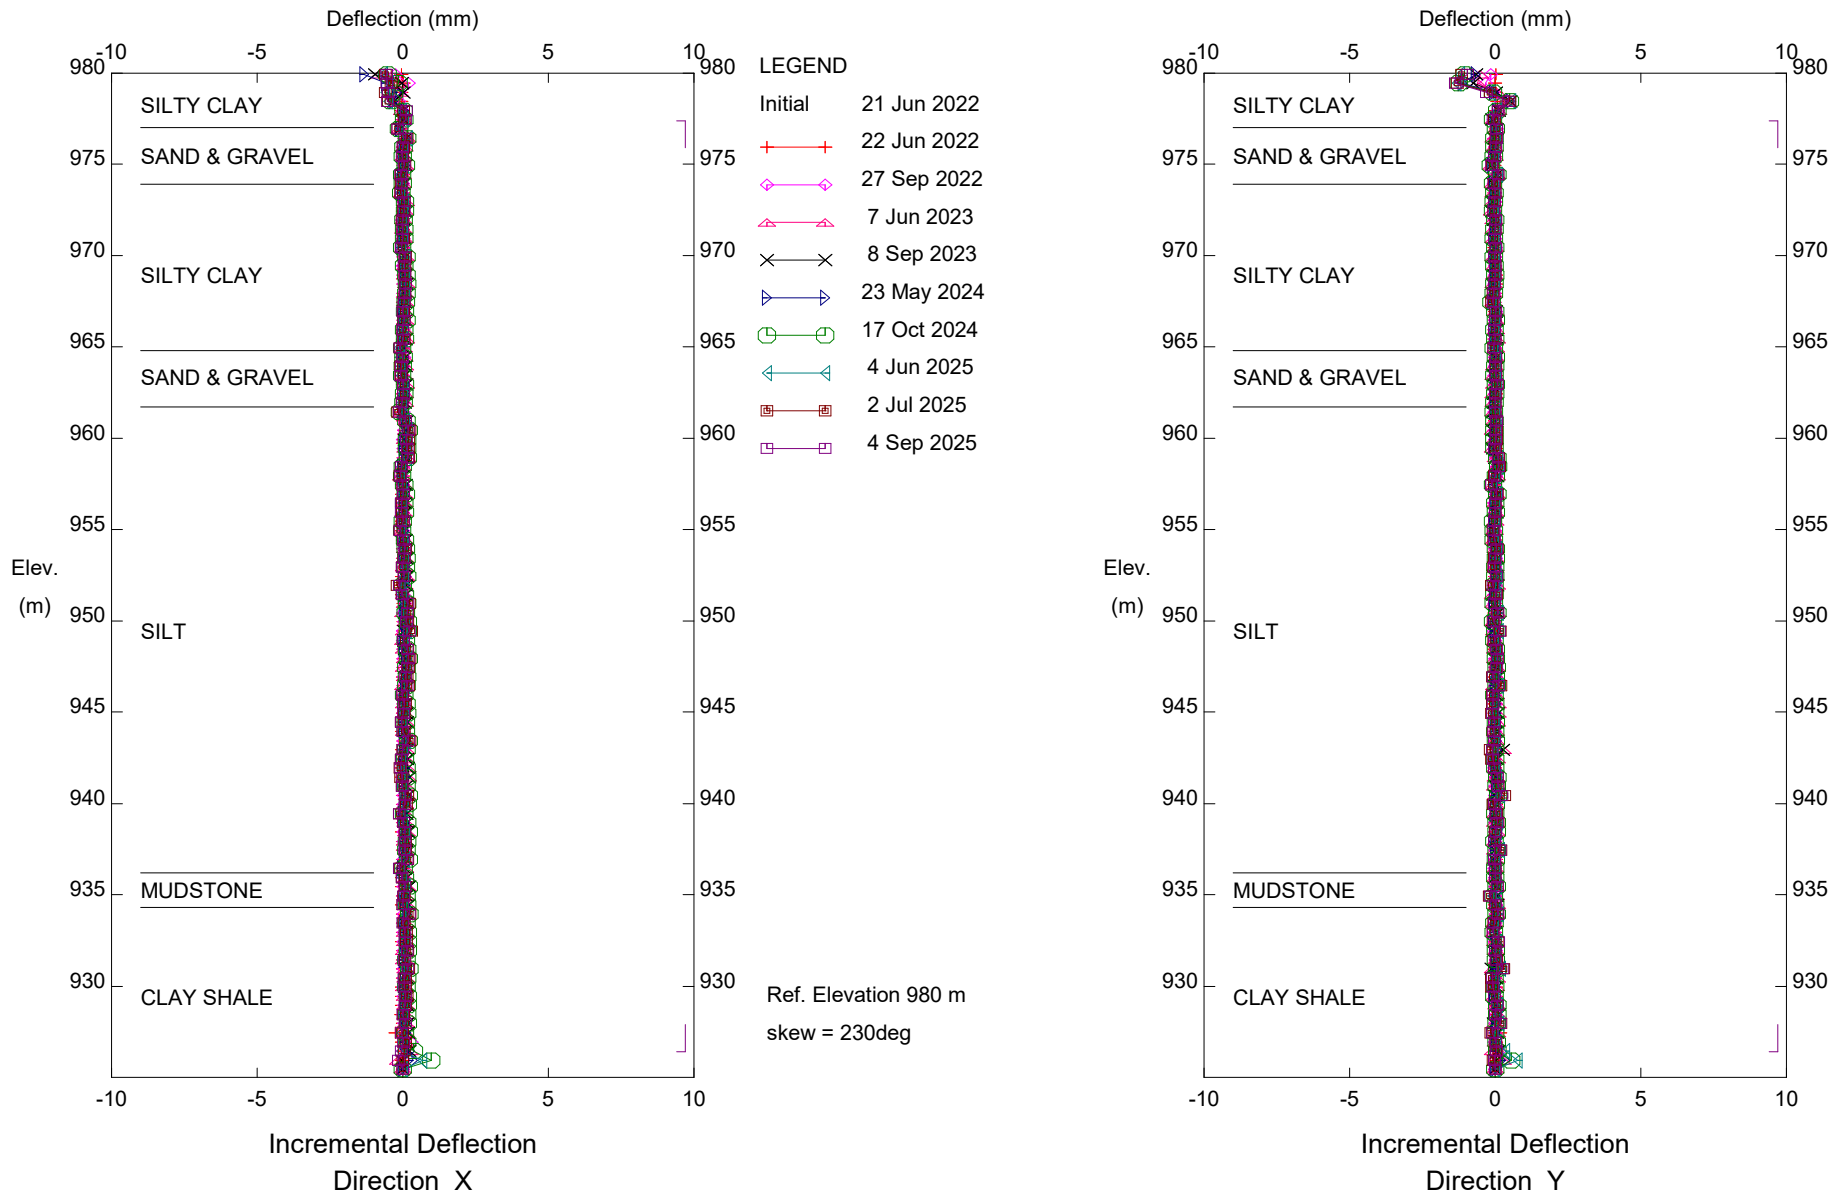
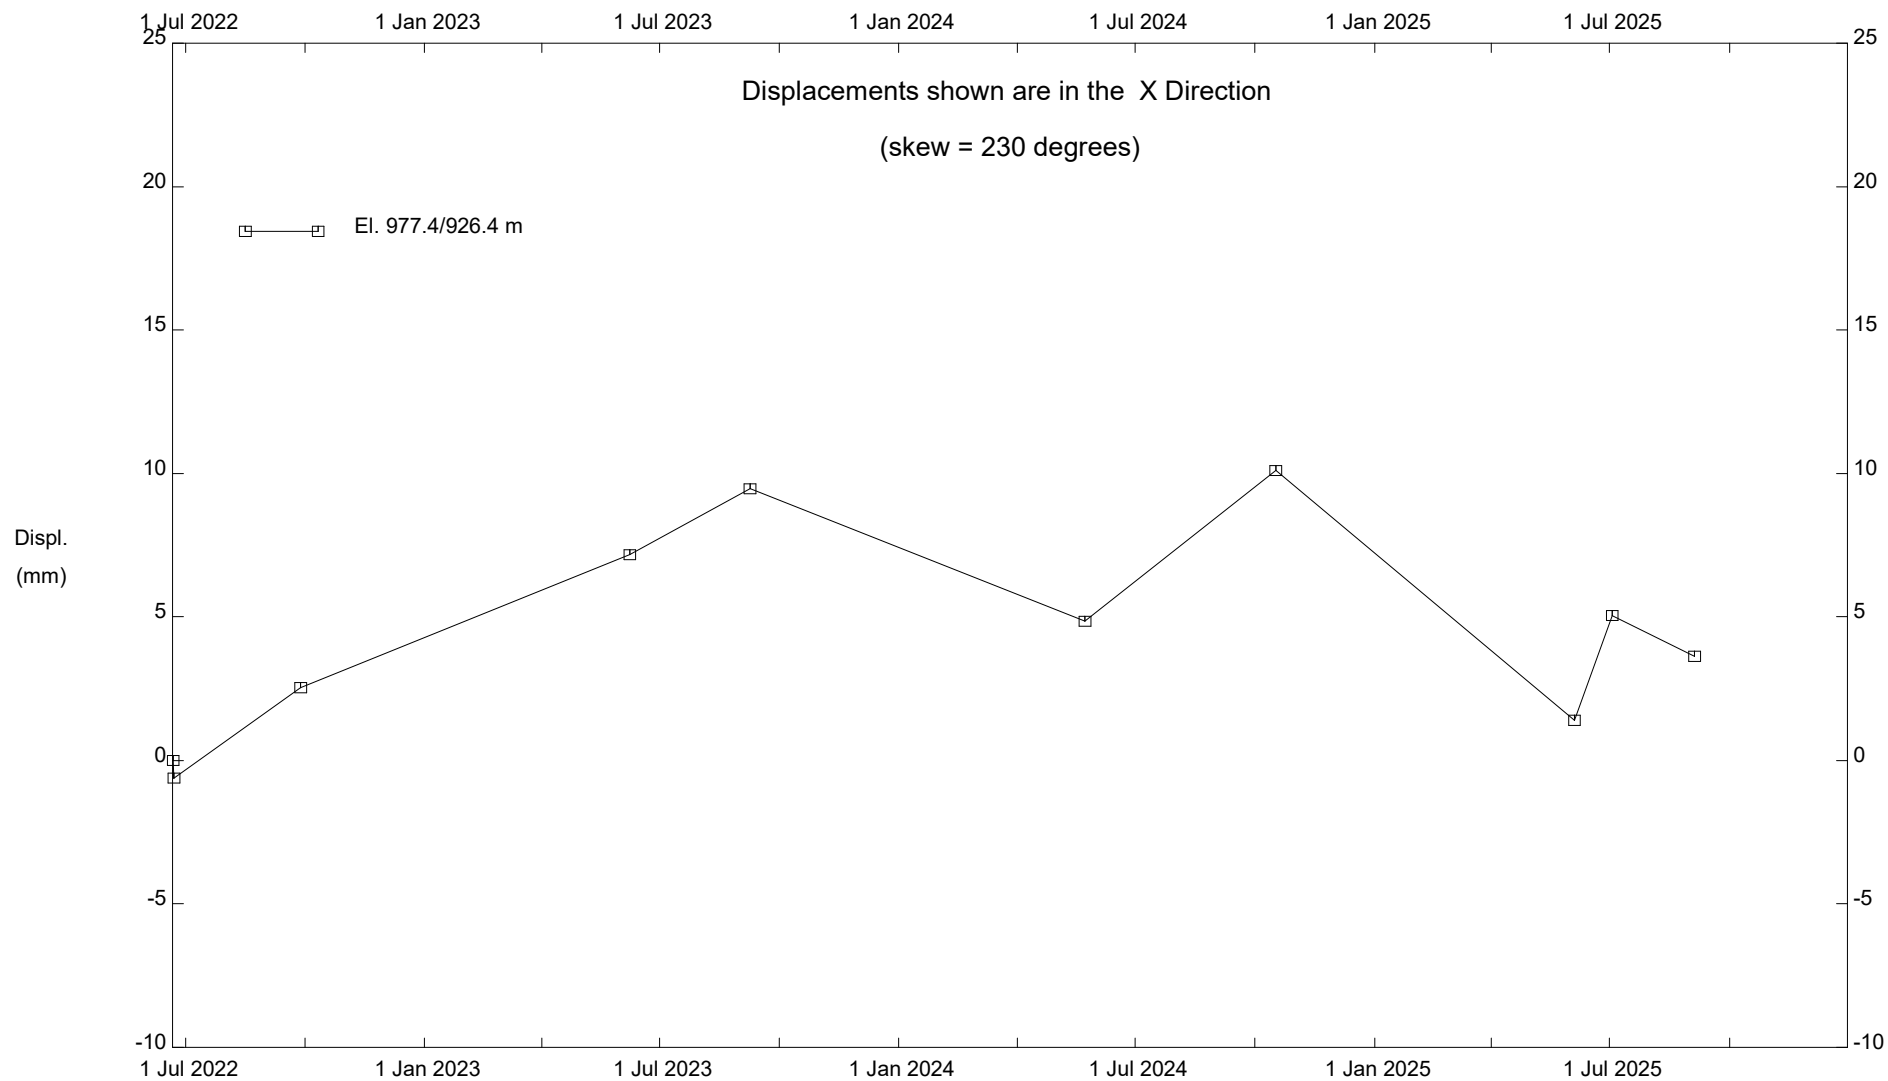
GP007; H40:36, Wanyandie Road Slide, Inclinometer SI22-04

In May 2022, a deeper SI (SI22-4) was installed on the north side of the highway to assess if deeper movements are occurring at the east end of the site. Distributed movement is being recorded along the entire length of the instrument (i.e., from near ground surface to the base of the instrument) since installation, with no discrete movement zones. It is noted that data recorded in SI22-4 is fluctuating with negative displacement sometimes being recorded.

Overall, the data recorded in SI22-4 does not reflect the increased pavement distress (cracking and settlement) observed near the east end of the site and this instrument since fall 2024.
