SITE INSPECTION FORM

SITE NUMBER AND NAME: GP007 Wanyandie Road Slide		HIGHWAY & KM: 40:36, 29.339	PREVIOUS INSPECTION DATE: June 10, 2024	INSPECTION DATE: June 3, 2025
LEGAL DESCRIPTION: NW 02-59-07-W6M NE 02-59-07-W6M	NAD 83 COORDINATES: UTM Northing Easting 11 5993890 372875		RISK ASSESSMENT: PF: 11 CF: 8 TOTAL: 88	
AVERAGE ANNUAL DAILY TRAFFIC (AADT): 401 (north) & 408 (south) (Reference No. 60403650, 2024)			CONTRACT MAINTENANCE AREA (CMA): 504

PEACE REGION (GRANDE PRAIRIE DISTRICT-SOUTH)
GEOHAZARD RISK MANAGEMENT PROGRAM

Site Plan
GP007 - Wanyandie Road Slide
Hwy 40:36, km 29.339

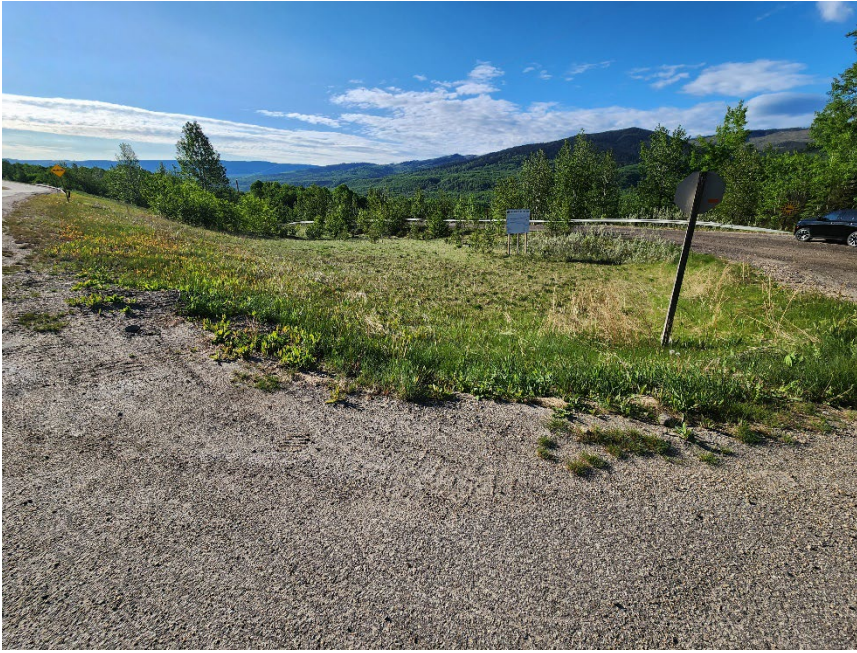
COMMENTS
Slope upslope and downslope of highway is landslide terrain.
Highway crosses deep gully/ravine and bridge-sized culvert (BF80699) at east end of site.
High fills located at western and eastern flanks of slide with lower side-hill fills in middle of slide area.
Cracking observed in pavement surface at west and east ends of site as follows: <ul style="list-style-type: none"> At west end of site (Photo 2): Cracking and settlement (up to approximately 10 m)) across both lanes through recent pavement patch to north shoulder, which was more noticeable than previous inspection.. Some skid marks observed in both lanes. At middle of site (Photo 5): Cracking and settlement (up to approximately 25 mm) in south (eastbound) lane, which was more noticeable than previous inspection. At east end of site (Photos 7 and 9): Cracking and settlement (up to approximately 100 mm) across both lanes through recent pavement patch, which was more noticeable than previous inspection. Some skid marks observed in westbound lane. <ul style="list-style-type: none"> It is noted that a call-out inspection was completed in August 2024 due to increased pavement distress at the east end of the site, including a circular depression or sinkhole along the highway centerline. Ongoing movement at the east end of the site could eventually impact the bridge-size culvert (BF80699). <p>Despite this increased movement observed at pavement surface, indications of increased movement were not observed on the south side of the highway at the time of the 2025 inspection (Photos 1, 6, and 10).</p>

Photo 1 South (downslope) side of Hwy 40:36 near west end of GP007 site. Photo taken June 2, 2025, facing southeast.

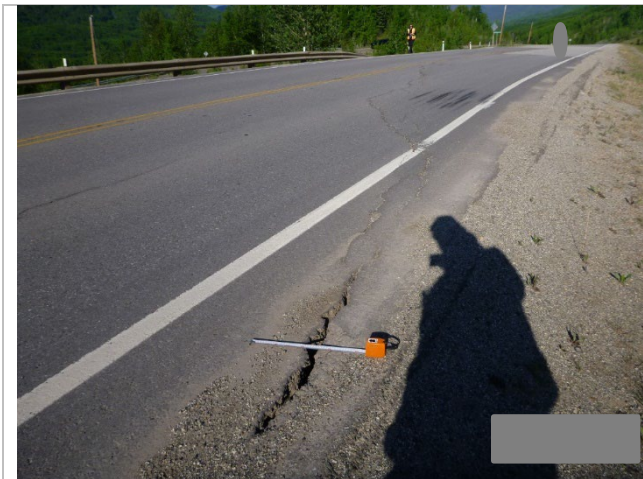
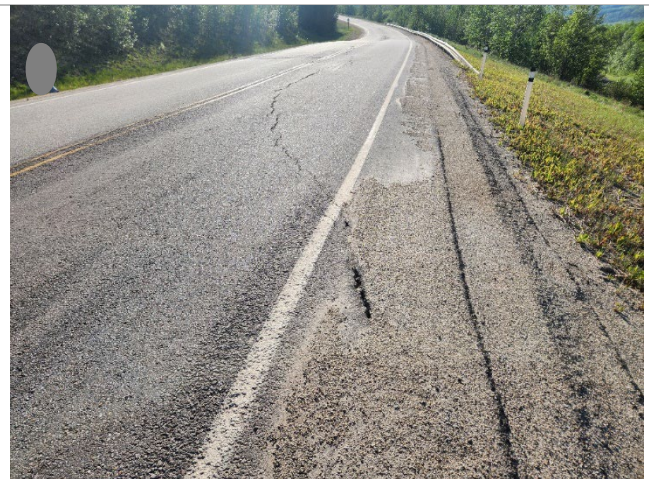
Photo 2 Cracking and settlement across pavement surface of Hwy 40:36 near west end of GP007 site. Photos taken June 2, 2025, facing southwest and east, respectively.

- Pavement surface should be patched again.
- Remove rock from culvert at west end of site (Photo 4).
- Guardrail on the south side of the highway at the east end of the site is low (approximately 0.5 m above pavement surface) and located too far from the highway (approximately 0.6 m from edge of pavement) and may not redirect motorist back onto the highway (Photo 8). There is also an approximate 0.9 m drop below the guardrail that could trap a tire and some guardrail rail posts that are unsupported. Guardrail should be moved closer to pavement surface. Estimated cost: \$20,000 to \$40,000 depending on the length.

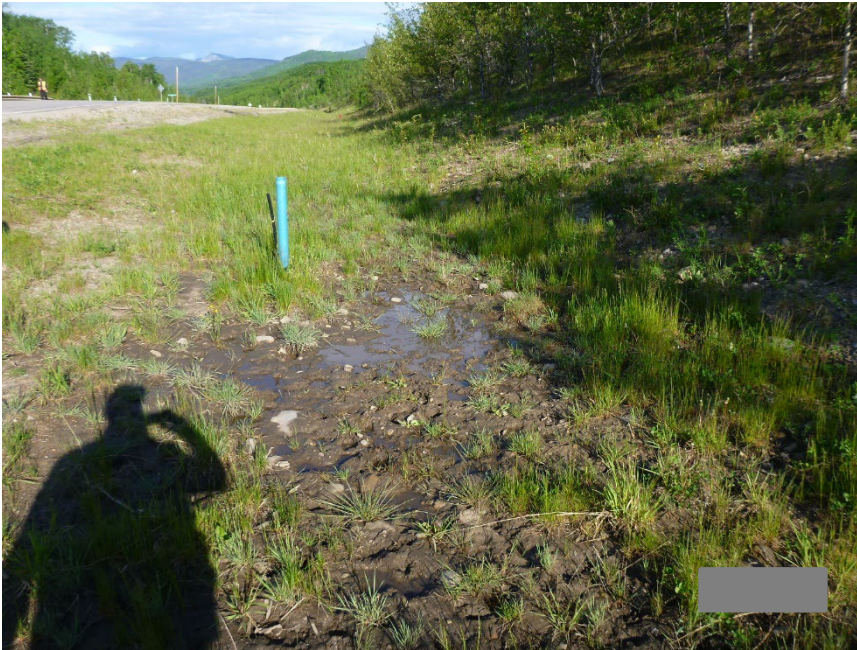
Photo 3 Ditch on north (upslope) side of Hwy 40:36. Note vegetation becoming established in ditch and ponded water in ditch. Photo taken June 2, 2025, facing west.

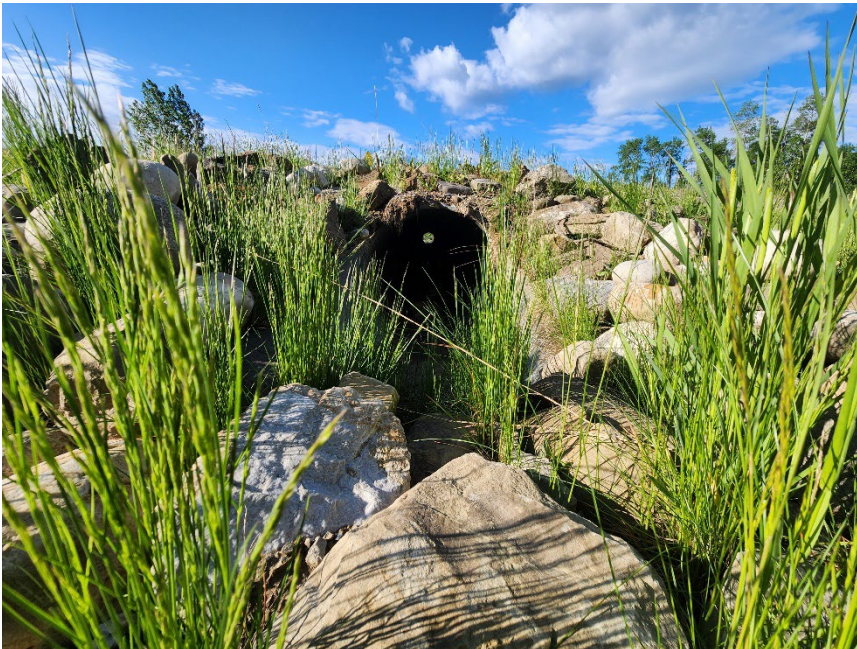
Photo 4 Inlet of culvert at west end of GP007 site. Photo taken June 2, 2025, facing south.

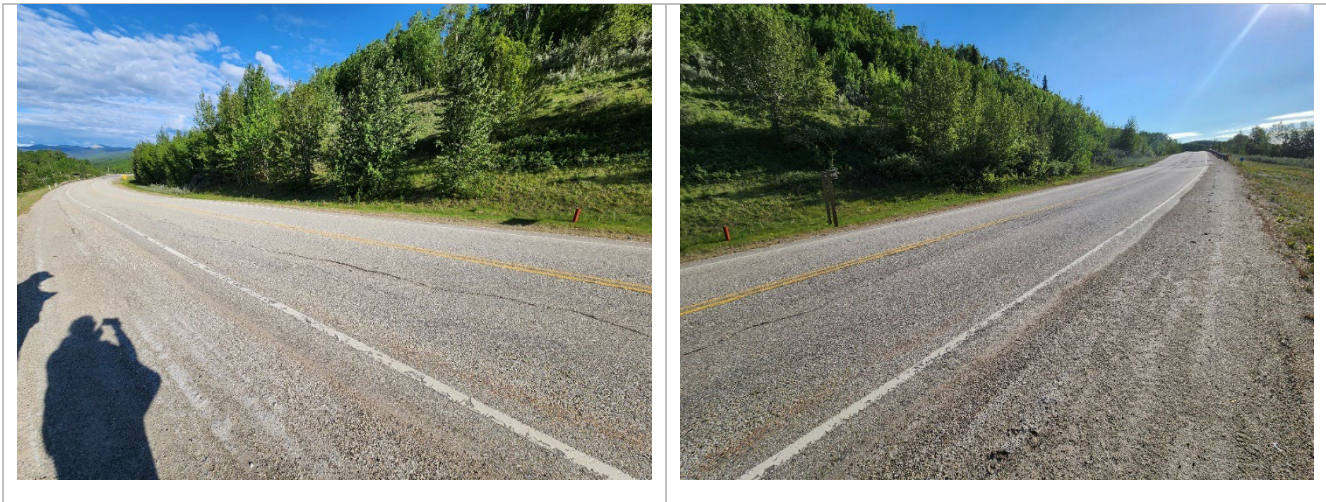
Photo 5 **Cracking and settlement across pavement surface of Hwy 40:36 near middle of GP007 site. Photo taken June 2, 2025, facing northwest and northeast, respectively.**

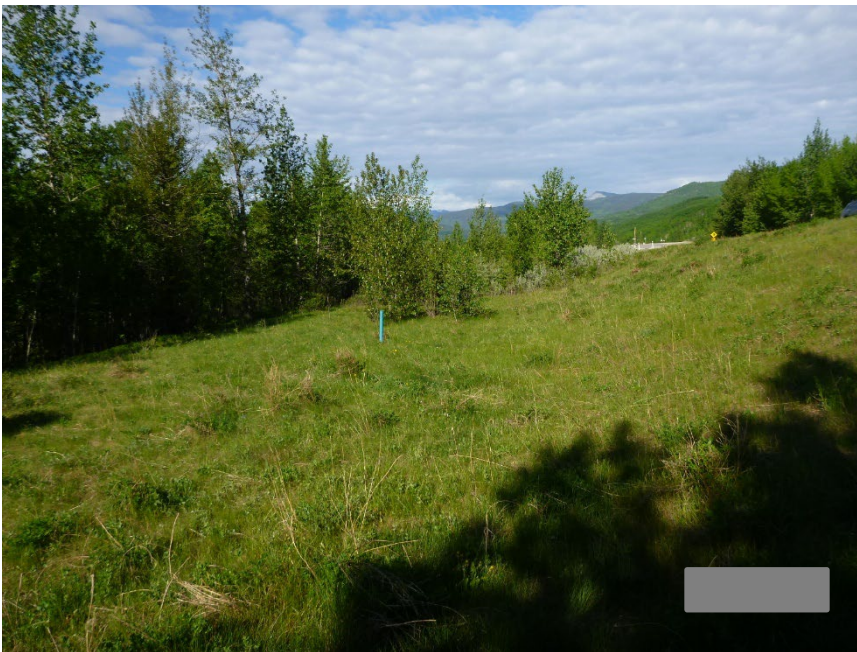
Photo 6 **South (downslope) side of Hwy 40:36 near middle of GP007 site. Photo taken June 2, 2025, facing east.**

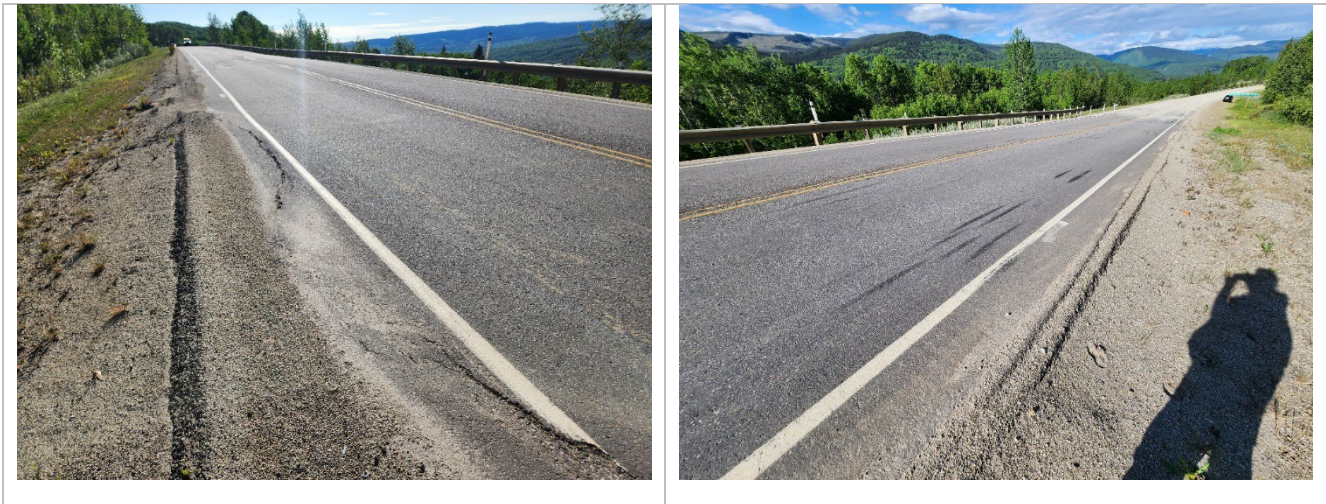
Photo 7 Cracking and settlement across pavement surface of Hwy 40:36 near east end of GP007 site. Photo taken June 2, 2025, facing southeast and southwest, respectively.

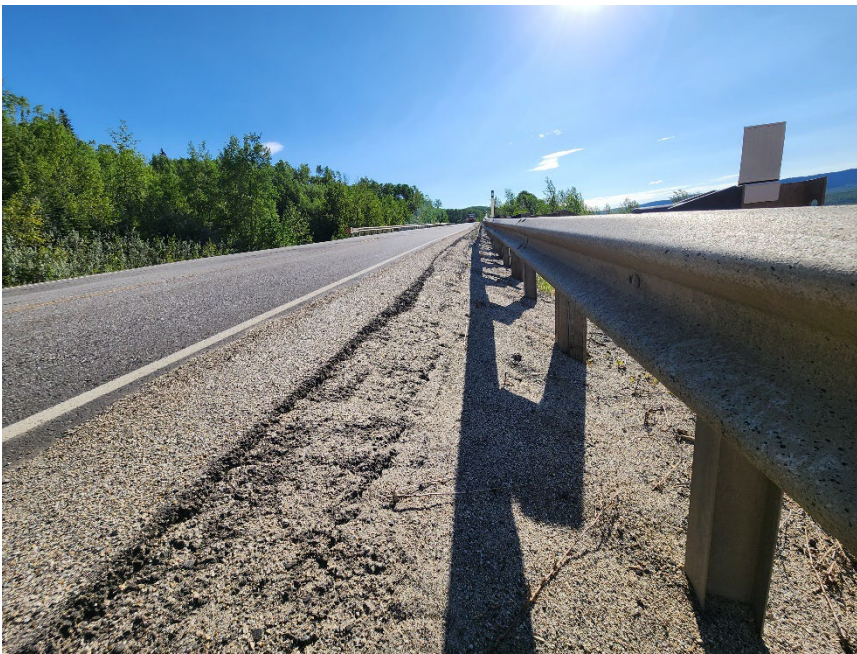
Photo 8 Guardrail on south side of Hwy 40:36 at east end of GP007 site is low and located far from highway. Photo taken June 2, 2025, facing east.

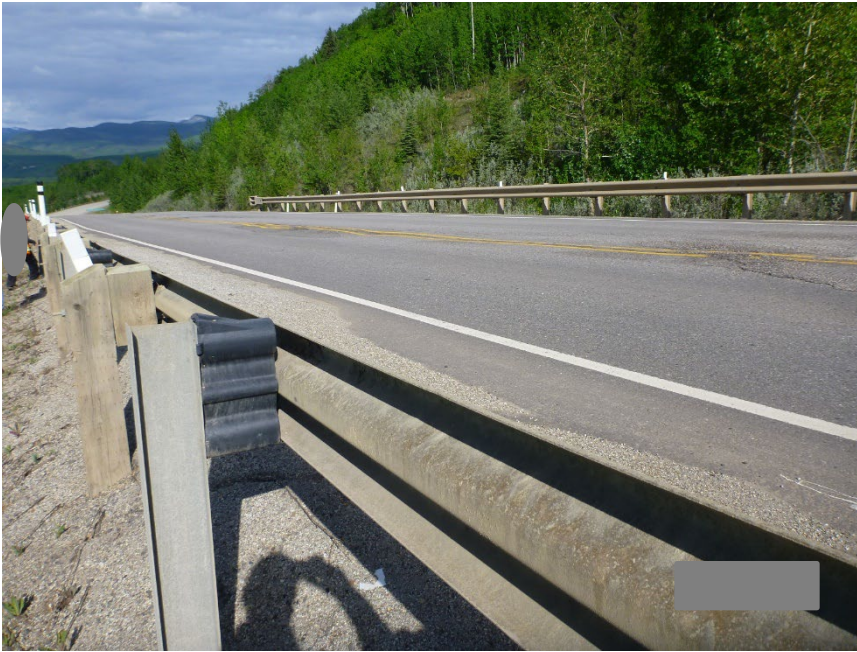
Photo 9 **Undulating pavement surface of Hwy 40:36. Photo taken June 2, 2025, facing northwest.**

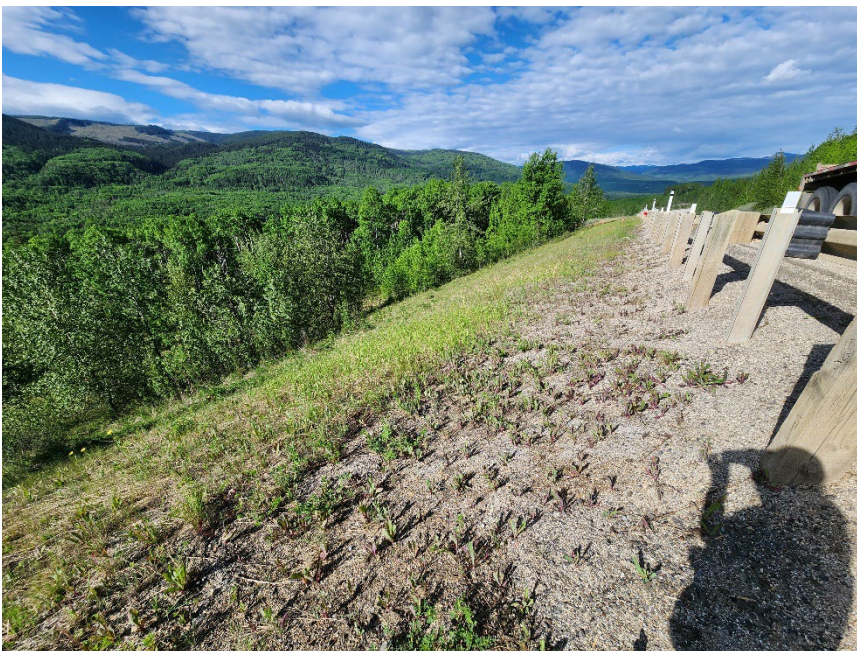
Photo 10 **South (downslope) side of Hwy 40:36 near middle of GP007 site. Photo taken June 2, 2025, facing west.**
