CON0022166 Peace Region (Grande Prairie District – South) GRMP Instrumentation Monitoring Site GP007; H40:36, km 29.339 Wanyandie Road Slide Section C – 2025 Spring Readings

2025 GP007 Spring Report
A05116A01

PEACE REGION (GRANDE PRAIRIE DISTRICT-SOUTH)
GEOHAZARD RISK MANAGEMENT PROGRAM

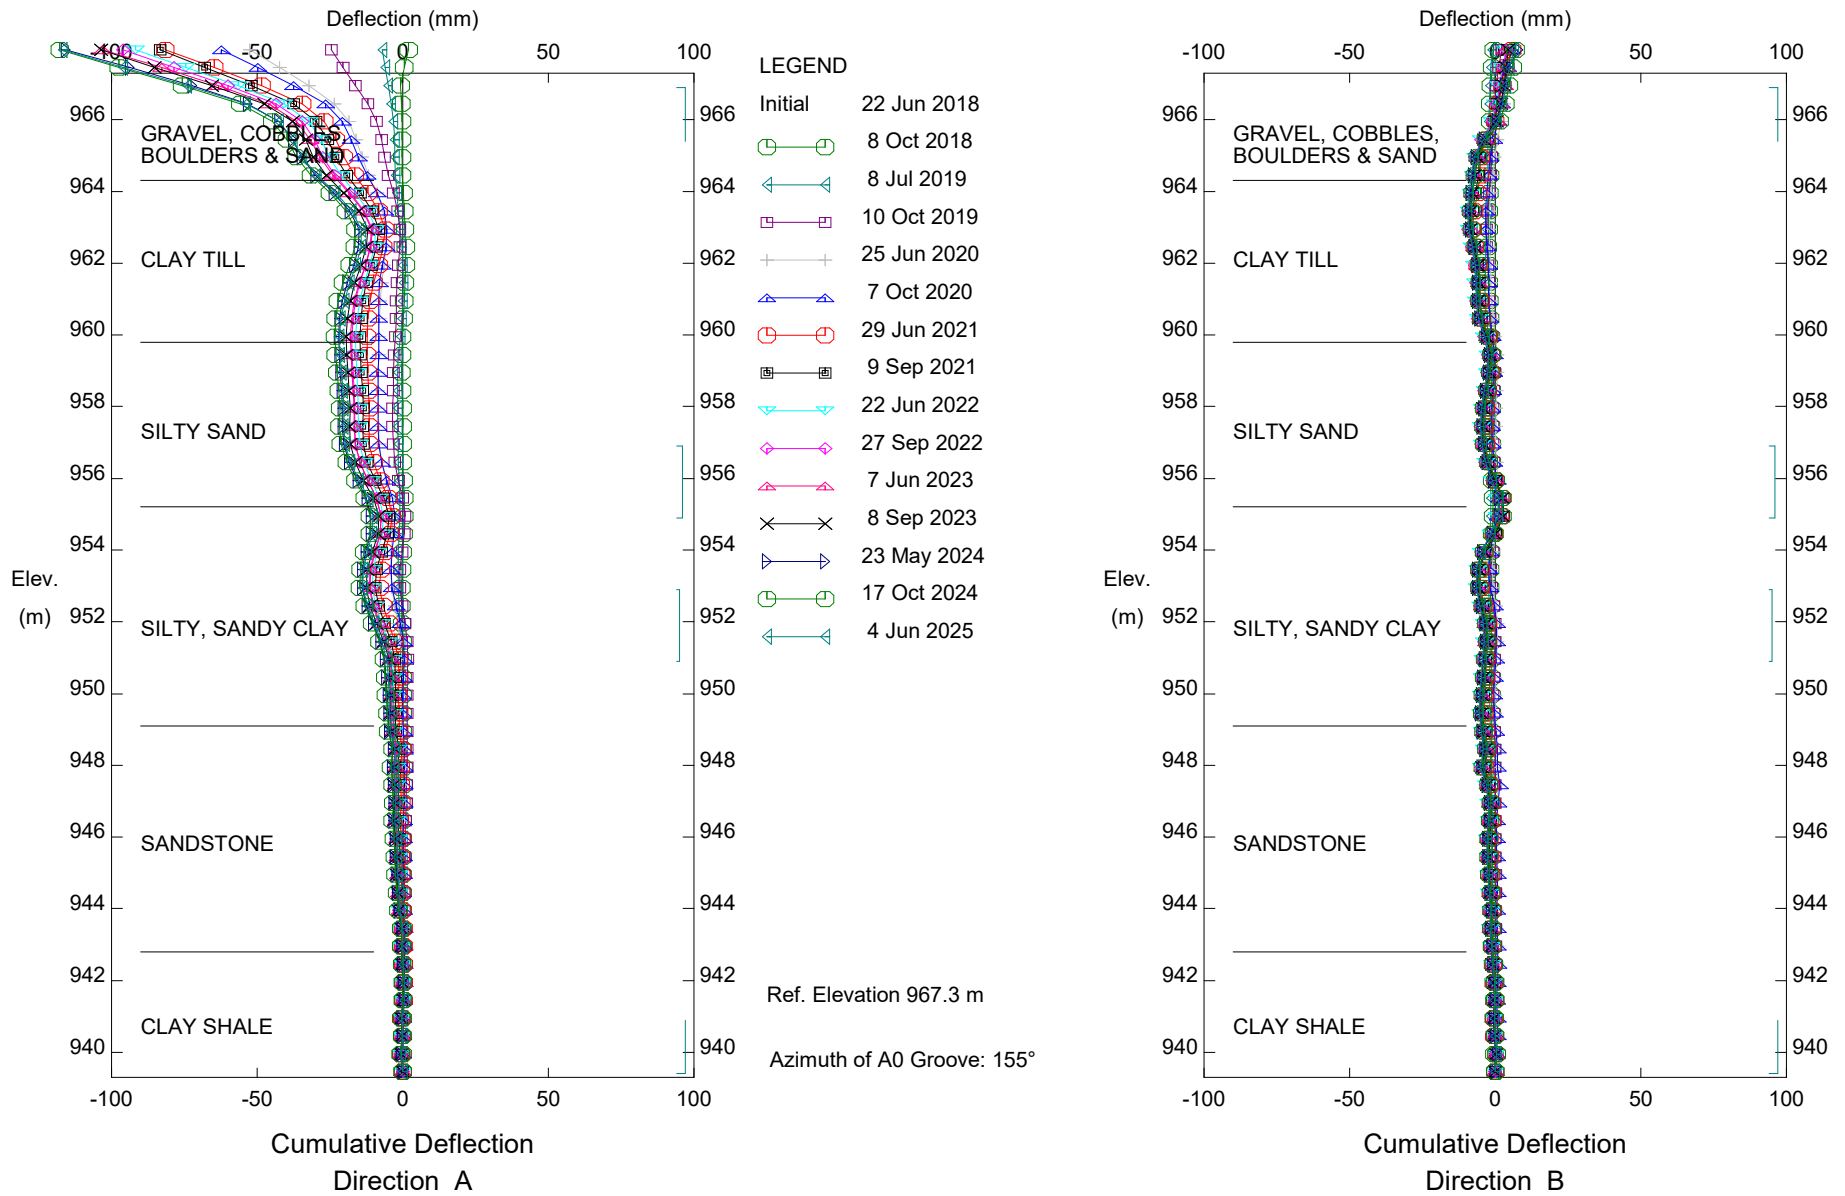
GP007; H40:36, Wanyandie Road Slide, Inclinometer SI98-06

It is noted that the data for SI98-6, SI98-7, and SI03-12 is noisy and difficult to interpret. Based on the absolute plots for these instruments, SI98-6 has kinks in the casing at an approximate depth of 11.9 m and 13.9 m below ground surface (mbgs), and SI98-7 and SI03-12 are tilted approximately 1.3 m and 1.5 m in the A direction, respectively. SI98-12 has also been re-sleeved twice (i.e., had a small-diameter casing installed in it) (dates unknown)

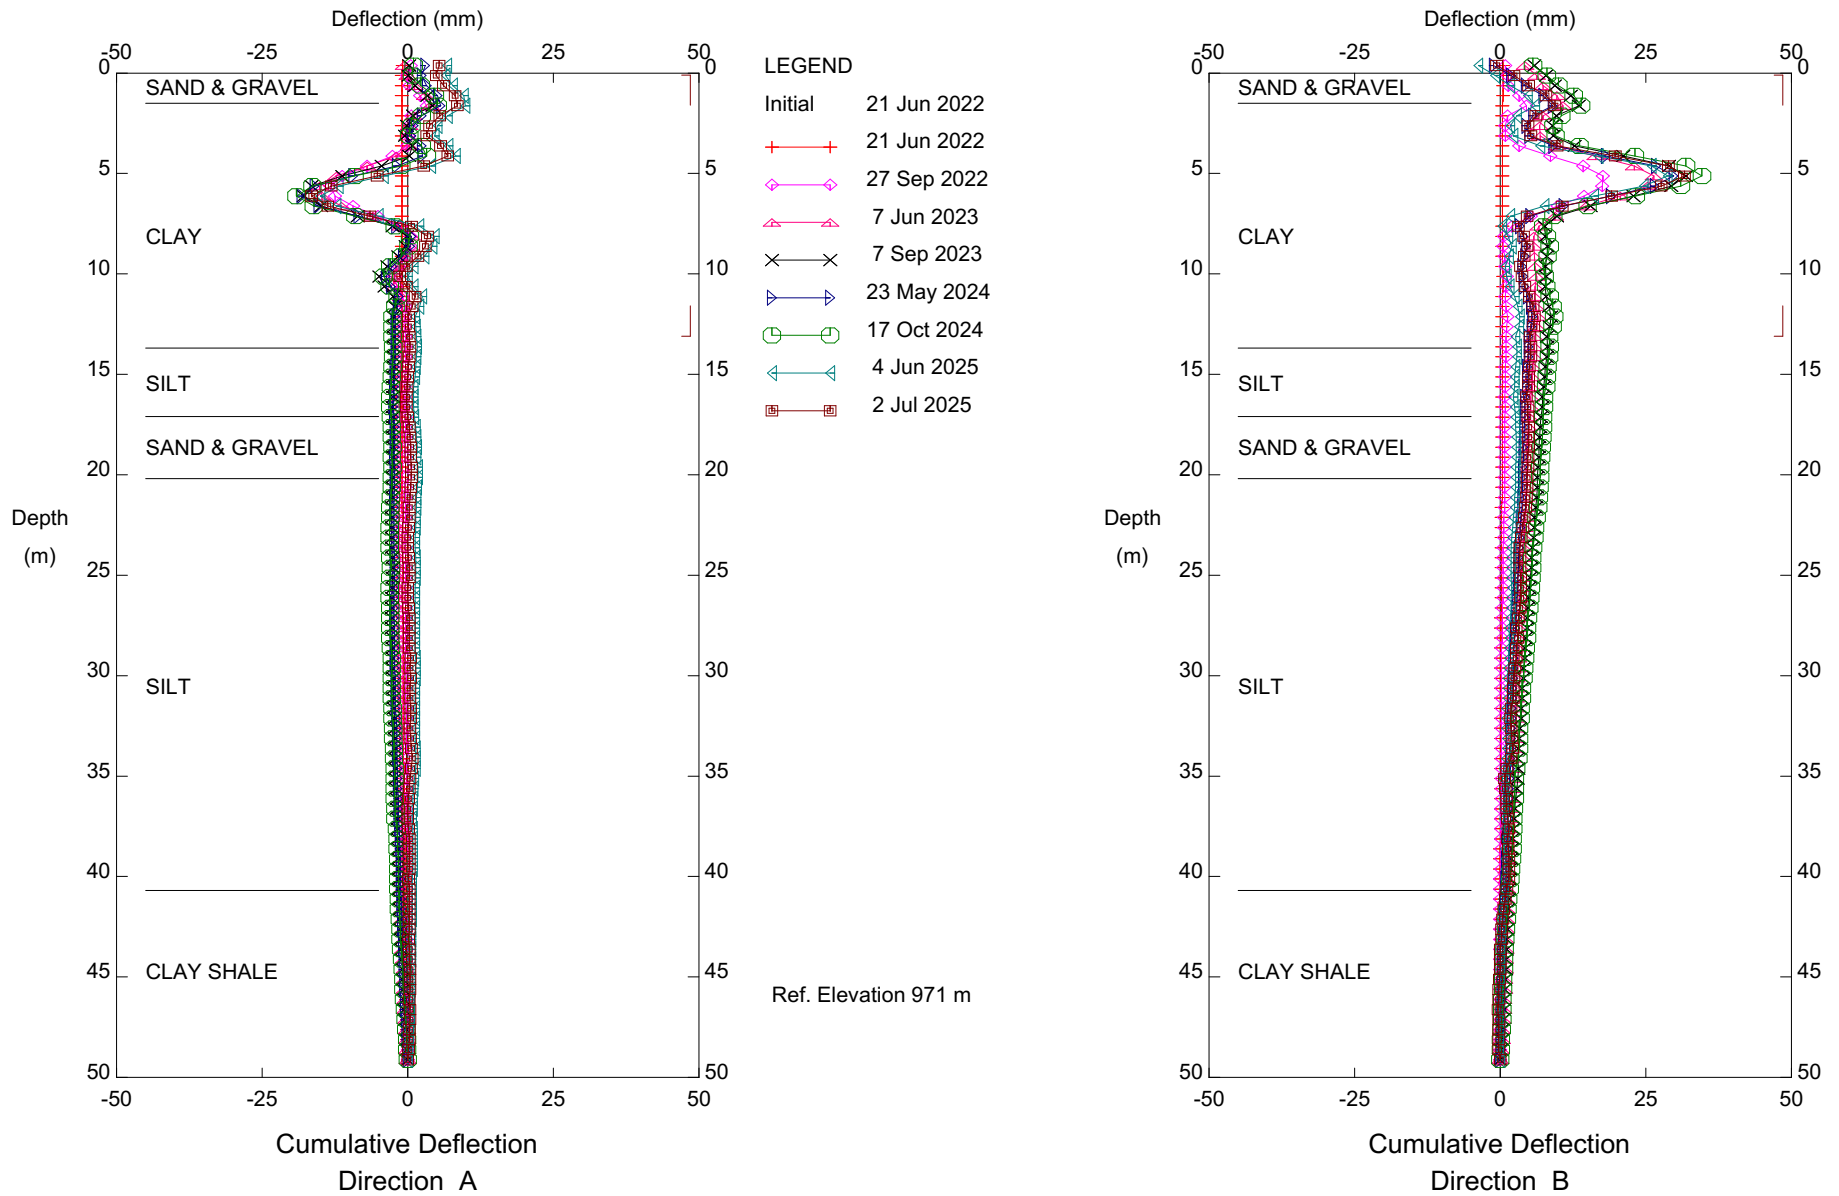
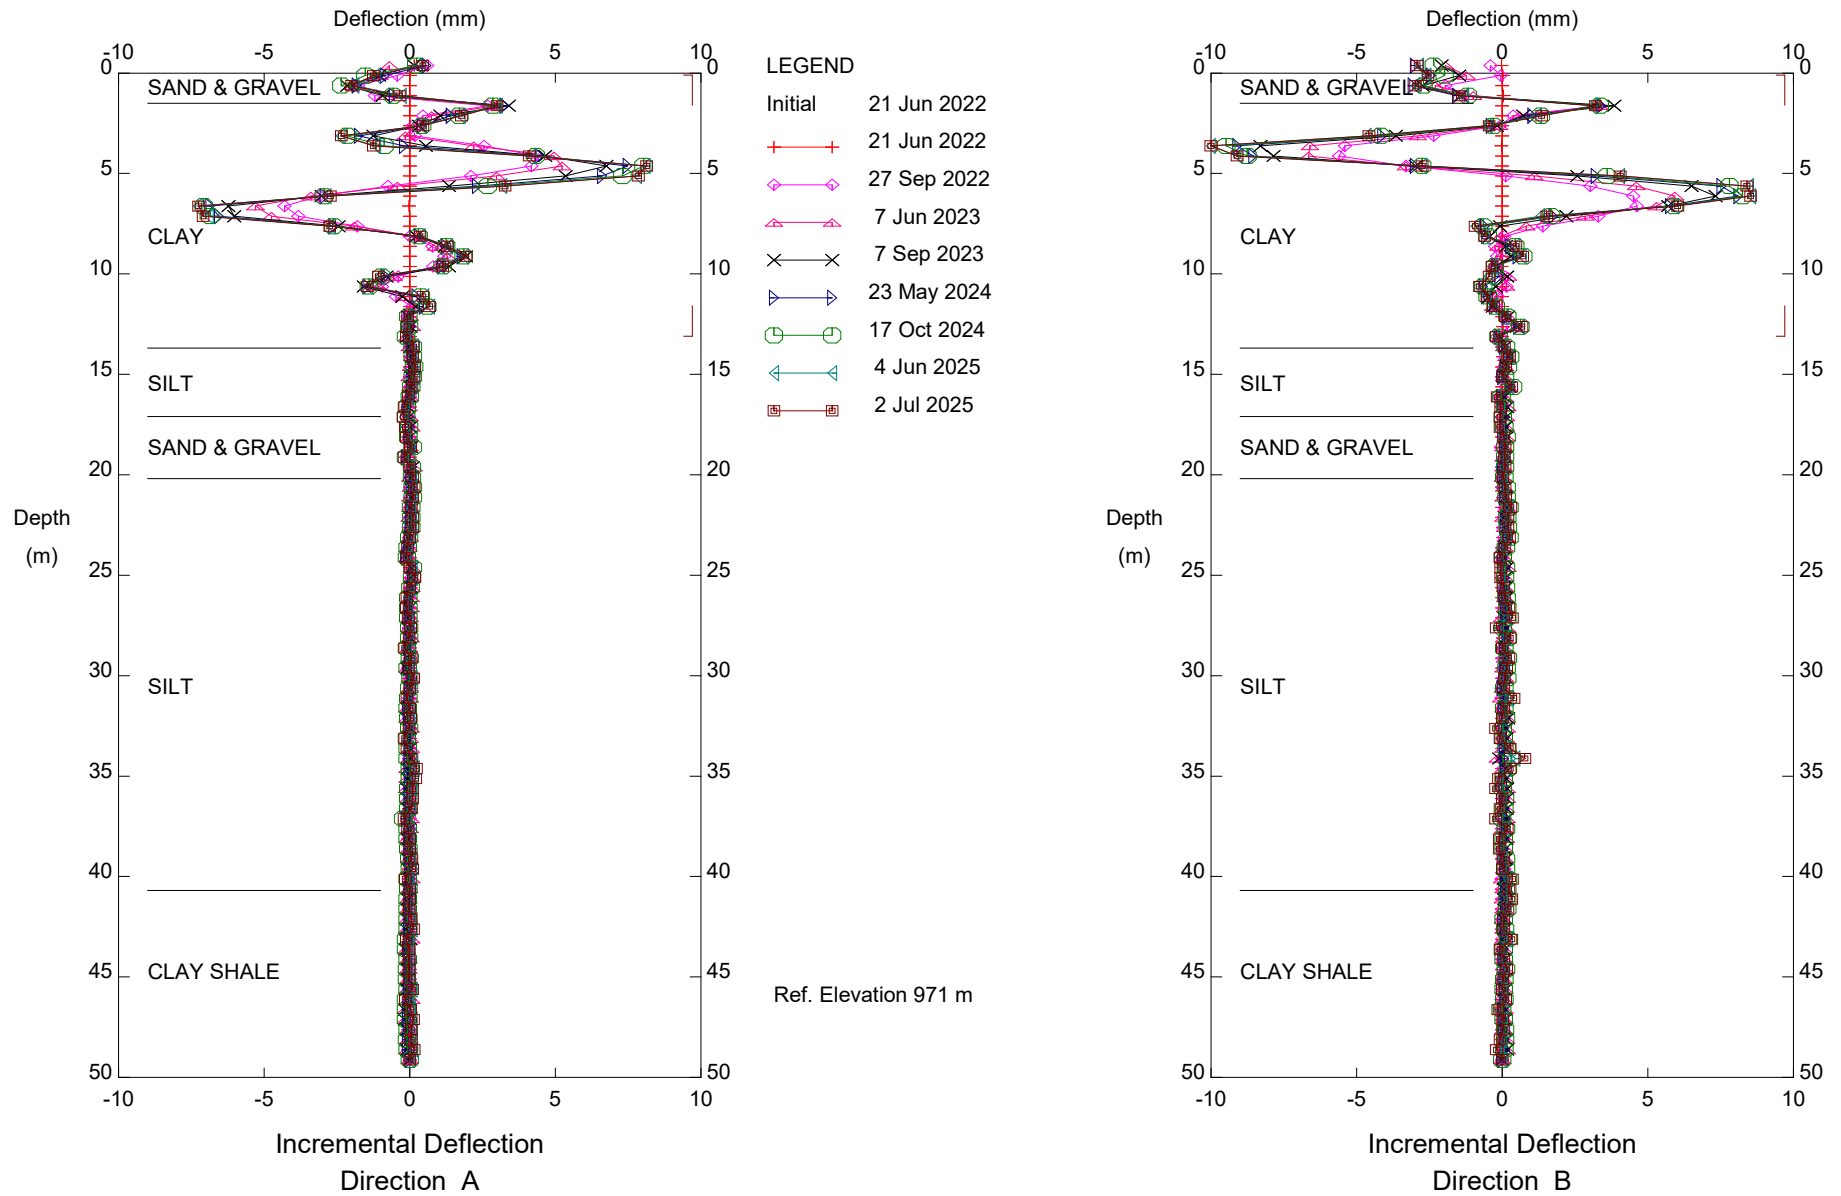
GP007; H40:36, Wanyandie Road Slide, Inclinometer SI22-03

As discussed in Section 1.1, SI98-6, SI03-11, and SI03-12 may not have been installed deep enough. In May 2022, two deeper SIs (SI22-2 and SI22-3) were installed in the north highway ditch to assess if deeper movements are occurring near the middle of the site. Distributed movement has been recorded in SI22-2 from an approximate depth of 6.6 mbgs to 10.6 mbgs (elevation 959.4 m to 955.4 m), which is confined to the colluvium/till unit, and post-installation casing settlement/flexure has been recorded in SI22-3 to an approximate depth of 12 mbgs, which may be caused by grout loss in a more granular zone in the colluvium unit. It is noted that data recorded in SI22-3 is fluctuating with negative displacement sometimes being recorded.

Overall, the data recorded in SI-6 and SI22-3 does not reflect the increased pavement distress (cracking and settlement) observed near the middle of the site and these instruments in fall 2024 or spring 2025.

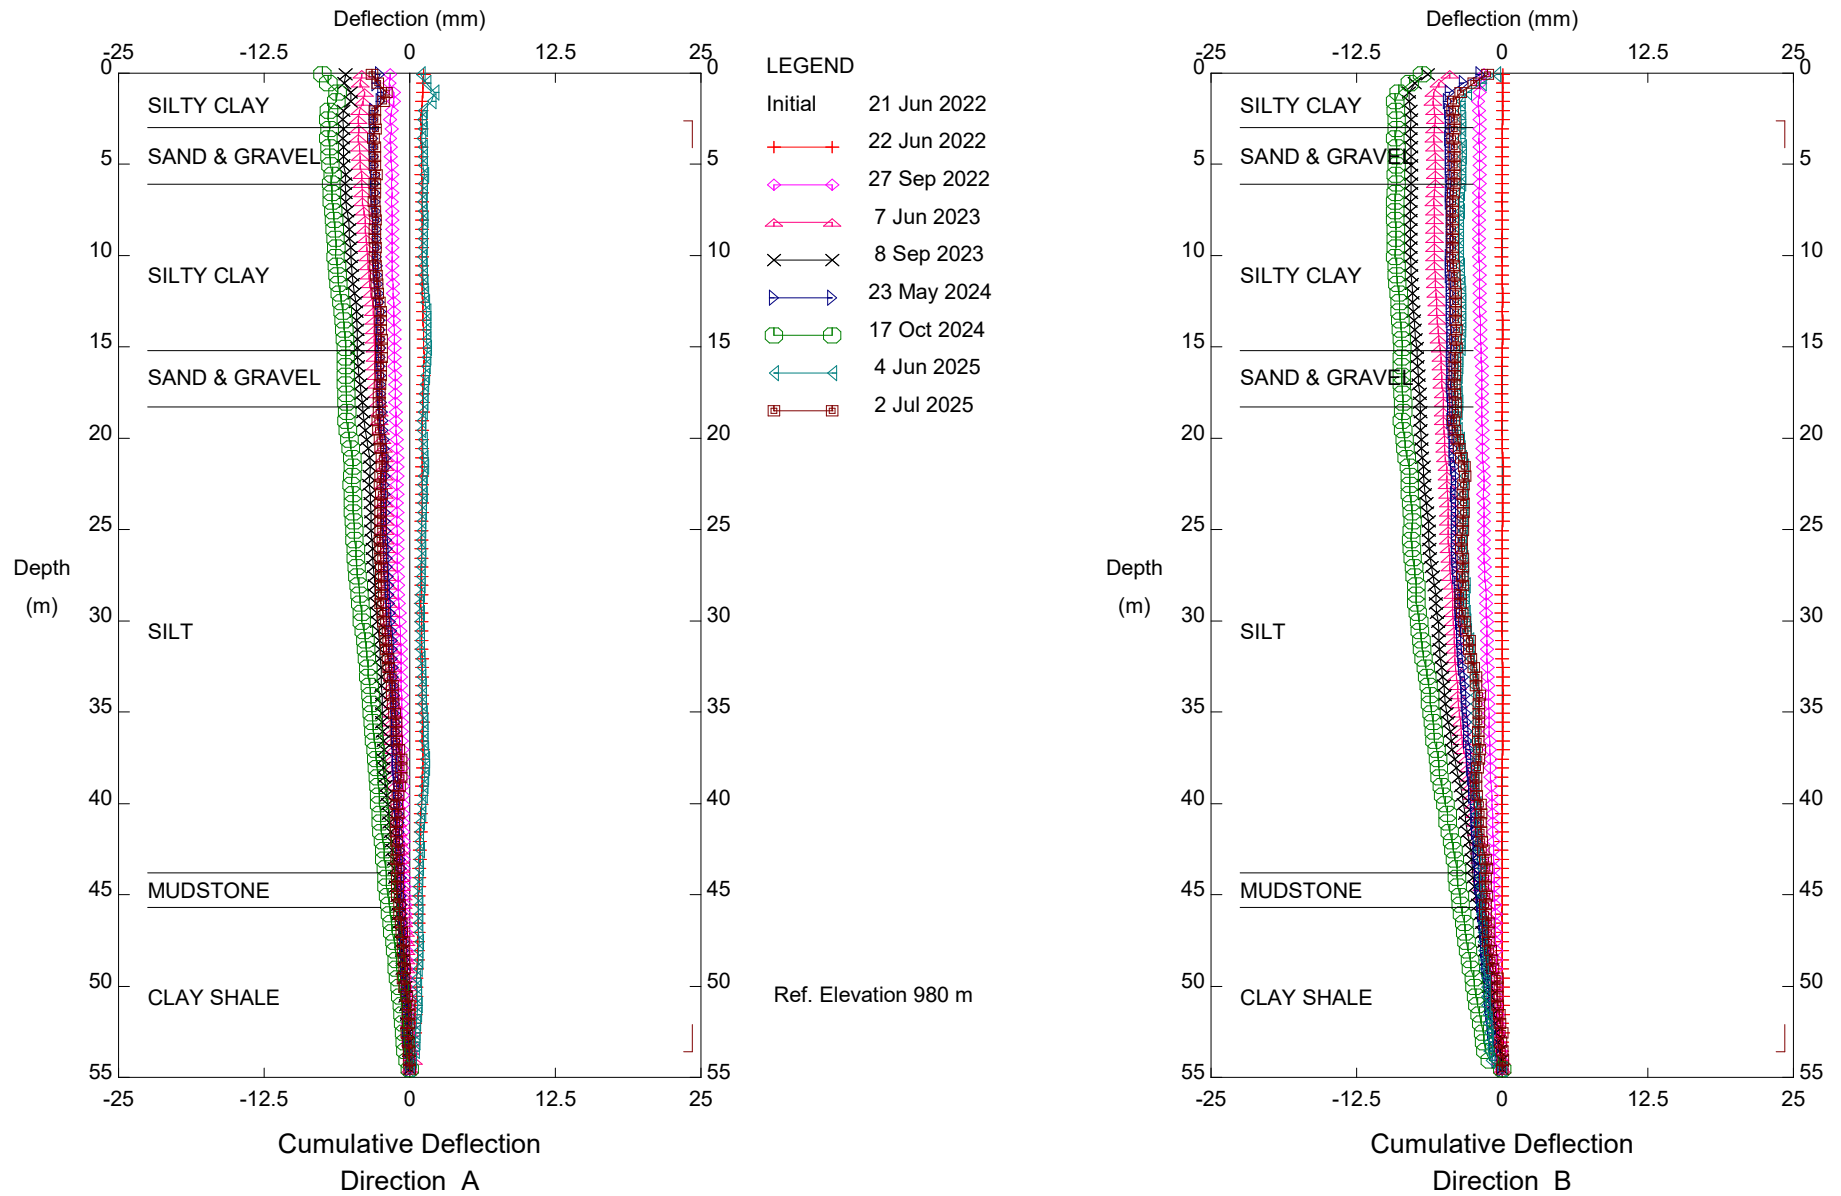
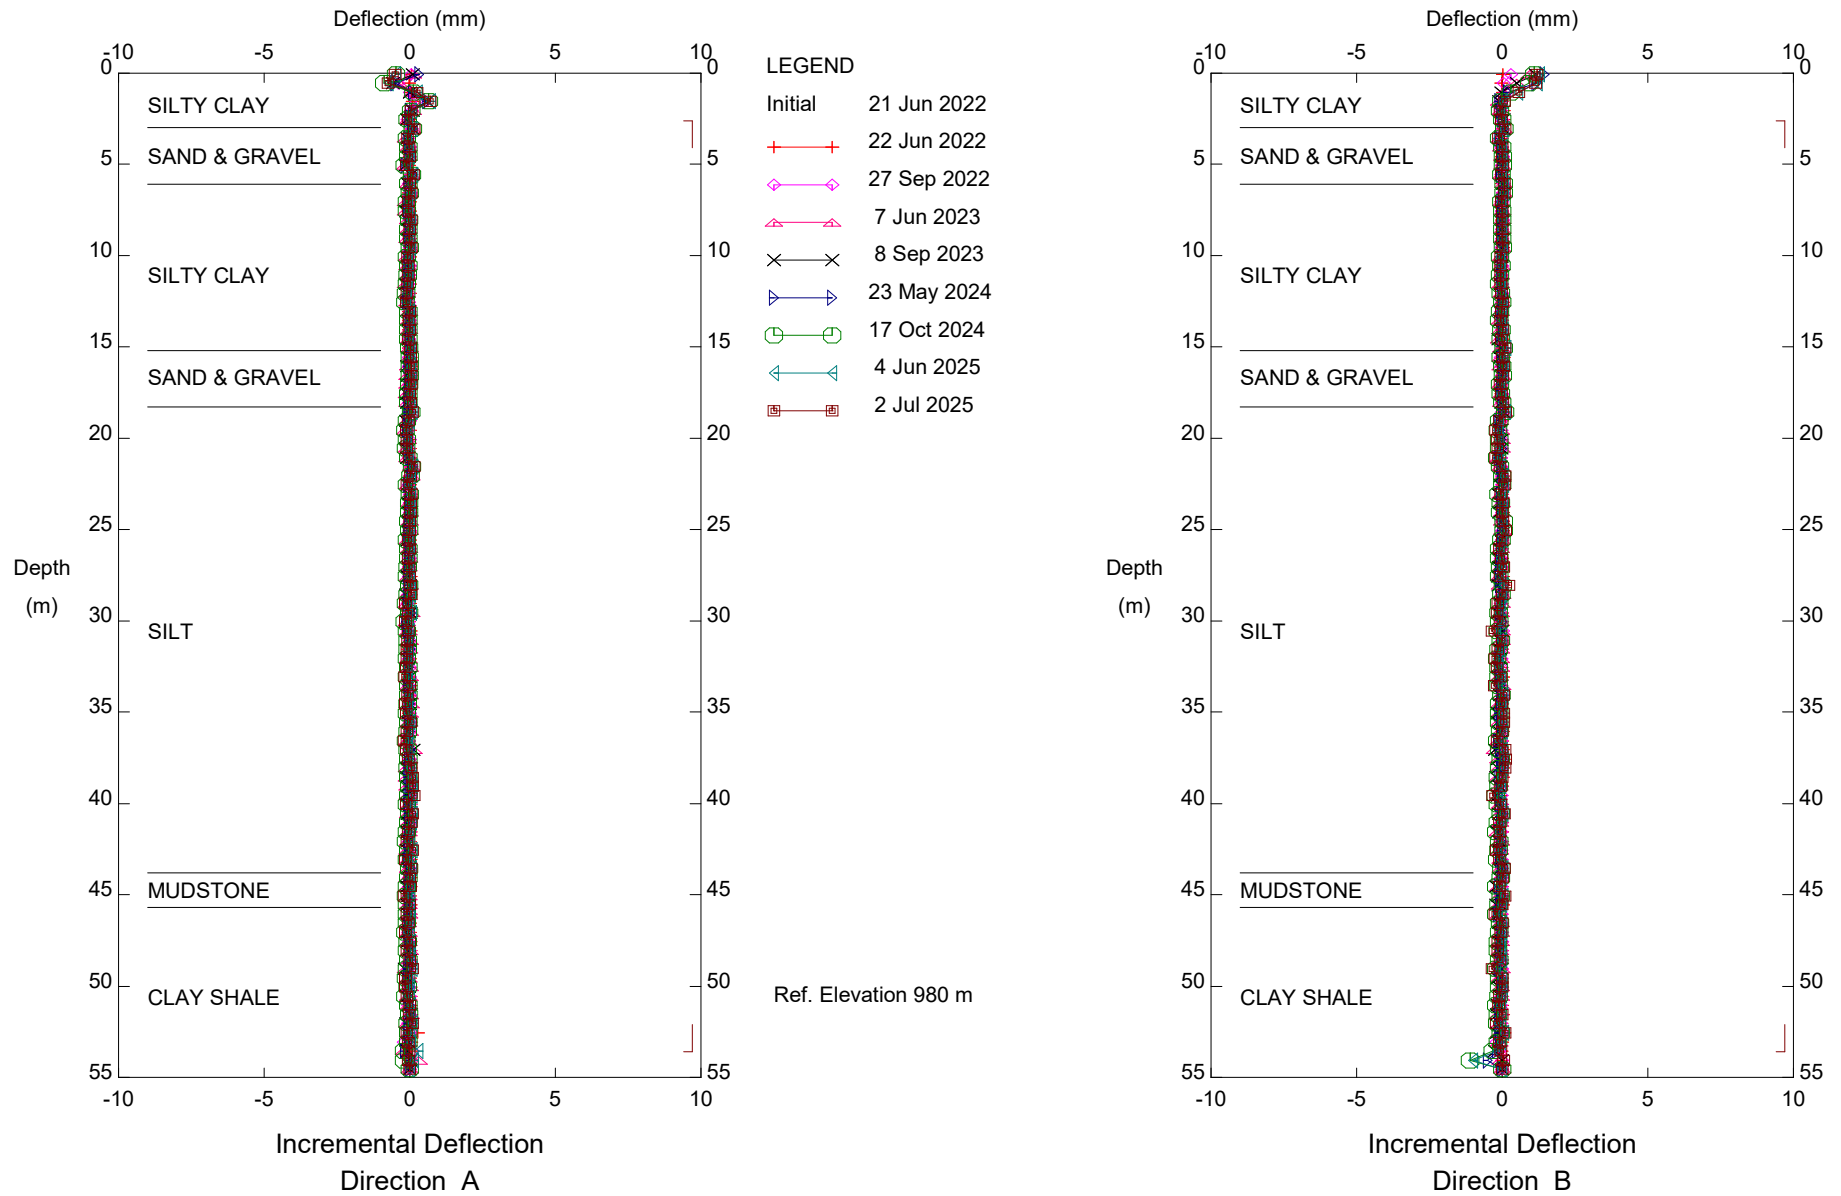
GP007; H40:36, Wanyandie Road Slide, Inclinator SI22-04

In May 2022, a deeper SI (SI22-4) was installed on the north side of the highway to assess if deeper movements are occurring at the east end of the site. Distributed movement is being recorded along the entire length of the instrument (i.e., from near ground surface to the base of the instrument) since installation, with no discrete movement zones. It is noted that data recorded in SI22-4 is fluctuating with negative displacement sometimes being recorded.

Overall, the data recorded in SI22-4 does not reflect the increased pavement distress (cracking and settlement) observed near the east end of the site and this instrument in fall 2024 or spring 2025.
