SITE NUMBER AND NAME: GP008a Road Surface Slumping (N. of McIntyre Mine)		HIGHWAY & KM: 40:36, 16.070	PREVIOUS INSPECTION DATE: May 25, 2020	INSPECTION DATE: July 21, 2021
LEGAL DESCRIPTION: SE 15-58-08-W6M	NAD 83 COORDINATES: UTM Northing Easting 11 5986931 362757		RISK ASSESSMENT: Middle Slide PF: 8 CF: 4 TOTAL: 32 North Slide PF: 9 CF: 5 TOTAL: 45 Rockfall PF: 11 CF: 4 TOTAL: 44	
AVERAGE ANNUAL DAILY TRAFFIC (AADT): 900 (north) & 900 (south) (Reference No. 70000788)			CONTRACT MAINTENANCE AREA (CMA): 504

PRIMARY SITE ISSUE: 3 slope failures in a possible mine-waste fill below the highway: South Slide cuts diagonally across the highway; Middle Slide confined to east bound driving lane and shoulder. The North Slide encompasses both lanes. Rockfall hazards located at north and south end of site.
APPROXIMATE DIMENSIONS: South Slide approximately 60 m wide across highway, approximately 90 m long (south slide was being paved at time of inspection and measurements could not be verified). Middle Slide is approximately 15 m wide and North Slide approximately 140 m crossing both lanes. The fill appears to be approximately 30 m high and could be an old mine waste fill that predated highwa

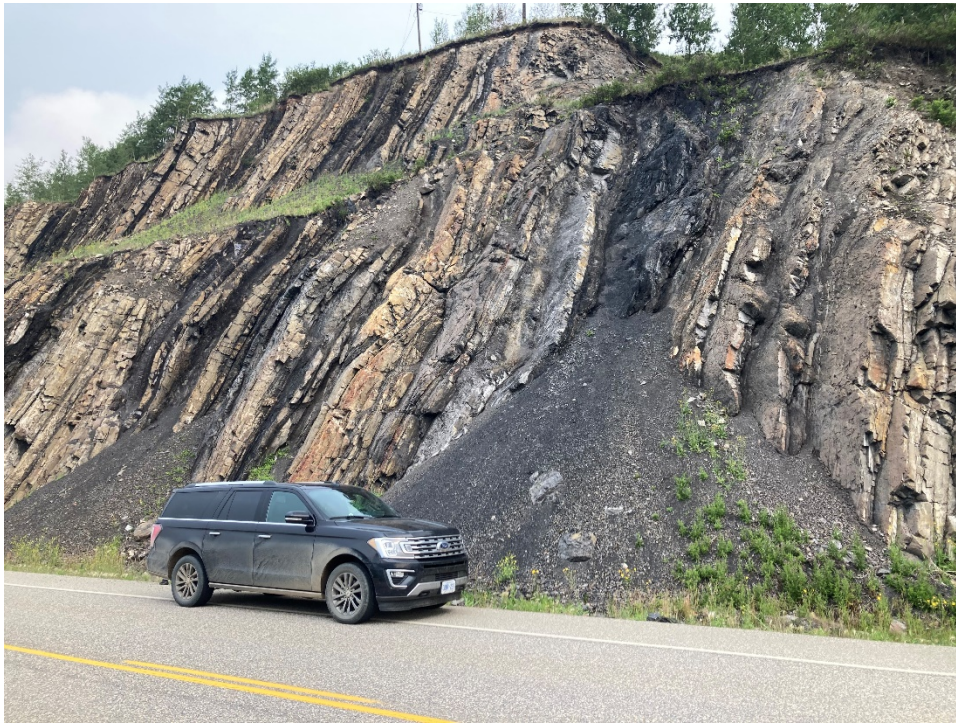
- The brow of the rock slope has minimal to no overburden and the bedrock appears to be good quality rock. There is a mid-slope bench that has a talus slope/cone, which could potentially launch rocks out onto road

Photo 1 Talus cones along the rock slope east of the slide site. Note power poles above slope. Photo taken July 21, 2021 facing north.

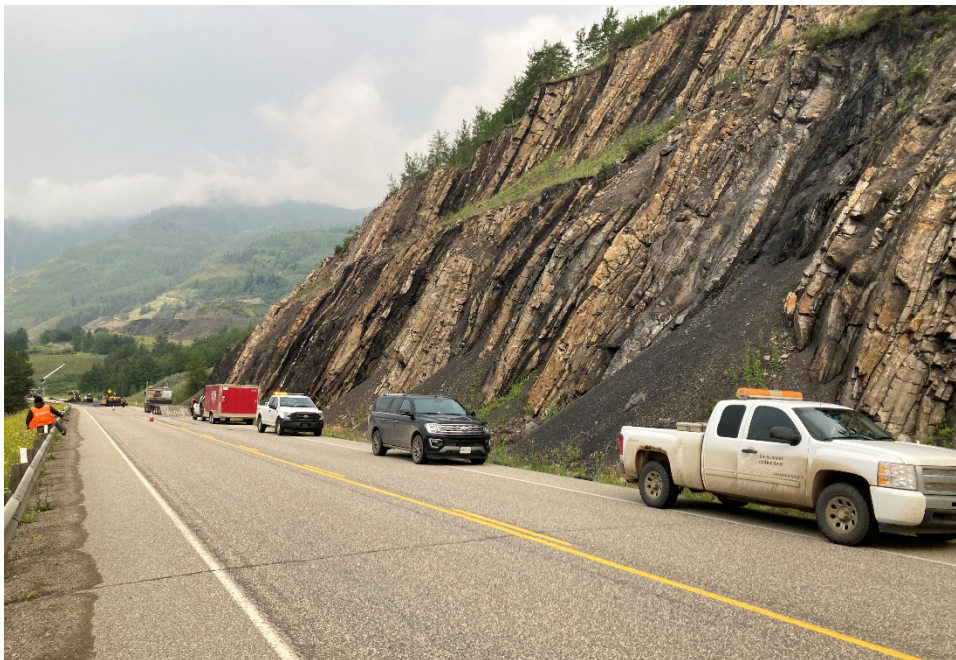
Photo 2 Talus cones along the rock slope. Photo taken July 21, 2021 facing northwest.

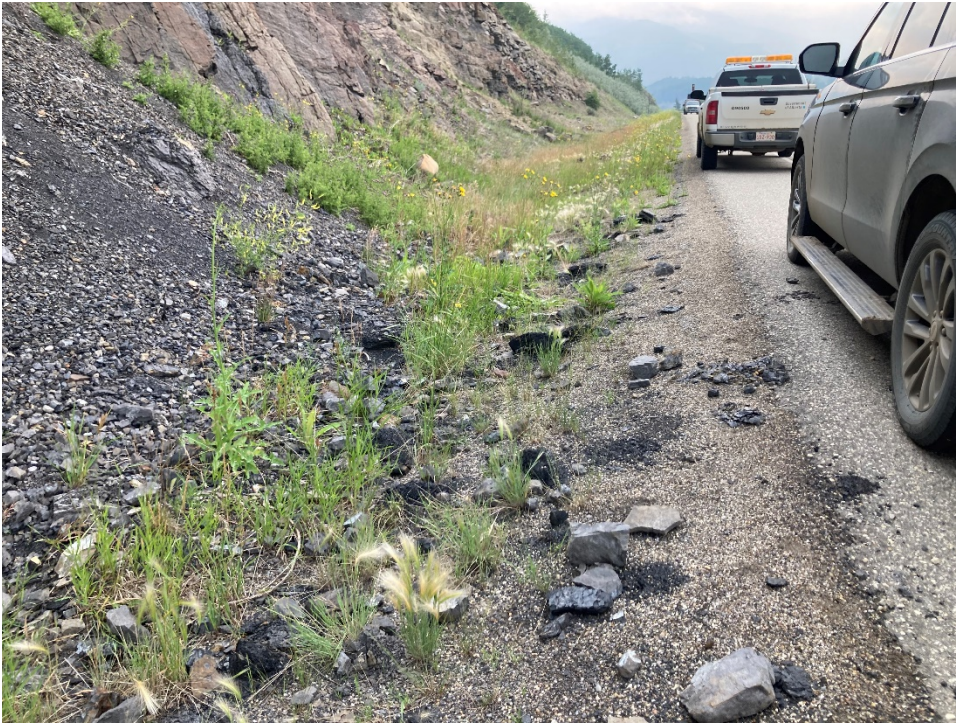
- Fragments from a fallen boulder in the ditch within 0.3 m of edge of pavement. The original particle looks like it was 0.3 x 0.3 x 0.3 m. AT says that some particles make it to the road and some are large enough to require a front-end loader to remove

Photo 3 Rock fall particles accumulating in the north (westbound) ditch at the base of the slope. Photo taken July 21, 2021 facing northeast.

- Ditch hasn't been cleaned in a while (about 8 years). Ditch should be cleaned to keep ditch as wide and as deep as possible so that rockfall particles are retained within the ditch. AT reported that there are no utilities below the ditch at this site

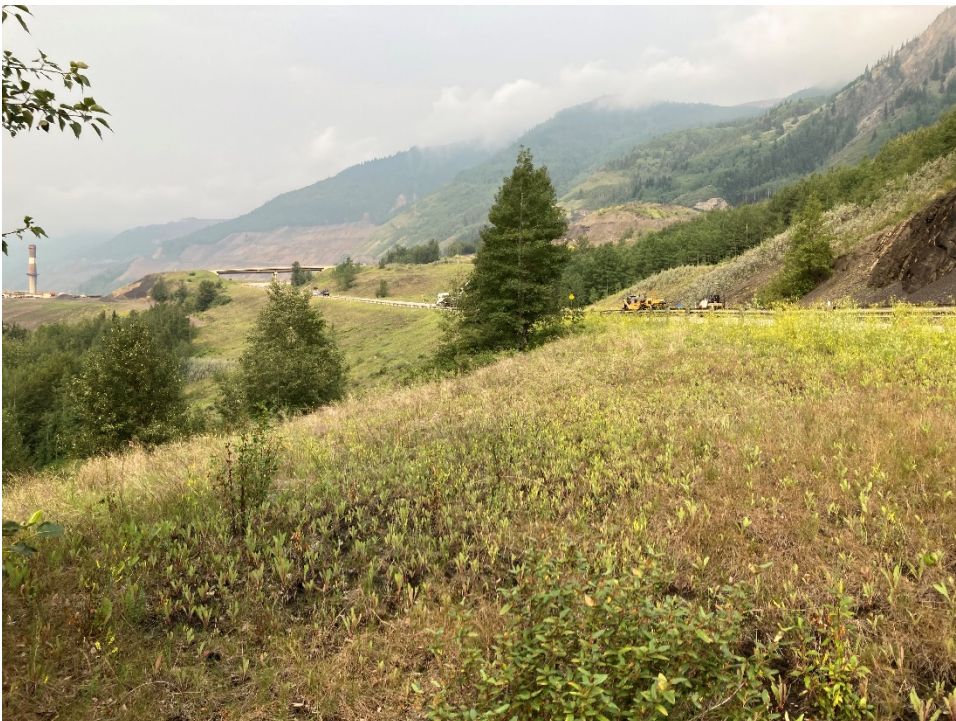
Photo 4 The South Slide site viewed from the slope below the Middle Side site. Photo taken July 21, 2021 facing west.

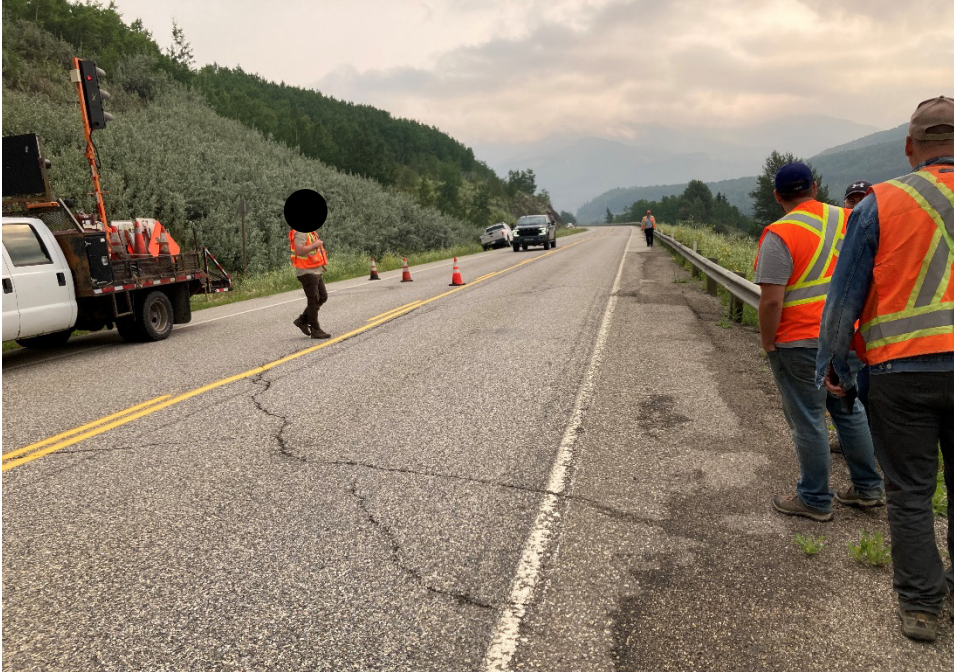
- North Slide pavement cracking does not appear to have changed since last inspection (based on AT recollections and previous photos). A possible toe roll/bulge was observed at WP 108 that could also have been poor grading.

Photo 5 Asphalt cracking at the North Slide approximately 100 m east of the debris flow site, extending from the edge of the asphalt to the centreline in the eastbound (south) lane. Photo taken July 21, 2021 facing northeast.

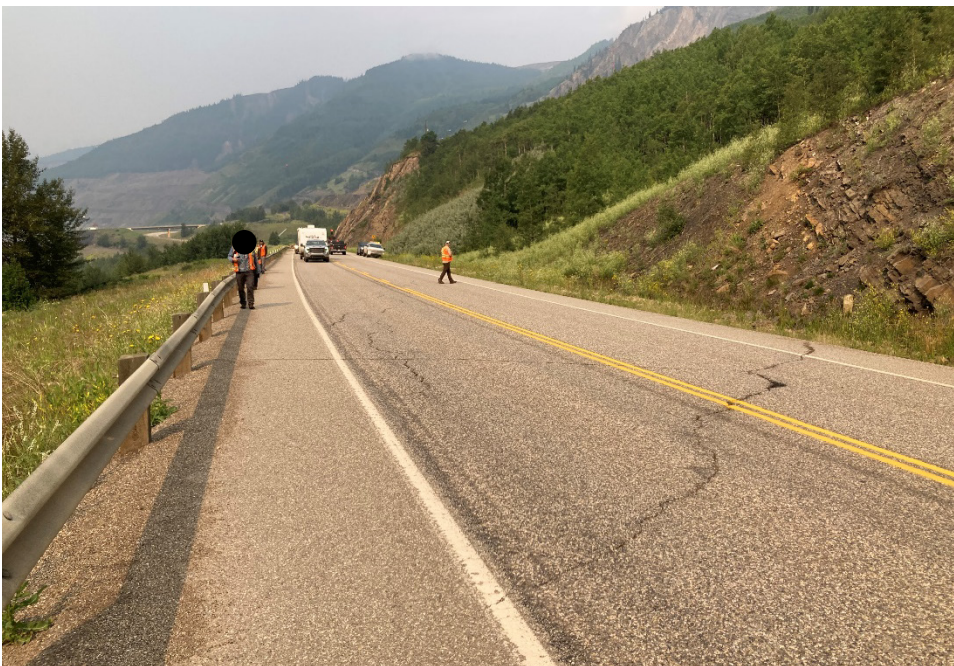
Photo 6 Asphalt cracking at the North Slide site approximately 150 m east of the debris flow site, extending from the edge of the eastbound lane to the edge of the westbound lane. Photo taken July 21, 2021 facing west.

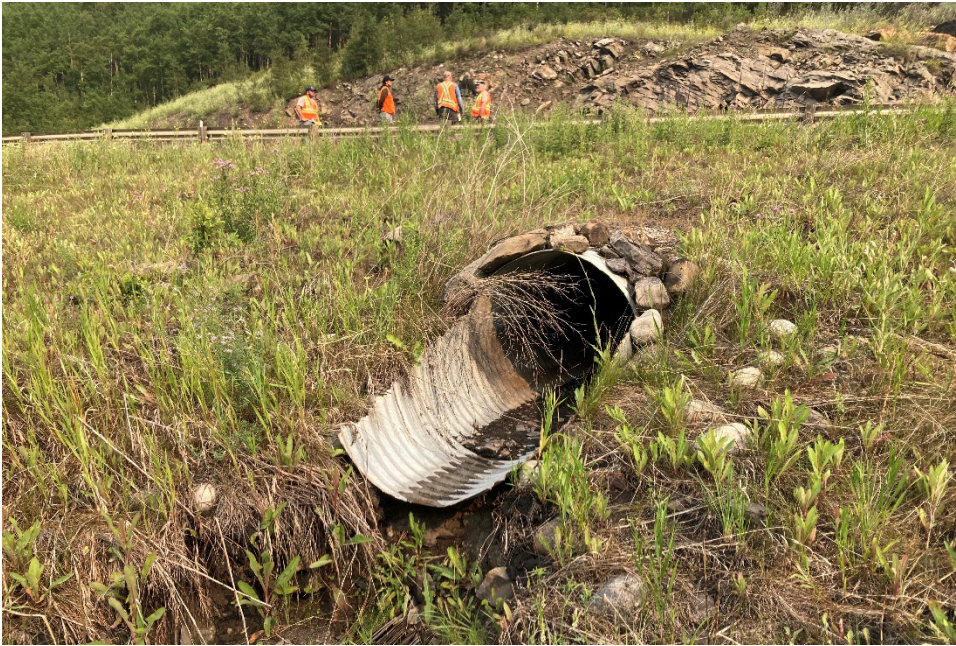
Photo 7 **Outlet of the 900 mm diameter CSP culvert underlying Hwy 40. Photo taken July 21, 2021 facing north.**

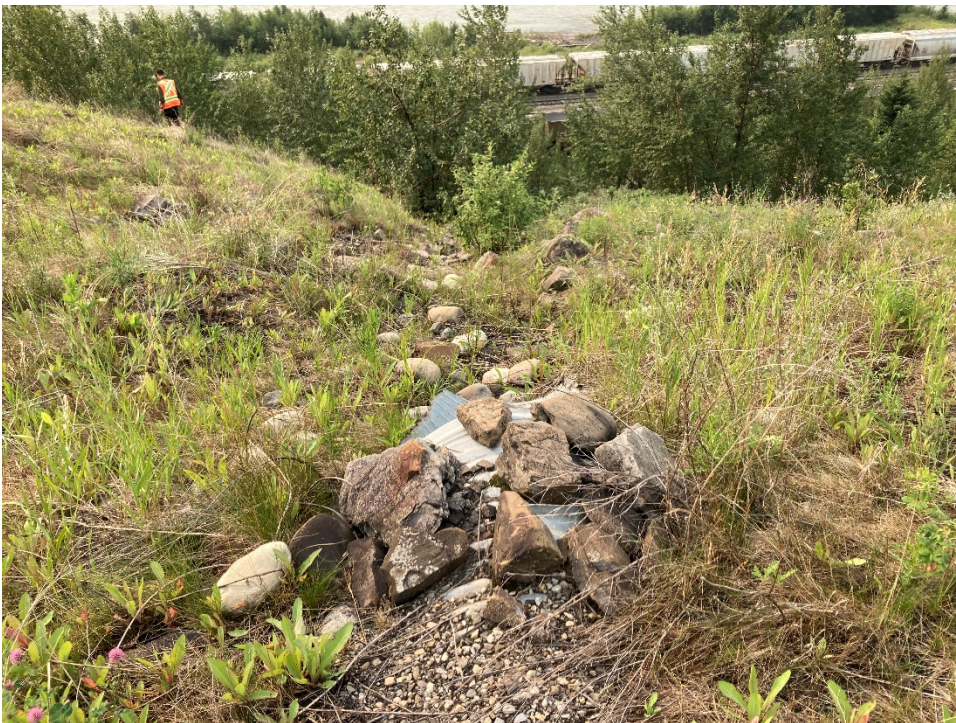
Photo 8 **Riprap lined outlet channel for the 900 mm diameter CSP culvert. Photo taken July 21, 2021 facing south.**

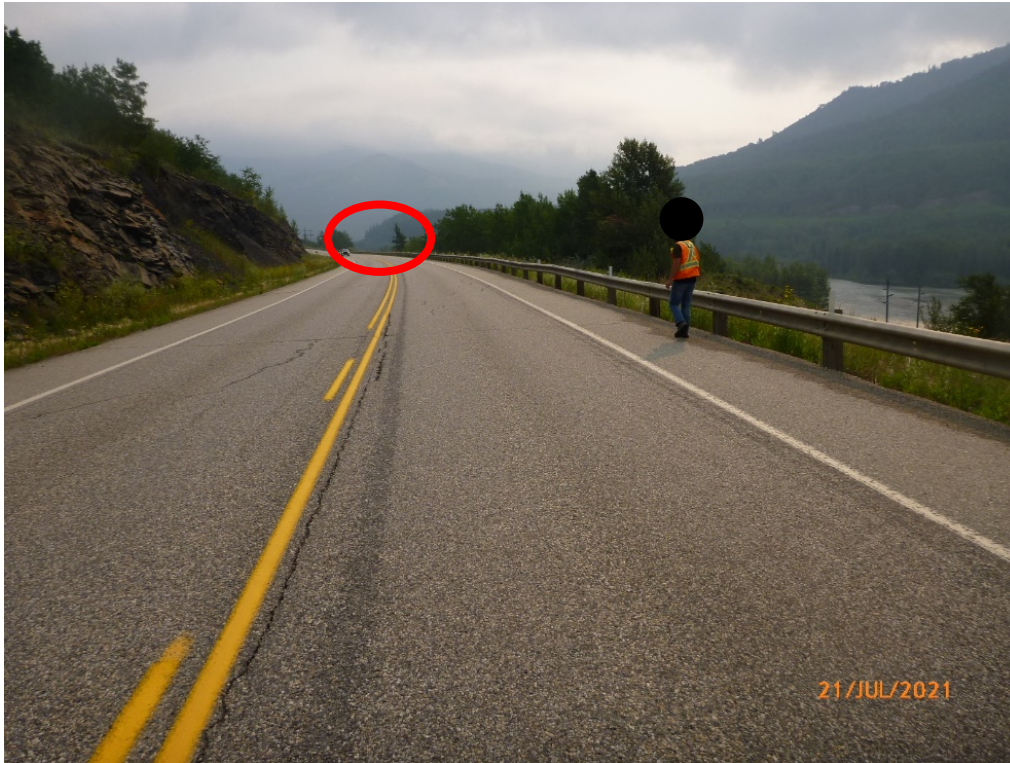
- ATCO have constructed a temporary bench for powerline work on the embankment slope east of the North Slide (WP0112). The bench was constructed using a cut and sliver fill method, resulting in an oversteepened backslope and fill slope. The backslope of the bench is approximately 1H:1V, the cut-fill bench is about 6 m wide and 20 m long. The steep backslope has resulted in slope movements that have resulted in additional pavement cracking at the edge of pavement near the white line at the edge of the northbound lane. The stability of the slope below the bench is unknown, and it is immediately above the train tracks.

Photo 9 Location of pavement cracking caused by ATCO temporary excavation 50 m to east of North Slide. Photo taken July 21, 2021 facing east. Red circle shows approximate location of pavement cracking in shoulder.
