SITE INSPECTION FORM

SITE NUMBER AND NAME: GP008 Road Surface Slumping (2.5 km North of McIntyre Mine)		HIGHWAY & KM: 40:36, 16.365 and 17.139	PREVIOUS INSPECTION DATE: July 21, 2021	INSPECTION DATE: June 14, 2022
LEGAL DESCRIPTION: SE 15-58-08-W6M SW 14-58-08-W6M SW 14-58-08-W6M NW 14-58-08-W6M	NAD 83 COORDINATES: UTM Northing Easting 11 5986982 362802 11 5987018 363134 11 5987028 363196 11 5987195 363778	RISK ASSESSMENT: West/South Slide PF: 8 CF: 4 TOTAL: 32 Middle Slide PF: 8 CF: 4 TOTAL: 32 East/North Slide PF: 9 CF: 5 TOTAL: 45 ATCO Slide PF: 8 CF: 4 TOTAL: 32		
AVERAGE ANNUAL DAILY TRAFFIC (AADT): 820 (north) & 820 (south) (Reference No. 70000788, 2021)		CONTRACT MAINTENANCE AREA (CMA): 504

PROJECT	PEACE REGION (GRANDE PRAIRIE DISTRICT-SOUTH) GEOHAZARD RISK MANAGEMENT PROGRAM	
TITLE	Site Plan GP008 - Road Surface Slumping (2.5 km North of McIntyre Mine) Hwy 40:36, km 16.365 and 17.139	
SCALE	PROJECT No.	FIG No.
1:4,000	A05116A01	1

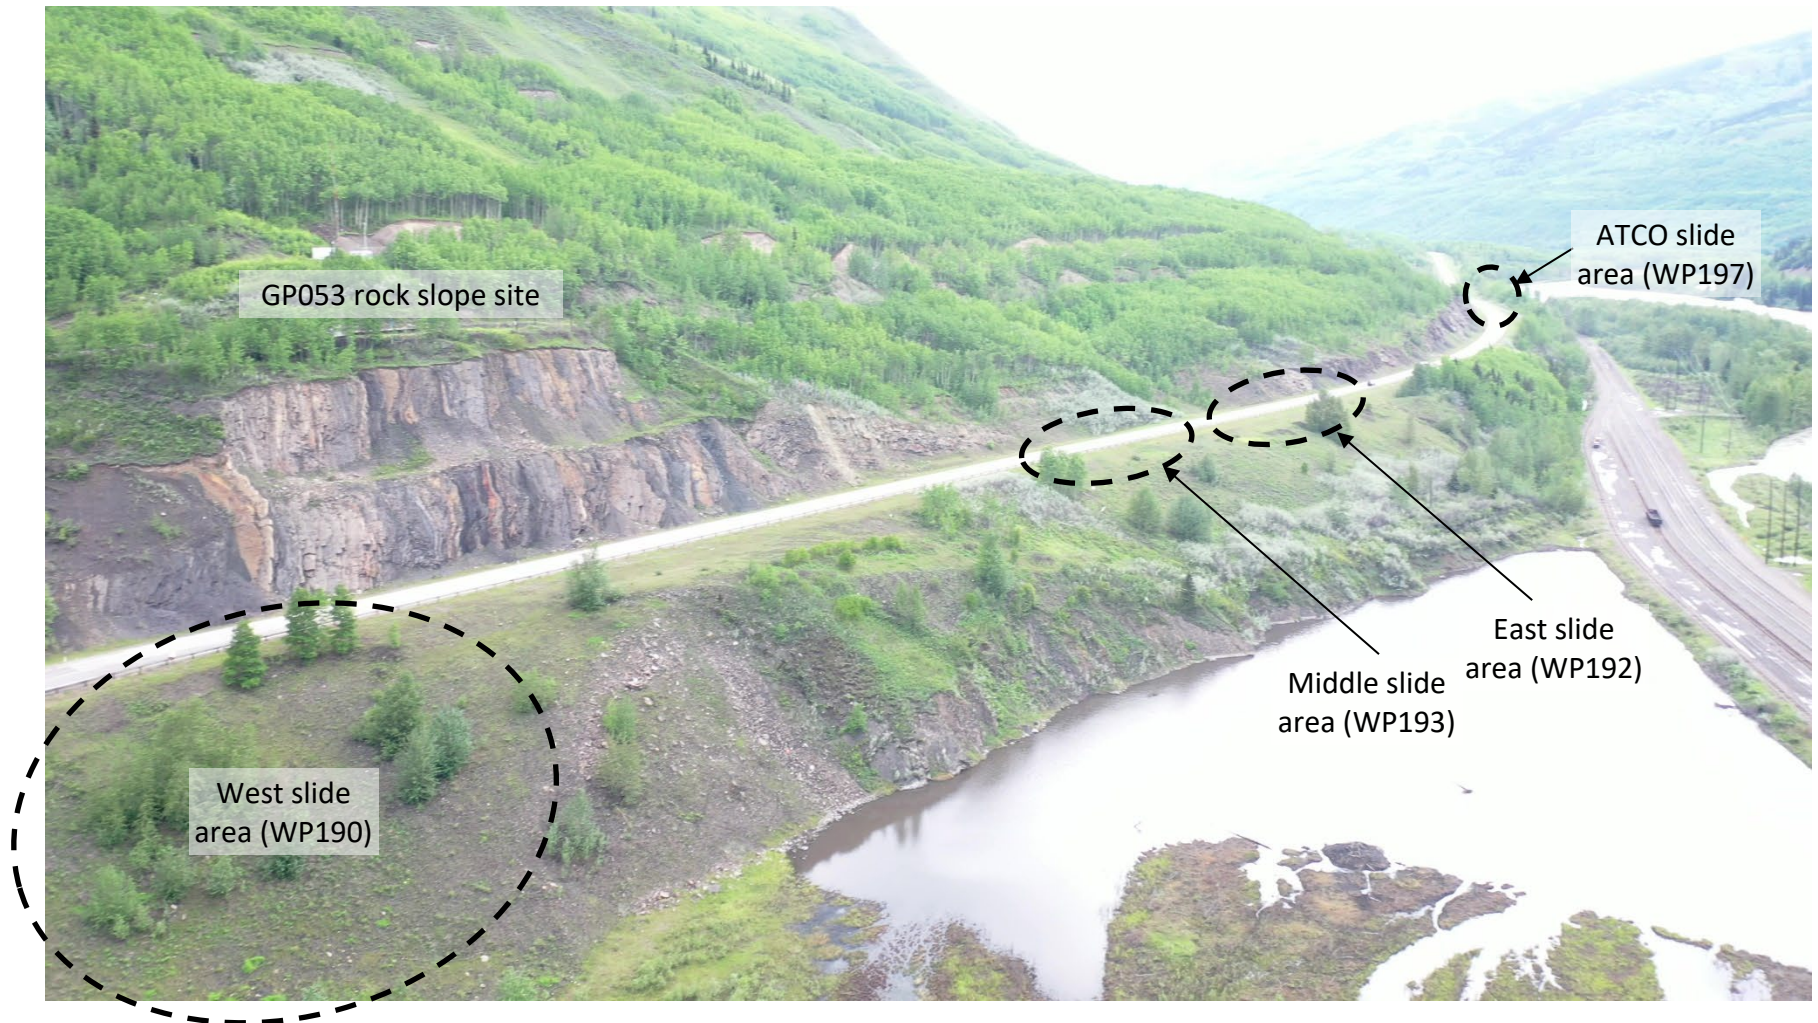
Photo 1 Overview of GP008 site on Hwy 40:36. West (WP190), middle (WP193), east (WP192), and ATCO slide (WP197) areas circled in black. Photo taken June 14, 2022, with unmanned aerial vehicle (UAV) facing northeast.

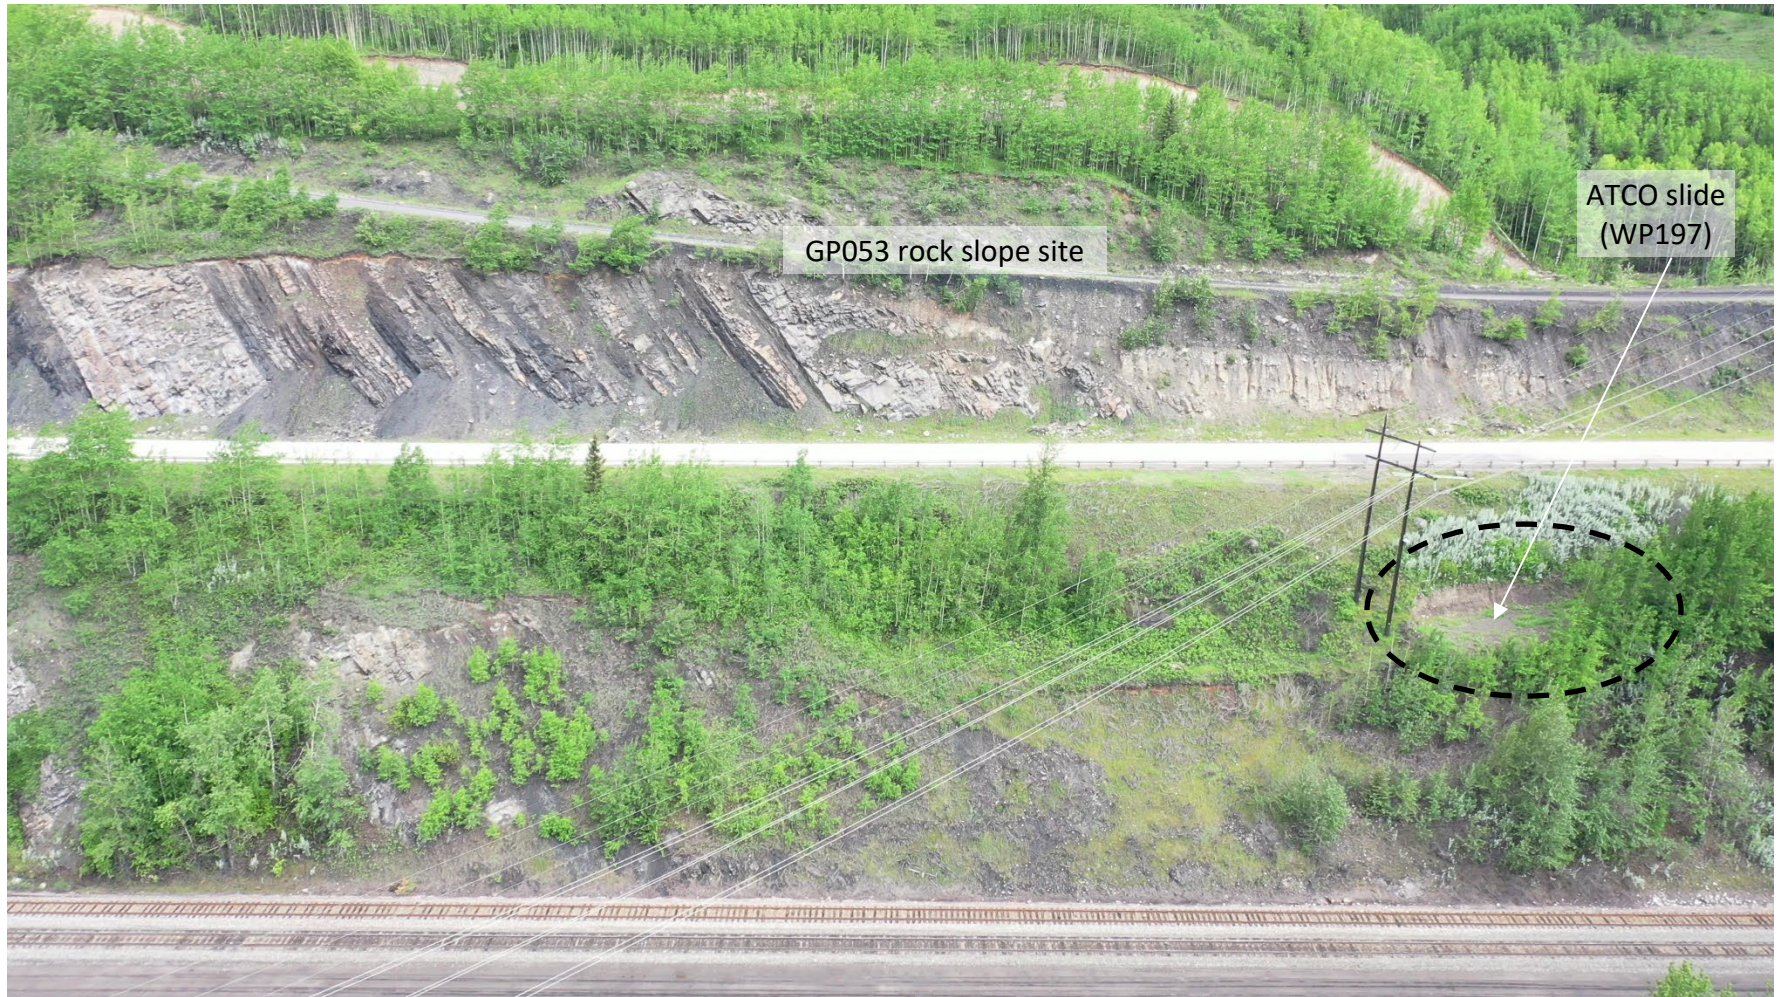
ATCO slide: The bench is approximately 6 m wide by 20 m long and 5 m below pavement surface with a 1H:1V backslope.

Photo 2 Overview of ATCO slide area (circled in black) at WP197. Photo taken June 14, 2022, with UAV facing north.

<p><u>Maintenance/Repair/Monitoring Recommendations:</u></p> <ul style="list-style-type: none"> • ATCO have constructed a temporary bench for powerline work on the downslope/east side of the highway embankment at WP197. The bench was constructed using a cut and sliver fill method, resulting in an over-steepened backslope and fill slope. The bench is approximately 6 m wide by 20 m long with a 1H:1V backslope. The over-steepened backslope has resulted in pavement cracking near the white line/shoulder of the northbound lane of Hwy 40:36. The stability of the slope below the bench is unknown, and it is immediately above the train tracks. AT would like to repair the ATCO slide and backfill the bench before the highway is paved. The repair could involve excavating and reconstructing the slide with geogrid-reinforced fill and drainage. Wolf willow observed on the highway embankment slope and along ATCO bench, which could be habitat for birds. A pre-disturbance nest sweep will be required. Estimated cost: \$150,000 to \$200,000.

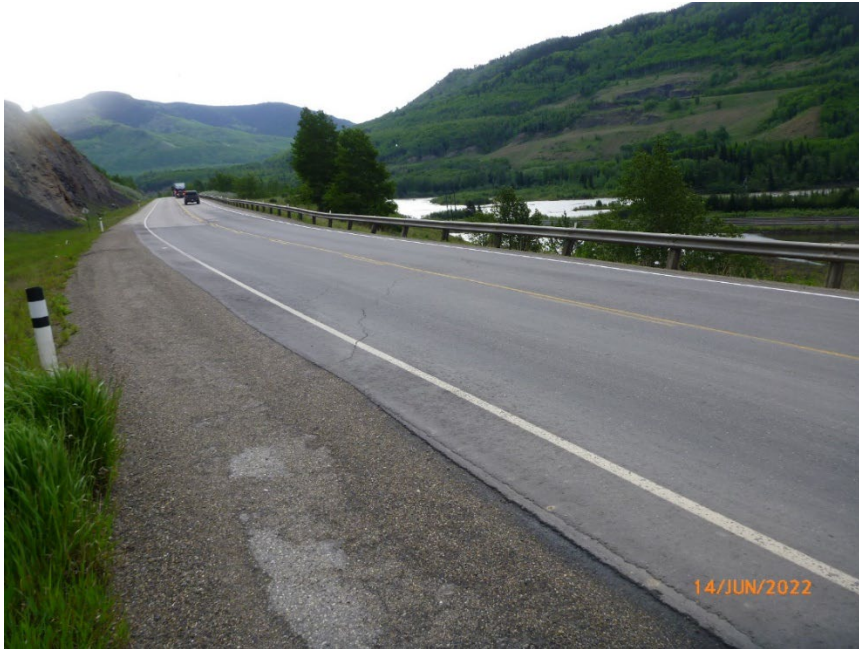
Culvert Distress		X	Culverts not inspected, but no previous distress observed by KCB.		X
COMMENTS					
<p>AT says that pavement cracks from west (WP190), middle (WP193), and east (WP192) slide zones usually reflect through pavement patches very quickly.</p>					
<p>Pavement cracking at middle slide is about 15 m wide. The width of the slide as indicated by pavement cracking does not appear to indicate a large failure that extends far down the slope. The surface of the slope below the middle slide appears to be stable with the possibility of a toe bulge approximately 10 m downslope in the bushes that could also be a remnant from poor slope grading.</p>					
<p>Material exposed on slope below middle slide appears to be mine-waste material and could be from a former mine-waste dump that predates highway construction. There is several meters distance between the guardrail and the crest of the slope which could also indicate a former mine waste structure as opposed to a highway embankment fill. Mine-waste dumps are typically built-in thick lifts with minimal compaction by end dumping with haul trucks. Settlements of the embankment could occur with time that might explain the movements at the western site limits, as would sliding of the waste dump slopes on thin sloping layers of segregated and/or fine-grained waste-dump materials that become preferential drainage paths.</p>

Photo 3 Cracking in pavement surface/patch of Hwy 40:36 above west slide area at WP190.
Photo taken June 14, 2022, facing east.

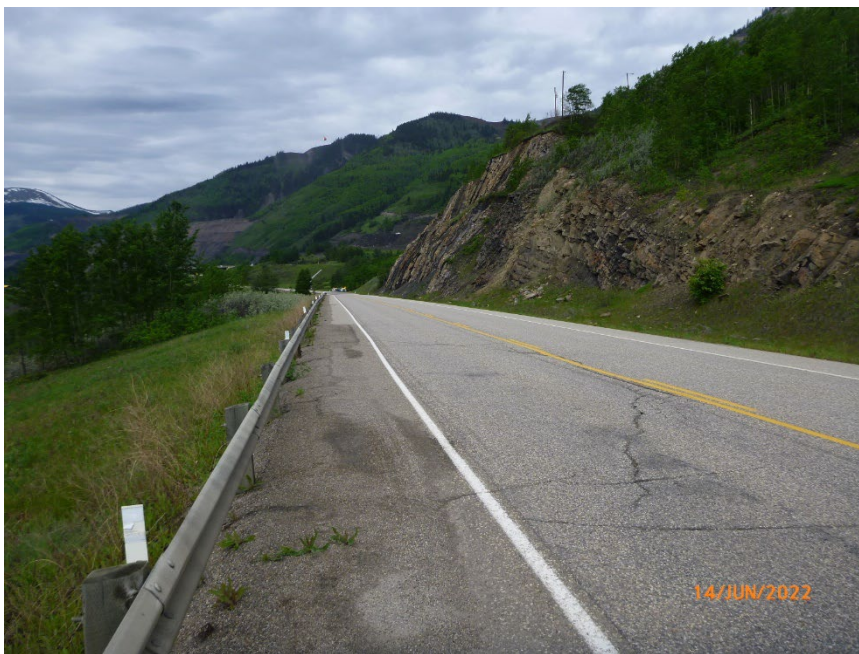
Photo 4 Cracking in pavement surface/patch of Hwy 40:36 above middle slide area at WP193.
Photo taken June 14, 2022, facing west.

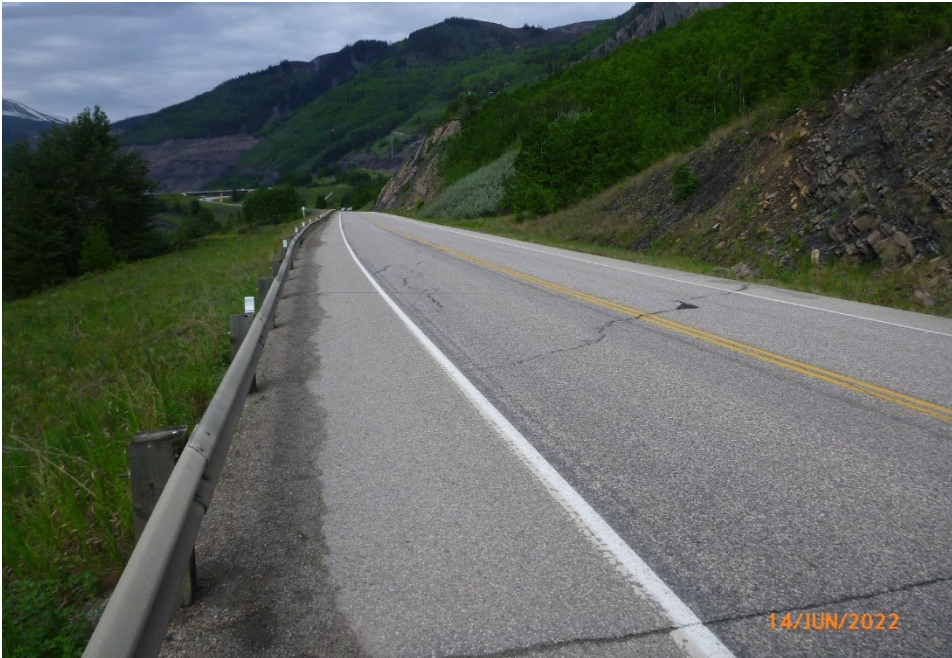
Photo 5 Cracking in pavement surface/patch of Hwy 40:36 above east slide area at WP192.
Photo taken June 14, 2022, facing west.

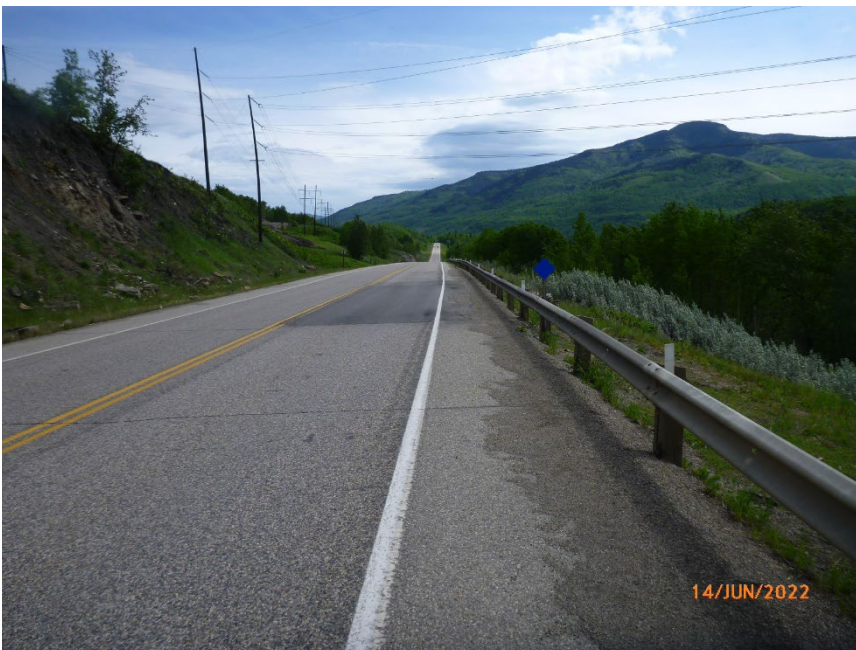
Photo 6 Pavement surface/patch of Hwy 40:36 above ATCO slide at WP197
(downslope/south of blue highway marker). Photo taken June 14, 2022, facing
northeast.

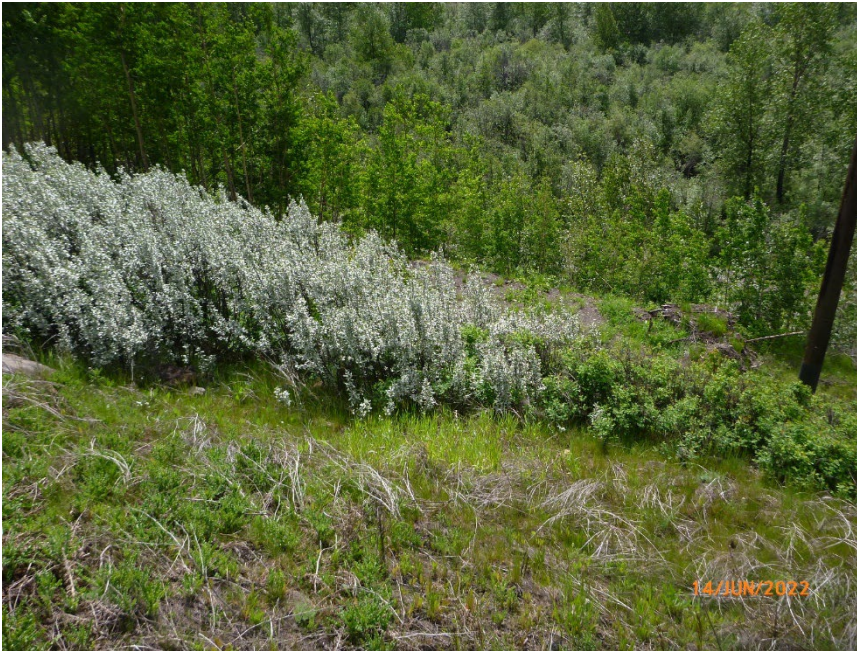
Photo 7 Temporary access bench constructed by ATCO for powerline work on downslope/east side of Hwy 40:36. Photo taken June 14, 2022, facing south.

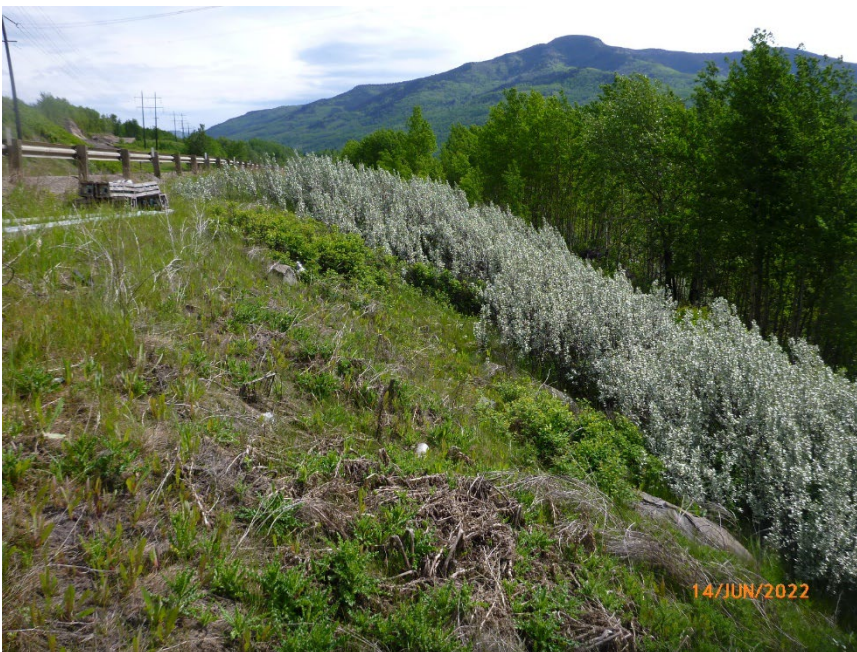
Photo 8 Temporary access bench constructed by ATCO for powerline work on downslope/east side of Hwy 40:36. Photo taken June 14, 2022, facing east.
