**SITE INSPECTION FORM**

<b>SITE NUMBER AND NAME:</b> GP008 Road Surface Slumping (2.5 km North of McIntyre Mine)		<b>HIGHWAY &amp; KM:</b> 40:36, 16.365 and 17.139	<b>PREVIOUS INSPECTION DATE:</b> July 21, 2021	<b>INSPECTION DATE:</b> <b>June 14, 2022</b>
<b>LEGAL DESCRIPTION:</b>	<b>NAD 83 COORDINATES:</b>		<b>RISK ASSESSMENT:</b>	
	UTM	Northing	Easting	
SE 15-58-08-W6M	11	5986982	362802	<b>West/South Slide</b> PF: 8 CF: 4 TOTAL: 32
SW 14-58-08-W6M	11	5987018	363134	<b>Middle Slide</b> PF: 8 CF: 4 TOTAL: 32
SW 14-58-08-W6M	11	5987028	363196	<b>East/North Slide</b> PF: 9 CF: 5 TOTAL: 45
NW 14-58-08-W6M	11	5987195	363778	<b>ATCO Slide</b> PF: 8 CF: 4 TOTAL: 32
<b>AVERAGE ANNUAL DAILY TRAFFIC (AADT):</b> 820 (north) & 820 (south) (Reference No. 70000788, 2021)			<b>CONTRACT MAINTENANCE AREA (CMA):</b> 504

PROJECT	PEACE REGION (GRANDE PRAIRIE DISTRICT-SOUTH) GEOHAZARD RISK MANAGEMENT PROGRAM	
TITLE	Site Plan GP008 - Road Surface Slumping (2.5 km North of McIntyre Mine) Hwy 40:36, km 16.365 and 17.139	
SCALE	PROJECT No. A05116A01	FIG No. 1

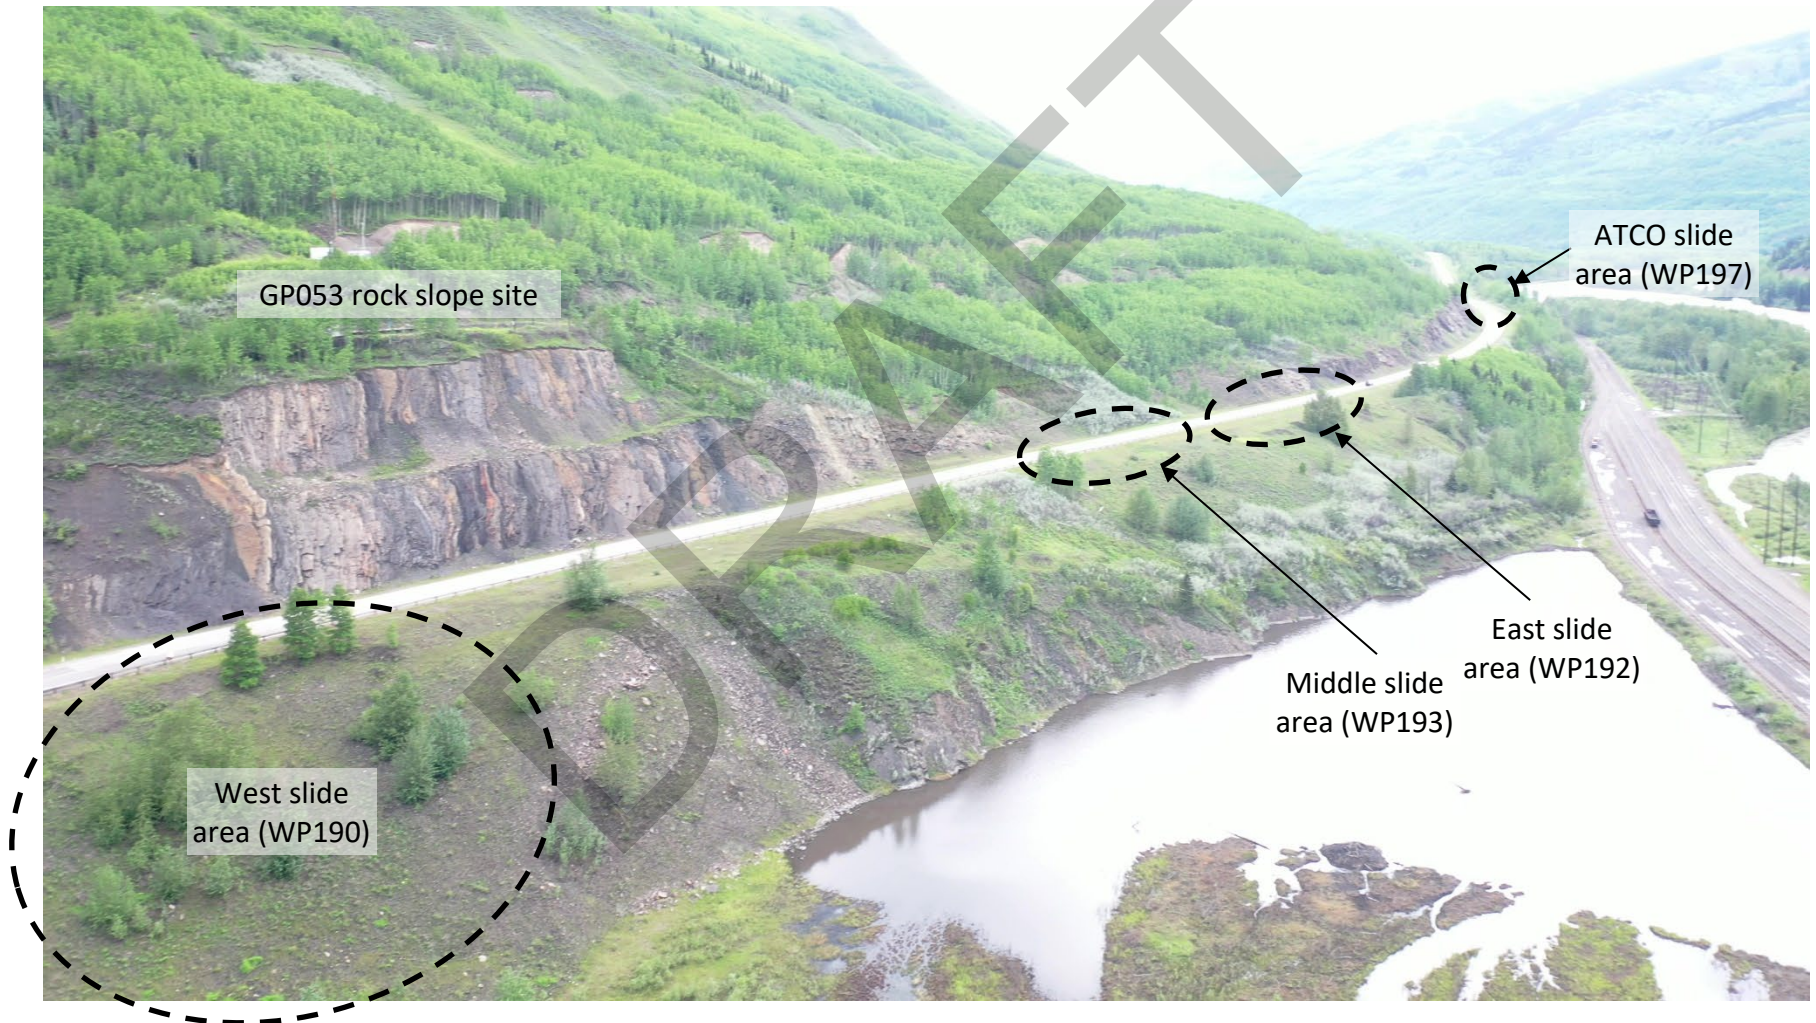
**PRIMARY SITE ISSUE:** Three slides/slope failures in a possible mine-waste fill/dump below Hwy 40:36 at the west/southern site limit: west slide cuts diagonally across highway (WP190), middle slide confined to northbound lane and shoulder (WP193), and east slide encompasses both lanes (WP192). In 2022, ATCO slide to north (WP197) added to GP008 site. ATCO slide triggered by temporary bench constructed for powerline work and affects northbound lane of highway. The site is located along the west valley slope of the Smoky River. Rockfall component of this site made into a separate site (GP053) for rockfalls only.

**Photo 1** Overview of GP008 site on Hwy 40:36. West (WP190), middle (WP193), east (WP192), and ATCO slide (WP197) areas circled in black. Photo taken June 14, 2022, with unmanned aerial vehicle (UAV) facing northeast.

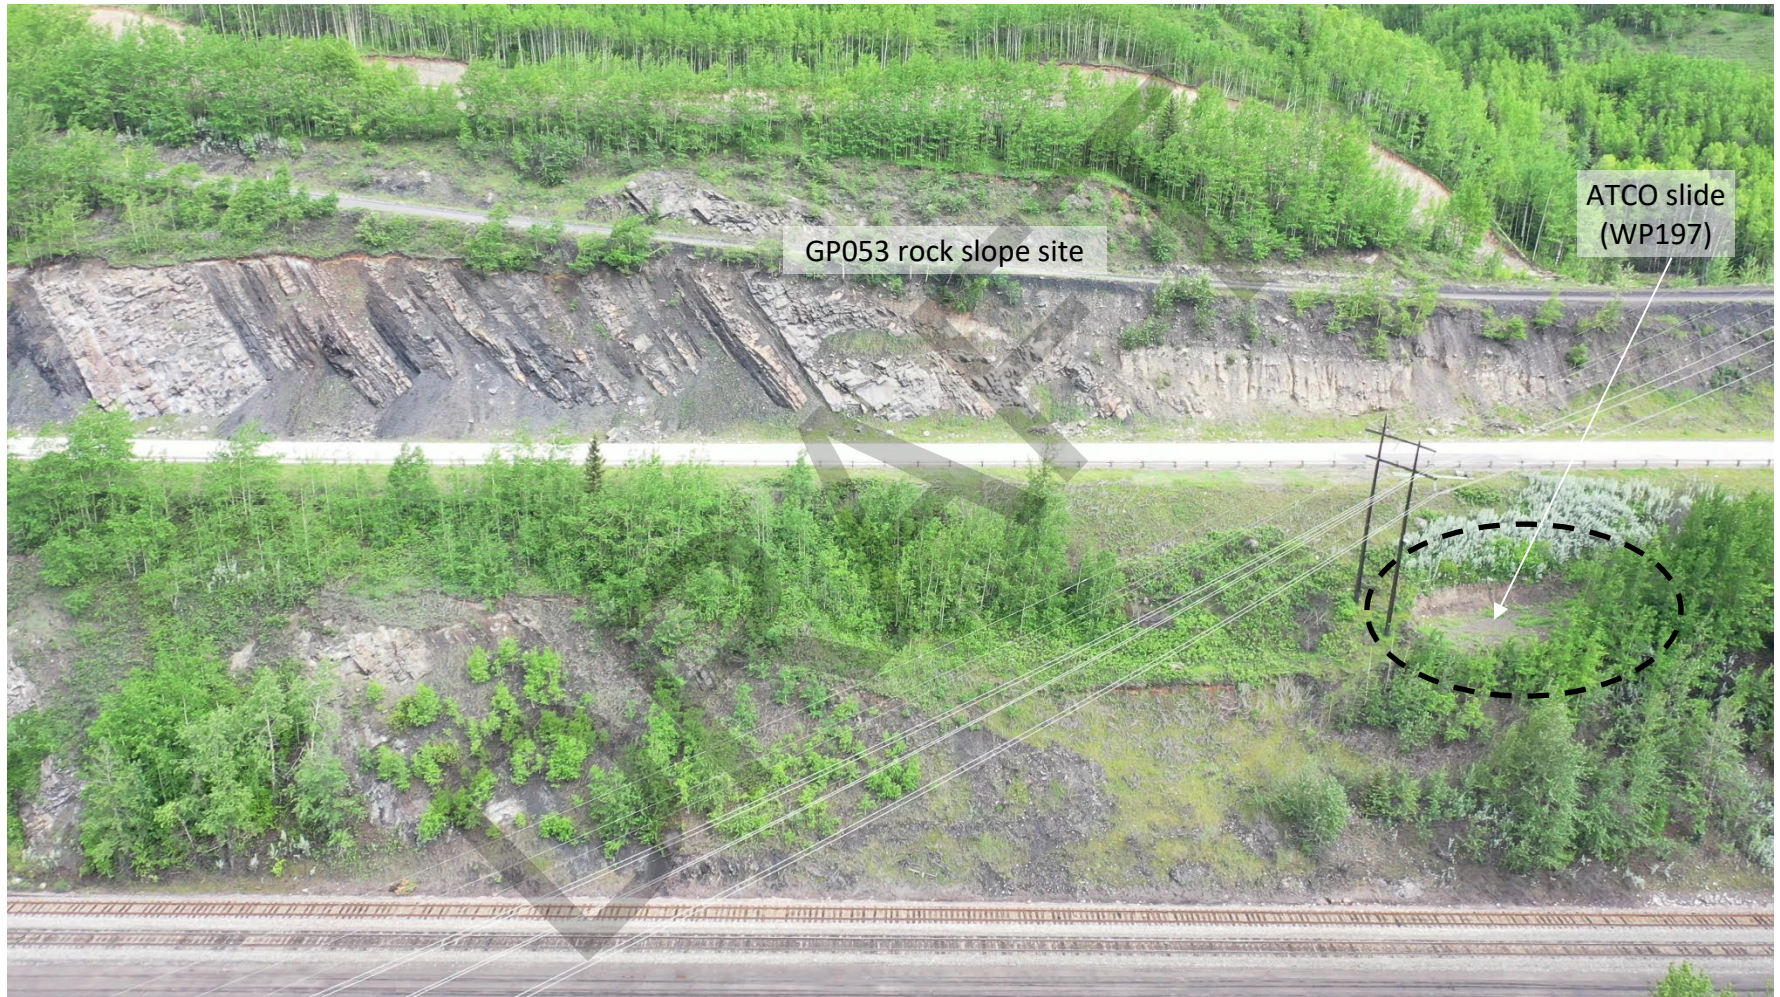
ATCO slide: The bench is approximately 6 m wide by 20 m long and 5 m below pavement surface with a 1H:1V backslope.

**Photo 2** Overview of ATCO slide area (circled in black) at WP197. Photo taken June 14, 2022, with UAV facing north.

<p><u>Maintenance/Repair/Monitoring Recommendations:</u></p> <ul style="list-style-type: none"> <li>• ATCO have constructed a temporary bench for powerline work on the downslope/east side of the highway embankment at WP197. The bench was constructed using a cut and sliver fill method, resulting in an over-steepened backslope and fill slope. The bench is approximately 6 m wide by 20 m long with a 1H:1V backslope. The over-steepened backslope has resulted in pavement cracking near the white line/shoulder of the northbound lane of Hwy 40:36. The stability of the slope below the bench is unknown, and it is immediately above the train tracks. AT would like to repair the ATCO slide and backfill the bench before the highway is paved. The repair could involve excavating and reconstructing the slide with geogrid-reinforced fill and drainage. Wolf willow observed on the highway embankment slope and along ATCO bench, which could be habitat for birds. A pre-disturbance nest sweep will be required. Estimated cost: \$150,000 to \$200,000.</li> </ul>

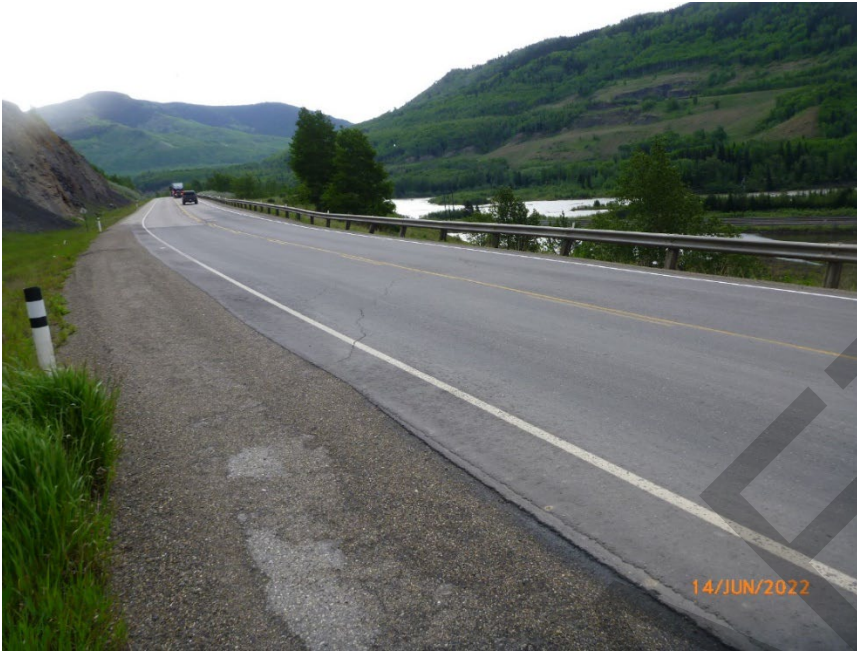
Culvert Distress		X	Culverts not inspected, but no previous distress observed by KCB.		X
<b>COMMENTS</b>					
<p>AT says that pavement cracks from west (WP190), middle (WP193), and east (WP192) slide zones usually reflect through pavement patches very quickly.</p>					
<p>Pavement cracking at middle slide is about 15 m wide. The width of the slide as indicated by pavement cracking does not appear to indicate a large failure that extends far down the slope. The surface of the slope below the middle slide appears to be stable with the possibility of a toe bulge approximately 10 m downslope in the bushes that could also be a remnant from poor slope grading.</p>					
<p>Material exposed on slope below middle slide appears to be mine-waste material and could be from a former mine-waste dump that predates highway construction. There is several meters distance between the guardrail and the crest of the slope which could also indicate a former mine waste structure as opposed to a highway embankment fill. Mine-waste dumps are typically built-in thick lifts with minimal compaction by end dumping with haul trucks. Settlements of the embankment could occur with time that might explain the movements at the western site limits, as would sliding of the waste dump slopes on thin sloping layers of segregated and/or fine-grained waste-dump materials that become preferential drainage paths.</p>

**Photo 3** Cracking in pavement surface/patch of Hwy 40:36 above west slide area at WP190.  
Photo taken June 14, 2022, facing east.

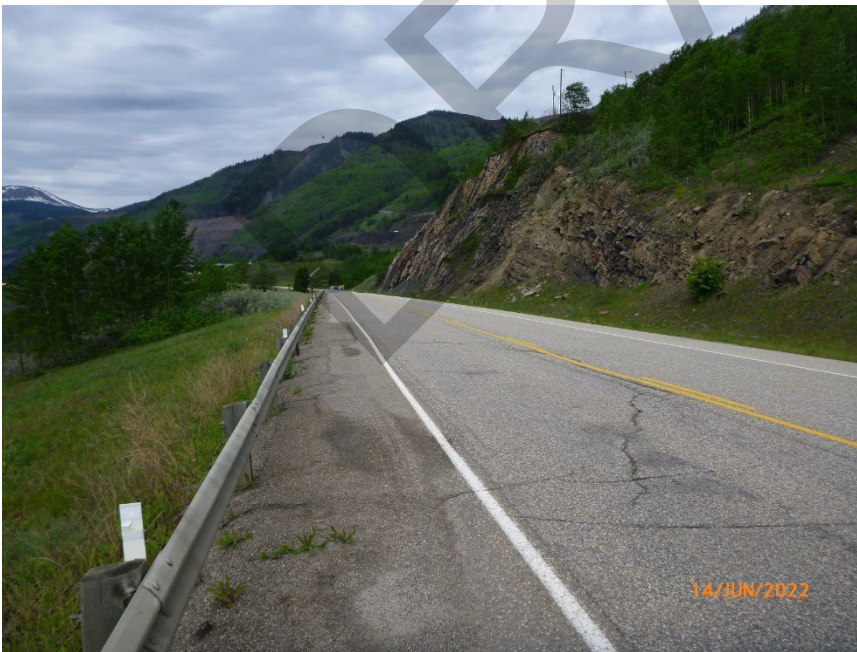
**Photo 4** Cracking in pavement surface/patch of Hwy 40:36 above middle slide area at WP193.  
Photo taken June 14, 2022, facing west.

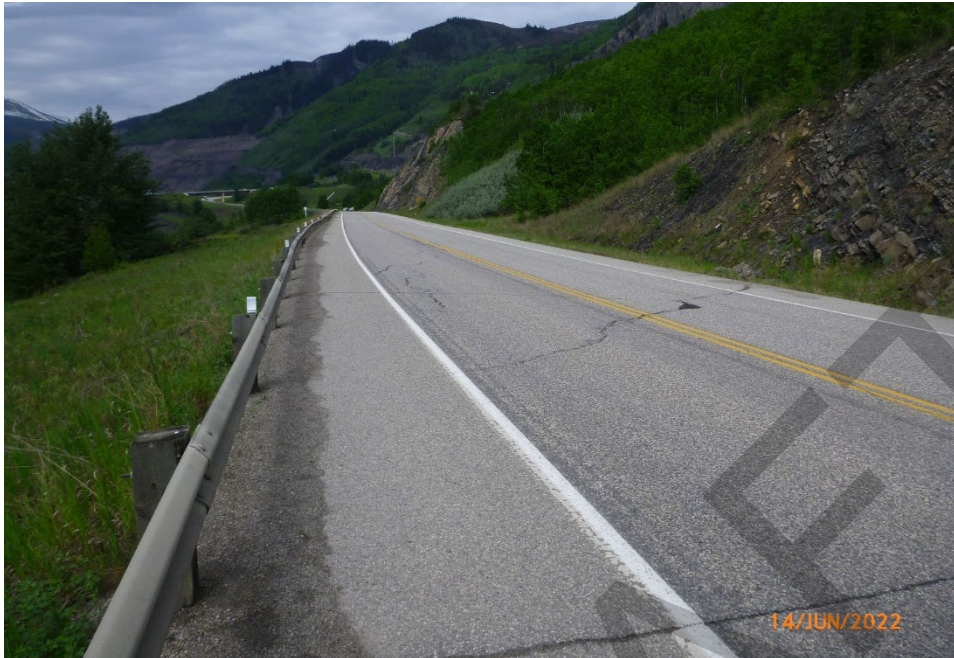
**Photo 5** Cracking in pavement surface/patch of Hwy 40:36 above east slide area at WP192.  
Photo taken June 14, 2022, facing west.

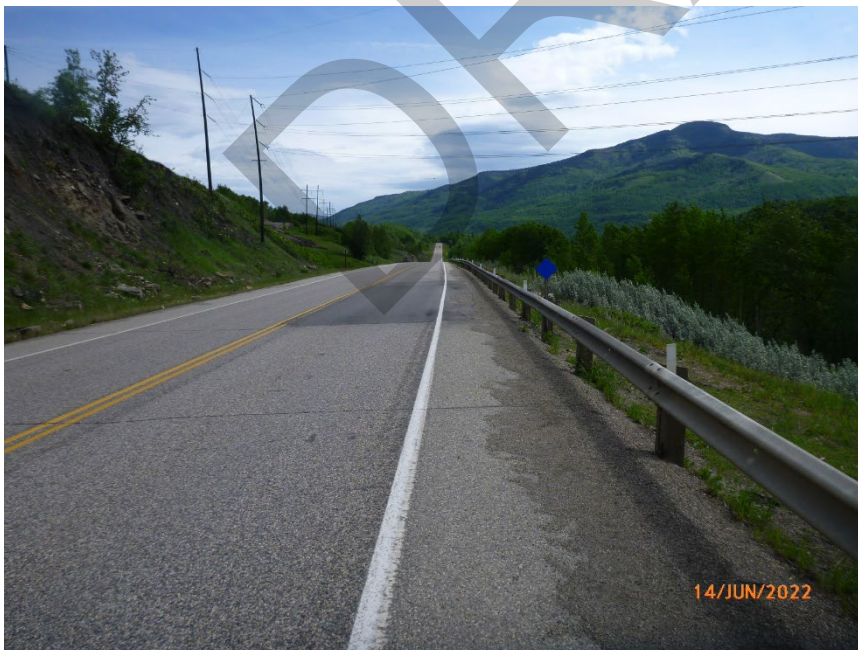
**Photo 6** Pavement surface/patch of Hwy 40:36 above ATCO slide at WP197  
(downslope/south of blue highway marker). Photo taken June 14, 2022, facing  
northeast.

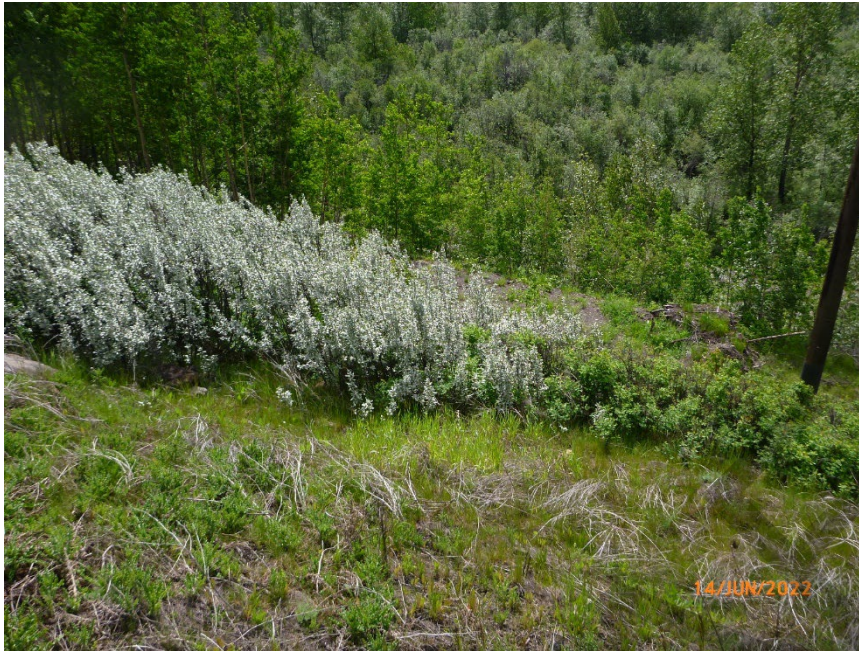
**Photo 7** Temporary access bench constructed by ATCO for powerline work on downslope/east side of Hwy 40:36. Photo taken June 14, 2022, facing south.

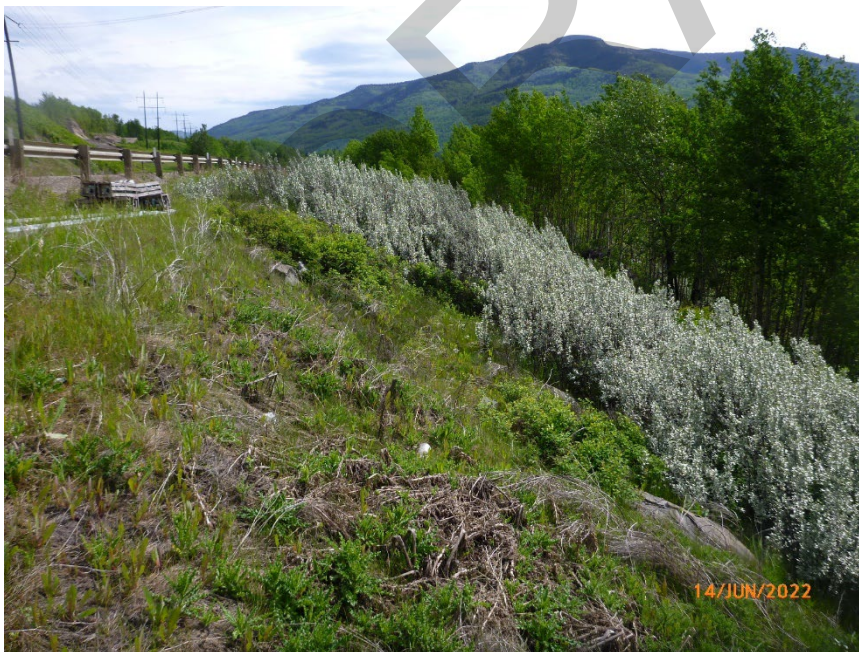
**Photo 8** Temporary access bench constructed by ATCO for powerline work on downslope/east side of Hwy 40:36. Photo taken June 14, 2022, facing east.
