SITE INSPECTION FORM

SITE NUMBER AND NAME: GP008 Road Surface Slumping (2.5 km North of McIntyre Mine)		HIGHWAY & KM: 40:36, 16.365 and 17.139	PREVIOUS INSPECTION DATE: June 10, 2024	INSPECTION DATE: June 2, 2025
LEGAL DESCRIPTION:	NAD 83 COORDINATES:		RISK ASSESSMENT:	
	UTM	Northing	Easting	
SE 15-58-08-W6M	11	5986982	362802	West Slide: PF: 8 CF: 4 TOTAL: 32
SW 14-58-08-W6M	11	5987018	363134	Middle Slide: PF: 8 CF: 4 TOTAL: 32
SW 14-58-08-W6M	11	5987028	363196	East Slide: PF: 8 CF: 5 TOTAL: 40
NW 14-58-08-W6M	11	5987195	363778	ATCO Slide: PF: 1 CF: 4 TOTAL: 4
AVERAGE ANNUAL DAILY TRAFFIC (AADT): 840 (east) & 840 (west) (Reference No. 70000788, 2024)			CONTRACT MAINTENANCE AREA (CMA): 504

PEACE REGION (GRANDE PRAIRIE DISTRICT-SOUTH)
GEOHAZARD RISK MANAGEMENT PROGRAM

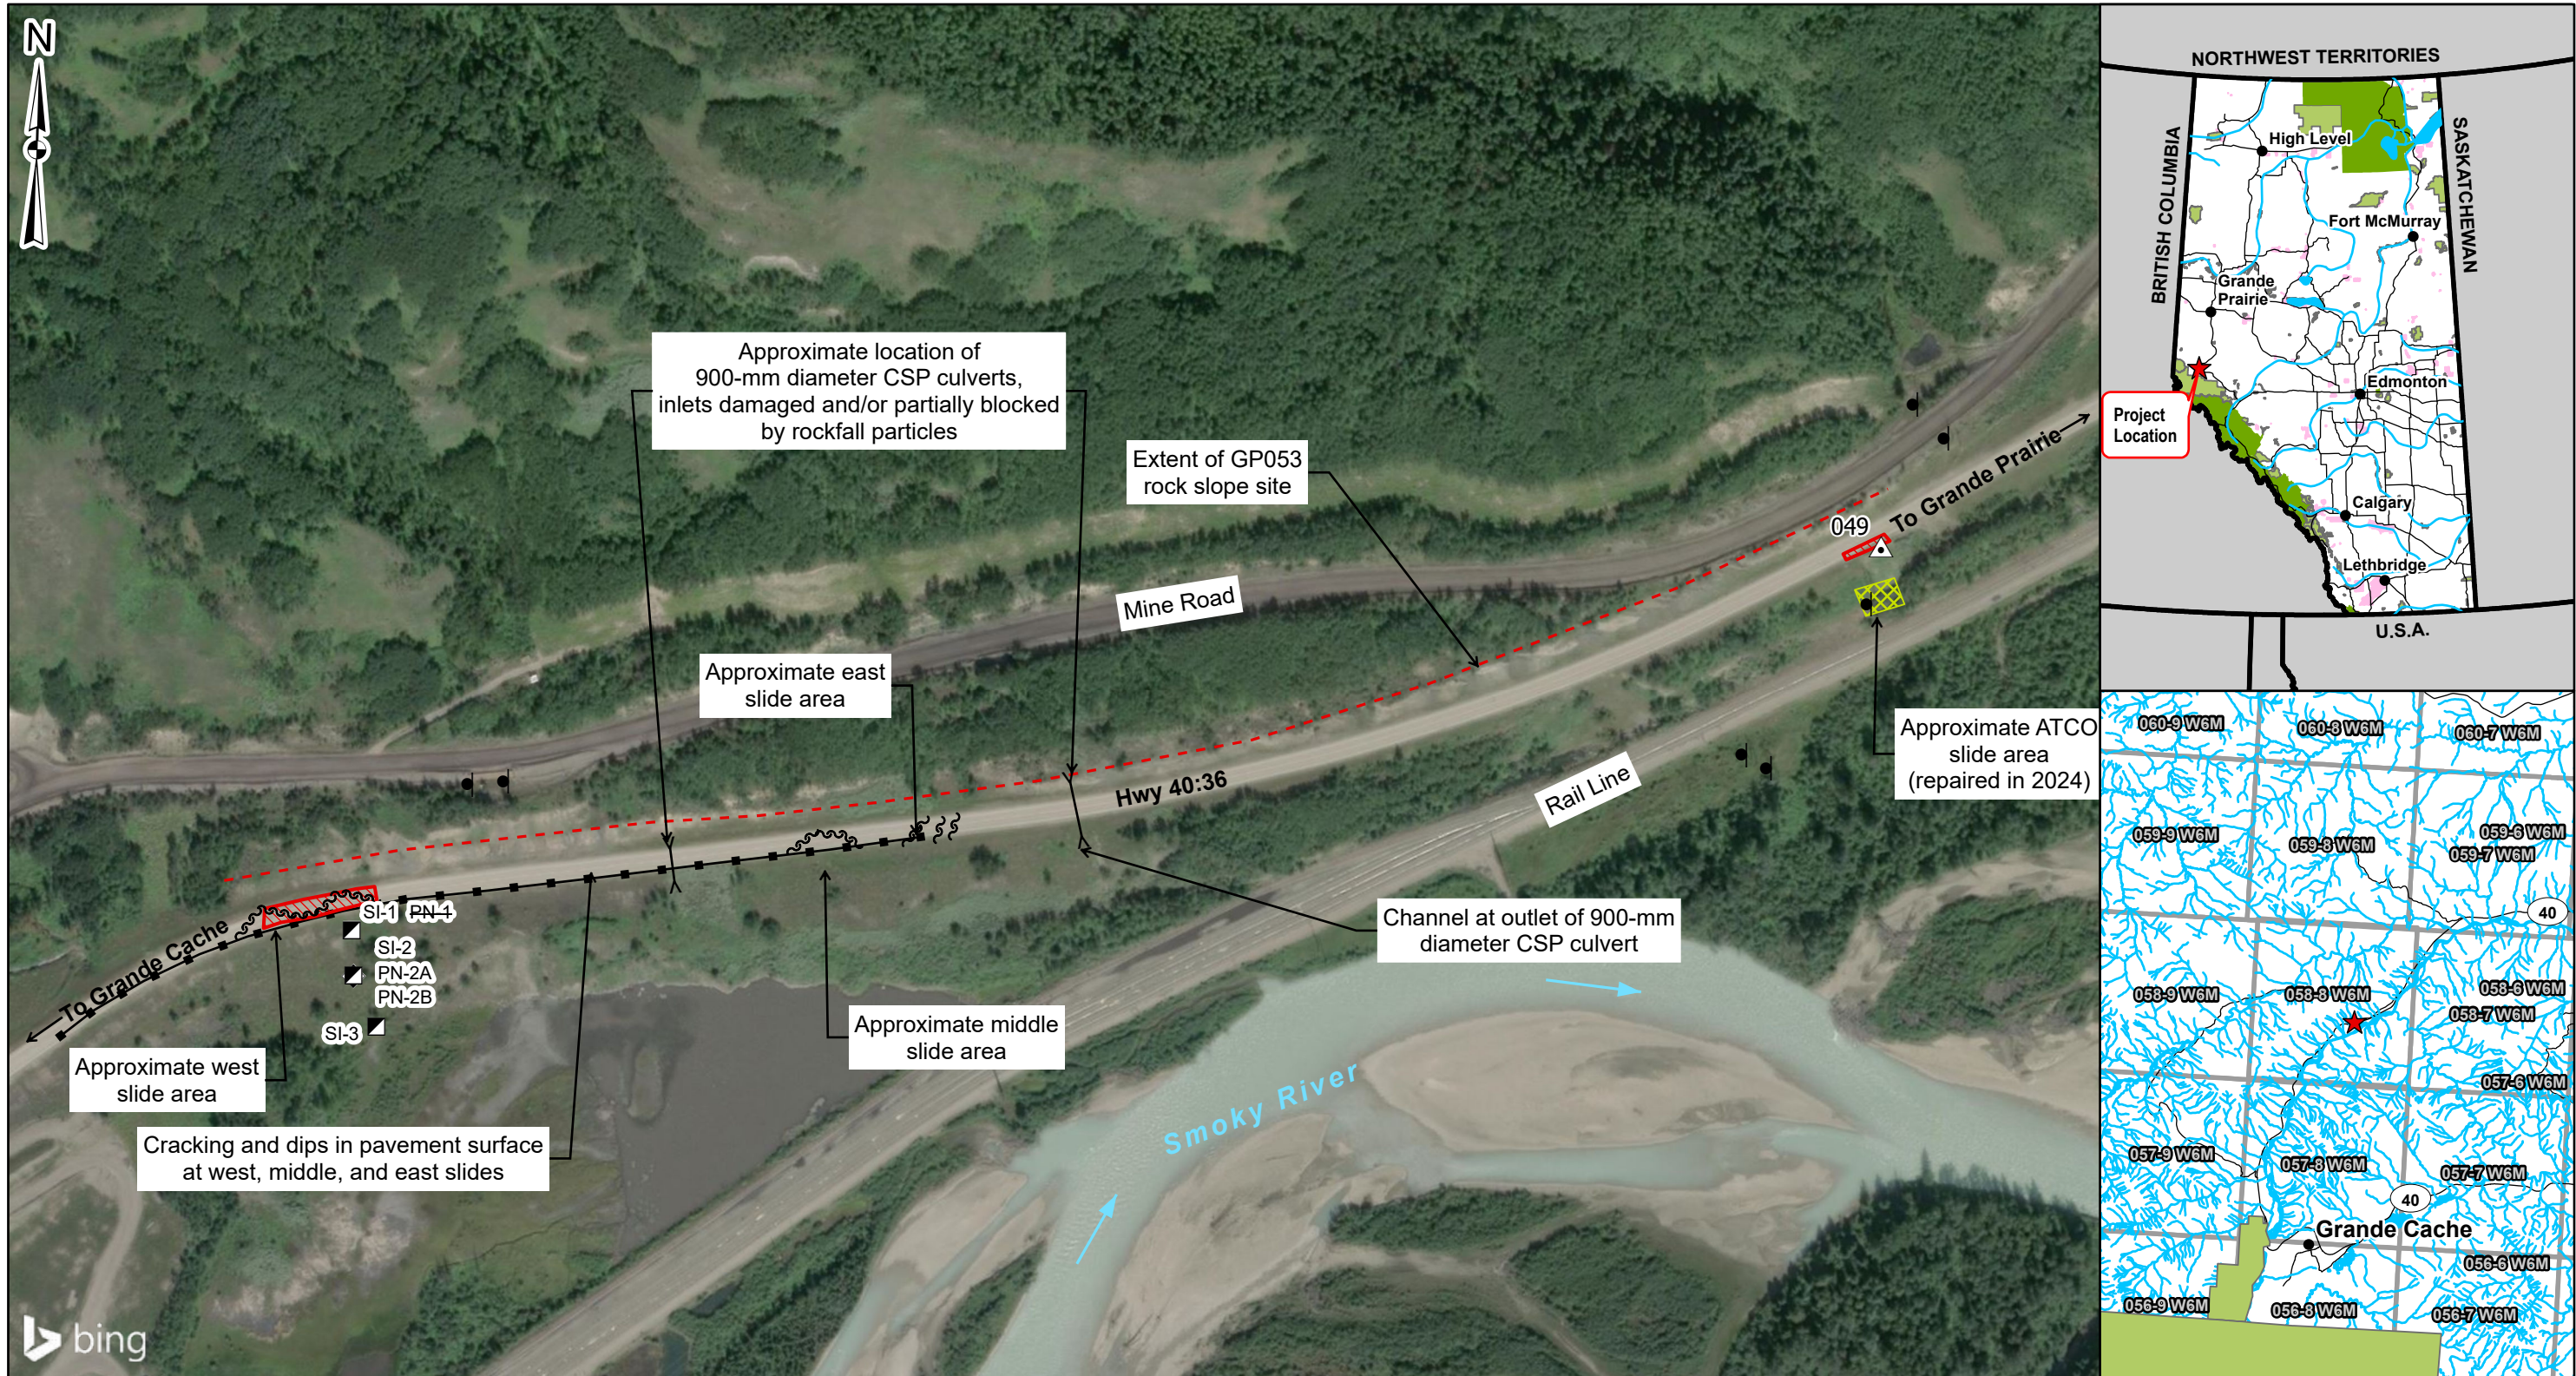
FIG No. 1

Site Plan
GP008 - Road Surface Slumping
(2.5 km North of McIntyre Mine)
Hwy 40:36, km 16.365 and 17.139

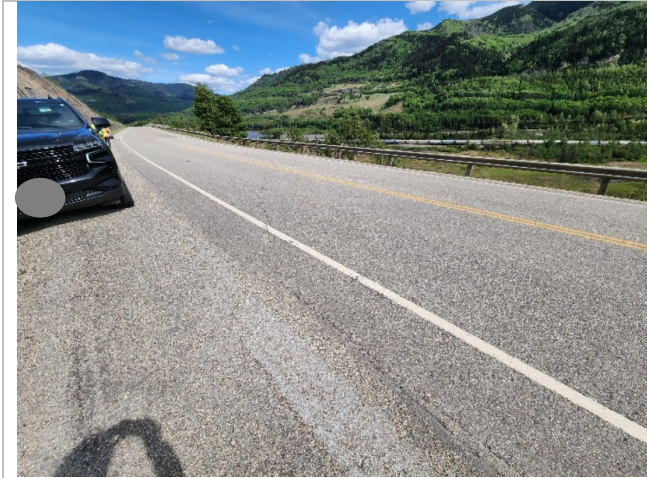
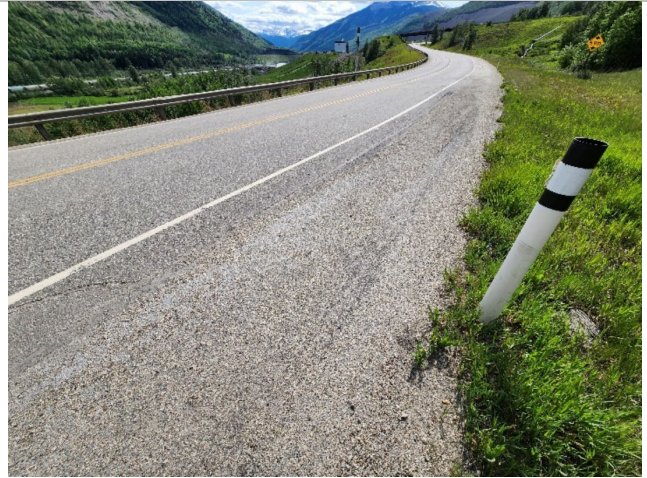
West Slide (Photos 1 and 2):

- Cracking extends across both lanes of the highway. Guardrail tips slightly to south (downslope).
- There appears to be a subtle dip or low spot in the pavement surface just west of the slide, mostly notably in the northbound lane.

Photo 1 **Cracking and dip in pavement surface of Hwy 40:36 at west slide area. Photos taken June 2, 2025, facing southeast and southwest, respectively.**

- All subsites should continue to be inspected by the Maintenance Contract Inspector (MCI). However, based on the slow movement recorded and observed at the original three slides and the performance of the repairs at the ATCO slide, so far, TEC could consider making the site a monitoring only site or removing the site from the list of active GRMP sites and excluding it from GP South GRMP Section B inspections. If site conditions were to deteriorate, the site could always be returned to the list of active GRMP sites and/or inspected again as part of a Section B inspection or Section D call-out inspection.
- TEC should consider patching the pavement at the four slide locations.

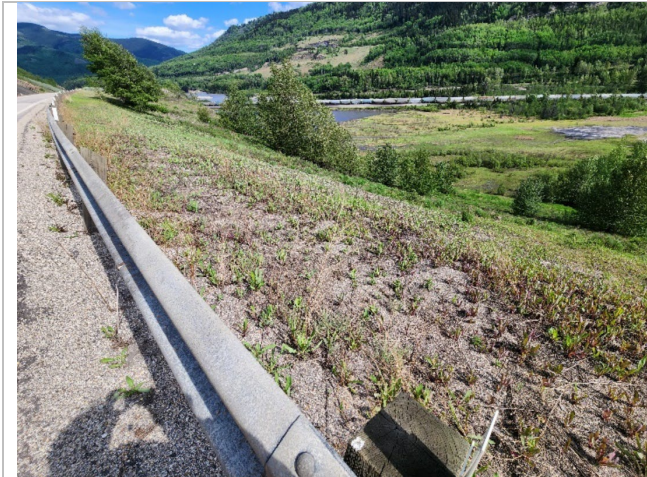
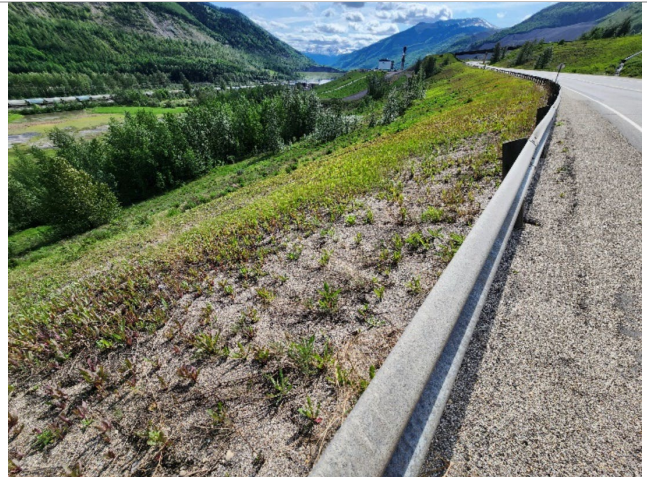
Photo 2 **Slope on south side of Hwy 40:36 at west slide area. Photos taken June 2, 2025, facing southeast and southwest, respectively.**

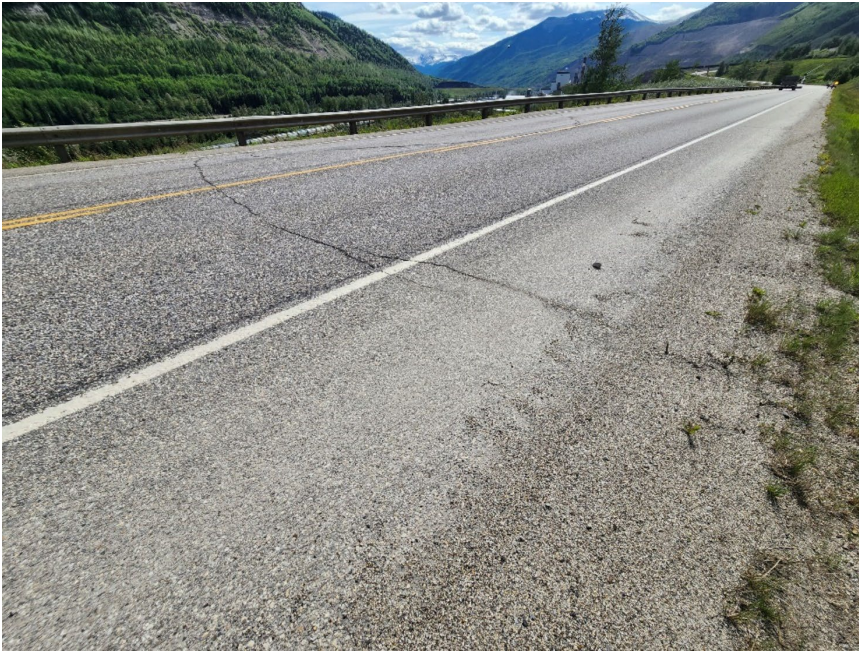
Middle Slide (Photos 3 and 4):

- Pavement cracking and subtle dip at the middle slide is about 15 m wide with a roughly circular pattern that extends from the highway centerline to the northbound shoulder. The width of the slide as indicated by pavement cracking does not appear to indicate a large failure that extends far down the slope. The surface of the slope below the middle slide appears to be stable with the possibility of a toe bulge approximately 10 m downslope in the bushes that could also be a remnant from poor slope grading.

Photo 3 **Cracking and dip in pavement surface of Hwy 40:36 at middle slide area. Photo taken June 2, 2025, facing southwest.**

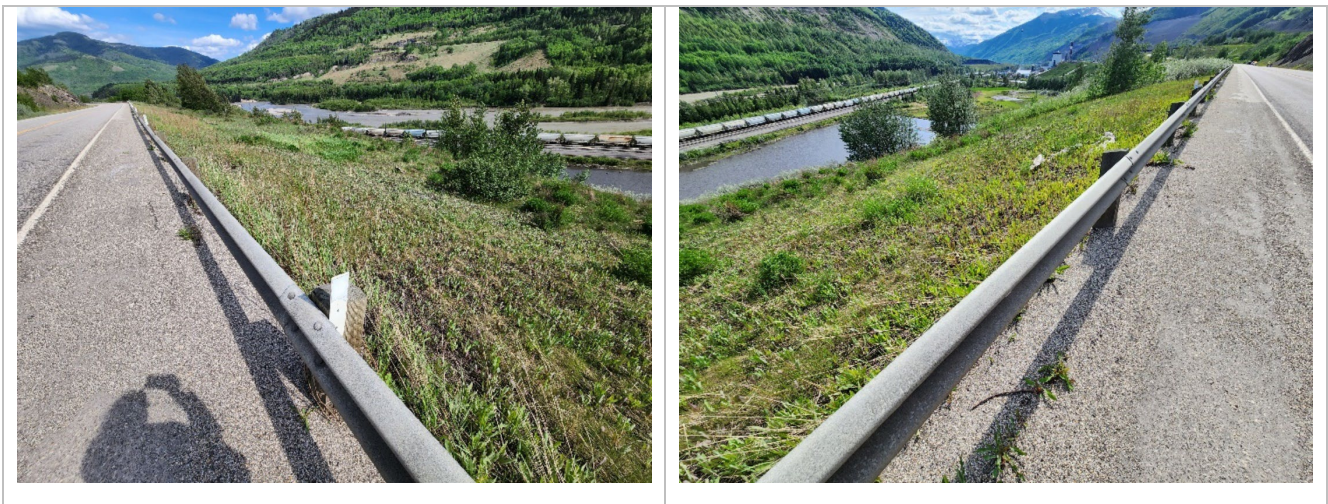
- Material exposed on slope below middle slide appears to be mine-waste material and could be from a former mine-waste fill/dump that predates highway construction. There is several meters distance between the guardrail and the crest of the slope which could also indicate a former mine waste structure as opposed to a highway embankment fill. Mine-waste dumps are typically built-in thick lifts with minimal compaction by end dumping with haul trucks. Settlements of the embankment could occur with time that might explain the movements at the western site limits, as would sliding of the waste dump slopes on thin sloping layers of segregated and/or fine-grained waste-dump materials that become preferential drainage paths.

Photo 4 **Slope on south side of Hwy 40:36 at middle slide area. Photos taken June 2, 2025, facing southeast and southwest, respectively.**

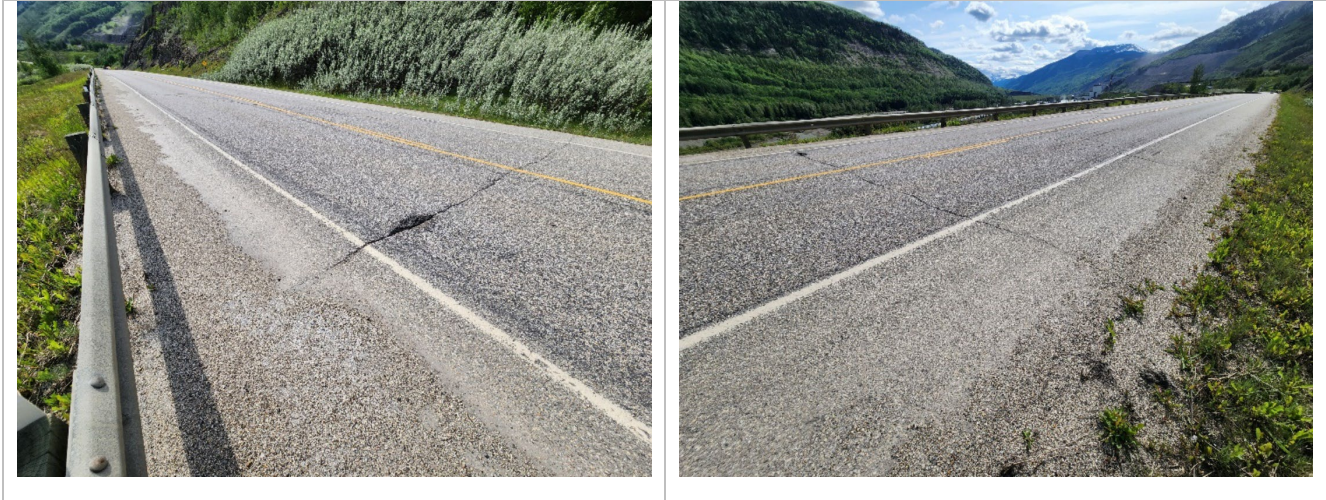
East Slide (Photos 5 and 6):

- Cracking extends across both lanes of the highway with a subtle dip in the northbound lane. Pieces of pavement missing along one crack that extends roughly perpendicular across the highway (Photo 5).
- Brake marks observed in the southbound lane near the blue-hazard-diamond sign.

Photo 5 **Cracking and dip in pavement surface of Hwy 40:36 at east slide area. Photos taken June 2, 2025 facing northwest and southwest, respectively.**

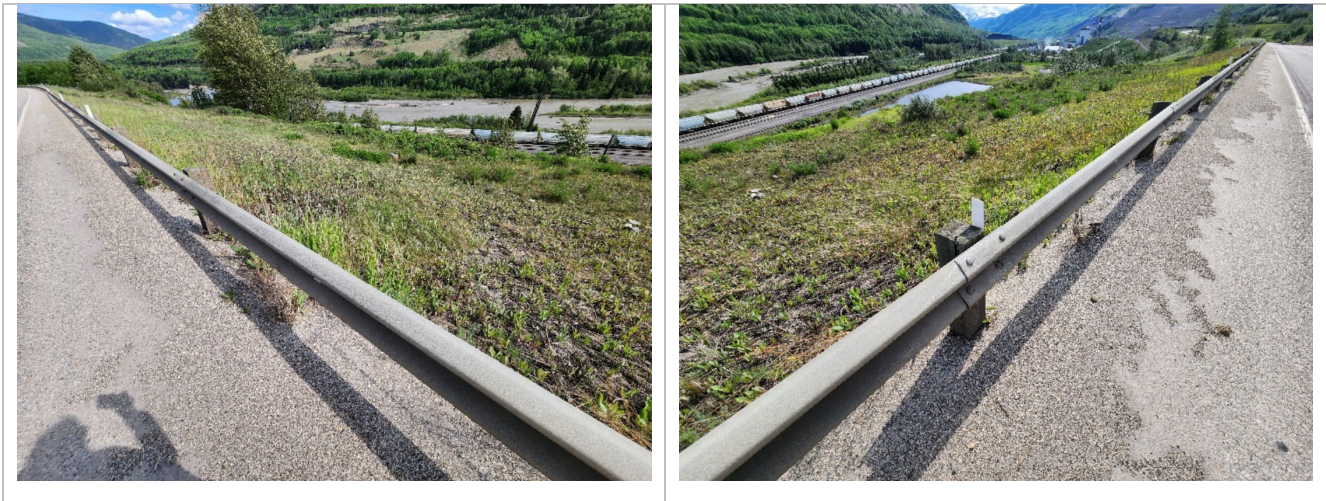
Photo 6 **Slope on south side of Hwy 40:36 at east slide area. Photos taken June 2, 2025, facing southeast and southwest, respectively.**

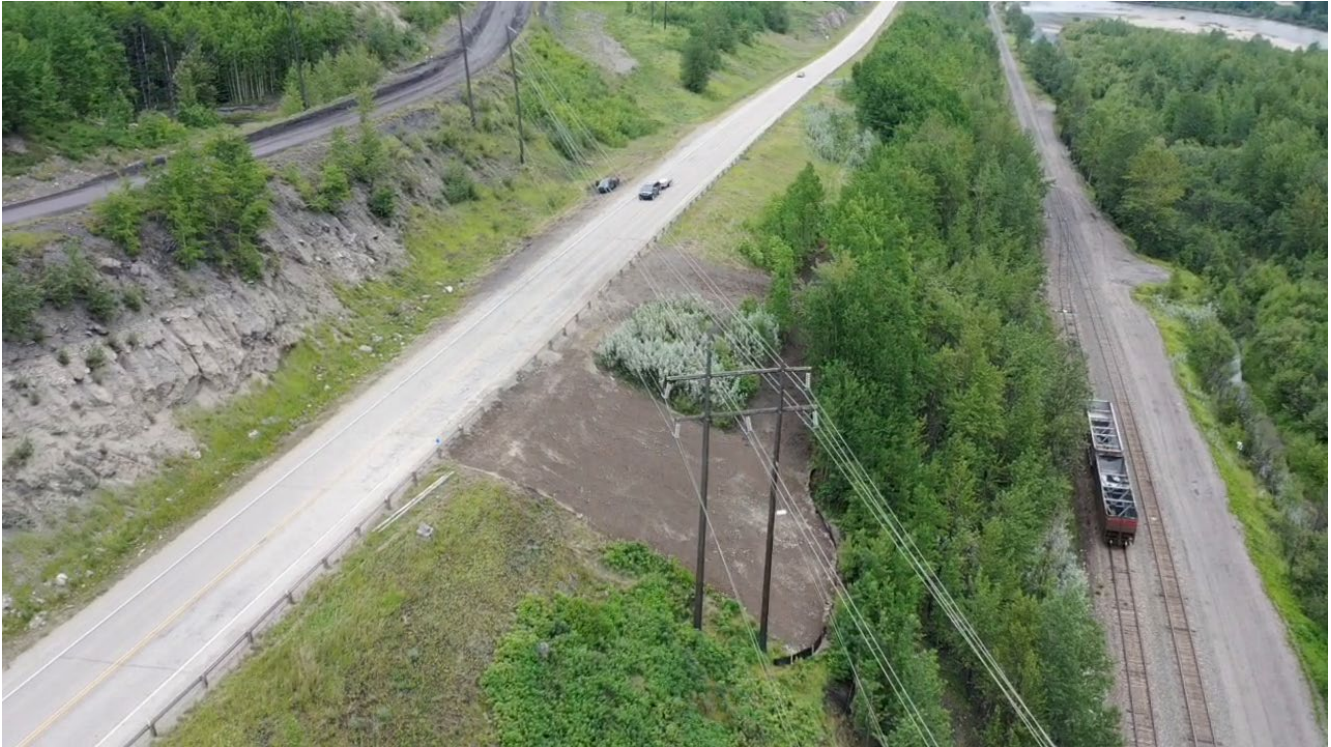
ATCO Slide (Photos 7 to 12) (WP049):

- ATCO constructed a bench for powerline work on the downslope/east side of the highway embankment. The bench was constructed using a cut and sliver fill method, resulting in an over-steepened backslope and fill slope that led to the slide above the bench. Slides movements resulted in pavement cracking near the shoulder of the northbound lane and a dip in the pavement surface. The slide was repaired in 2024.
- Observations made during the 2025 inspection:

Photo 7 **Repaired ATCO slide. UAV photo taken June 26, 2024, facing northeast.**

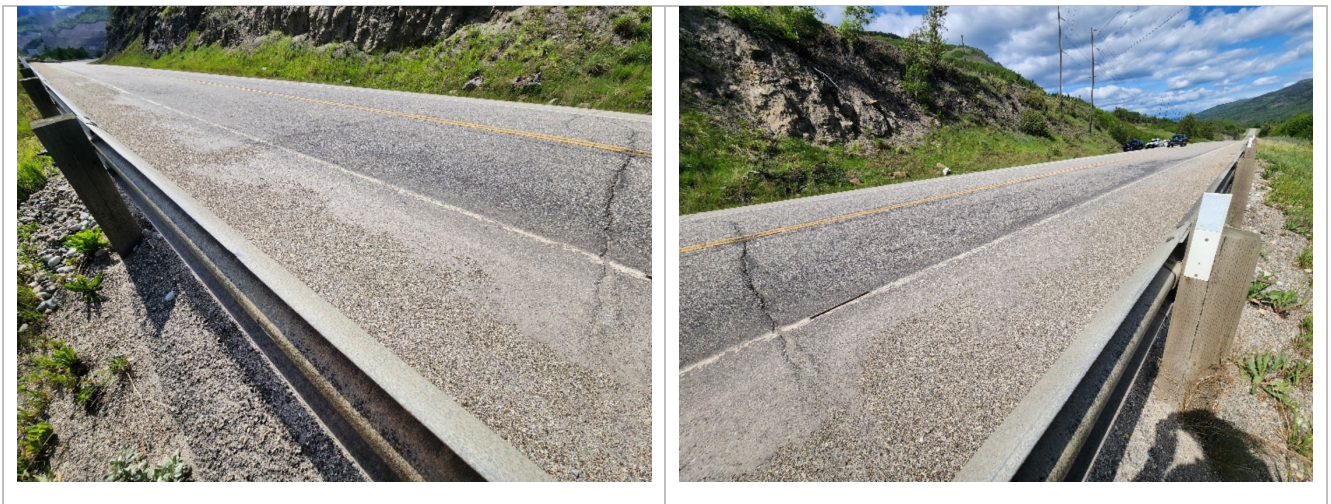
Photo 8 **Pavement surface of Hwy 40:36 at repaired ATCO slide. Photos taken June 2, 2025, facing northwest and northeast, respectively.**

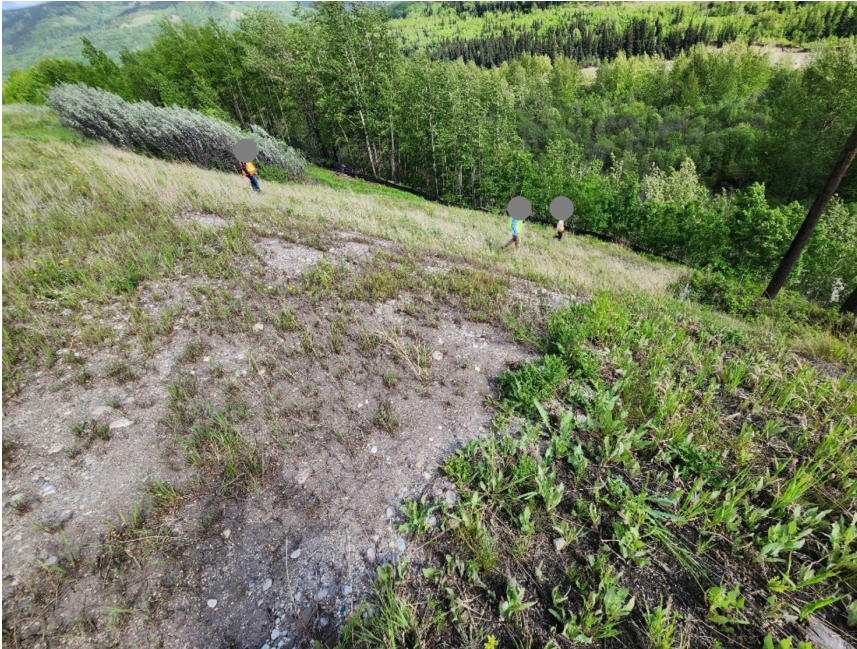
- No visual indications of instability on the repaired slope (Photos 9 and 10). Movements appear to have slowed since repair work was completed in 2024.
- Vegetation (mostly weeds) is beginning to re-establish on the repaired slope (Photos 9 and 10) and access areas.
- Some minor erosion has occurred along the south side of the repaired slope (Photo 11).
- Drain outlets at the toe of the repaired slope were dry (Photo 12).

Photo 9 **Repaired ATCO slide. Photo taken June 2, 2025, facing southeast.**

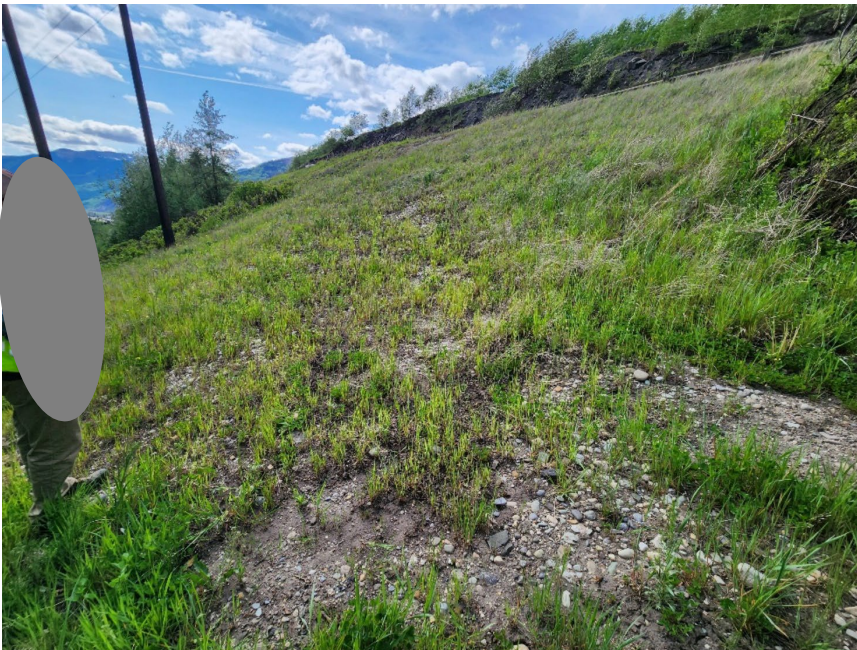
Photo 10 **Repaired ATCO slide. Photo taken June 2, 2025, facing northwest.**

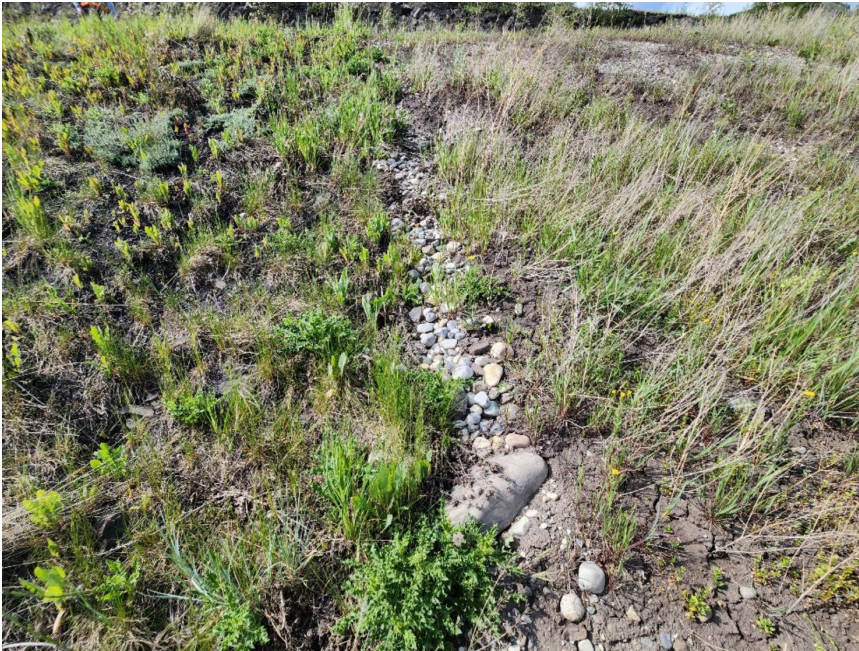
Photo 11 Erosion along west side of ATCO slide repair. Photo taken June 2, 2025, facing northwest.

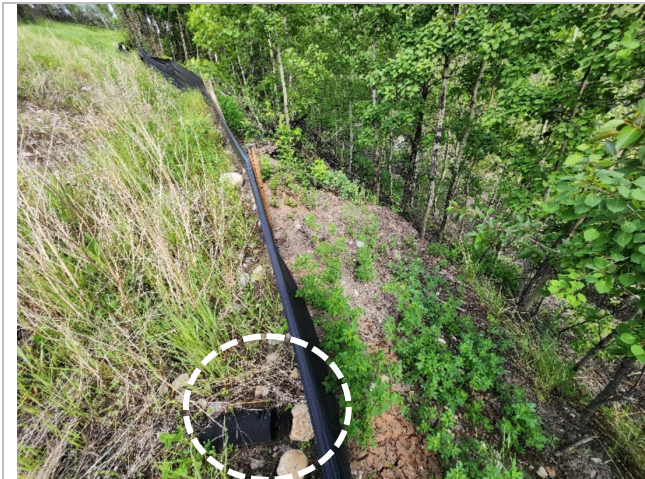
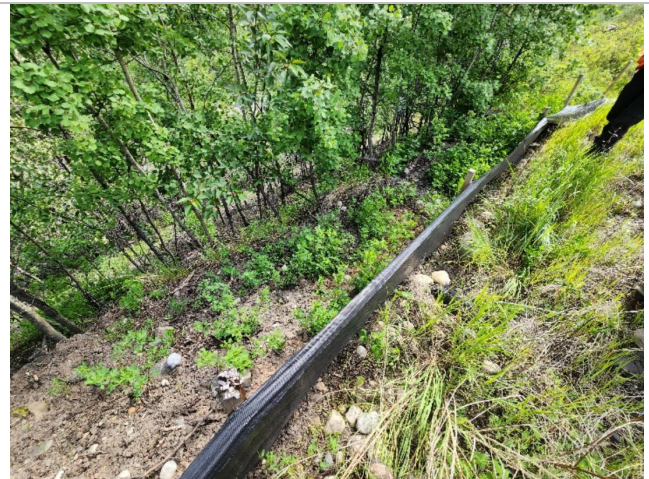
Photo 12 Slope between repaired ATCO slide and rail line. Note outlet of drainpipe (circled in white) installed in 2024 to convey flow from within the slide zone. Photos taken June 2, 2025, facing southeast and southwest, respectively.
