**SITE INSPECTION FORM**

<b>SITE NUMBER AND NAME:</b> GP053-1, -2, & -3 Rock Slope North of McIntyre Mine		<b>HIGHWAY &amp; KM:</b> 40:36, 16.295 to 17.161	<b>PREVIOUS INSPECTION DATE:</b> June 10, 2024	<b>INSPECTION DATE:</b> <b>June 2, 2025</b>
<b>LEGAL DESCRIPTION:</b>  West SE 15-58-08-W6M East NW-14-58-08-W6M	<b>NAD 83 COORDINATES:</b> UTM    Northing    Easting 11      5986971    362772 11      5987248    363835		<b>RISK ASSESSMENT:</b>  PF: 12    CF: 5    TOTAL: 60	
<b>AVERAGE ANNUAL DAILY TRAFFIC (AADT):</b> 840 (east) & 840 (west) (Reference No. 70000788, 2024)			<b>CONTRACT MAINTENANCE AREA (CMA):</b> 504

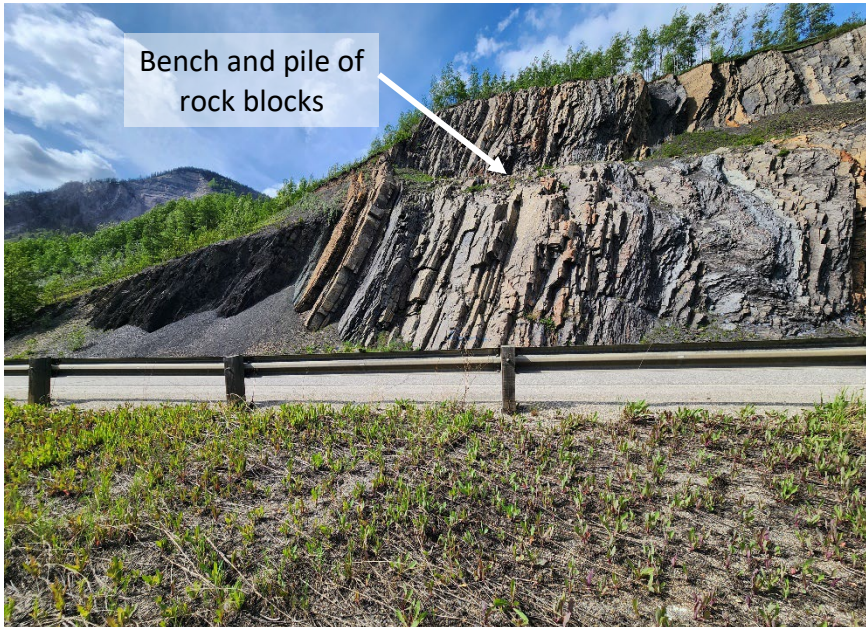
- Bedrock structure consists of bedding planes dipping from the south to southwest (dip estimated between 59° to 86°). The rock mass appears to have relatively tight bedding planes, but the rock mass is fractured perpendicular to the bedding planes which generates rockfall events. The bedrock structure changes in the east part of the slope to a gentle fold with dip of approximately 20° (Photo 5), dipping to the southeast towards the highway.
- Mid-slope bench that has talus cones/slopes, which could potentially bounce/launch/roll rockfall particles out onto the highway (Photos 1 and 2). A pile of rock blocks was also observed along this bench.

**Photo 1** Rock slope along north side of Hwy 40:36 at GP053-I site. Note bench which could launch rockfall particles from upper slope. Photo taken June 2, 2025, facing north.

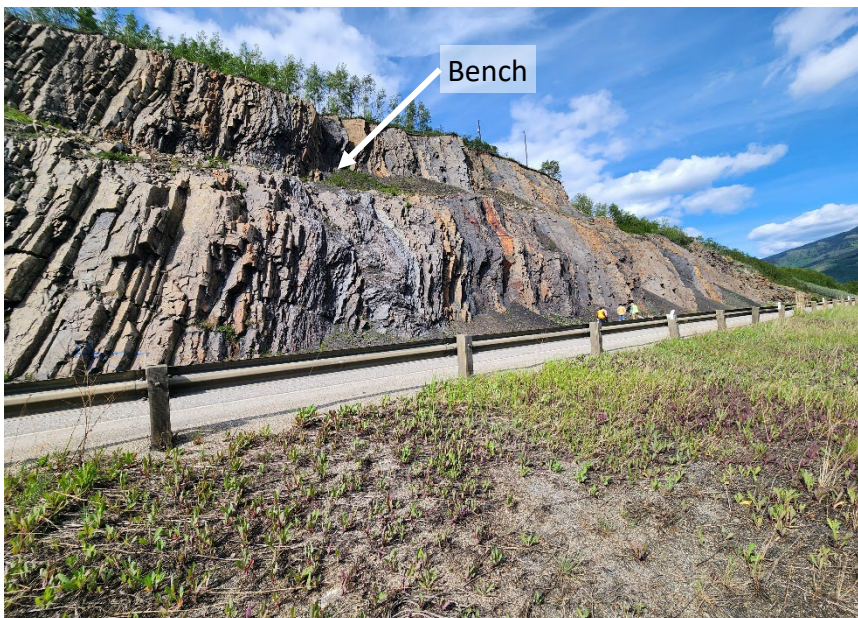
**Photo 2** Rock slope along north side of Hwy 40:36 at GP053-I site. Note bench which could launch rockfall particles from upper slope. Photo taken June 2, 2025, facing northeast.

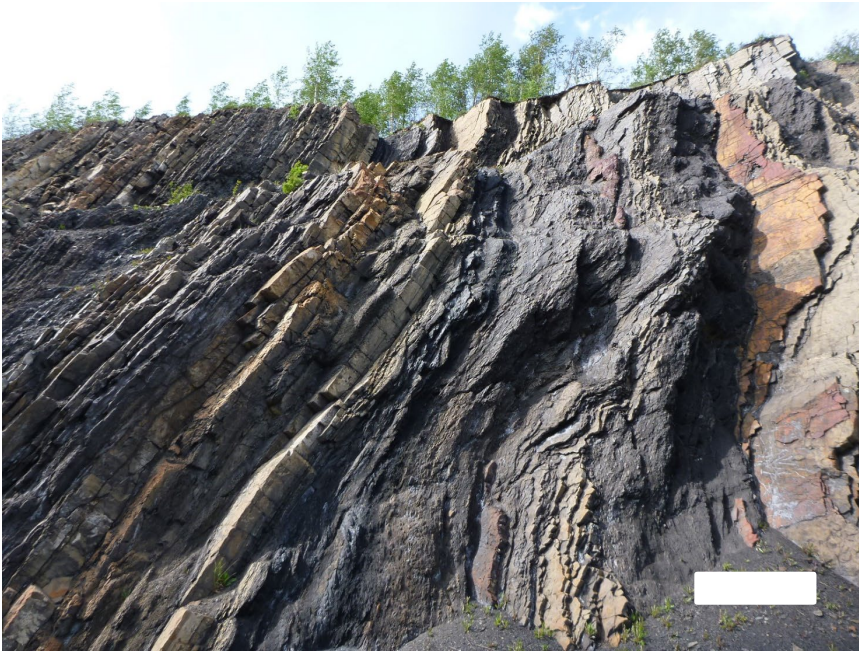
Brow of rock slope has minimal to no soil and some trees (Photos 1 through 3, 8, and 9).

**Photo 3**      **Rock slope along north side of Hwy 40:36 at GP053-I site. Note near-vertical bedding orientation of bedrock. Photo taken June 2, 2025, facing north.**

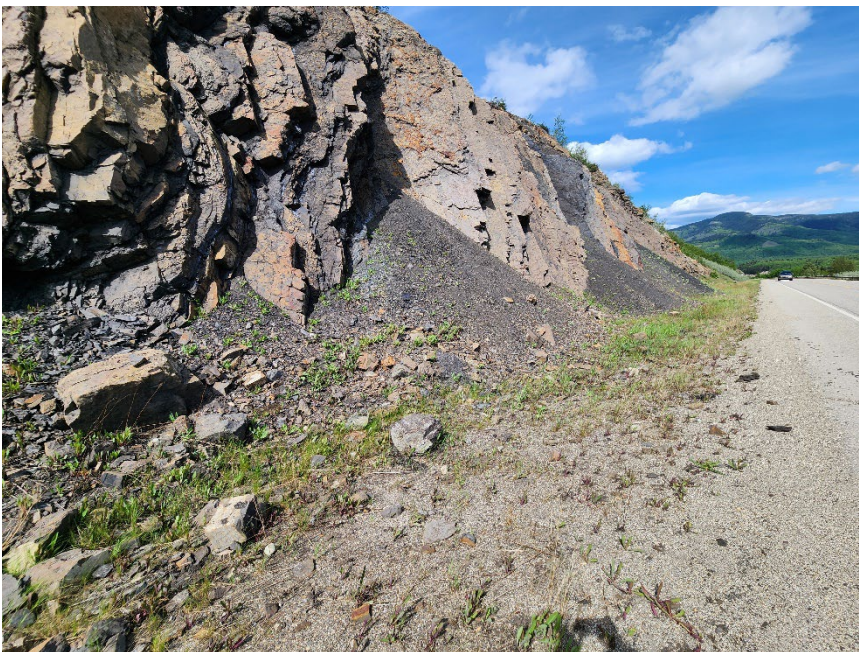
**Photo 4**      **Rock slope along north side of Hwy 40:36 at GP053-I site. Note talus material mainly from coal seams in highway ditch. Photo taken June 2, 2025, facing northeast.**

- Clean highway ditch regularly to maintain rockfall storage volume (i.e., keep the ditch as wide and deep as possible to retain material within the ditch) and reduce the potential for material reaching the highway. TEC reported that there are no utilities below the ditch at this site, but AbaData indicates there may be a pipeline (depth unknown) that crosses the highway from south to north near the GP053-I site. Estimated cost for removing debris at the three subsites: approximately \$100,000 to \$130,000.

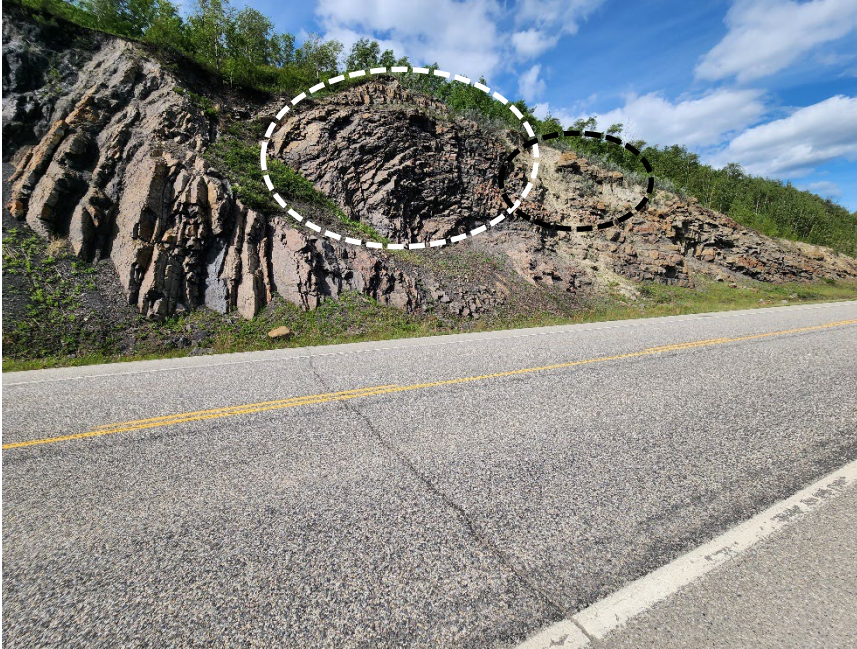
**Photo 5** Rock slope along north side of Hwy 40:36 at GP053-I site. Note change in orientation of bedrock structure at fold (circled in white and erosion and hanging rock blocks at crest of slope (some circled in black). Photo taken June 2, 2025, facing northeast.

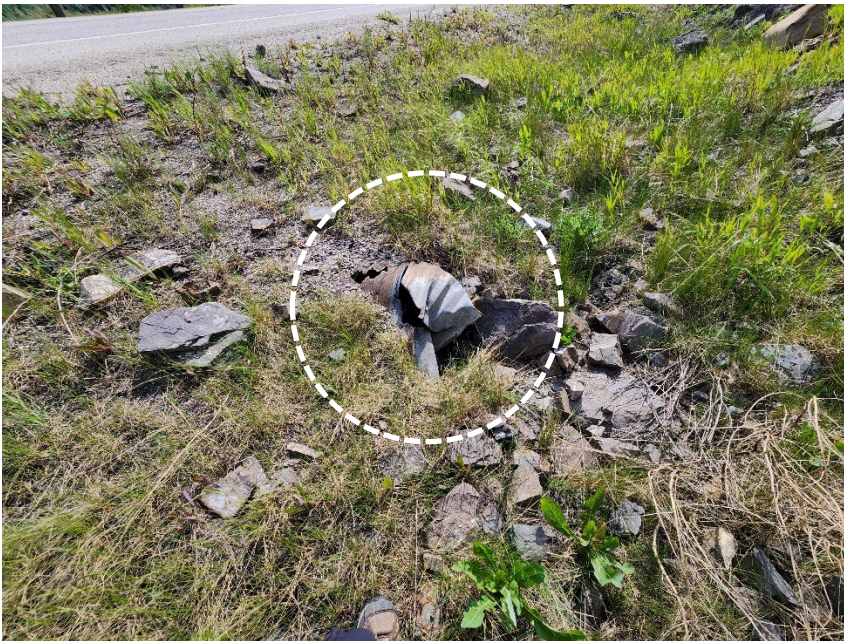
**Photo 6** Culvert inlet (circled in white) in west ditch of Hwy 40:36 damaged and partially blocked with rocks. Photo taken June 2, 2025.

- Repair and/or clean-out culvert inlets which are damaged and partially covered by rockfall particles (Photo 6) to maintain ditch flow.
- Tender package for rockfall hazard mitigations:

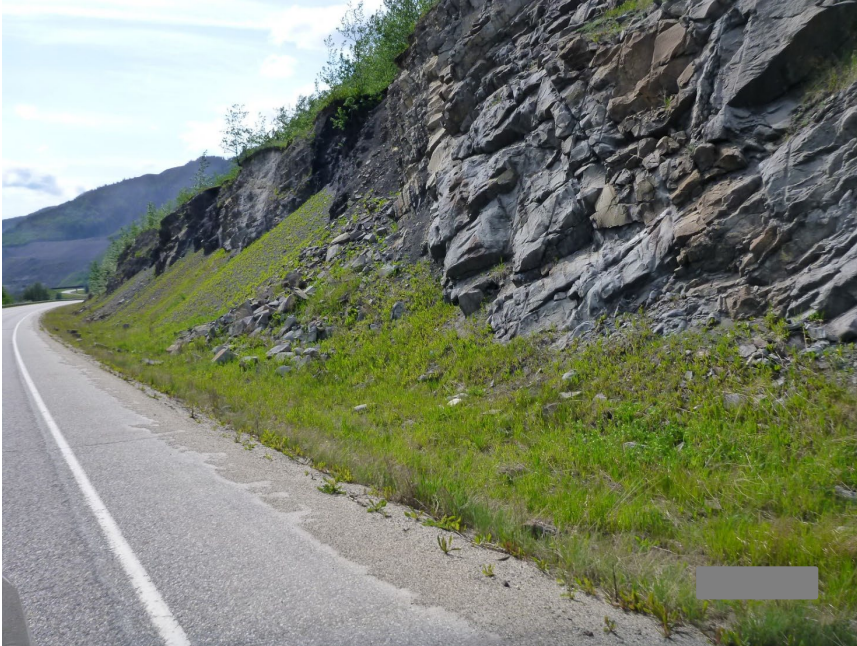
- Bedrock structure consists of bedding planes dipping into the slope towards the north (dip estimated between 39° to 80°). The rock mass appears to be of similar quality to the GP053-I site, with one location showing more intact and massive bedrock that still shows drill-and-blast-hole “barrels”.
- Thick coal seams are present at five locations towards the west side of the site (Photo 7). Debris fans below coal seams have partially or completely filled the ditch, and vegetation has started to grow.

**Photo 7**      **Rock slope along north side of Hwy 40:36 at GP053-II site. Note talus material mainly from coal seams and rockfall particles in highway ditch. Photos taken June 2, 2025, facing west.**

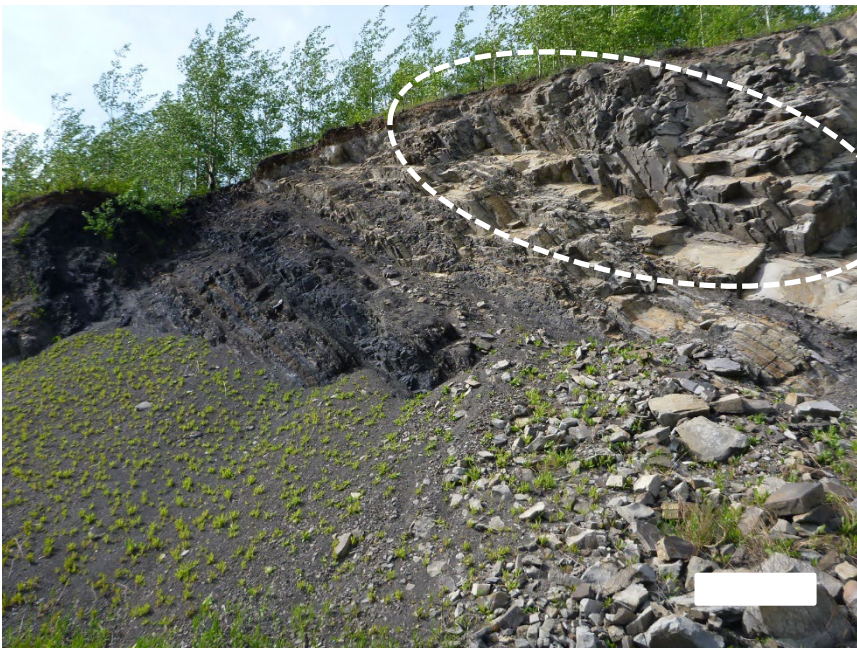
Rock mass consists of bedded and sheared sedimentary rocks, with carbonaceous shale and coal seams which are weathering faster. Faster weathering of the coal results in the undermining of more competent rocks, which results in overhanging blocks and particles with little support that eventually fall (Photo 8), and the deposition of talus cones/slopes at the toe of the coal seams with occasional adjacent lateral rock block piles/cones (Photos 2, 4, and 7). Cubical shaped rockfall particles appear to be rolling and bouncing down the talus cones bringing them closer to the highway (i.e., the talus cones act like chutes for rockfall particles). Whereas flat platy shaped rockfall particles appear to get hung up in the talus.

Several hanging rock blocks are observed at the subsites (Photos 8 and 9), with some close to falling.

**Photo 8**      **Rock slope along north side of Hwy 40:36 at GP053-II site. Note overhanging rock blocks (circled in white). Photo taken June 2, 2025, facing northwest.**

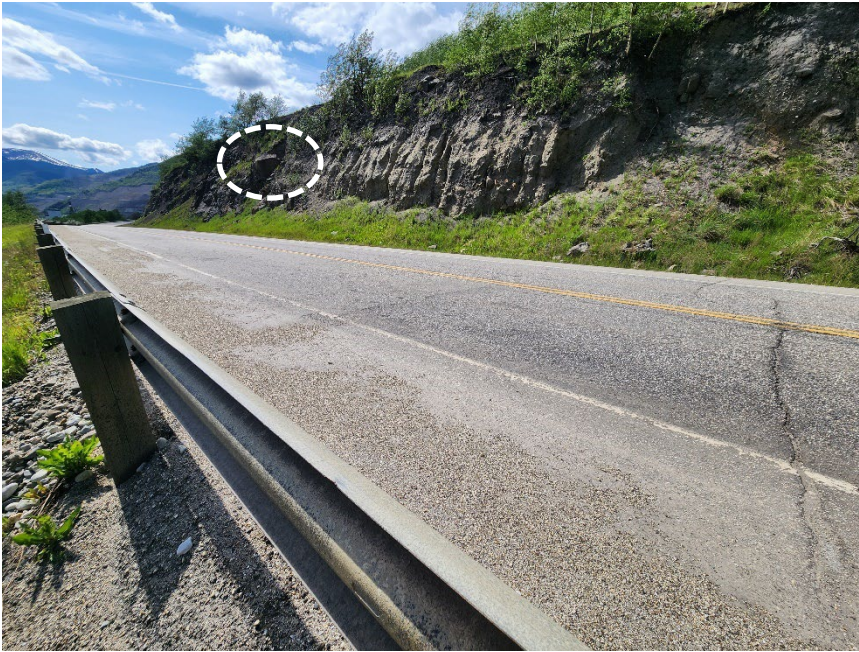
**Photo 9**      **Rock slope along north side of Hwy 40:36 at GP053-II site. Note large overhanging rock block (circled in white). Photo taken June 2, 2025, facing northwest.**

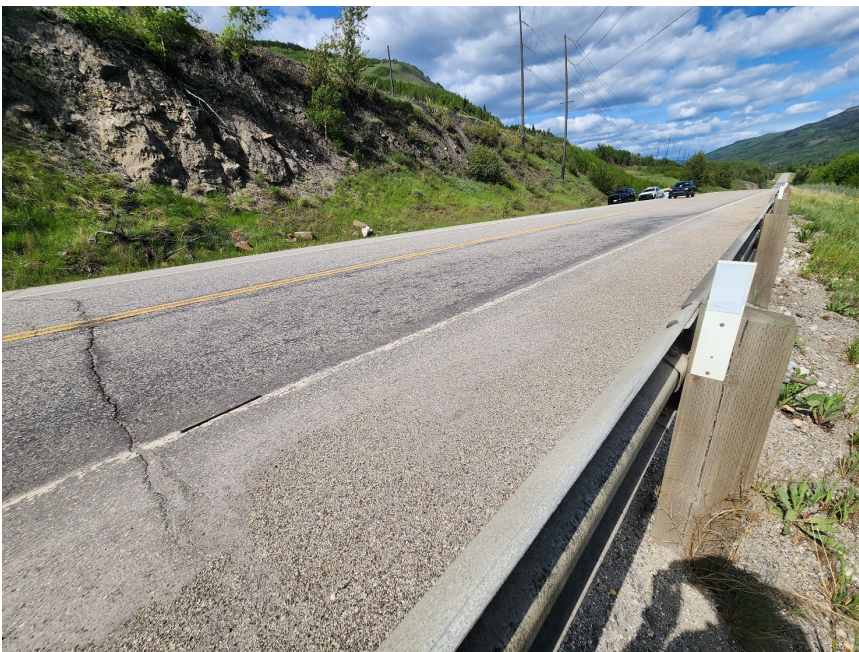
**Photo 10**      **Rock slope along north side of Hwy 40:36 at GP053-II site. Photo taken June 2, 2025, facing northeast.**
