SITE NUMBER AND NAME: GP056 Debris Flow near McIntyre Mine	HIGHWAY & KM: 40:36, 13.700	PREVIOUS INSPECTION DATE: June 10, 2024	INSPECTION DATE: June 02, 2025
LEGAL DESCRIPTION: NE 09-58-08-W6M	NAD 83 COORDINATES: UTM Northing Easting 11 5985608 361022	RISK ASSESSMENT: PF: 8 CF: 5 TOTAL: 40	
AVERAGE ANNUAL DAILY TRAFFIC (AADT): 760 (north) & 960 (south) (Reference No. 25592, 2024)		CONTRACT MAINTENANCE AREA (CMA): 504

SITE INSPECTION FORM

PEACE REGION (GRANDE PRAIRIE DISTRICT-SOUTH)
GEOHAZARD RISK MANAGEMENT PROGRAM

Site Plan
GP056 - Debris Flow Near McIntyre Mine
Hwy 40:36, km 13.7

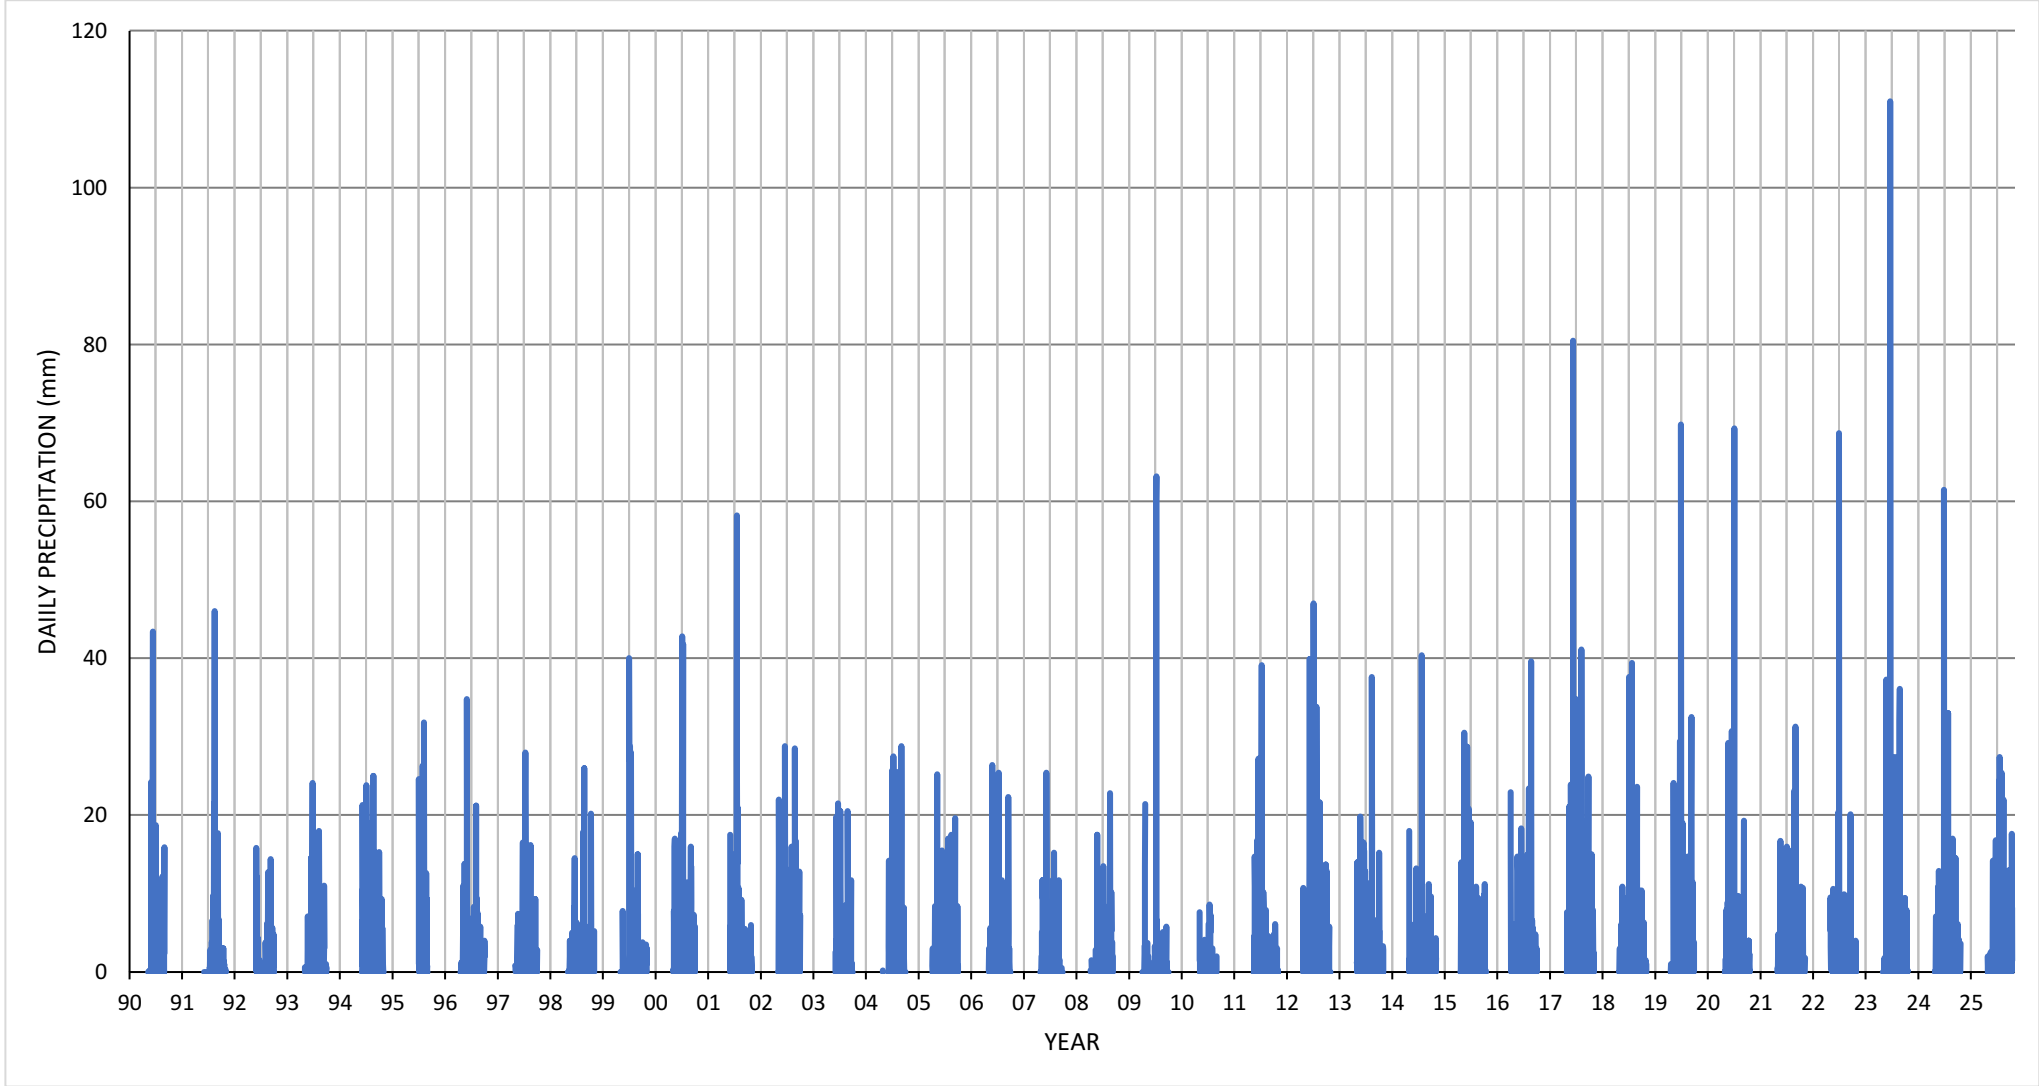
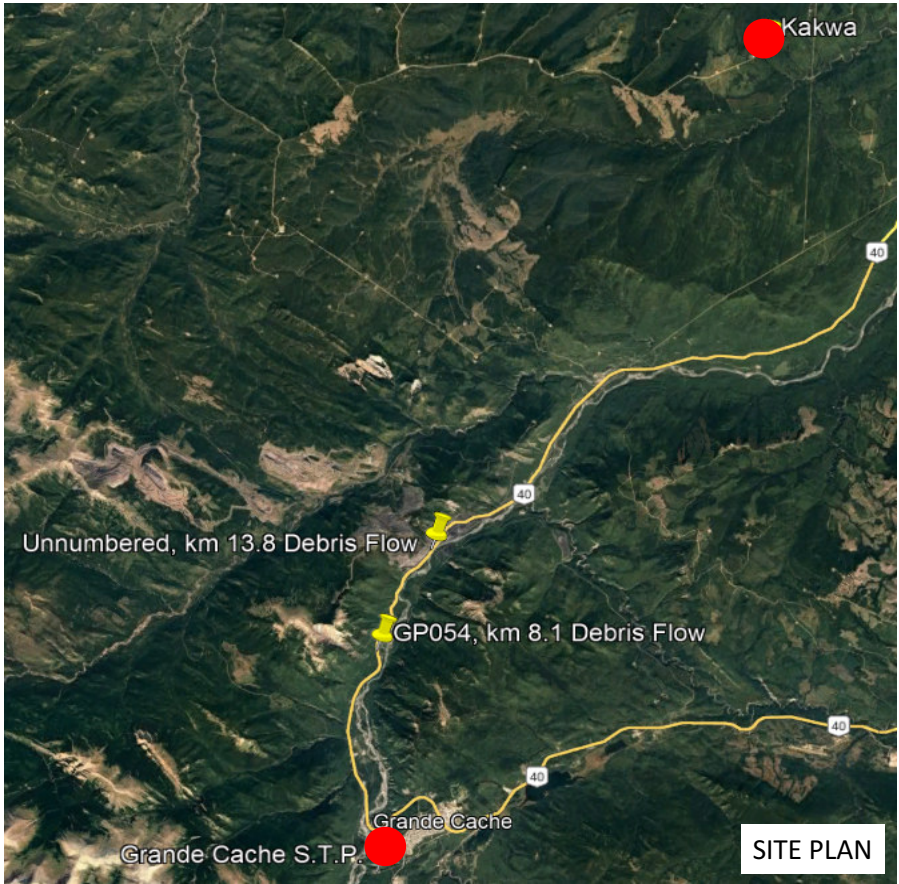
KCB reviewed available precipitation data recorded at Kakwa weather station (located approximately 30 km northeast of site) from 1967 to 2025. Record discontinuous before 1990, but average daily precipitation data from 1990 to 2025 is shown on Figure 2. Based on data from Kakwa weather station higher-than-average rainfall events were recorded on June 9, 2017 (approximately 80 mm), June 28, 2019 (approximately 70 mm), July 1, 2020 (approximately 70 mm), June 29, 2022 (approximately 70 mm), June 19, 2023 (approximately 110 mm), and June 27, 2024 (approximately 60 mm). Based on available data intensity and frequency of heavy precipitation events appears to be increasing in recent years.

PEACE REGION (GRANDE PRAIRIE DISTRICT - SOUTH)	
		GEOHAZARD RISK MANAGEMENT PROGRAM	
		TITLE	
		DAILY PRECIPITATION DATA	
		GP056 DEBRIS FLOW SITE	
		HWY 40:36	
SCALE	-	PROJECT No.	FIG No
		A05116A01	2

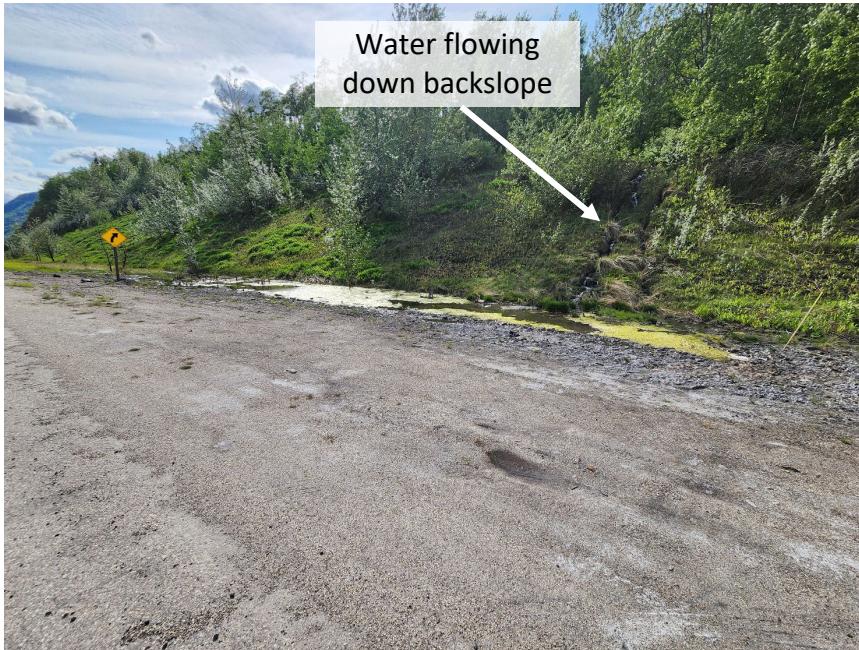
Seepage from the toe of the mine-waste dump flows through the treed area down the backslope into the west highway ditch. Some of the water ponds in the ditch and the remainder flows to the culvert at the north end of the site across the highway (Photos 1 through 4). The seepage may be from a possible drain below the mine-waste dump.

Photo 1 Water flowing down backslope and in ditch on west side of Hwy 40:36. Note some ponding in highway ditch. Photo taken June 2, 2025, facing southwest.

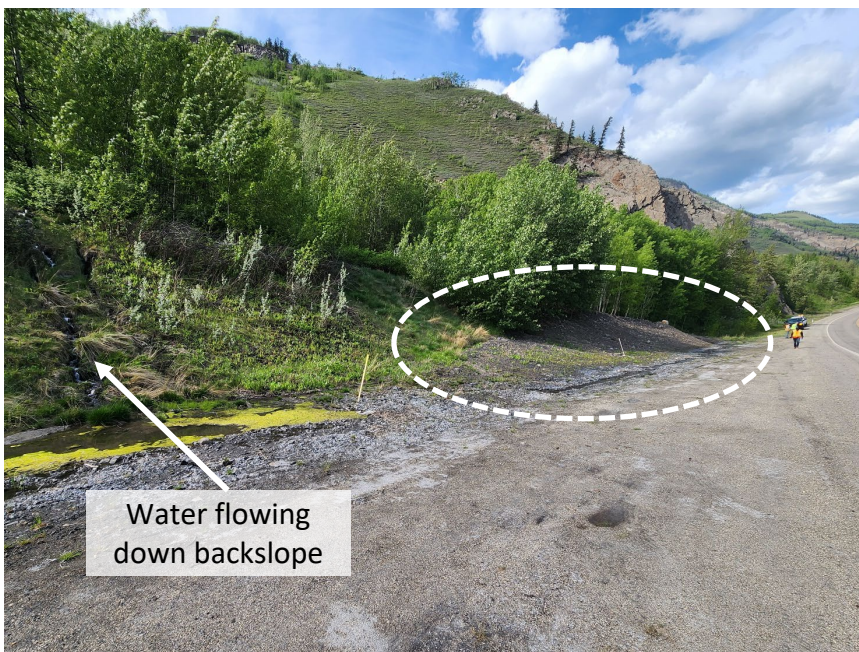
- Debris flow material in the west highway ditch has been removed and graded back to the tree line (backslope up to approximately 4 m high, Photos 2 and 3) improving storage capacity in the highway ditch and removing load/weight from the high-pressure natural-gas line. It appears the majority of the flow material overtop of the high-pressure natural-gas line has been removed. It does not appear any debris flow material has been removed upslope of the ditch within the treed area (approximate distance of 60 m).

Photo 2 Debris flow material on west side of Hwy 40:36 (circled in white). Photo taken June 2, 2025, facing north.

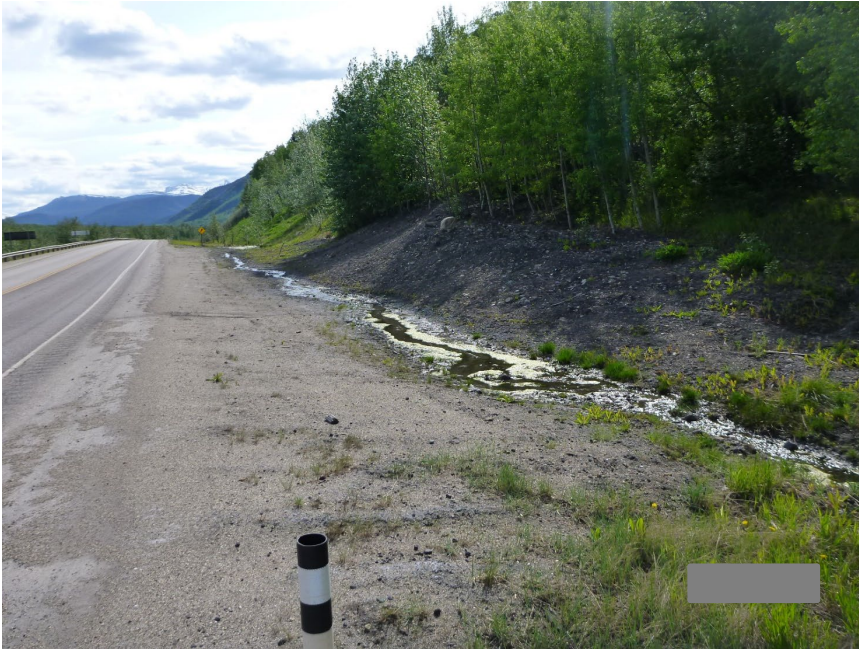
Photo 3 Debris flow material on west side of Hwy 40:36. Note flowing water in highway ditch. Photo taken June 2, 2025, facing southwest.

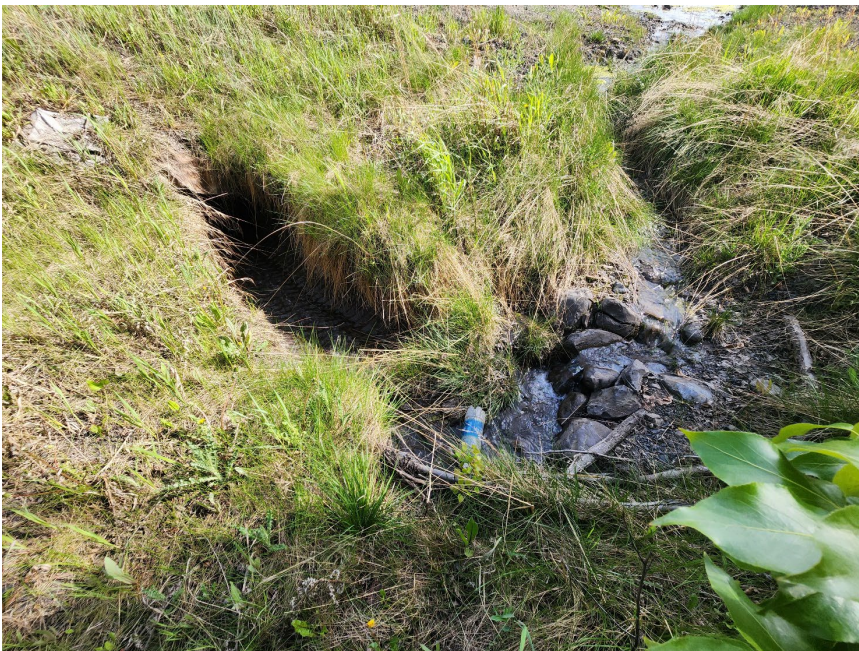
Photo 4 Inlet of culvert that conveys flow from west side to east side of Hwy 40:36. Photo taken June 2, 2025, facing south.

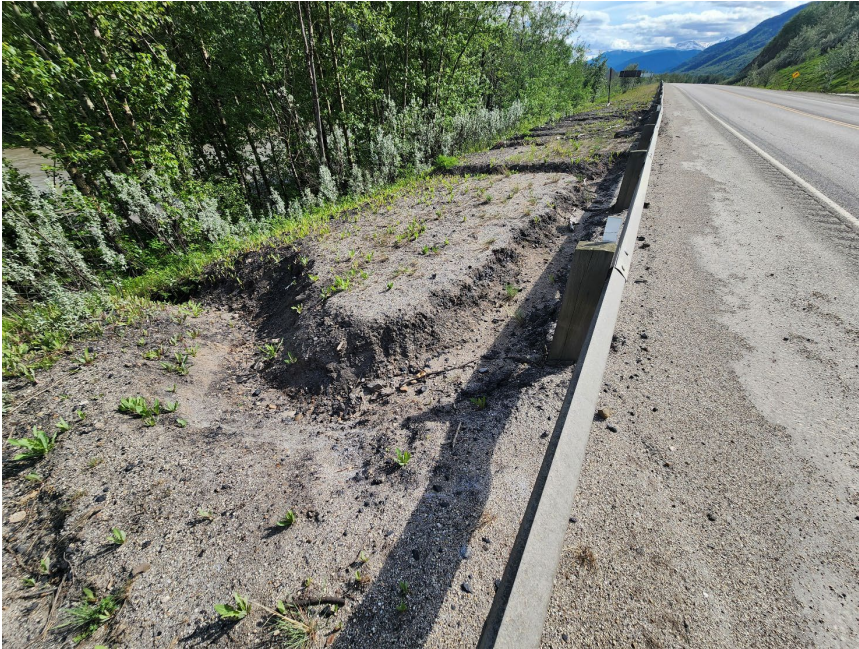
Photo 5 **Erosion gullies along east side of Hwy 40:36. Photo taken June 2, 2025, facing southwest.**

- Short-term:
 - Debris flows crossing the highway have eroded channels on the east side of the highway, partially exposing the highway subgrade, partially undermining the pavement, and leaving some w-beam guardrail posts unsupported along the east highway shoulder (Photos 5 and 6). The erosion gullies on the east side of the highway should be backfilled to provide support to the highway pavement, subgrade, and guardrail posts where exposed. The estimated cost for the HMC to complete this work is between \$20,000 and \$40,000.

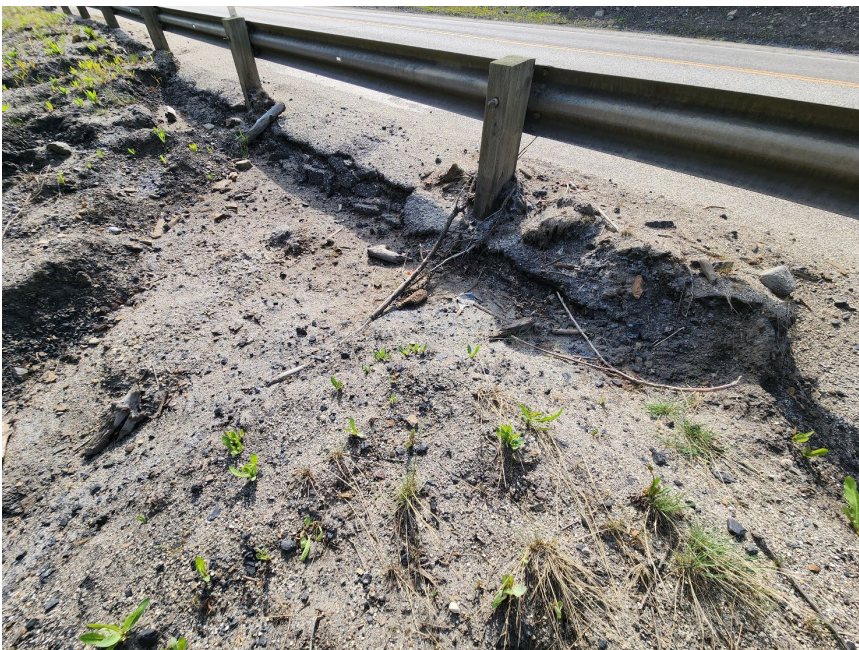
Photo 6 **Subgrade exposed and edge of pavement partially undermined on east side of Hwy 40:36. Some guardrail posts also unsupported. Photo taken June 2, 2025, facing southwest.**
