SITE INSPECTION FORM

SITE NUMBER AND NAME: GP057 Rockfall Slope near McIntyre Mine		HIGHWAY & KM: 40:36, 13.8	PREVIOUS INSPECTION DATE: June 14, 2023	INSPECTION DATE: June 2, 2025
LEGAL DESCRIPTION: NE 09-58-08-W6M	NAD 83 COORDINATES: UTM Northing Easting 11 5985700 361059		RISK ASSESSMENT: PF: 6 CF: 4 TOTAL: 24	
AVERAGE ANNUAL DAILY TRAFFIC (AADT): 760 (north) & 960 (south) (Reference No. 25592, 2024)			CONTRACT MAINTENANCE AREA (CMA): 504

PROJECT
PEACE REGION (GRANDE PRAIRIE DISTRICT-SOUTH)
GEOHAZARD RISK MANAGEMENT PROGRAM

TITLE
Site Plan
GP057 - Rock Slope Near McIntyre Mine
Hwy 40:36, km 13.8

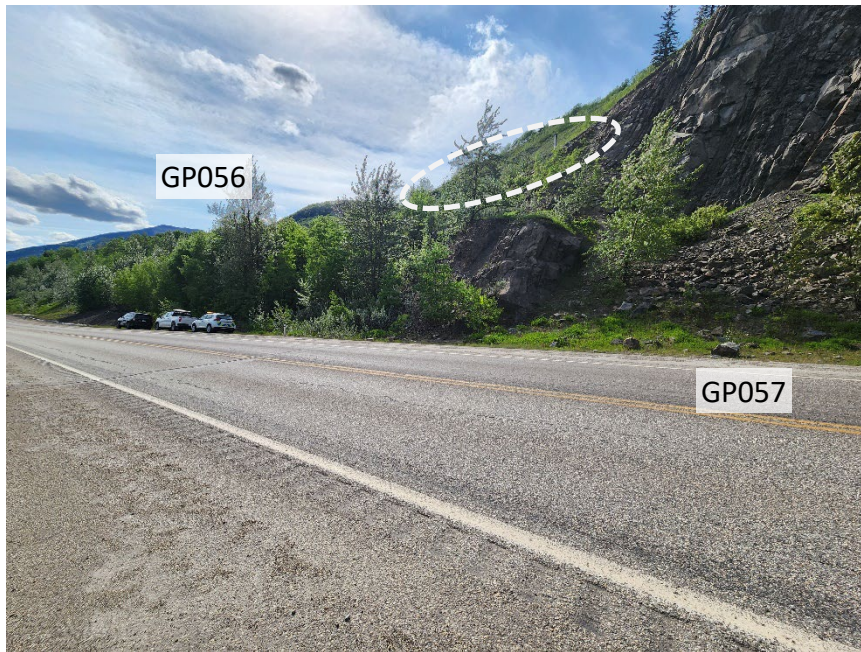
Bedrock structure is non-planar with evidence of folding on the eastern section of the slope. Towards the west side of the site, the rock cut is fractured from a closely jointed structure (Photo 1), and on the east, the rock becomes more massive (Photo 2). Also, the sedimentary bedrock consists of oblique and near-vertical layered bedding of varying thicknesses (ranging from centimetres to meters). The slope dips to the Southeast while the bedding layers dip Southeast to Southwest.

- Photo 1** **West side of Hwy 40:36, including GP054 debris flow site and south end of GP057. Note rockfall barrier installed by mine south of site (circled in white). Photo taken June 2, 2025, facing north.**

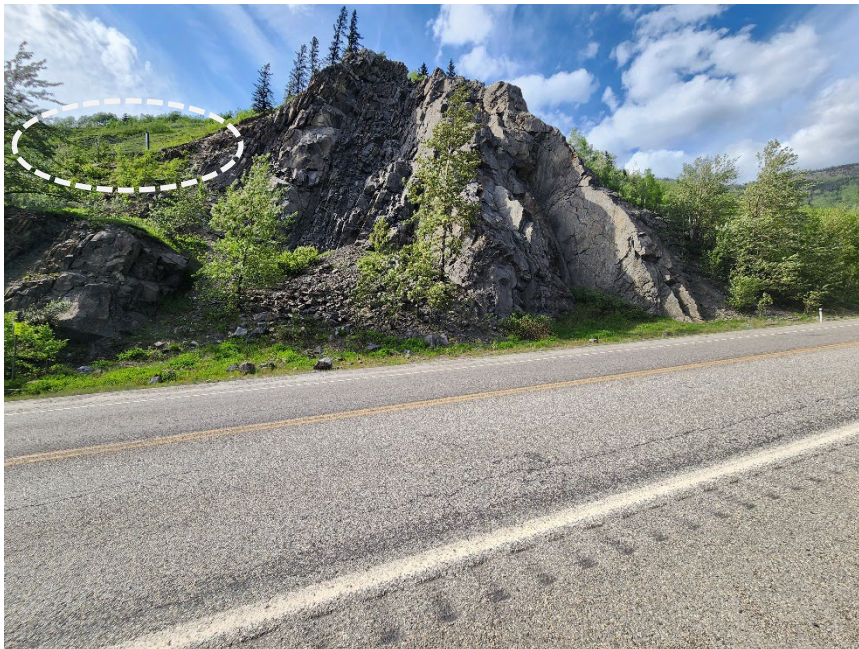
On the west side of the highway, previously fallen rockfall particles have accumulated into debris fans and discrete rockfall blocks have rolled close to the highway (Photo 2). One rock block observed during the 2025 inspection was approximately 0.5 m in diameter (Photo 3). Some rockfall particles, including one particle over 3 m in diameter, observed on east side of highway, but they may have been cleaned off the highway or pre-date the highway or mine.

- Kinematic analysis indicated that wedge failures are the most likely mode of failure for large blocks. The estimated factors of safety for large wedge failure were above 1.5; however, large block failures can still occur due to deterioration of the resisting forces at the joint surface forming the blocks.
- Rockfall trajectory analysis showed that the existing conditions, including the talus fan (see Photo 2), permit rocks to roll onto the highway, with approximately 22% of rocks reaching it.

- Photo 2** **Rock slope along west side of Hwy 40:36. Note talus material and rockfall particles in highway ditch, and rockfall barrier installed by mine south of site (circled in white). Photo taken June 2, 2025, facing north.**

- Clean the west highway ditch regularly to maintain rockfall storage volume (i.e., keep ditch as wide and deep as possible to retain material within the ditch) and reduce the potential for material reaching the highway. A buried gas line and fiber optics cable along the ditch limits the depth the ditch can be excavated or cleaned out. Estimated cost: approximately \$10,000 to \$20,000.

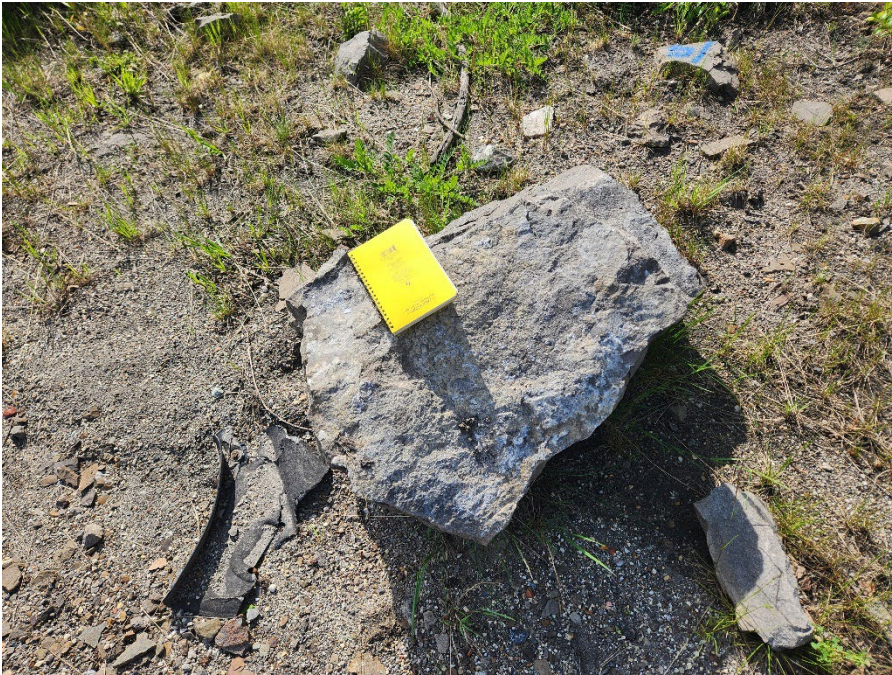
Photo 3 **Rock block approximately 0.5 m in diameter observed in west ditch of Hwy 40:36.
Photo taken June 2, 2025.**

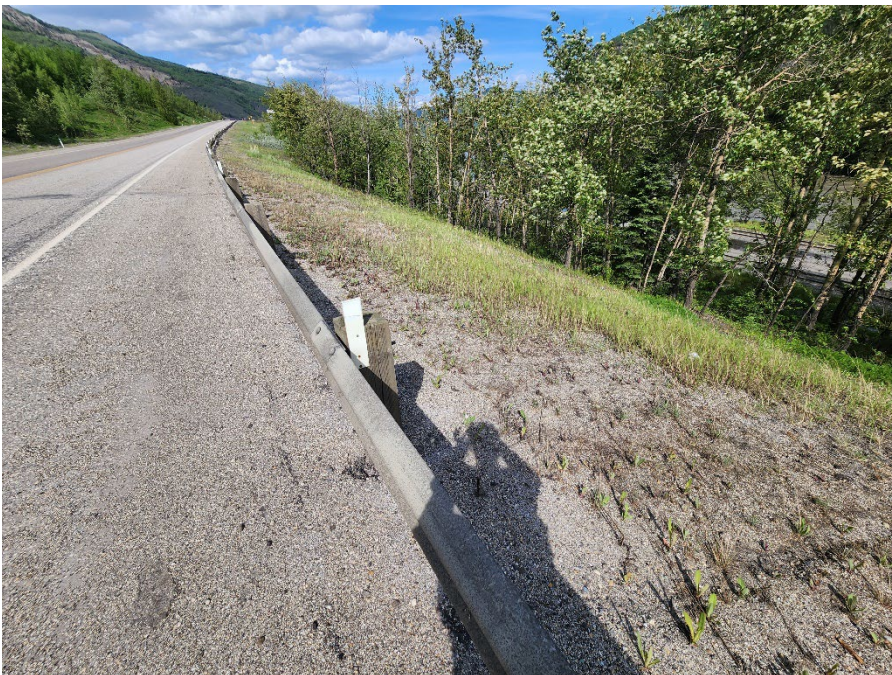
Photo 4 **East side of Hwy 40:36 across from GP057 site. Photo taken June 02, 2025, facing
northeast.**
